PROGRESS REPORT
RESEARCH ON NEW PAINTS

A STUDY OF VARIOUS PAINT SYSTEMS APPLIED TO LEFFINGWELL AND SAN SIMEON CREEK BRIDGES IN A CORROSIVE MARINE ATMOSPHERE

APRIL, 1964

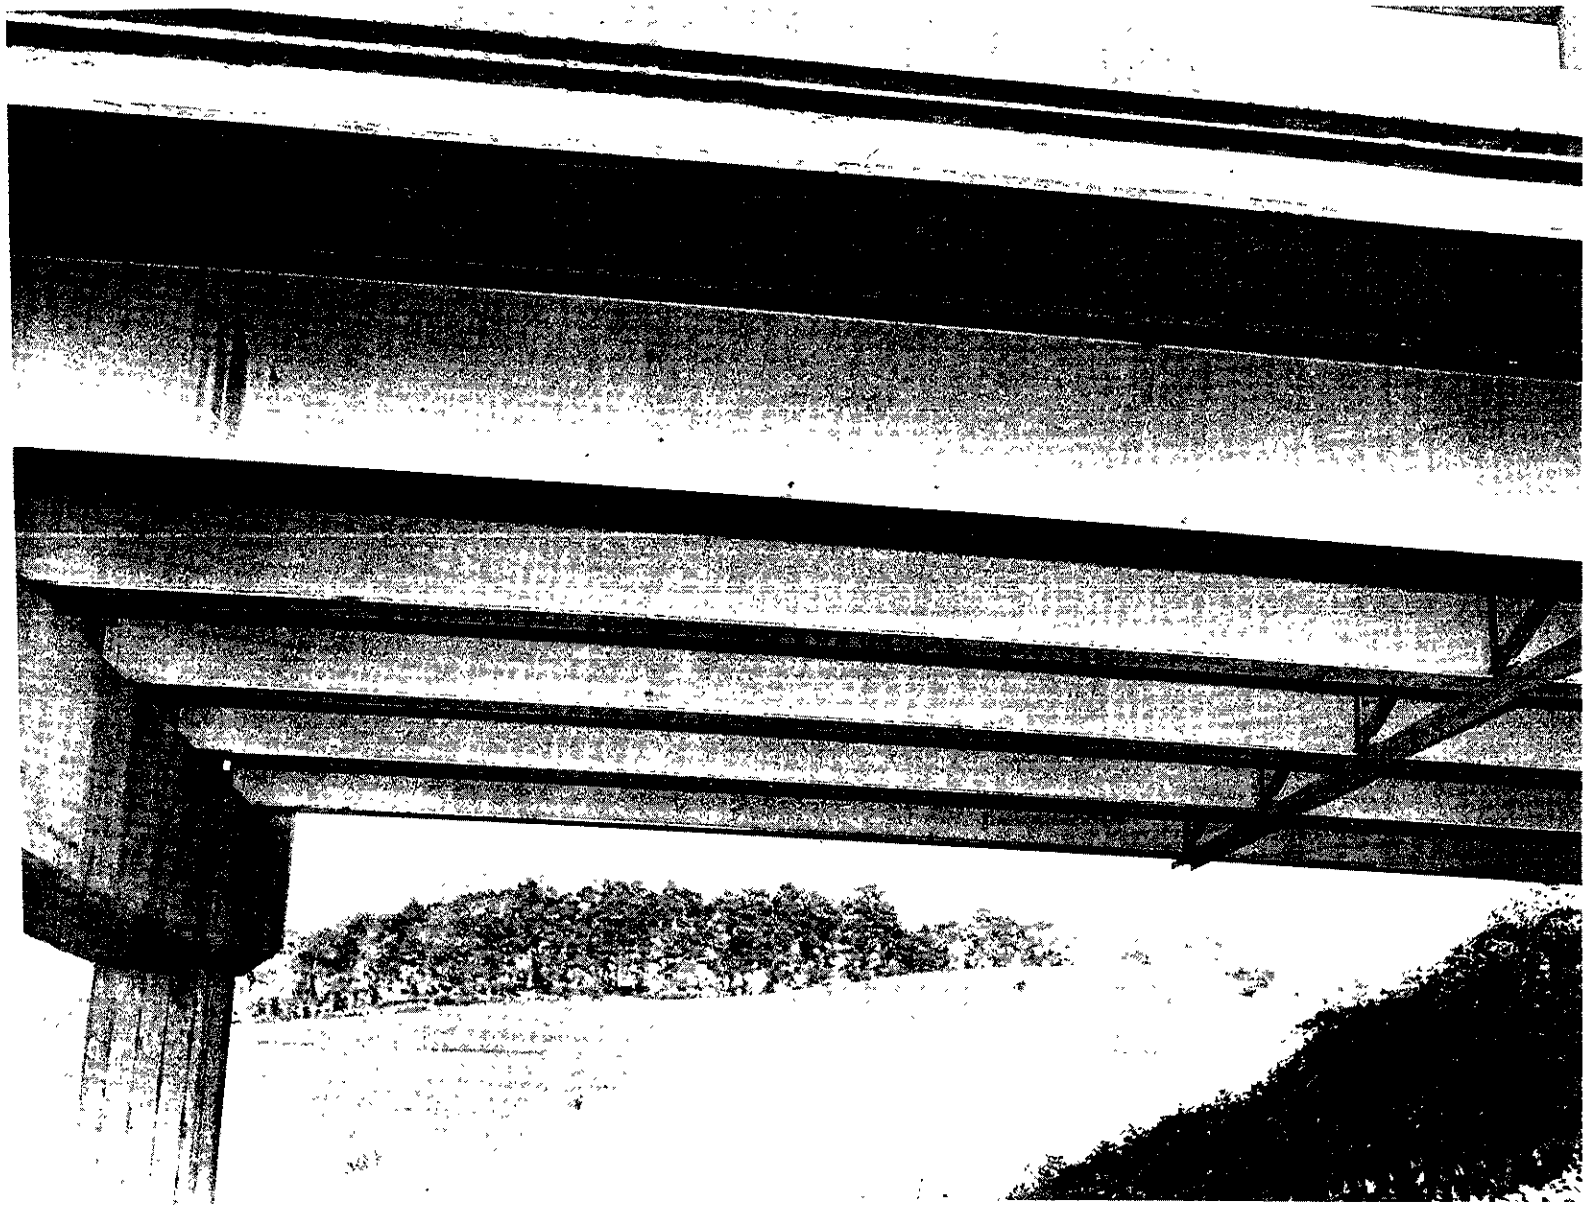
Ends of several bracing members showing tubercules. Some rust around bearings. A few spots on bottom of bottom flange and on bottom flange edges. Top flange edge rust growing slowly.
Rating: 8

Very good shape for 6 years exposure. Light rust scattered throughout mainly on flange edges, bracing member edges and ends and around bearings.
Rating: 8

Photograph No. 2. Leffingwell Creek Bridge. Span 1, North Section System No. 4 (except front beam which is System No. 5). Painted October 1958 - Photographed March 2, 1964.

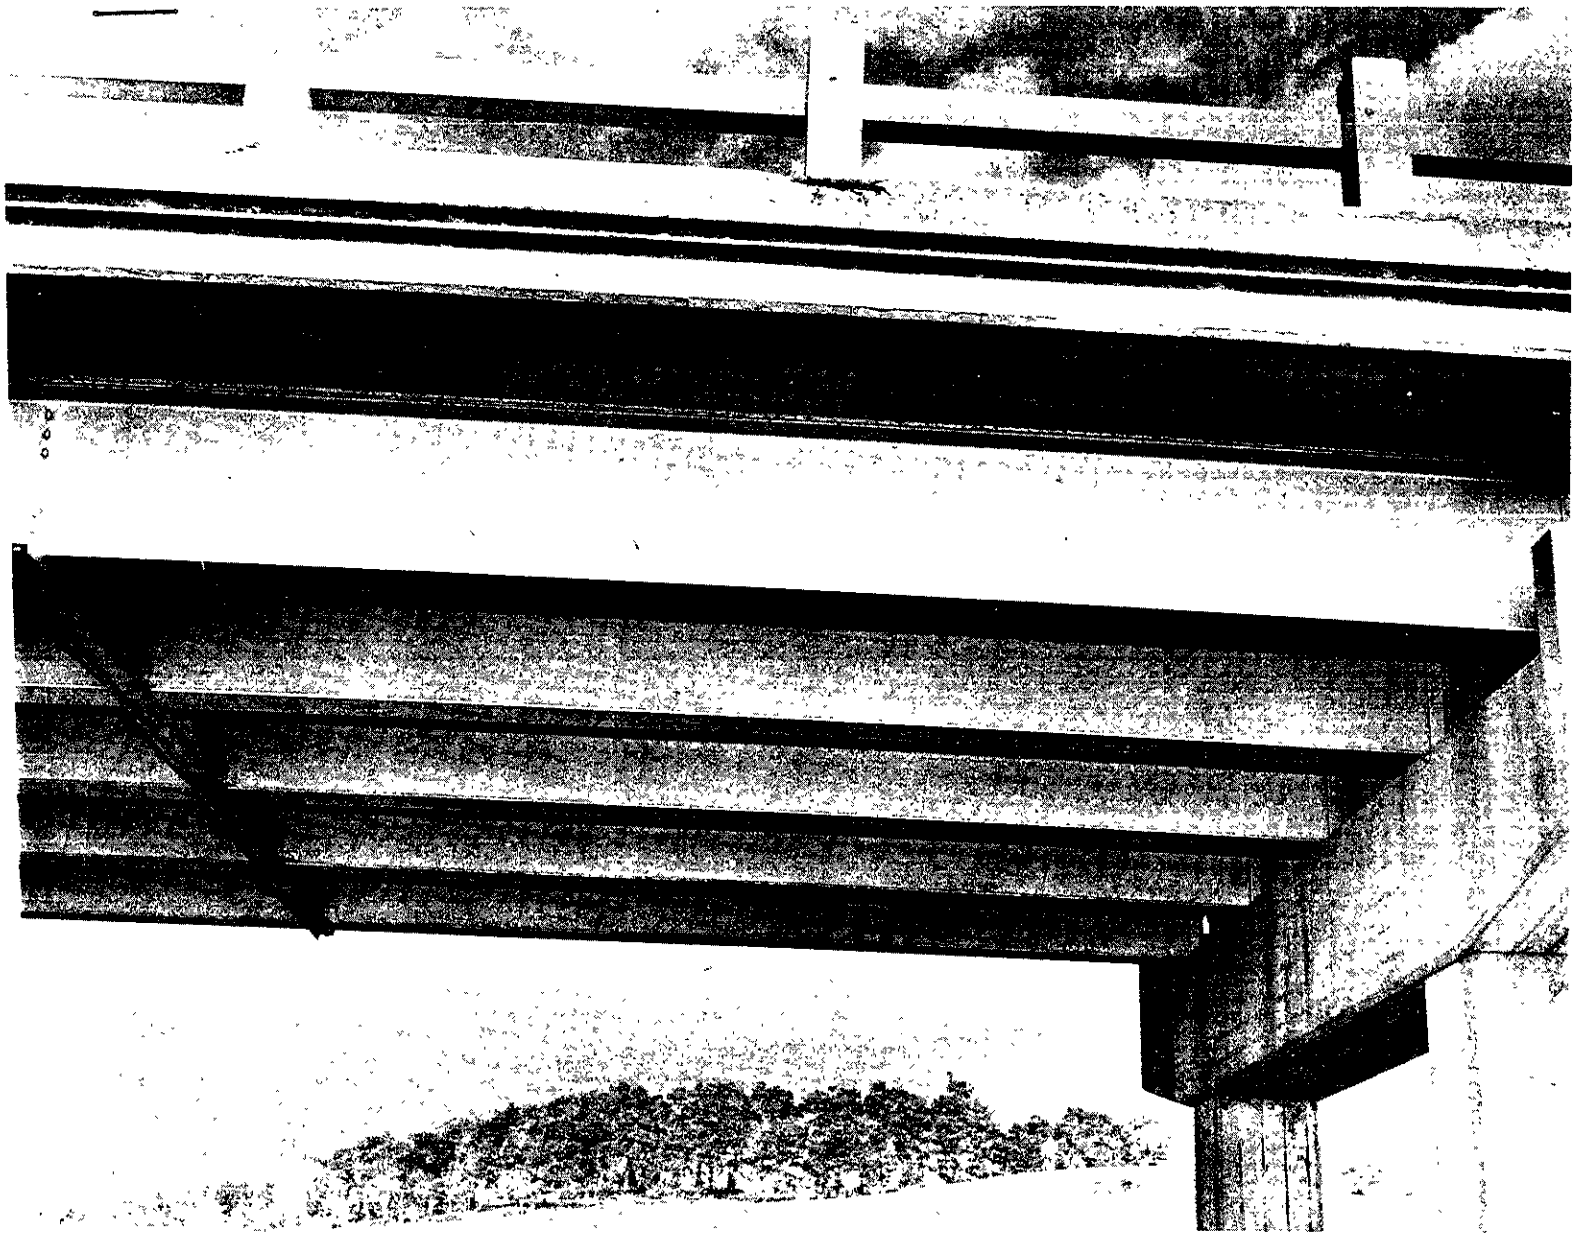
Good shape. Rust or rust stain along top edge of top flange does not appear to be growing much. Bracing good. Light rust on steel slivers has not penetrated steel proper.
Rating: 9+

Photograph No. 4. Leffingwell Creek Bridge. Span 2, South Section
System No. 1. Painted October 1958 - Photographed March 2, 1964.

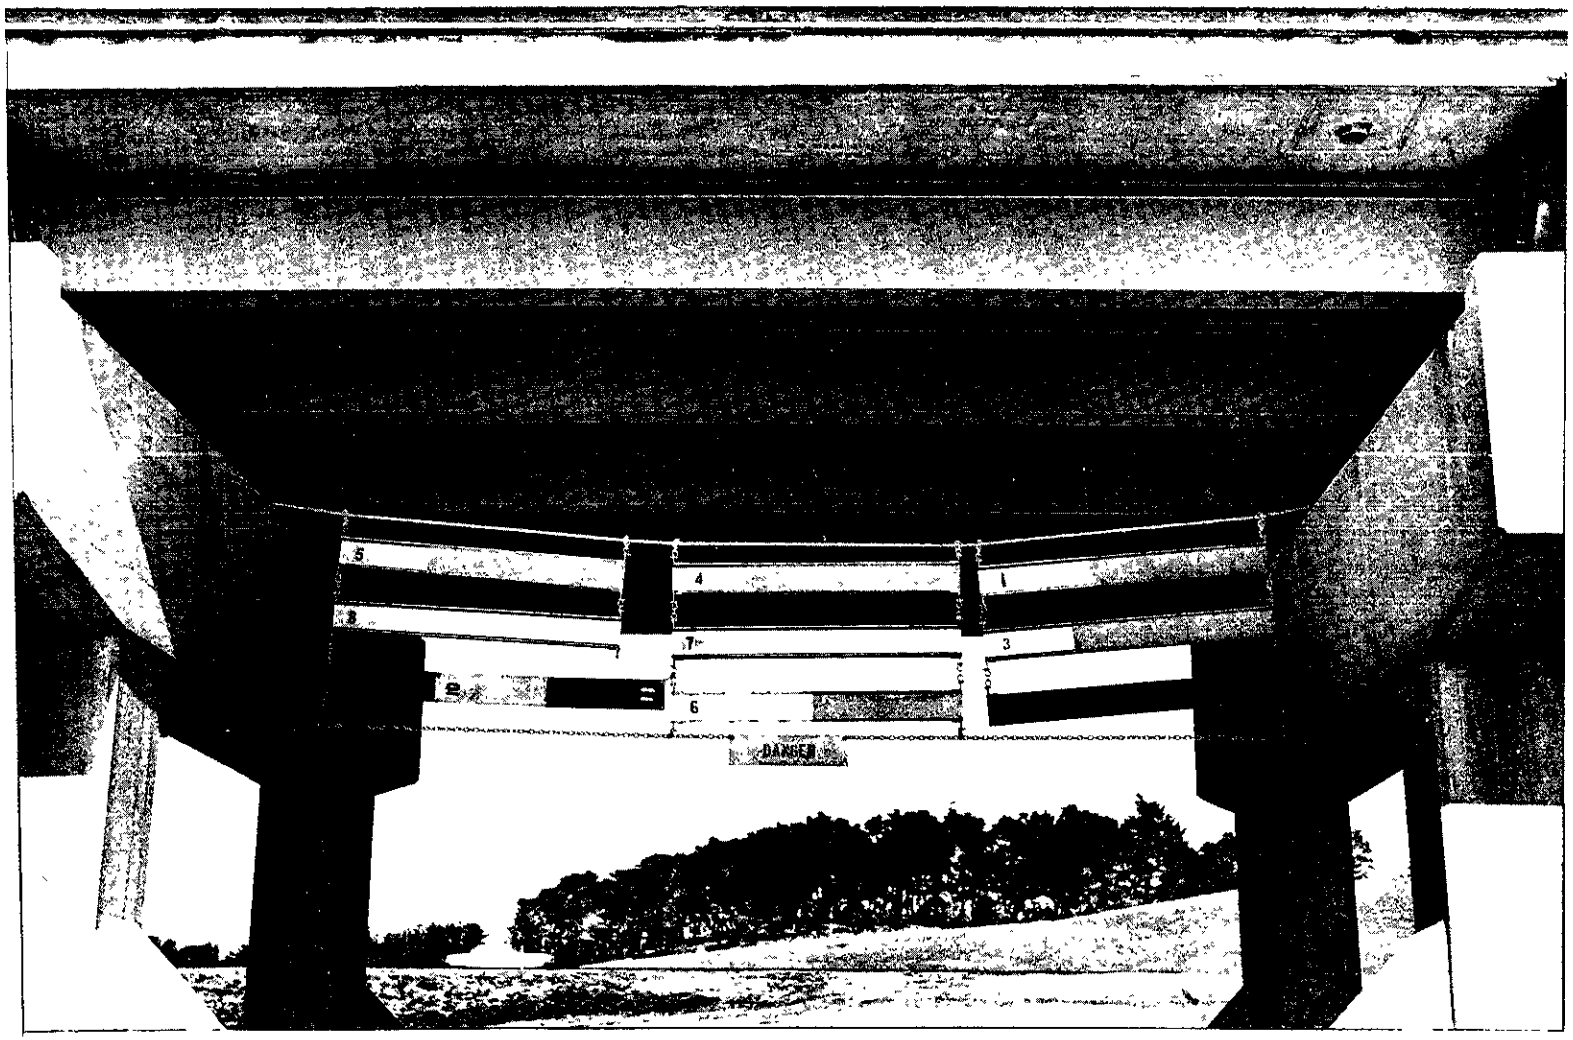
Prior to applying the vinyl green topcoat, State Specification 61-G-75, on Span 3 over the Laboratory formulated inorganic zinc silicate primer 1R310, the excess curing agent used over the inorganic zinc silicate primer was removed by scrubbing with water and wire brushes and a bonding coat of vinyl wash primer applied. In the scrubbing operation, some of the inorganic zinc silicate primer was removed from the steel because of its not having had sufficient time to cure properly in the foggy weather. It is necessary to remove the curing solution to secure adhesion of the vinyl wash primer, State Specification 52-G-52, to the inorganic zinc silicate primer. Despite the inadvertent removal of some of the zinc primer, Span 3 appears to be in excellent condition after almost two years of exposure.

Photograph No. 6. Leffingwell Creek Bridge. Span 3. Originally painted in October 1958 with System No. 3. Repainted in June 1962 with Laboratory Formulated Inorganic Zinc Silicate, Formula 1R310, and Vinyl Green Topcoat, State Specification 61-G-75. Original System No. 3, an epoxy system failed within a few months after application. Photographed March 2, 1964.

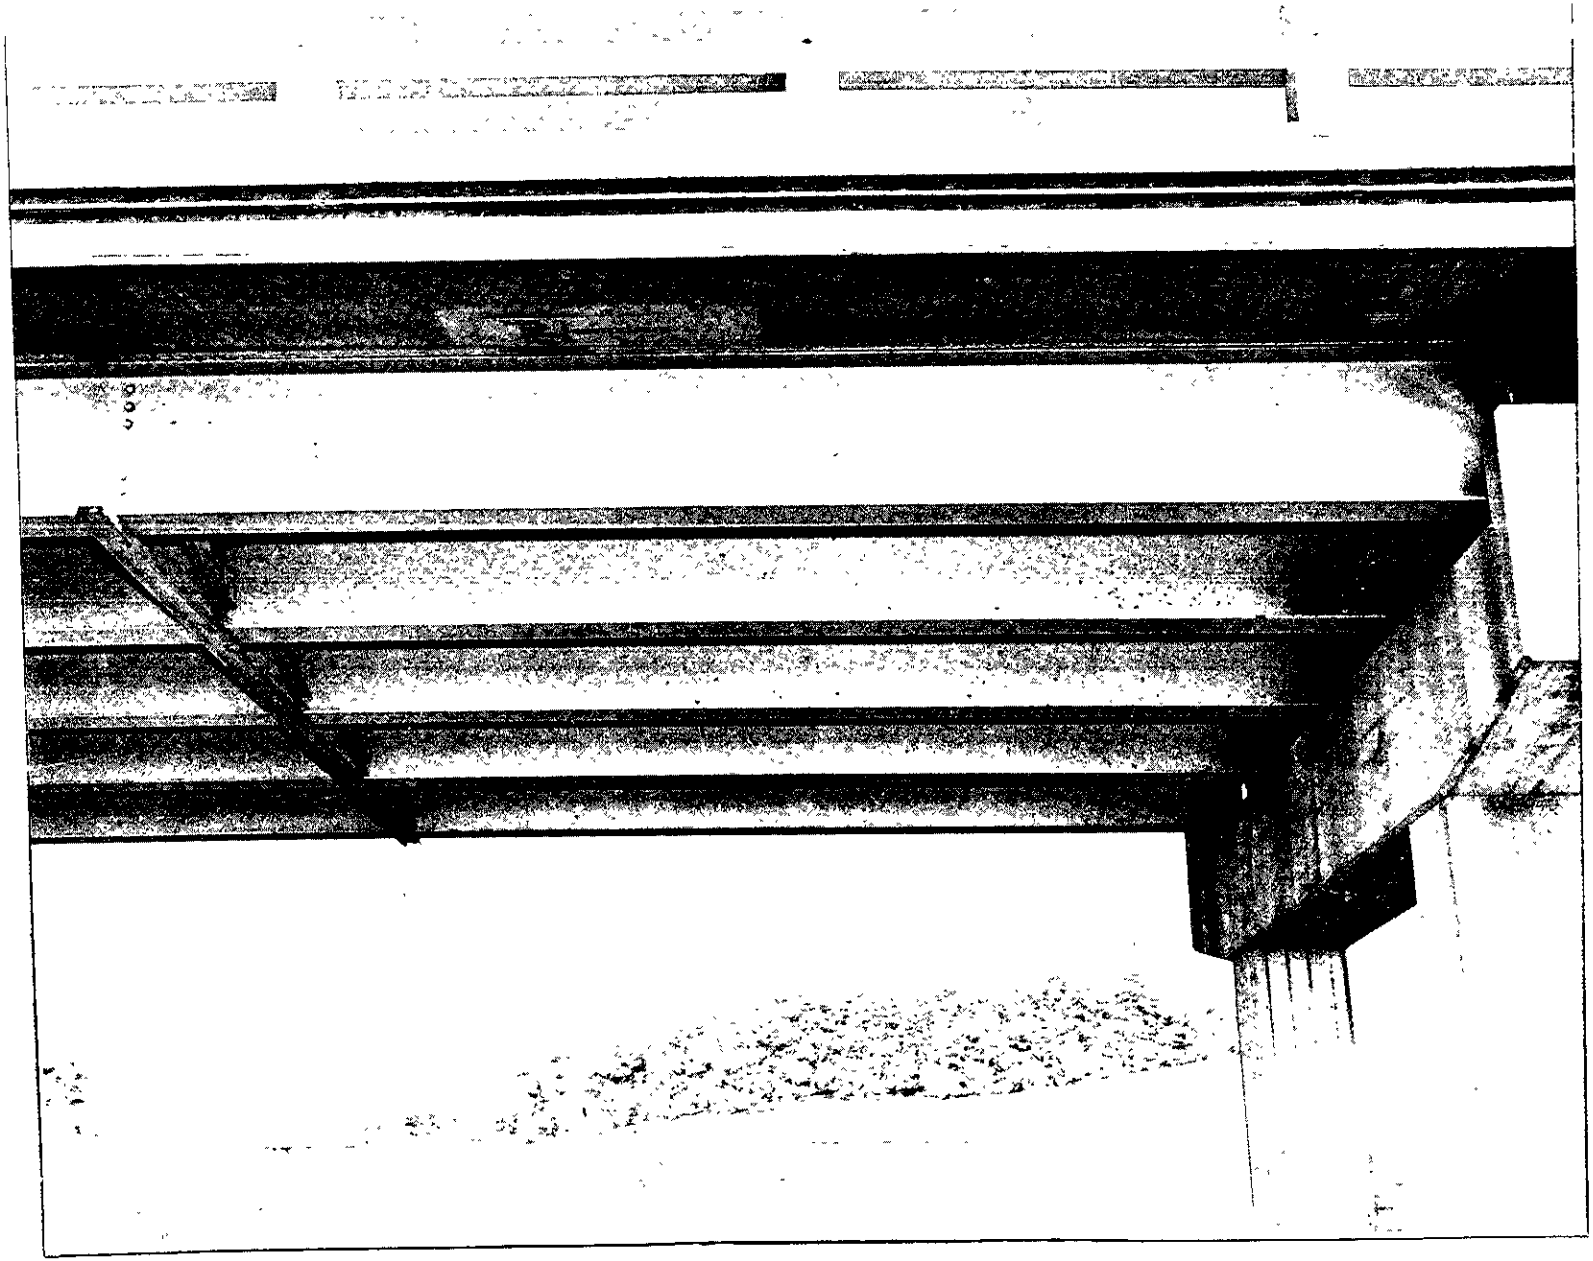
Freckle rust throughout. This system is a "bust" for coastal exposures.
Rating: 6

Photograph No. 7. Leffingwell Creek Bridge. Span 4, South Section
System No. 2. Painted October 1958 - Photographed March 2, 1964.

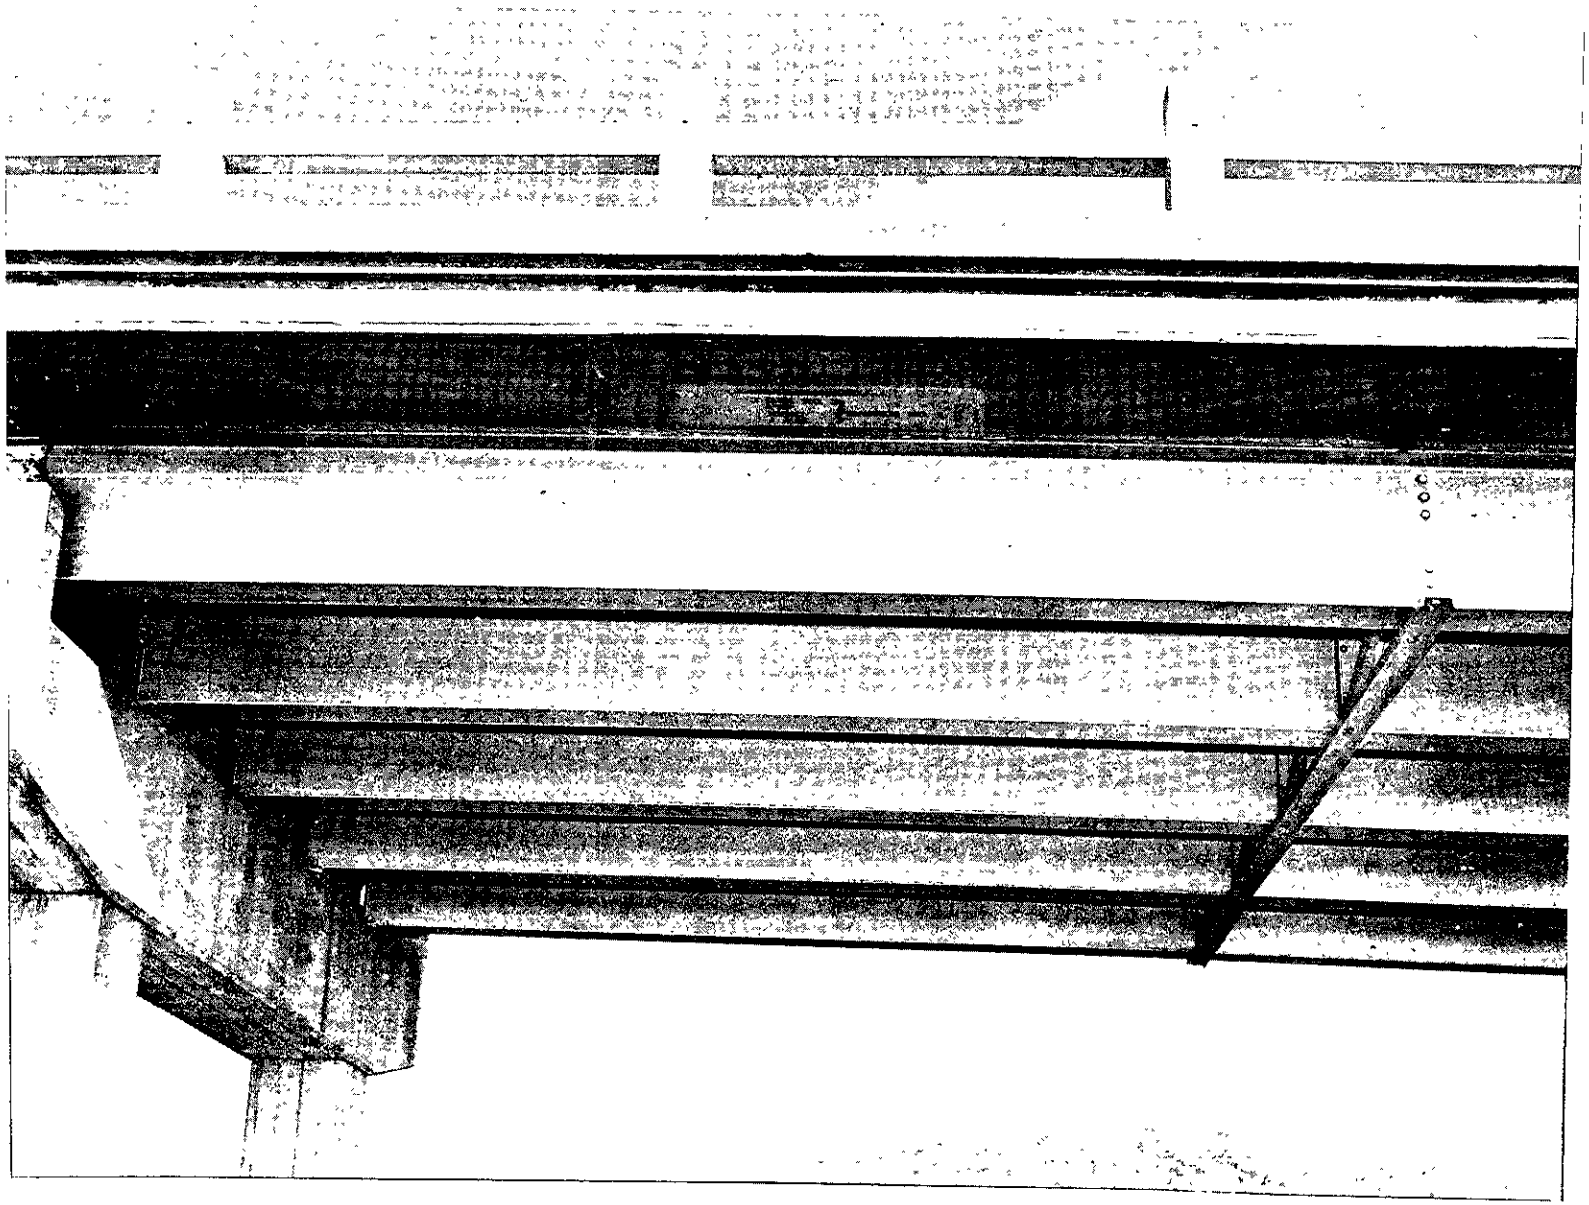
Only rust is on abrasions and laminations. Excellent shape.
Rating: 9+

Photograph No. 9. Leffingwell Creek Bridge. Span 4, North Section
System No. 1. Painted October 1958 - Photographed March 2, 1964.

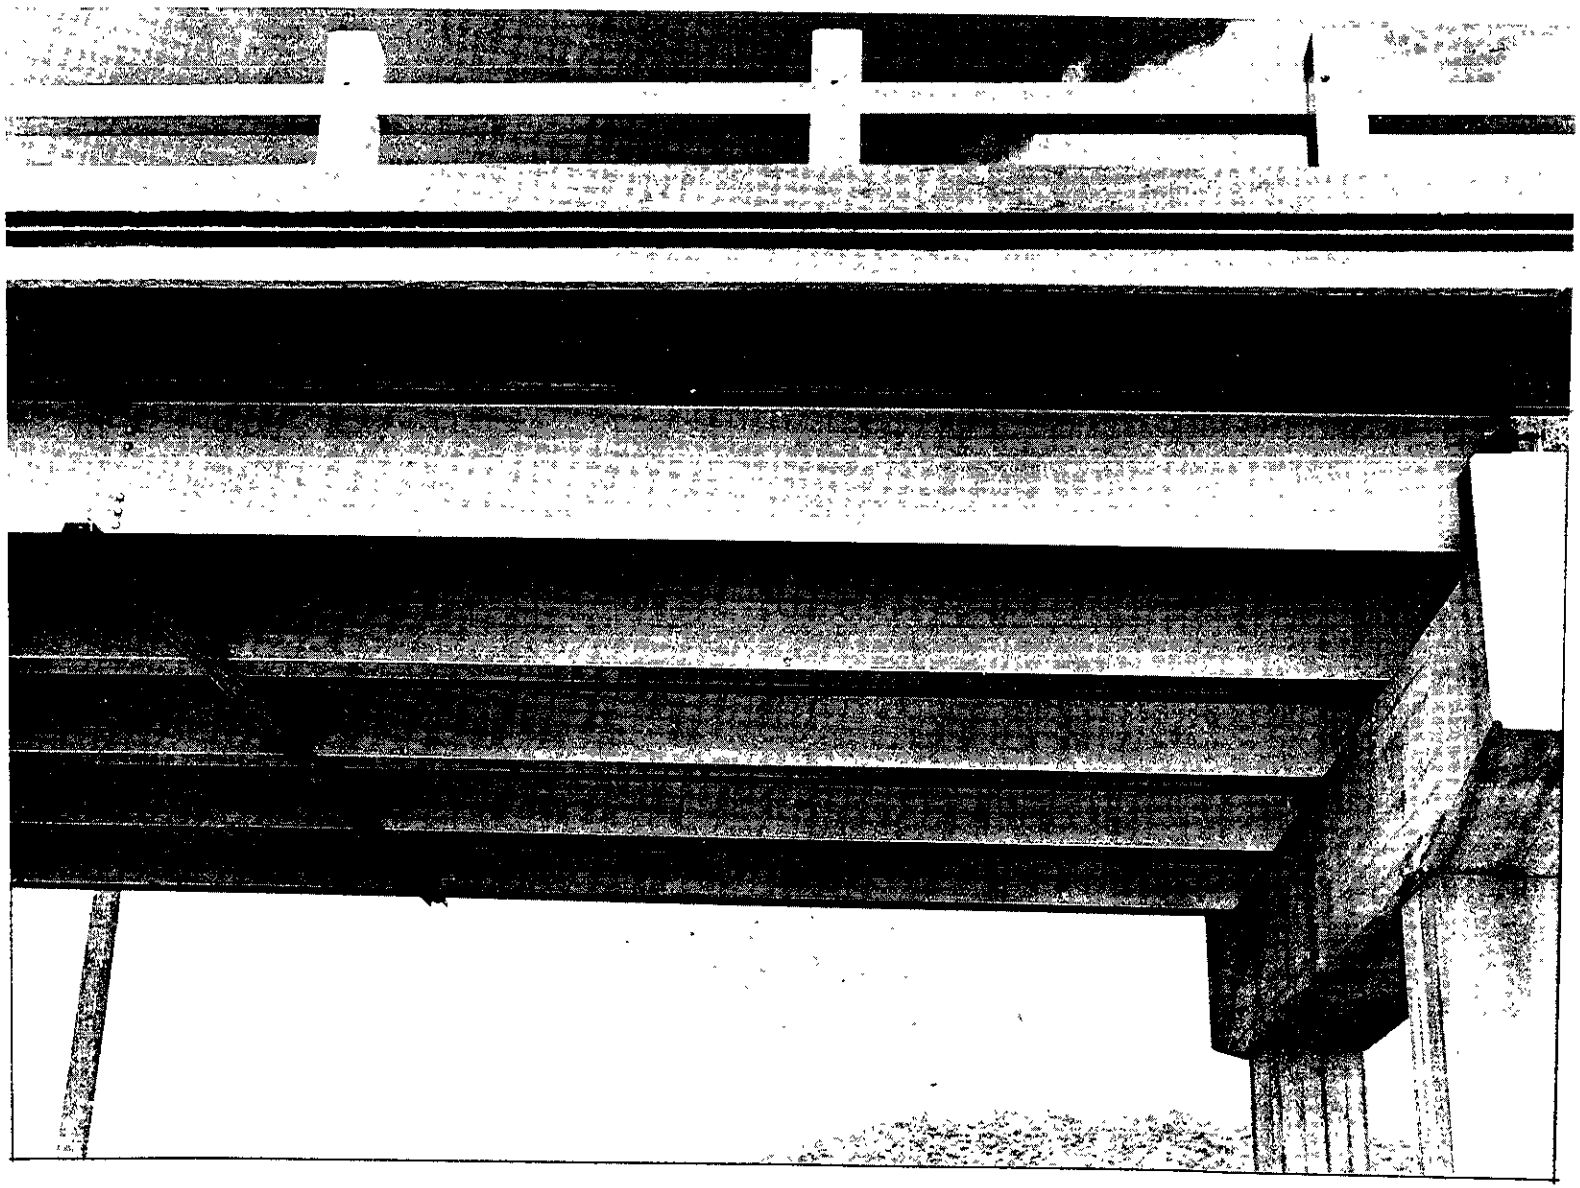
Condition similiar to Span 4, System No. 1. Very good.
Rating: 9+

Photograph No. 10. Leffingwell Creek Bridge. Span 5, South Section
System No. 1. Painted October 1958 - Photographed March 2, 1964.

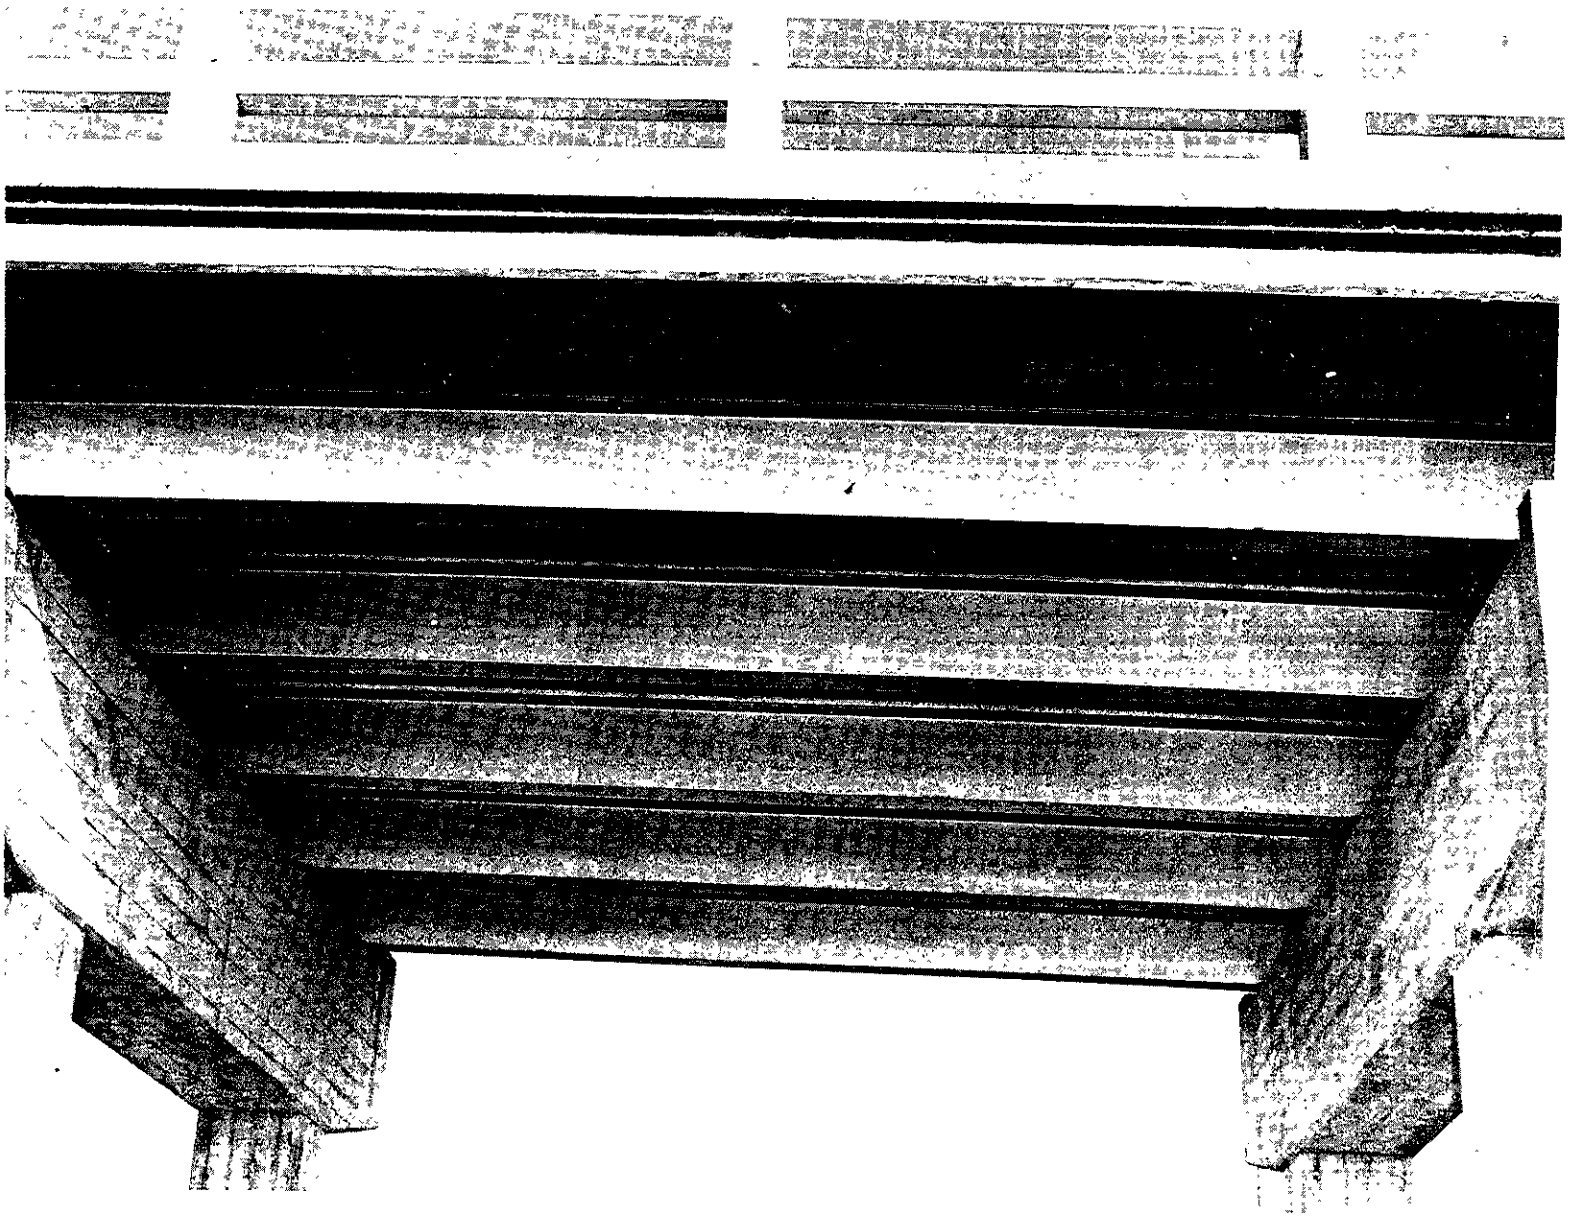
Photograph No. 12. Leffingwell Creek Bridge. Span 6, System No. 4.
Painted October 1958 - Photographed March 2, 1964.

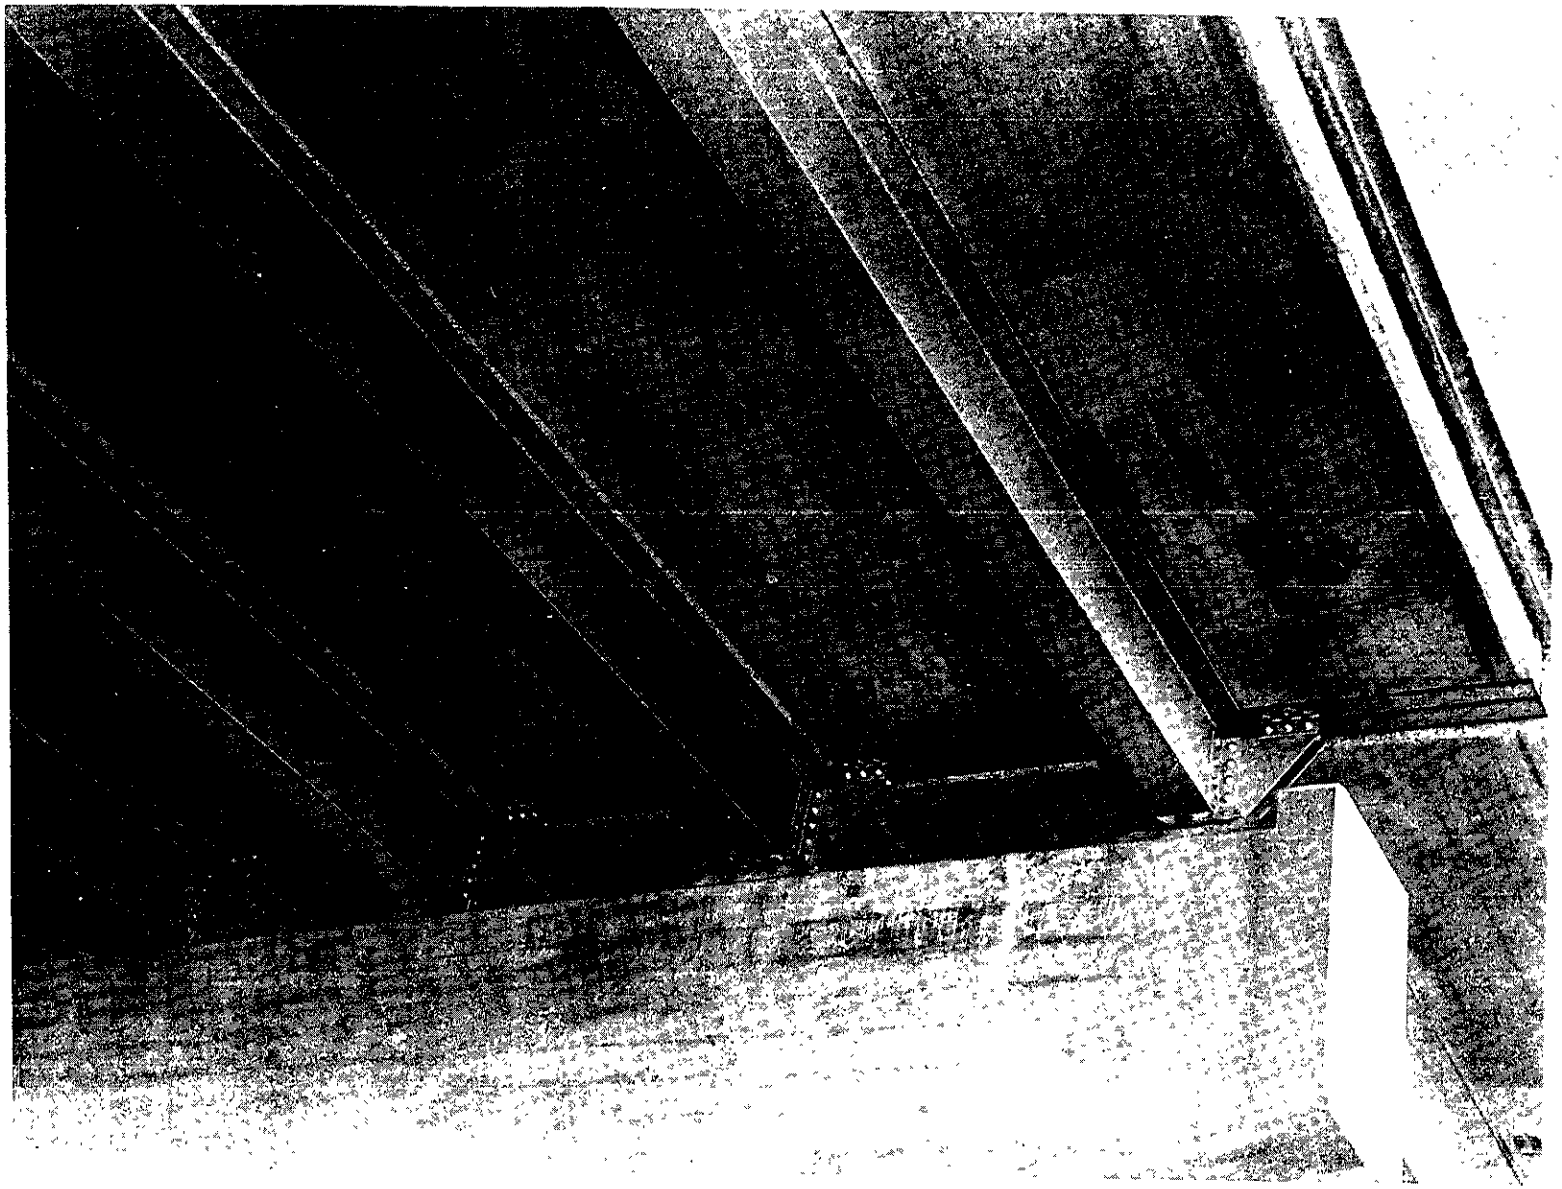
Photograph No. 13. Leffingwell Creek Bridge. Span 6 (close-up picture) System No. 4. Painted October 1958 - Photographed March 2, 1964.

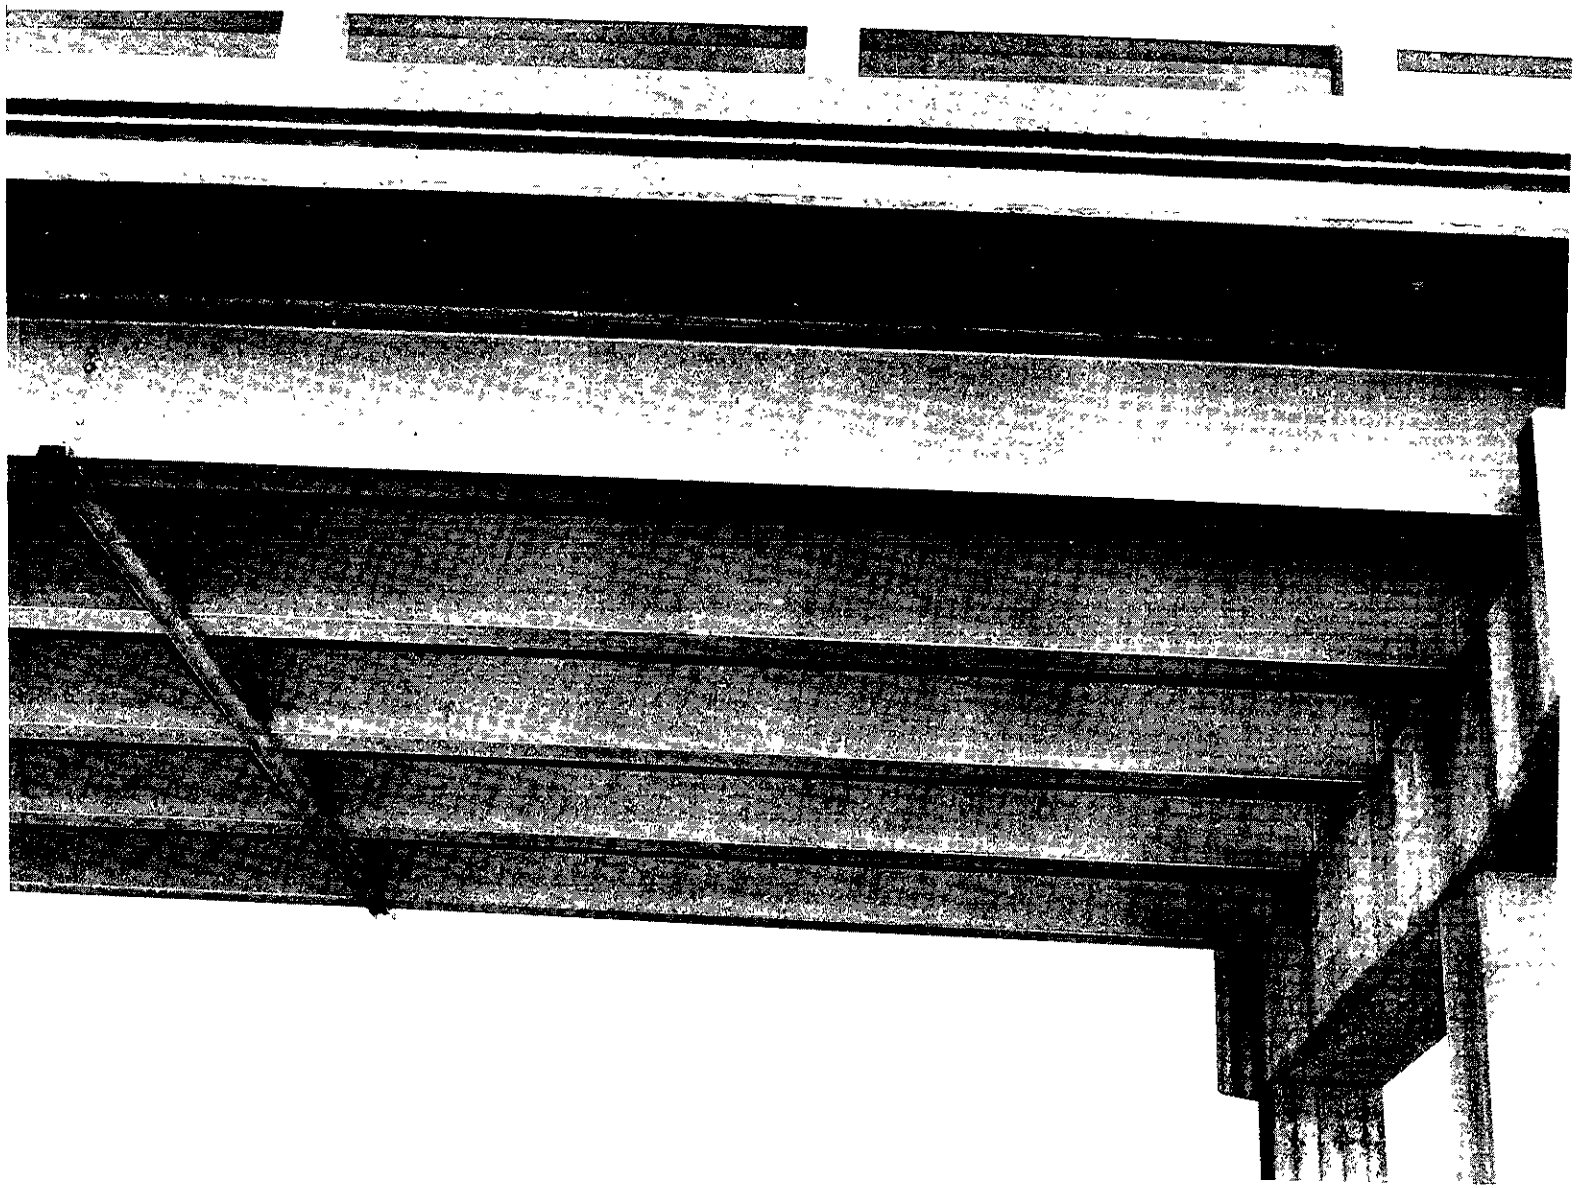
Photograph No. 14. Leffingwell Creek Bridge. Span 7, South Section
System No. 4. Painted October 1958 - Photographed March 2, 1964.

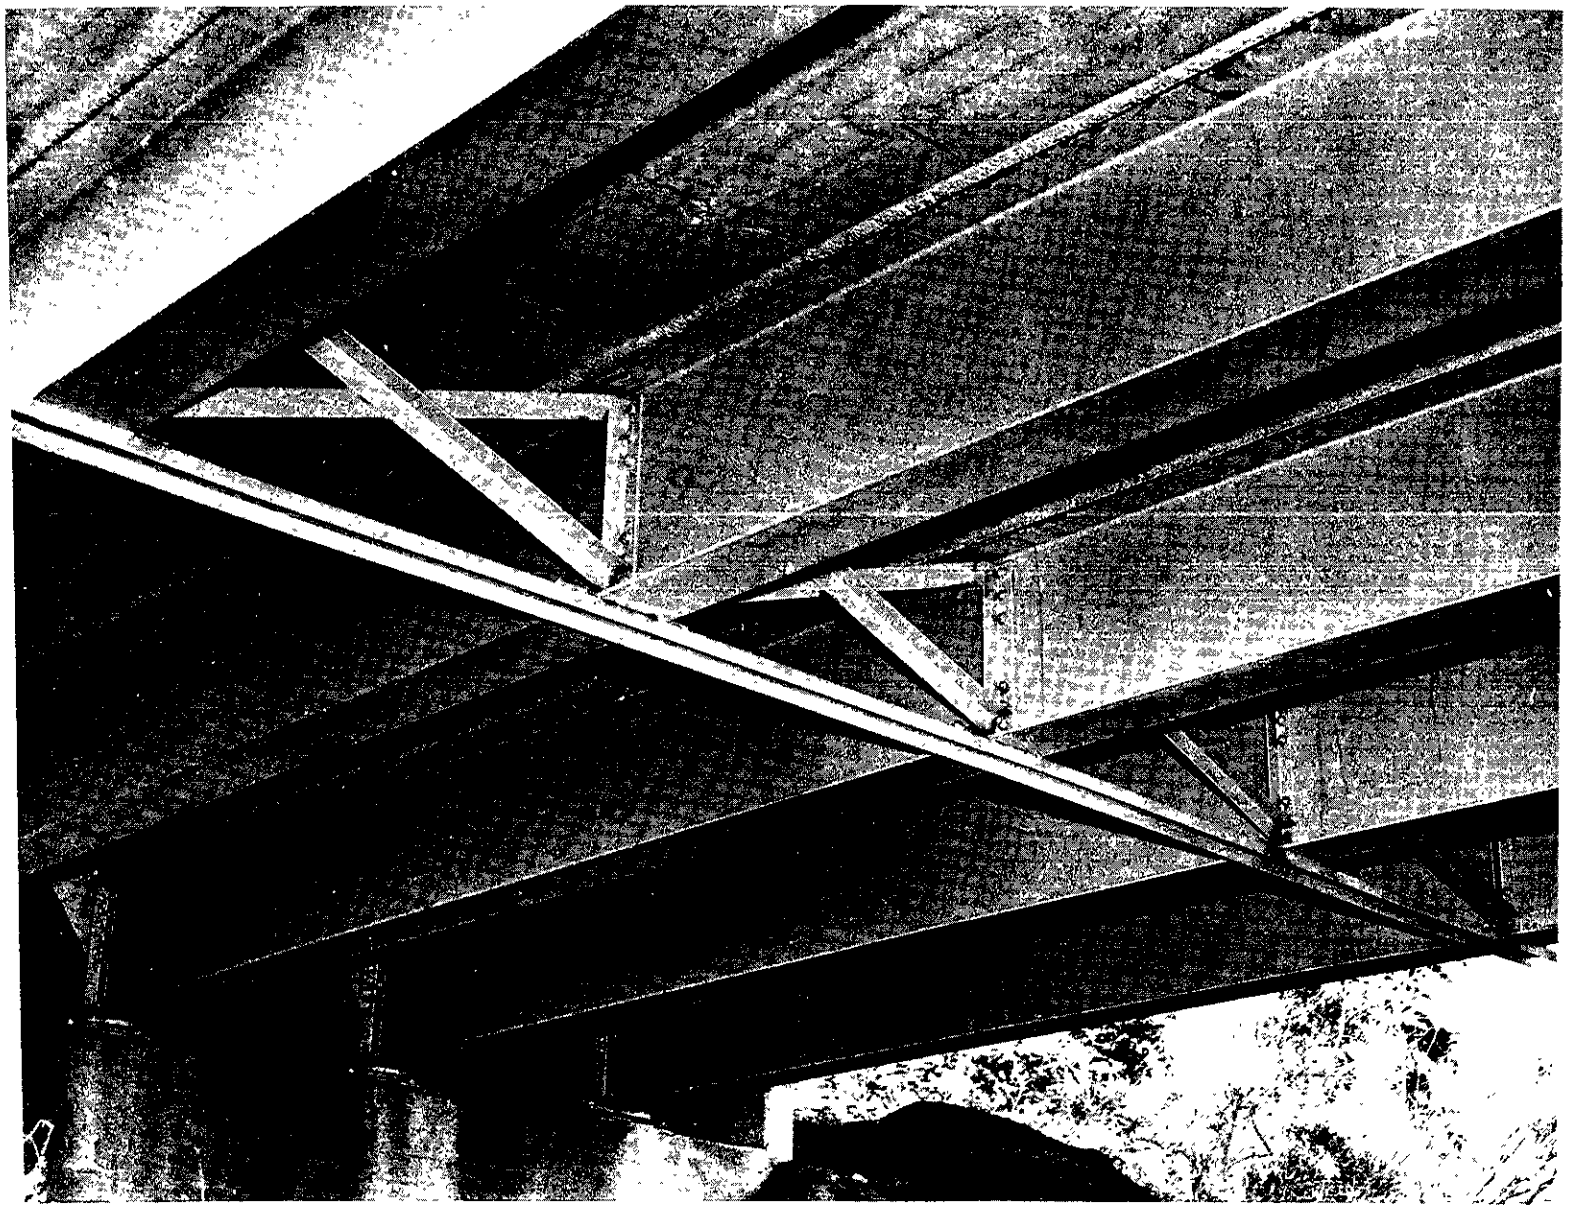
Photograph No. 16. Leffingwell Creek Bridge. Span 8 (close-up picture) System No. 4. Painted October 1958 - Photographed March 2, 1964.

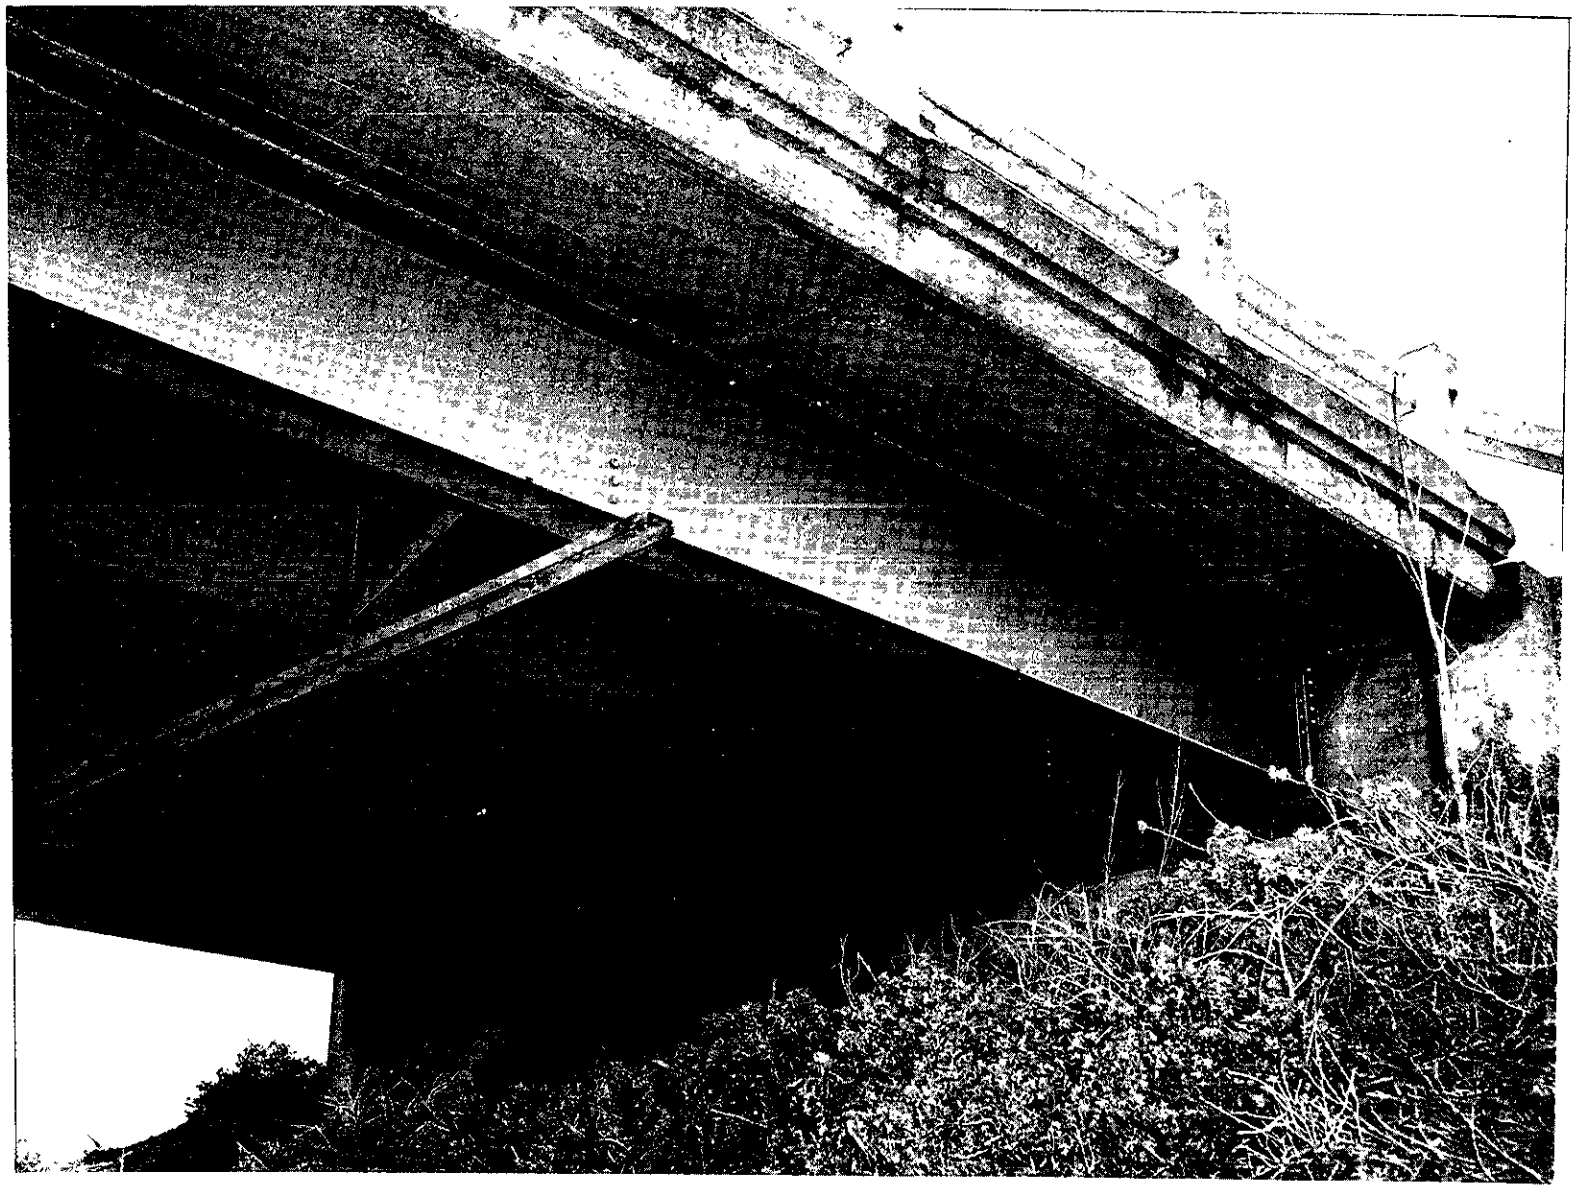
Photograph No. 17. San Simeon Creek Bridge. South End, Span 1. 4 mils Basic Lead Silico Chromate, Federal Specification TT-P-00615a, Type I, and 2 mils Phenolic Iridescent Green, State Specification 58-G-79. Painted June-October 1959 - Photographed March 3, 1964.
