PROGRESS REPORT
RESEARCH ON NEW PAINTS

A STUDY OF VARIOUS PAINT SYSTEMS APPLIED TO LEFFINGWELL AND SAN SIMEON CREEK BRIDGES IN A CORROSIVE MARINE ATMOSPHERE

APRIL, 1964

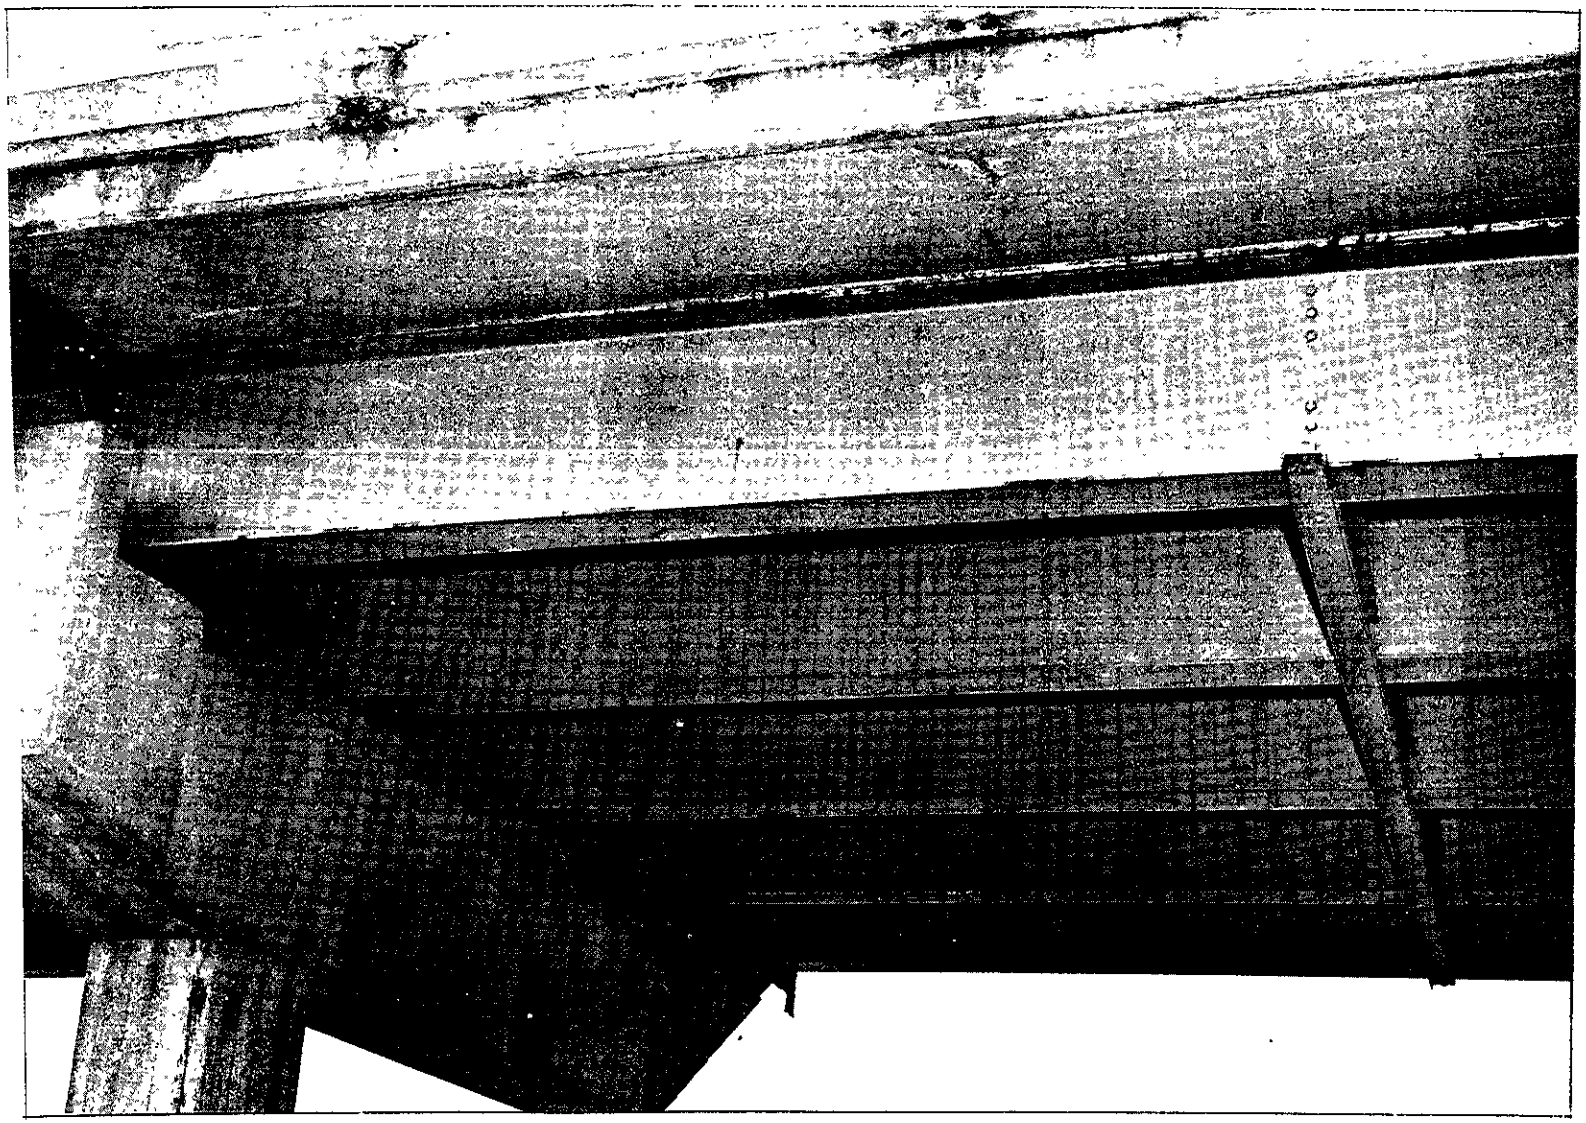
Photograph No. 19. San Simeon Creek Bridge. Span 1, Section 3.
4 mils Basic Lead Silico Chromate, Federal Specification TT-P-00615a,
Type I, and 2 mils Phenolic Iridescent Green, State Specification
58-G-79. Painted June-October 1959 - Photographed March 3, 1964.

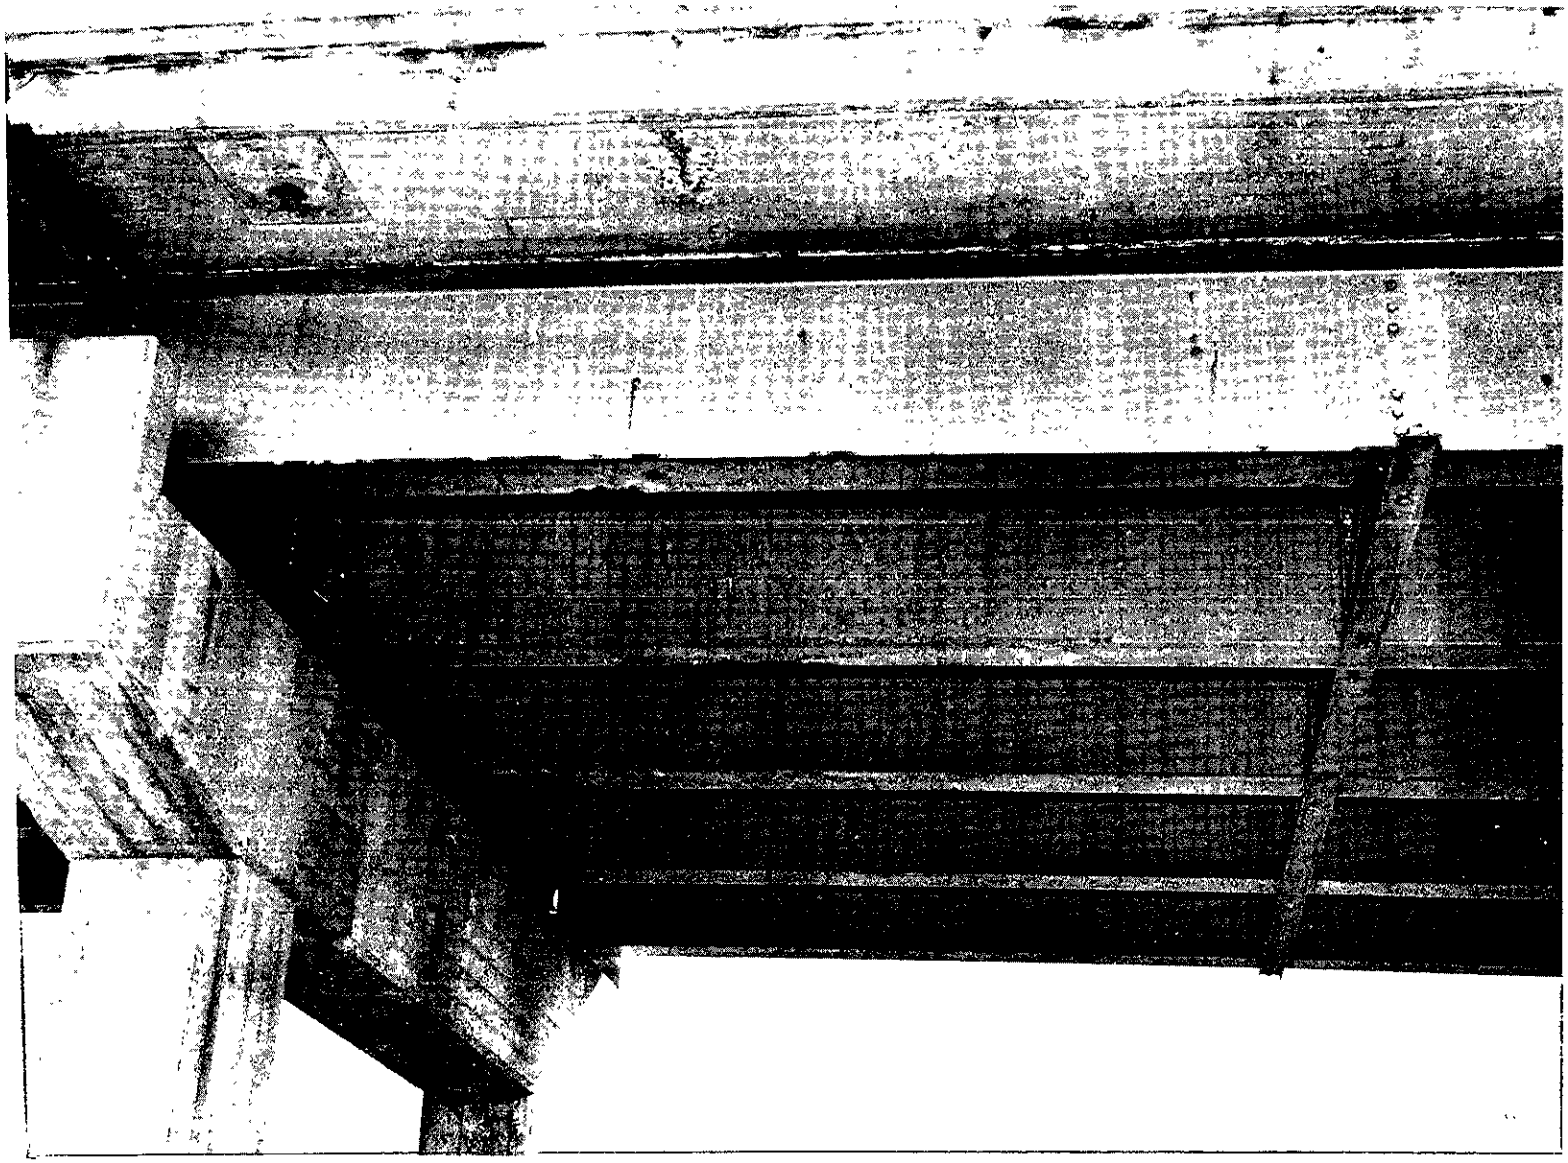
Photograph No. 22. San Simeon Creek Bridge. Span 2, Section 3. 4 mils Basic Lead Silico Chromate, Federal Specification TT-P-00615a, Type I, and 2 mils Phenolic Iridescent Green, State Specification 58-G-79. Painted June-October 1959 - Photographed March 3, 1964.

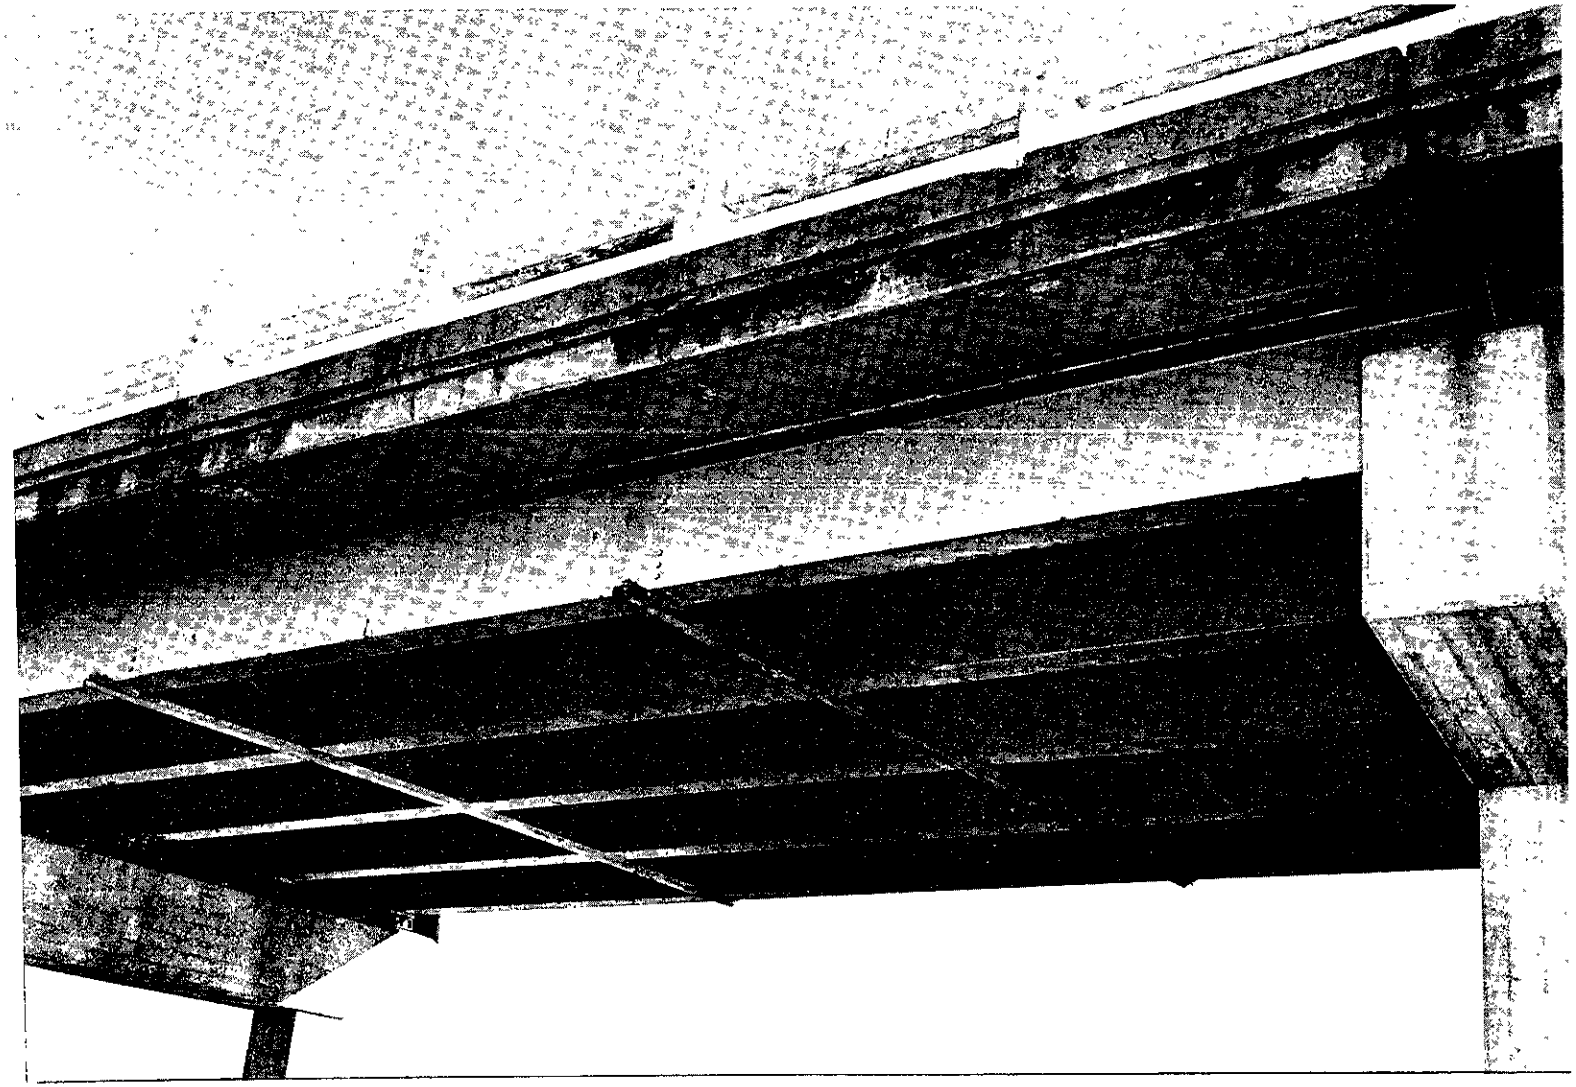
Photograph No. 24. San Simeon Creek Bridge. Span 4. 4 mils Red Lead Primer, State Specification 58-G-53, and 2 mils Phenolic Iridescent Green, State Specification 58-G-79. Painted June-October 1959 - Photographed March 3, 1964.

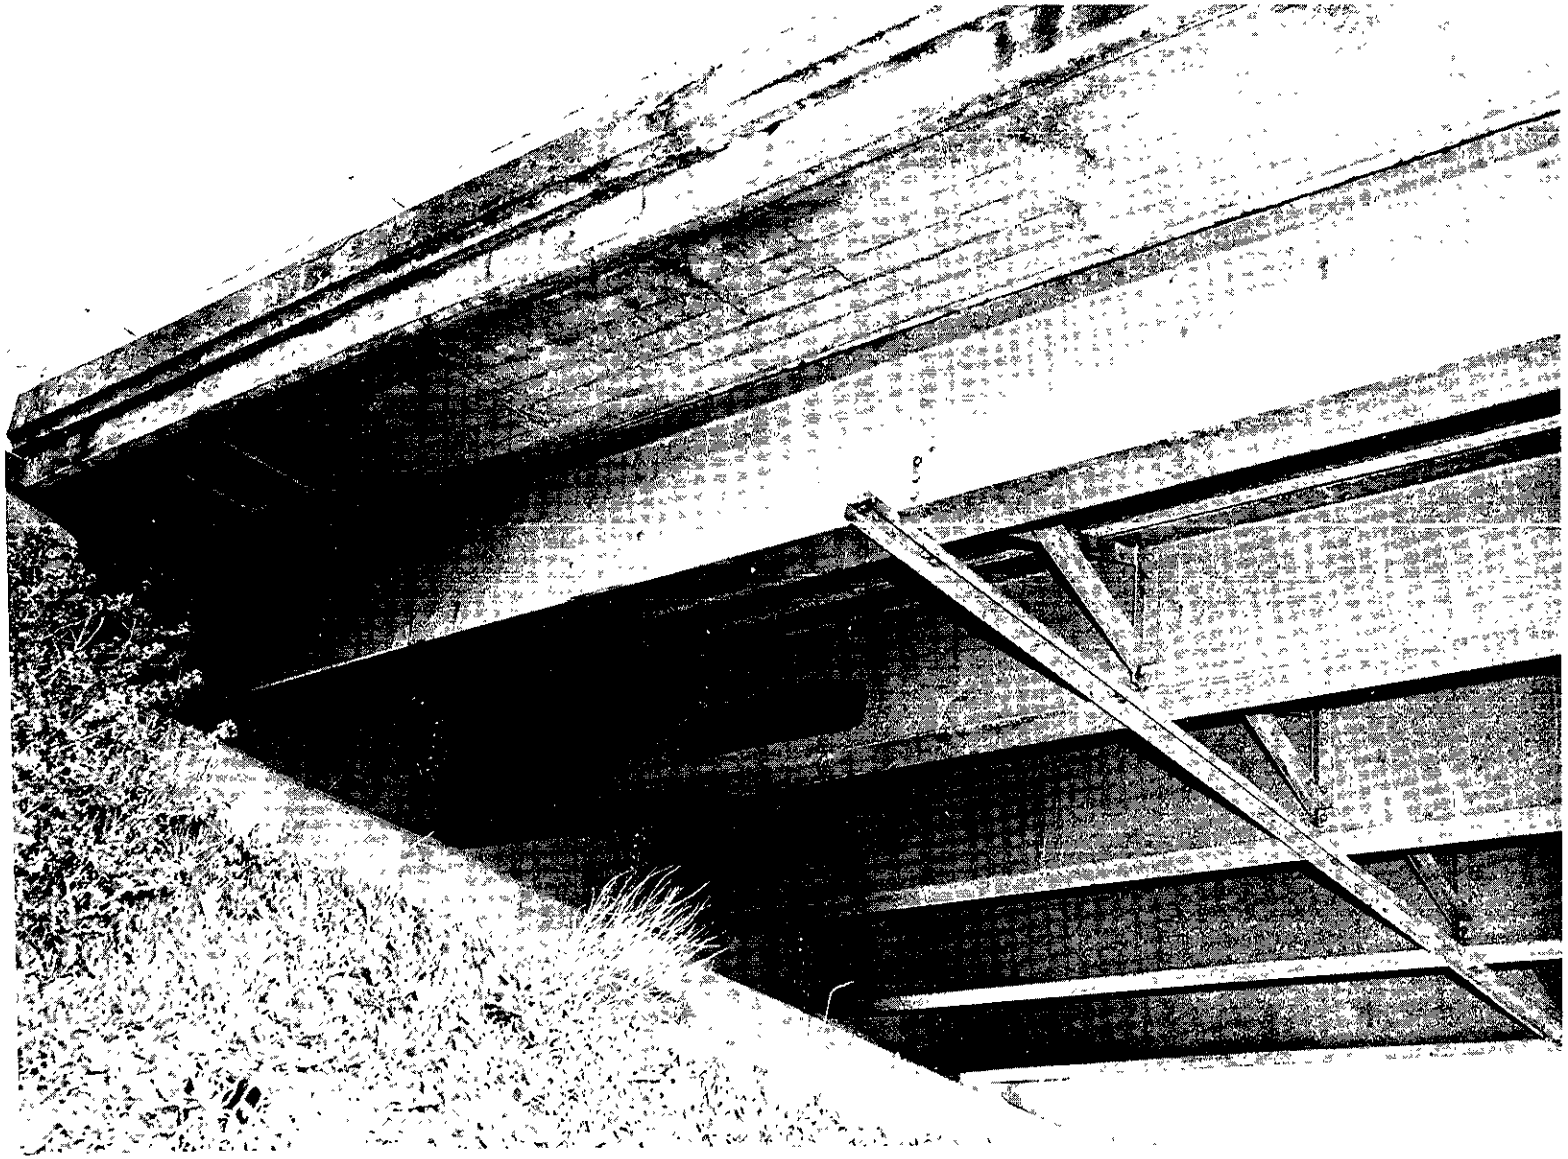
Photograph No. 25. San Simeon Creek Bridge. North End Abutment Span. 4 mils Red Lead Primer, State Specification 58-G-53, and 2 mils Phenolic Iridescent Green, State Specification 58-G-79. Painted June-October 1959 - Photographed March 3, 1964.

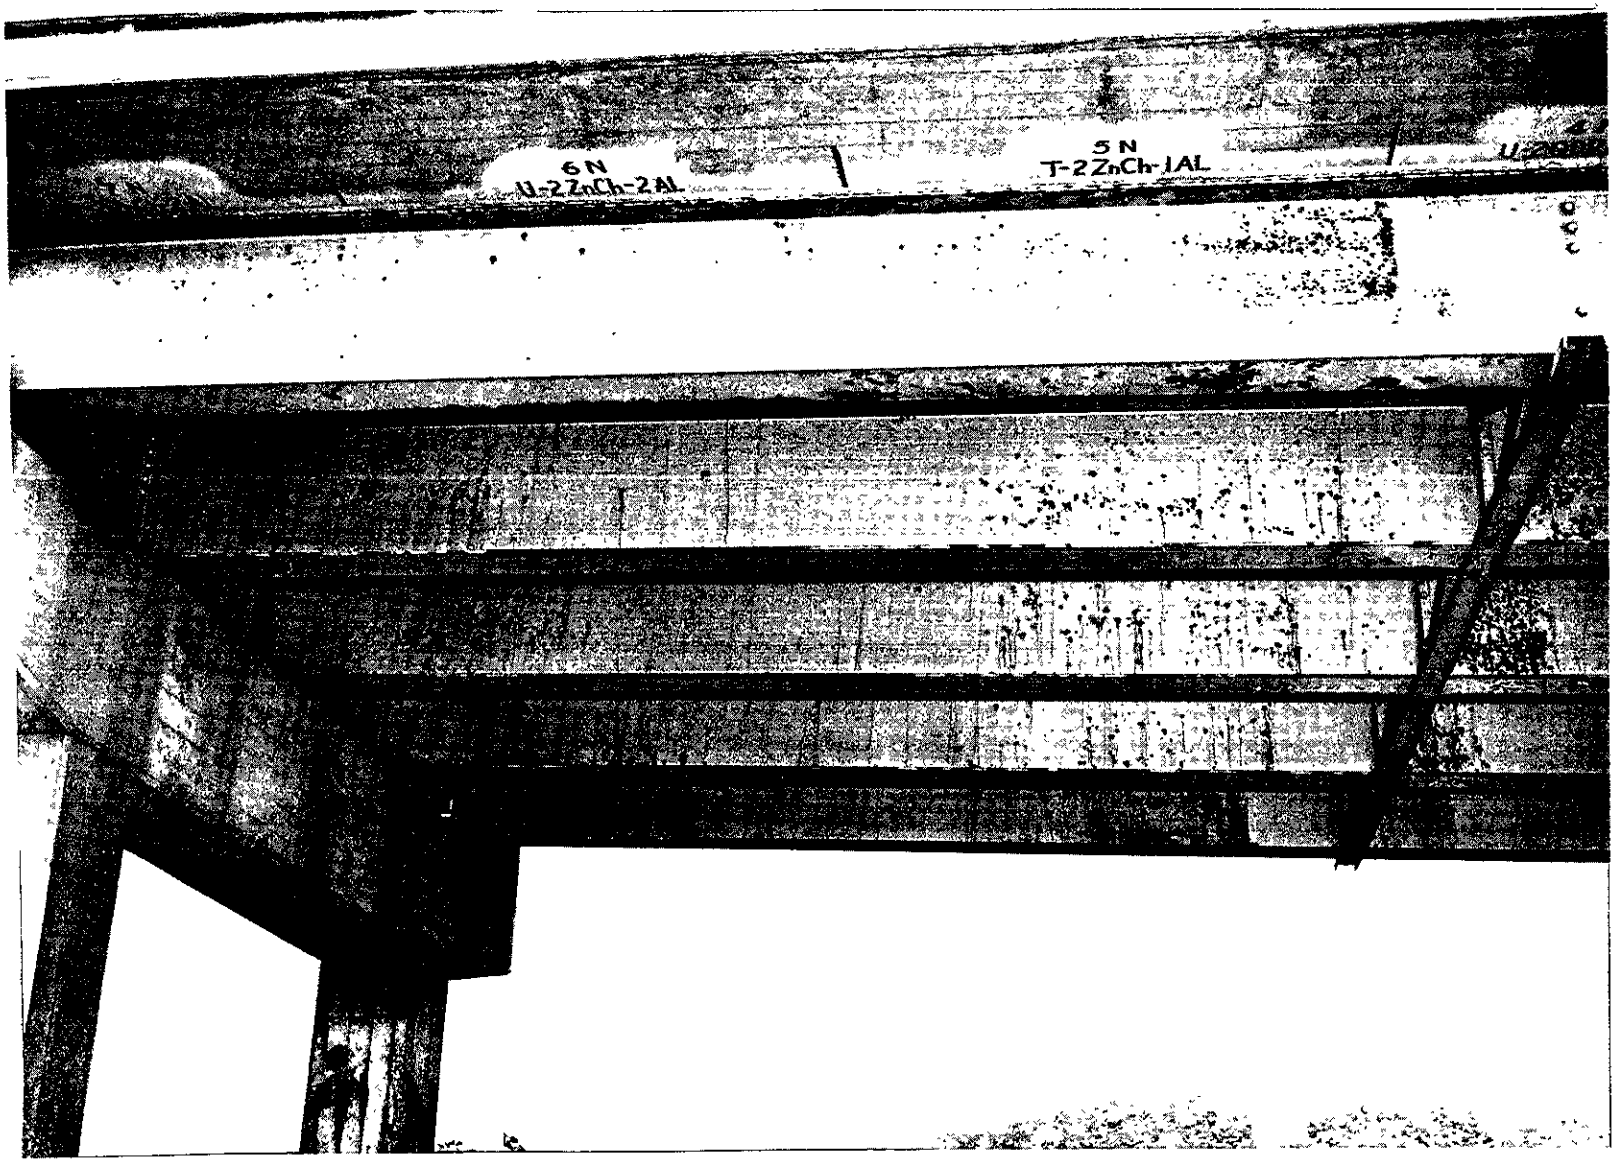
Photograph No. 26. Condition of the average paint system applied to Leffingwell Creek Bridge in 1952 as of October 1958.

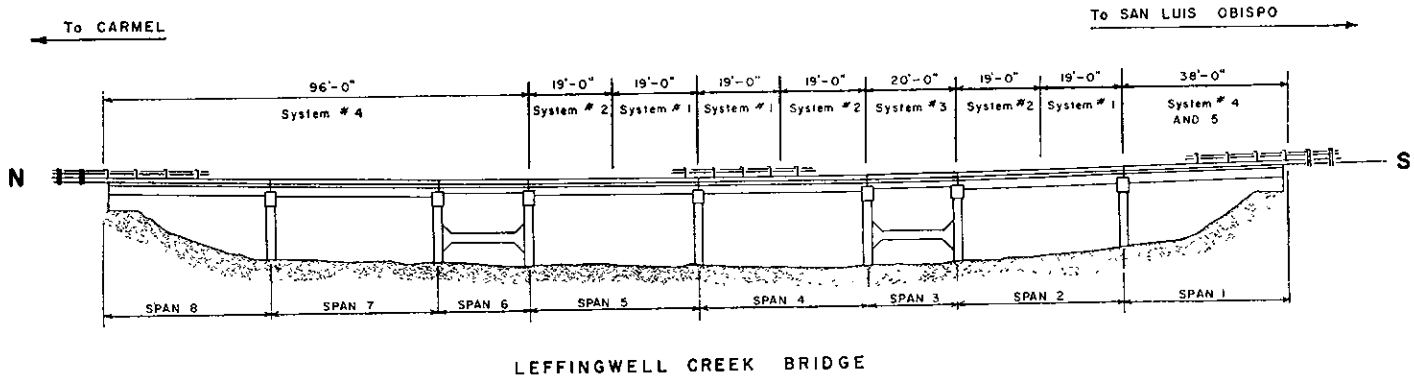
FIGURE 1—A diagram of the Leffingwell Creek Bridge on State Sign Route 1 in San Luis Obispo County showing the location on the structure of the various systems of painting discussed in this article.

Figure 1 is a drawing of the Leffingwell Creek Bridge showing where each paint system was applied and Table I is a description of the coatings comprising each system. Figures 3 to 6 show the conditions of these various coating systems as of May 10, 1961.

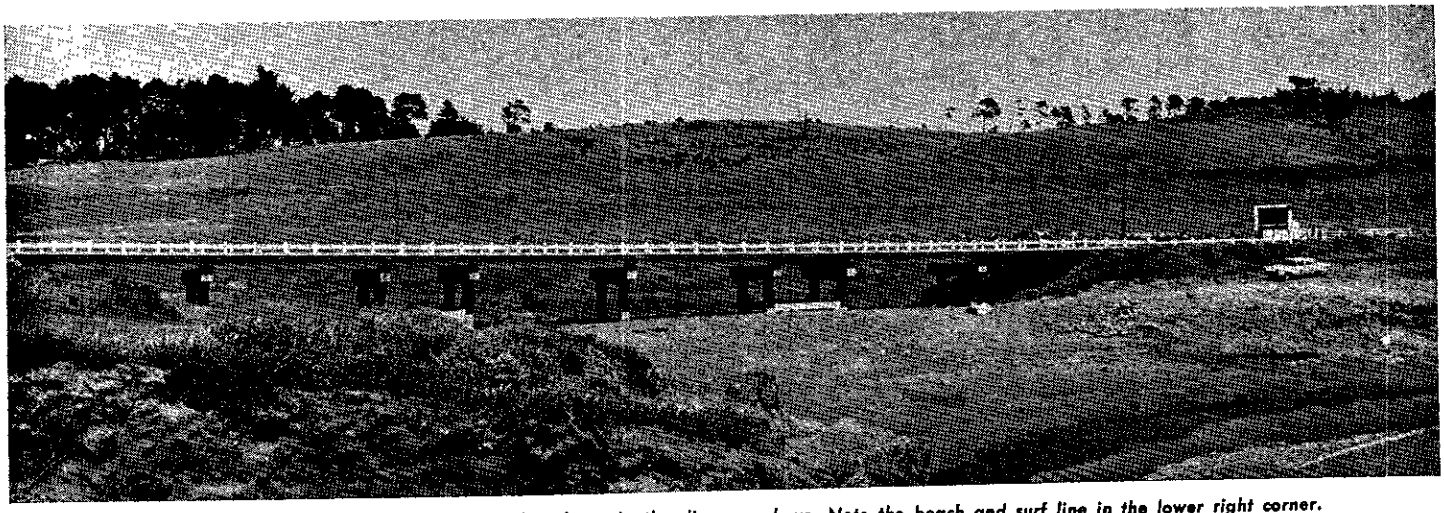
The Leffingwell Creek Bridge is situated just north of the town of Cambria on Road V-SLO-56-B (State Sign Route 1) in San Luis Obispo County and is close to the shoreline of the ocean as shown in Figure 2. It is a low level structure containing eight steel stringer spans with a concrete deck supported on concrete piers and abutments. The 24-foot wide concrete deck shields the steel girders to a limited extent from rain thereby allowing salt to accumulate in heavier deposits than would occur if the steel were more exposed as in a superstructure. This bridge and several others similarly situated with respect to the ocean present an ideal location where protective coatings may be tested in a very corrosive environment.

FIGURE 2—A photograph of the actual bridge shown in the diagram above. Note the beach and surf line in the lower right corner.

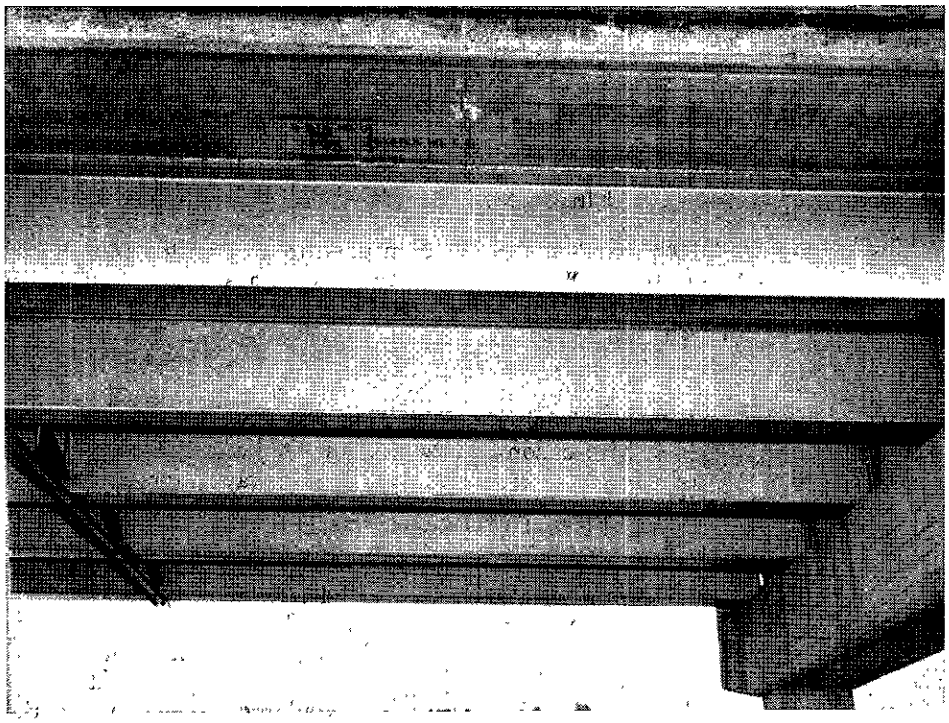
FIGURE 3—Under view of the south portion of Span 2 on which Painting System No. 1 was used.

As of the date of May 10, 1961, the best system appeared to be No. 1 (Figure 3), the inorganic chemically cured zinc coating with the complete vinyl System No. 4 (Figure 6) almost equivalent to System No. 1 in durability. The greatest failure occurred in the 100% solids epoxy coating represented by System No. 3 and as shown in Figure No. 5. It may be of significance that the application of System No. 3 was not preceded by a vinyl wash treatment. It has not been customary to use this treatment in advance of epoxy coatings.

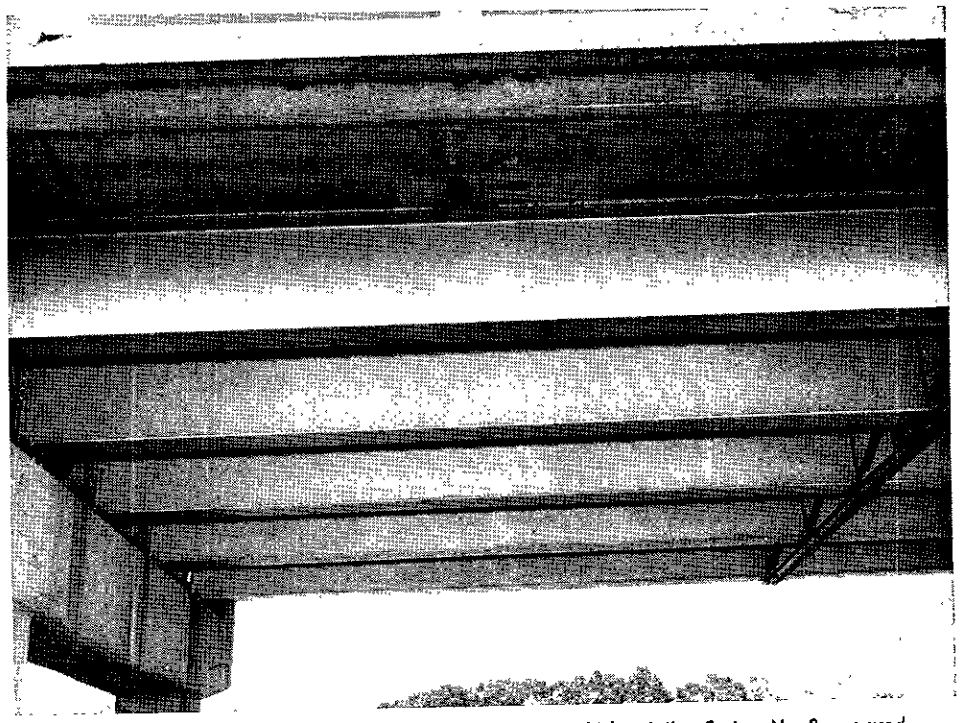
FIGURE 4—Under view of the north portion of Span 2 on which Painting System No. 2 was used.

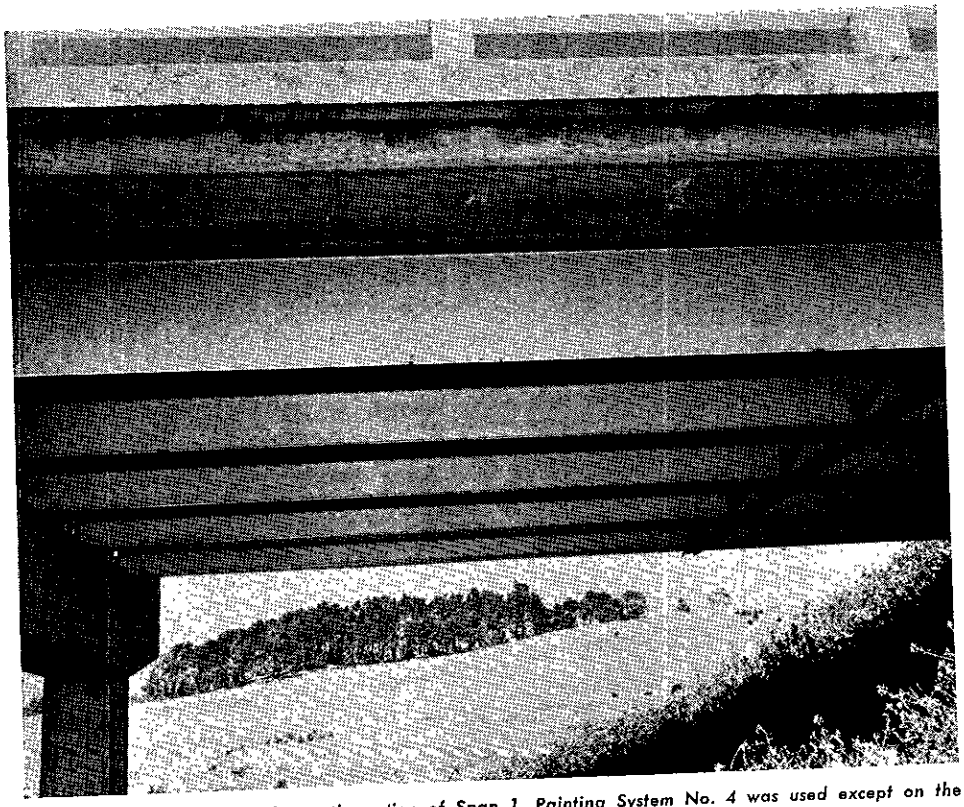
FIGURE 6—Under view of the north portion of Span 1. Painting System No. 4 was used except on the stringer in the foreground on which System No. 5 was used.

A rating of System No. 5 is not justified because of the relatively small area to which this system was applied.
