THE EFFECTIVENESS OF FLEXIBLE BASE CUSHION COURSES OVER OLD PAVEMENTS

January 1966

66-29

State of California
Department of Public Works
Division of Highways
Materials and Research Department

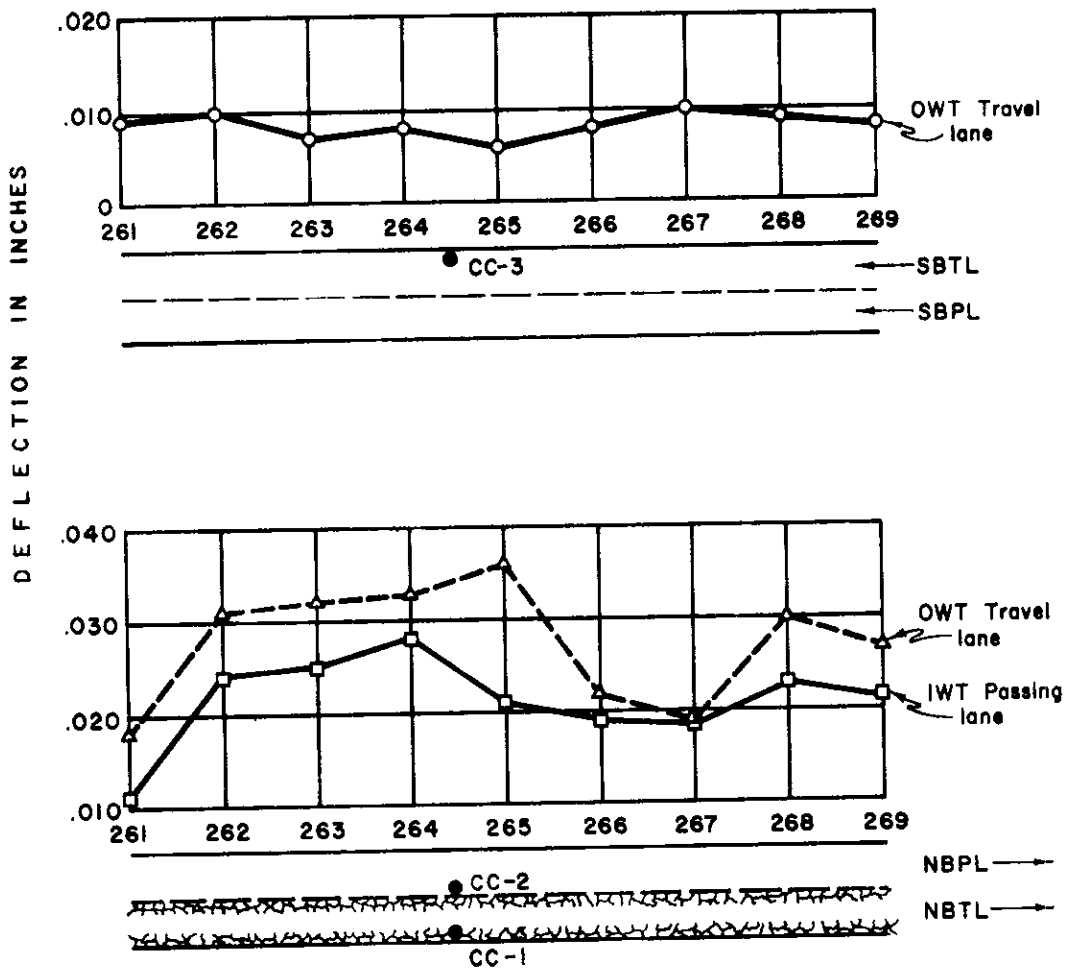
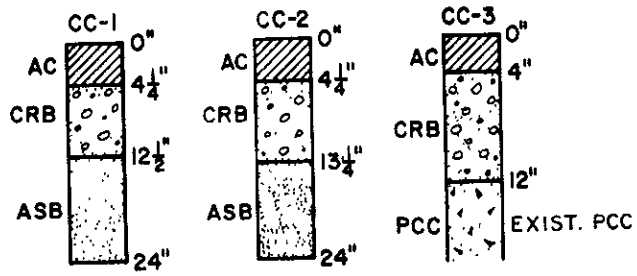
FIGURE 1

PROJECT CORING LOCATIONS,
AREAS OF DISTRESS DEFLECTIONS
V SBt -2-B, A
Sta. "B" 261+00 to 269+00

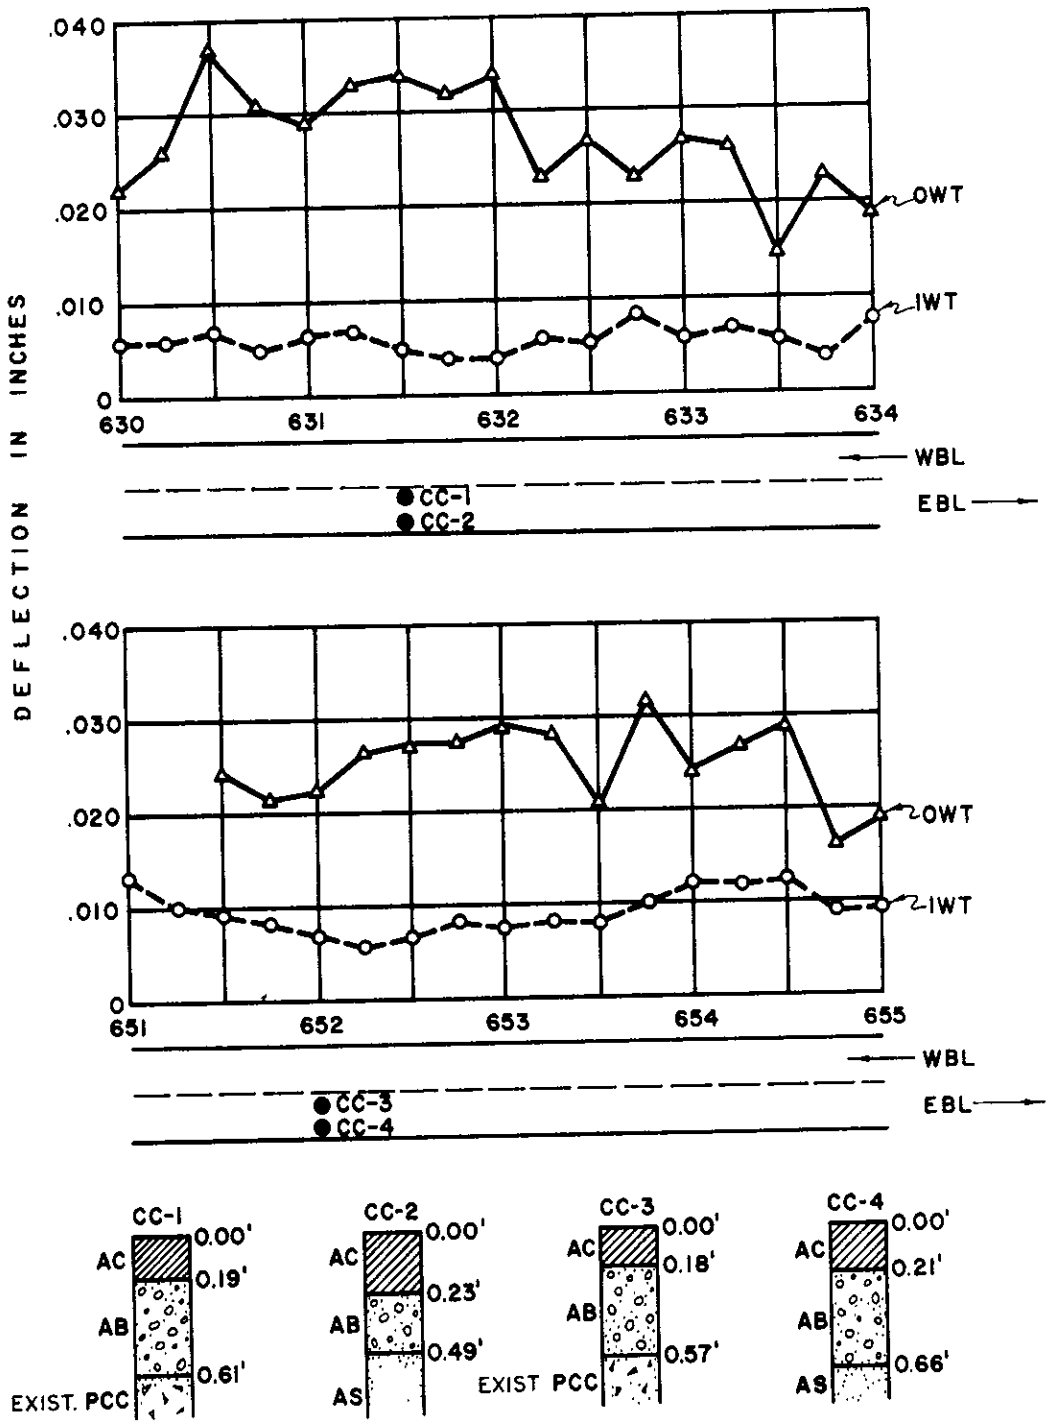
FIGURE 2

The new construction (including the two 4.5' widening strips on both sides of the old PCC pavement) consisted of a 2½" A.C. surfacing over 6" of aggregate base over 6" of aggregate subbase. Inspection of the roadway revealed that virtually all visible distress is confined to the all new construction. This distress is in the form of scattered hairline cracks predominantly in the outer wheel track. To provide the basis of comparison, samples were taken at two locations, in the inner wheel track over the cushion section and in the directly adjacent outer wheel track consisting of all new construction. The core logs, deflection measurements, and results of the condition survey for each location are shown in Figure 2.

PROJECT CORING LOCATIONS,
AREAS OF DISTRESS DEFLECTIONS
X STA, TUO-13-B, A
Sta. 630 to 634 and Sta. 651 to 655
