STATE OF CALIFORNIA
BUSINESS AND TRANSPORTATION AGENCY
DEPARTMENT OF PUBLIC WORKS
DIVISION OF HIGHWAYS
BRIDGE DEPARTMENT

DETERIORATION IN DE-ICING SALTED BRIDGE DECKS

To be presented at the Highway Research Board

by C. F. STEWART

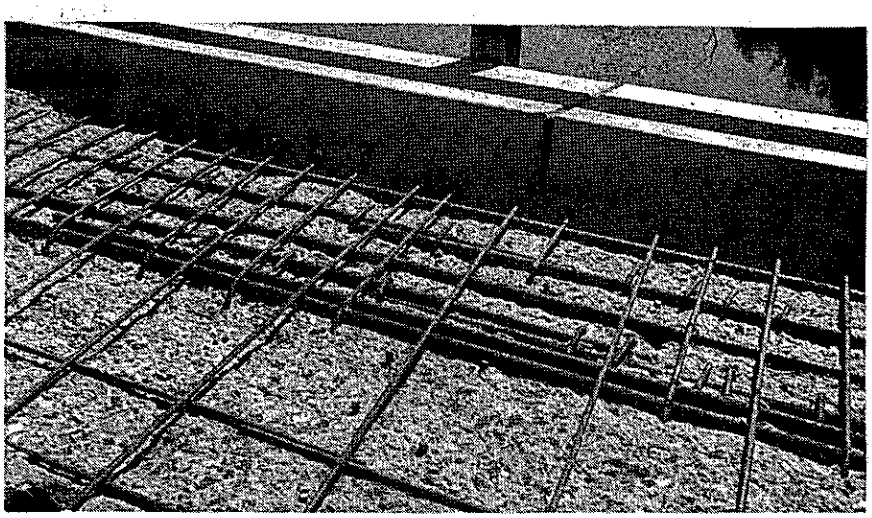
Fig. 3

One might ask that if continued deterioration in the deck is expected when only that portion of the concrete in the corroded area is removed (partial restoration, figure 2) why limit the removal, why not remove all salt laden concrete (total restoration, figure 3)? The primary

Total restoration - All salt laden concrete removed.

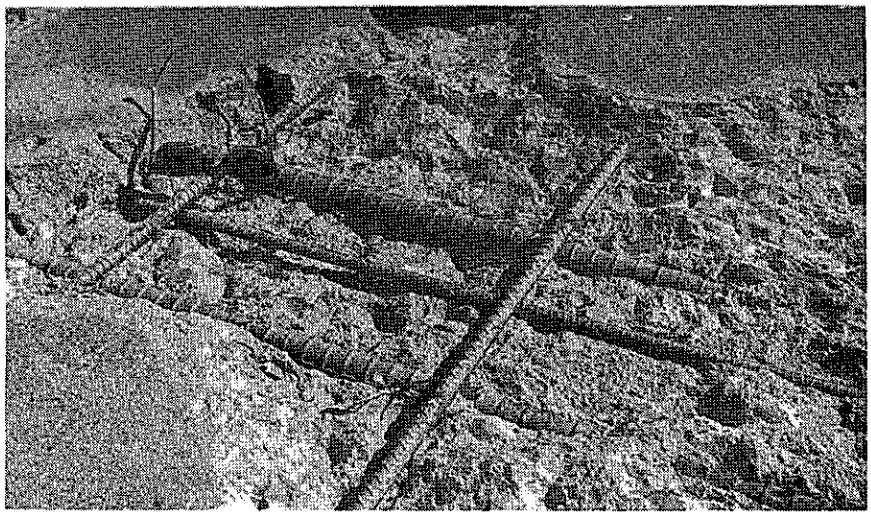
Fig. 4

Corrosion sandblasted from steel. Note minor pitting.

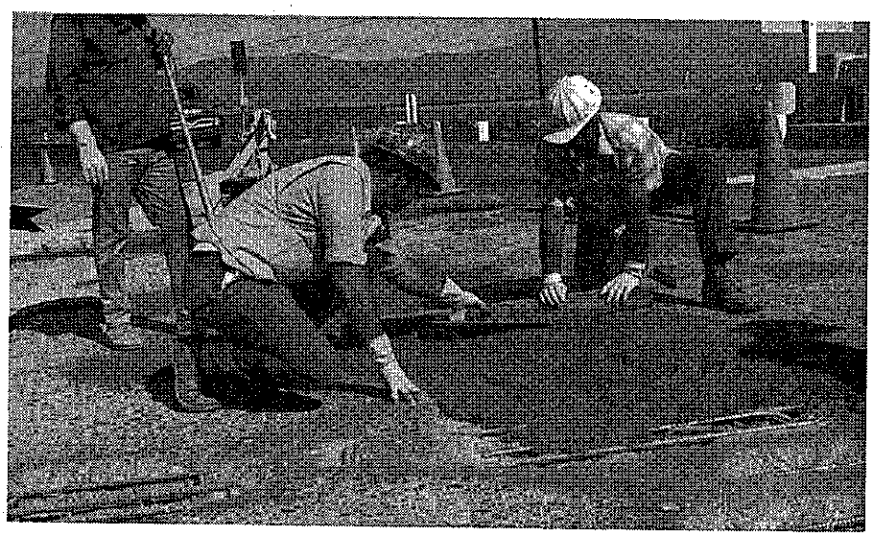
Fig. 5

After a decision on the type of restoration is made, partial or total, the type of patching material to be used must be decided. There is only one economical choice for total restoration: Portland cement mortar. In partial restoration there are two: Cement mortar or epoxy mortar. Important differences between the two which must be considered when choosing between them are: Epoxy mortar is more expensive, has a greater tendency to flow under a sustained load, is more sensitive to the weather during placing, but requires less lane closing time than does cement mortar. Due to the large difference in thermal coefficient of expansion of epoxy and PCC, a vital requirement of the epoxy in an epoxy mortar patch is that it be flexible enough to "give" during low temperature changes. Figure 5 shows an epoxy mortar patch being placed.

Placing epoxy mortar patch.

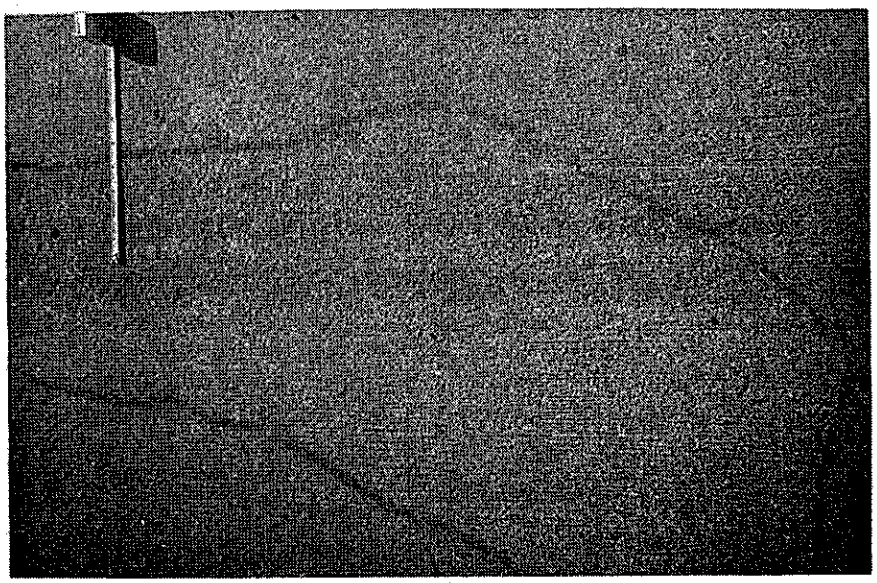
Fig. 6

Not all damaged concrete areas are visible on the surface; frequently, incipient potholes exist in the form of undersurface fractures, see figure 6. These areas should be located and treated the same way as the potholed areas. Sounding the concrete by striking it or dragging an object over it is the best way to locate undersurface fractures. A low pitched "hollow sound" results when there is an

Outline of a horizontally oriented undersurface fracture plane.

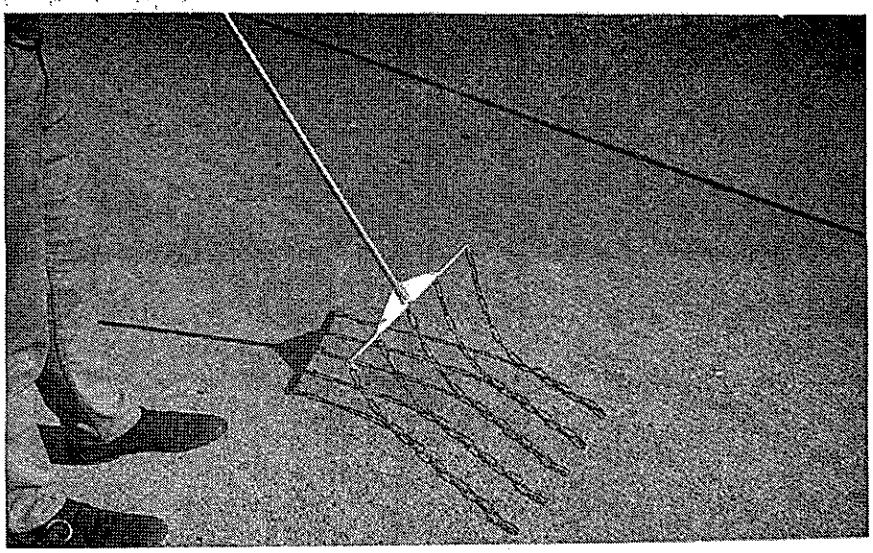
Fig. 7

undersurface fracture. The chain "broom" shown in Figure 7 has proven to be a very effective device for finding undersurface fractures in concrete bridge decks.

A chain "broom" for locating undersurface fracture planes.

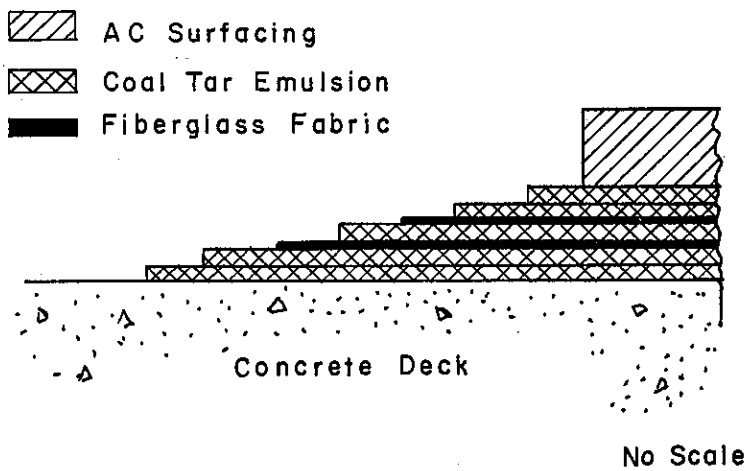
Fig. 8

The coal tar-glass fabric system figure 8, has for several years proven its effectiveness in sealing industrial building roofs. Massachusetts highway engineers report that the coal-tar system has also been an effective deck sealant in their state for several years. The ability

Coal tar-glass fabric deck seal.
