HIGHWAY RESEARCH REPORT

COLD ASPHALT CONCRETE OVERLAY

INTERIM REPORT

CA-HY-MR-3542-1-72-48

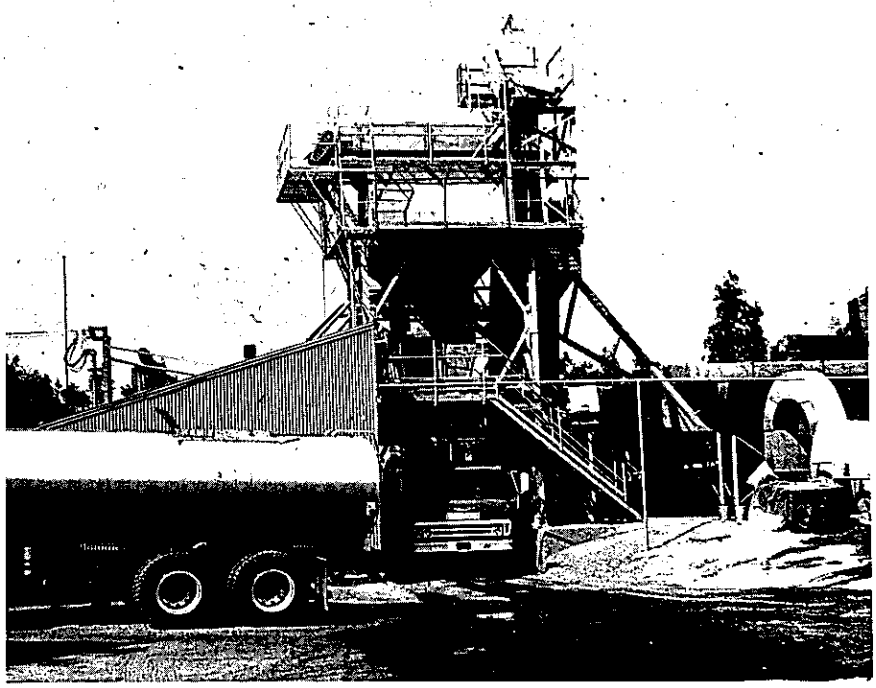
Figure 1 - Mixing Plant

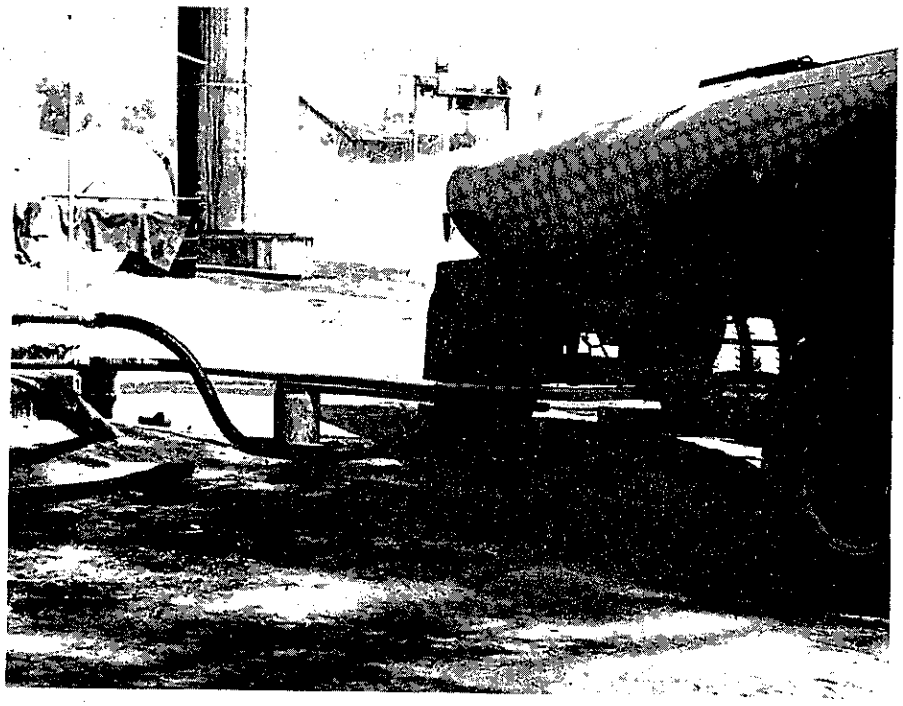
Figure 2 - Emulsion Fed to Plant From Truck

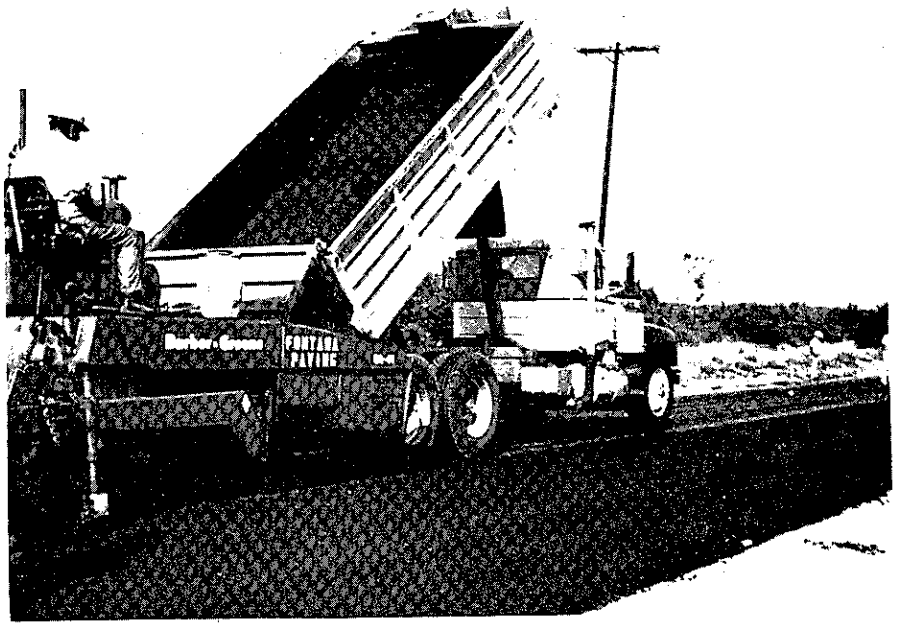
Figure 3 - Open Graded Paving Operation

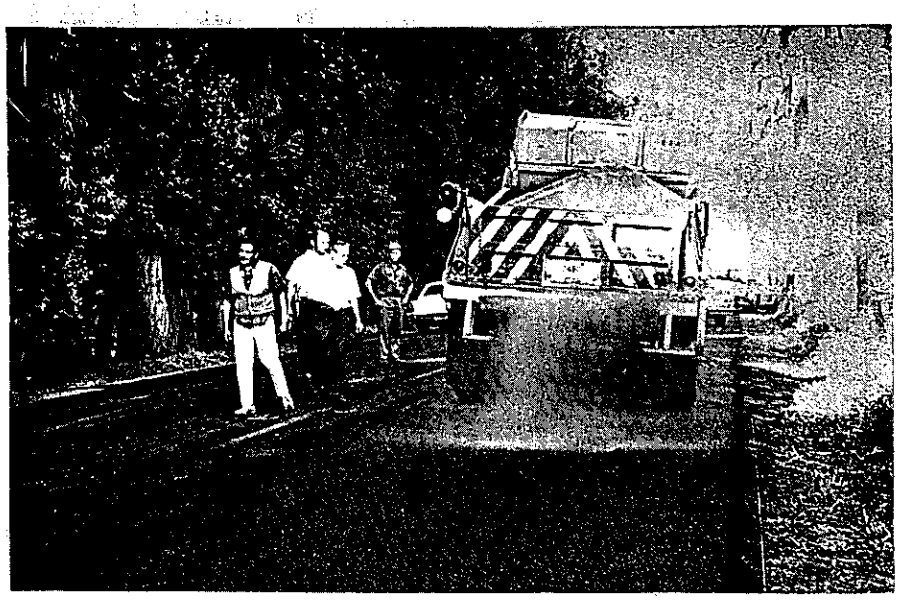
Sand choker was spread through a sand spreader (Figure 7). The first sand choker applied was seen to nearly hide the mixture with an estimated cover of 1/8-inch and was felt to be excessive. Subsequent amounts (after the first 100 feet of the first paved lane) were reduced so as to give the appearance of a lightly scattered sand effect.

Figure 7 - Applying Sand Choker

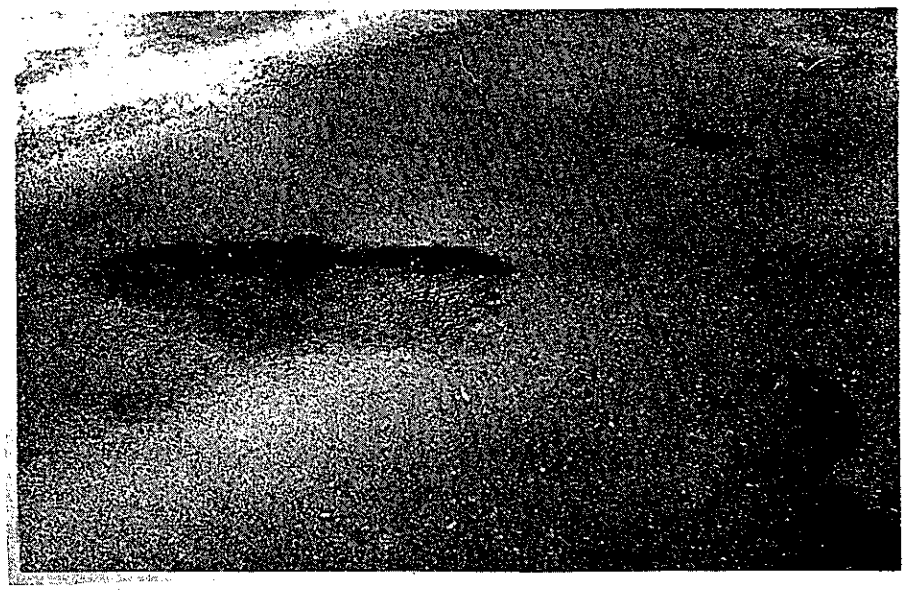
Dense graded mixture was placed using the following construction sequence: (a) placement of the mixture, (b) rolling immediately with a steel tandem roller - 2 coverages. The dense graded mixture did not have a sand choker applied. This mixture after placing appeared to take longer to cure and several wet spots could be detected (Figure 8). After 4 to 6 hours the entire surface was covered by a film of free water.

Figure 8 - Wet Spots Appearing
in Dense Graded Surfacing

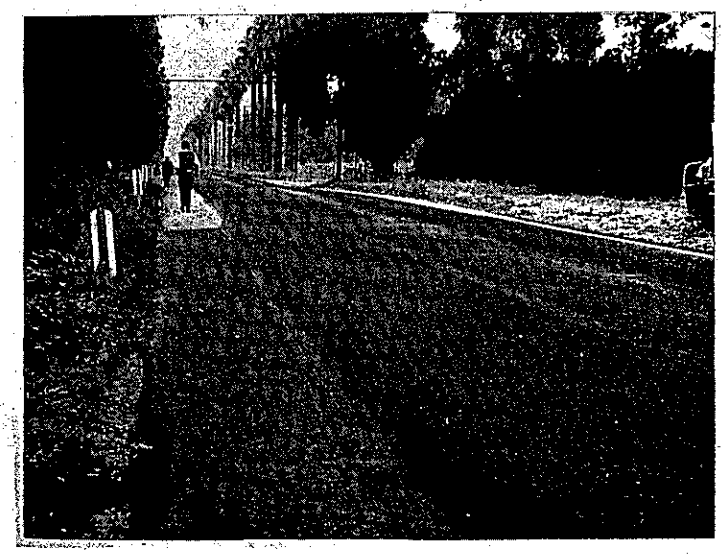
The dense graded mixture also showed a slight amount of raveling after 24 hours (Exhibit 4) and there was visual evidence the mixture had not cured completely. A 2-foot section near each edge of pavement appeared brownish compared to the rest of the pavement, which indicated the asphalt still was emulsified (Figure 10).

Figure 10 - Indication of Insufficient Cure in Dense Graded Mix

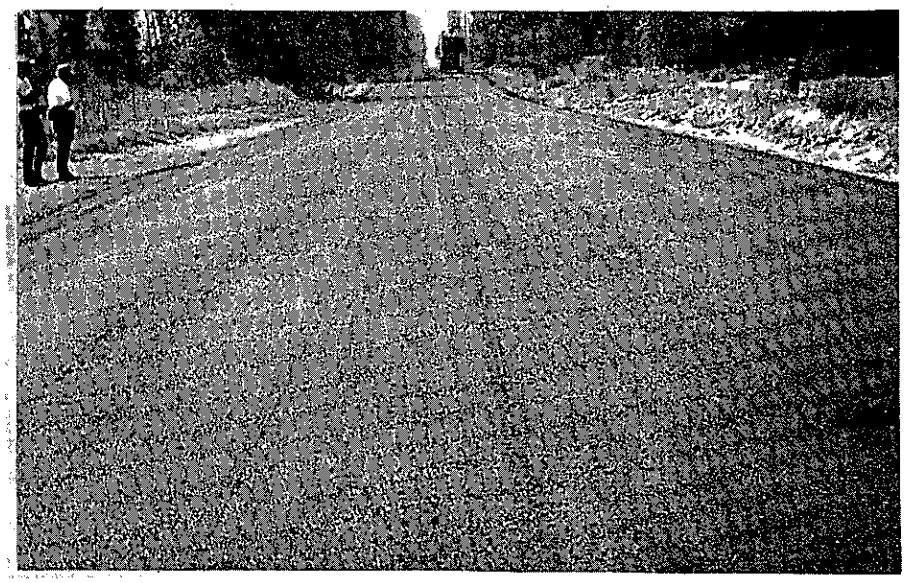
The wheel track areas appeared black and cured; however, this was only a surface condition. The fact that this area was not sufficiently cured in depth was confirmed a few hours later when a fog seal was applied consisting of CSS-1h emulsion diluted three parts emulsion to one part water and applied to obtain a theoretical 0.10 gal. per sq. yd. residue. A short section was not fog sealed for comparative purposes. Traffic was allowed over both areas immediately and, as the emulsion in the sealed section began to break, it stuck to both tires and surfacing. The results were serious tearing and raveling of the surface (Figure 11). Rocks ripped from the surface were thrown by the tires of fast moving traffic, creating a hazard. Sand was immediately brought out and placed on the surface to blot the emulsion. This was successful and additional raveling and tearing of the surface was arrested.

Figure 11 - Dense Graded Surface
1 Hour After Fog Seal

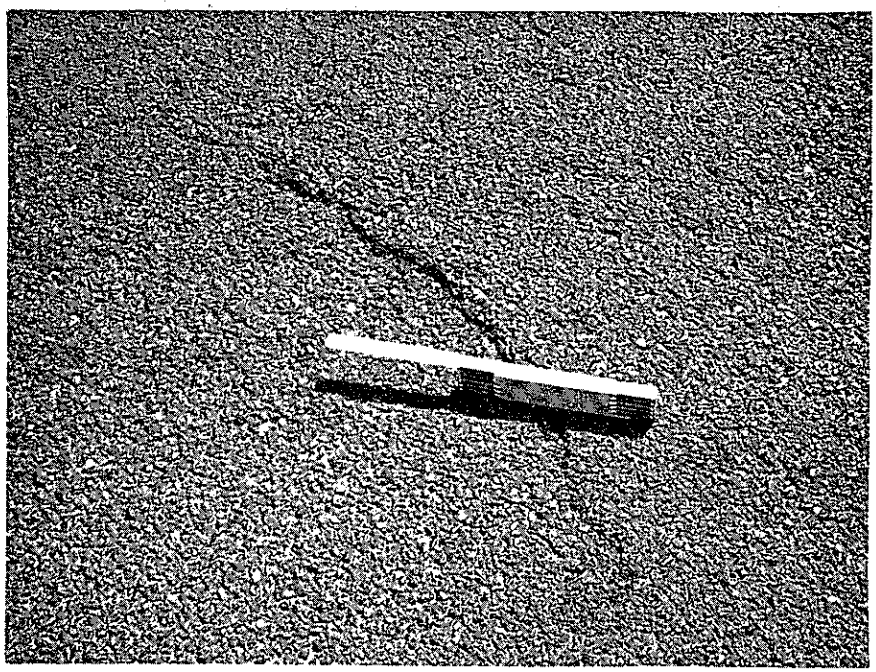
The next field review occurred approximately six months after construction and revealed that the open graded mix had deteriorated. Previously observed hairline reflective cracking had increased and some cracks were spalling (Figures 13 and 14). There was

Figure 14 - Raveled Reflective Crack in Open Graded Surface

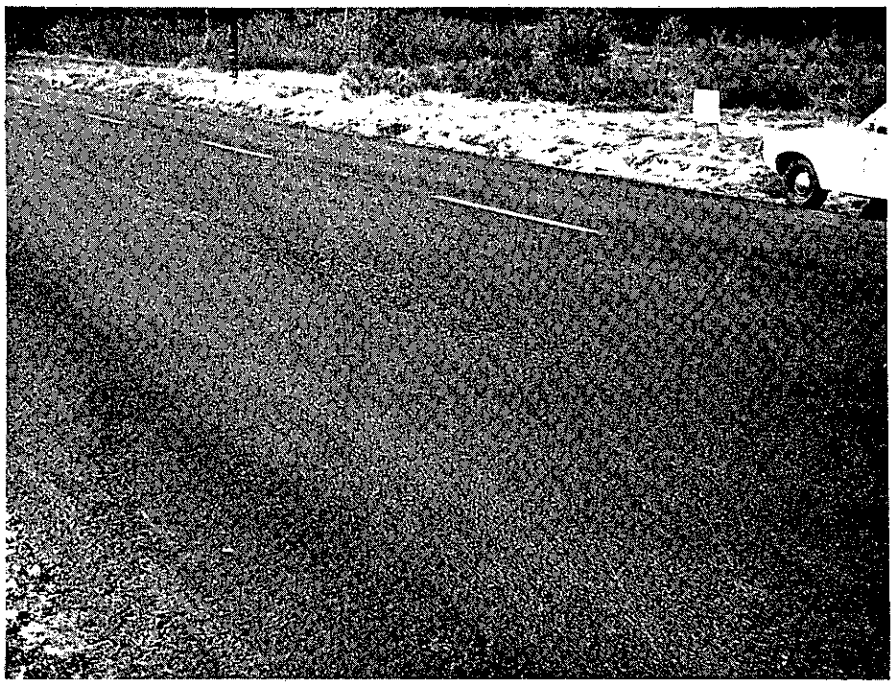
The 90-day pavement survey indicated that dense graded mix in the area where fog seal was not applied had substantial surface raveling (Figure 17). The dense graded mix with fog seal also had surface raveling (Figure 18); however, it was difficult to determine whether it had increased in severity. District personnel feel there has been some progression since the first occurrence. A small amount of hairline cracking was also noted.

Figure 18 - Raveling in Dense Graded Surface
(Fog Seal - 90 Days)

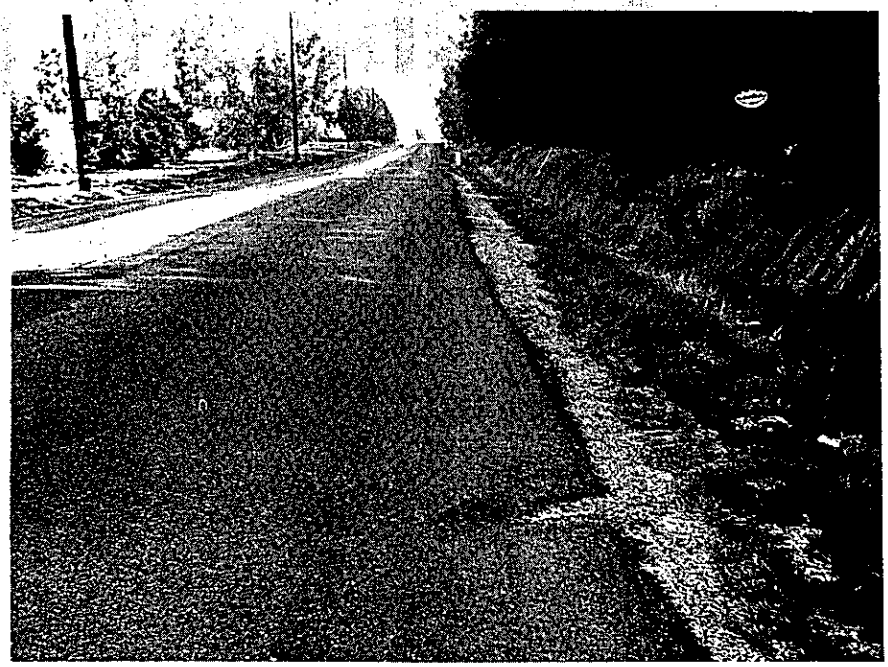
Edges of the mix were friable and easily displaced with foot pressure as in the case of the open graded mix. Also, some loss of material from the edge at the lanes was noted (Figure 19).

Figure 19 - Friable Shoulders Due to Lack of Compaction

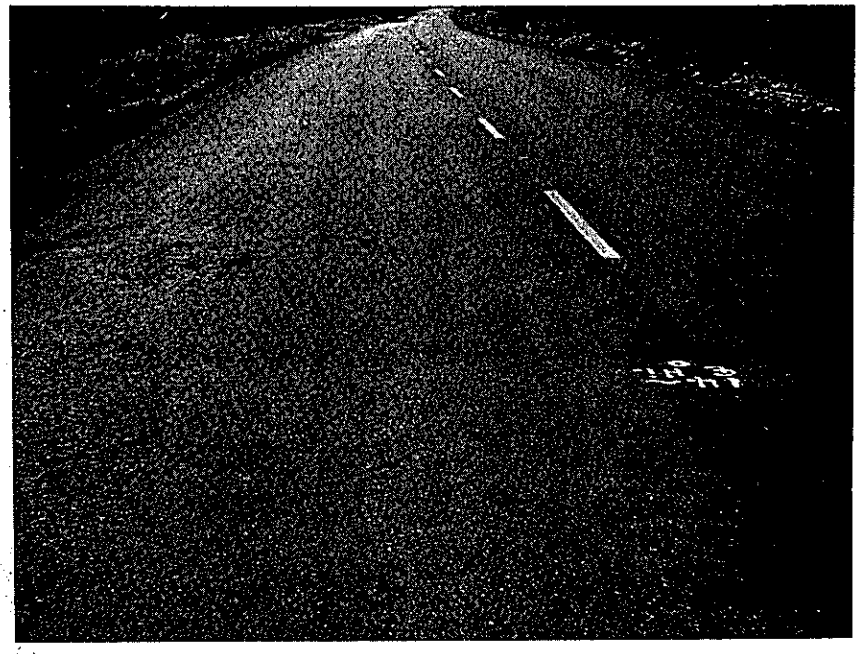
the effects of raveling caused by the original fog seal though some signs still appear and in some areas there is evidence of the longitudinal construction joint (Figure 22). The unsealed area had continued to deteriorate and was definitely in

Figure 22 - Evidence of Raveling and Construction Joint in Dense Graded Surface After One Years Service Life

need of a maintenance seal. Crescent shaped slippage cracks, caused by the heavy truck traffic shortly after paving, were still present and in one case the material had raveled through to the overlayed pavement in an area approximately 6-inches in diameter.

necessary; however, experience with this job proved that it should not be applied until the emulsion is sufficiently cured. It is also evident that traffic should be kept off the dense graded mix for as long as possible to allow proper curing and prevent initial surface damage. However, this is not generally possible, particularily with overlay work. In any case the performance of this cold mix dense graded material is sufficient to warrant additional investigation.

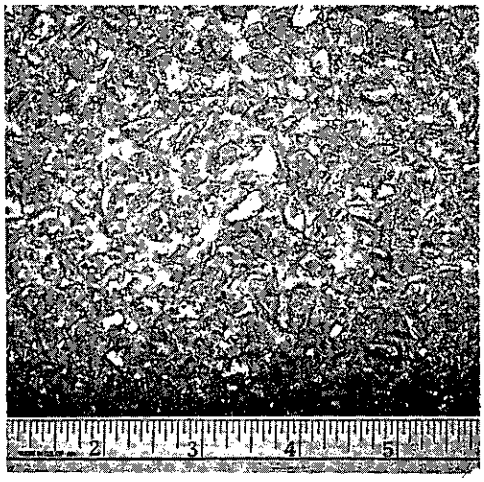
The first section of open graded mix had noticeable surface raveling (Exhibit 3) and two or three areas were raveled through to the overlayed surface. Subsequent sections of this mixture showed less severe raveling. It was felt that raveling in the first section was due, at least in part, to placing the sand choker too early, which retarded curing and resulted in a lack of surface cohesion. Raveling was generally confined to the wheel track areas.

24 Hrs. of Traffic
(5)
