DYNAMIC TESTS OF METAL BEAM GUARDRAIL SERIES XXVII

INTERIM REPORT

74-14

TRANSPORTATION LABORATORY

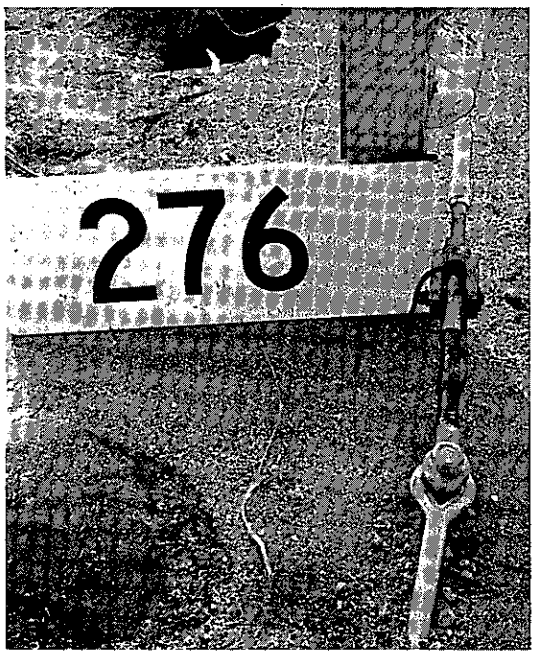
Figure 11
Cable End Anchor Used on Barrier for Test 276

b. The cable clips at the standard end anchor connection were replaced with a swaged fitting and clevis resulting in a positive cable connection.

To correct this condition, two changes were made to the barrier design for Test 276; (1) a swaged fitting and clevis were used to replace the five cable clips on the cable end anchorage to provide a positive anchorage and (2) twelve inch long backup sections of W-section beam were placed behind the beam at alternate posts where beam splices did not occur. These backup sections reduced the tendency of the rail to tear along the hard sharp edge of the steel blocks and posts. The results of Test 276 proved the effectiveness of these modifications.

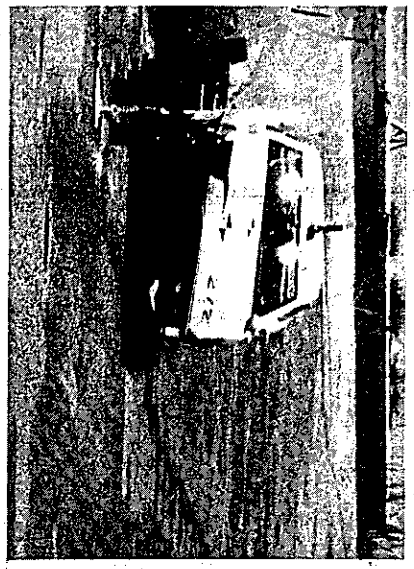
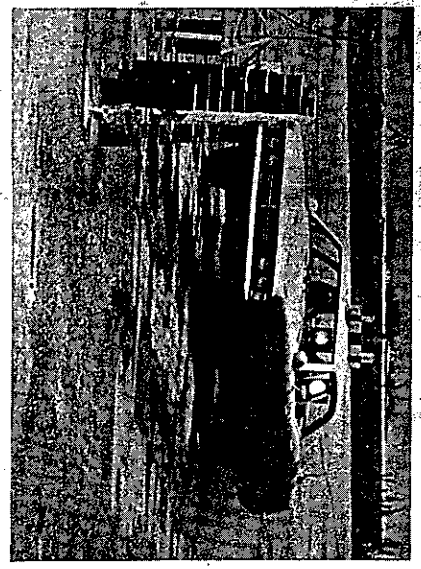
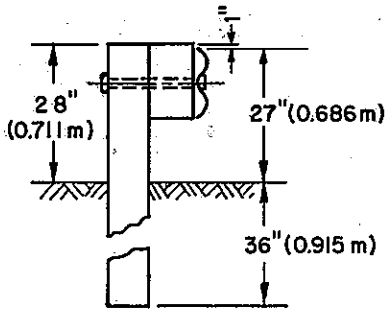
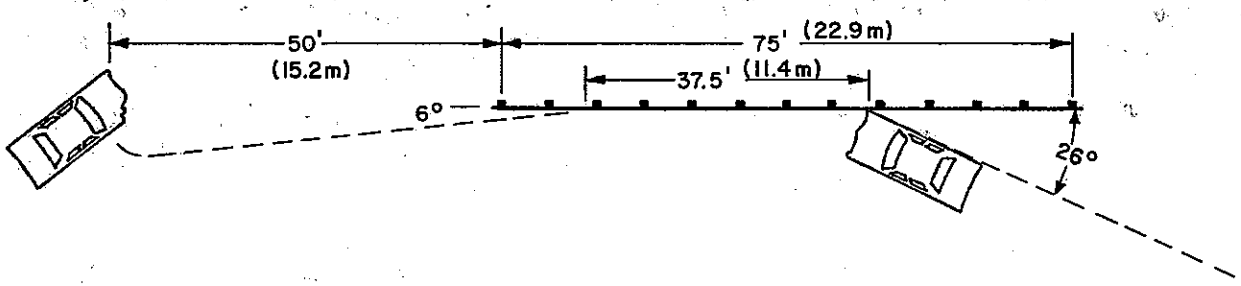
FIGURE 12, TEST 272

There was little rise or roll imparted to the vehicle during impact until it was nearly parallel to the barrier. Then the vehicle rolled away from the barrier about 15° and the right front end rose about 0.9 ft (0.274 m). The vehicle traveled smoothly through impact and had an exit angle of the vehicle c.g. of about 6° and an exit heading angle of 0° so that it stayed close to the barrier and almost parallel to it. Figure 12 shows sequential photographs of the impact event.

Principal damage to the vehicle included: a severely crushed right front bumper and fender, severe damage to the right front wheel, cracked windshield, crushed and jammed right front door, right door post torn loose at roof, and crimps in the roof on the right side. The car could not be driven away. There was no intrusion of vehicle parts or barrier components into the passenger compartment. Vehicle damage is shown in Figure 31 in Discussion of Test Results.

Two guardrail posts, #8 and #9, near the point of impact were destroyed and pieces of the posts and their blocks were splintered and broken and thrown behind the barrier. Two other posts, #4 and #7 and their blocks were split. The metal beam was partially flattened and raised near the area of impact. Maximum displacement of the posts at ground level was one foot. Table 5 in the Discussion of Test Results shows the post movement at ground level. Figure 22 in Discussion of Test Results shows the barrier damage.

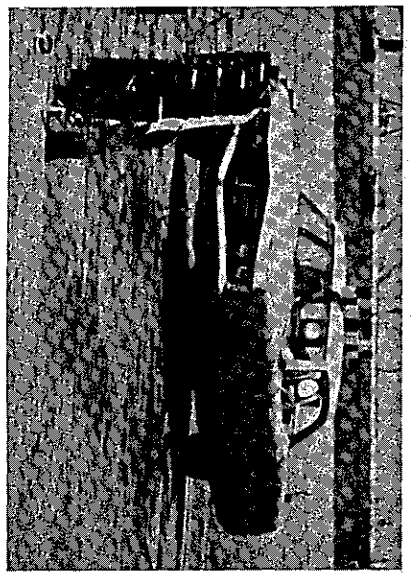
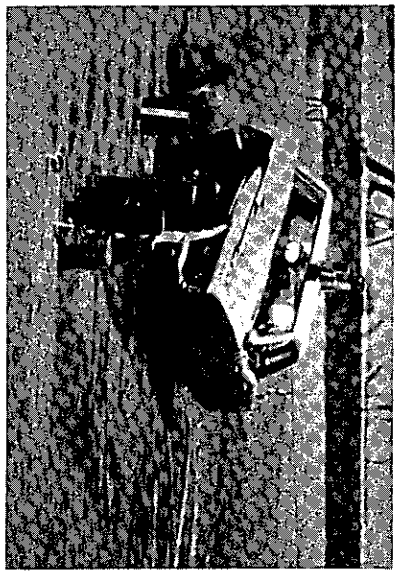
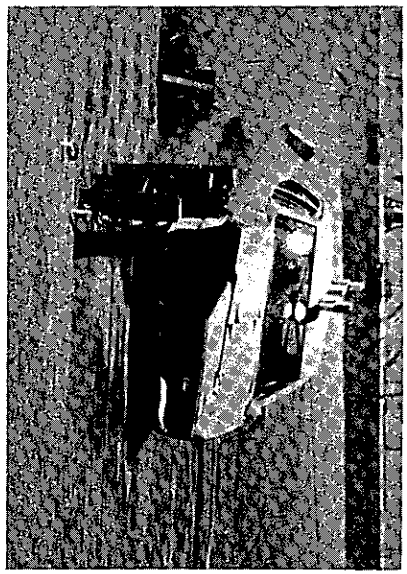
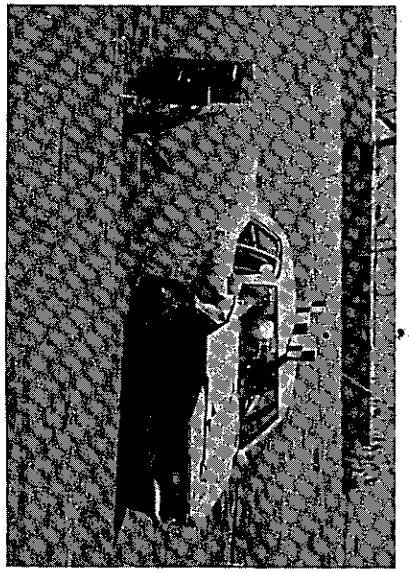
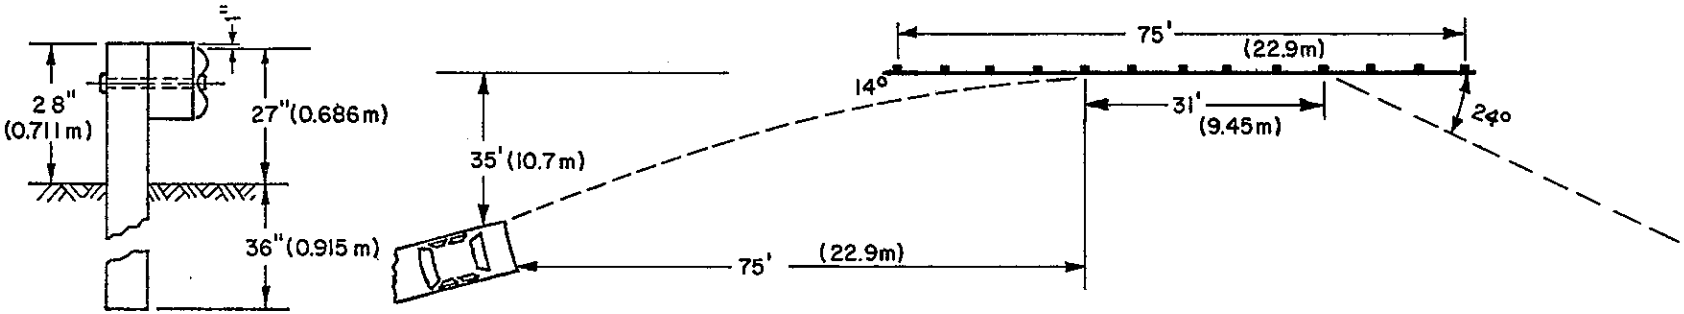
FIGURE 13, TEST 273

Vehicle behavior was very similar to that in Test 272. There was little rise or roll imparted to the vehicle during impact until it was nearly parallel to the barrier. Then the vehicle rolled away from the barrier about 15° and the right front end rose about 0.8 ft. (0.244 m). The vehicle traveled smoothly through impact. The exit angle of the vehicle c.g. was 14° which was the same as the exit heading angle of the vehicle. This angle gradually increased as the vehicle moved away from the barrier. Figure 13 shows sequential photographs of the impact event.

Principal damage to the vehicle included: severely crushed right front bumper and fender, severe damage to the right front wheel, cracked windshield, crushed and jammed right front door, and the

right door post torn loose at the roof. The car could not be driven away. There was no intrusion of vehicle parts or barrier components into the passenger compartment. Vehicle damage is shown in Figure 32 in Discussion of Test Results.

Two guardrail posts, #6 and #7, near the point of impact were destroyed. A third adjacent post, #8, was splintered and one post near each end of the barrier was split. Three blocks were broken and thrown behind the barrier along with some of the splintered post debris. The beam was partially flattened and raised near the area of impact. Maximum displacement of the posts at ground level was 1.65 ft (0.503 m) perpendicular to the barrier at post #5. Table 5 in the Discussion of Test Results shows the post movement at ground level. Barrier damage is shown in Figure 23 in Discussion of Test Results.

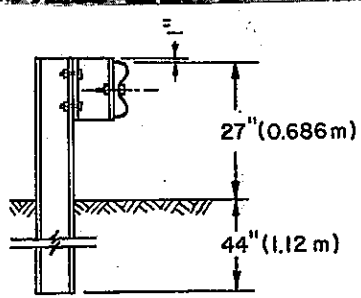
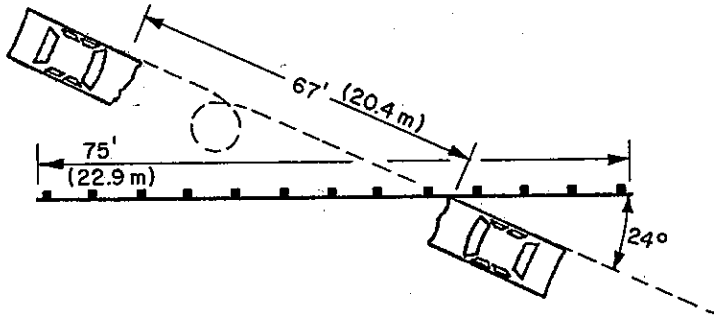
FIGURE 14, TEST 274

Beam Rail	(2.68 mm) 12 ga. Galv. Steel
Post	(152mmx12.65kgf/m) W6x8.5 Steel
Post Embedment	(1.12 m) 3'-8"
Post Spacing	(1.90 m) 6'-3"
Length of Installation	(22.9 m) 75'-0"
Max. Perm. Rail Deflec. (lateral)	Penetration
End Anchorage	Cable, 5 cable clips
Max. 50msec. avg. vehicular deceleration - Lateral	4.75G's
Longitudinal	5.80G's

Test No.	274
Date	8/22/72
Vehicle	1970 Mercury
Vehicle Weight (w/dummy & instrumentation)	(2260 kgf) 4960#
Impact Speed	(101 km/hr) 63 mph
Impact Angle	24°
Exit Angle	Penetration
Vehicle Rise	None
Dummy Restraint	Lap Belt

very little roll imparted to the vehicle during impact. Figure 14 shows sequential photographs of the impact event.

Principal damage to the vehicle included: severely crushed left and right front fenders and bumper, broken headlights, crushed hood, the engine moved upward about 12 inches (0.305m), the left front door jammed, and the left and right front tire movement were restricted. The car could not be driven away. There was no intrusion of vehicle parts or barrier components into the passenger compartment. No marks were apparent on the dummy or vehicle interior that would indicate a dummy to vehicle impact except for a five inch (127 mm) deformation of the steering wheel away from its original plane. The dummy was found lying on its right side on the car seat. The driver's seat back was broken. Vehicle damage is shown in Figure 33 in Discussion of Test Results.

The barriers impacted in Tests 272, 273 and 276 all met the above requirements. There were no indications that the barriers were on the brink of failure. The barrier impacted in Test 274 was penetrated which was unacceptable. An analysis of that failure is described in a later section. Figures 22 through 25 show barrier damage for all four tests. Figures 26 through 30 show closeup views of posts near the impact area for Test 276. The backup plates at posts #4 and #8 clearly resisted excessive bending of the W-section beams at the posts. Samples of soil from the barrier test site were tested. A copy of the soil report is contained in the Appendix in Section D. This report indicates the soil was quite strong. It consisted of a layer

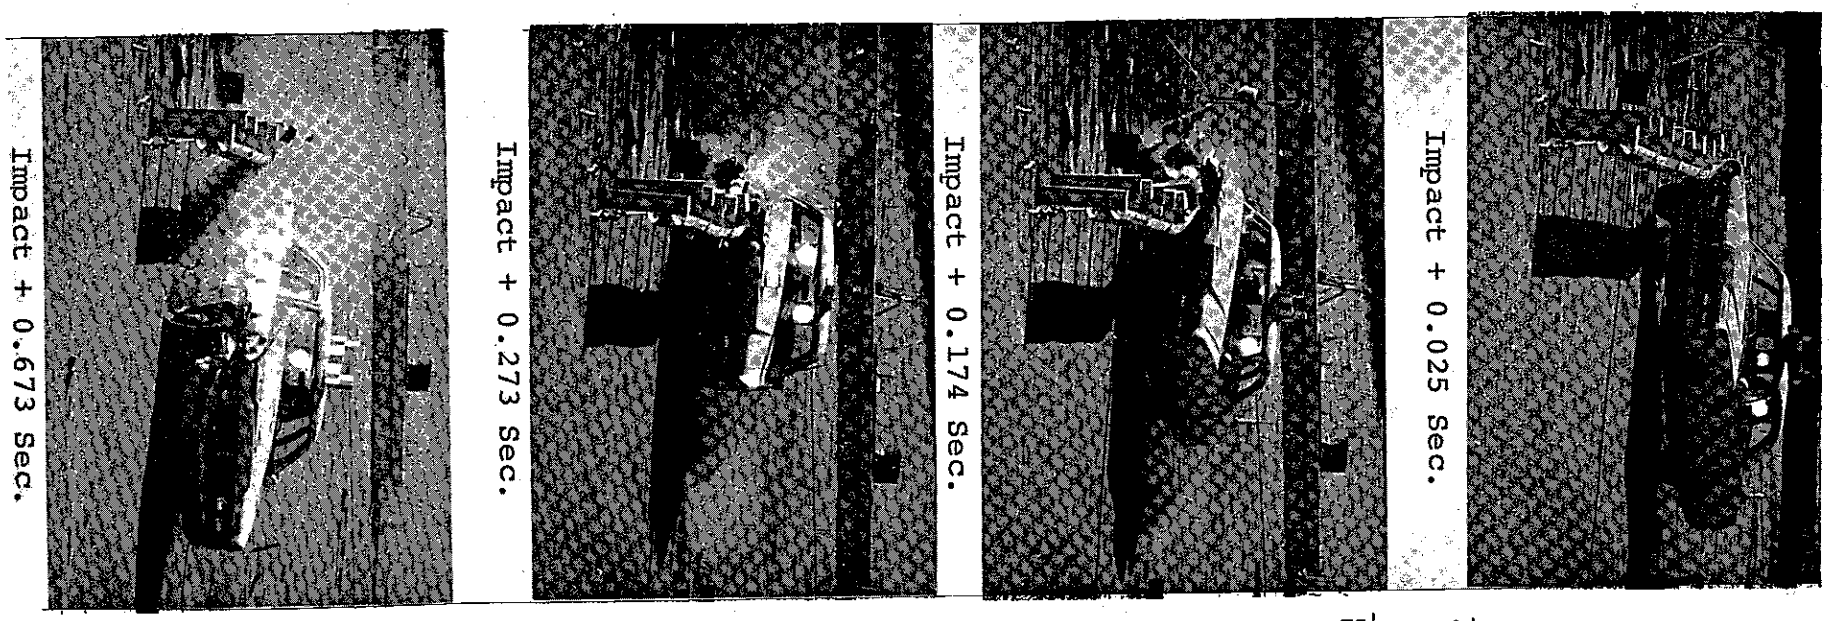
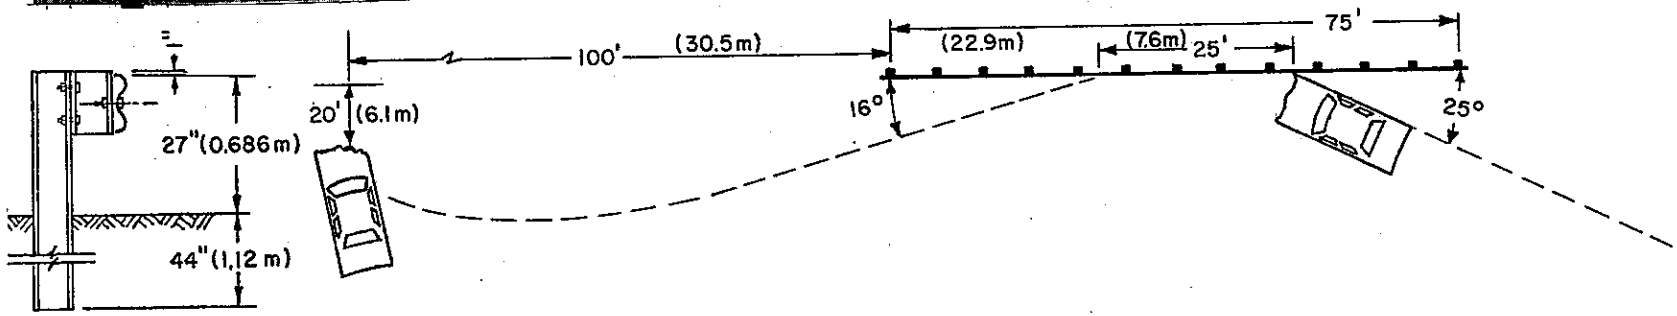
FIGURE 15, TEST 276

Beam Rail	(2.68 mm) 12 ga. Galv. Steel
Post	(152 mmx12.65 kgf/m) W6x8.5 Steel
Post Embedment	(1.12m) 3'-8"
Post Spacing	(1.90m) 6'-3"
Length of Installation	(22.9m) 75'-0"
Max. Perm. Rail Deflec. (lateral)	(0.536m) 1.76'
End Anchorage Cable, Swaged fittings both ends	
Max. 50msec. avg. vehicular deceleration - Lateral	6.85G's
Longitudinal	3,78G's

Vehicle behavior was very stable during impact; there was virtually no vehicular roll or rise as redirection occurred. The exit angle of the vehicle c.g. was about 16° and was the same as the exit heading angle of the vehicle. This angle decreased as the car skidded clockwise to a stop, coming back towards the barrier. Figure 15 shows sequential photographs of the impact event.

Principal damage to the vehicle included: severe crushing of the right front fender and bumper, jamming of the left and right front doors, damage to the right front wheel structure, and moderate crushing of the right rear fender. Vehicle damage is shown in Figure 34 in Discussion of Test Results.

Barrier damage consisted mainly of moderate twisting and bending of posts #5, #6 and #7 although none of the posts were bent to the ground. Separation of the metal beam guardrail from the steel post block occurred only at post #6. Severe buckling of the blocks occurred at posts #5, #6, and #7. A maximum of 3/8" (9.5 mm) slippage of a beam splice occurred at post #5. Minor twisting of the posts and blocks occurred at posts #4 and #8. Barrier damage is shown in Figures 25 through 30 in Discussion of Test Results.

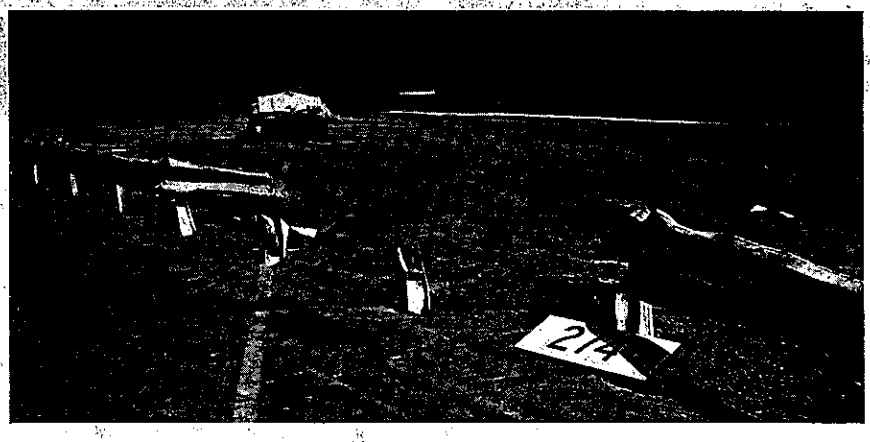
Figure 24, Test 274 Barrier Damage

the Appendix shows the rail which tore next to a post at the downstream edge. This section describes the analysis of that failure which led to the successfully revised barrier design used in Test 276.

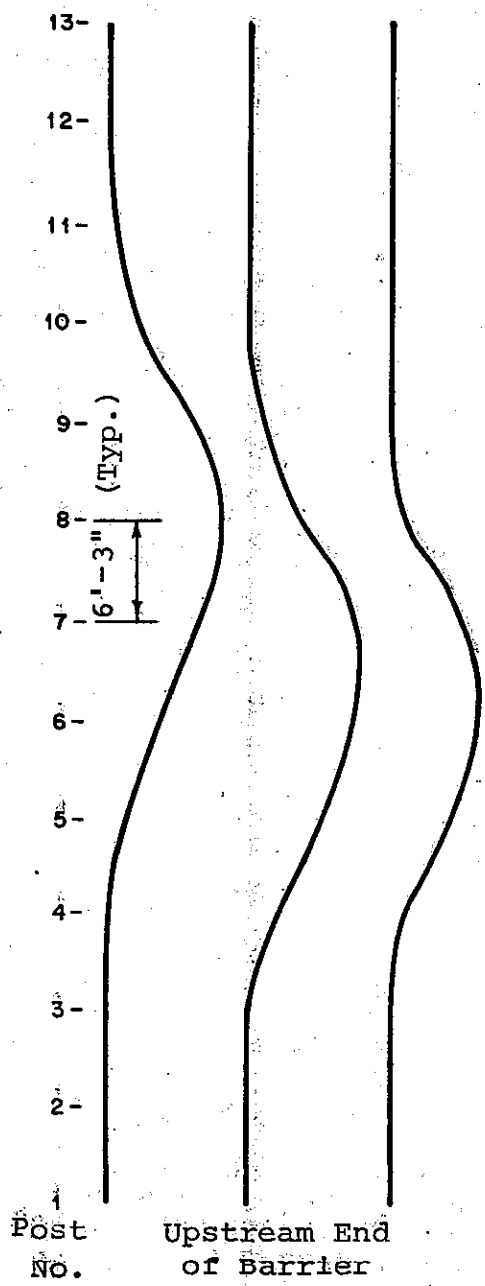
The deflection of the rail in Test 276 is less than that for Tests 272 and 273 and may account for the relatively low longitudinal vehicle deceleration. Table 6 compares the barrier rail deflections of these tests with other test series. This table clearly shows that the permanent barrier rail deflections were in the same range as those recorded for previous test series. It should be noted that the vehicle kinetic energy at impact for Tests 272, 273 and 276 was appreciably higher than that for other tests in the table. Barrier damage in Tests 272 and 273 was very

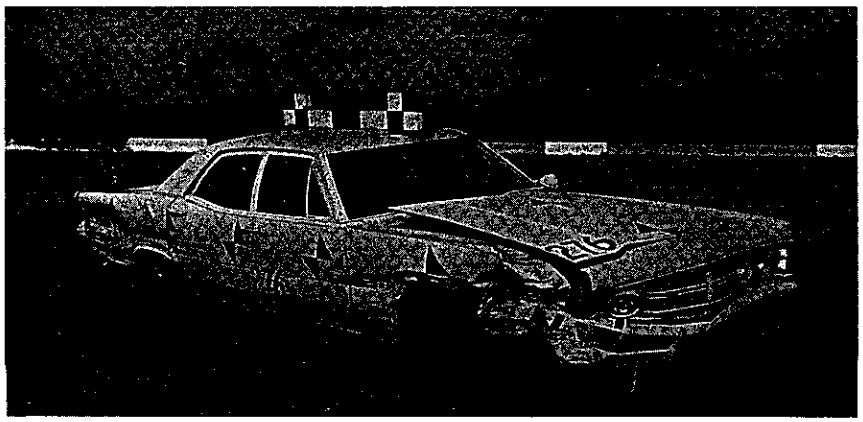
Figure 34, Test 276 Vehicle Damage

Figures 31 through 34 compare the vehicle damage incurred in the four tests. Comparing Tests 272, 273 and 276 the damage to the right front portion of the vehicle was quite severe and roughly similar for all tests. The right front wheel was disabled in all three tests.

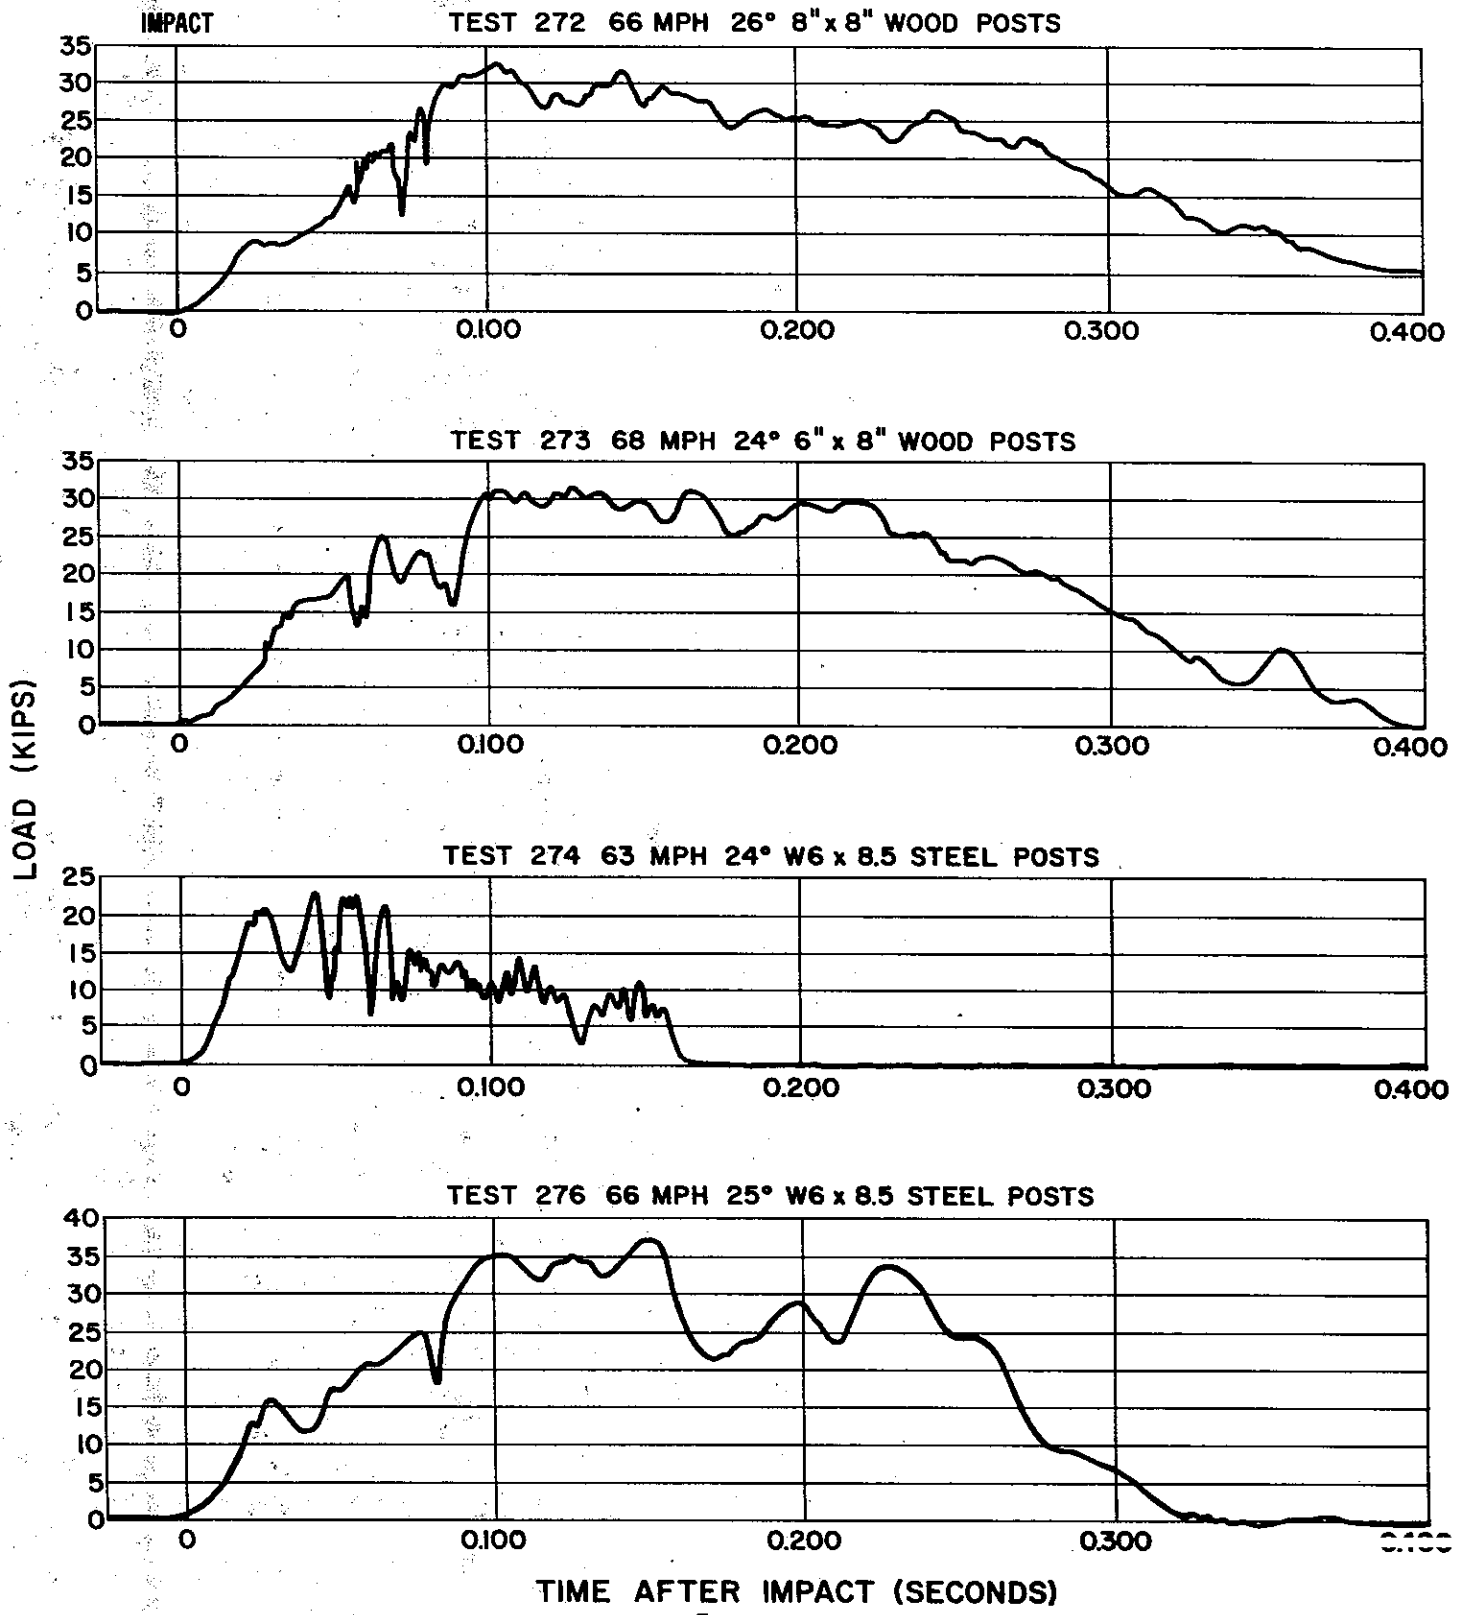
Figure 16A UPSTREAM ANCHORAGE
LOAD VS TIME

Time After Impact	Event (Reference Figure 19A)
I (Impact) + 0 to I+25 (milliseconds)	The rate of onset of load in the upstream cable is much higher for steel posts than wood posts. (Figure 16A). The wood posts, possessing much higher torsional rigidity, help the cable anchor carry the load.
I + 25 to I + 50	Upstream cable slips slightly, say 1"± (2.5 cm), due to the high rate of onset. The loss of tension in the W-section decreases its beam strength - the compressive bending stresses exceed the tensile cable stresses allowing the beam to buckle at post #5. Because of this hinge, post #5 is not moved (perpendicular to rail) prior to being impacted by the car.
I + 50 to I + 60	Post #5 is solidly hit by the car. The upstream cable slips drastically.
I + 60 to I + 80	The upstream posts are bent severely as they attempt to carry the tension in the upstream beam. The downstream anchor carries tension in accordance with the tension carried by the upstream posts.

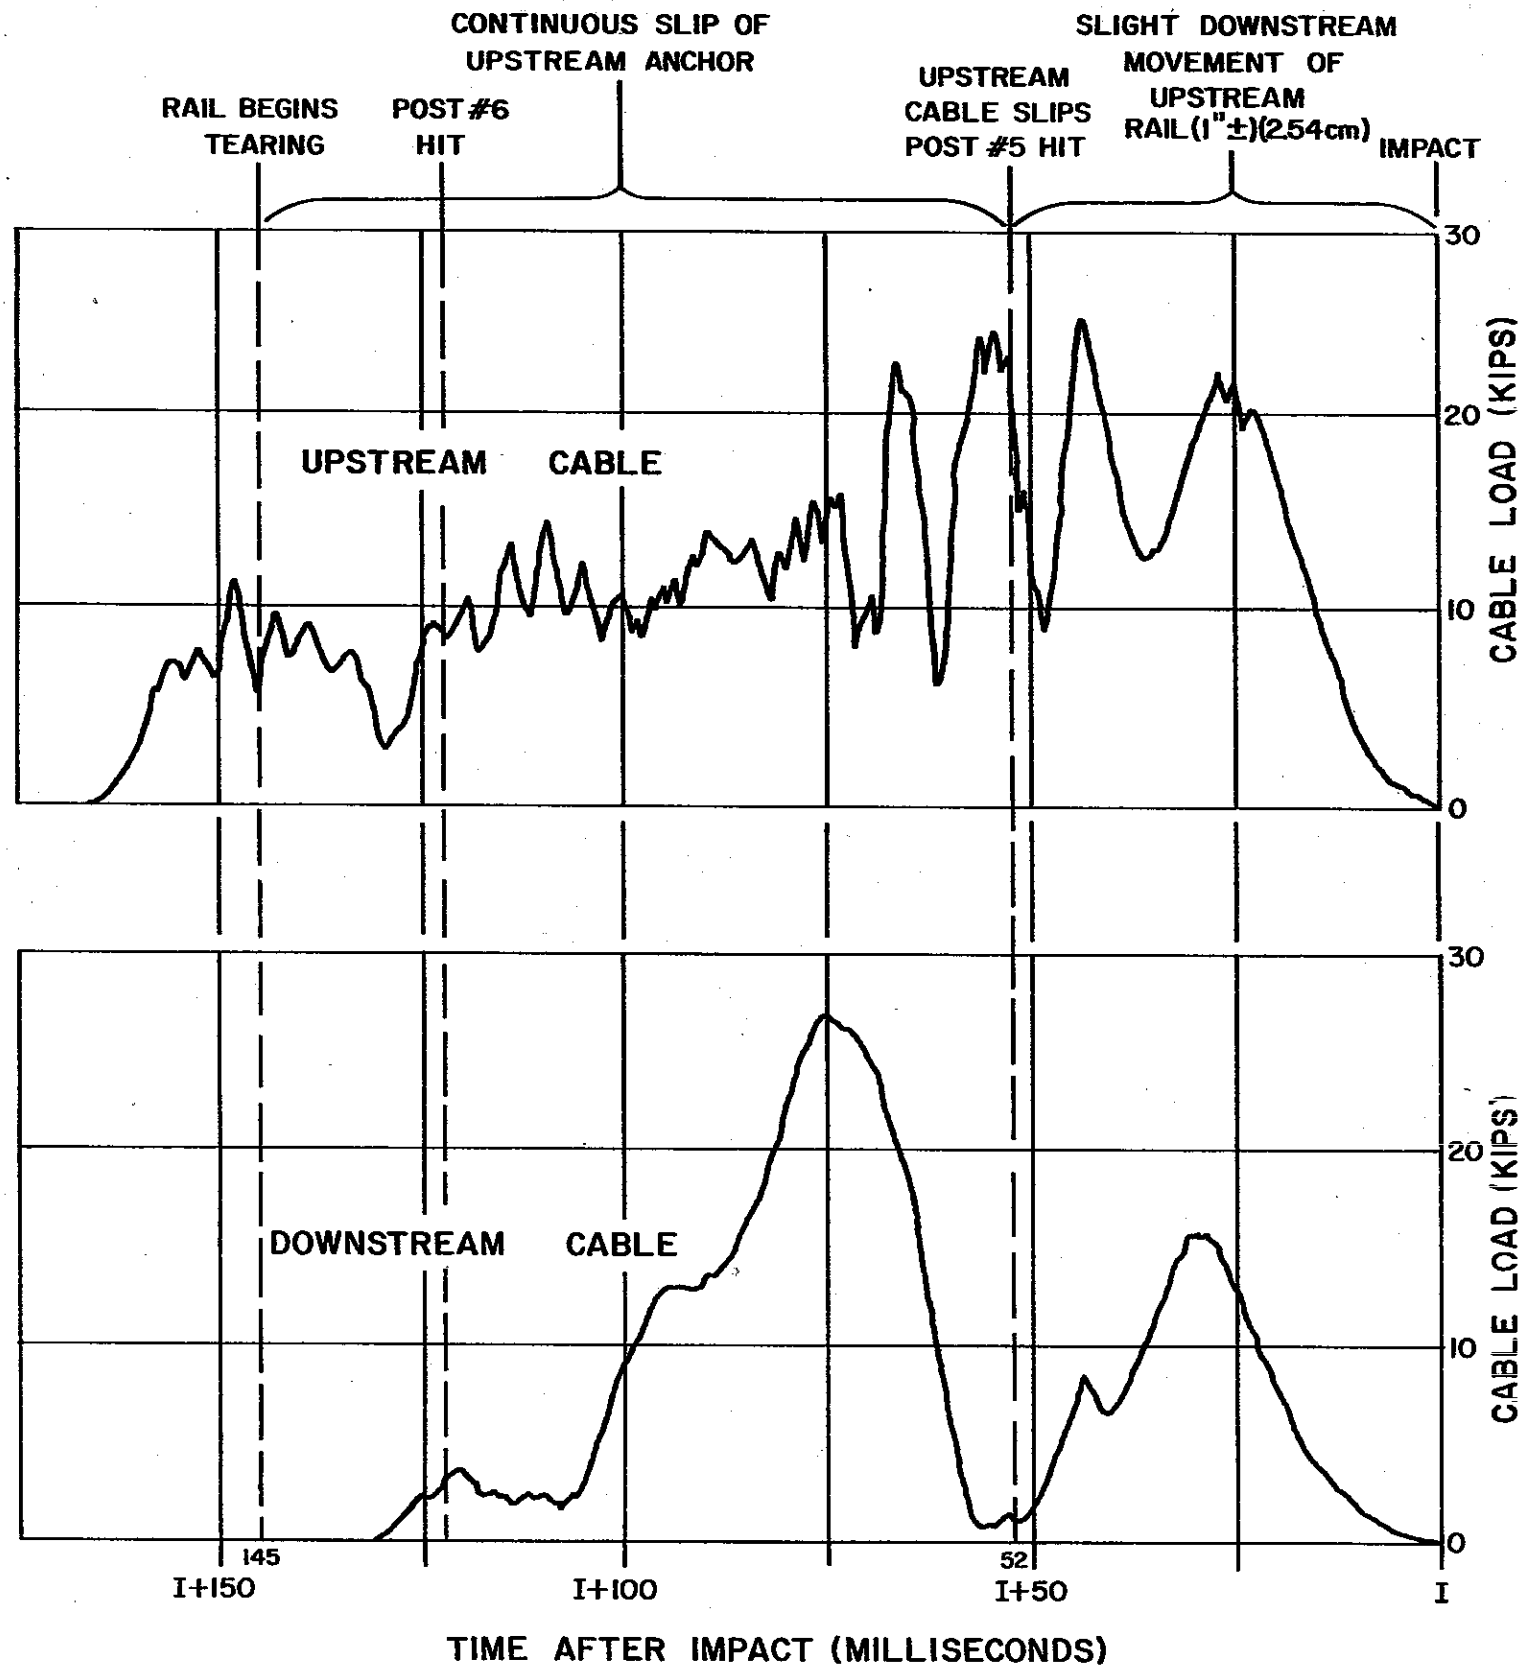
FIGURE 19A, TEST 274

The following analysis is made with reference to Figure 19A which shows load vs. time of the end anchor cables during impact and events observed on the data movies at the specified times. Figure 20A also relates to this analysis.

I + 80 to I + 120	Rail has pocketed so far that car is tending to push rail downstream. Upstream anchor continues to slip.
I + 120 to I + 150	Post #6 is solidly hit by car. At upstream end, the bolts connecting the W-section to the blockouts are sheared off (or torn through rail).
I + 150	Rail is under engine compartment of car when it tears at the downstream face of post #6 (Figure 18A).
I + 205	Car hits post #7 which pushes the remaining portion of the downstream rail downstream.

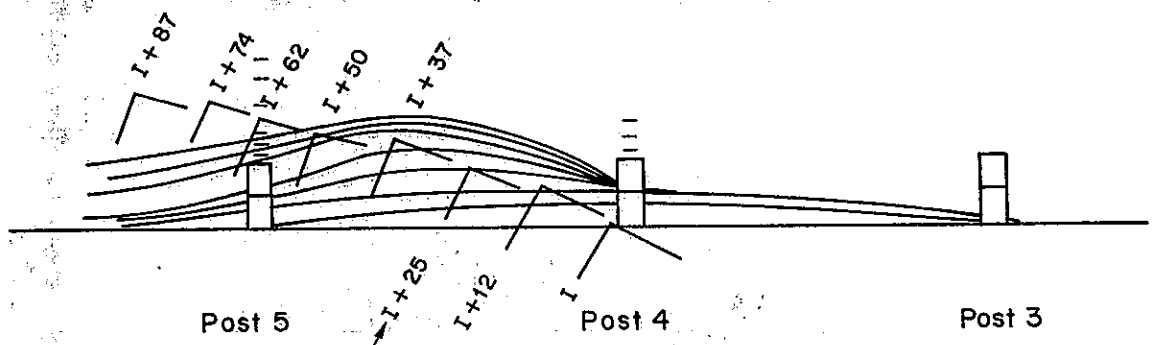
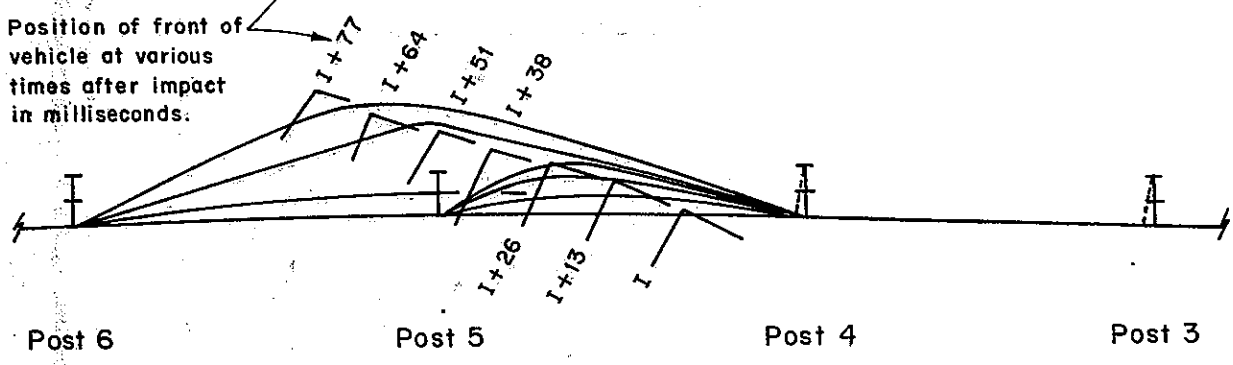
FIGURE 20 A

2. The steel posts did not move prior to being impacted. The wood post in our Tests 272 and 273 and the steel posts in Southwest Research Test #120 did move prior to impact[3]. (Figure 20A)

These are tracings from overhead camera #2, as viewed on the Vanguard Motion Analyzer. Note that the steel posts do not move prior to being impacted by the car.
