TRANSPORTATION LABORATORY
RESEARCH REPORT

DYNAMIC TESTS OF METAL BEAM GUARDRAIL

CA-DOT-TL-6392-5-75-04

Presented at the 54th Annual Meeting
of the Transportation Research Board
January 1975

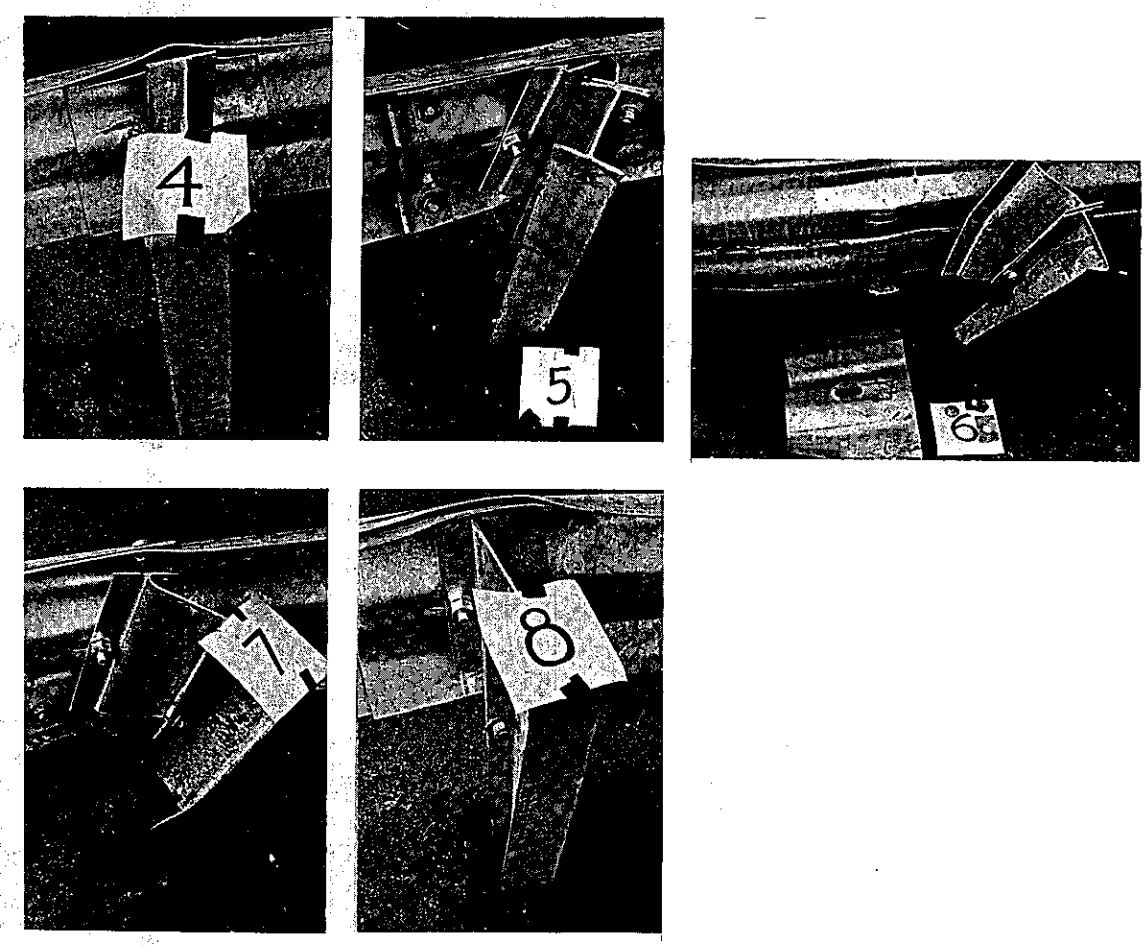
Figure 4 Barrier Damage, Test 276

Barrier damage consisted mainly of moderate twisting and bending of posts #5, #6, and #7 although none of the posts were bent to the ground. Separation of the metal beam guardrail from the

steel post block occurred only at post #6. Severe buckling of the blocks occurred at posts #5, #6, and #7. A maximum of 3/8" (9.5 mm) slippage of a beam splice occurred at post #5. Barrier damage is shown in Figure 4.

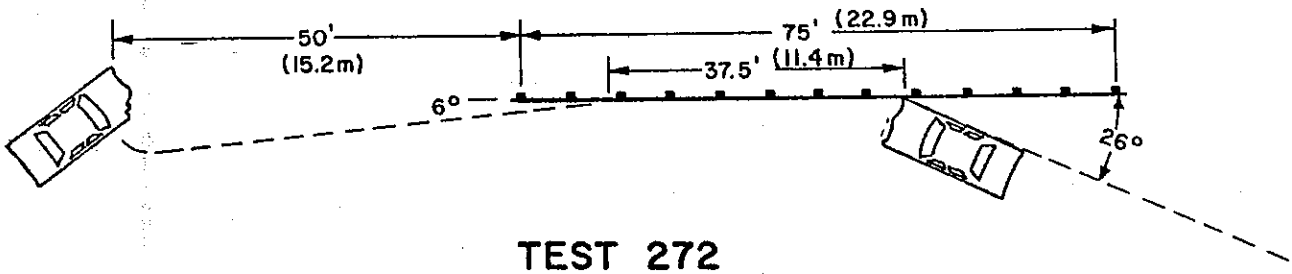
TEST 272

Figure 5 shows the test vehicle paths after impacting the test barriers. There is no easy answer to explain the variance in post impact trajectories. Various factors may have an effect including barrier deflection, vehicle crush and damage to the wheel, time when brakes are actuated by remote control, amount of rise and roll, paving surface conditions, etc.

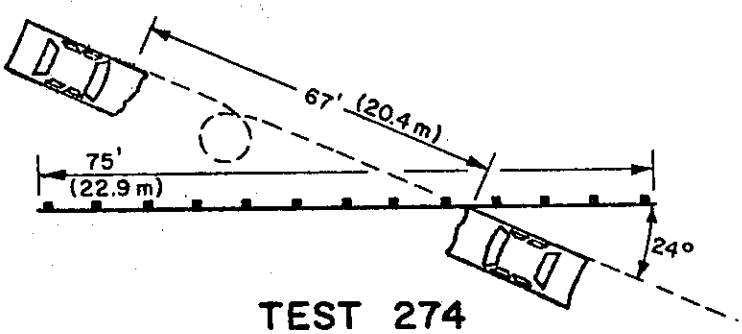
TEST 274

The vehicle penetrated the barrier with little change in direction and spun around 180° as it slid to a stop. There was no rise and very little roll imparted to the vehicle during impact. Figure 3 shows sequential photographs of the impact event.

The barrier used in this test incorporated W6 x 8.5 (152 mm x 12.65 kgf/m) steel posts and blocks. Penetration of the rail resulted when the vehicle impacted the barrier. This section summarizes the analysis of that failure which led to the successfully revised barrier design used in Test 276.

To correct this condition, two changes were made to the barrier design for Test 276; (1) a swaged fitting and clevis were used to replace the five cable clips on the cable end anchorage to provide a positive anchorage and (2) twelve inch long backup sections of W-section beam were placed behind the beam at alternate posts where beam splices did not occur. These backup sections reduced the tendency of the rail to hinge or tear along the hard sharp edge of the steel blocks and posts. The results of Test 276 proved the effectiveness of these modifications.

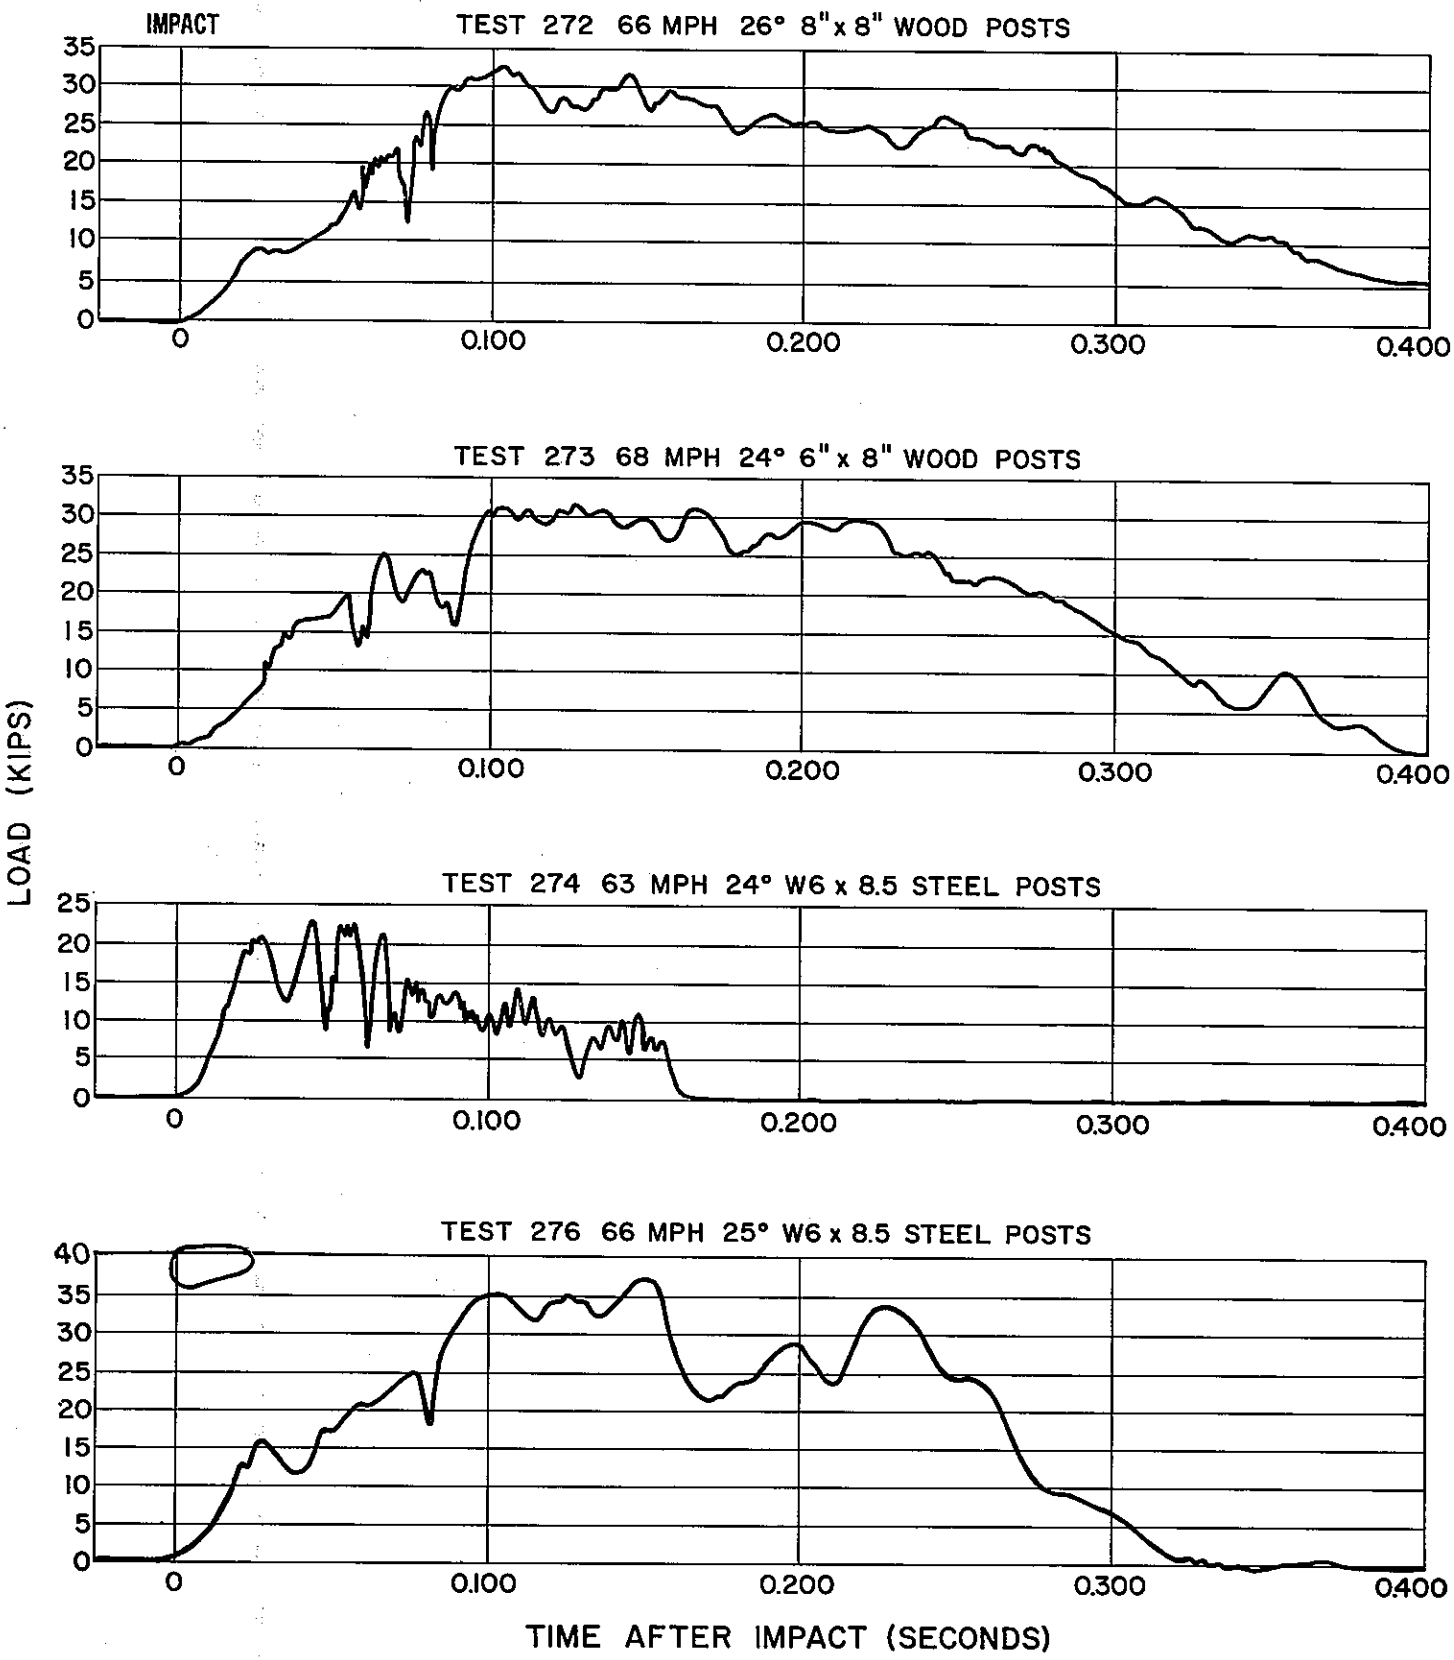
Figure 6 UPSTREAM ANCHORAGE
LOAD VS TIME

Figure 6 shows the loads on the anchorage cables during impact. They indicate more rapid load initiation times for Tests 274 and 276 where steel posts were used. They also show the cables are not overdesigned.
