# WIND SCREEN SUBDUES GALE FORCE WINDS ON A MOUNTAIN BRIDGE

## INTERIM REPORT

**NO. M & R 636357**

November 1968
Interim Report
M & R No. 636357-1

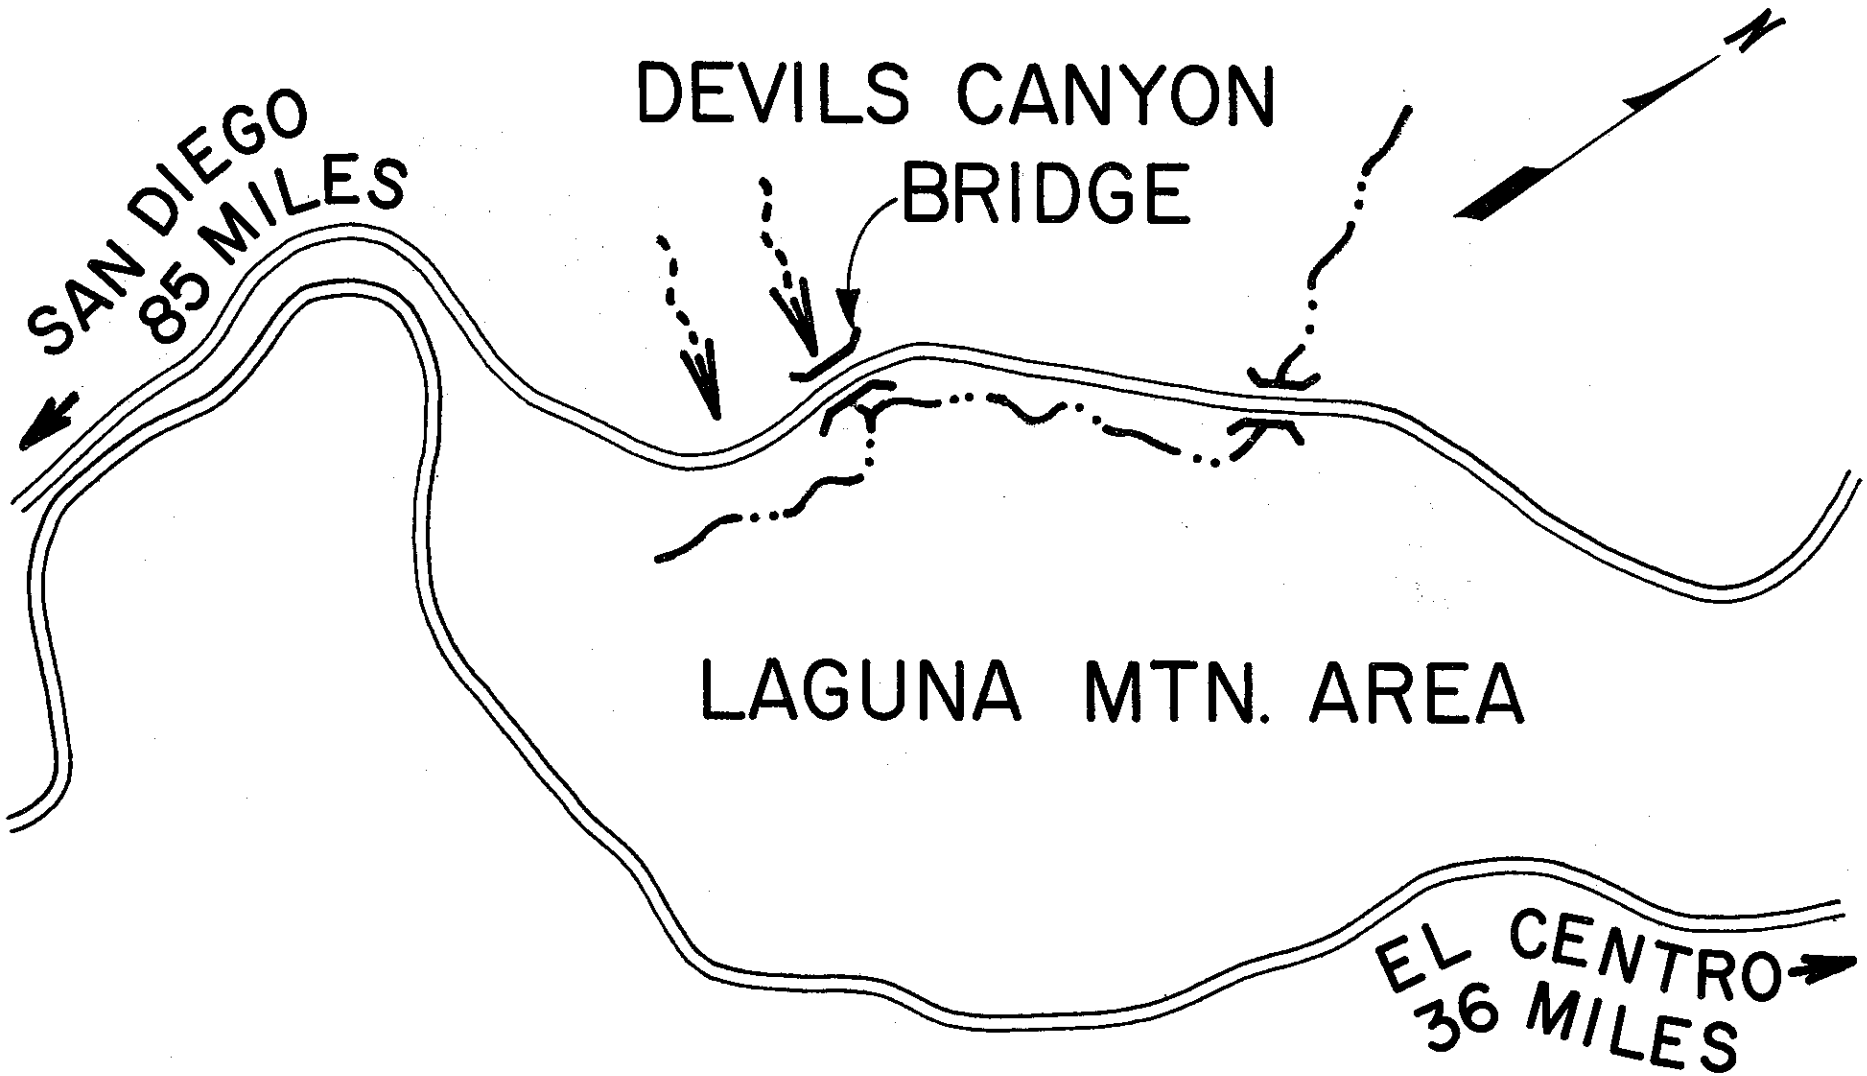
FIGURE 1

Most of the westbound lanes of the new freeway were completed first in the Laguna Mountain area to give the motorist a safer high level route with less turns and hazards from falling rock. To this end, some of the newly completed westbound lanes were temporarily required to handle both east and westbound traffic while work continued on the unfinished eastbound lanes (Figure 1).

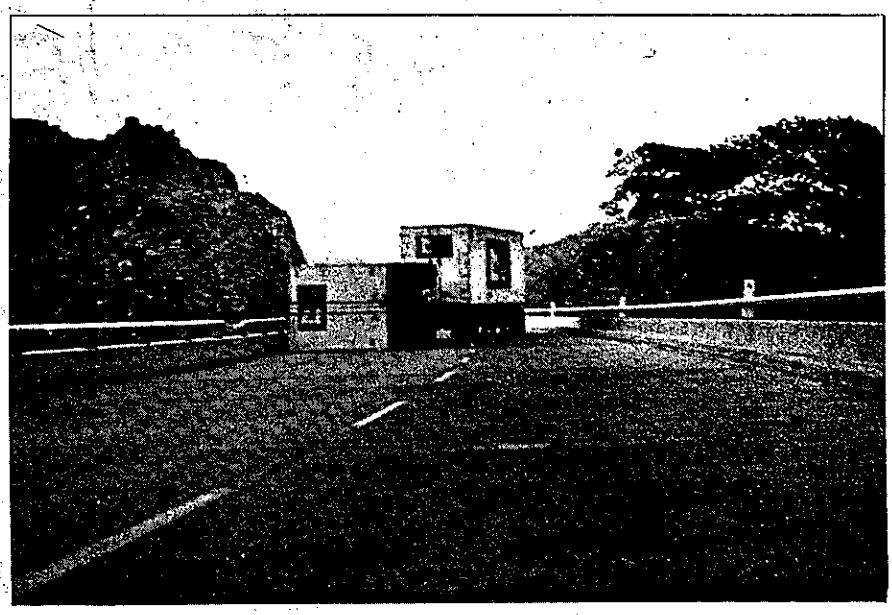
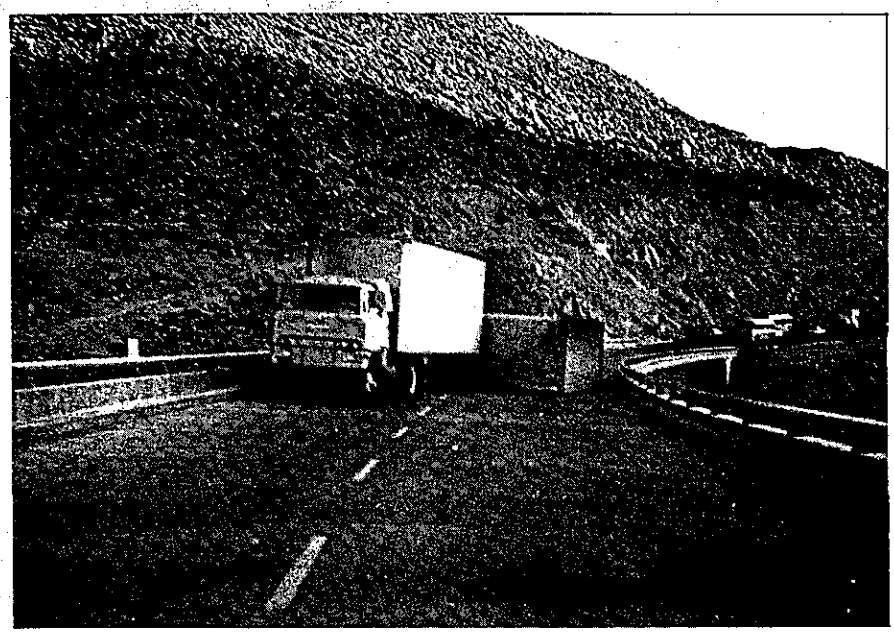
The two-way use of the westbound lanes began in December 1963 and continued while a few comments of strong but sporadic westwinds came in from various sources. These comments were dramatically verified on April 2, 1964, when two truck and trailer combinations traveling in the westbound lane had their trailers overturned on Devils Canyon Bridge No. 1, between 0130 and 0230 in the morning (Figures 2 and 3). This bridge runs from north to south, and west winds are at normal incidence. The bridge was completely blocked by the overturned vehicles in two separate places and all traffic was halted for over 10 hours. Fortunately, there were no human injuries, and the California Highway Patrol was able to prevent any collisions with the trucks and trailers. The portent of accidents of greater severity was very clear. Either a collision or crushing accident could have occurred had any other vehicles been in the eastbound lane. Had the trucks been traveling in the eastbound lane, the trailers would likely have toppled over the barrier rail. After this accident, the California Division of Highways and the California Highway Patrol jointly assumed the responsibility to restrict truck and camper traffic during too frequent periods of high winds.

FIG. 2 TWO LARGE TRUCK TRAILERS BLOWN OVER WITHIN 30 MINUTES. 0145 AND 0215, APRIL 2, 1964.

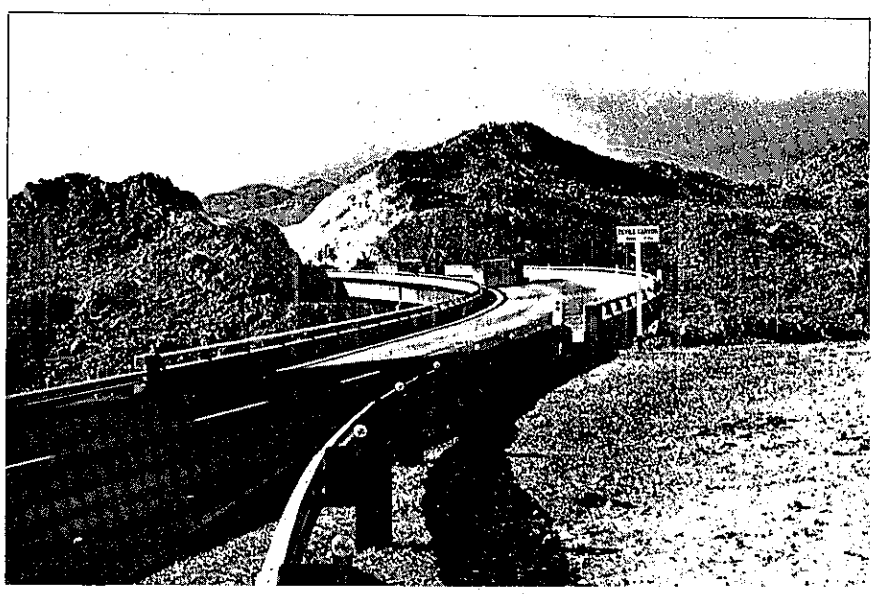
FIG. 3 THE HIGHWAY WAS CLOSED FOR MORE THAN 10 HOURS

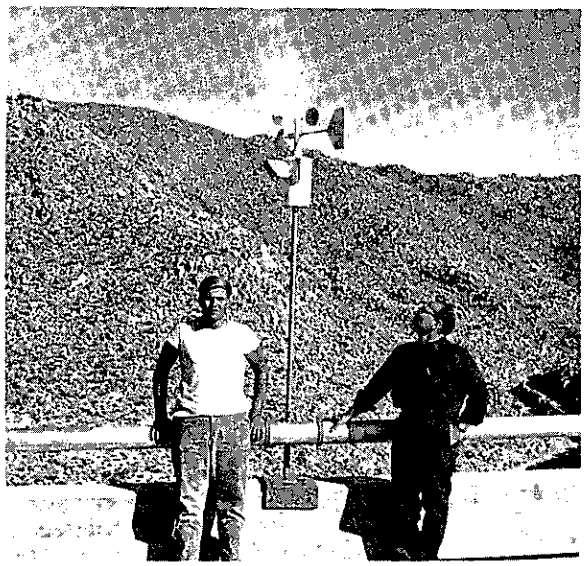
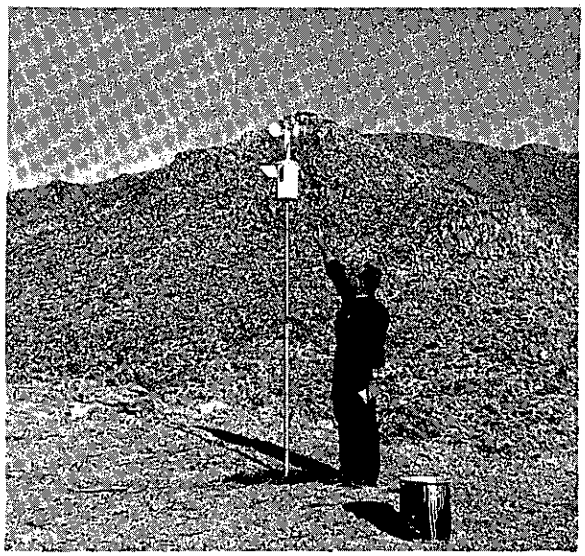
Wind measurements were begun on October 19, 1965, in two places: on the bridge at a height of 9 feet above the paved deck and at 40 feet below the bridge on a windswept ledge (Figure 9). The first tests continued through mid April 1966. The free wind reference site below the bridge gave no signs of interfering turbulence from the structure during any of the long term tests. The tests "before" a wind screen was installed continued for over 6 months. West winds showing hourly averages of 18 or more miles per hour at the "free wind site" were considered significant for reducing the data. None of the east winds ever exceeded 16 mph.

FIGURE 9 WEATHER STATIONS -- 9' ABOVE DECK AND 40' BELOW THE BRIDGE

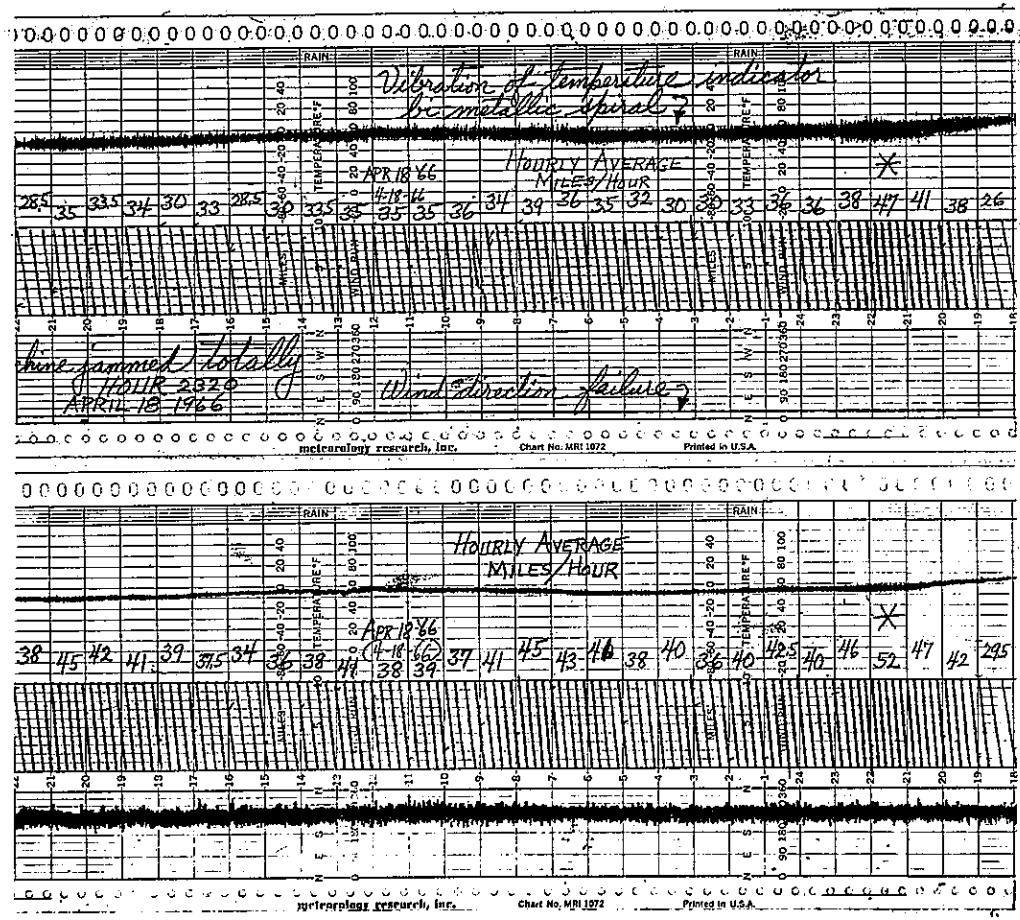
FIGURE 10 WIND CHART SAMPLES - BEFORE WIND SCREEN

The following Table 1 summarizes the predominant west cross-wind data recorded at the two instrumentation locations during the recording period prior to installation of the wind screen along the west side of the bridge. Figure 10 shows chart samples from the wind measuring instruments at the two locations prior to the wind screen installation.

9' ABOVE DECK
21 TO 47 MPH
WEST WINDS

FREE WINDS
40' BELOW BRIDGE
28.5 TO 52 MPH
WEST WINDS

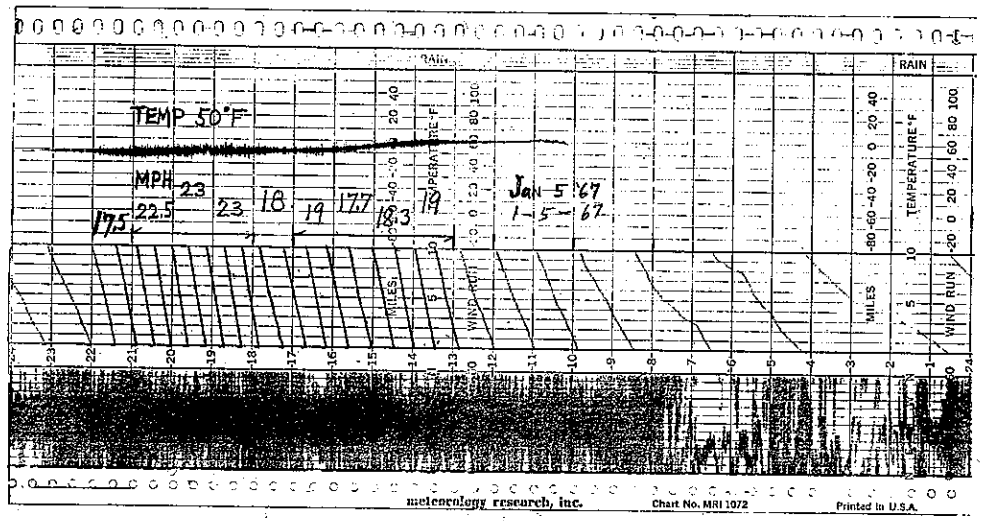
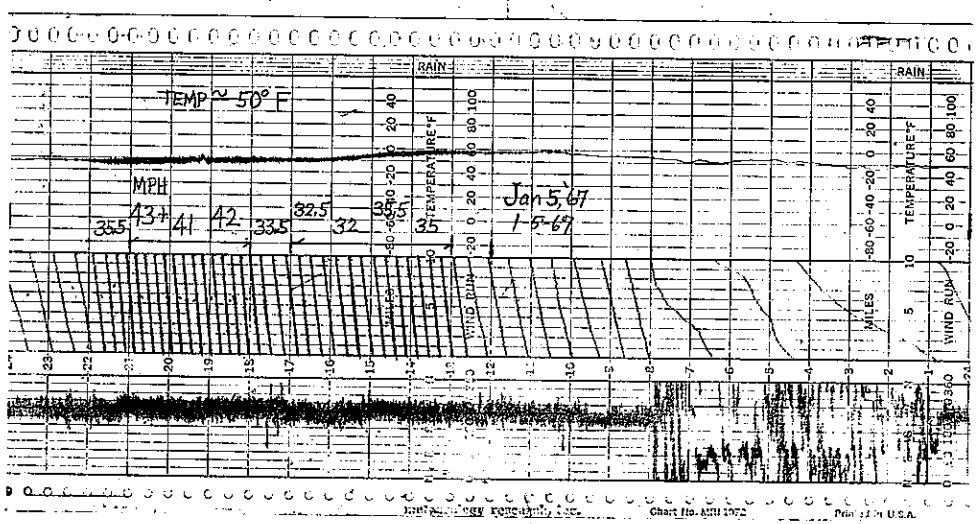
FIGURE 11 WIND CHART SAMPLES -- AFTER WIND SCREEN

Some salient comments must be made before reporting the wind data obtained after the wind screen was installed. The crosswinds are no longer measurable on the bridge due to some low velocity south head winds that now find a protected path behind the wind screen for the full length of the bridge. The south head winds have replaced the damaging west crosswinds as the predominant wind on the bridge. The highest head wind velocity measured over a 6 month period was an hourly average of 23 mph. The crosswind that filters through the screen is completely turned within one inch of the screen surface and merges with the head wind. It is estimated that the screen is reducing the crosswind to about 0.35 of the free west wind velocity. A comparison of the south head winds on the bridge after erection of the wind screen and the west free winds is shown for informational value in the following Table 2. Figure 11 shows chart samples from the wind measuring instruments at the two locations after the wind screen installation.

9' ABOVE DECK
18 TO 23 MPH
SOUTH HEADWINDS

40' BELOW BRIDGE
32 TO 43 MPH
WEST CROSSWINDS

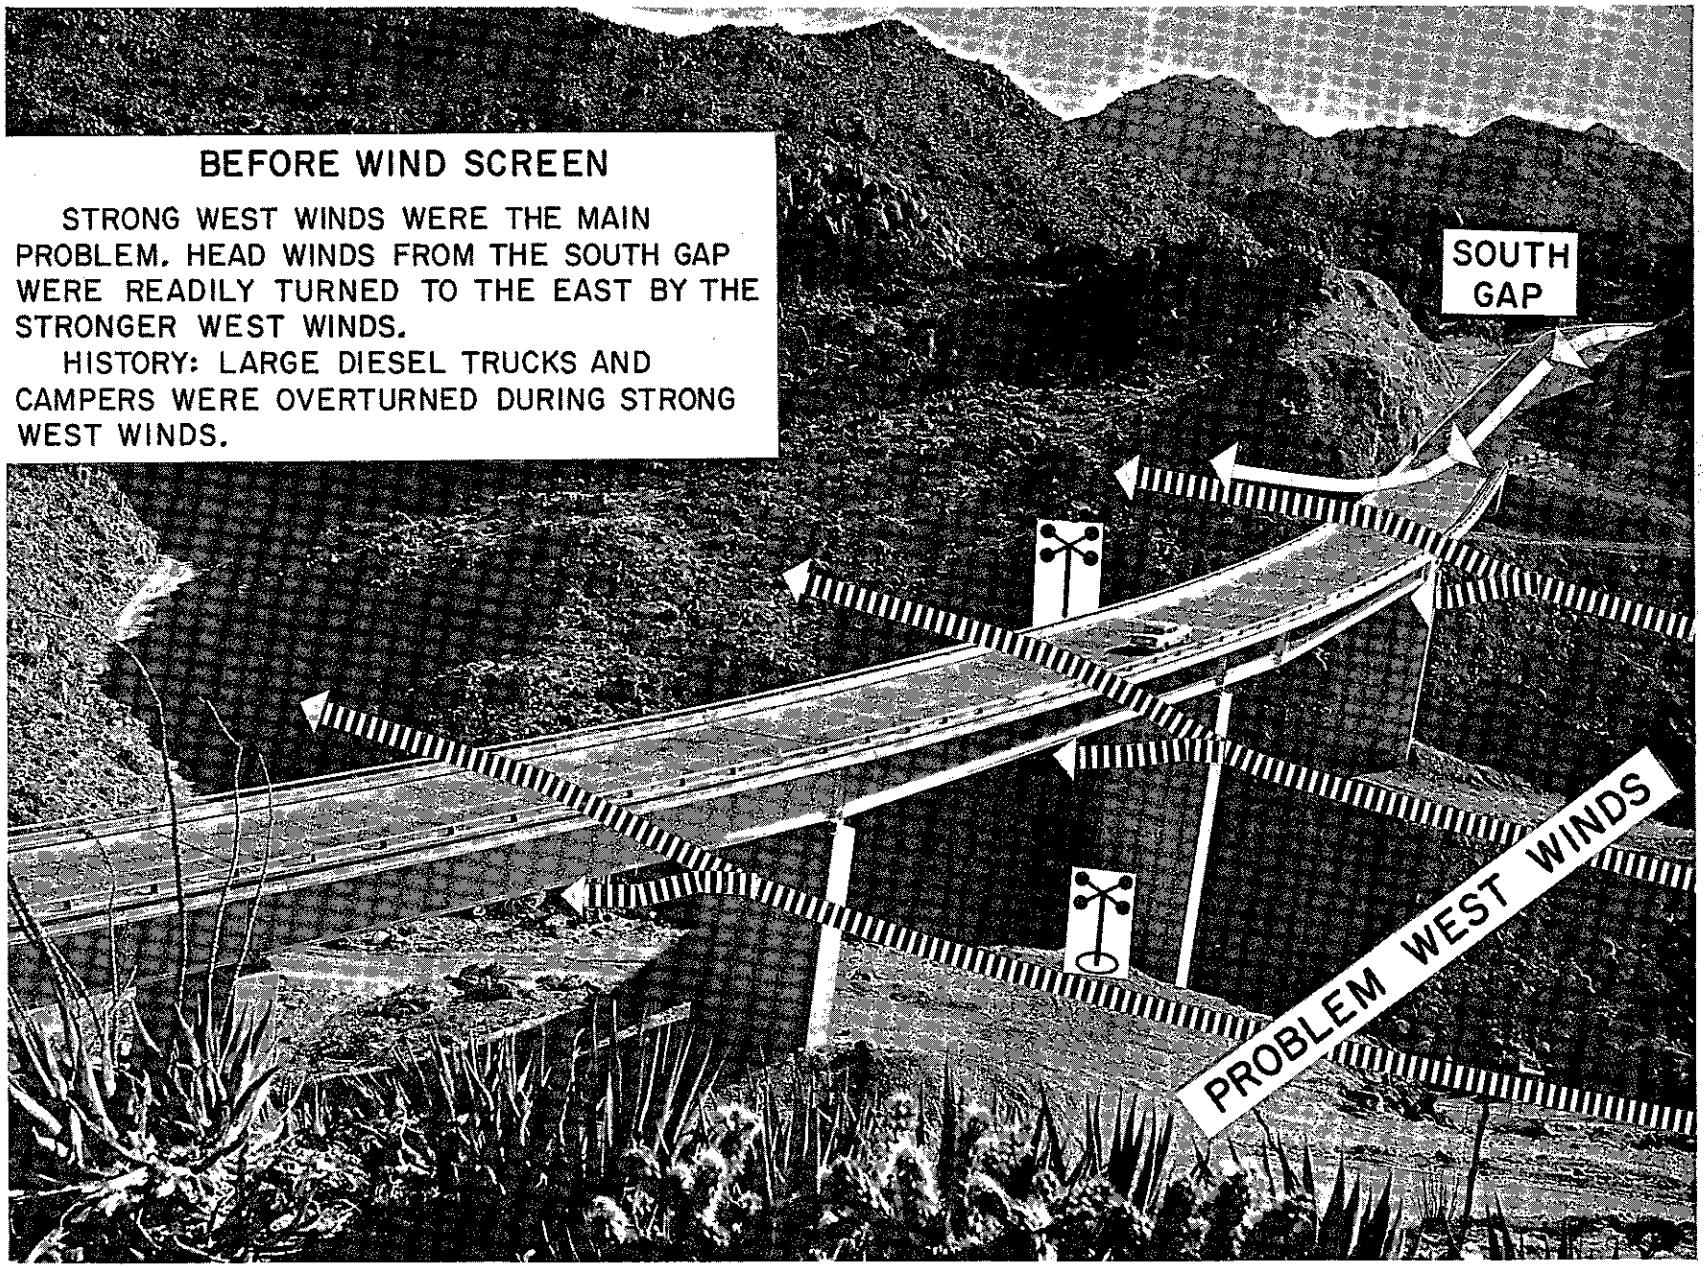
Some of the strong west winds over the entire area find a spillway beyond the south pass of the bridge. The contours of the terrain at this location reduce and deflect the west wind to a half velocity head wind that filters through the south gap traveling north on the bridge (Figure 12). This head wind was readily turned by the predominant west crosswind on the bridge before the screen was installed and no evidence of a head wind appeared on the wind instruments mounted near the center of the bridge (Figure 13). After the screen was installed, the west crosswind was so drastically reduced that the south head wind became the predominant wind measured on the bridge.

FIGURE 13 CONDITIONS BEFORE WIND SCREEN

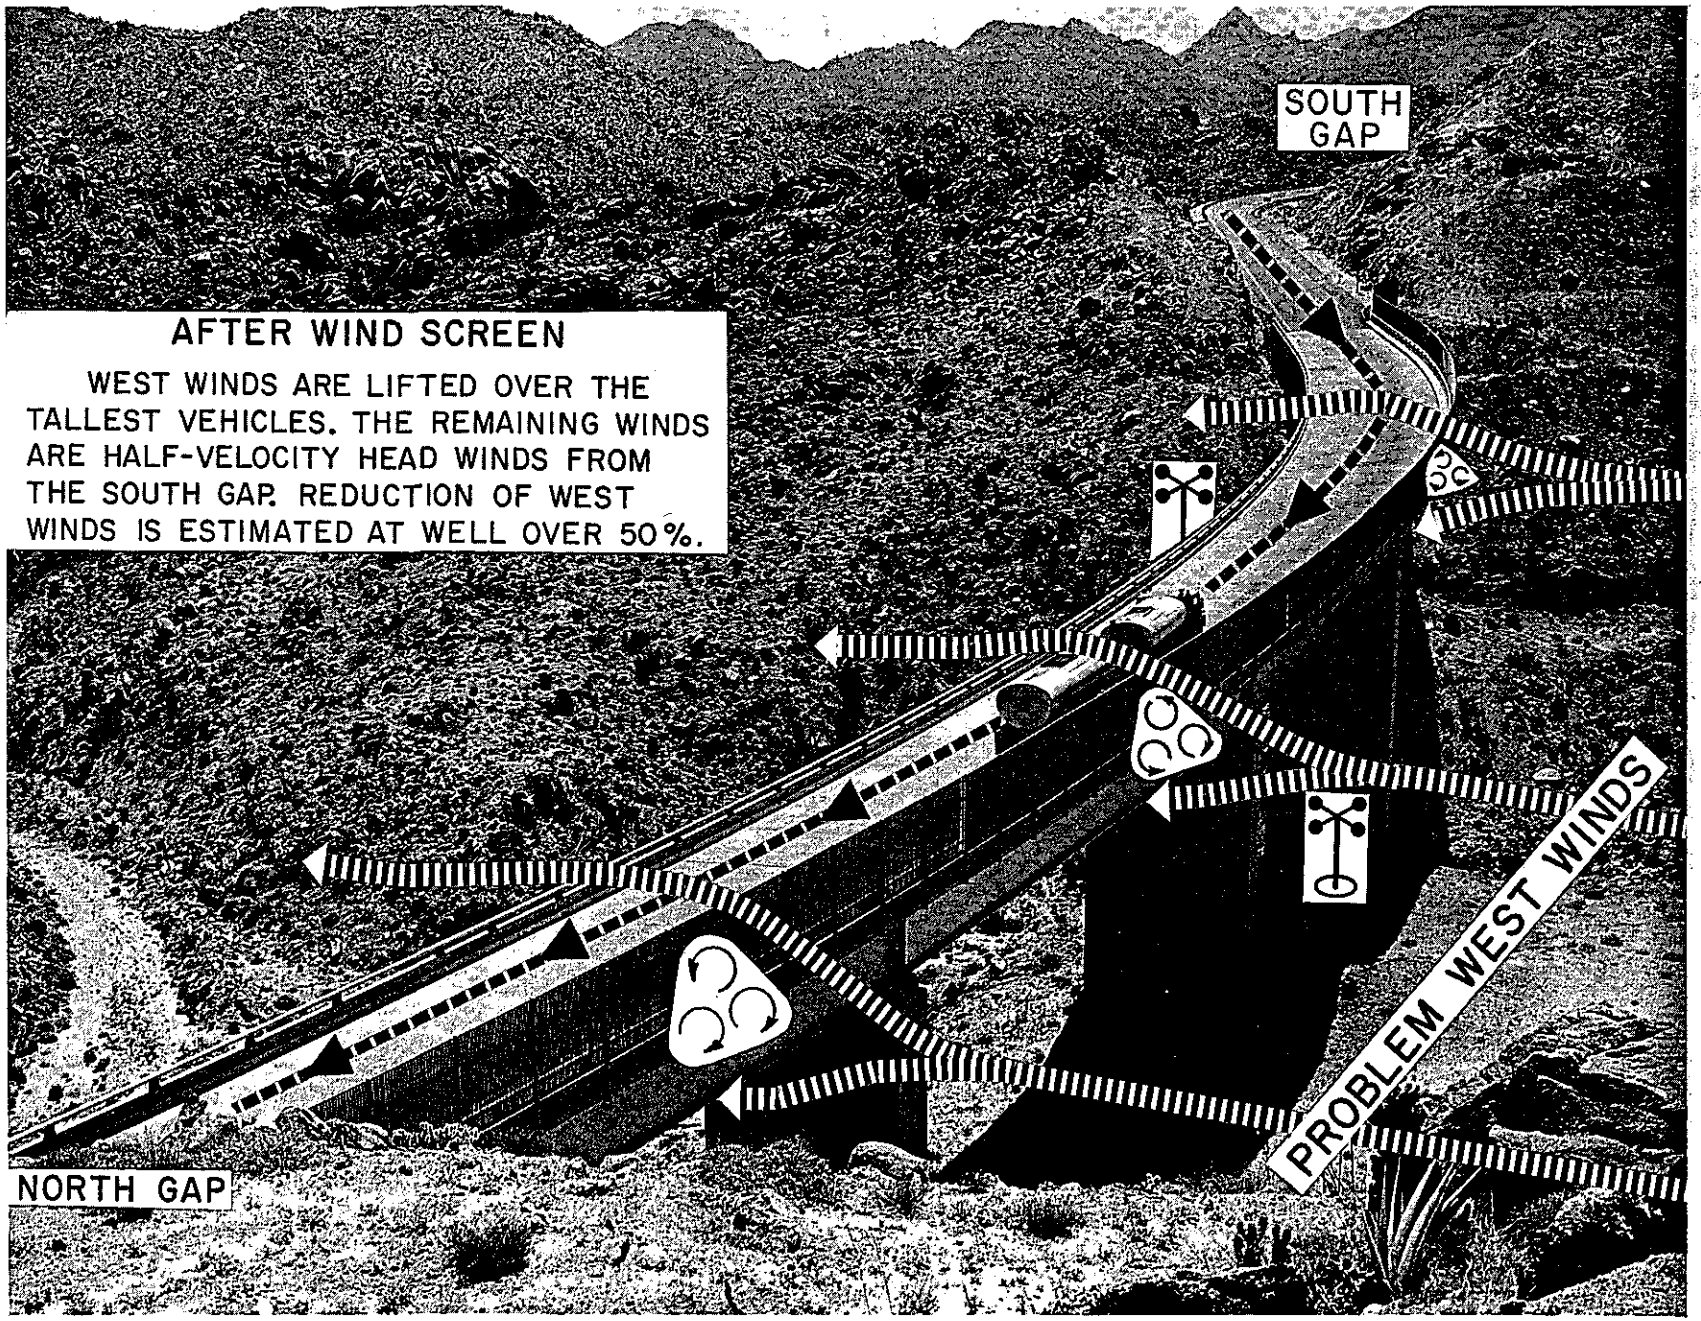
Wind flag probes were also valuable in disclosing the beneficial lifting of the crosswinds as a result of the turbulence produced on the windward face of the screen. The amount of wind lift varies with the wind speed thus producing a higher zone of protection when it is most needed for tall trucks during strong wind gusts. Typical values of extra wind lift varied from 20 to over 30 percent higher than the wind screen itself during the tests. This extra lift was sustained across the entire 37 foot width of the bridge (Figures 14, 15, and 16).

FIGURE 14 CONDITIONS AFTER WIND SCREEN

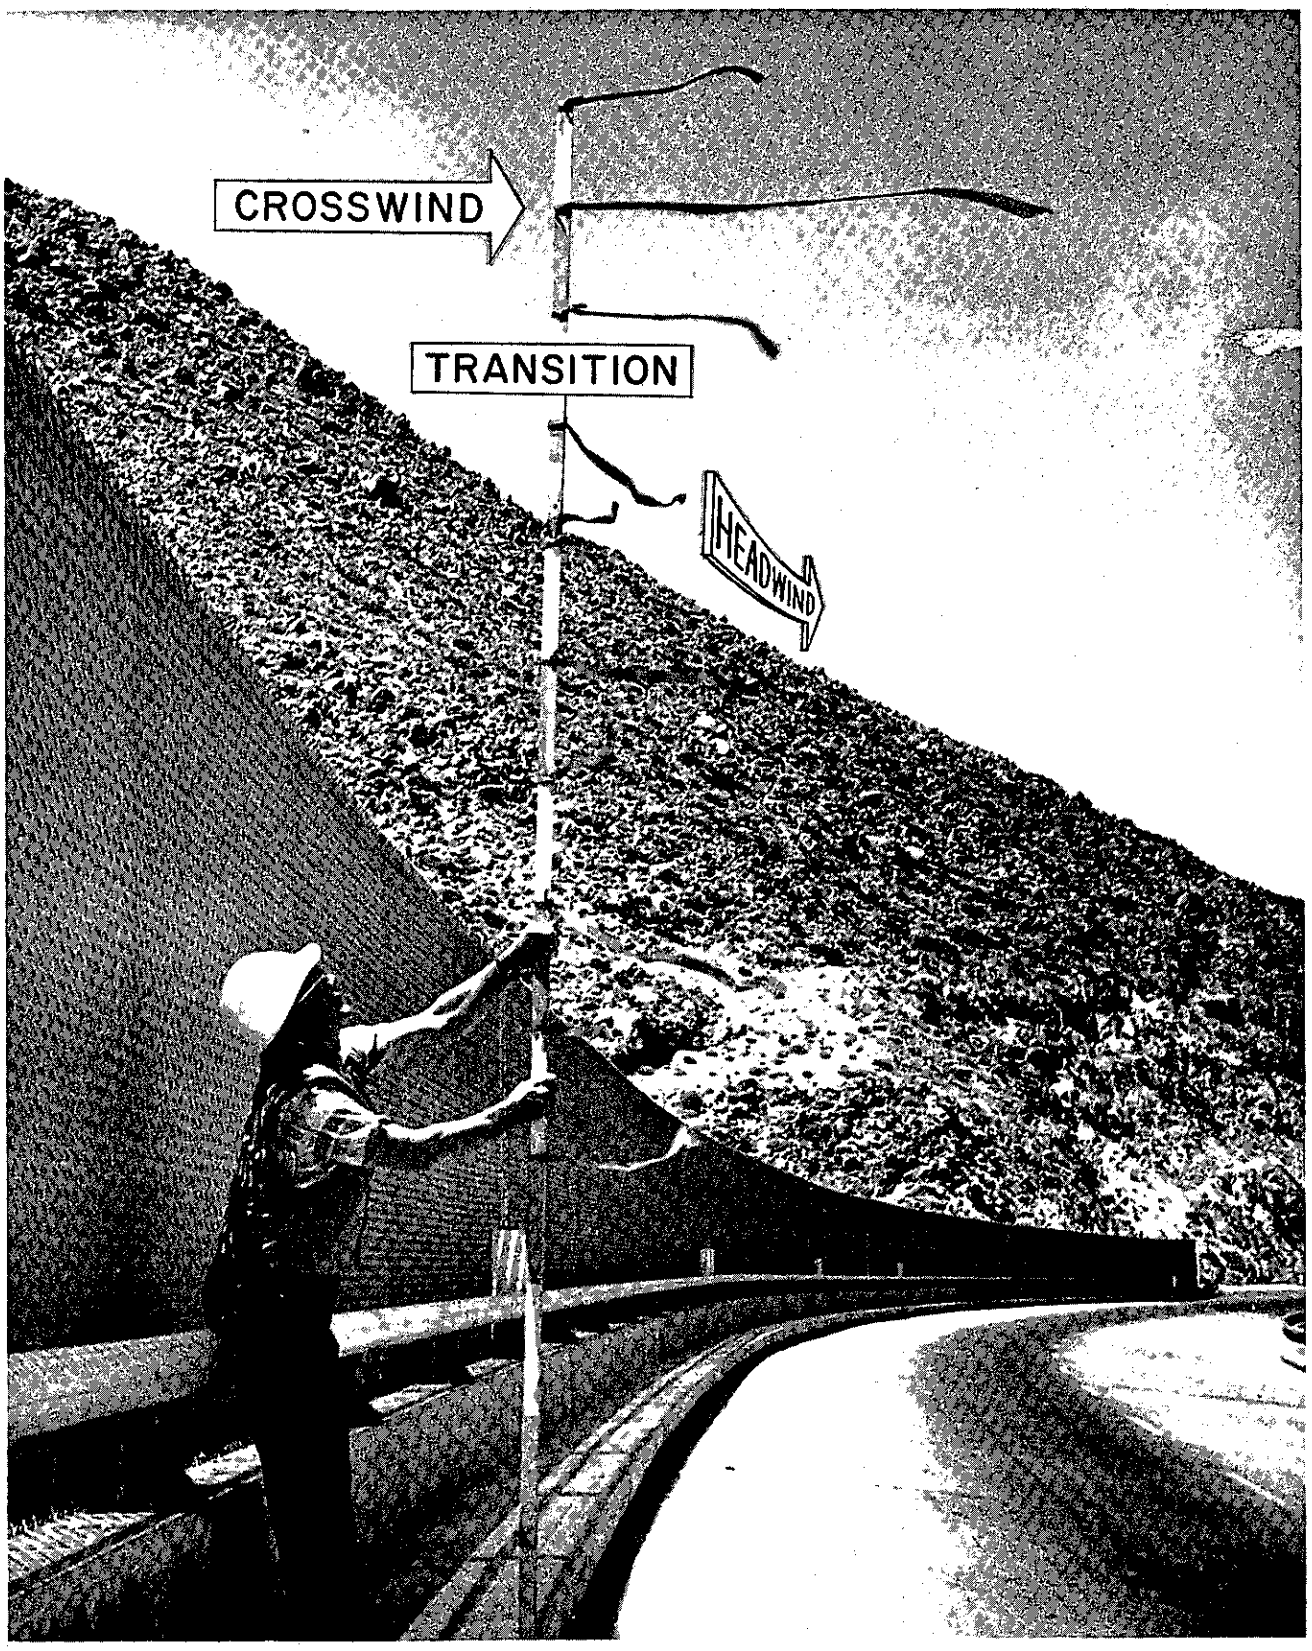
FIGURE 15 STRONG CROSSWINDS ARE DEFLECTED OVERHEAD
LESSER HEADWINDS REMAIN ON BRIDGE

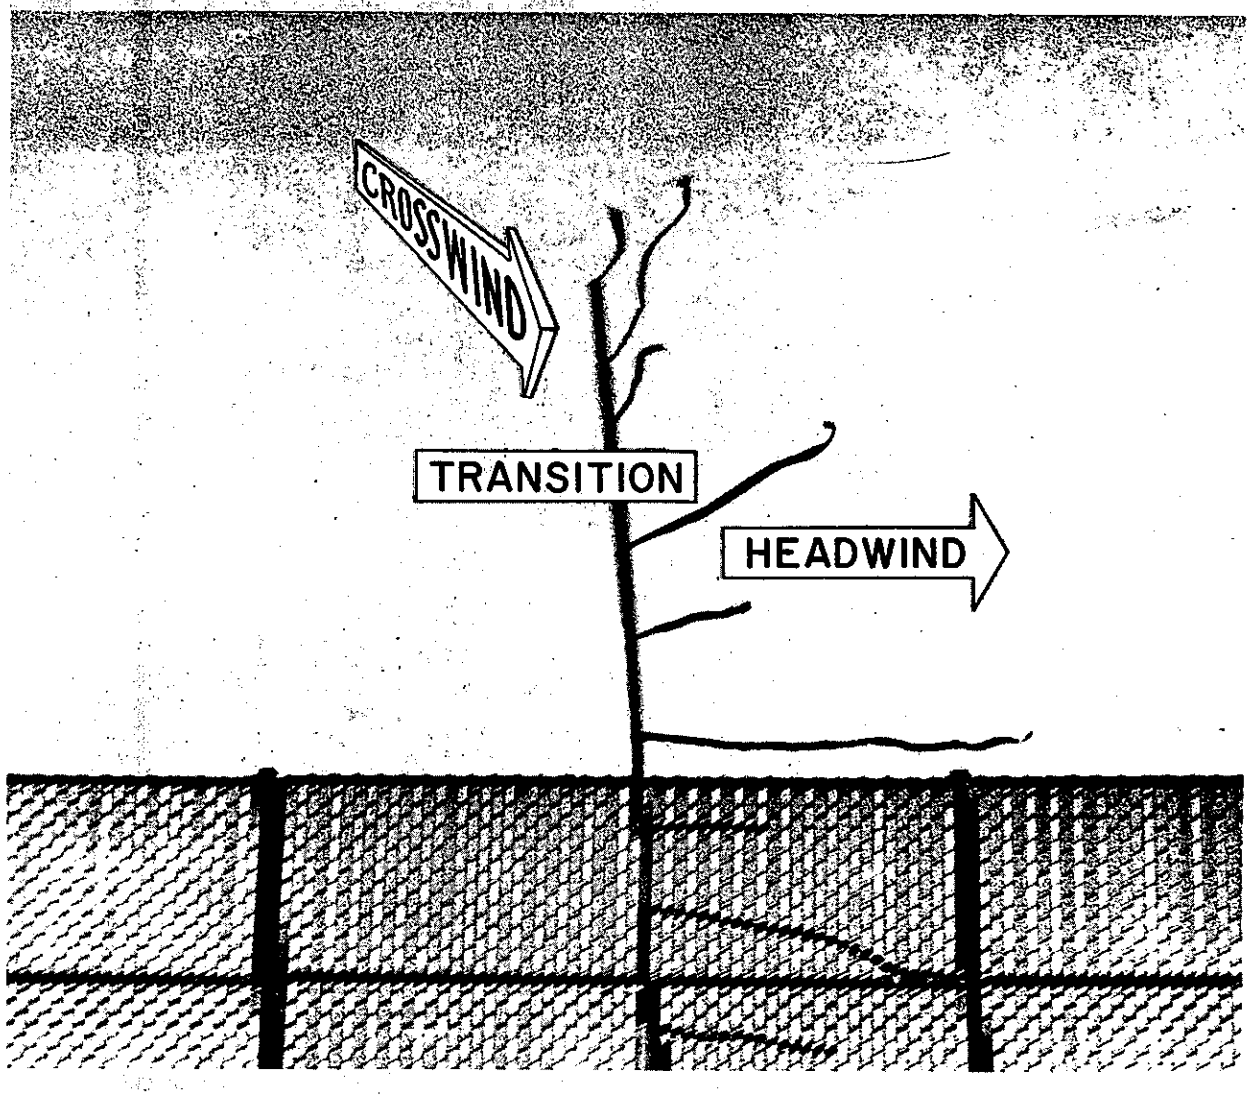
FIGURE 16 SAME AS FIGURE 15, FACING THE SLATTED SCREEN
