DYNAMIC TESTS OF STEEL BOX BEAM AND CONCRETE MEDIAN BARRIERS

RESEARCH REPORT

NO. M & R 636392-3

Eric F. Nordlin
Assistant Materials and Research Engineer

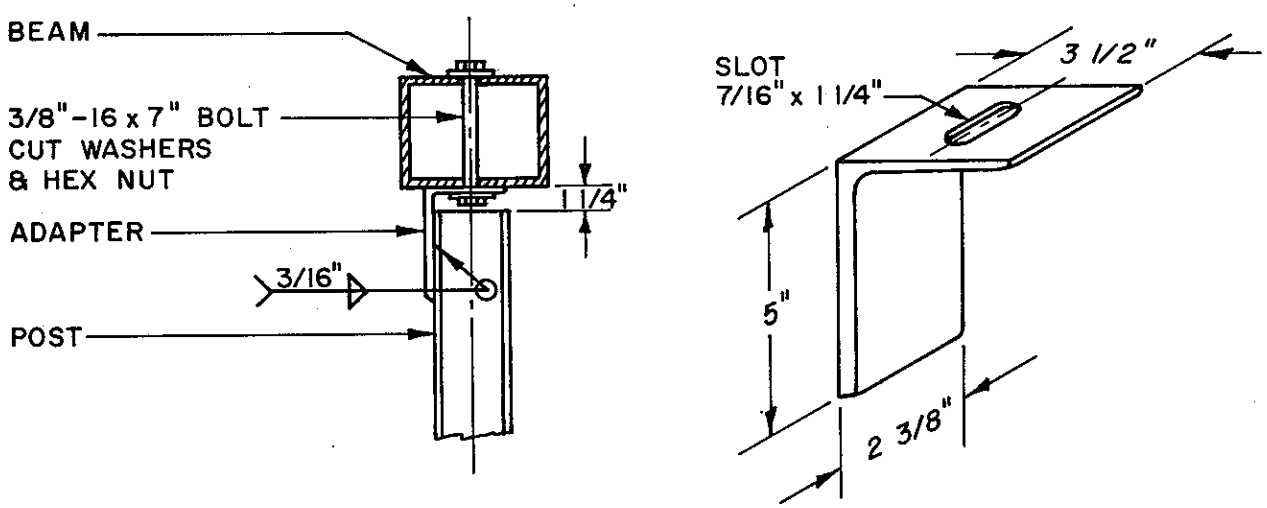
FIGURE 1 (TEST 141)

However, in Test 141 the barrier failed to retain the vehicle under the relatively severe 71 mph/25 deg. impact conditions. The box beam was torn free of all posts and thrown more than 50 ft from the original centerline when the 3/8-in. diameter beam-to-post clip bolts throughout the entire length of the test installation failed in "zipper" action by shear and tension. Three 18-ft sections of beam were damaged beyond economical repair. However, based on the results of the succeeding Test 142, it is felt that an anchored installation with larger or high strength beam-to-post bolts would have successfully retained the vehicle.

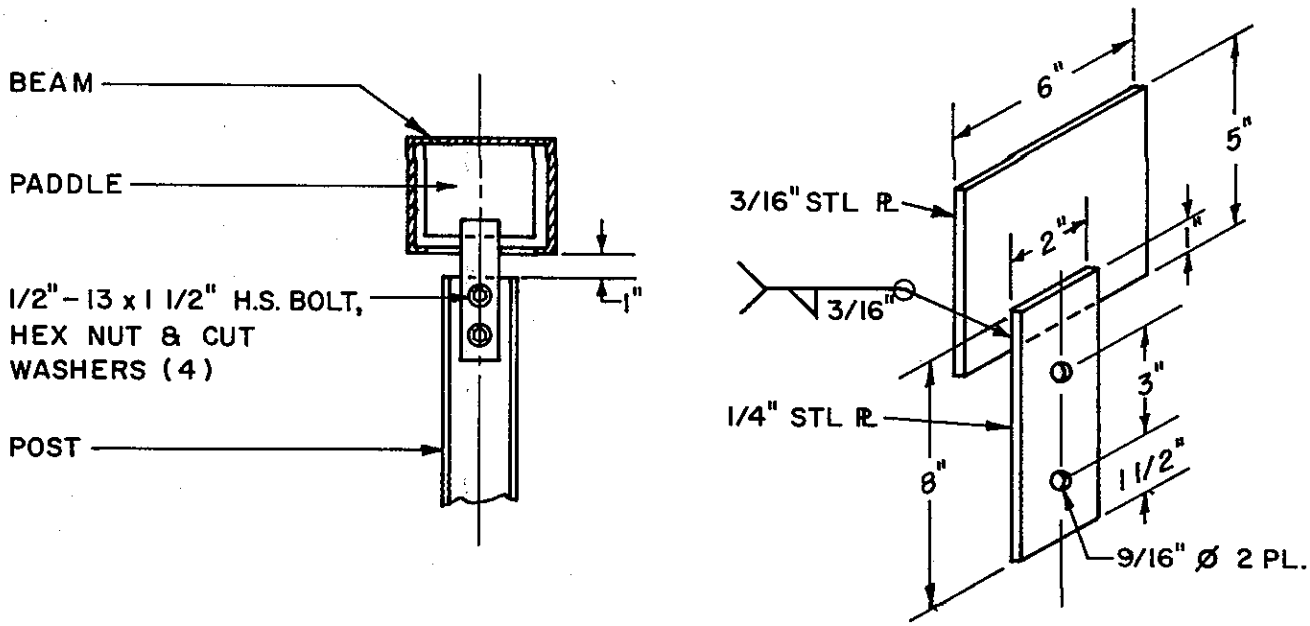
FIGURE 2 (TEST 142)

In Test 142 the vehicle was effectively redirected to an exit angle of 6 deg. during a contact distance of approximately 37 ft.

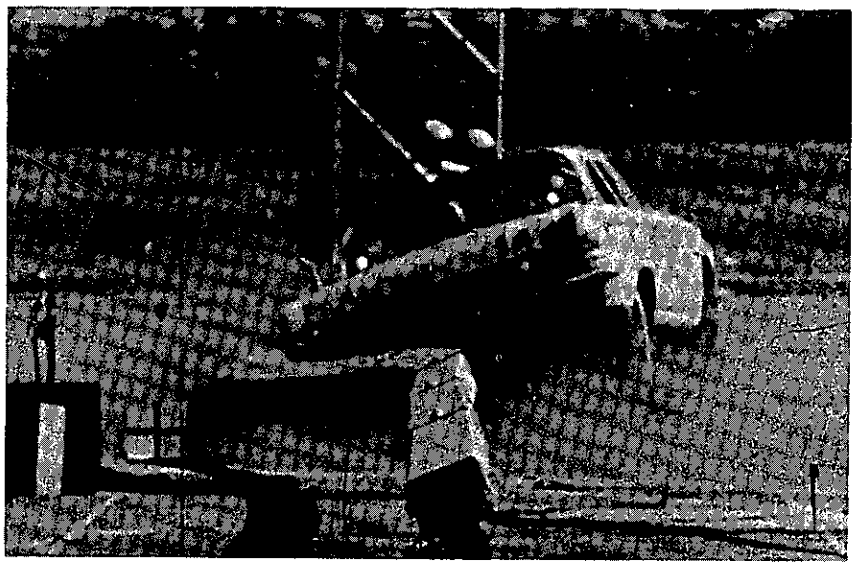
FIGURE 3

However, the 4-ft dynamic lateral deflection coupled with a considerable loss of beam height (10.5 in.) permitted the vehicle to roll more than 18 deg. into the barrier (Figure 3).

This roll was considerably more than has been experienced with a blocked-out "W" beam system impacted under similar conditions. Past impact test experience indicates it is possible that this vehicle reaction could result in a roll-over under more severe impact conditions. The 4-ft lateral deflection would govern the median width upon which this barrier should be installed. Three sections of the beam, 11 posts, and 22 paddles were damaged during the impact and one post was pulled out of the socket. The paddles on posts that

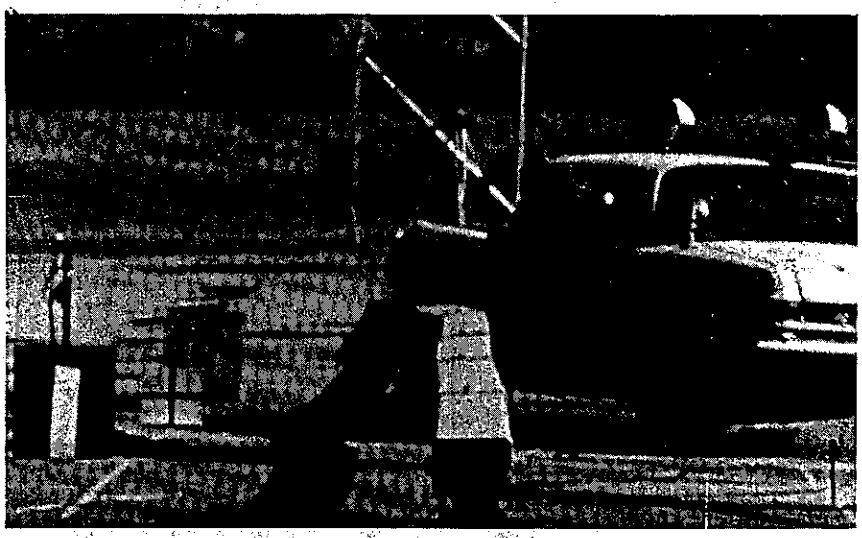
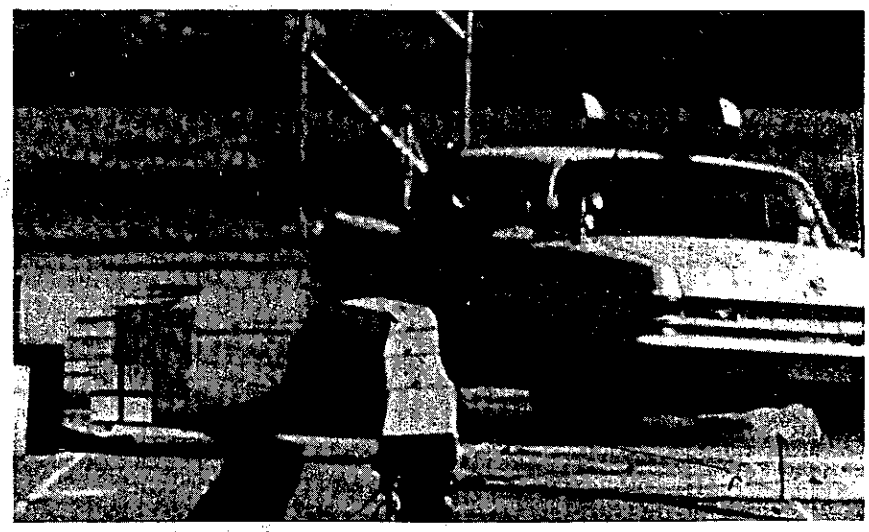
The immediate entrapment of the left front wheel with the first post contacted can be seen in Figures 4 and 5.

Past experience indicates that this wheel/post involvement is typical of most impacts on 27-in. high beam-type barriers that are not blocked-out or barriers over 27 in. high that are not provided with a rubbing rail mounted below the beam. However, with this strong beam/weak post system, it was felt that the relatively light 3I5.7 posts did not affect the smooth progression of the vehicle through impact as would an 8- by 8-in. timber post or 6-in. steel "H" post. Further review of the data films indicated that the severe damage to the front wheel and suspension was caused primarily by the paddles hanging up in the beam slots. It is apparent that the post twisted when impacted and the paddle hung up diagonally in the 1½-in. beam slot, locking the post to the beam. Figures 6a and 6b show two posts with sheared paddles. For Test 143 the paddles were lengthened and beveled to minimize the snagging.

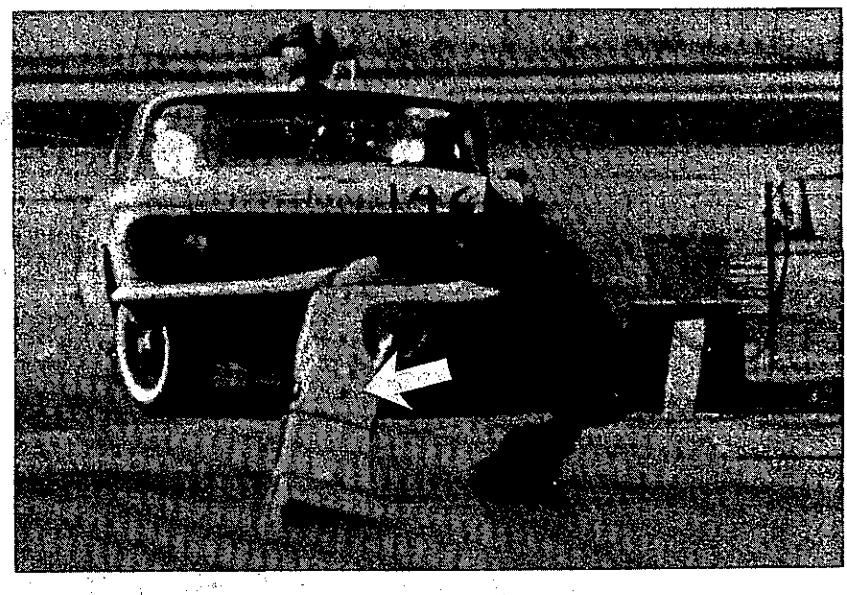
FIGURE 7

All of the beam splice bolts (ASTM Designation: A307 steel) used in Test 142 sustained some shear deformation and the top and bottom were sheared completely off one bolt. Figure 7 shows the head of the splice bolt and the washer just after shearing. This failure occurred at the time of maximum dynamic deflection and is a good example of the magnitude of the tensile forces that can be transmitted a considerable distance downstream as well as upstream from impact on any tension barrier system such as the box beam barrier.

This splice bolt failure had no appreciable effect on the over-all performance of the barrier for this test as the vehicle had almost been redirected and maximum dynamic deflection had occurred. However, rather than chance a splice bolt failure affecting the results of succeeding tests, the A307 bolts were replaced with high strength bolts.

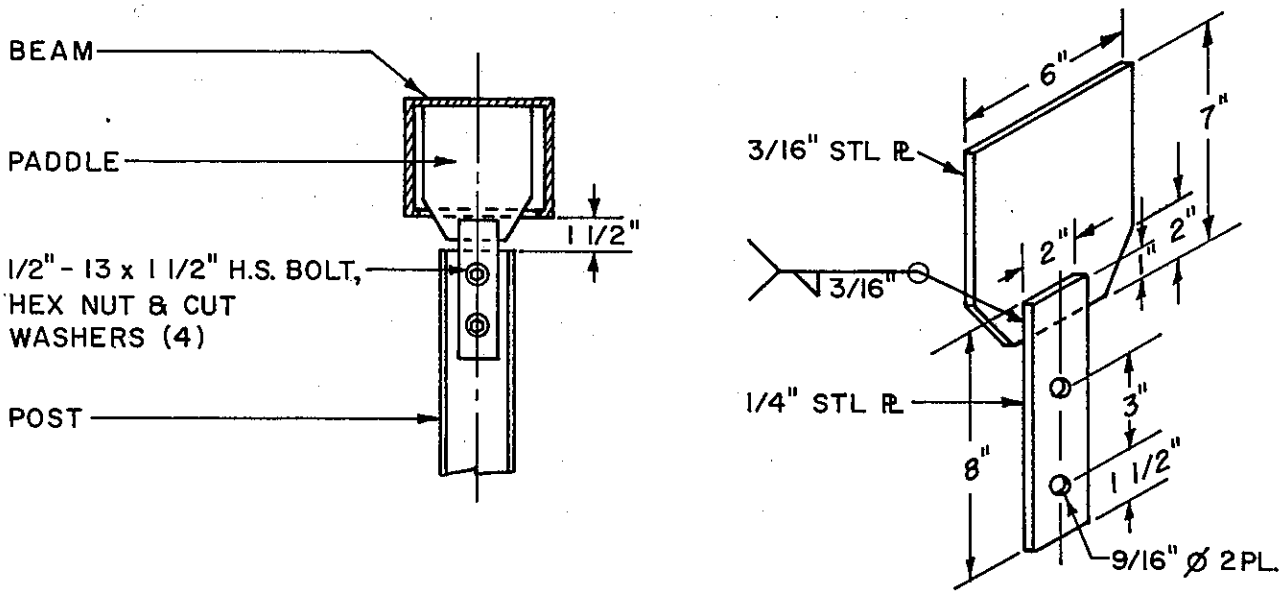
FIGURE 8

To correct the deficiencies noted in barrier Test 142, the barrier used in Test 143 incorporated a beveled paddle design (Figure 8) to minimize the snagging tendency and high strength steel beam splice bolts (ASTM Designation: A325) to minimize the splice bolt shear deformation.

The test vehicle impacted the barrier 100 ft from the upstream end and was redirected to an exit angle of 3 deg. during a contact distance of approximately 21 ft. The left front tire was ruptured by a post causing the vehicle to curve into a secondary impact with the barrier 42 ft beyond the initial contact and traveled parallel in contact with the beam for an additional 30 ft before finally leaving the barrier at a 3 deg. angle. Three posts were damaged beyond repair and nine paddles required replacement. However, the beam sustained the impact with no evidence

of bending and as expected, no damage to the 3/4-in. high strength splice bolts. There was no evidence of snagging with the beveled paddle design and no tendency for the vehicle to roll. Repairs to the damaged barrier are discussed under Section C of this report.

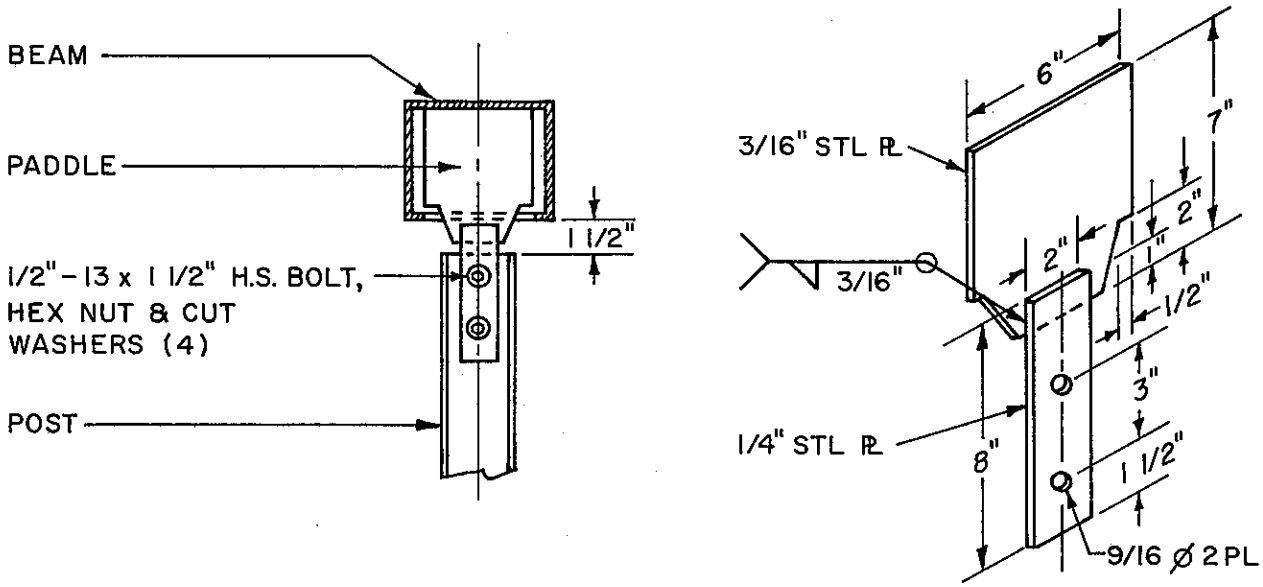
FIGURE 9

New York's experience with the paddles in a test on an aluminum box beam design(3) indicates that an offset would be desirable in the edge of the paddle to restrain the vertical deflection of the beam upwards under severe impact conditions. This offset as shown in Figure 9 would

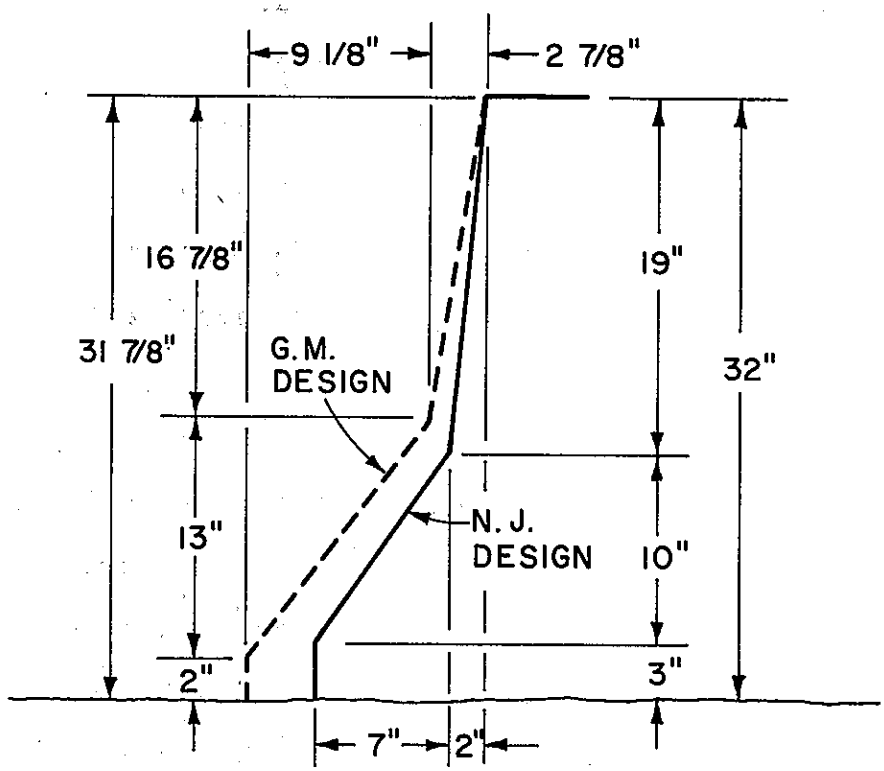
FIGURE 10

In 1963 General Motors conducted a series of 21 full scale tests on a concrete bridge parapet design[8] adapted from the New Jersey median barrier design as shown in Figure 10 in comparison with the New Jersey design.

This General Motors sloped front design proved to be entirely adequate in redirecting an impacting vehicle with no barrier damage and minimal vehicle damage. However, it should be noted that the

tests were all conducted at speeds less than 50 mph and at impact angles of 12 deg. and less. This test criteria did not impose as severe a test loading as would the California standards of 65 mph/25 deg. for dynamic impact proof testing of barriers. The General Motors design included a metal railing mounted on top of the concrete wall to insure containment of high-speed wide-angle impacts.

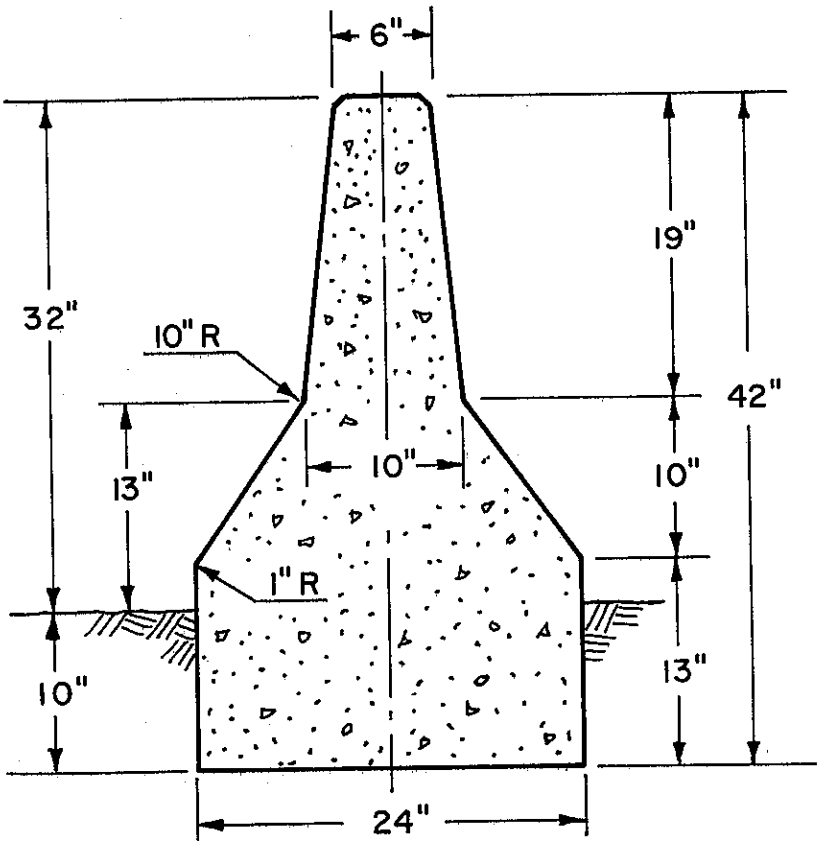
FIGURE 11

The median barrier tested was a contoured, solid concrete wall design developed by the State of New Jersey Highway Department as shown in Figure 11.

The installation consisted of eight 32-in. high, 20-ft long, nonreinforced, cast-in-place concrete wall sections. Each individual section consisting of a footing and parapet was a single monolithic pour of approximately 3 cubic yards weighing 6 tons. Adjacent sections were not doweled or

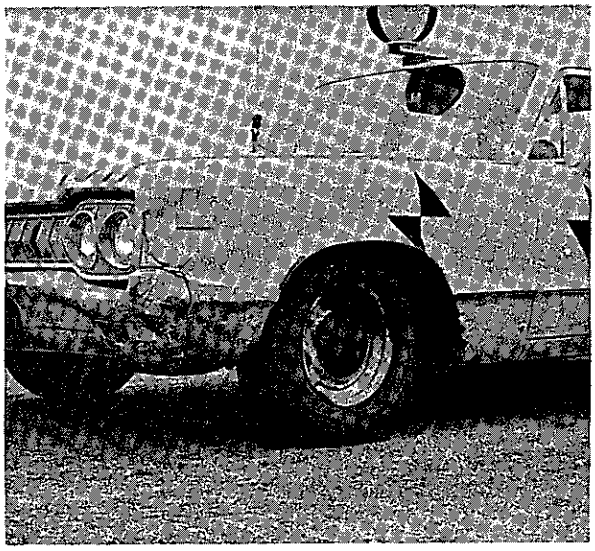
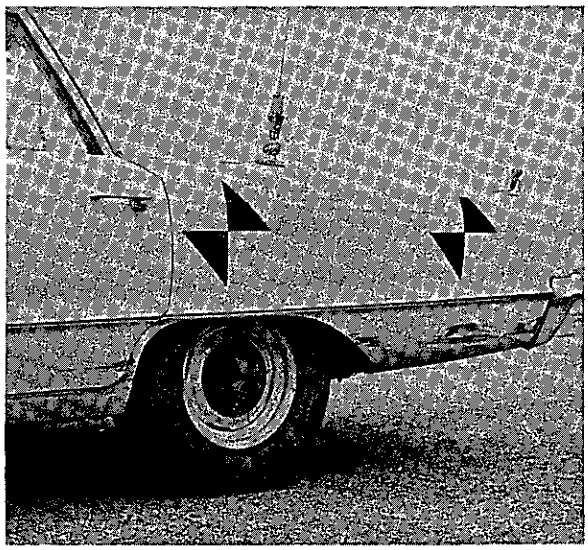
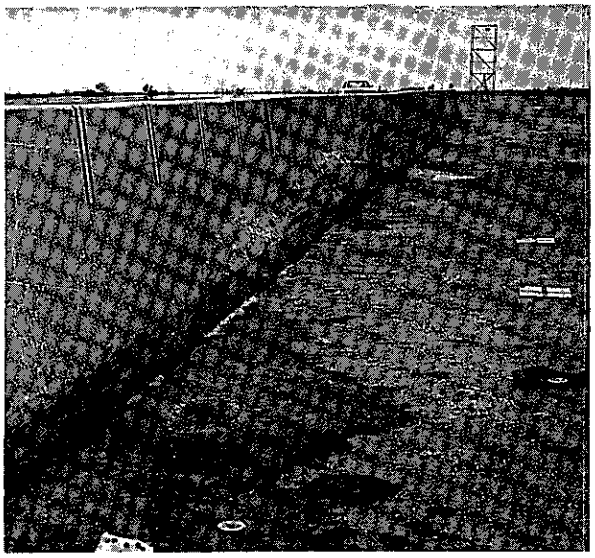
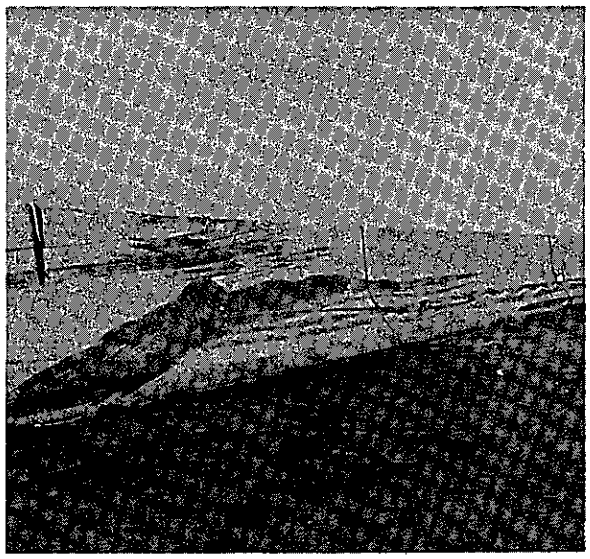
TEST 161-B PLATE C

The vehicle body contacted the upper portion of the parapet at initial impact and for a distance of 12.5 ft. Vehicle damage consisted of minor sheet metal damage to the front fender, a dented bumper, and scratched paint

at the left rear door and quarter panel. The left front wheel was bent and required replacement. No damage to the steering mechanism or running gear was found, and this vehicle was used with no further repairs for the succeeding test.

Data film and impactograph recordings of the dummy driver indicate that a live driver could have sustained slight shoulder bruises. The barrier sustained no damage.

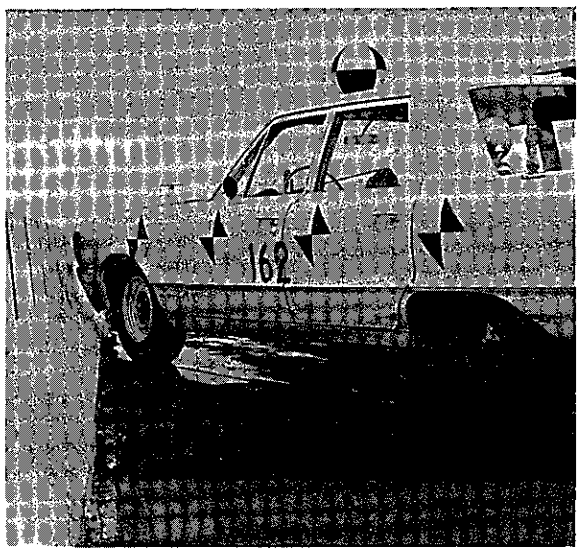
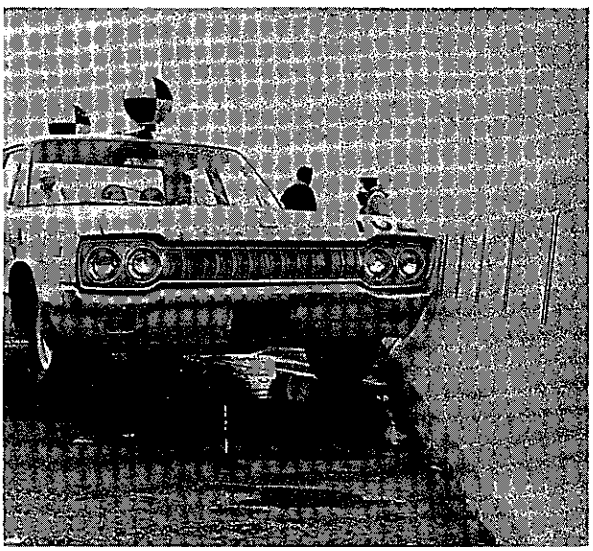
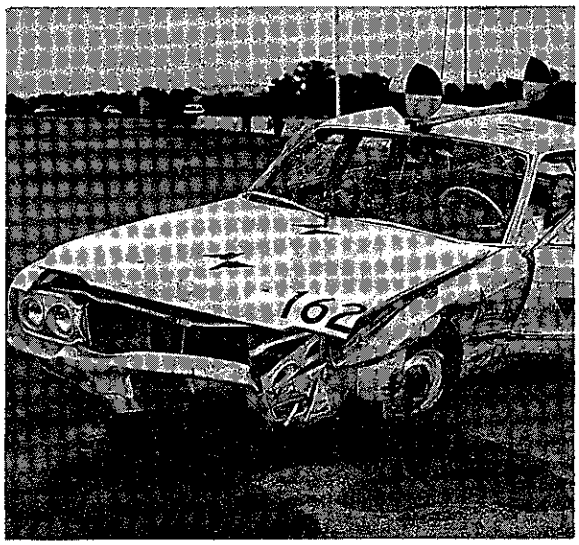
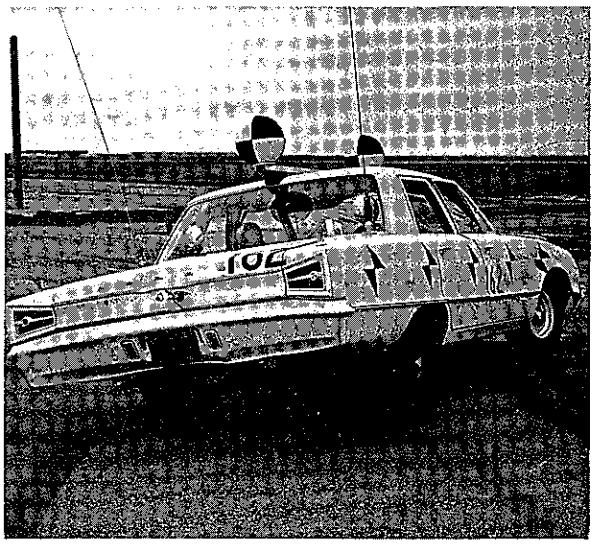
TEST 162 PLATE D

barrier, moderate damage was sustained by the left front quarter panel and rear bumper with minor scratches to the paint along the left side. The left front end sustained severe sheet metal and undercarriage damage.

The barrier sustained no damage other than very slight spalling of concrete at the expansion joint immediately adjacent to the point of impact.

C. & D. Detailed photographs of barrier and vehicle damage.

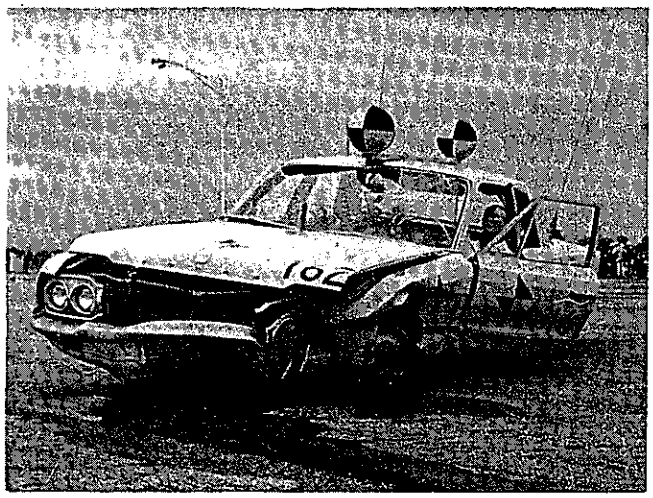
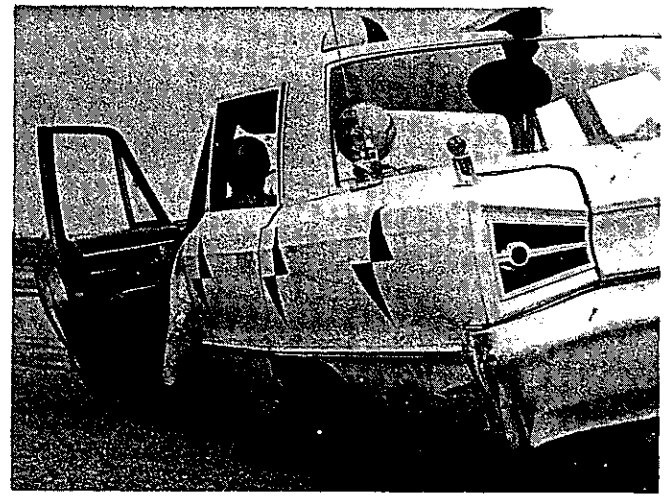
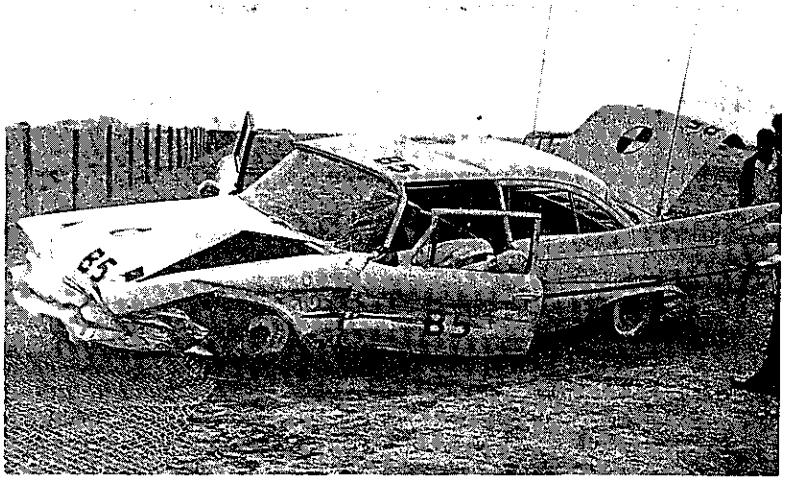
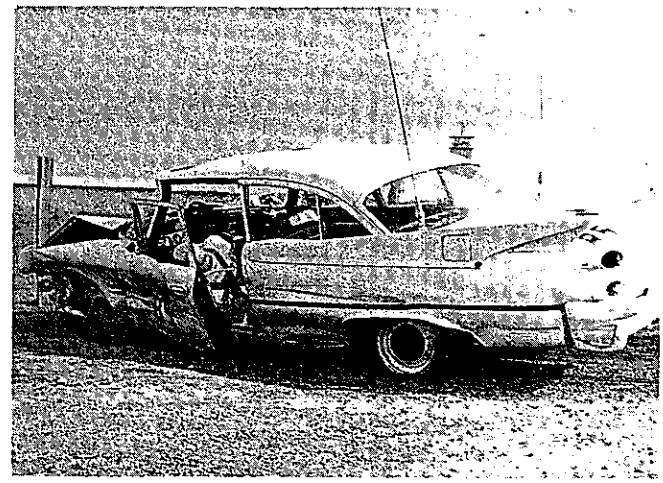
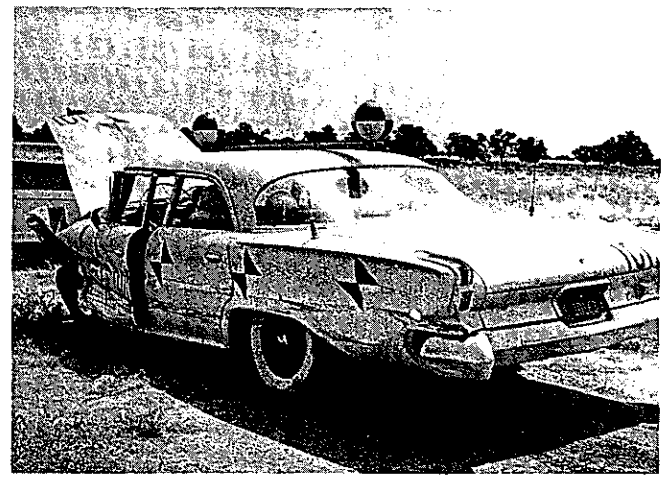
COMPARISON OF VEHICLE DAMAGE ON THREE BARRIER TYPES

Although the damage to the vehicle was considered severe, it was comparable to that sustained in similar high-speed, wide-angle tests on the standard blocked-out beam type barrier and a test on a concrete parapet bridge rail as shown in Exhibit 7 (Appendix).
