FIELD PERFORMANCE EVALUATION OF SOIL PRESSURE CELLS

71-13

NO. M & R 632954-1

SOIL PRESSURE CELLS
(General Transducer Company)

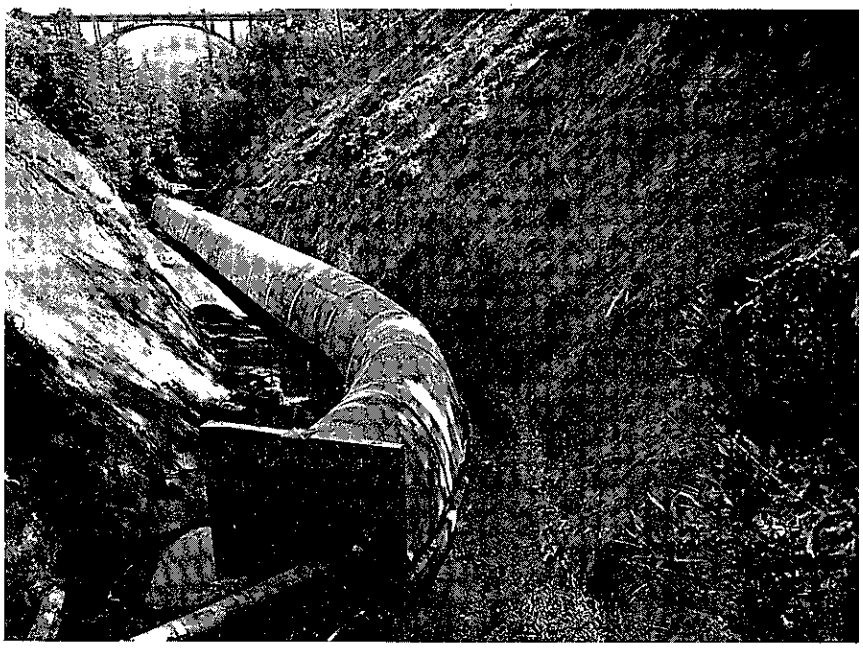
sand of low to moderate plasticity. The view in Figure 7 is from the downstream end of the culvert prior to placing the backfill and embankment. The bridge shown in the background carries traffic on the existing highway and is approximately the same elevation as the top of embankment over the culvert. (Note the steep side slopes of 1:1 or steeper at the bottom of this V-shaped canyon.)

Figure 7. Cedar Creek Culvert - looking northeast from downstream end.

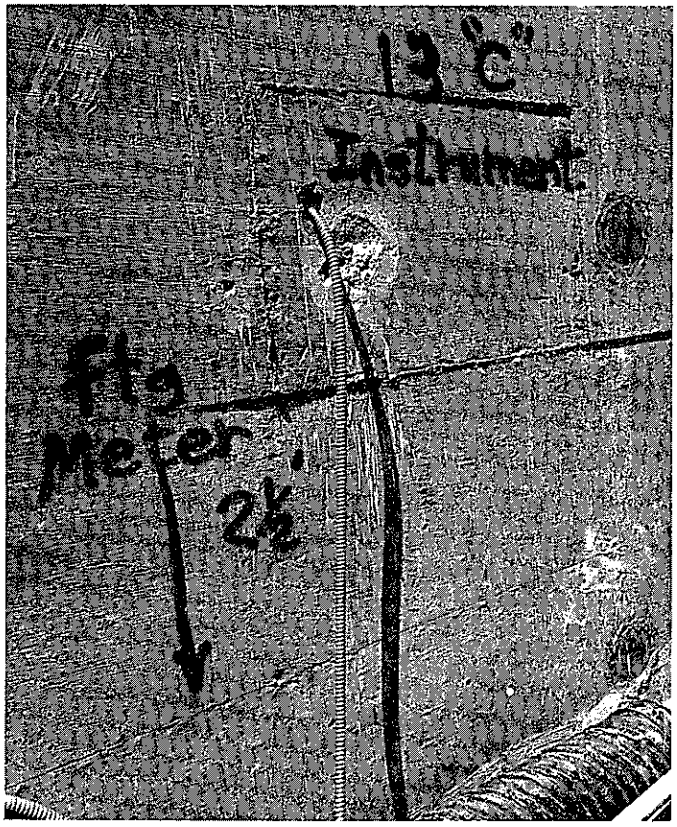
Figure 8. Soil pressure cell lead wires routed through culvert wall.

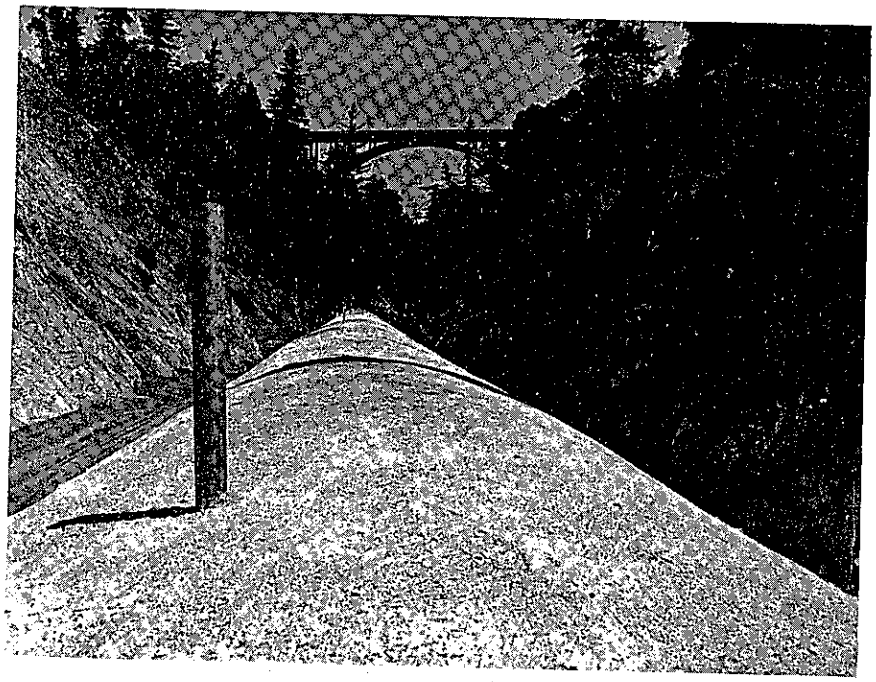
Figure 10. Bottom segment of telescoping pipe slip joint on which junction box of Fig. 9 is mounted.

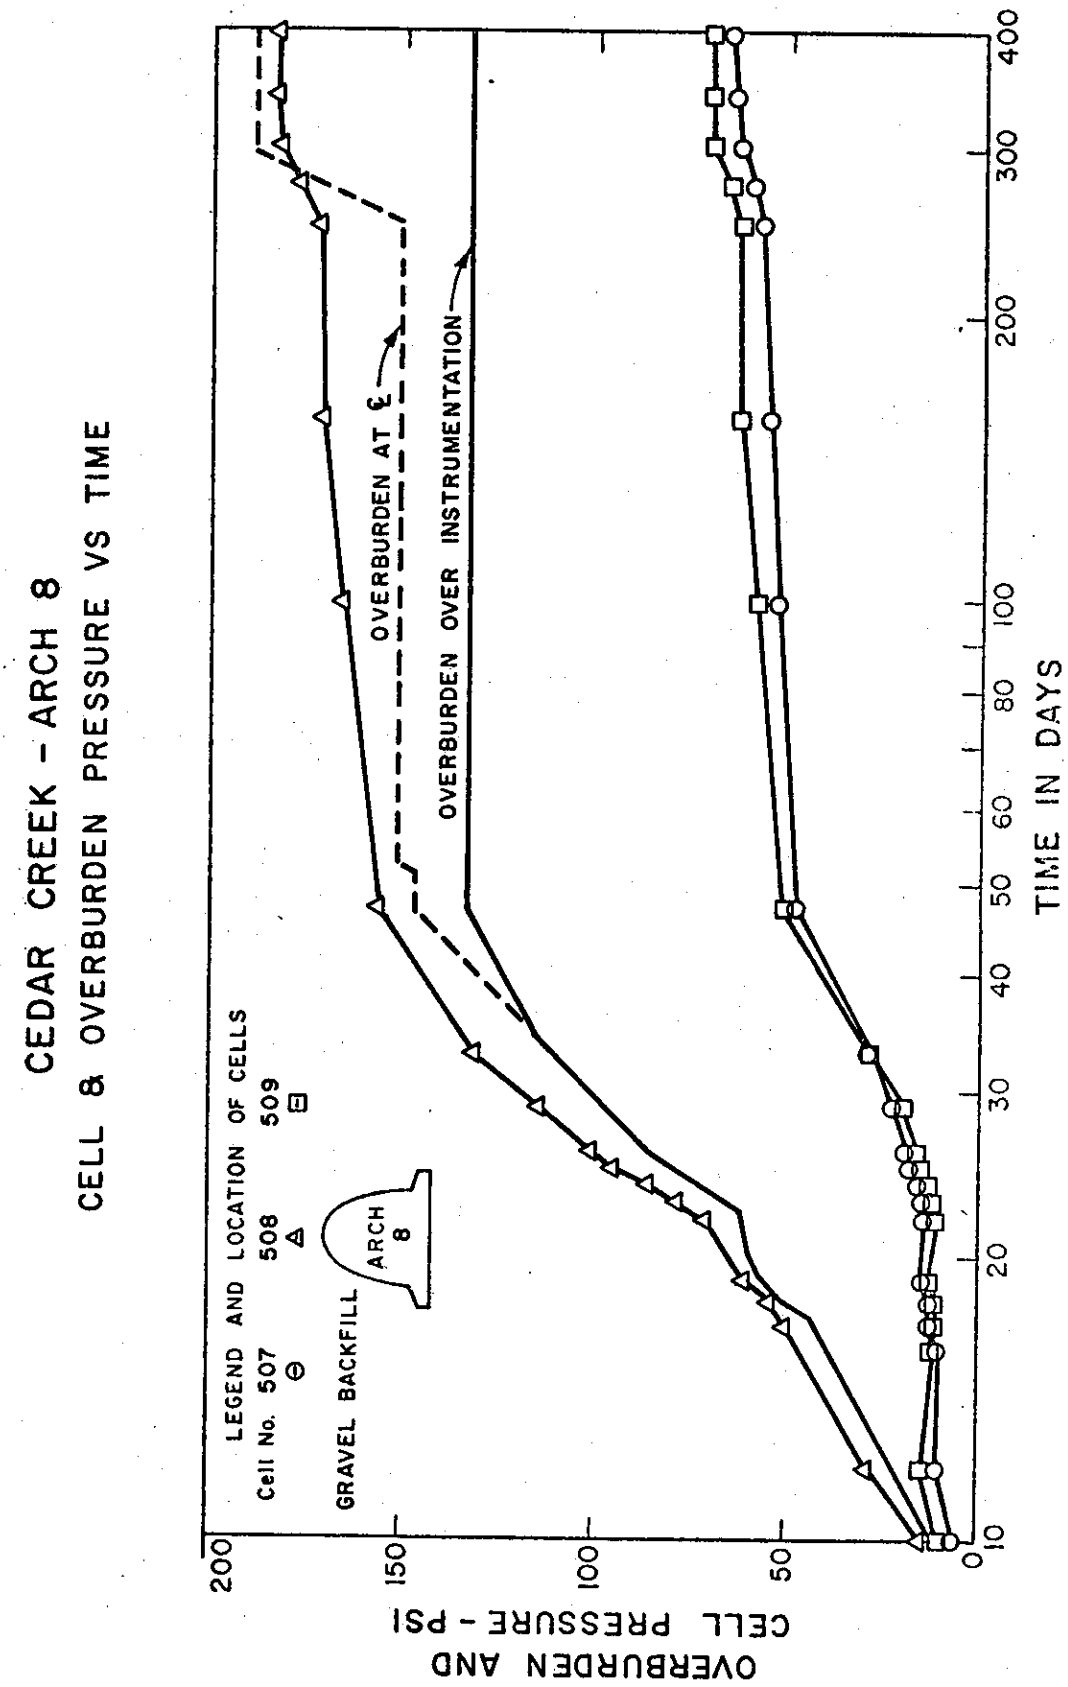
Figure 15

Slightly erratic readings were obtained from several other cells, but results appear to reflect actual test conditions. As an example, pressure cell 508 (Fig. 15) indicates the soil stress at the crown of arch 8 to be significantly greater than the recorded soil stress immediately to the sides or at the crown of the adjacent arches 6 and 10. Since this cell responded quite well to the rise of the embankment, and transducer resistances were found to be normal, the readings are assumed to be accurate. Somewhat erratic readings were also evident with cells 3012 (Fig. 18), 3014 (Fig. 19) and 3009 (Fig. 20) after day 100. But due to similarity in the recorded data from these three adjacent cells, reliability in data was also assumed.

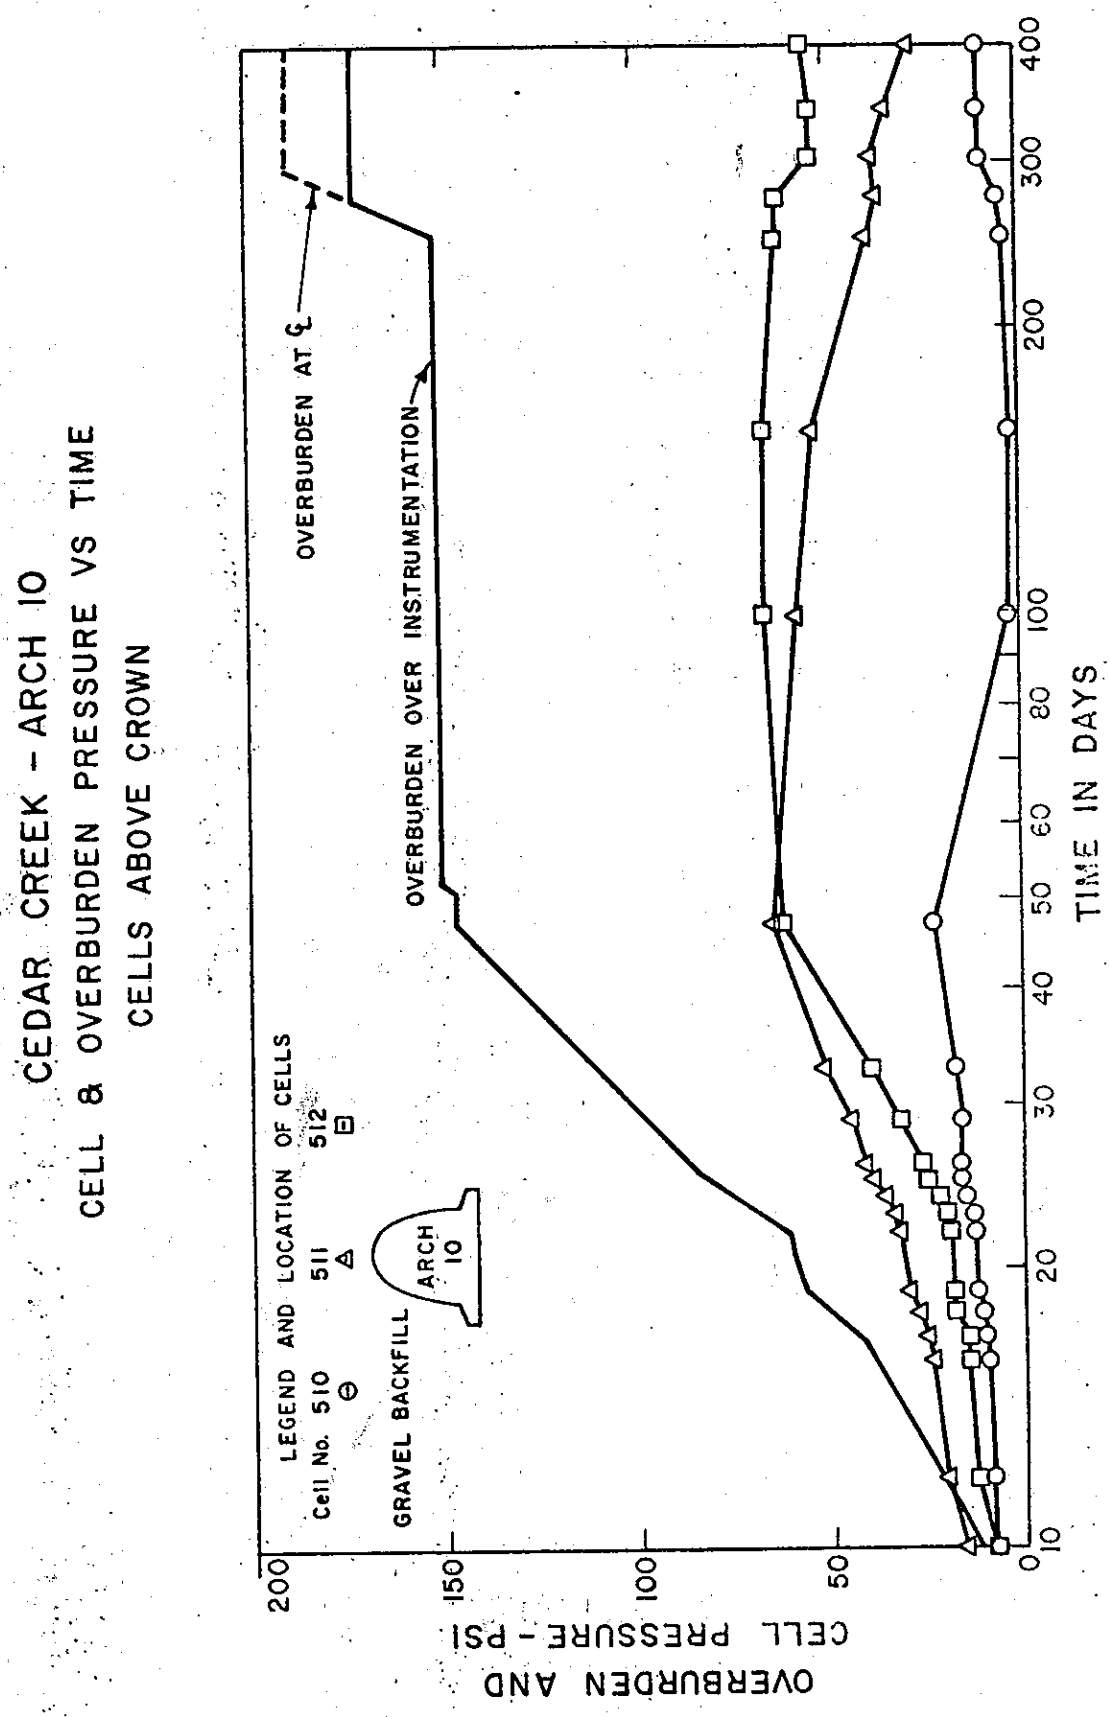
Figure 16

Four hundred days after installation 24 of the 28 cells were still providing reasonable data. Figures 13 to 22 illustrate the vertical pressure vs. long-time plots for various sections of the arch culvert. Of the four questionable cells, two (#510 and 511) may have developed small leaks in the hydraulic systems after 50 days, one (#3008) has developed a major hydraulic failure after 300 days and one (#3003) developed electrical problems after 35 days.

The rapid loss of pressure as shown for cell 3008 after 300 days is indicative of hydraulic leakage or circuit failure (generally from shorting by moisture). Since resistivity to ground was high in this case, it appears that this cell developed a failure in the hydraulic system.

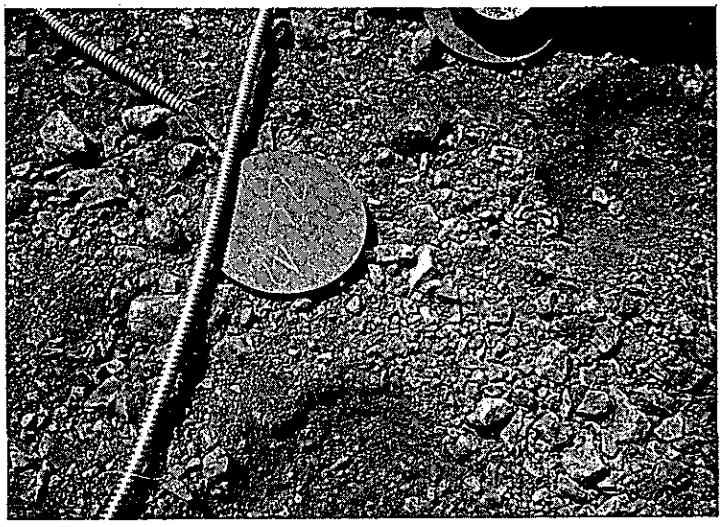
The embankment material consists of hard, metamorphic rock from adjacent cuts. Because of the blasting methods used to presplit the rock slopes, and the hardness of the materials encountered, the fill material was very coarse-graded with little fine material to act as a binder (Fig. 26 and 27).

Figure 26. Soil texture of embankment material at Pressure Cell Cluster 1. Typical of material encountered at all instrumentation sites.

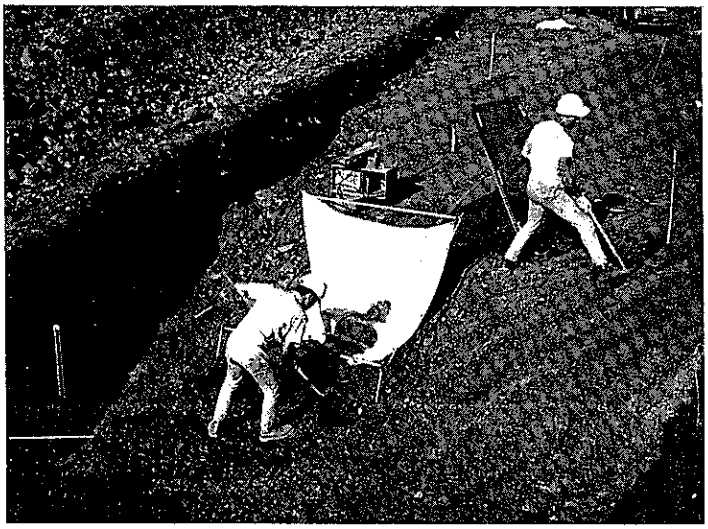
Figure 27.
Instrumentation trench side wall. Note extremely rocky embankment material.

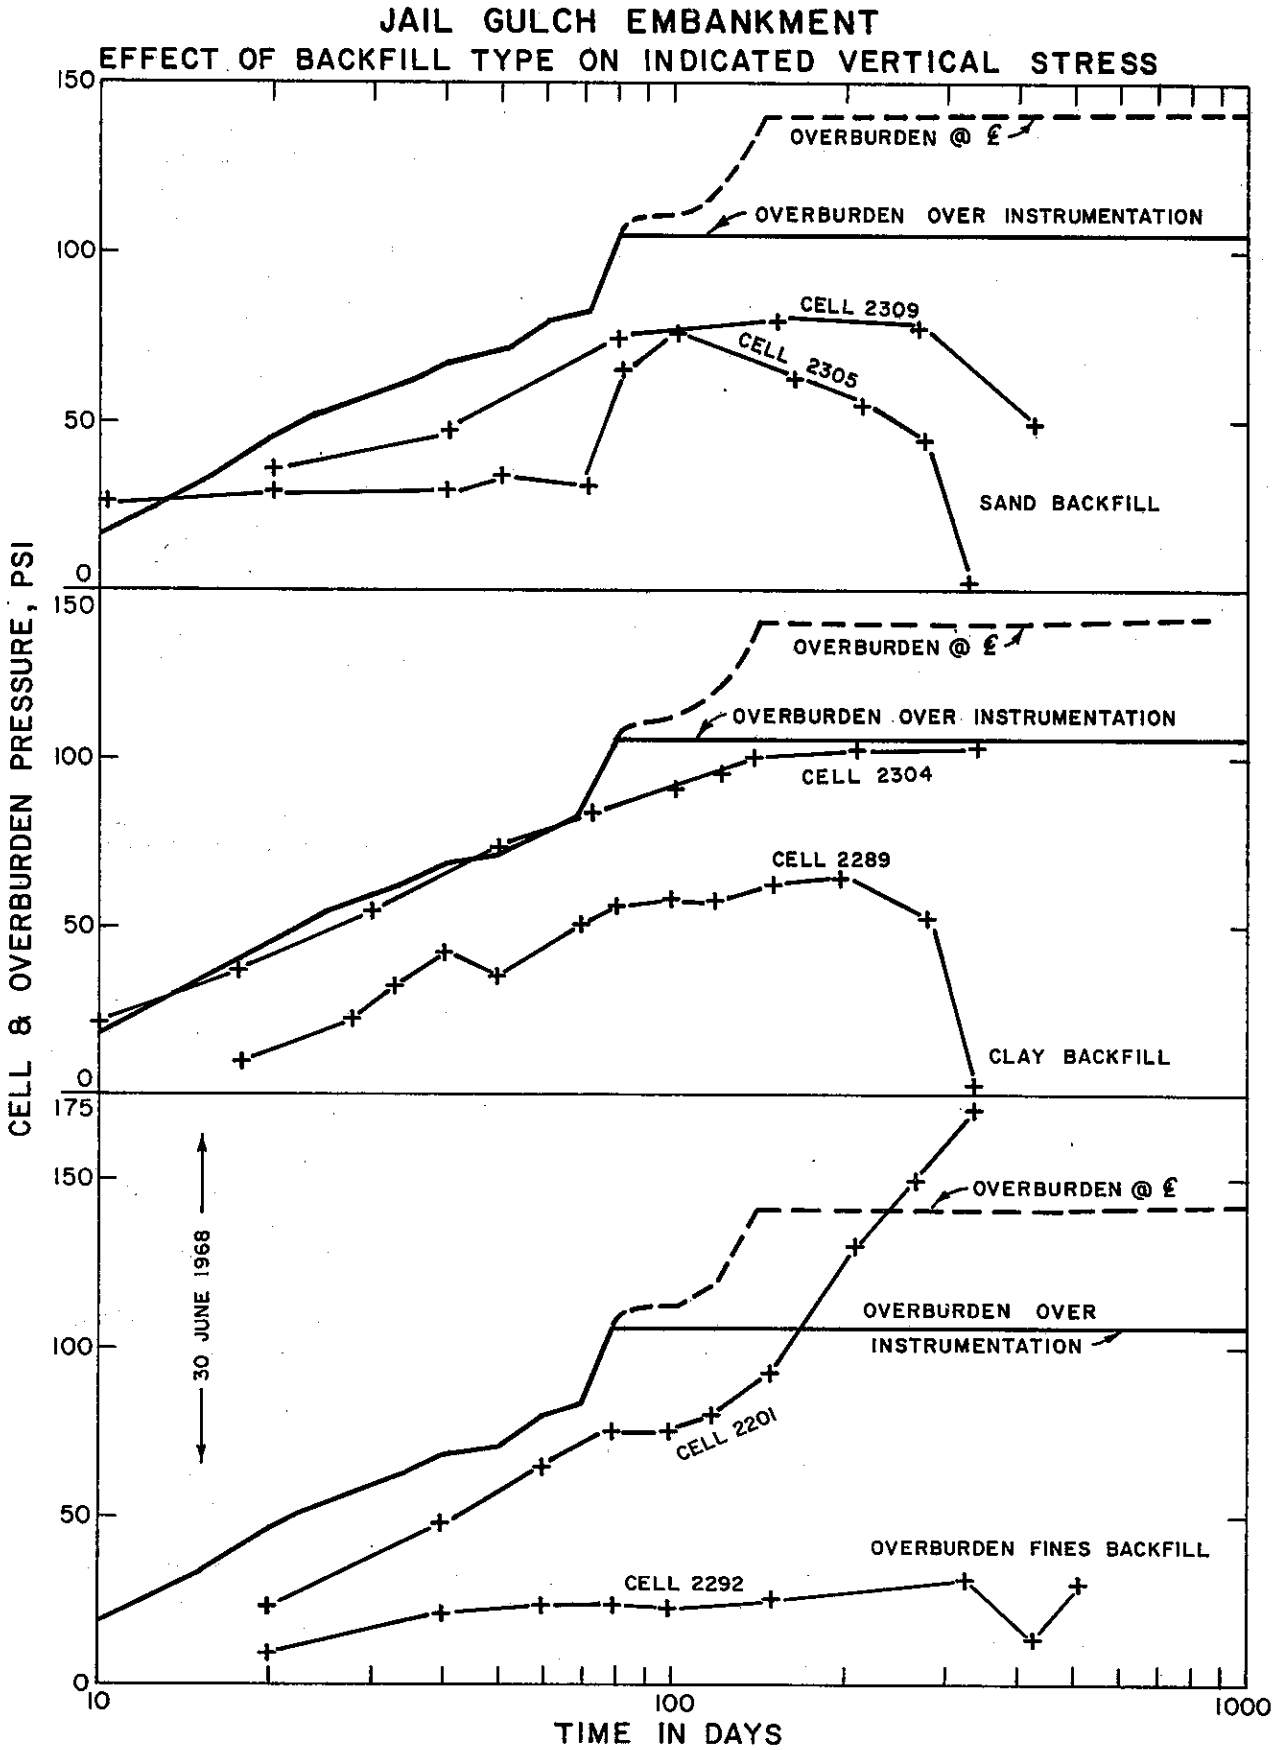
Figure 33 shows the time plot of pressure cell response for each of the three types of bedding material. As can be seen from this figure, no conclusions can be made concerning the effect of backfill on the accuracy or reliability of data obtained. Of the two vertical cells installed in the sand backfill, one shows definite cell failure at approximately day 200, and the other cell appears to have developed a leak in the hydraulic system sometime after day 300.

Curves developed from the data of one cell in clay backfill and one in sand backfill were very similar. Both of these cells recorded approximately the same maximum stress before failing in almost identical patterns. Since these two cells were installed adjacent to each other, failure may have been caused by localized stresses in the embankment. It appears that accurate and consistent data are being obtained from the other pressure cells installed in clay backfill at this location.

The exceptionally high and increasing stress indicated by one of the cells in embankment fines backfill was caused by an electrical short between the lead wires and ground. It is assumed that arching action is the cause of the low stress readings obtained from the other cell in this backfill material.
