DYNAMIC TESTS OF AN ENERGY ABSORBING BARRIER EMPLOYING STEEL DRUMS

By
Eric F. Nordlin, James H. Woodstrom
and Robert N. Doty

RESEARCH REPORT

NO. M & R HRB 636405-2

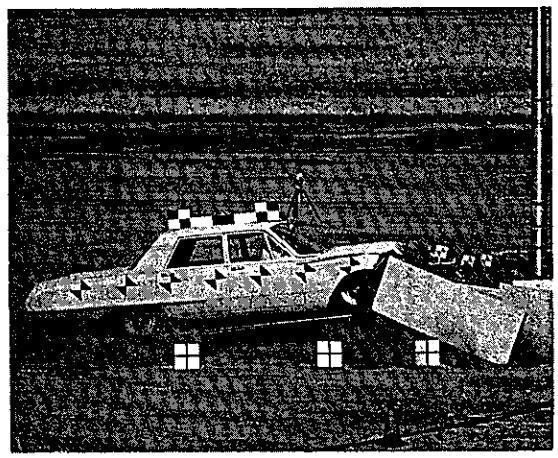
FIGURE 5

There was a noticeable vertical force imparted to the vehicle as shown by the vehicular rise in Figure 5, below. The rise was caused, at least in part, by the right front wheel riding up on the cable. There was virtually no vehicular "rebound".

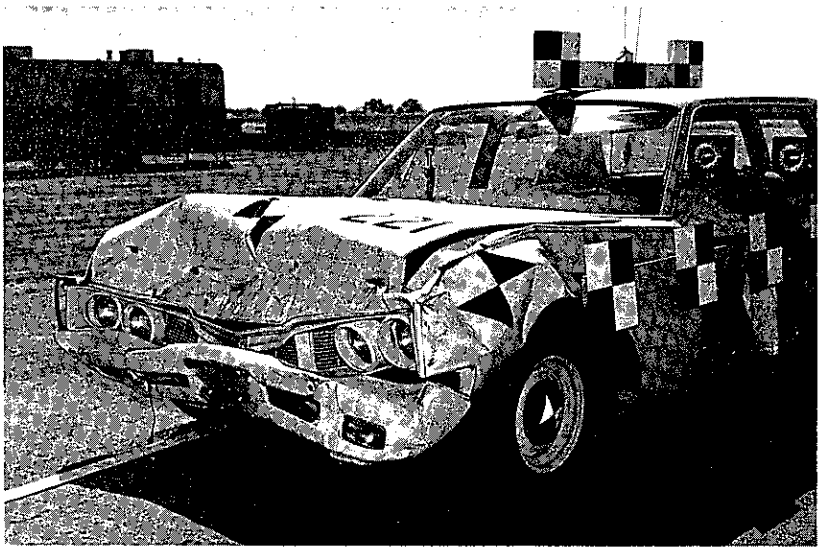
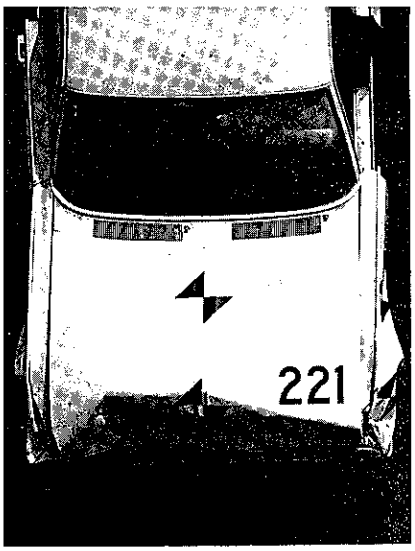
Vehicular damage consisted of some bumper deformation, a cracked windshield, a jammed door on the right front side, damage to both front quarter panels, 3.4 inches of steering column collapse

(energy absorbing steering column), and some dashboard deformation (see Figures 6 and 7, below). Maximum vehicular crush was 16.5 inches.

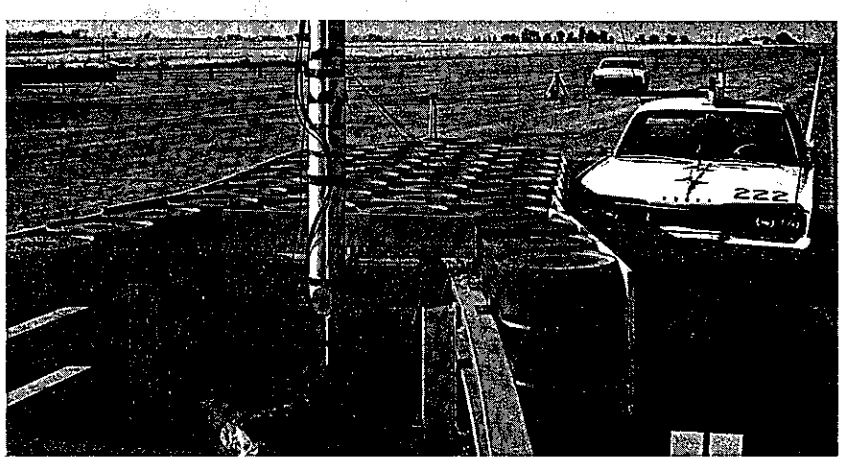
FIGURE 10

The 4760 pound 1968 Dodge sedan impacted the left side of the barrier 10.2 feet in front of the bridge approach guardrail at a speed of 59.8 mph and an angle of 11 degrees with the barrier (see Figure 10, below, for approximate location at impact). The vehicle was redirected but minimal redirectional forces were provided by the drums. The vehicle axis was displaced 12 inches laterally from its location at impact before any redirection began (i.e., crabbing occurred). At this time, solid contact with the bridge approach guardrail had been established.

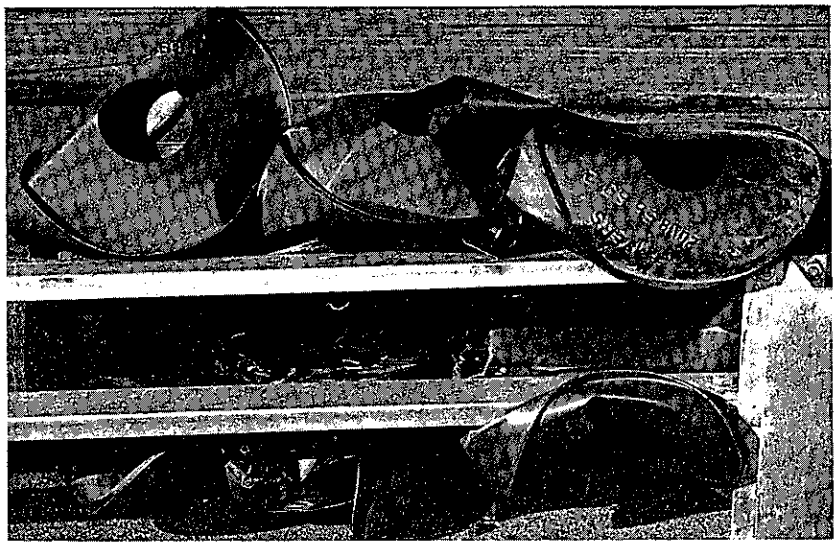
FIGURE 11

The force of the impact caused a clamping action to take place between the rear drums and the bridge approach guardrail, thus preventing drum ejection (see Figure 11).

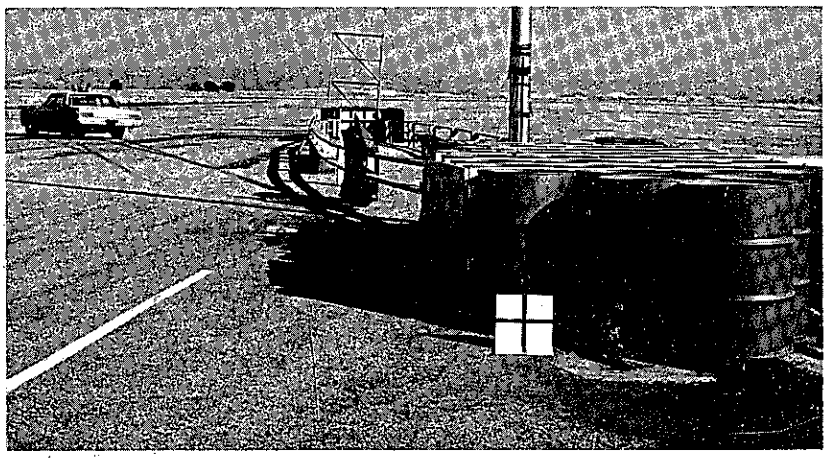
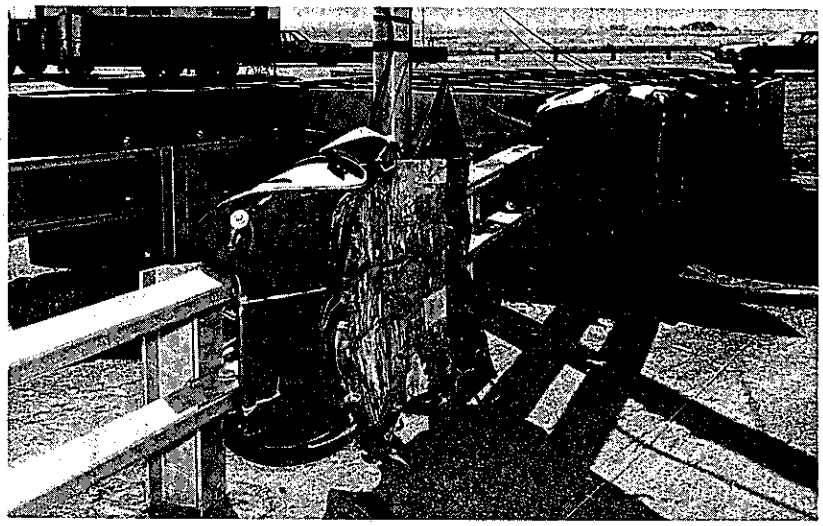
Additional barrier damage consisted of crushing of the outside drums in the back half of the barrier on the impacted side. All the fender panels beyond the point of impact were torn off the barrier. There were some failures at hinge pins; the ends of the last few diaphragms were broken off on the impact side. There was an unacceptable amount of debris deposited in what would be the adjacent traveled way. Some of the fender panel fragments were thrown 155± feet from the point of impact (see Figures 12 and 13).

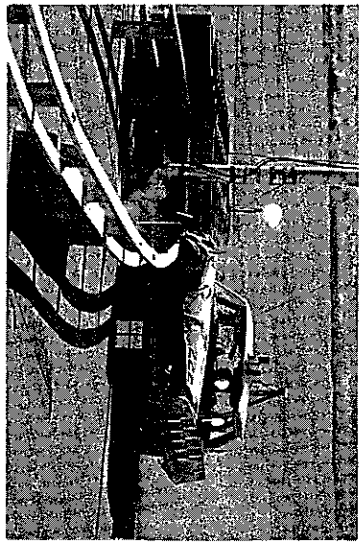
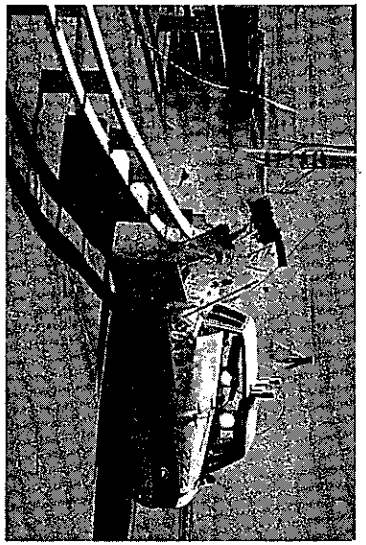
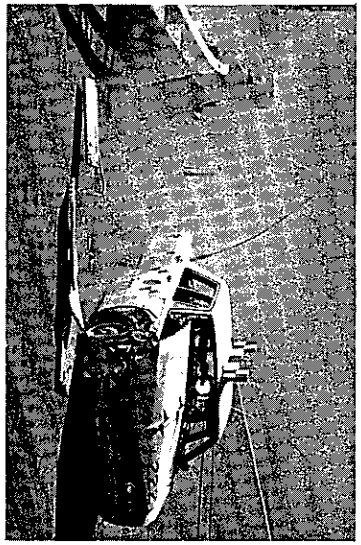
Vehicle damage included severe crushing of the right front quarter panel, jamming of the right front door, scars on the right doors and right rear panel, and displacement of the radiator to the point of touching one fan blade (see Figure 14, below). See Plate 4 (following page) for additional test data.

Barrier Depth	19.6 Ft.	Test No.	222
No. of Drums	41	Date	11-21-69
Permanent Displacement of Barrier Nose	None	Vehicle	1968 Dodge
Deceleration Distance-Passenger Compartment	Redirected	Vehicle Weight (W/Dummy and Instrumentation)	4760 Lbs.
Maximum Vehicular Deformation	27 In.		
Steering Column Collapse[1]	None	Impact Velocity	59.8 MPH
Passenger Compartment Deceleration (Highest 50 ms avg.)	6.6 G's Long. 5.3 G's Lat.	Impact Angle	11° (Side)
		Dummy Restraint	Lap Belt
Vehicle Average Deceleration-Calculated	-

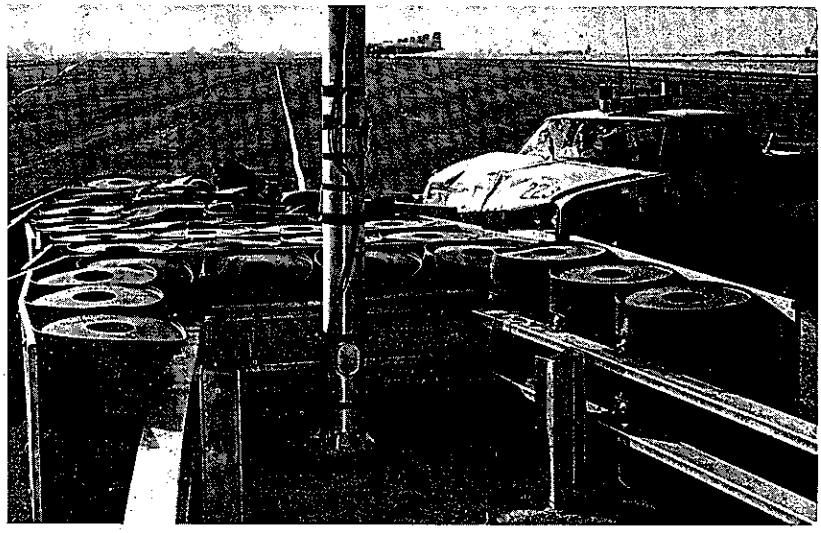
FIGURE 15

Test 223. This test consisted of a 4740 pound 1968 Dodge sedan impacting the same barrier design used for the previous test. The vehicle impacted the left corner of the barrier nose at a speed of 53.6 mph and an angle of 9 degrees. At impact, the center of the front of the vehicle was offset 3.5 feet from the barrier axis. Significant elastic lateral deflection of the barrier took place as the vehicle penetrated 13.2 feet, rotated clockwise, and then rebounded 2.5 feet. The maximum 50 ms average vehicular passenger compartment deceleration, based on accelerometer data, was 10.9 G's (in the longitudinal direction). The average passenger compartment longitudinal deceleration was 7.2 G's. (The vehicular rotation was neglected because the longitudinal velocity was approximately zero before rotation began.) Deceleration of this magnitude would probably result in moderate to severe injury for an unrestrained occupant, minor to moderate injury for an occupant restrained by a lap belt, and little or no injury for an occupant using both a lap belt and a diagonal shoulder harness. The position of the vehicle after the collision was such that it would have been a hazard to adjacent traffic (see Figure 15, below).

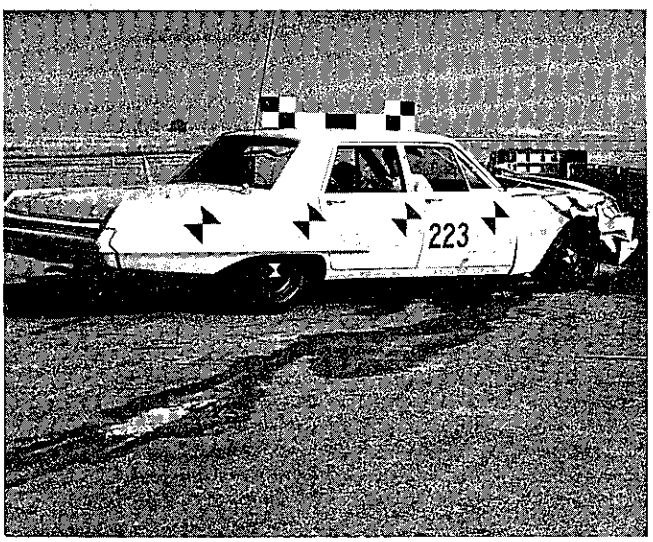
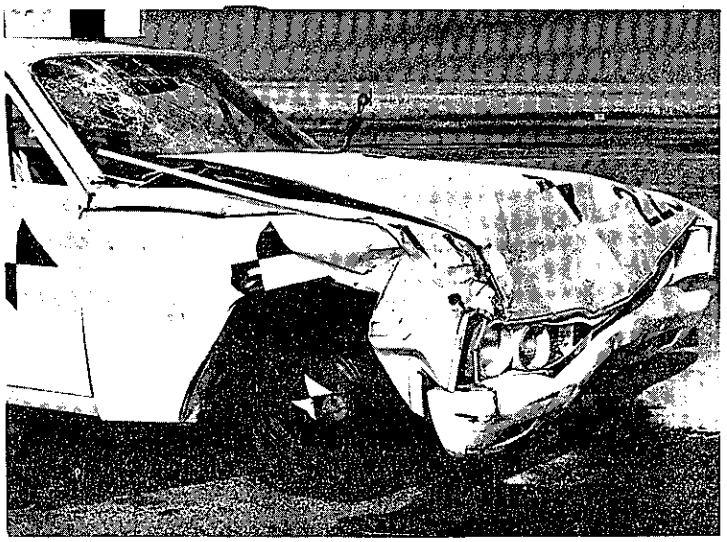
Vehicle damage consisted of a crimp in the roof on the passenger side, extensive hood deformation, slight displacement of the left front quarter panel, and 3.6 inches of (energy absorbing) steering column collapse (see Figures 16 and 17). There was a slash high on the cheek of the dummy driver and the windshield was broken in front of the dummy passenger. The dummy passenger was badly cut on the tip of the bridge of his nose, over his right eye and on his forehead, and on the right side of his face and cheek. This dummy's lower legs were removed before the crash; this may have contributed to some excessive movement of his upper body during the collision.

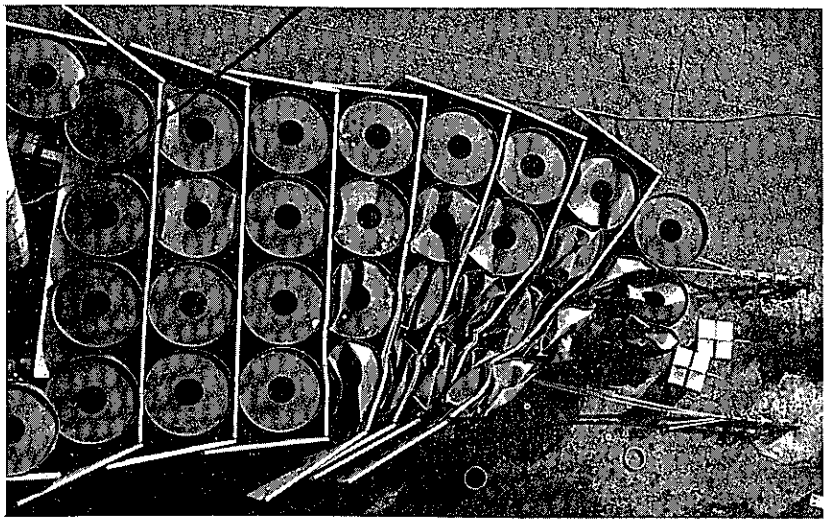
FIGURE 18

All but two drums were damaged. The left front and the right rear plywood fender panels were the only ones damaged. It appeared that the impact force was transmitted somewhat diagonally from the left front to the right rear of the barrier (see Figure 18, below). The left front portion of the barrier was crushed much more than the right front side. The film record shows the drums crushing one row at a time in successive order with the exception of the back row, which was deformed soon after impact. This was very similar to the dynamic barrier compression sequence observed during Test 221 and again verified the design assumptions. From a maintenance standpoint, all the drums would have required replacement.

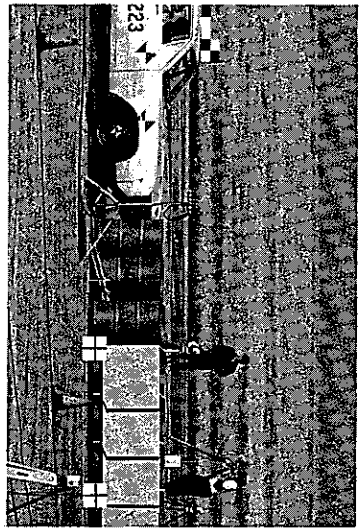
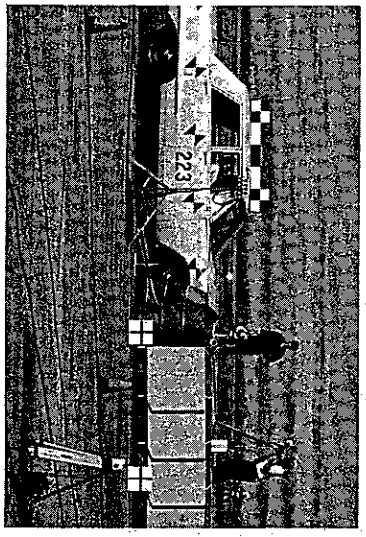
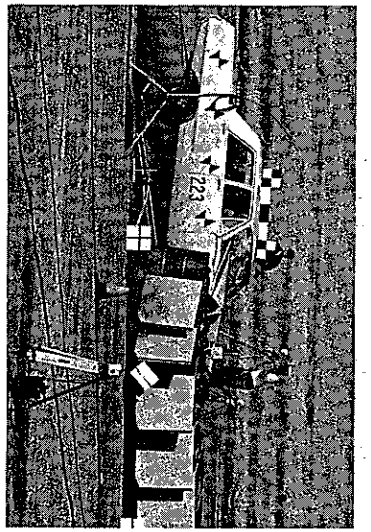
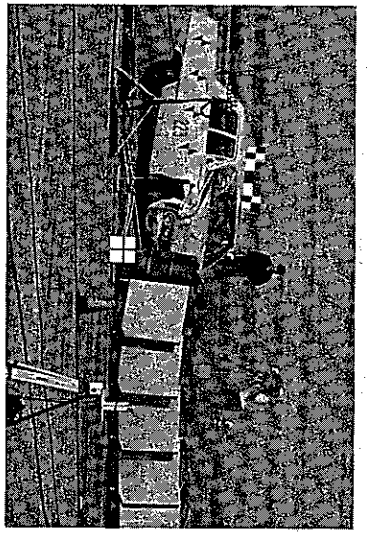
The movies showed the car being ejected outward from the barrier due to the elastic energy stored within the barrier. The clockwise rotation of the car was probably caused by a moment couple consisting of the vehicular momentum, acting through the vehicle CG, and this "elastic" energy, acting through the centroid of the vehicle-barrier contact interface. See Plate 5 (following page) for additional test data.

Barrier Depth	19.6 Ft.
No. of Drums	41
Permanent Displacement of Barrier Nose	5.5 Ft.
Deceleration Distance-Passenger Compartment	13.2 Ft.
Maximum Vehicular Deformation	14.5 In.
Steering Column Collapse[1]	3.6 In.
Passenger Compartment Deceleration (Highest 50 ms avg.)	10.9 G's Long.
Vehicle Average Deceleration-Calculated	7.2 G's[2]
