EVALUATION OF GROOVED TRAFFIC STRIPES ON PORTLAND CEMENT CONCRETE HIGHWAYS

FINAL REPORT

CA-HY-MR-5193-1-72-31

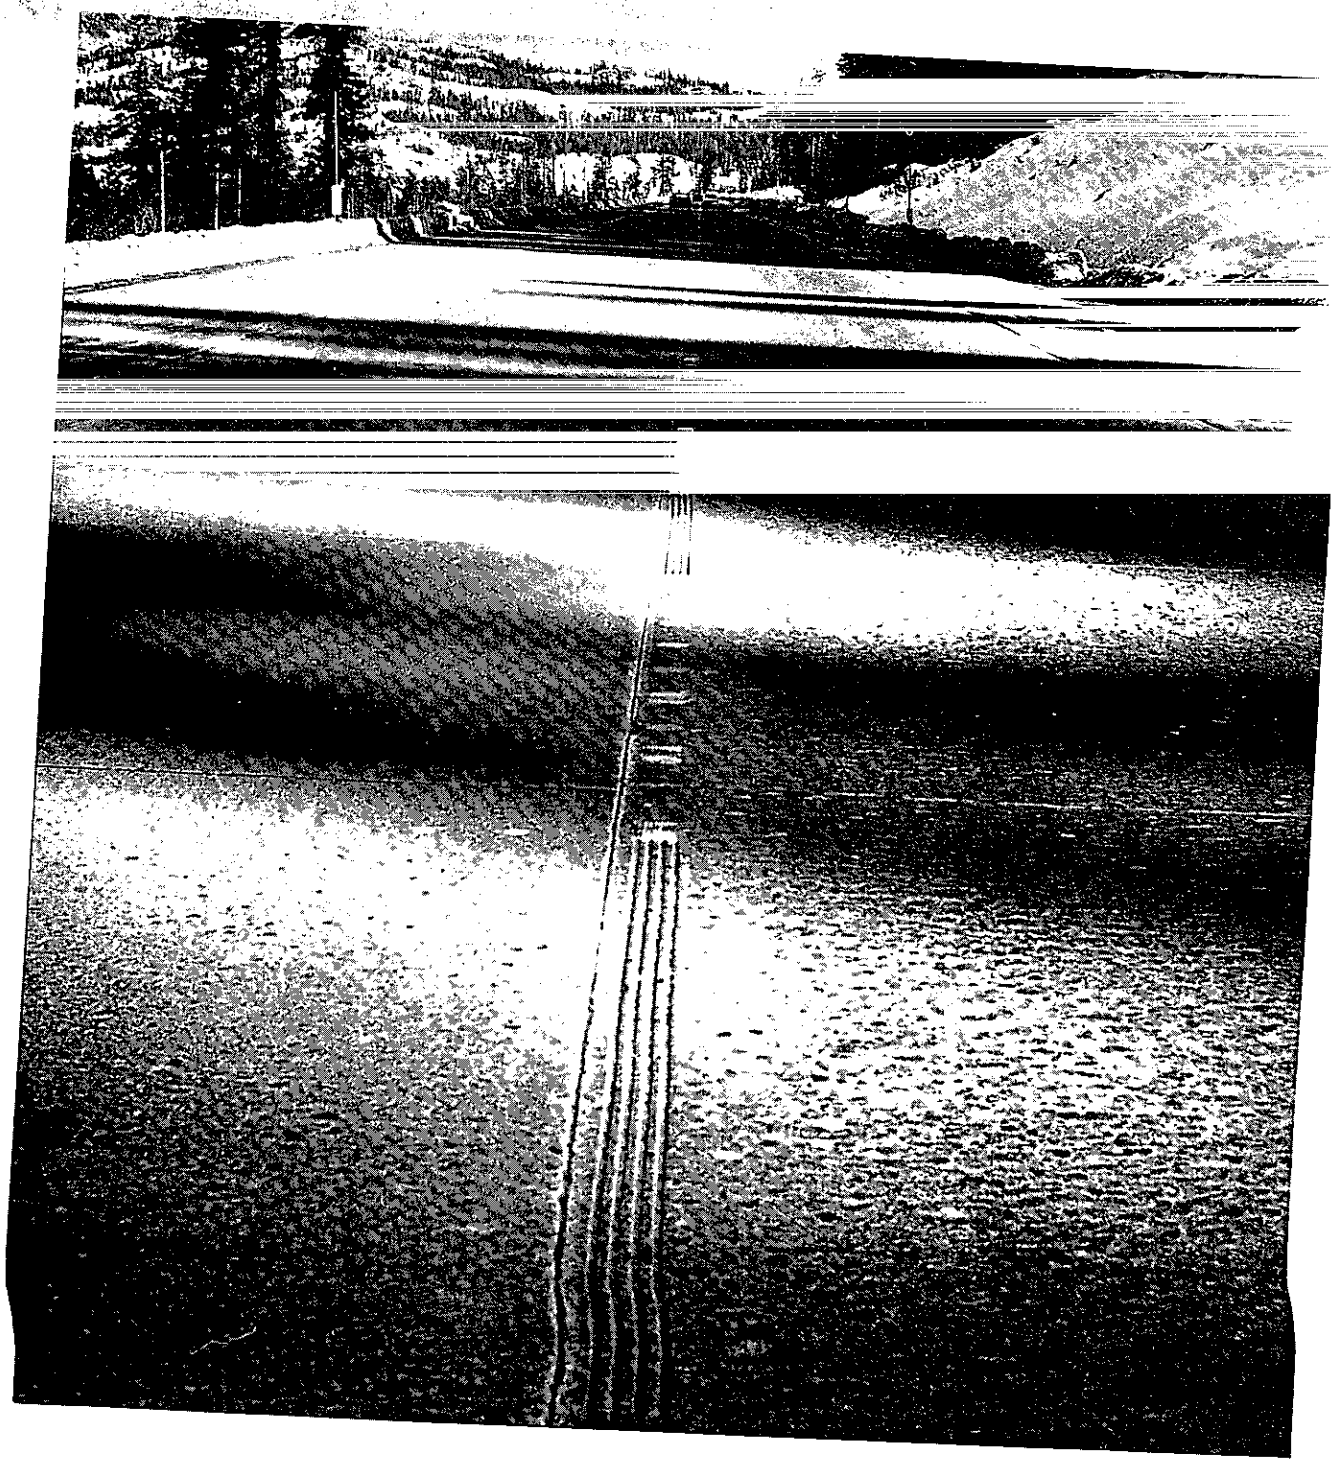
Figure 6

This site was observed again on December 31, 1969. There had been several rain and snow storms since the October inspection. The paint was almost obliterated in both the grooved and control sections. Due to chain and snow plow action, the crests of the grooved line were already beginning to flatten. (Figure 6.)

Kingvale Area after Several Rain and Snow Storms

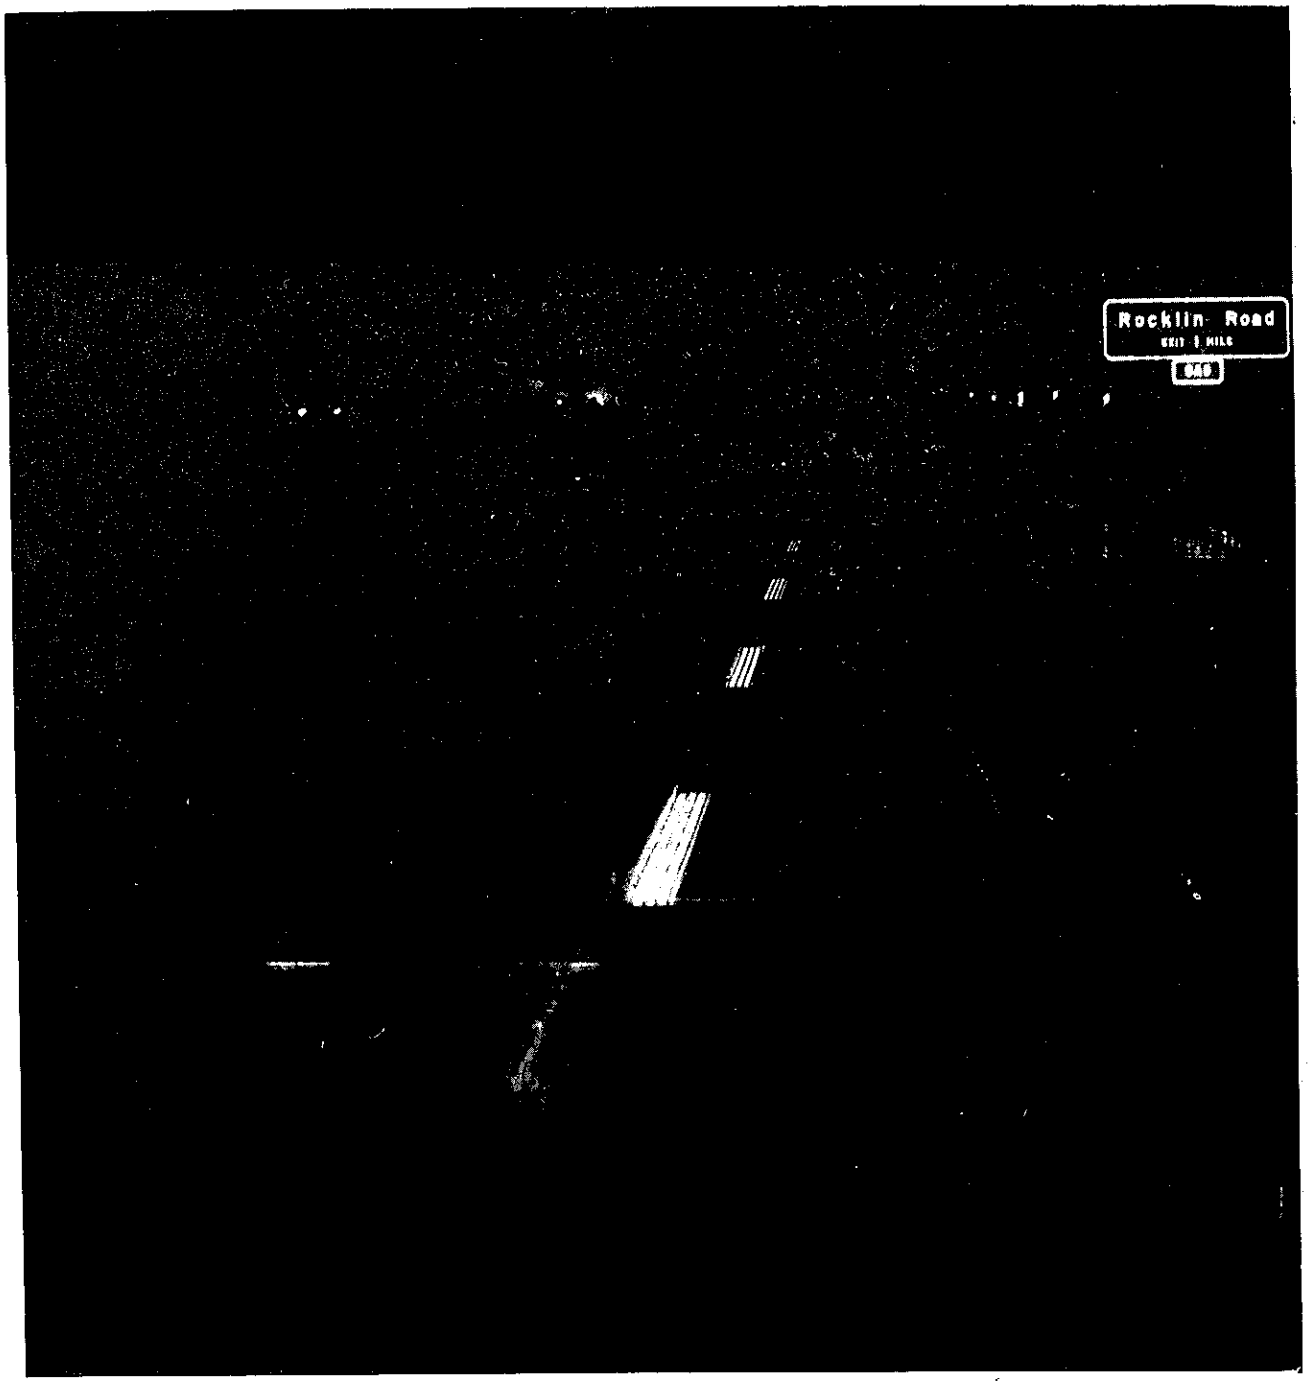
Figure 7

On December 23, 1969, the test stripes were photographed at night, again during a moderately heavy rain. The grooved lines (Figure 7) were far superior to the control lines (Figure 8). No significant difference was observed between the grooved stripe area with the transverse drainage cuts and the area with no such cuts.

Rocklin Area Grooved Section. Night photograph during rain.

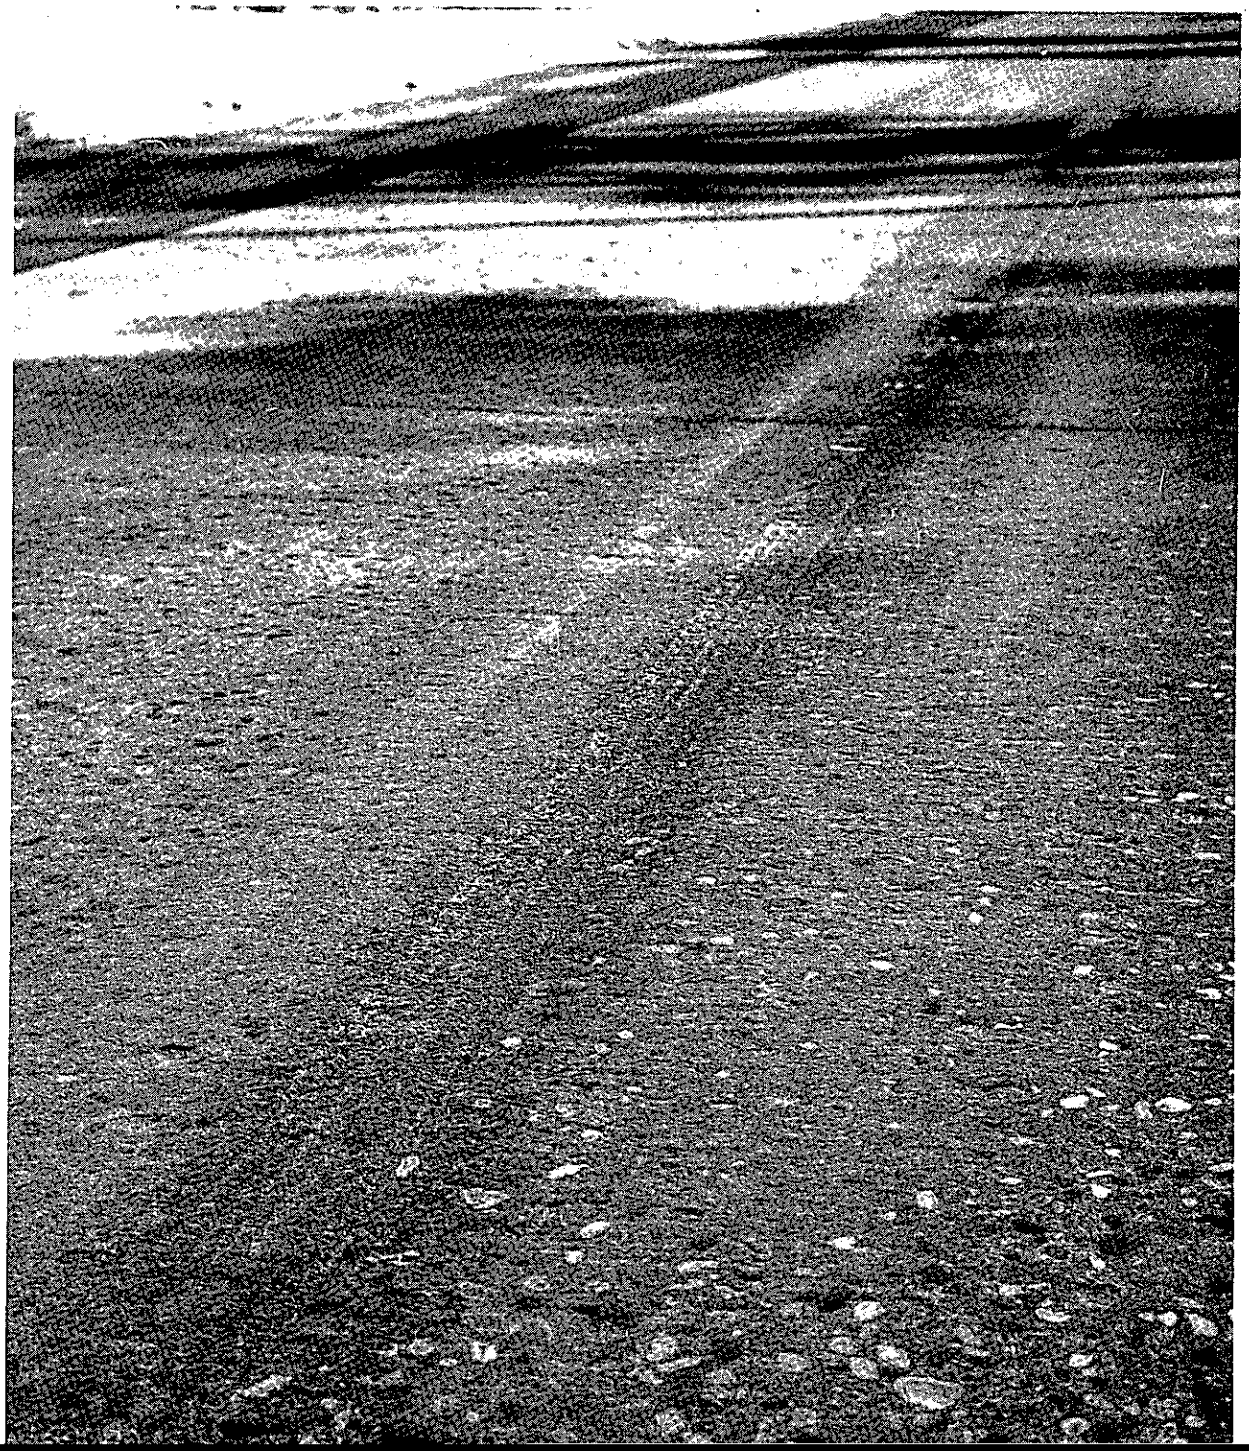
On December 30, 1970, this test site was inspected again. Up to this time it had been 15 months since the grooves were cut and three months since the last painting. Several storms had occurred and there was no trace of paint left in either the control or grooved lines. The grooves were filled with sand and mud. (See Figure 9 taken after a later repainting.)

It has been noted that the grooved line at Kingvale often filled with dirt so that there was little or no delineation. This condition was photographed in late November 1971 (Figure 9). At this time the paint was about 80% intact.

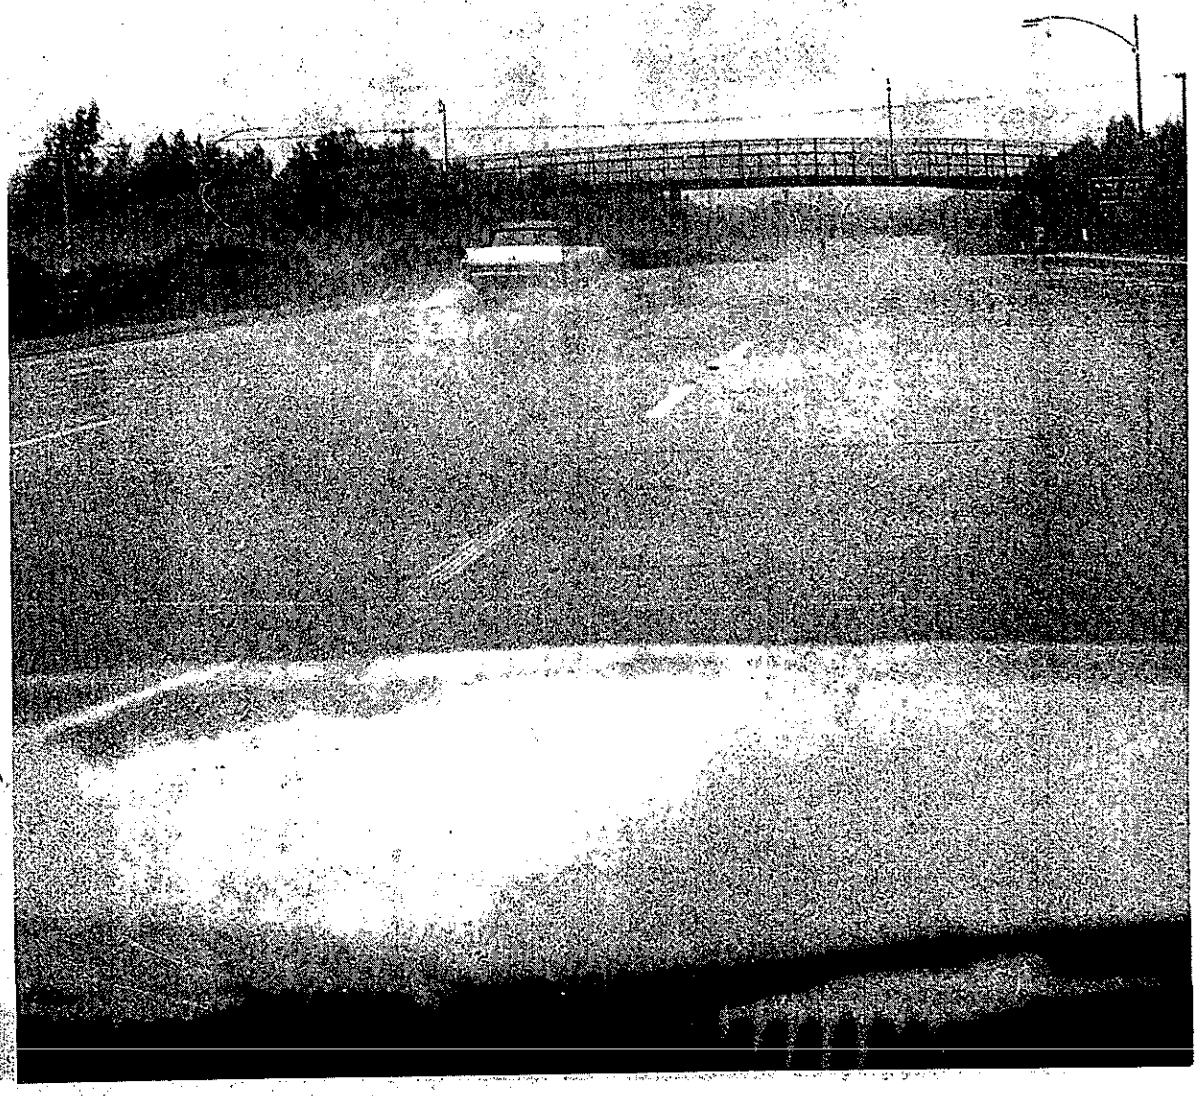
Figure 10 shows the transition from the grooved to the control section. The first stripe in front of the car is grooved and is actually slightly less visible than the next stripe which is a control stripe. The actual visual observations agreed with the photograph since it was very easy to observe the transition from the grooved to control sections. In contrast, Figures 11, taken during dry weather showing the transition from the grooved to the nongrooved section, shows the lines to be equivalent, and it was very difficult to detect the transition point at freeway speed. (This photograph was taken at the Rocklin section.) All photographs taken at the South

South Sacramento Area During Moderate Rain. Grooved stripe in front of car is slightly less visible than the next control stripe.

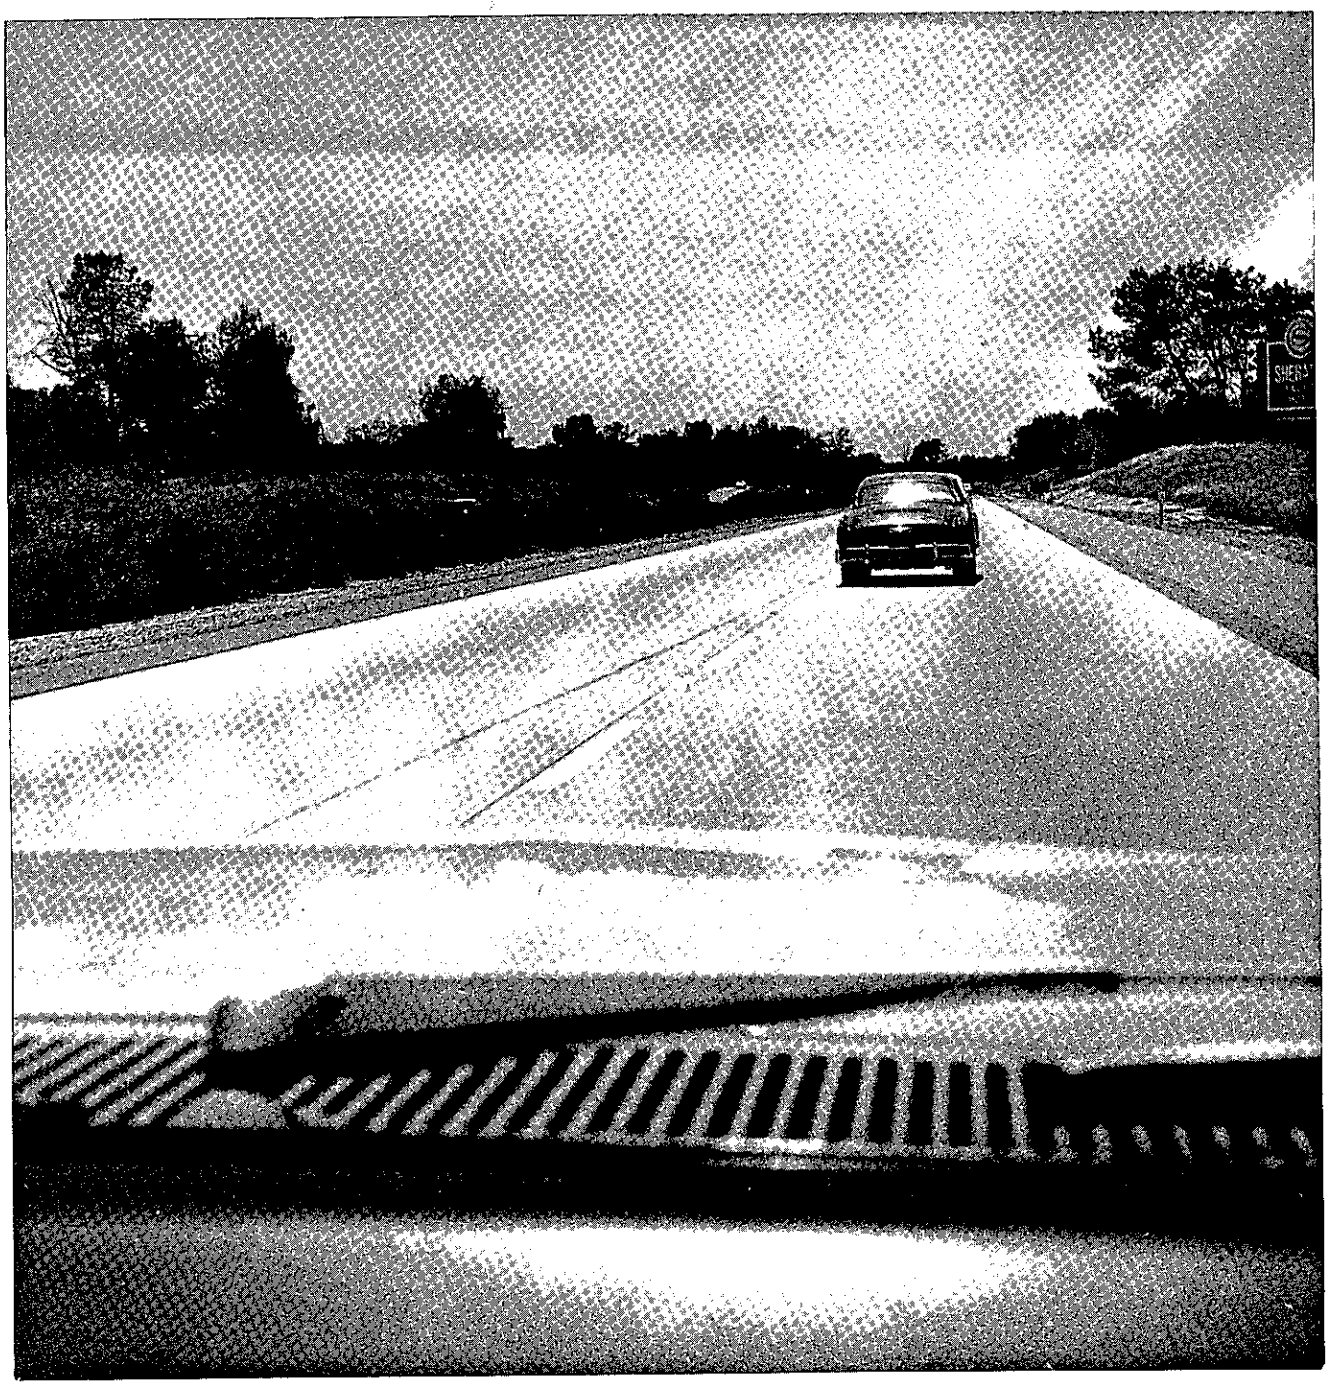
Figure 11

Rocklin Area During Dry Weather. Grooved stripe in front of car is scarcely distinguishable from next control stripe.

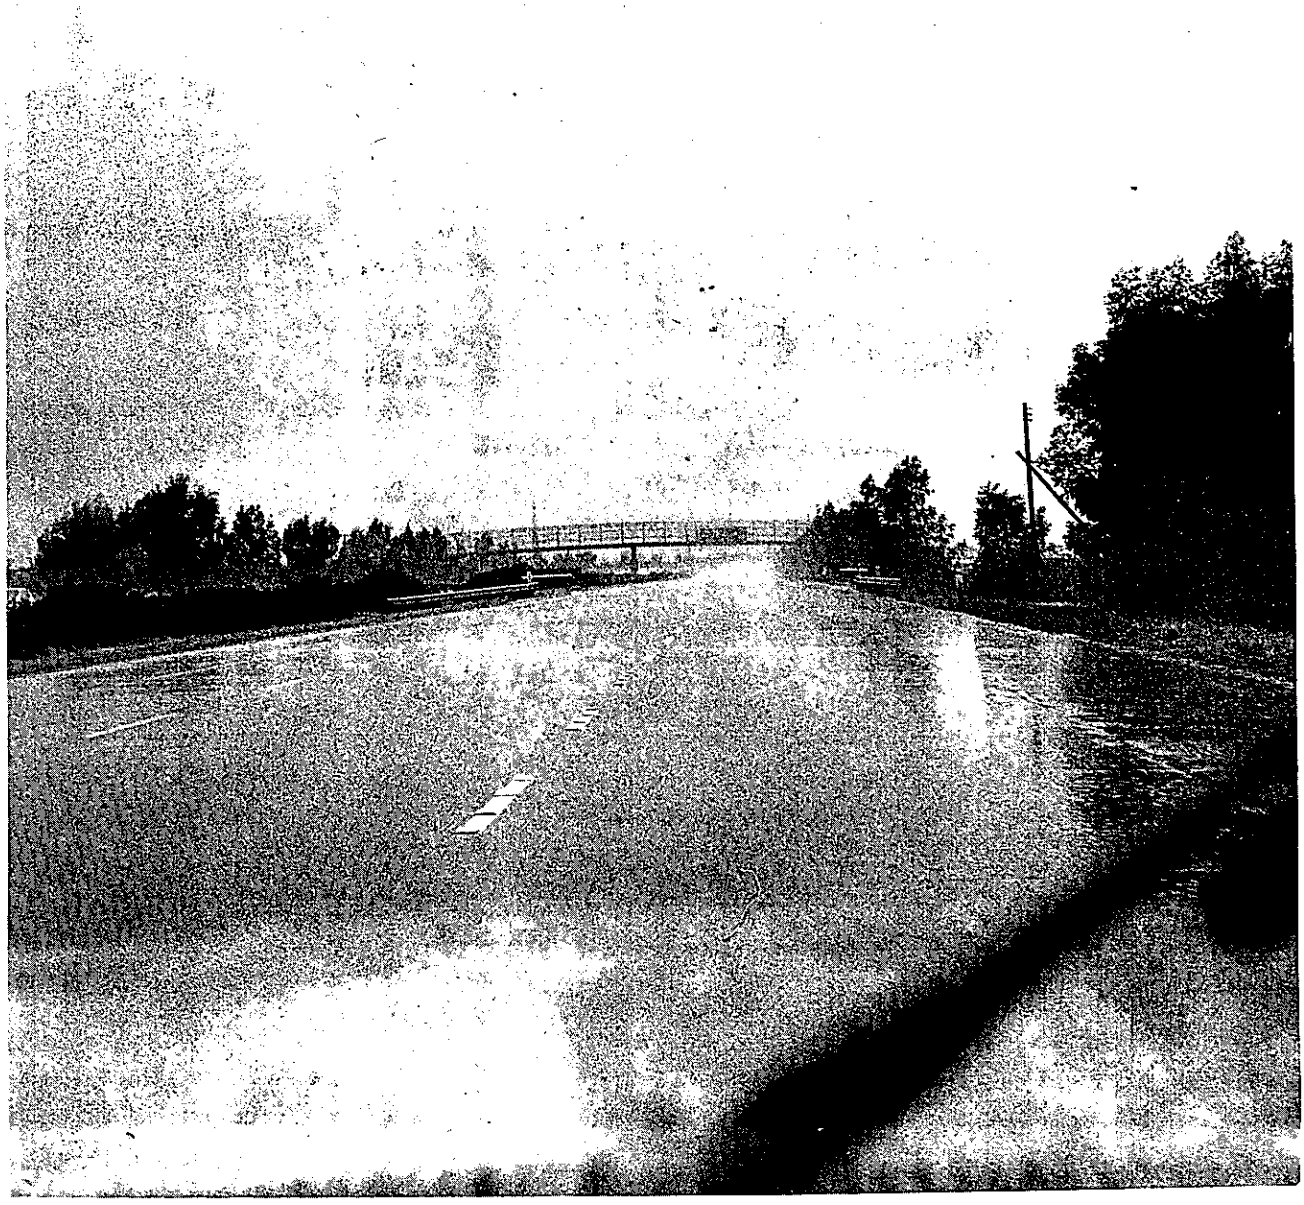
Figure 12

The grooved line is very inferior to ceramic raised markers during wet weather daytime conditions. Photographs taken April 17 on the South Sacramento Freeway in a moderately heavy rain, show a series of raised markers of different types, the whitest of which are ceramic (Figure 12). The grooved section is immediately beyond the last ceramic markers and is completely invisible.

Sacramento Area During Moderate Rain. Series of raised markers followed by the grooved section shows the superiority of raised markers.

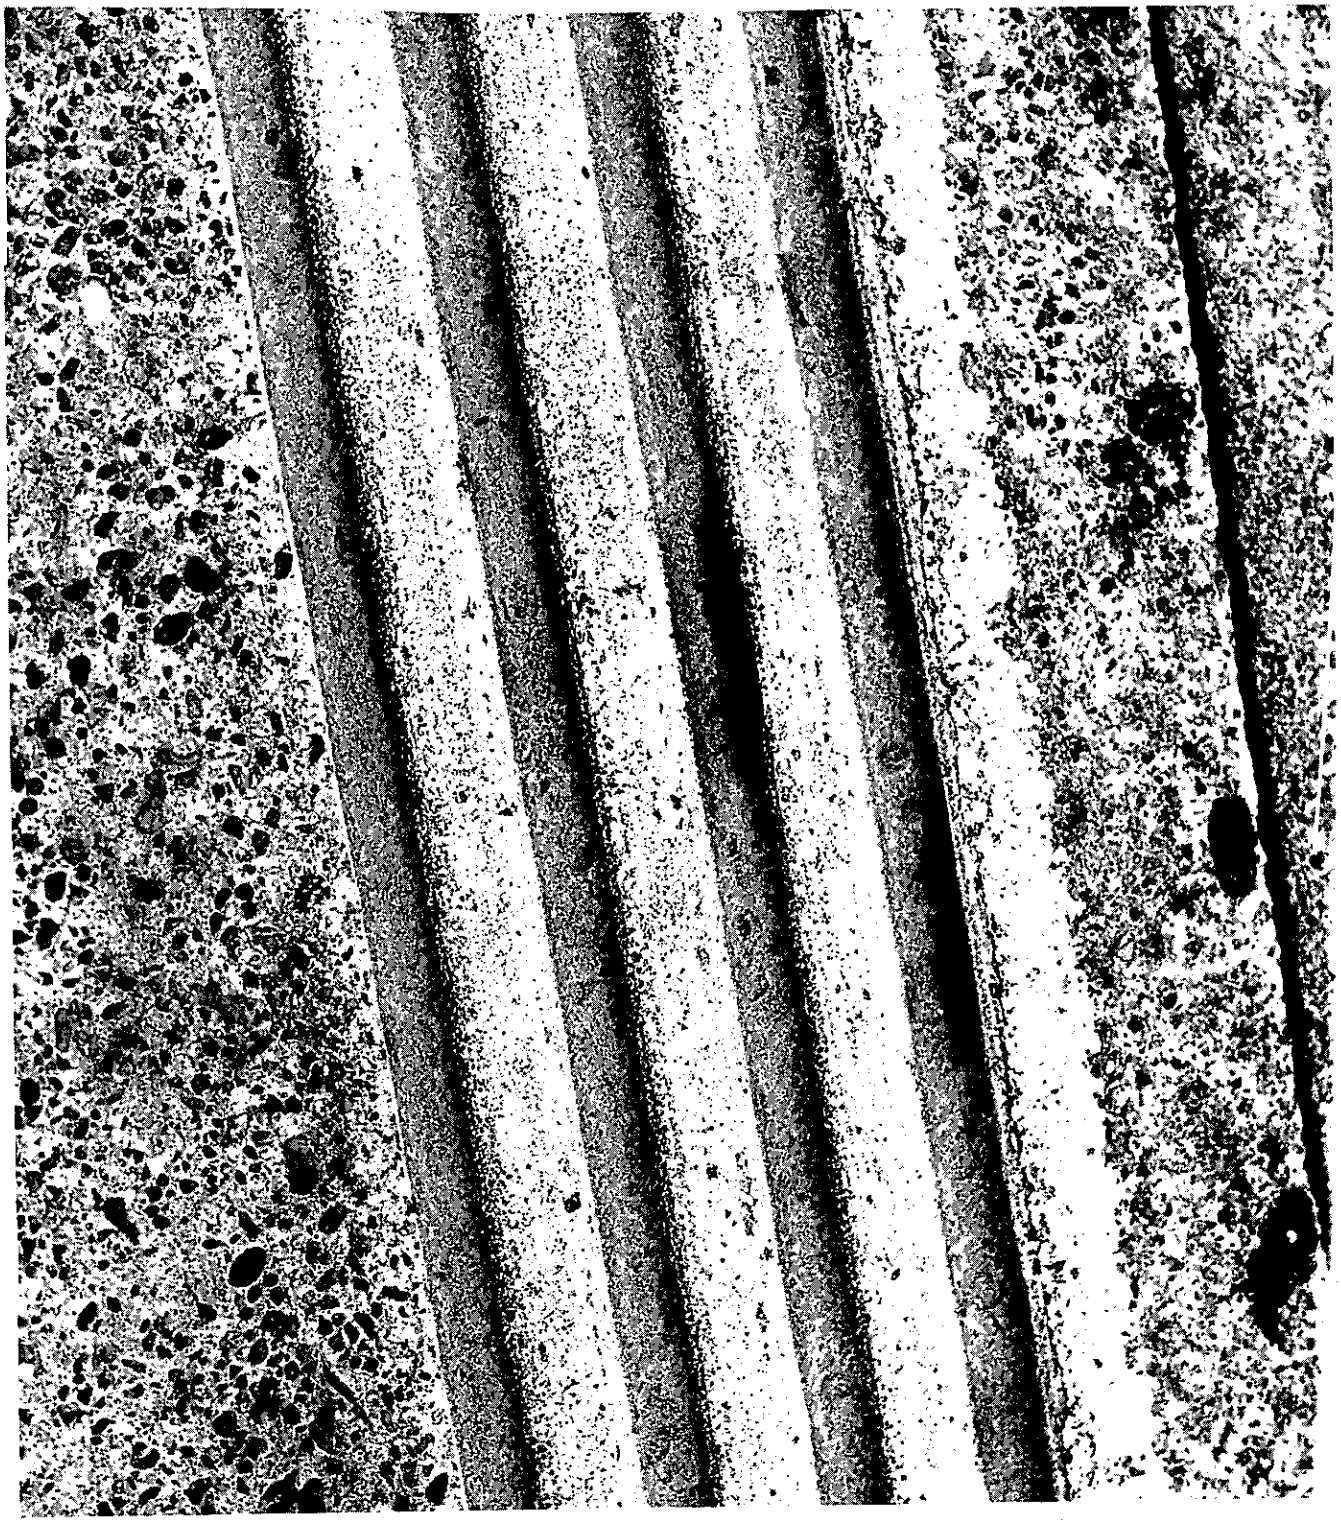
As mentioned before, the paint on the crest of the groove is about one-half the thickness of the paint on a flat stripe due to runoff of the paint. The rate of wear on the crest is, nevertheless, about the same as a flat stripe. Figures 13 and 14, taken on the South Sacramento Freeway February 8, 1972. Figure 13 also shows the tendency for dirt to collect in the groove which decreases the white surface exposed to the driver and decreases the visibility somewhat.

Painted Grooved Traffic Stripe in Sacramento Area. The accumulation of dirt in the trough decreases the visibility somewhat. The wear on the crests is about equal to the adjacent control section (Fig. 14).
