INVESTIGATION OF LIME SLURRY TO CONTROL ABSORPTIVE AGGREGATES USED IN ASPHALT CONCRETE

INTERIM REPORT

RESEARCH REPORT

CA-DOT-TL-3113-3-73-28

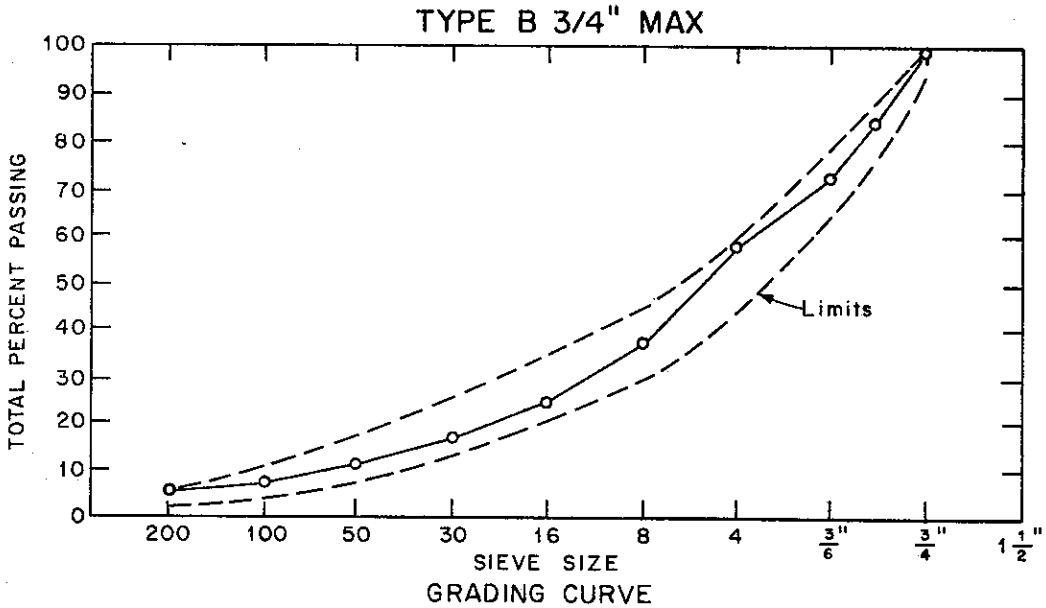
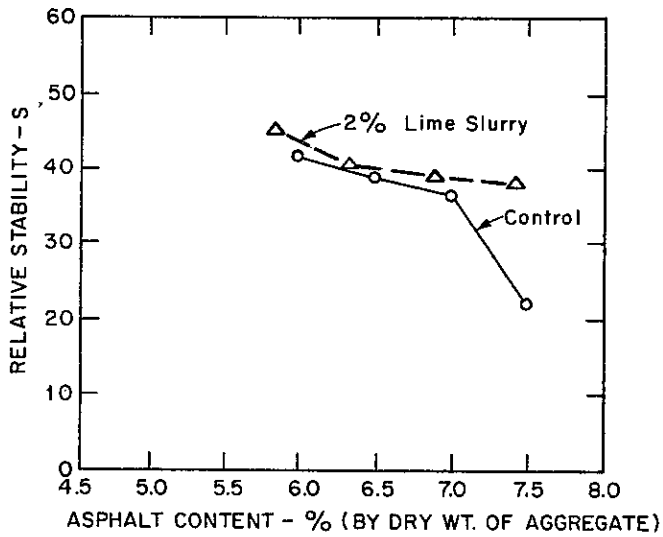
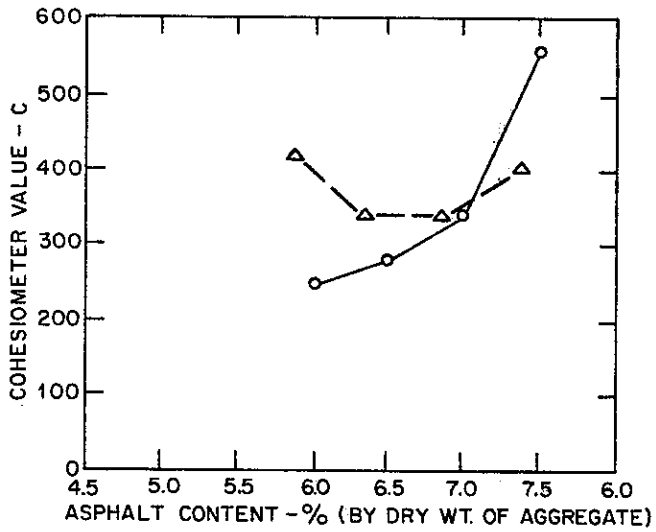
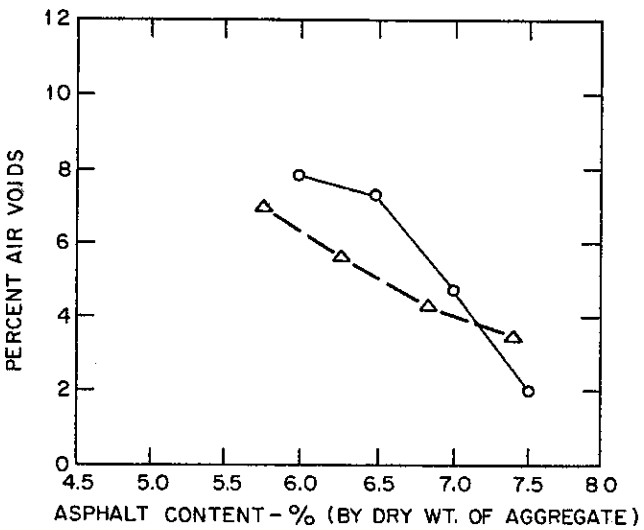
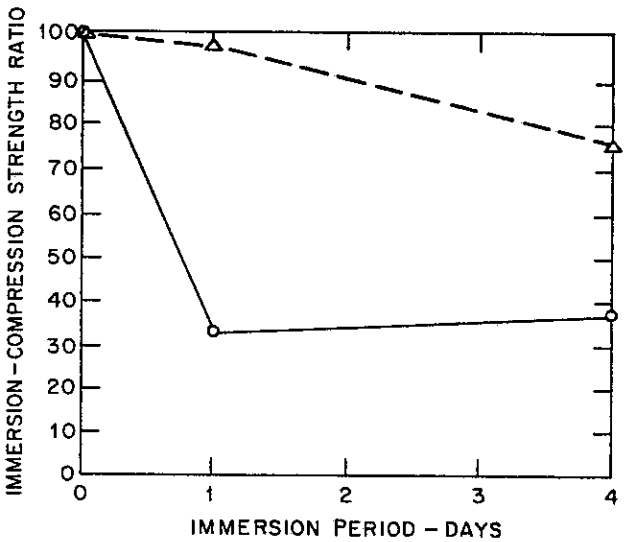
Figure 3

The grading curve used as well as the results of the stability, cohesion, percent air voids, and immersion compression tests for the laboratory specimens fabricated with the lime treated and untreated aggregate are presented in Figure 3. The results

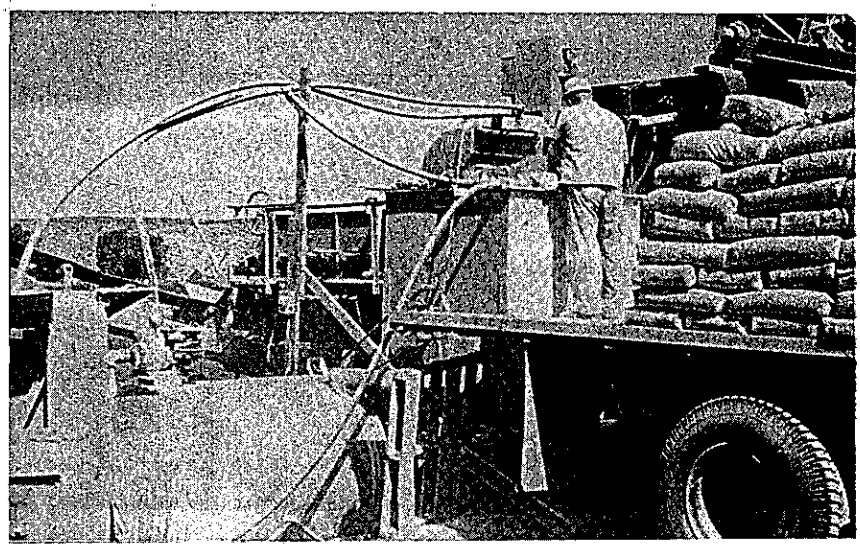
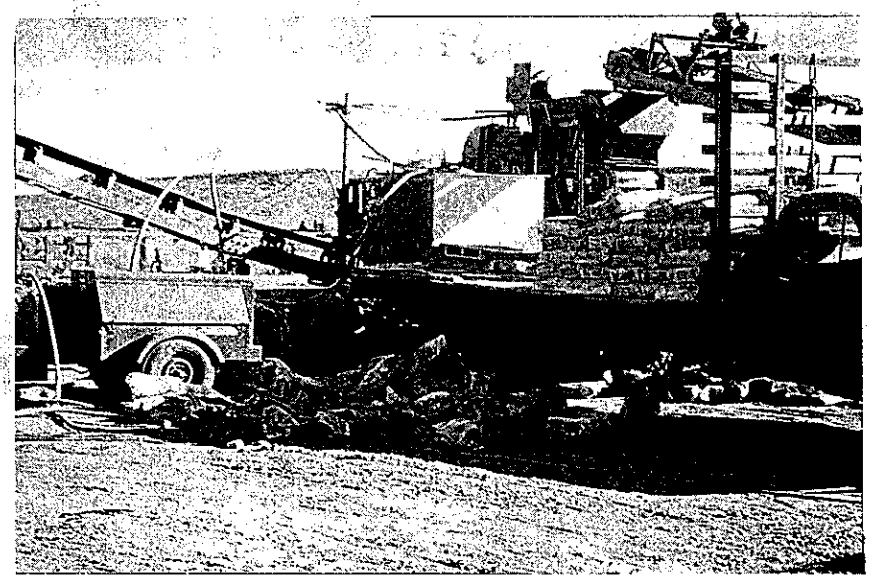
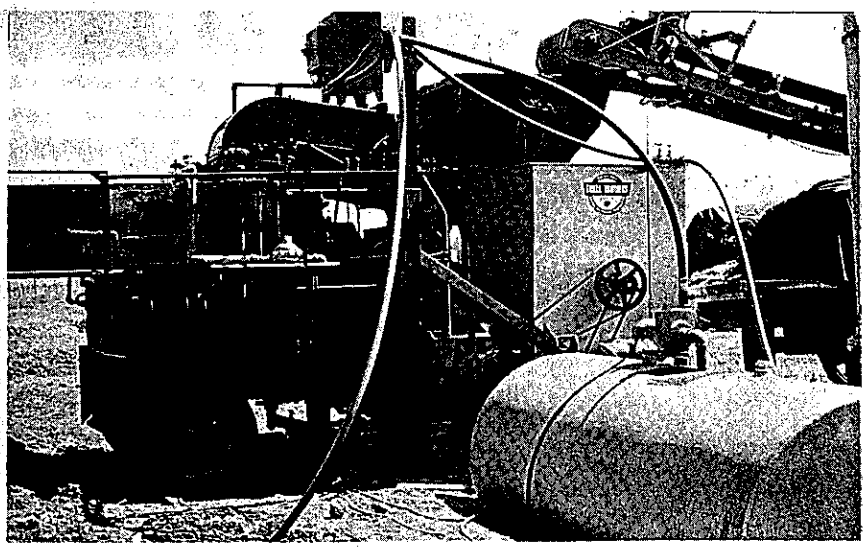
Figure 6

Hydrated lime is combined with water.

Conveyor belt carrying aggregates from various stockpiles is shown in upper right hand corner.

From the batching tank the hydrated lime-water slurry is pumped into mixing tank (lower right).

Metering device is shown in upper left center of photo.

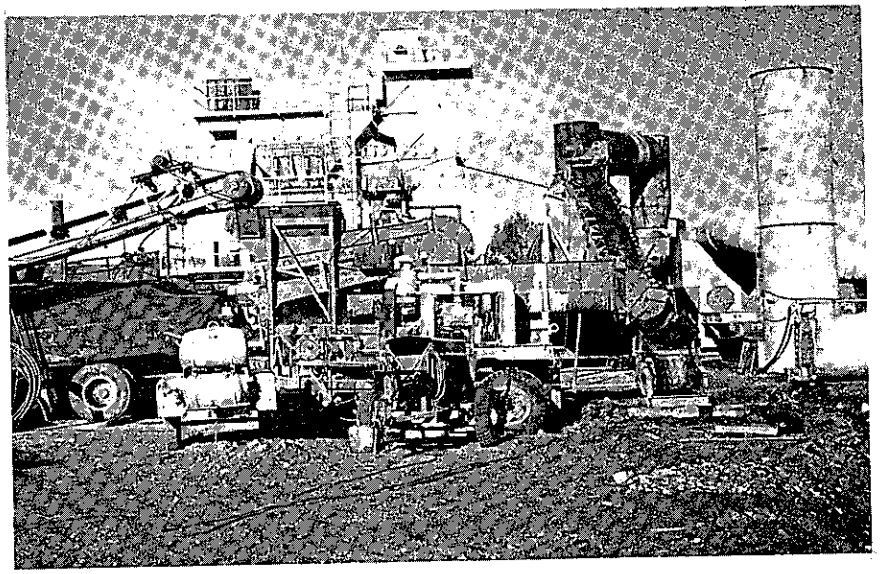
Figure 7

Overall view of plant-cold feed belt shown on left.

Lime slurry aggregate mix being discharged on belt to dryer shown on right.

Lime slurry being added to aggregate from metering device.

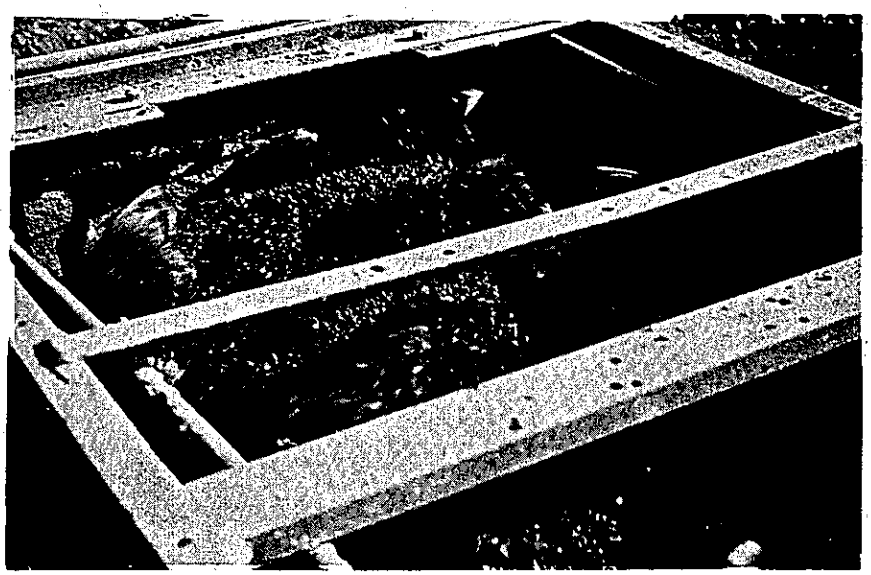
Figure 8

Location 5, aggregate/lime slurry mixing pugmill, showing twin-screws.

The lime slurry/aggregate mix is thoroughly mixed.

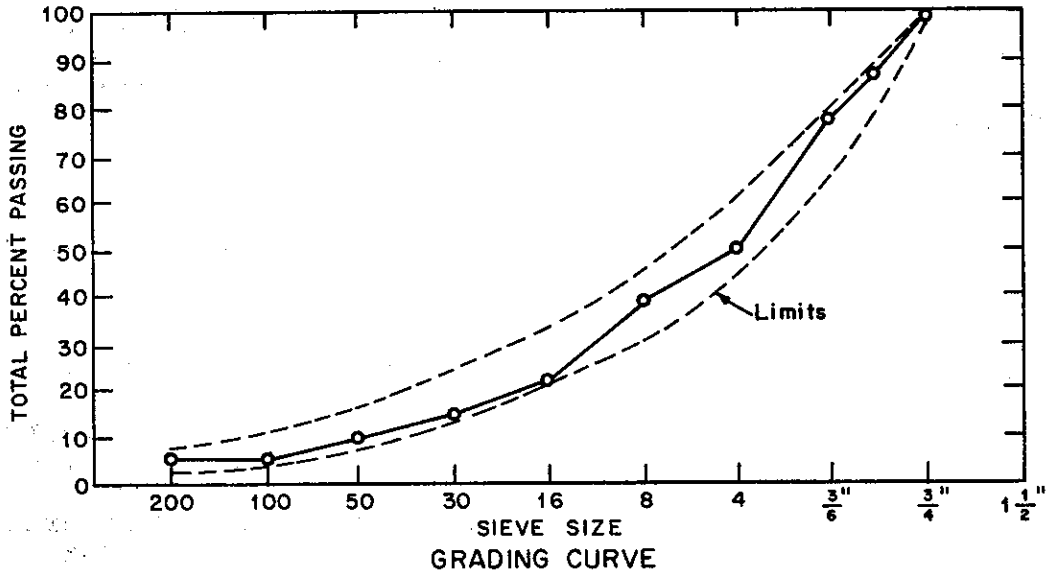
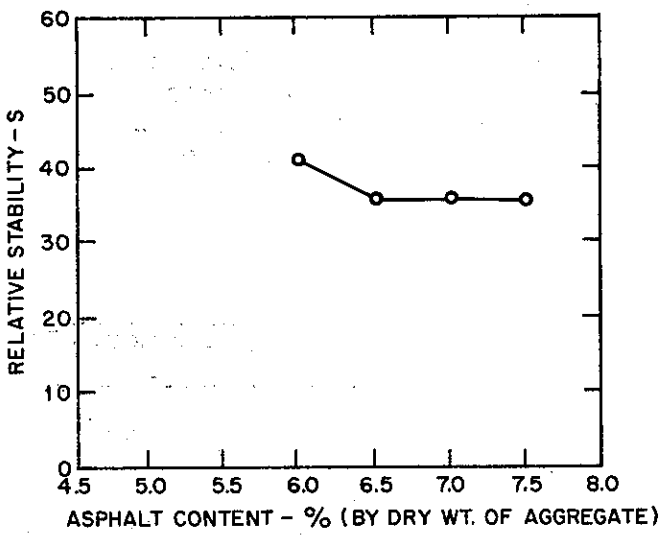
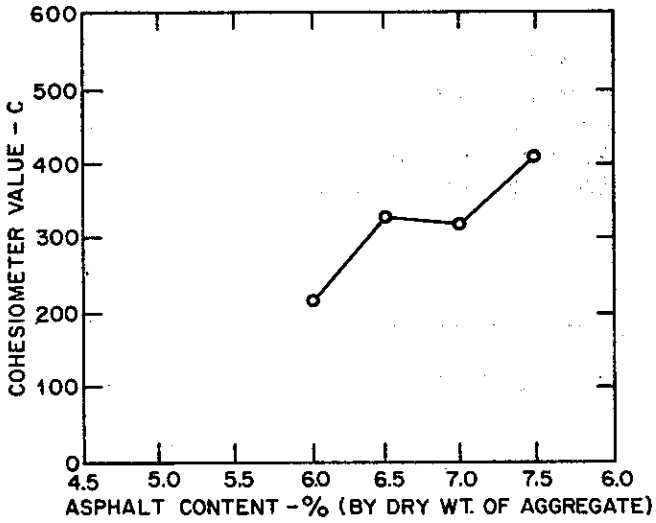
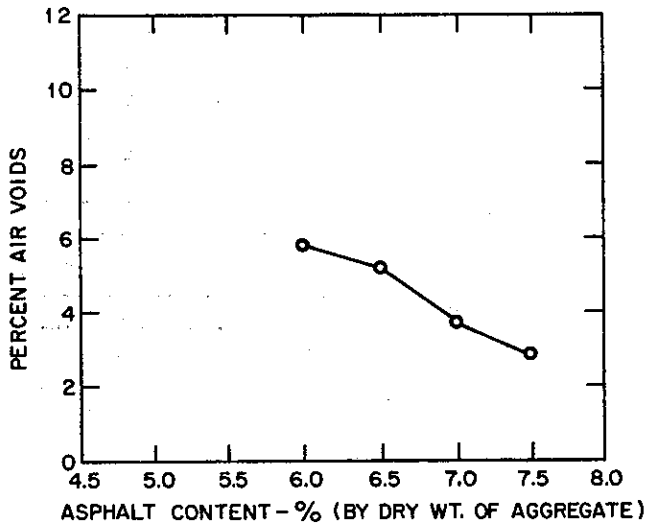
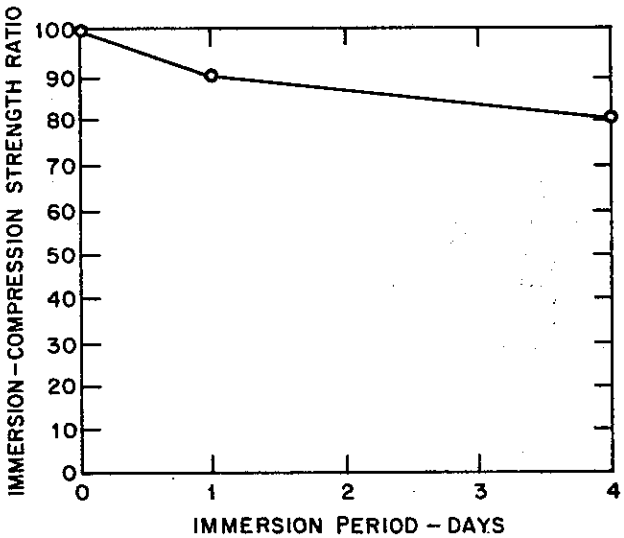
Lime-slurry treated aggregate samples were taken at the hot plant. These samples were mixed with various amounts of 120-150 pen asphalt and laboratory fabricated specimens then tested. The results are presented in Figure 9. When comparing the aggregate grading curves in Figure 2 (untreated) and Figure 9 (lime slurry treated) it can be seen that both curves are within the specified grading envelope.

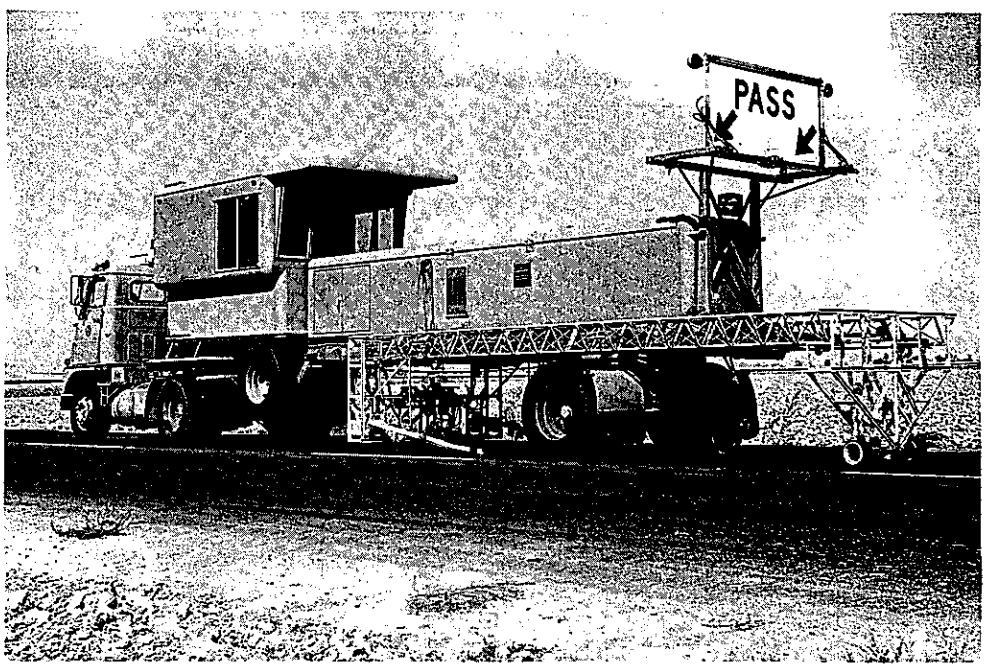
Figure 10

Deflection measurements were made on three different dates for the various experimental sections. The California Traveling Deflectometer (see Figure 10) was used to make the deflection measurements.

Deflection measurements were recorded for both wheel tracks. The results are presented in Table 5. As shown, the maximum deflections were recorded during the 1970 survey; however, these deflections were not excessive. It is interesting to note that the low lime slurry section which was constructed over an old existing AC pavement had the least deflection, as well as the least amount of failed area.

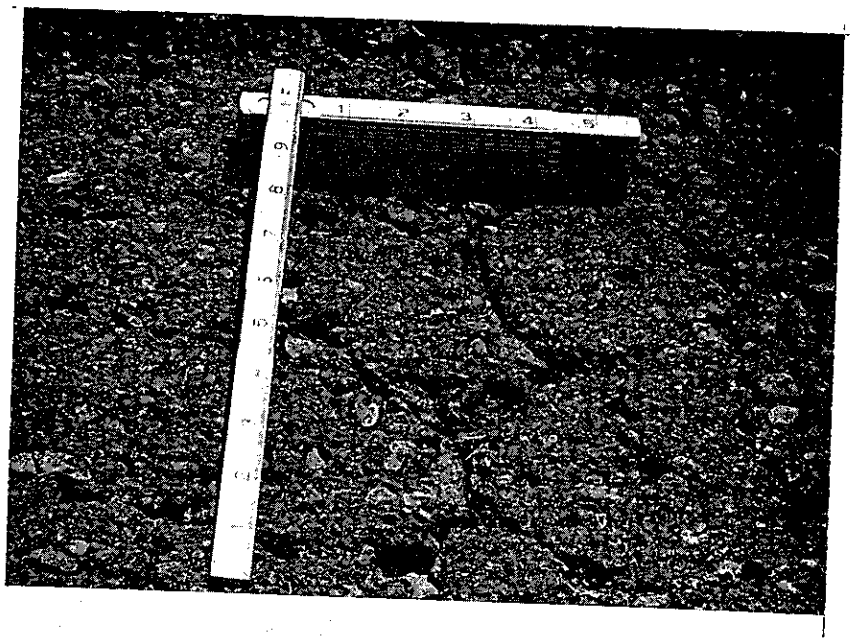
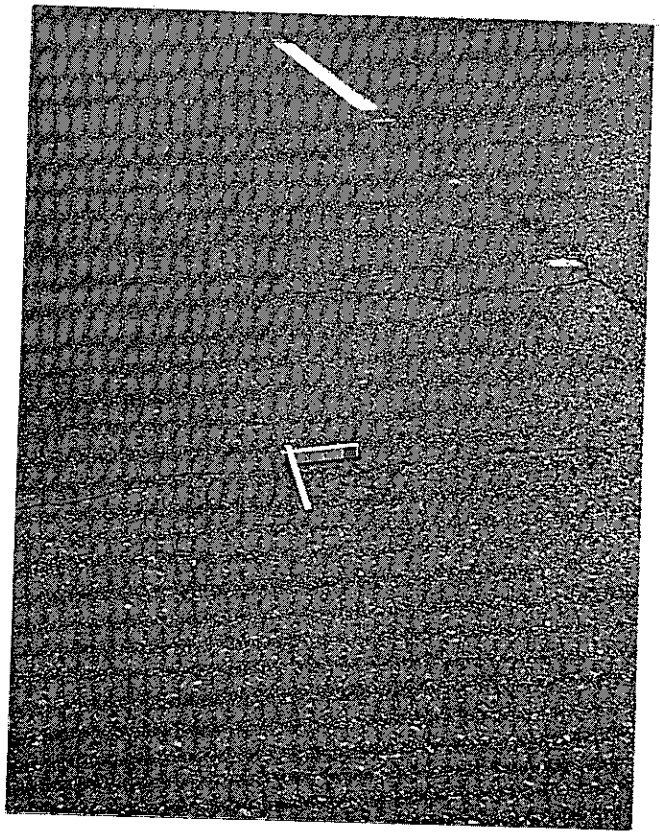
Figure 11

Condition surveys have been made yearly since this project was constructed. The survey consisted of recording the amount of cracking and spalling that had occurred and the amount of patching that had been required. Photographs taken during the 1969 survey are shown in Figures 11 and 12.

Cracks were recorded in all the sections during the 1968 survey; however, more cracks appeared in the control #1 than control #2, and both sections had more cracks than either of the lime slurry treated sections.

Top photo shows Control Section #1: Bottom photo shows Control Section #2. 1969 Photos

The reason for the wide variance between the two control sections, with respect to cracking, is probably the difference in compaction procedure used in these two sections during construction. In control section #1, one coverage by a 12-ton tandem was used for the breakdown. This was followed by one to three coverages by a 9-ton pneumatic. The final rolling consisted of a coverage by an 8-ton tandem. In control section #2, the initial rolling consisted of a minimum of 10 coverages by a 12-ton tandem, while the intermediate and final rolling procedures were the same as those used for control section #1.

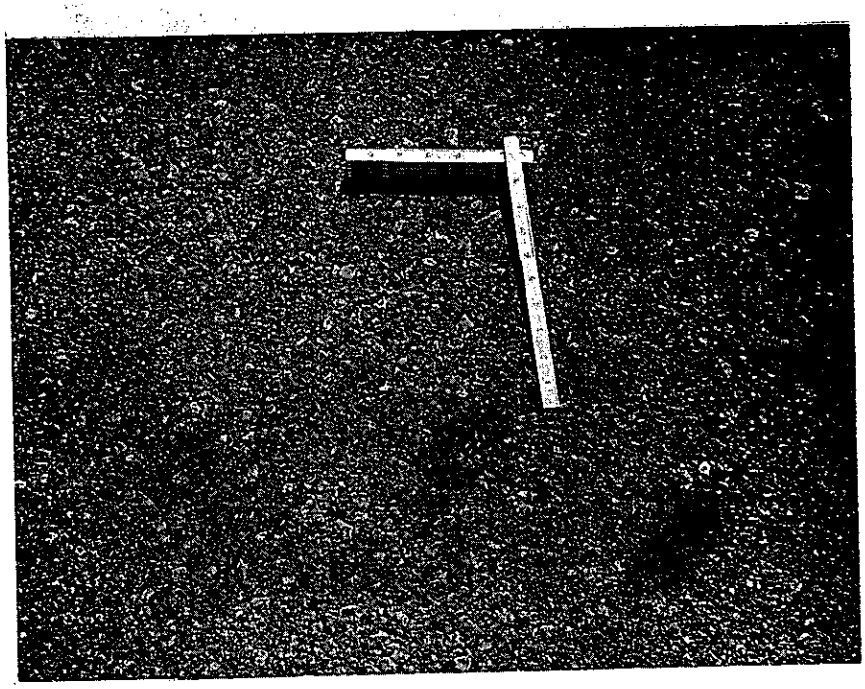
Figure 12

High Lime Section - 1970 Photo

As shown in Table 6 the amount of block cracking, as well as transverse and longitudinal cracking, has been increasing in all sections at a rapid rate since 1970. However, the sections with the lime slurry additive have block cracked much less than the control sections. This tends to confirm the results of the expansion test (Figure 3), in which the AC test bars with the lime slurry expanded much less than the control bars. Photographs of cores removed from representative areas from the various sections are shown in Figures 13 and 14. Notice that the cores with heavy compaction are denser than those with light compaction. It can also be seen that the cores without the lime slurry have more asphalt stripping, and more exposed aggregate.

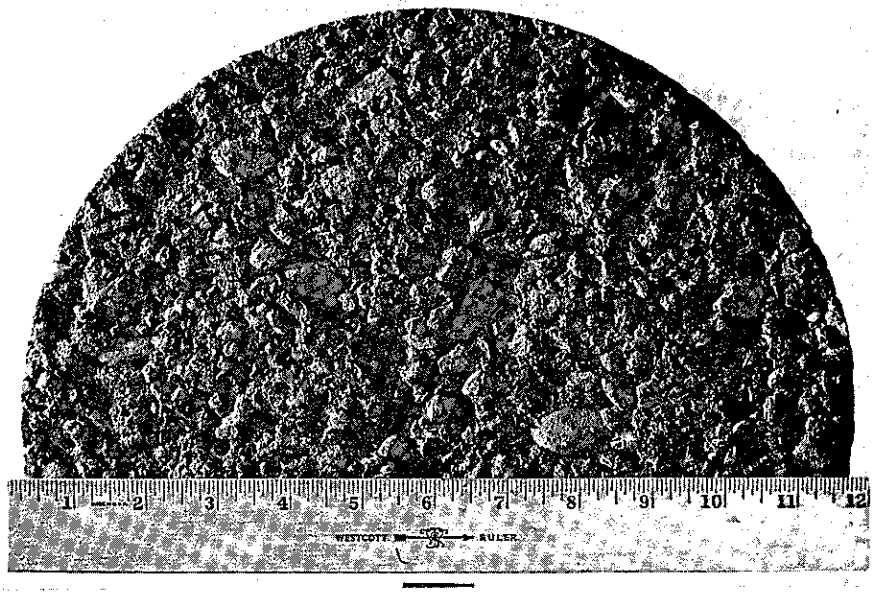
Figure 13

Taken from Control (1) Section - with light compaction.
Core Removed in 1970.

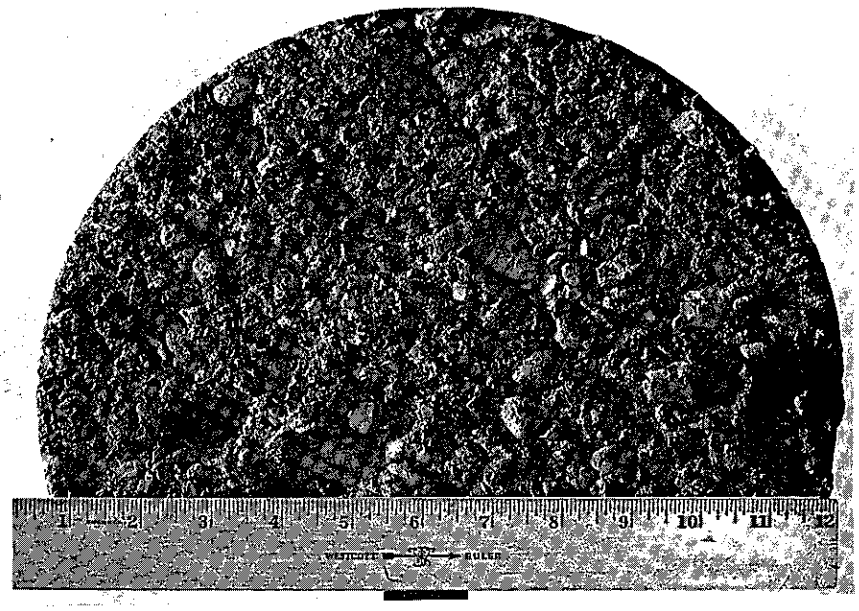
Taken from Control (2) Section - with heavy compaction.
Core Removed in 1970.

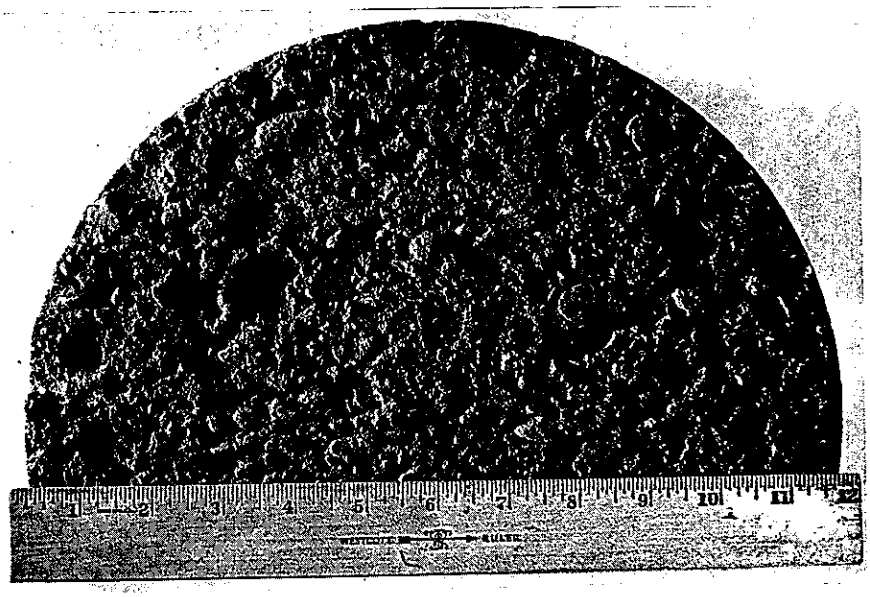
Figure 14

Taken from "high" lime section - with light compaction.
Core Removed in 1970.

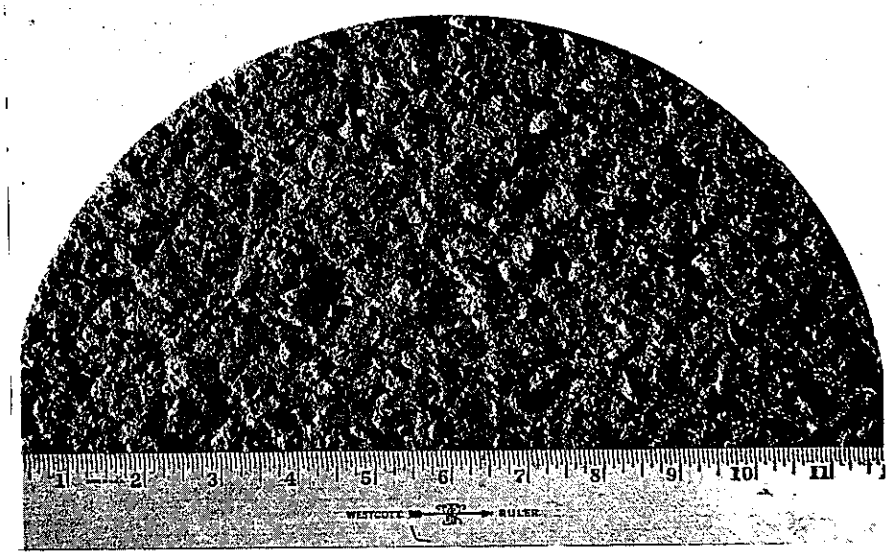
Taken from "low" lime section - with heavy compaction.
Core Removed in 1970.
