CALIFORNIA DIVISION OF HIGHWAYS
TRANSPORTATION LABORATORY

FOUNDATION AND SEISMIC INVESTIGATION FOR THE EXISTING AND PROPOSED STATE CAPITOL BUILDING SITES

October 26, 1974

State Capitol Project
Interagency Agreement
No. LCB9928

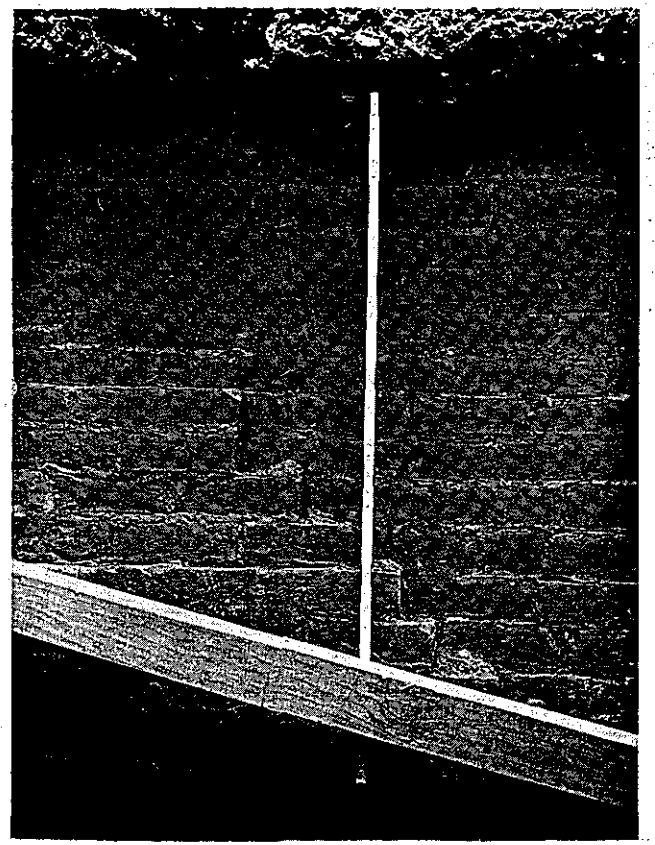
Figure E5 Exposed brick foundation wall, Pit No. 1.

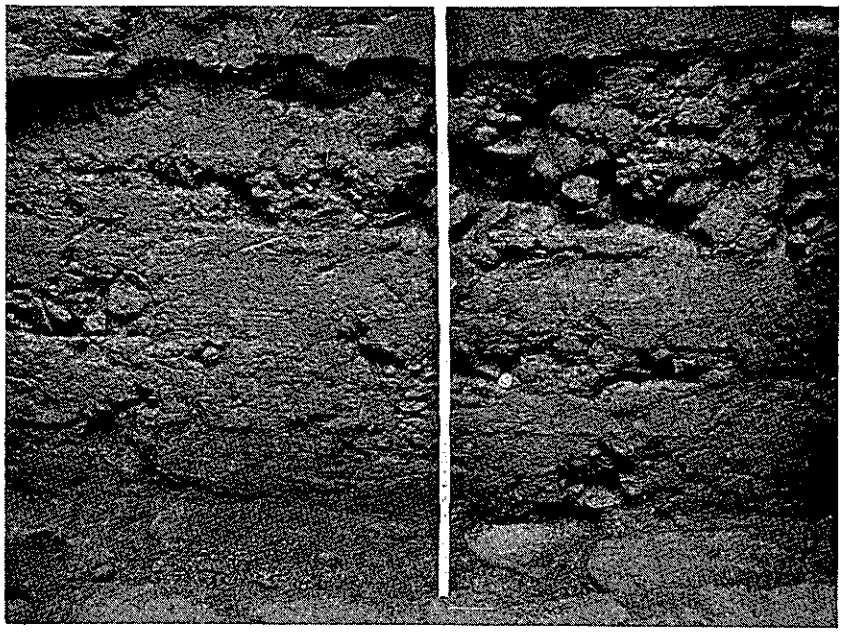
Figure E8 Concrete footing under north wall of Room 8.

Attempts to core the concrete footings met with limited success although two short 8-inch diameter samples were extracted. The problems encountered were created by the poor quality of the concrete as anchor bolts placed in the concrete to secure the coring rig would pull out under small loads. Also weakly cemented aggregate became dislodged in large quantity making it necessary to try another location. The two cores that were obtained are shown in Figure E9. As can be seen, large voids are present, especially in the core from the west wall footing. Apparently, the voids are the result of poor placement methods that allowed segregation of aggregate and cement to occur.

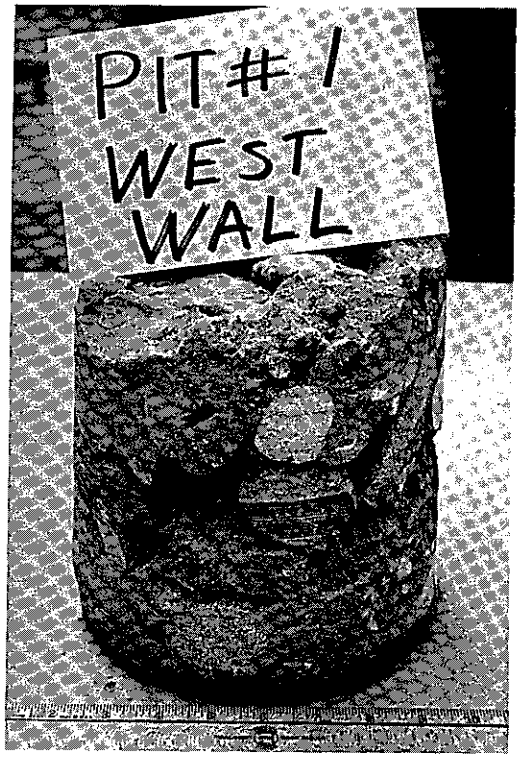
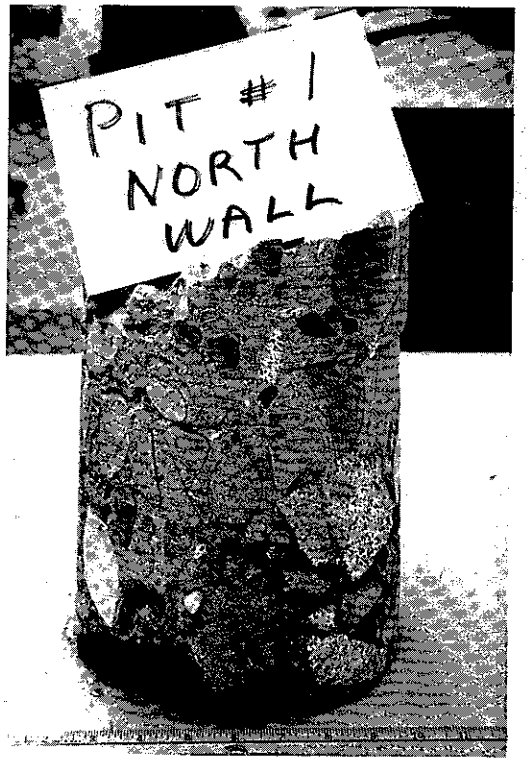
Figure E9 Cores from concrete footings, Pit No. 1.

Figure E10 Removal of brick sample, Pit No. 1.

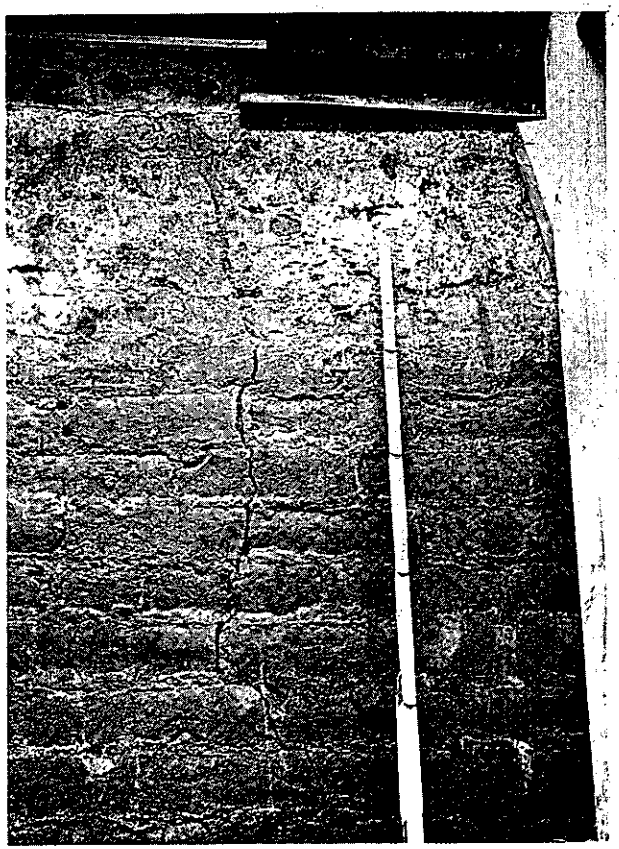
Figure E16 Crack in brick foundation wall, Pit No. 2.

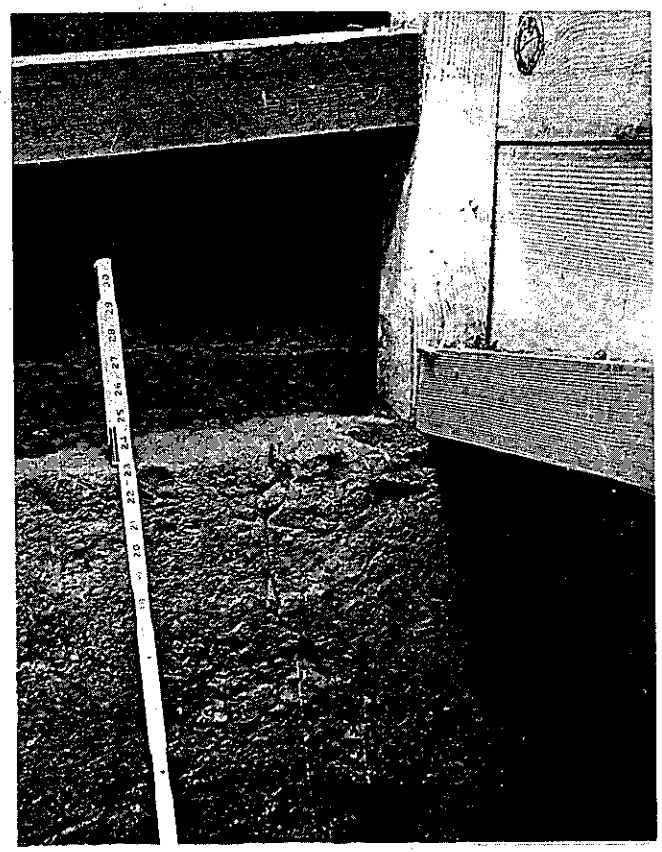
Figure E17 Continuation of wall crack into footing, Pit No. 2.

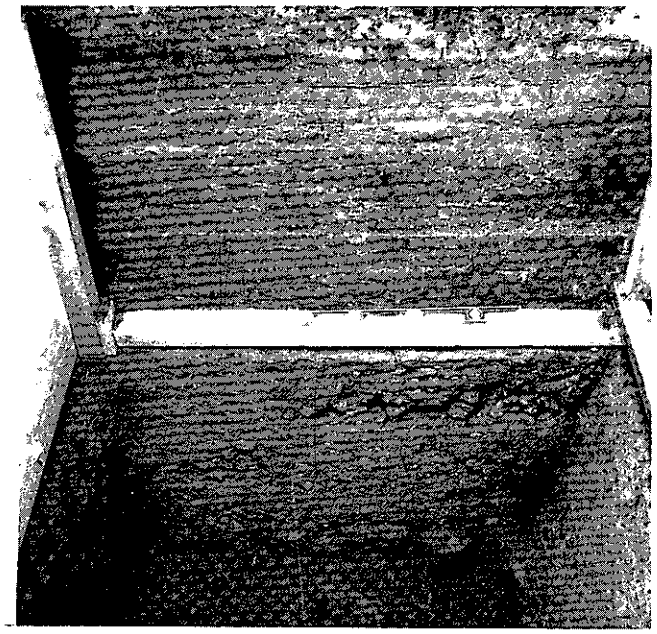
Figure E19 Exposed foundation wall and footing, Room 18 west wall, Pit No. 2.

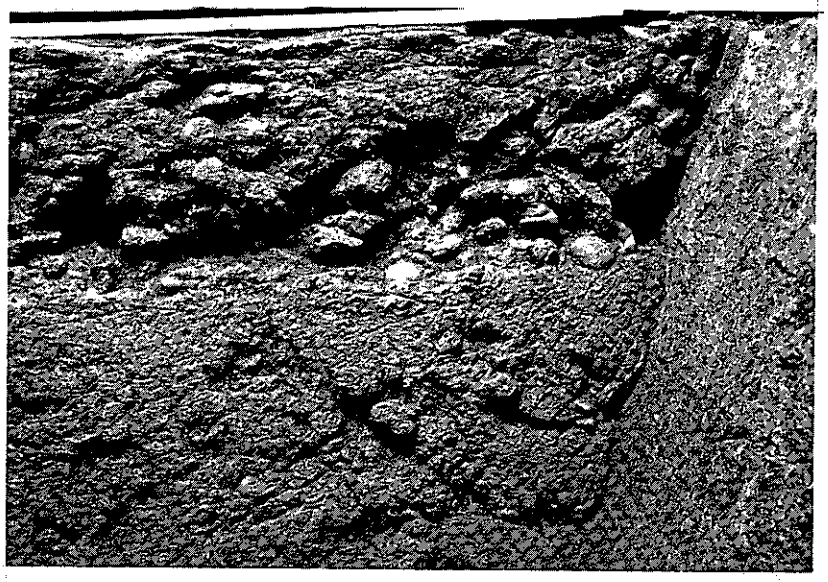
Figure E20 Concrete footing under Room 18 west wall, Pit No. 2.

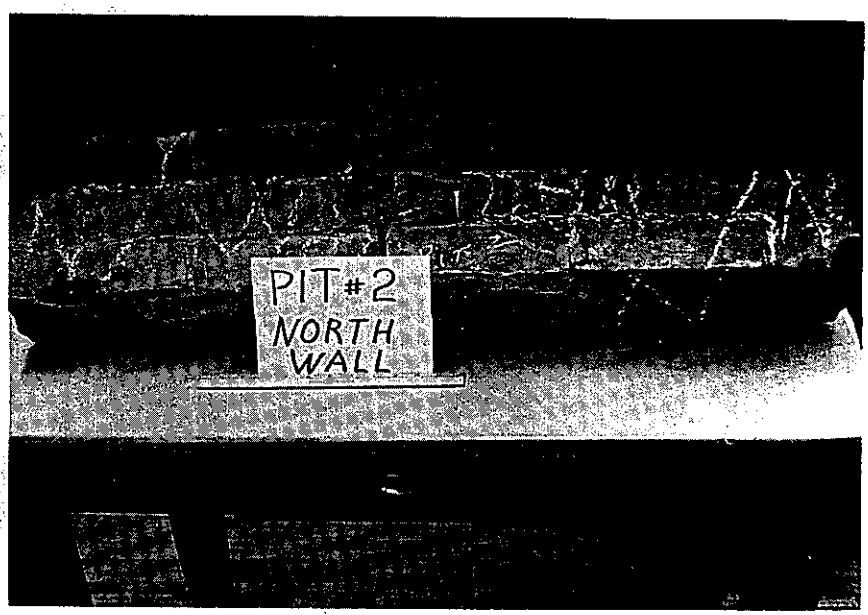
Figure E22 Samples from north brick foundation wall, Room 18, Pit No. 2.

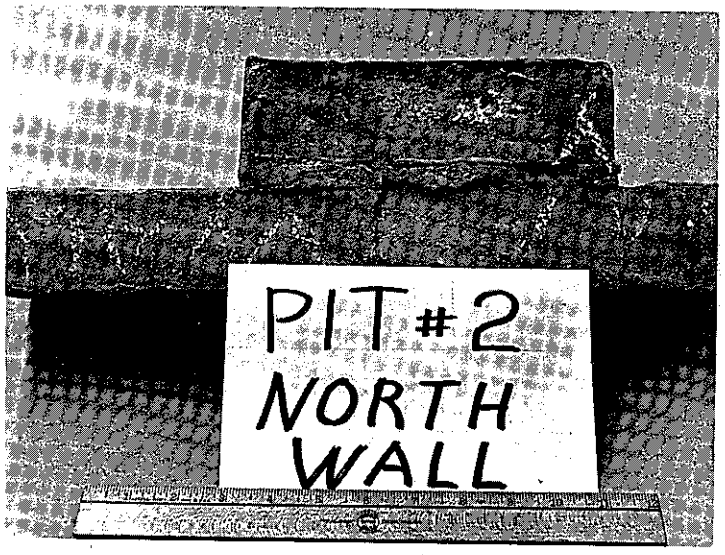
A total of four brick assemblies with brick-mortar bonds intact were obtained from the West Wing foundation walls. As shown in Figure G1, each assembly consisted of three bricks, two on the bottom and one overlapping the lower butt joint. Three of these assemblies were failed in shear and the fourth in compression. Before testing, excess mortar was carefully removed from the free surfaces of the bricks. The lower bricks were partially embedded in the high strength, fast setting compound to provide uniform bearing. The top brick was capped with the same compound, and a steel plate the same size as the brick was embedded in the capping compound to assure uniform load distribution, Figure G2. During shear testing the lower bricks were restrained laterally, while a normal force was applied to the steel plate and an increasing shearing force was applied to the end of the upper brick until failure, Figure G3. For the compression test the normal force was increased until failure occurred, Figure G4.

Figure G1 Section of West Wing foundation wall.

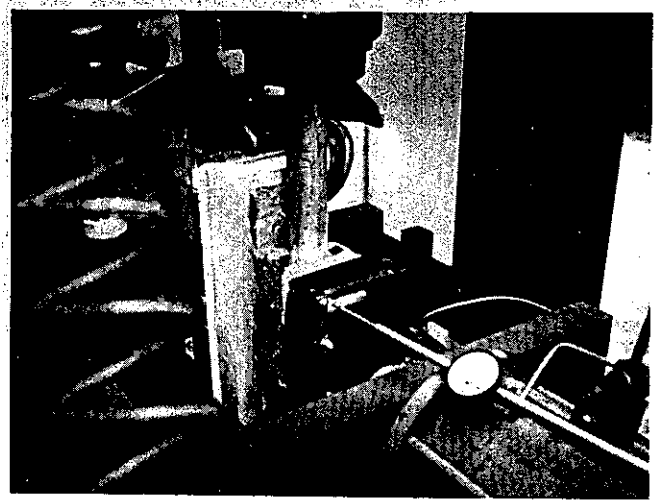
Figure G3 Foundation wall section during shear testing.

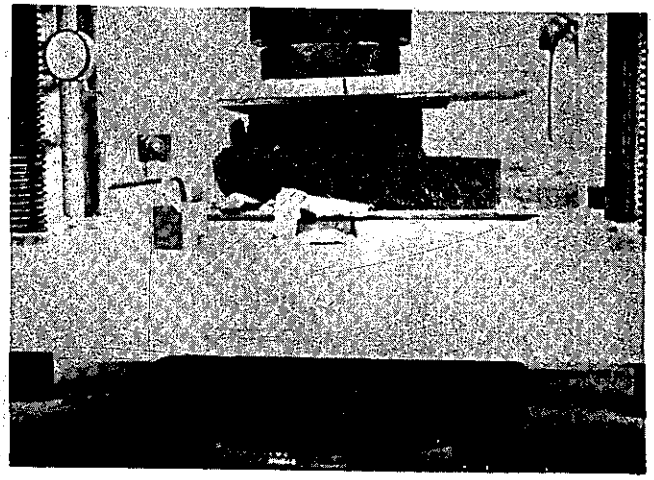
Figure G4 Foundation wall section following compression testing.

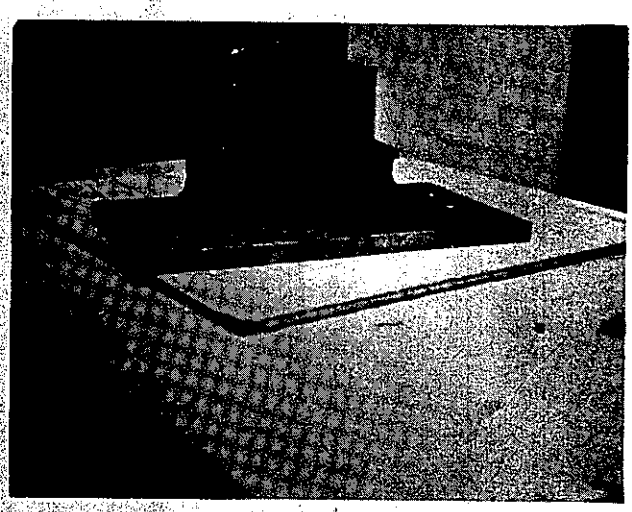
Figure G5 Test specimen following individual brick compression test.

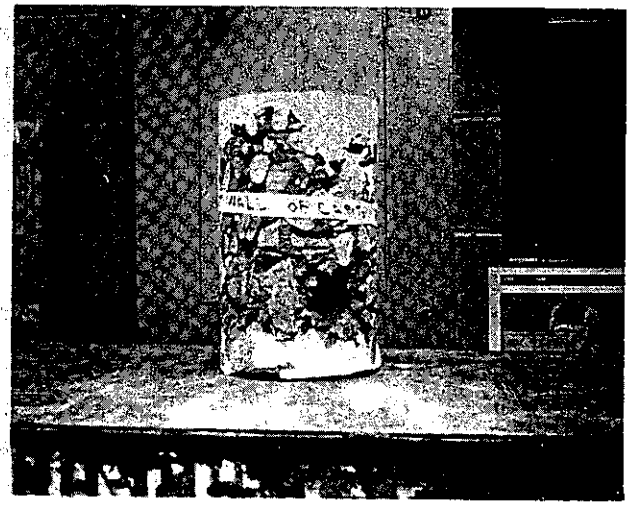
Two 8-inch diameter concrete cores were tested for compressive strength. One core was taken from the concrete footing supporting the north wall at Test Pit No. 1, and the other core was taken from the concrete footing supporting the west wall at Test Pit No. 2. The concrete was obviously of poor quality with numerous voids. Flat bearing surfaces at the ends of the cores were prepared using the high strength casting compound mentioned earlier, Figure G6. Figure G7 shows one of the cores just prior to testing. The test results for both cores are presented in Table G3.

Figure G6 West Wing foundation footing core after capping with casting compound.

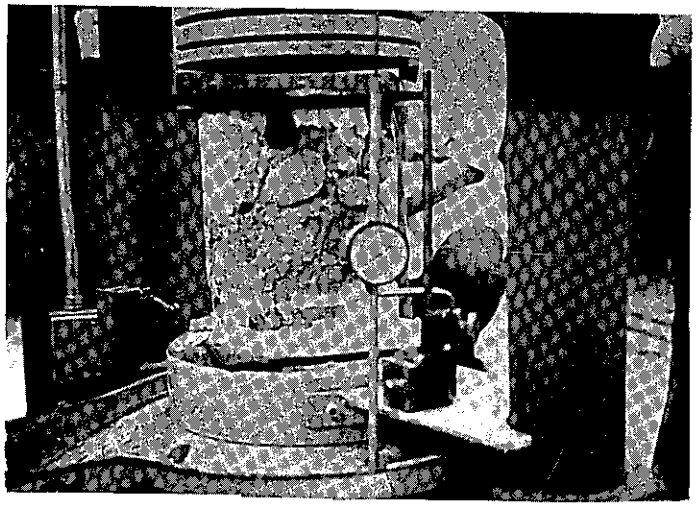
Figure G7 Footing core in compression testing.
