Control Of Slope Erosion Using Fiberglass Roving With Vegetation

FINAL REPORT

OCT. 1978

CALIFORNIA DEPARTMENT OF TRANSPORTATION

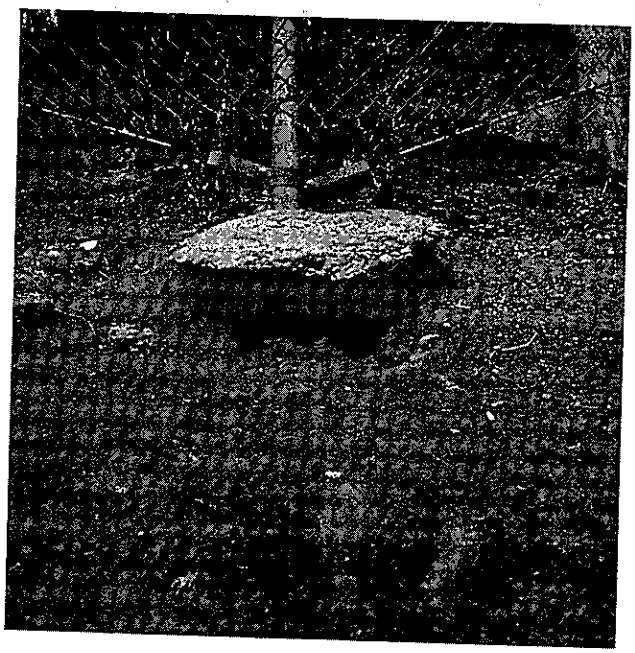
Plate 4. Erosion at base of fence post (Camino, Route 50).

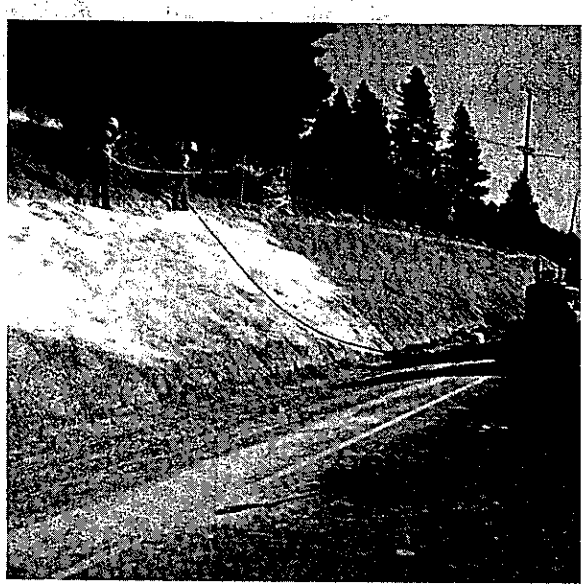
Plate 8. Fiberglass applied to slope at Camino.

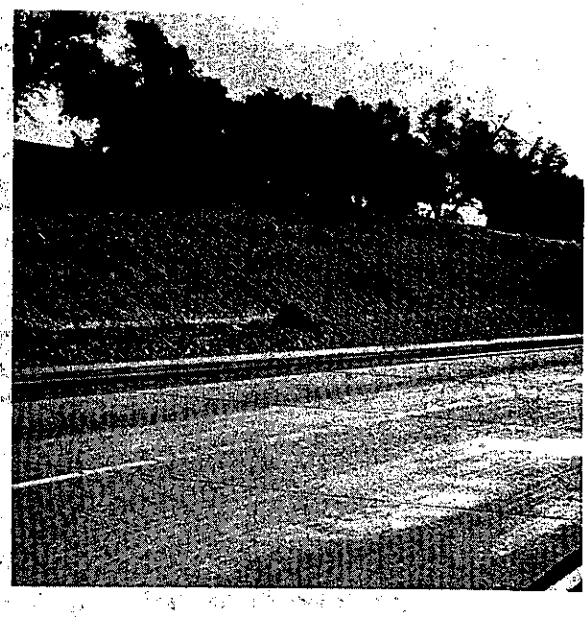
Plate 21 Cut Slope Before Treatment
January 10, 1978

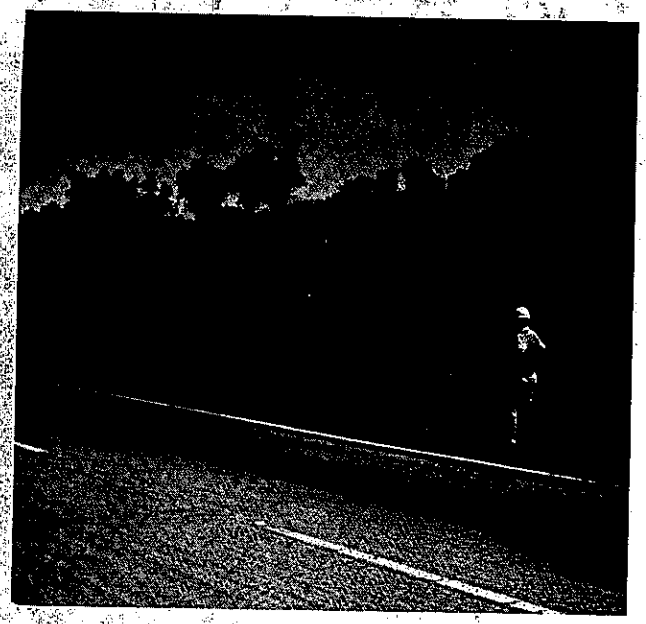
Plate 25

Cut Slope 24 weeks
after treatment,
June 30, 1978

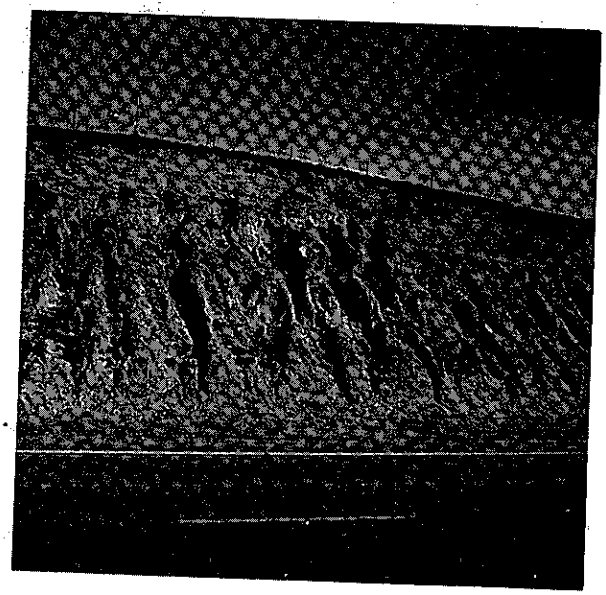
Plate 27 Cut Slope Before Treatment
November 15, 1977

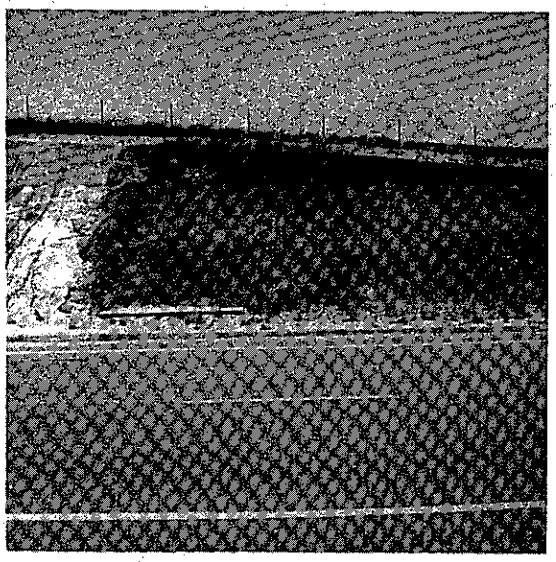
Plate 31 Cut Slope 28 Weeks After Treatment June 8, 1978

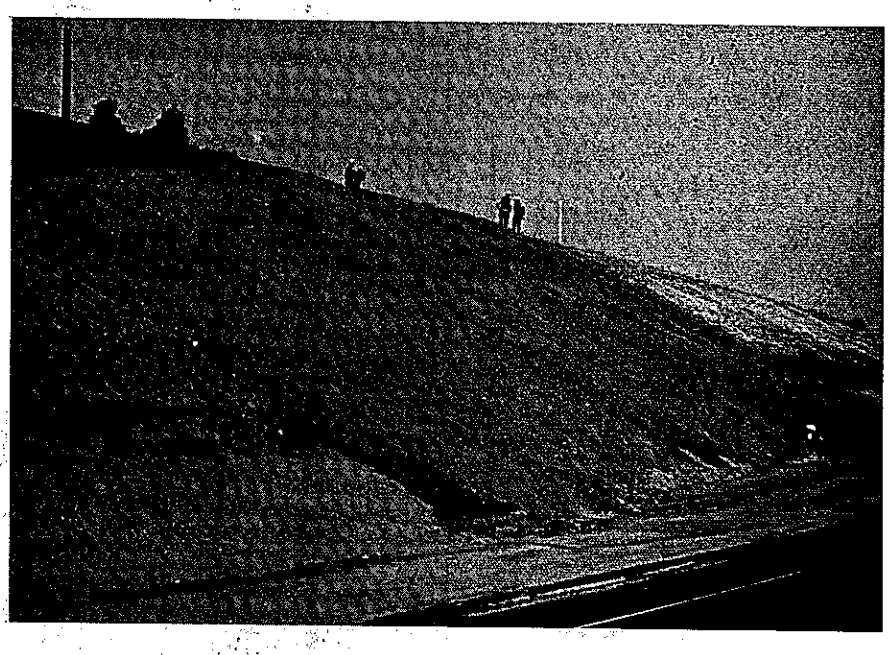
Plate 33 Cut Slope Before Treatment
October 18, 1976

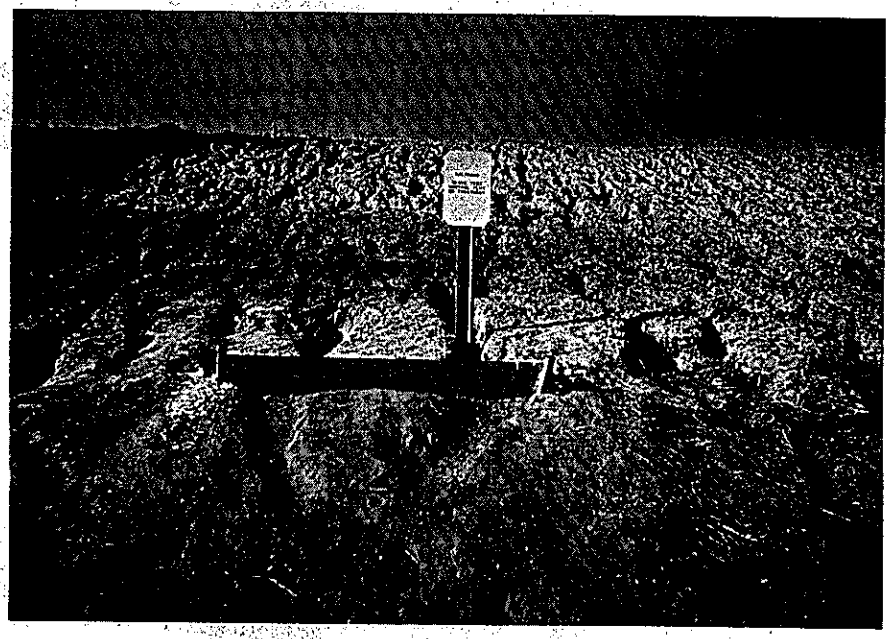
Plate 34 Cut Slope Surface Showing Rills
Before Treatment October 18, 1976

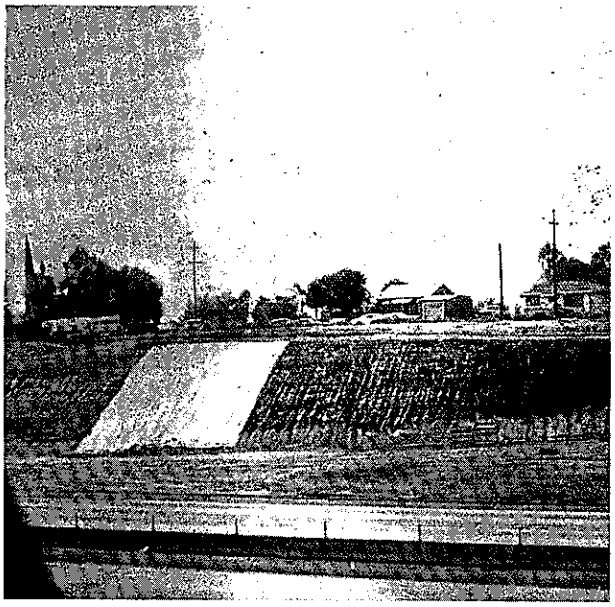
Plate 36 Cut Slope After Treatment October 19, 1976

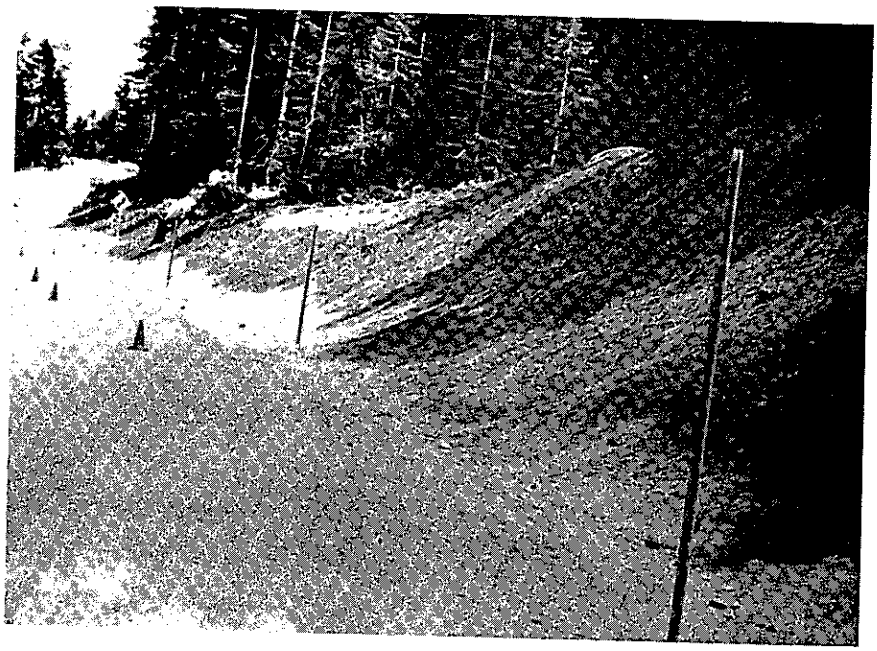
Plate 39 Cut Slope After Treatment
July 18, 1975

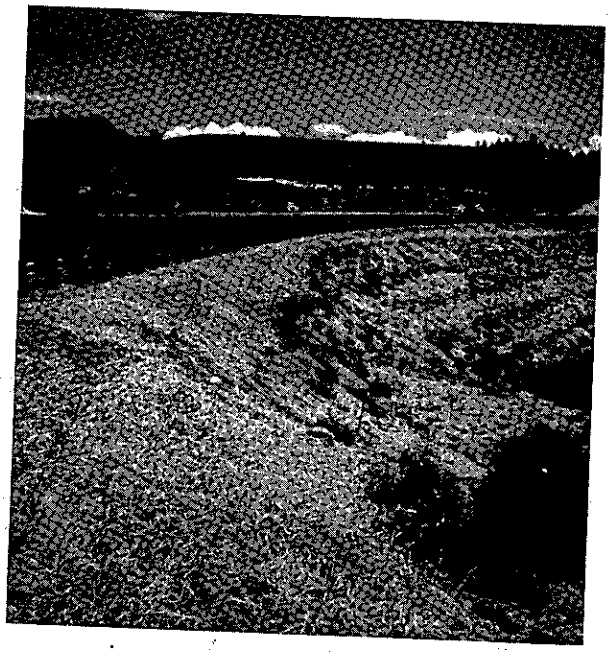
Plate 42 Fill Slope Before Treatment of Upper 25 Feet July 15, 1977

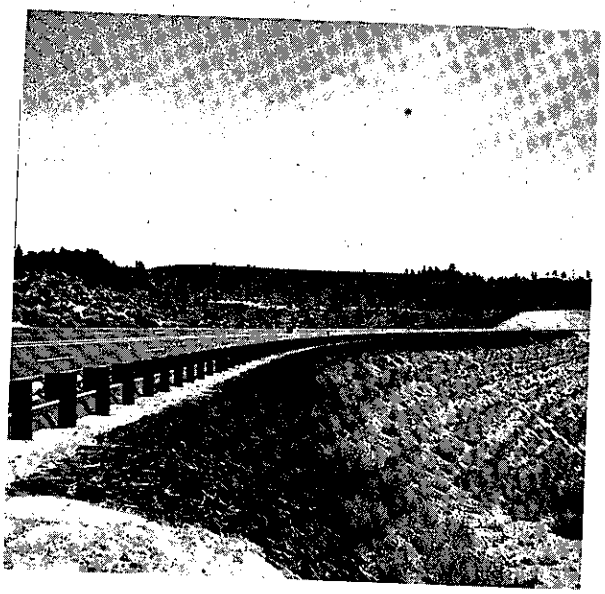
Plate 43 Fill Slope After Treatment of Upper 25 Feet September 13, 1977
