1. REPORT NO. FHWA-CA-TL-78-28	2. GOVERNMENT ACCESSION NO.	3. RECIPIENT'S CATALOG NO.
4. TITLE AND SUBTITLE STATEWIDE FLEXIBLE PAVEMENT PERFORMANCE AND DEFLECTION STUDY		5. REPORT DATE December 1978
		6. PERFORMING ORGANIZATION CODE
7. AUTHOR(S) John B. Skog, James A. Matthews, Gary W. Mann and Donald V. Roberts		8. PERFORMING ORGANIZATION REPORT NO. 19304-633167
9. PERFORMING ORGANIZATION NAME AND ADDRESS Office of Transportation Laboratory California Department of Transportation Sacramento, California 95819		10. WORK UNIT NO.
		11. CONTRACT OR GRANT NO. D-5-5
12. SPONSORING AGENCY NAME AND ADDRESS California Department of Transportation Sacramento, California 95807		13. TYPE OF REPORT & PERIOD COVERED Final 1978
		14. SPONSORING AGENCY CODE

STATE OF CALIFORNIA
DEPARTMENT OF TRANSPORTATION
DIVISION OF CONSTRUCTION
OFFICE OF TRANSPORTATION LABORATORY

December 1978

STATEWIDE FLEXIBLE PAVEMENT
PERFORMANCE AND DEFLECTION STUDY

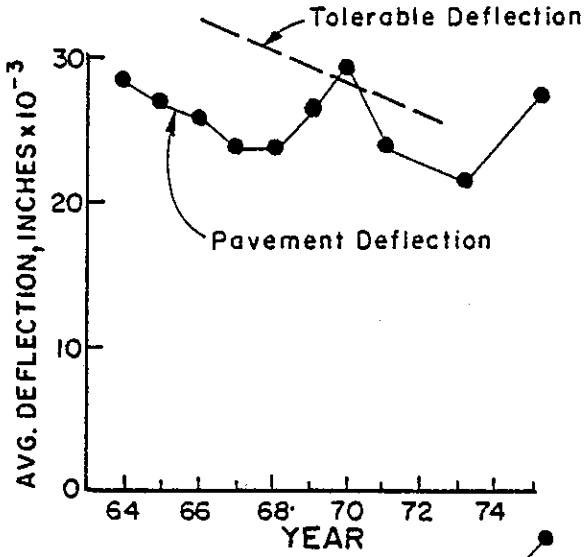
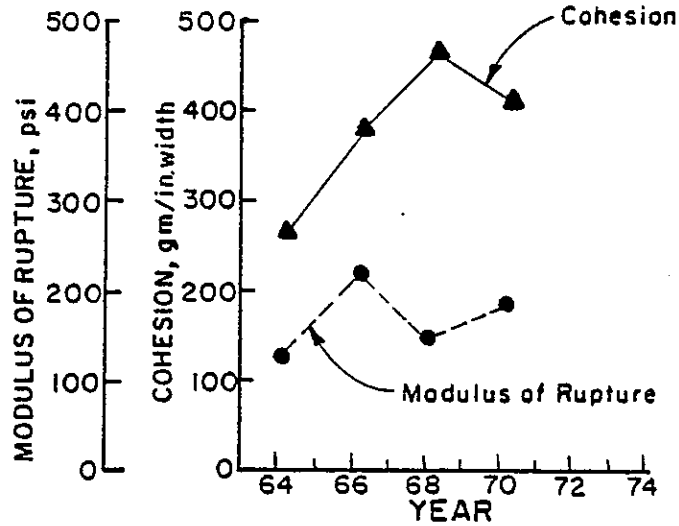
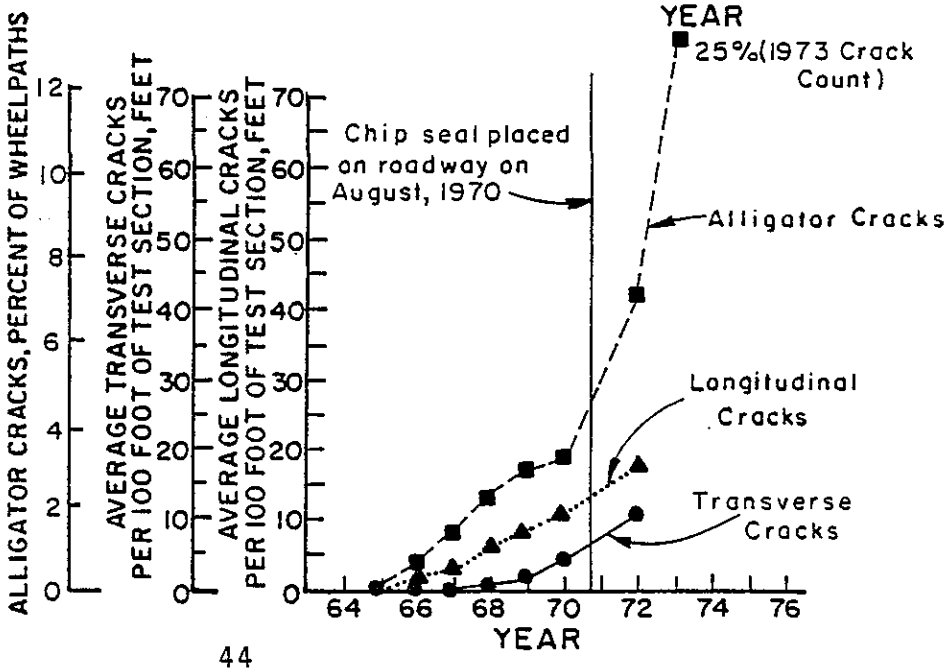
TABLE 3

Tolerable Deflection = 0.028". Deflections were greater than this in 1970. Alligator cracking accelerated rapidly after 1970.

1976 Maintenance Rating System shows 60% alligator cracks.

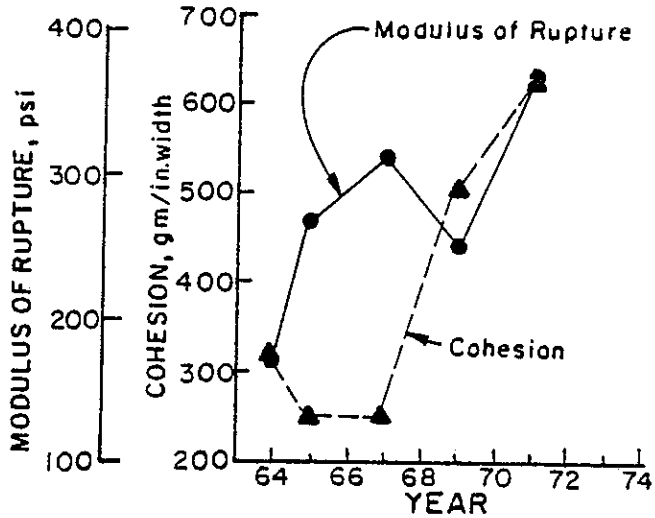
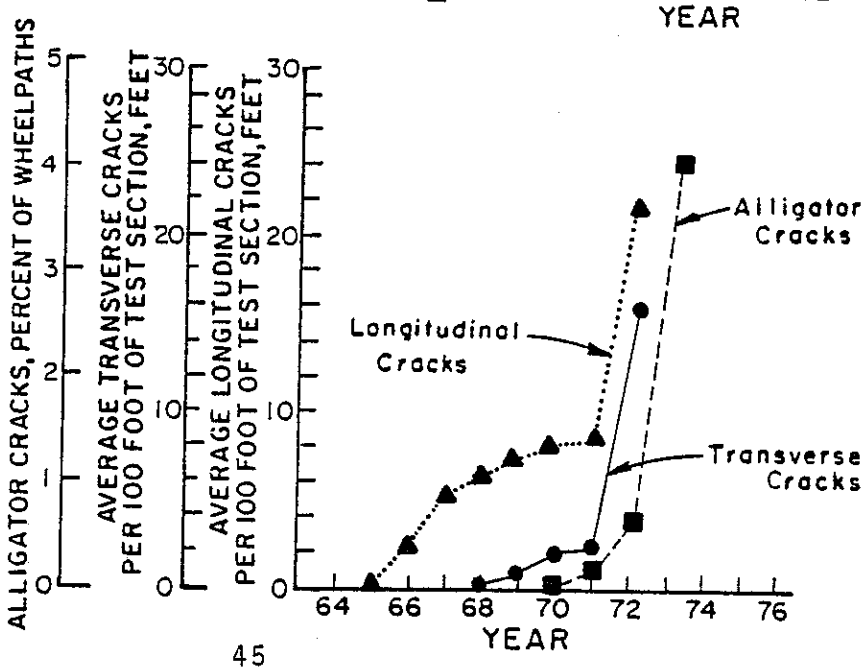
TABLE 4

Tolerable deflection = 0.027".

Based on 1974 condition survey from Maintenance Rating System, there was no significant alligator cracking.

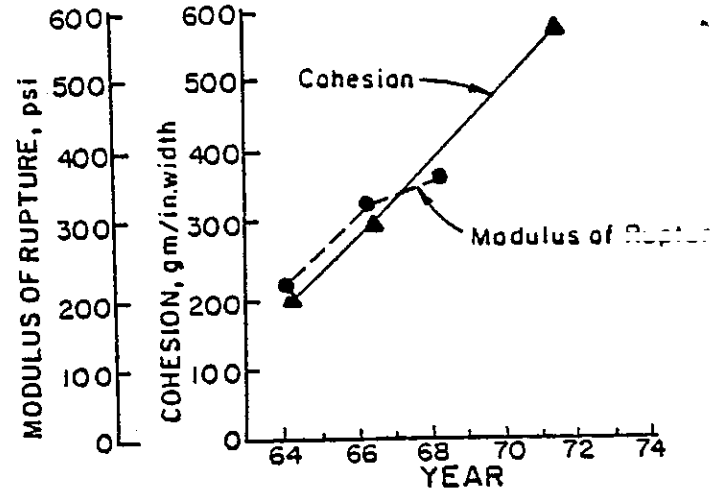
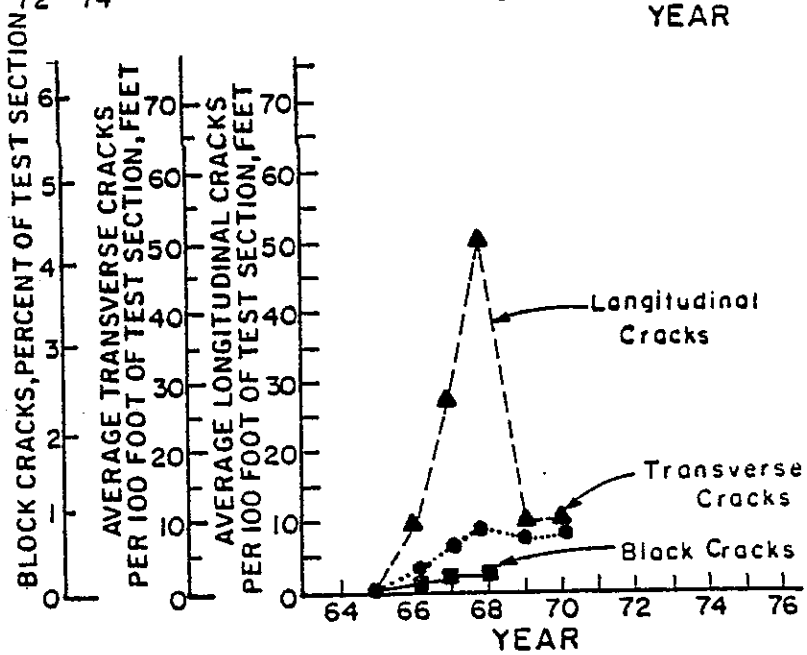
TABLE 5

T.I. ≈ 9.0 (1970 Data)
Tolerable deflection = 0.012"
One inch A C overlay placed during the spring of 1968

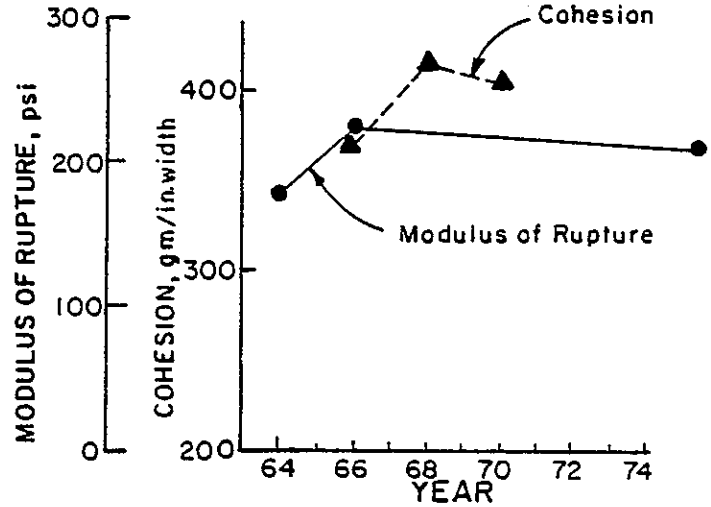
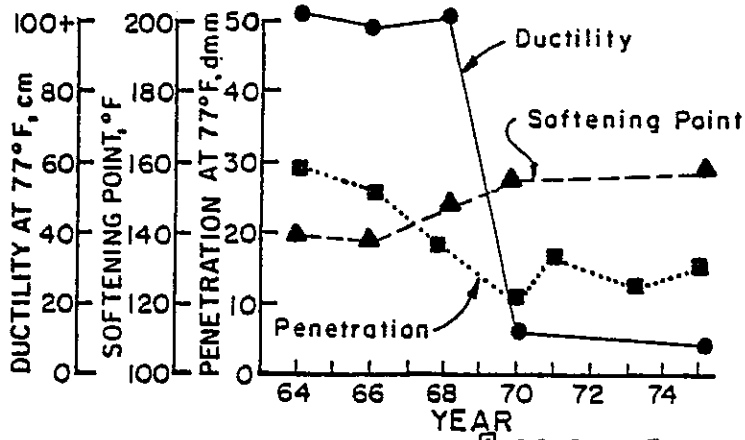
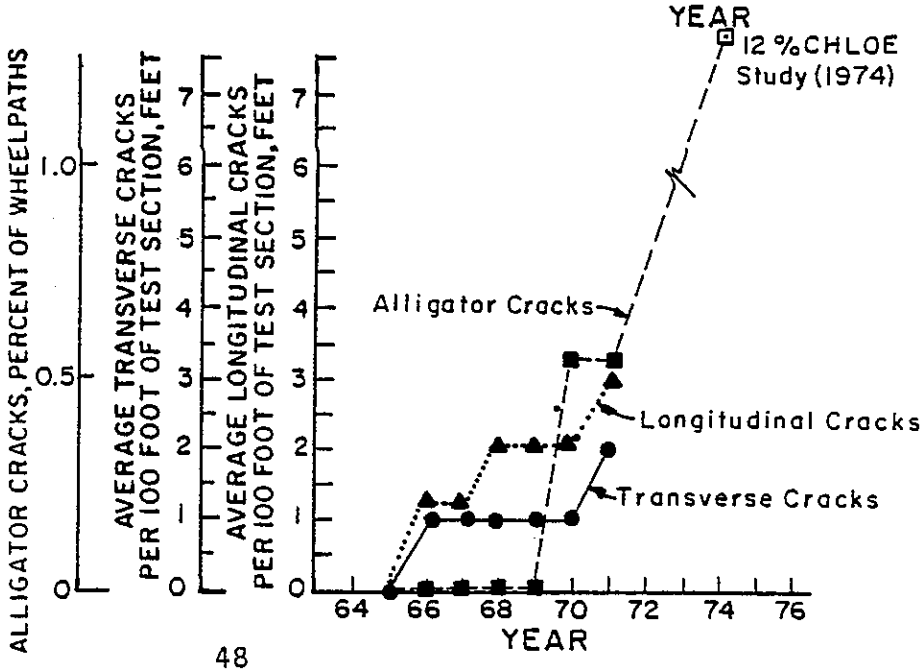
T.I. ≈ 9.0 (1970 data)
Tolerable deflection = 0.020".
Alligator cracking started in 1970.
Deflection study requested by the District in 1972 (This section was failing).

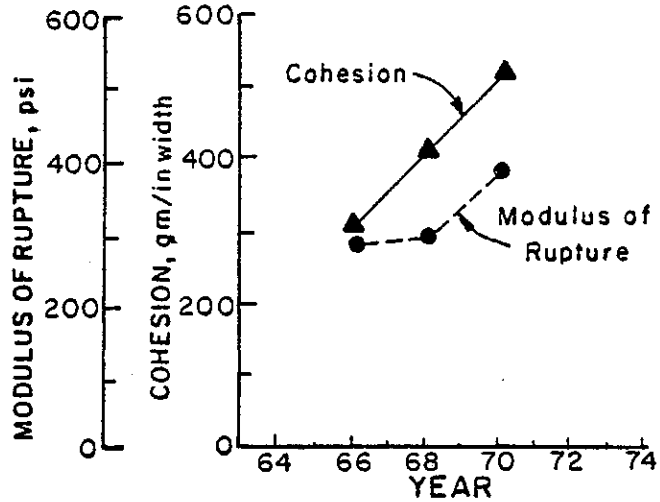
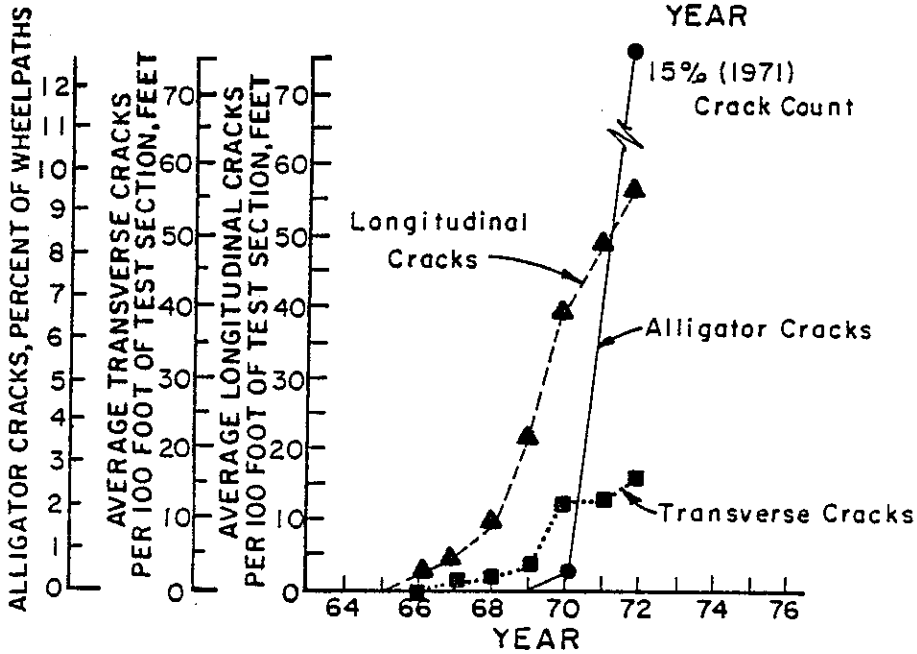
TABLE 8

Tolerable deflection = 0.024". Although mean deflections were below tolerable values, alligator cracking accelerated from 1970.

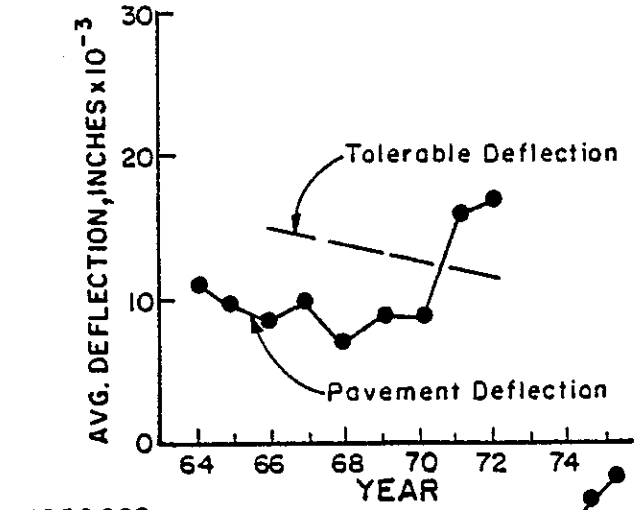
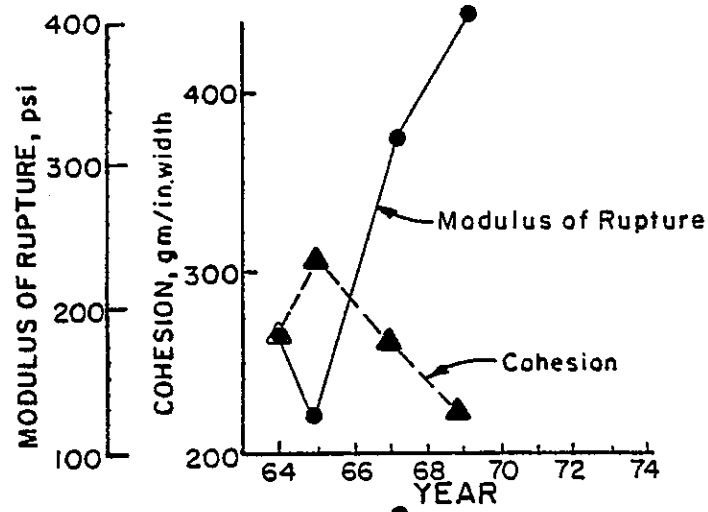
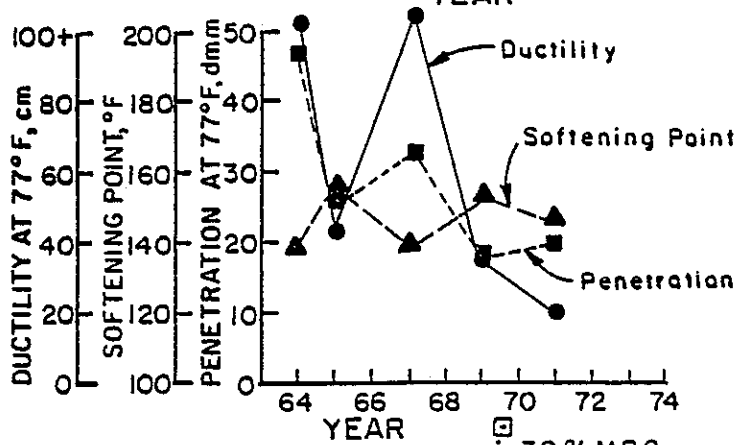
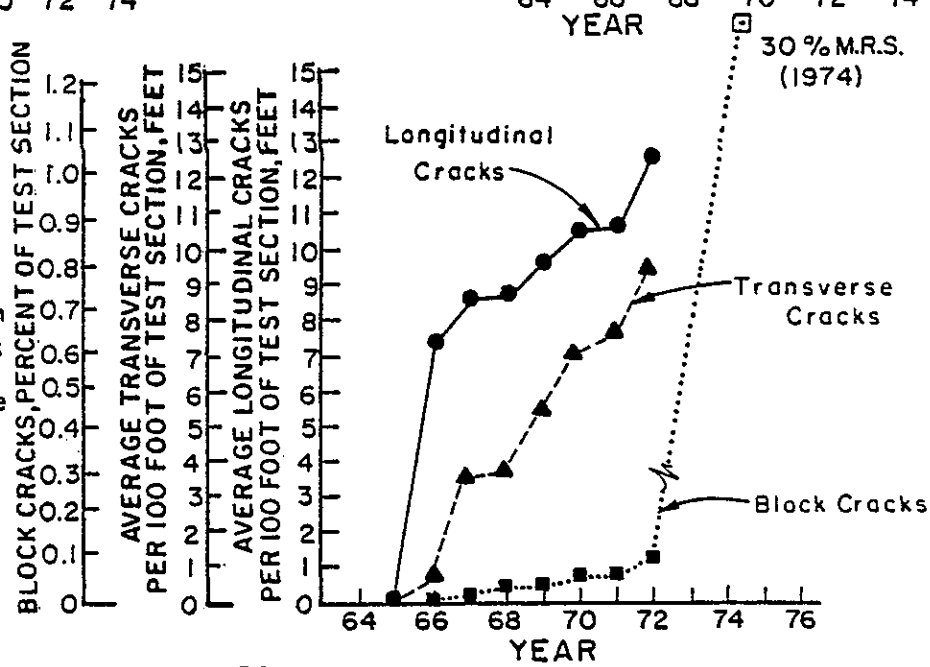
TABLE 9

Tolerable deflection = 0.013".
Measured deflections exceeded the tolerable beginning in 1971. 1974 pavement condition survey from Maintenance Rating System shows approximately 30% block cracking. From rating system it appears that some work was done between 1974 and 1976.

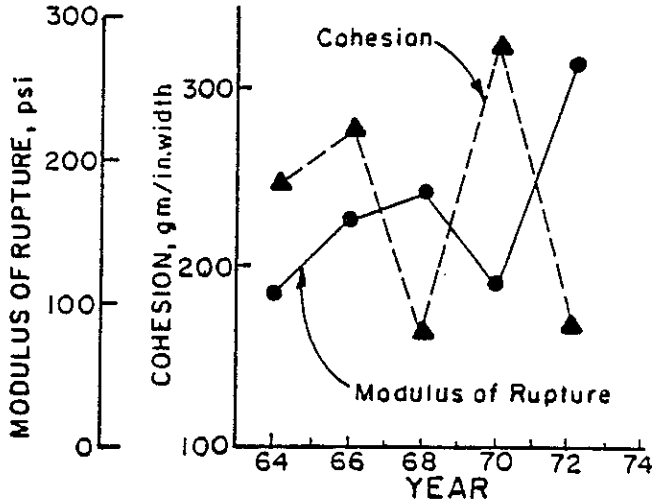
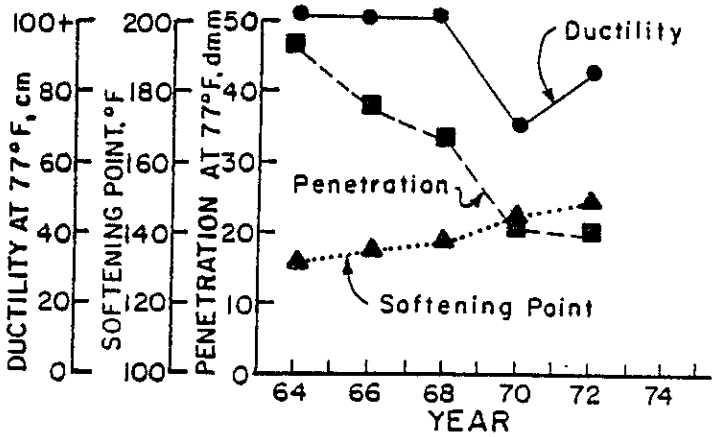
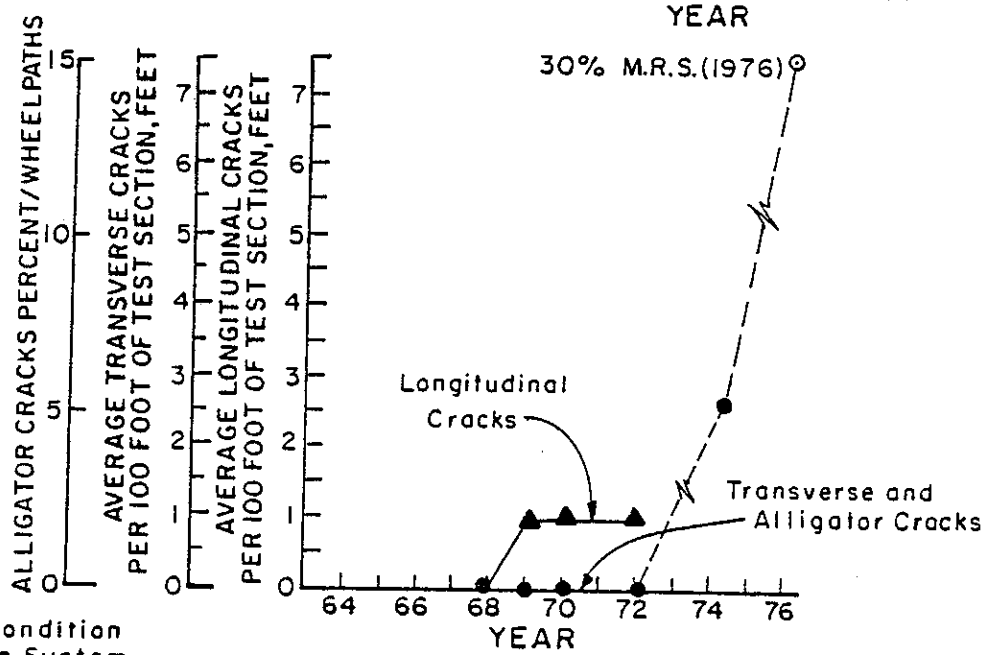
TABLE 10

T.I. ≈ 10.0 (1973 Data)
Tolerable deflection = 0.016".
No block cracking until 1972 then it progressed rapidly.
About 30% block cracking by 1976 as per Maintenance Rating System.
A 0.06' OGAC overlay was placed on this project in 1976.

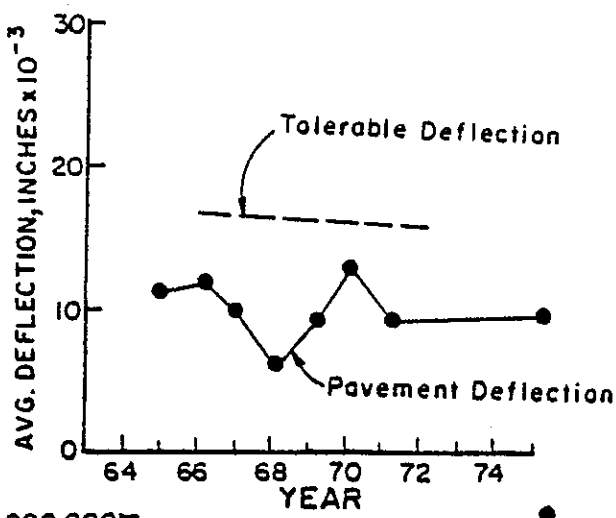
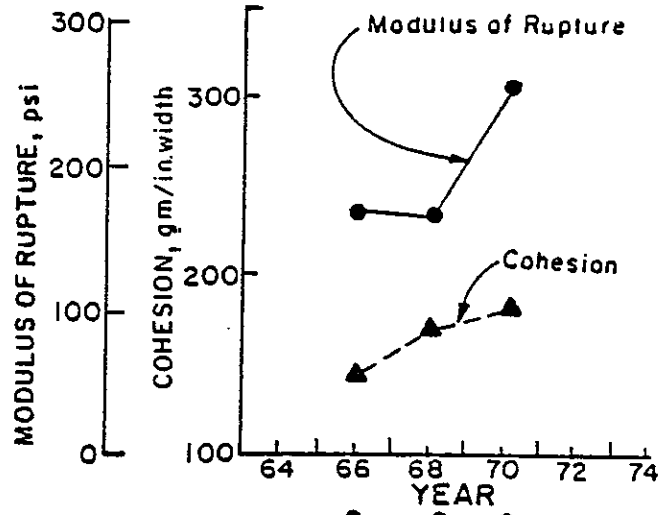
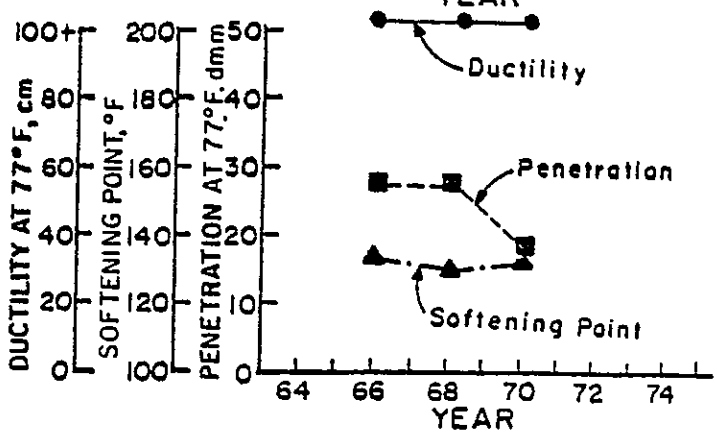
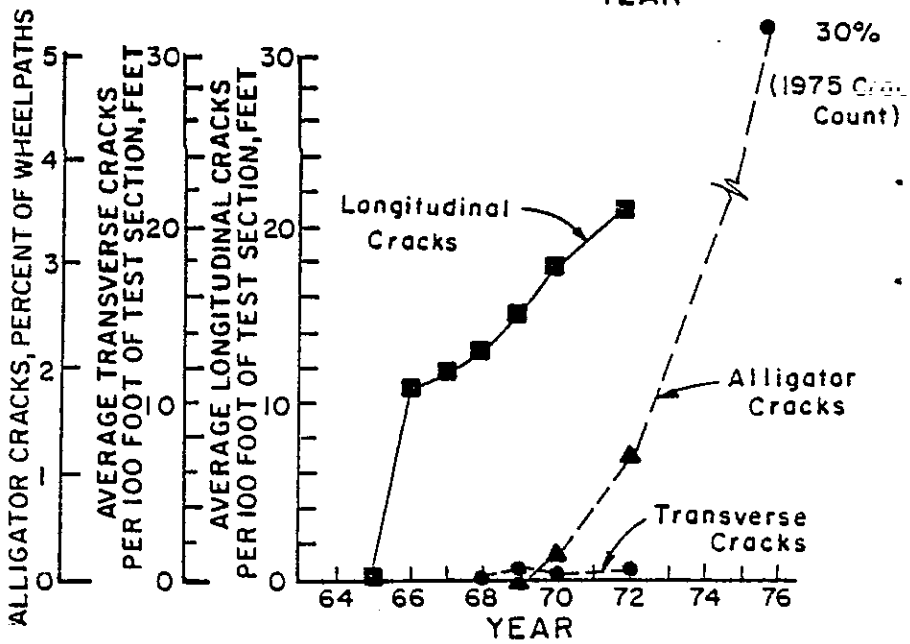
TABLE 11

T.I. ≈ 10.0 (1970 Data)
Tolerable deflection = 0.016".
Block cracking started increasing significantly in 1972. Chip seal placed during April 1971. A crack count in 1975 showed 30% cracking. A 1974 pavement condition survey from Maintenance Rating System also showed about 30% cracking. Project was resurfaced in 1975, possibly after rating was finished.

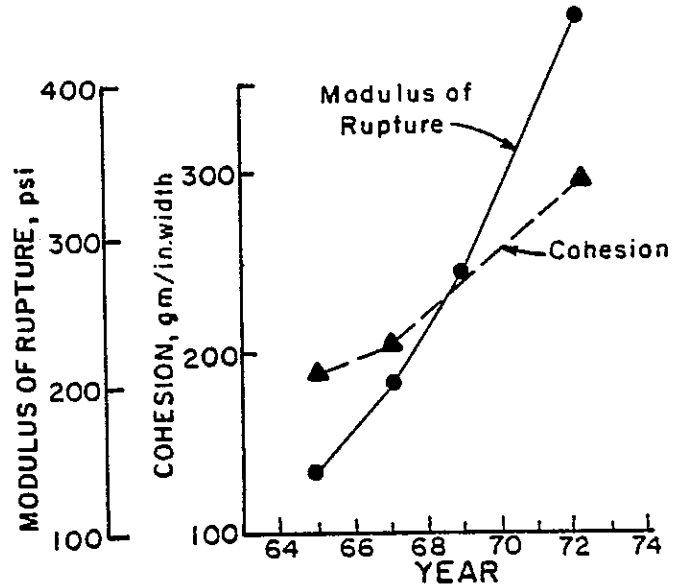
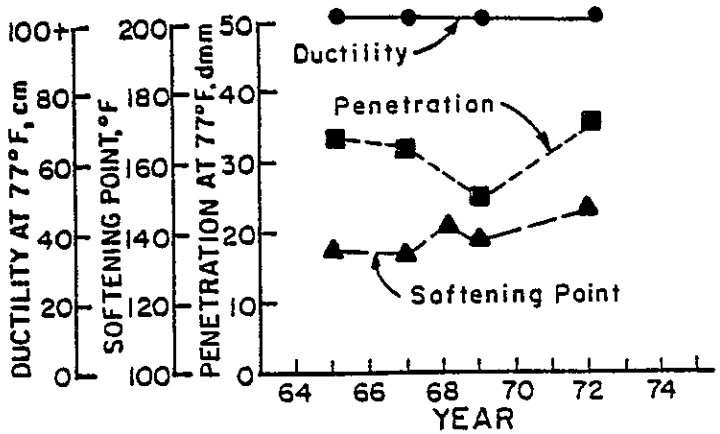
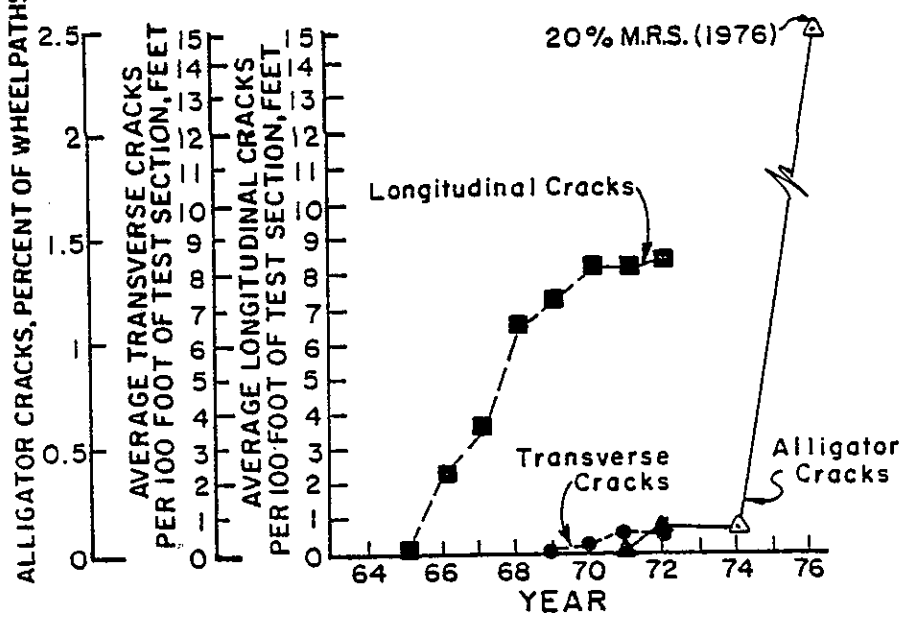
T.I. ≈ 9.5 (1974 Data)
Tolerable Deflection = 0.019".
Measured deflections below the tolerable level.
One-inch AC blanket placed in 1976.
△ – Based on 1974 & 1976 pavement condition rating from Maintenance Rating System.

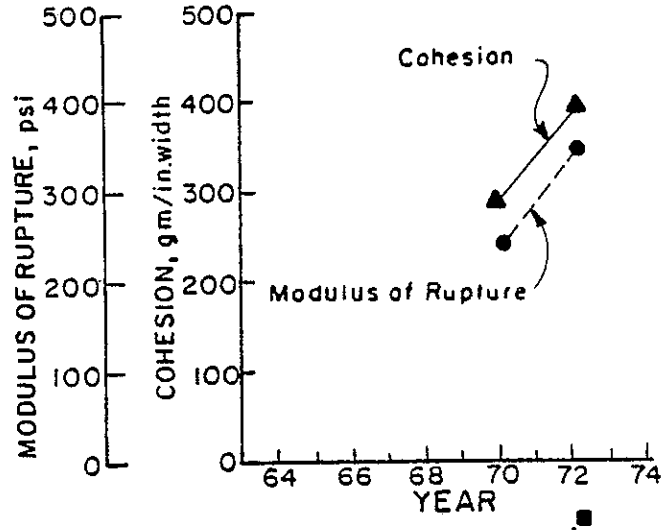
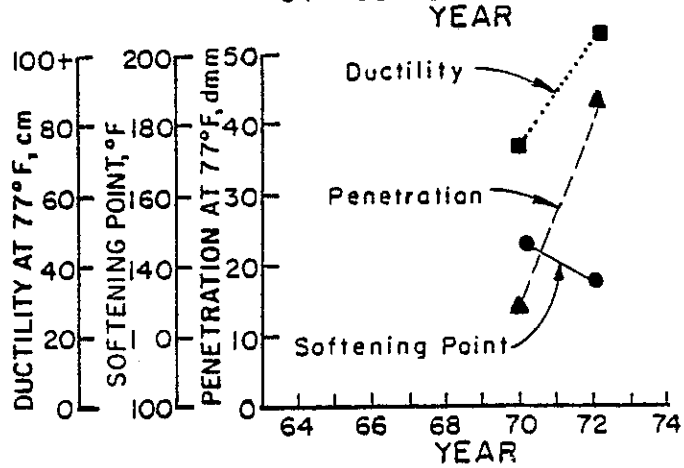
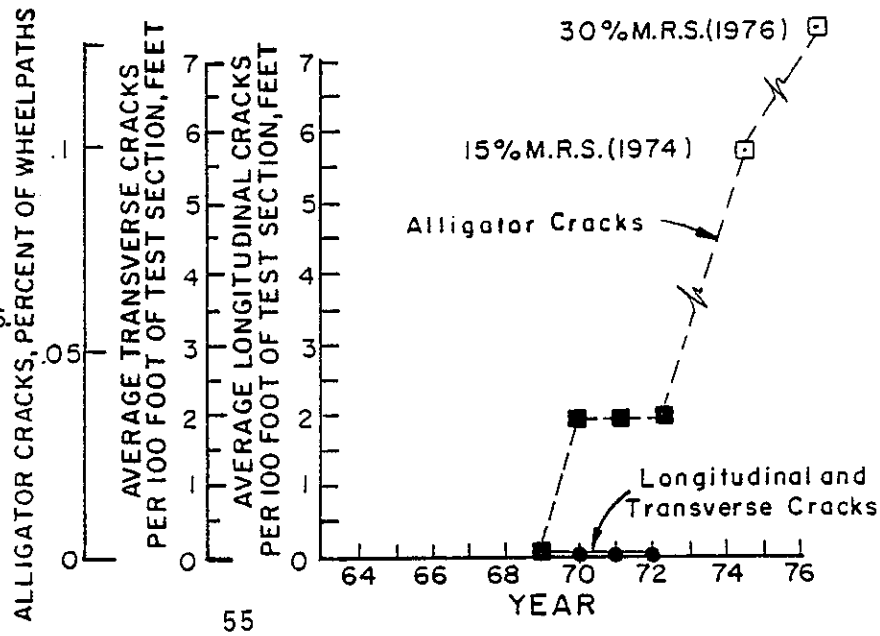
TABLE 14

T.I. ≈ 9.0 (1974 Data)
Tolerable deflection = 0.020".
Measured deflections close to tolerable level in 1974. Block cracking insignificant through 1972. Maintenance pavement ratings show alligator cracking of 15% in 1974 and 20% in 1976.

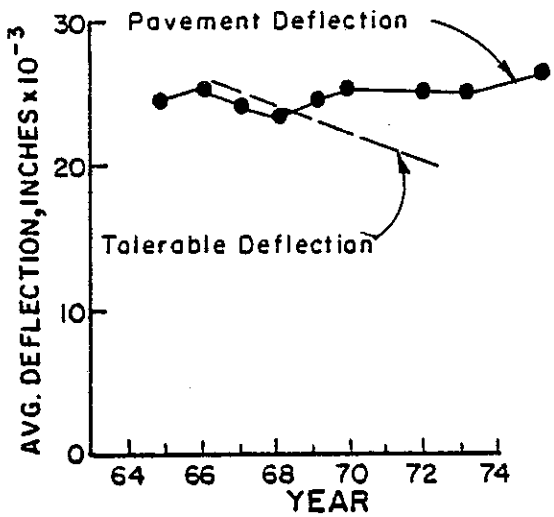
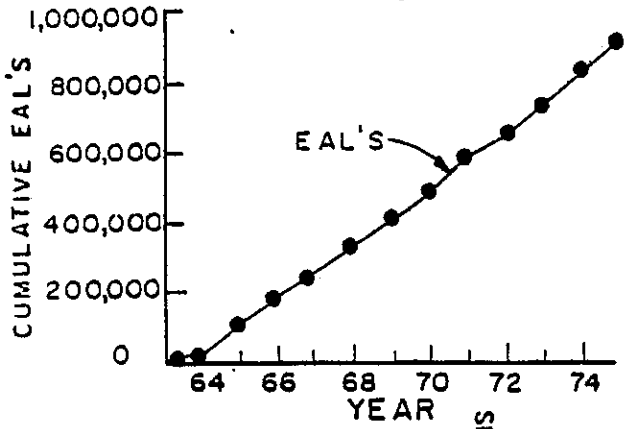
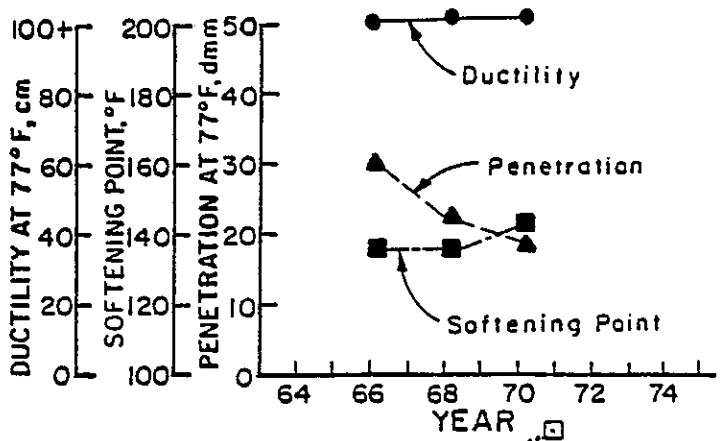
TABLE 17

Deflections have exceeded the tolerable level since 1968. Even though ductility and penetration of asphalt are not critical, block cracking began to accelerate about 1968. Although our last crack count showed 13% cracking in 1975, the pavement maintenance survey showed 20%± in 1971

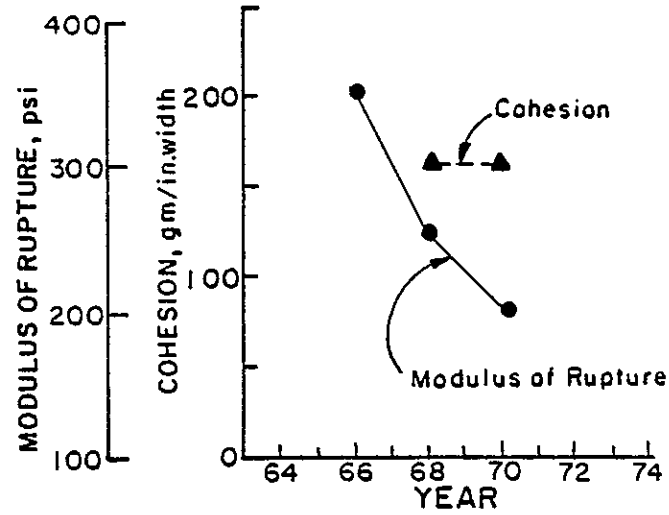
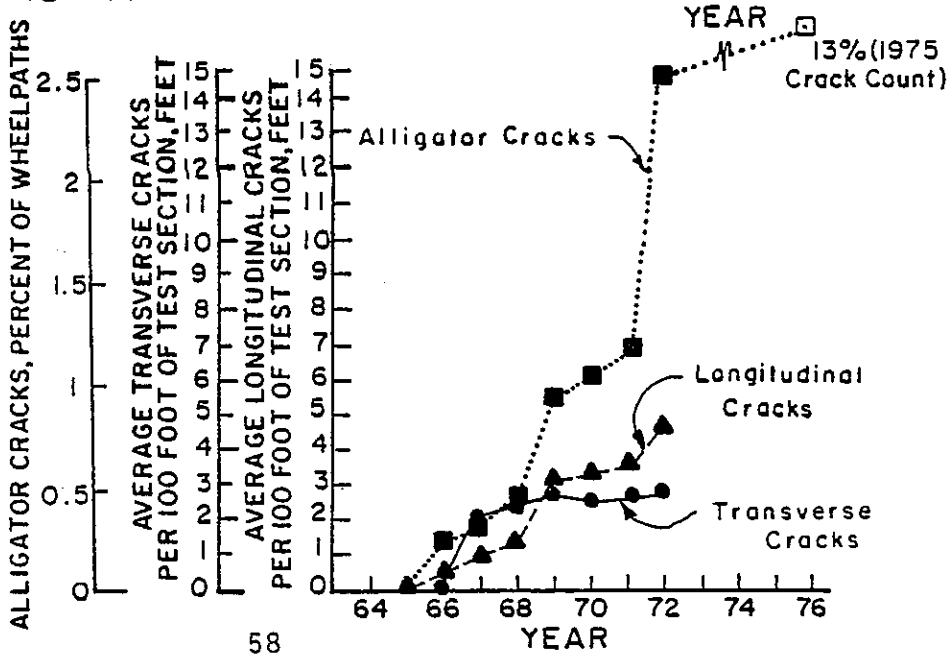
Tolerable deflection = 0.021".

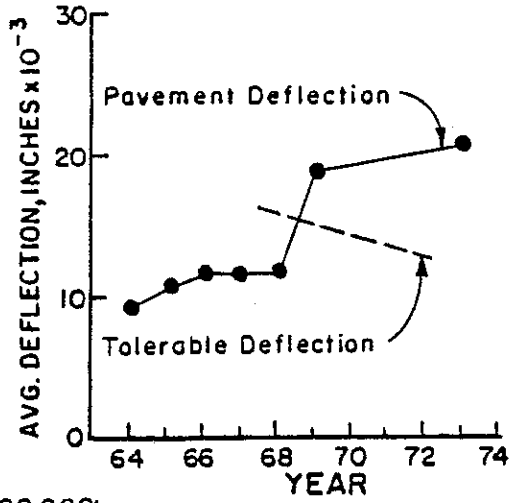
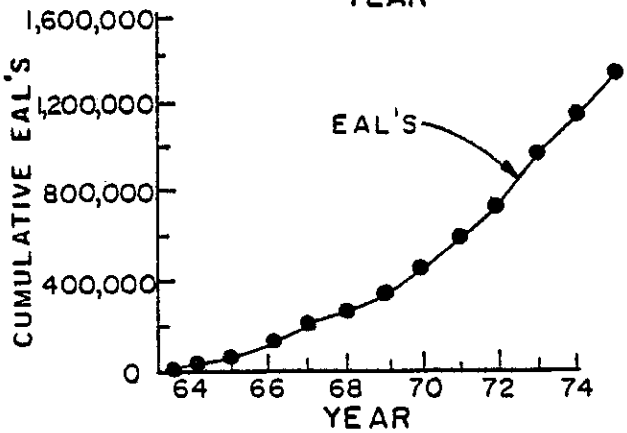
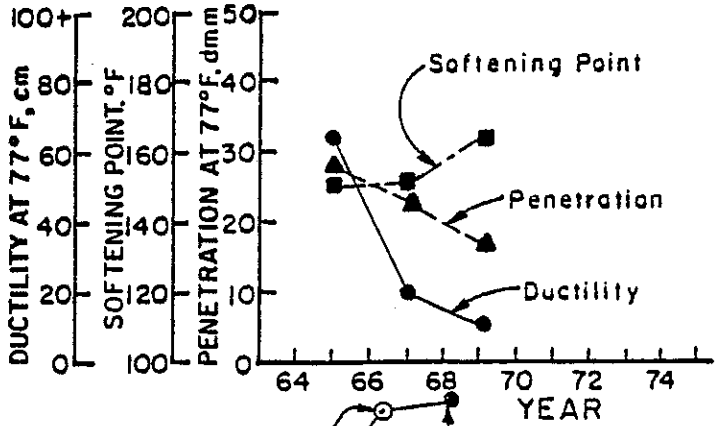
TABLE 18

Measured deflection approached tolerable about 1969. Ductility is critical (<10). Maintenance rating data shows 15% in 1969 and 30% in 1971. The last crack count was 1973 with 40% alligator cracking.

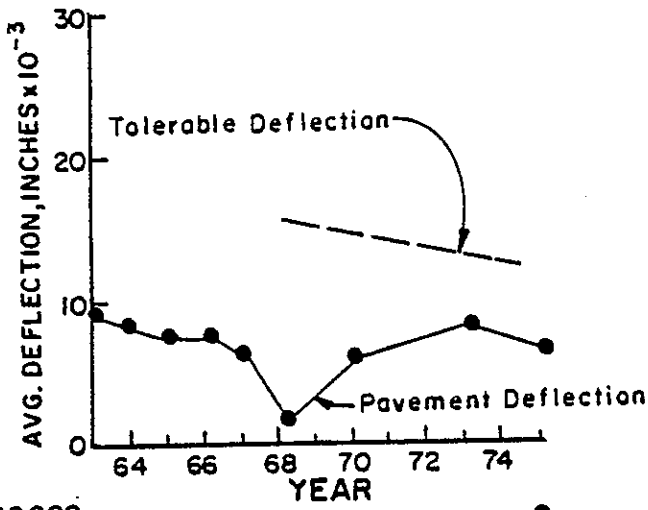
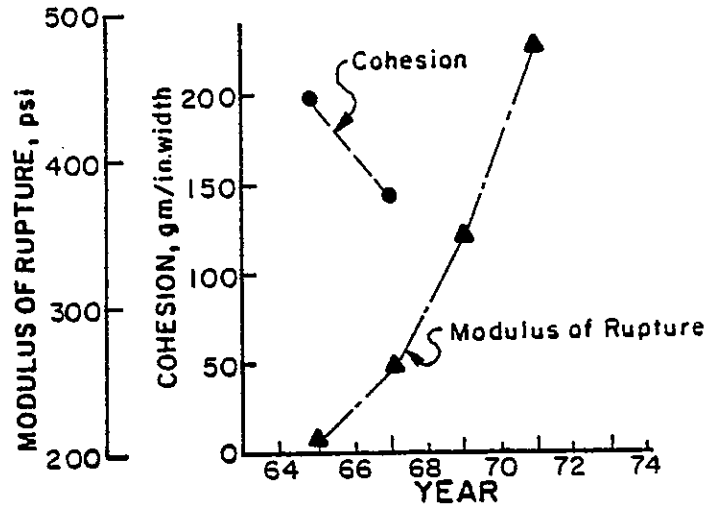
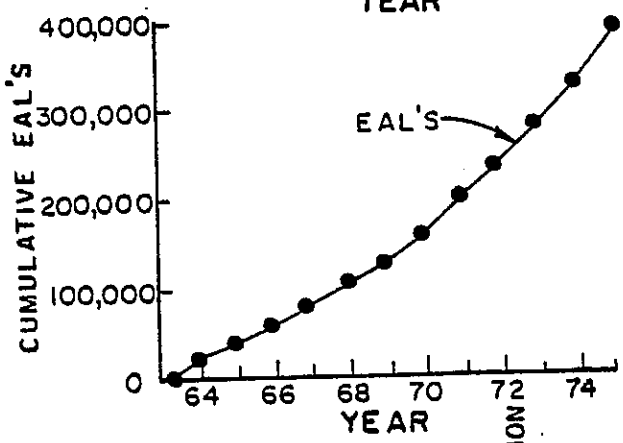
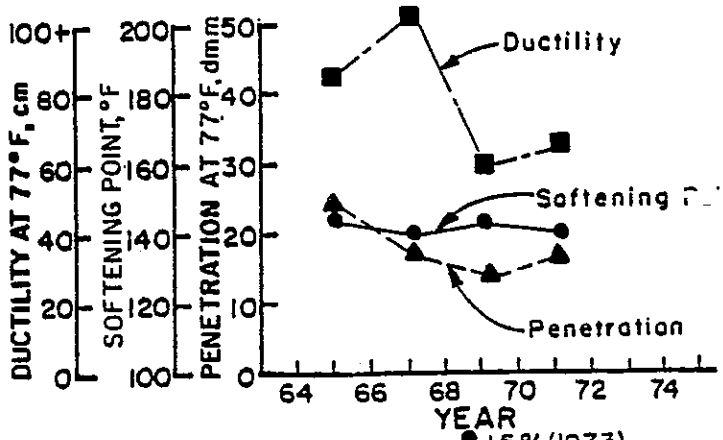
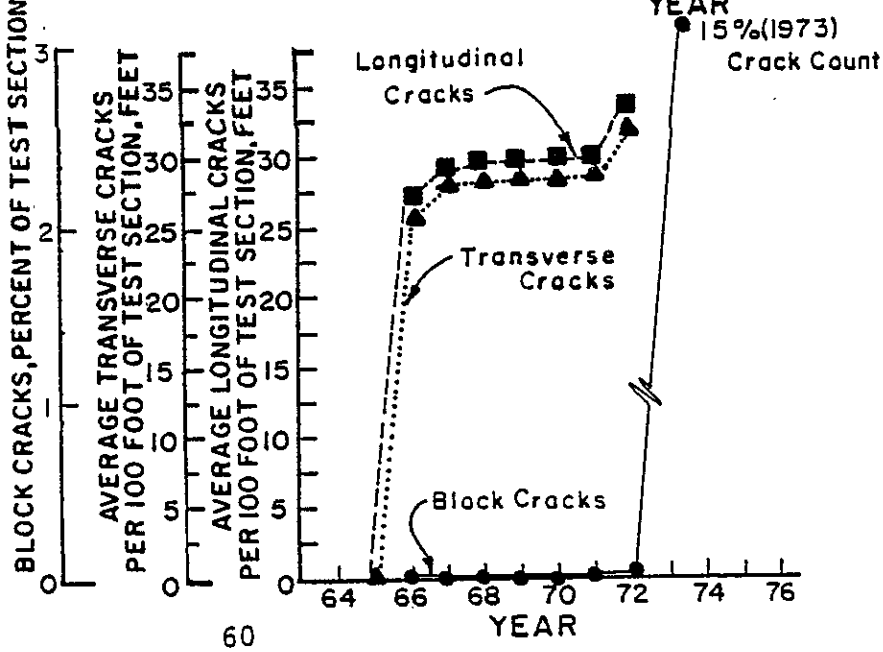
TABLE 19

T.I. ≈ 8.0 (1975 Data)
Tolerable deflection = 0.014".
Measured deflections have not exceeded tolerable level. No significant block cracking shown in Maintenance Rating System for 1974 and 1976.

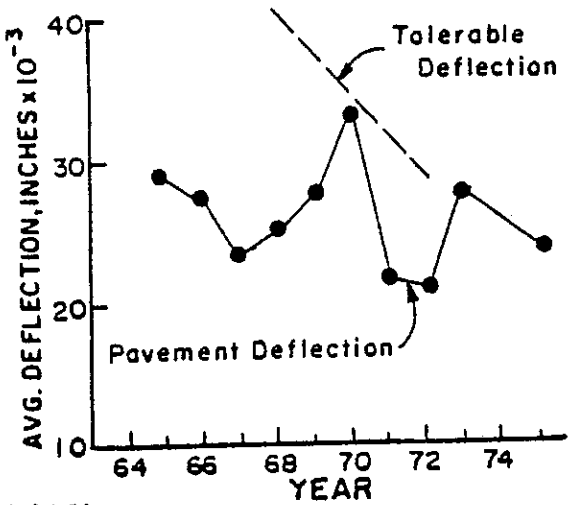
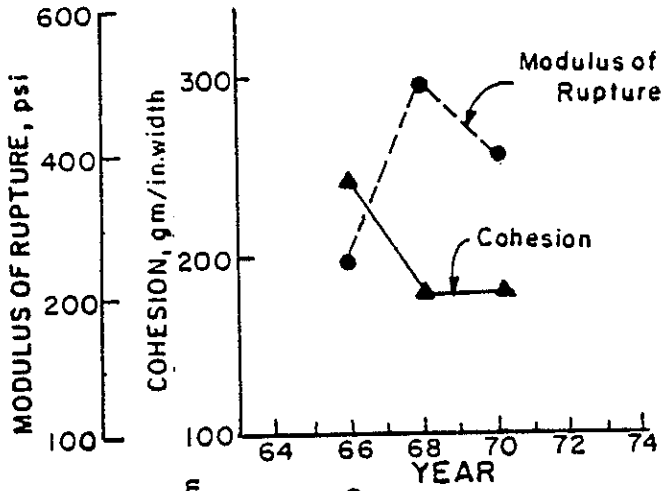
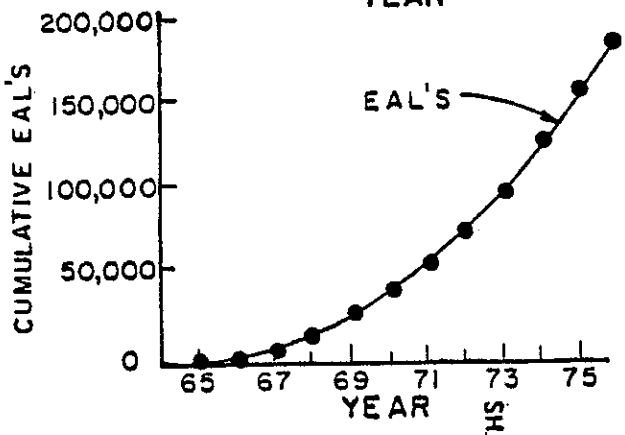
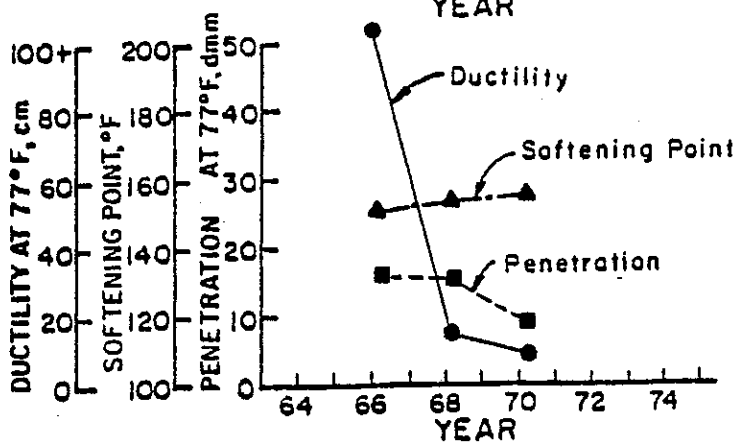
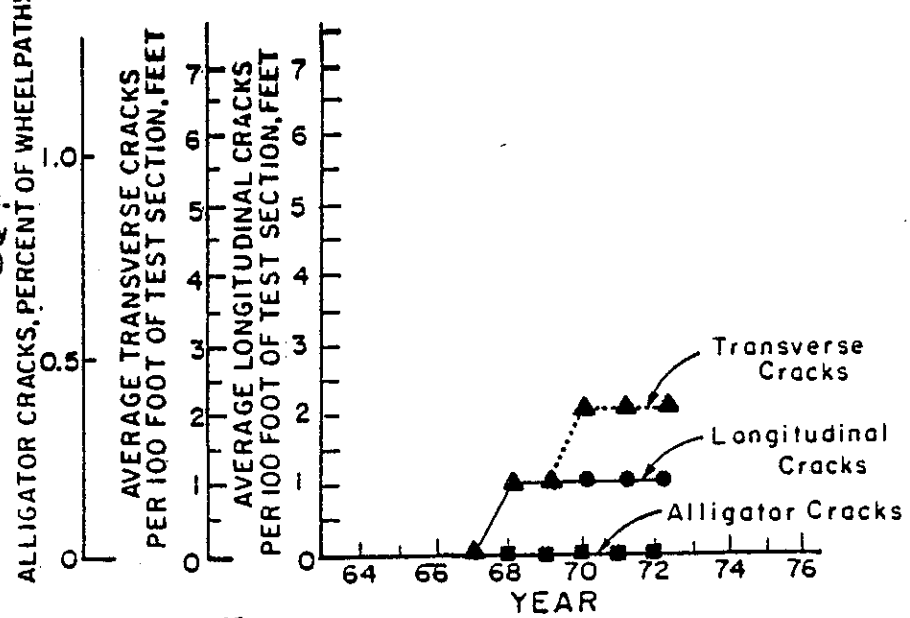
TABLE 20

Talerable deflection = 0.036".
This road had light truck traffic.
Both penetration and ductility values were extremely low (1970)

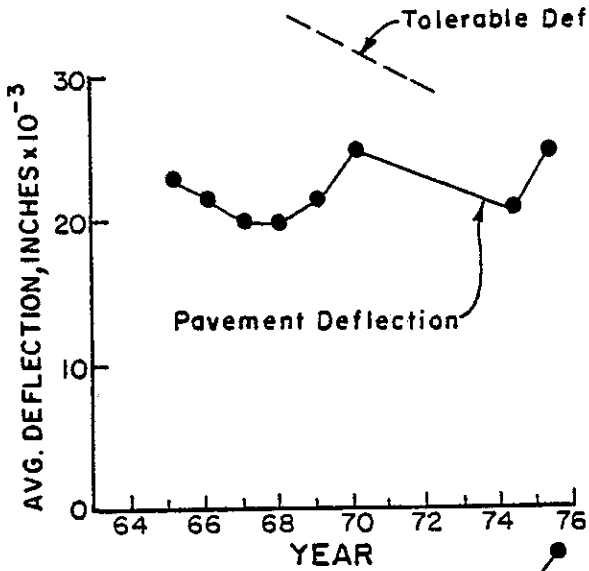
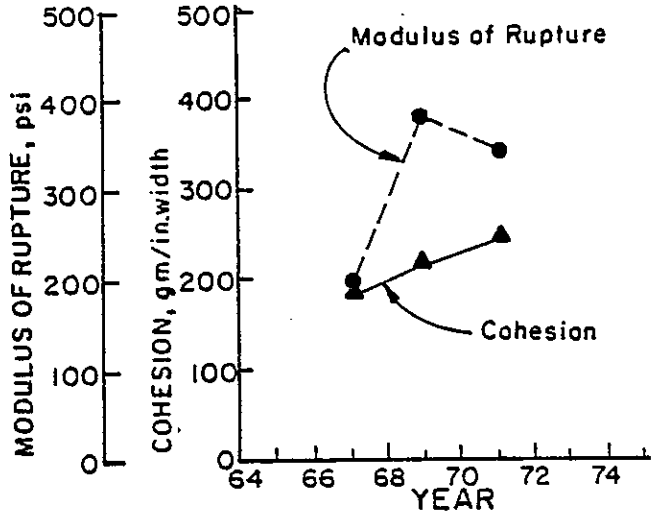
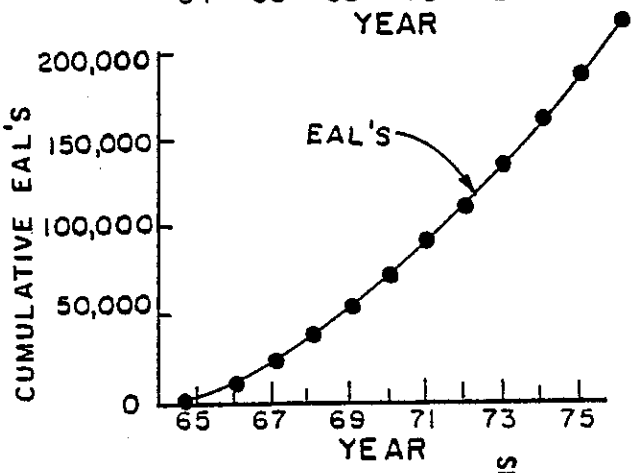
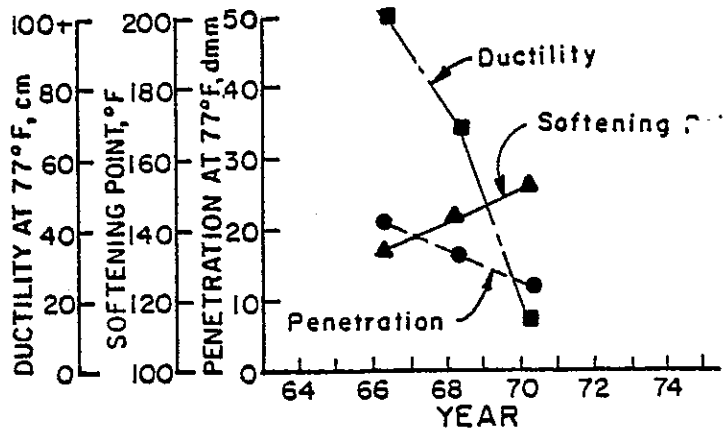
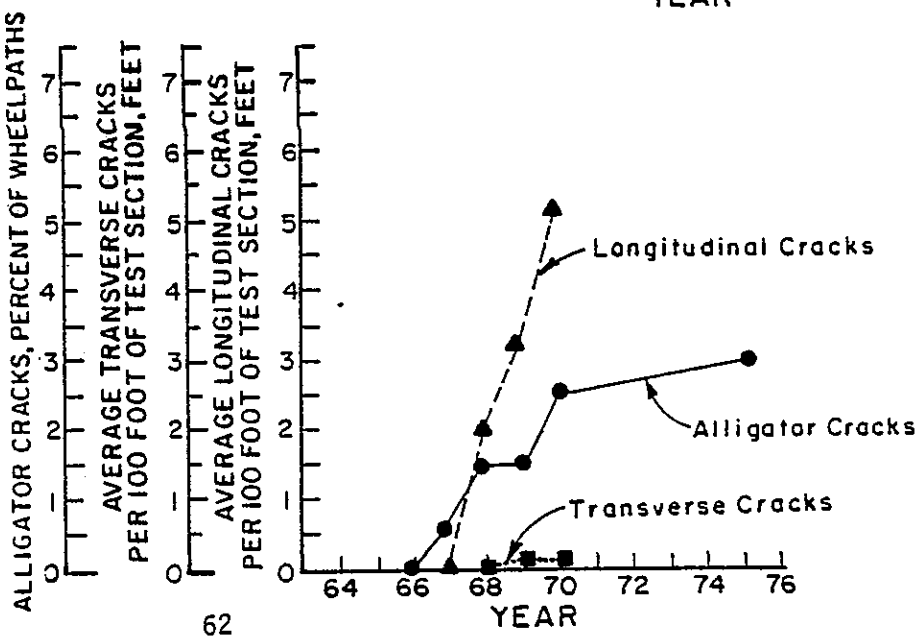
TABLE 21

T.I. ≈6.5 (1970 Data)
Tolerable deflection = 0.032".
This road had light truck traffic in 1970; the pavement maintenance rating showed insignificant alligator cracking. In 1975, pavement deflections were below critical values.

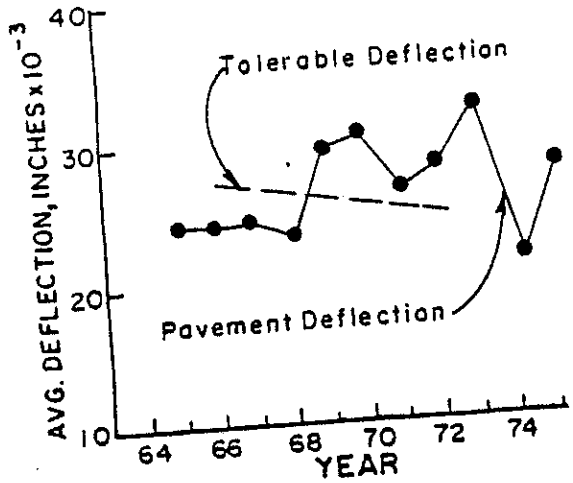
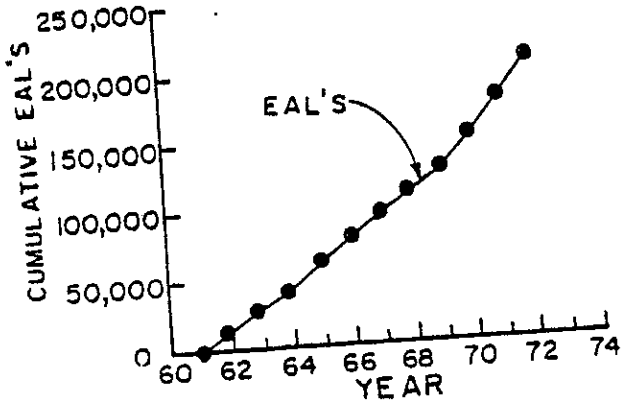
TABLE 22

T.I. ≈ 7.0 (1969 Data)
Tolerable deflection = 0.027".
In 1969 measured deflections were above the tolerable level. Block cracking started in 1969. Pavement condition survey showed 10% cracking in 1979. In 1973 this roadway was resurfaced.

△ 1972 pavement condition from Maintenance Rating System shows alligator cracking has developed in 10% of area.
