1. REPORT NO. FHWA-CA-TL-78-28	2. GOVERNMENT ACCESSION NO.	3. RECIPIENT'S CATALOG NO.
4. TITLE AND SUBTITLE STATEWIDE FLEXIBLE PAVEMENT PERFORMANCE AND DEFLECTION STUDY		5. REPORT DATE December 1978
		6. PERFORMING ORGANIZATION CODE
7. AUTHOR(S) John B. Skog, James A. Matthews, Gary W. Mann and Donald V. Roberts		8. PERFORMING ORGANIZATION REPORT NO. 19304-633167
9. PERFORMING ORGANIZATION NAME AND ADDRESS Office of Transportation Laboratory California Department of Transportation Sacramento, California 95819		10. WORK UNIT NO.
		11. CONTRACT OR GRANT NO. D-5-5
12. SPONSORING AGENCY NAME AND ADDRESS California Department of Transportation Sacramento, California 95807		13. TYPE OF REPORT & PERIOD COVERED Final 1978
		14. SPONSORING AGENCY CODE

STATE OF CALIFORNIA
DEPARTMENT OF TRANSPORTATION
DIVISION OF CONSTRUCTION
OFFICE OF TRANSPORTATION LABORATORY

December 1978

STATEWIDE FLEXIBLE PAVEMENT
PERFORMANCE AND DEFLECTION STUDY

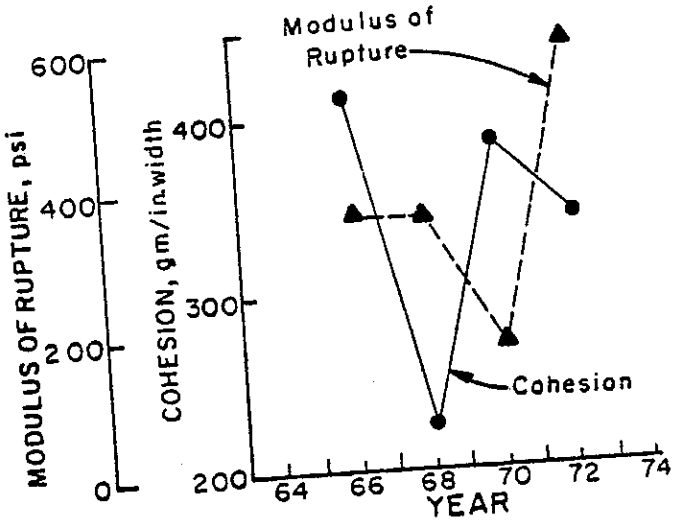
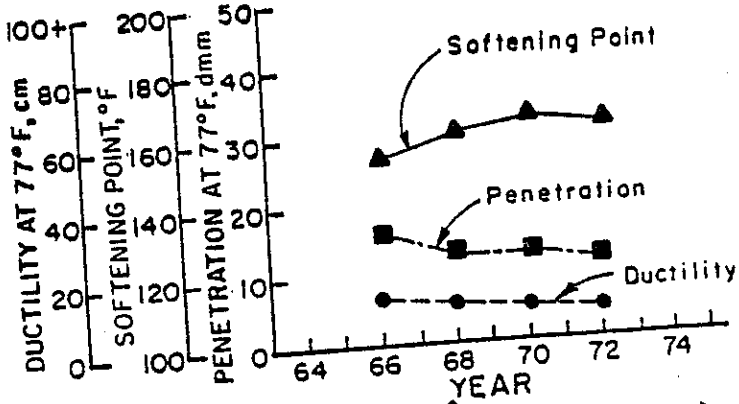
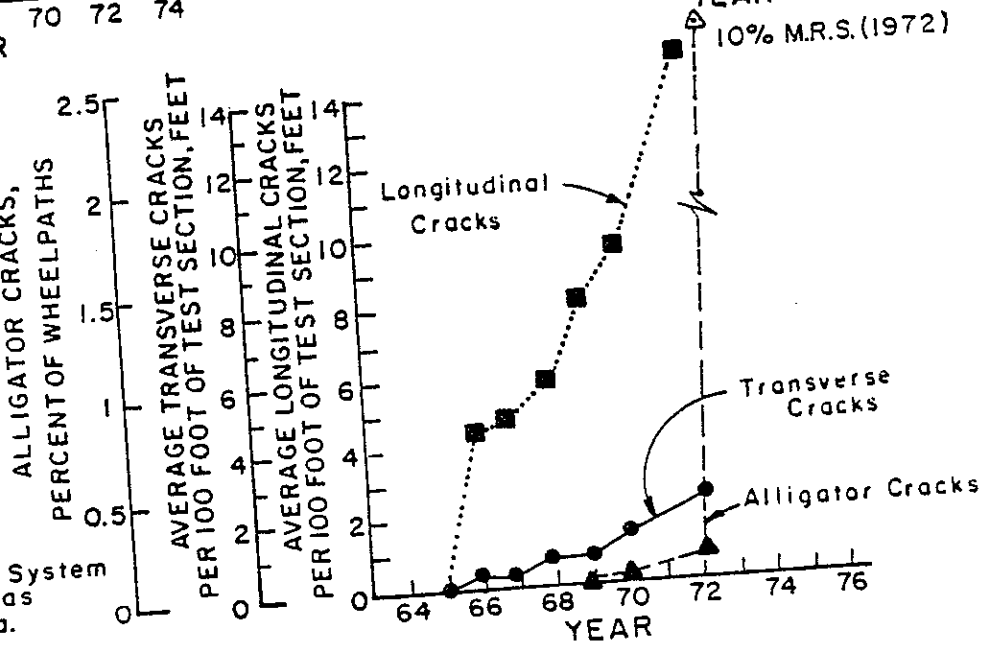
TABLE 22

T.I. ≈ 7.0 (1969 Data)
Tolerable deflection = 0.027".
In 1969 measured deflections were above the tolerable level. Block cracking started in 1969. Pavement condition survey showed 10% cracking in 1979. In 1973 this roadway was resurfaced.

△ 1972 pavement condition from Maintenance Rating System shows alligator cracking has developed in 10% of area.

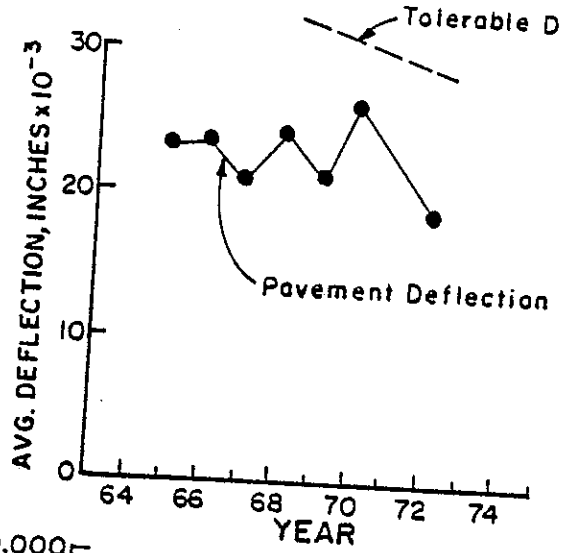
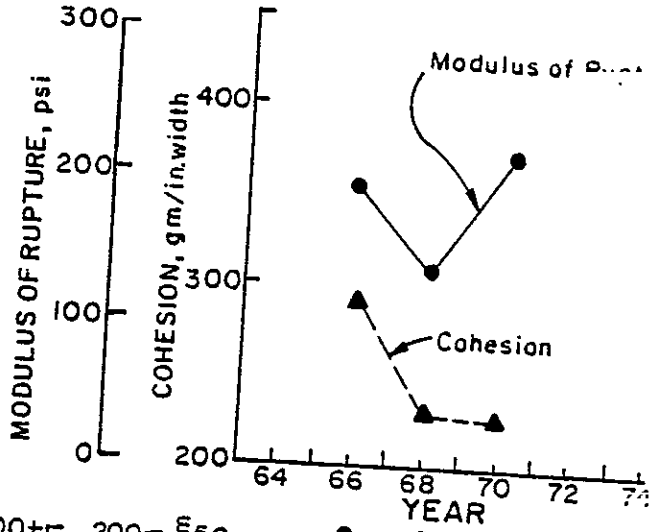
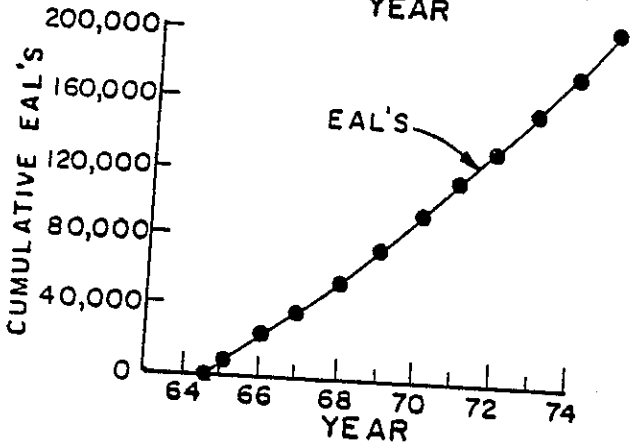
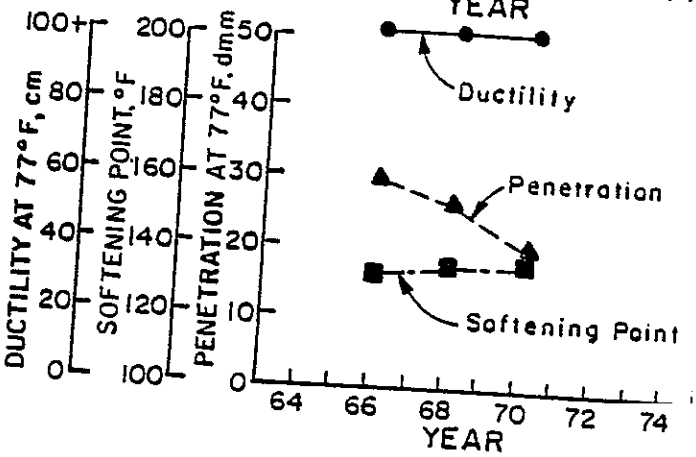
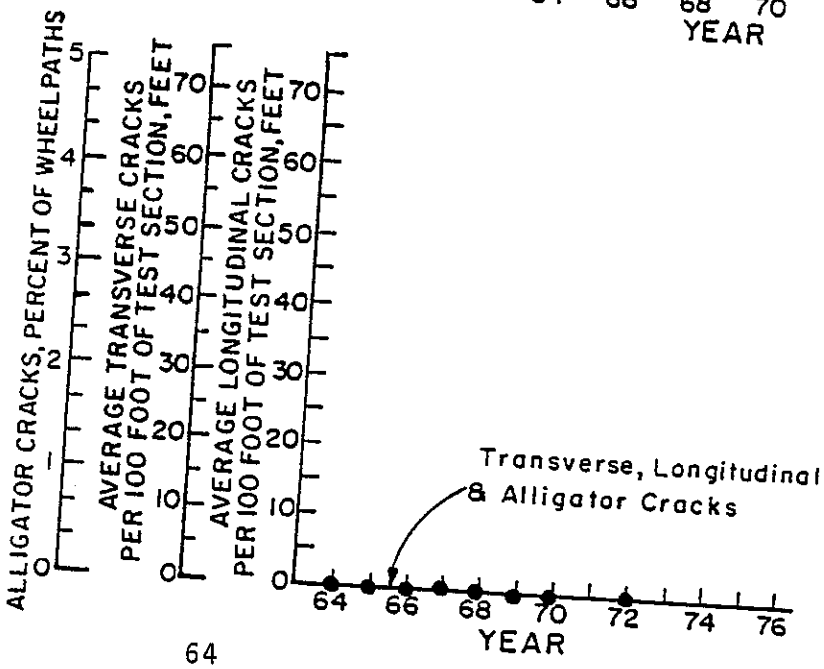
TABLE 23

Tolerable deflection = 0.028".

Measured deflections have not exceeded the critical value. Pavement condition surveys from maintenance ratings show no alligator cracking 1972 or 1976.

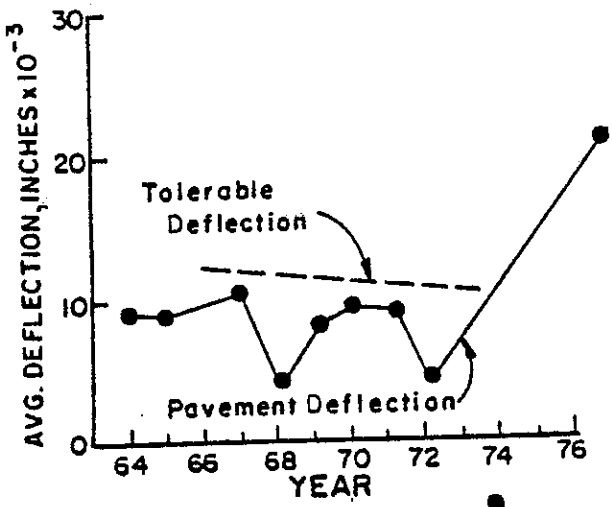
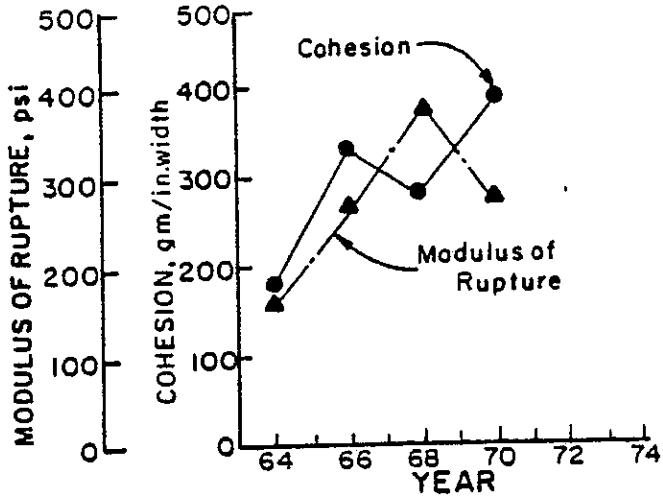
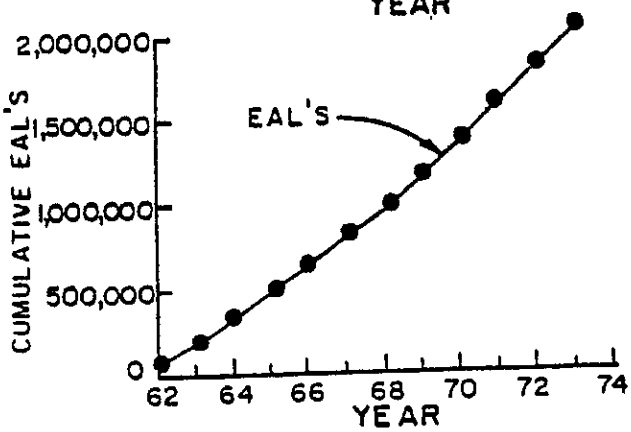
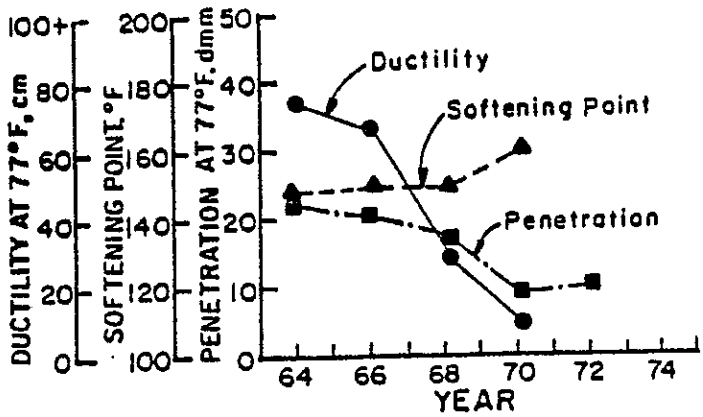
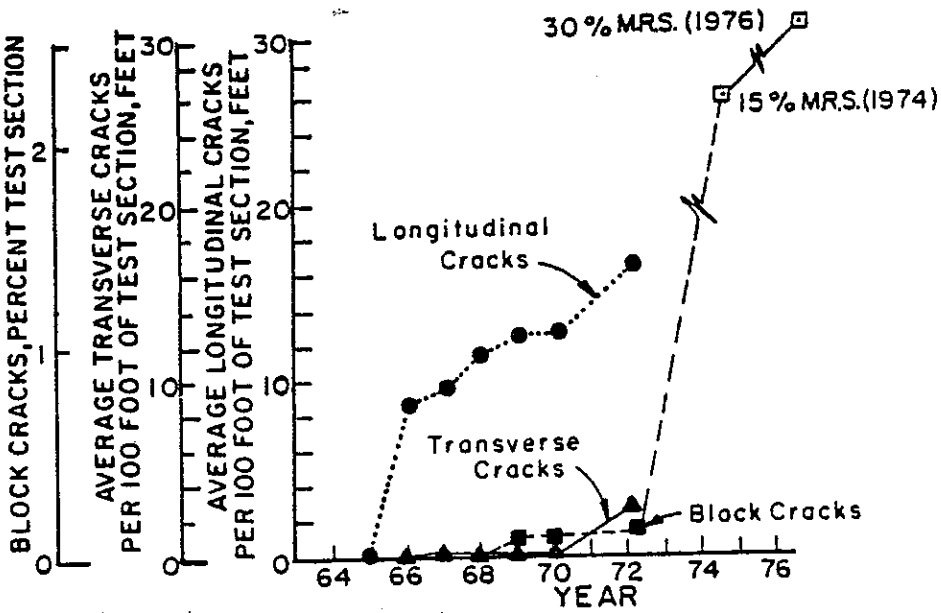
TABLE 24

T.I. ≈ 10.0 (1971 data)
Tolerable deflection = 0.011".
Deflections have not exceeded tolerable levels. No significant block cracking in spite of low penetration and ductility.
