REPORT NO. CA-TL-78-30

# Tests Of Flexible Plastic Guide Marker And Clearance Marker Posts

REVISED
INTERIM REPORT
SEPT. 1978

Caltrans
CALIFORNIA DEPARTMENT OF TRANSPORTATION

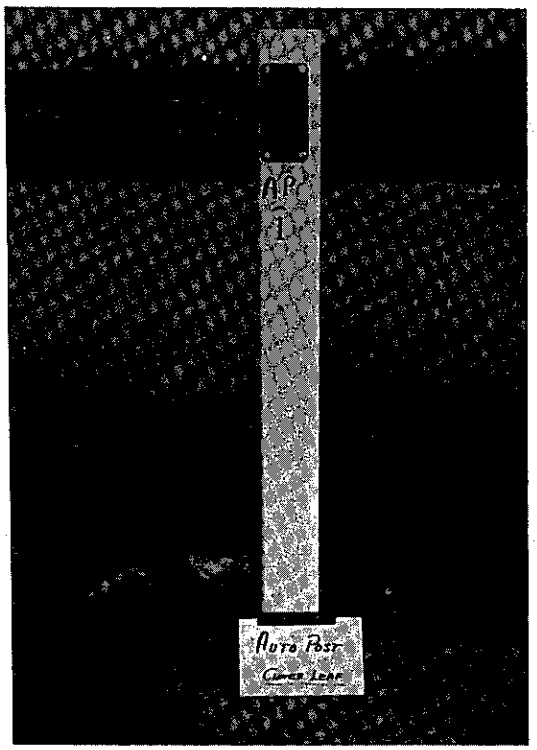
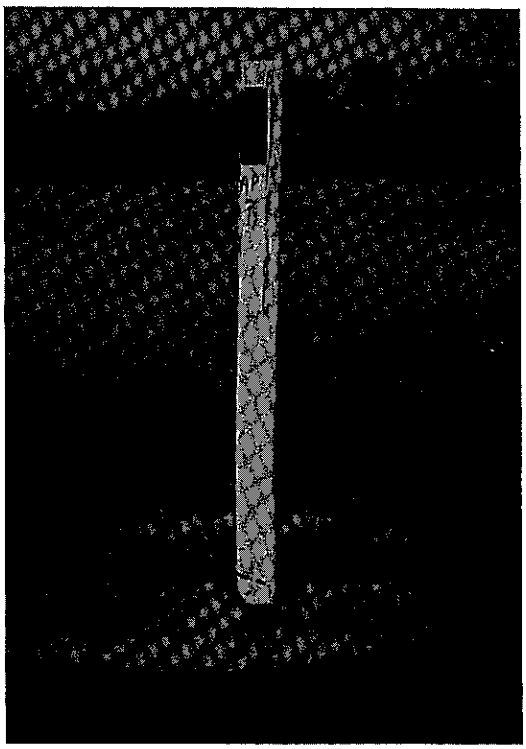
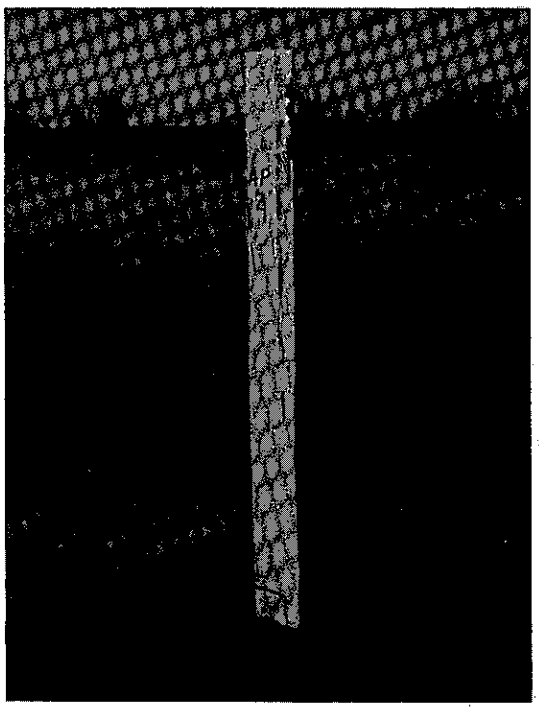
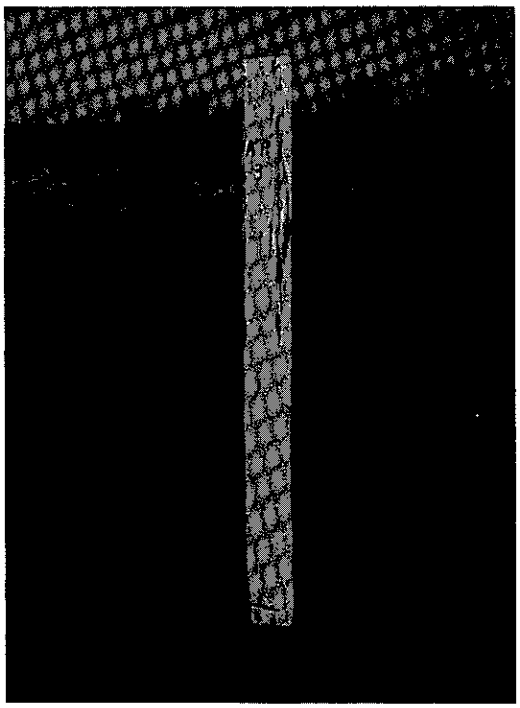
Figure 2

Both shapes of these guide marker posts were pulled out of the ground 1 to 3 inches after the 10 vehicular impacts. It is considered, however, that the anchoring system is adequate in restricting the pullout to the degree observed. The photos in Figures 2 and 4 show the amount of pullout as the distance the black line has been raised above the ground level.

No vehicular damage was detected after striking these guide markers at 55 mph. The damage to the three posts tested for each shape was considered minimal.

The photo in the upper left corner of each of Figures 2 and 4 shows one post before the first impact and the other three photos on the page show all three posts after 10 vehicular impacts. The reflective sheeting (Reflexite) on the post is damaged from the vehicular impacts and allowances must be made for replacement after a few impacts, even though in some cases the reflective sheeting lasted for the entire ten vehicular impacts.

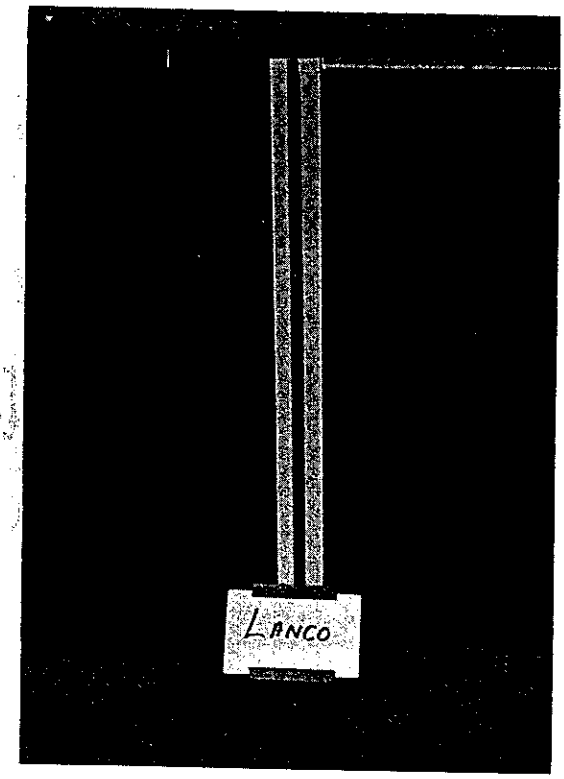
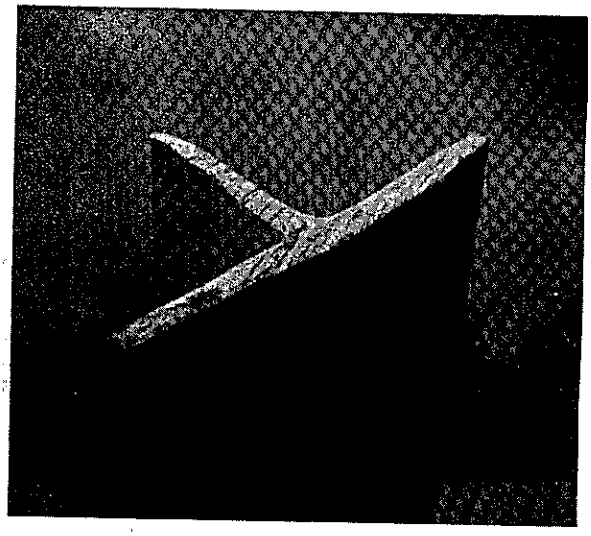
This guide marker post is made of a flexible white plastic with a 3" face and a 1 1/2" T web. The thickness of the face and the web is approximately 1/8". This guide marker is a non-driveable type which does not require interior backfilling. See Figure 5 for details of the Lanco T-post. Photos in Figure 6 show the appearance of the guide marker before and after impact.

It is recommended that no further testing be performed with the LDP-8 Lanco T-post design as a flexible guide marker post. Its performance does not compare with the other flexible guide marker posts being evaluated.

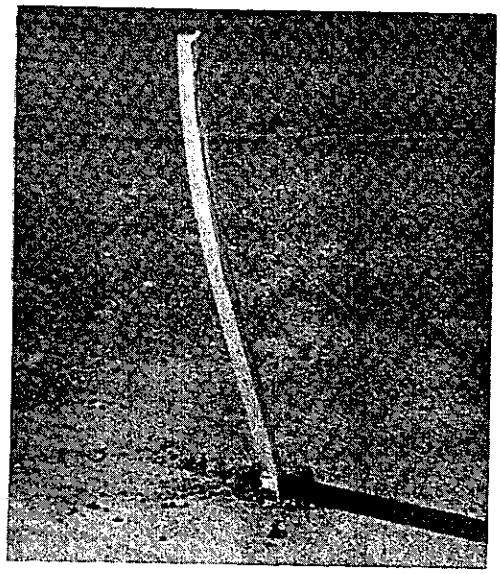
Side View of Post
After 10 Impacts

There was little or no damage to the vehicle from any of the 55 mph impact tests. The guide marker post tended to return to an approximate vertical position after each impact with a pullout of 0 to 1/2" from the ground. After the first vehicular impact the marker canted 5 to 20° from the vertical. After 10 impacts the post approached a canted position of 30° from the vertical. During the vehicular impacts the post developed an S-shaped curve as can be seen in one of the photos. It is considered that this shape and appearance would not be acceptable even though the marker returned to a semi-upright position. Due to this deformed shape, this marker is not considered acceptable.

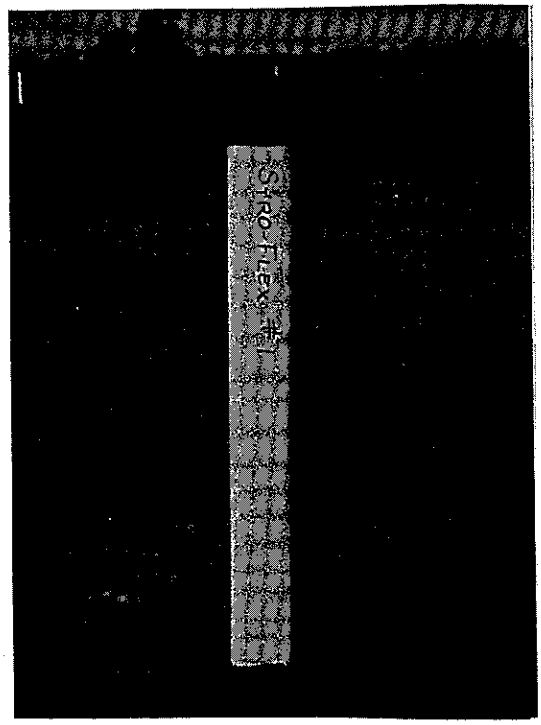
On February 14, 1977, the Syroflex guide marker post was tested with 10 vehicular impacts. This guide marker post had previously been tested and approved by Caltrans and there are many installations throughout the state. It is fabricated from a flexible white plastic and has an isosceles triangle cross section. The long sides of the isosceles triangle are approximately 4 3/4" and the short side approximately 4" wide. The side facing the traffic consists of one of the long legs of the triangle. See Figure 7 for details of the Syroflex post. This guide marker post is a non-driveable type; a hole has to be provided in the ground to install the guide marker, the interior of the marker requires backfilling. A black cap is provided by the manufacturer to cover the top and keep water and debris out of the interior of the post. This post is shown in the photos in Figure 8.

This guide marker post was able to withstand the 10 vehicular impacts at 55 mph and satisfactorily return to a vertical position, as was found in earlier tests and evaluations. The black cap cover on the top of the post was knocked off on the first vehicular impact. The upper left photo in Figure 8 shows one of the three posts before the first vehicular impact and the other three photos show all three posts after the 10 impacts. The damage to the vehicle from the impact was minimal. The damage to the posts was also considered minimal. The anchoring system for this guide marker was satisfactory with only 1/2" to 1" pullout from the ground after the 10 vehicular impacts.

It is recommended that further installations of this marker post be deferred until suitable evidence is developed or obtained which would attest to its long term serviceability.

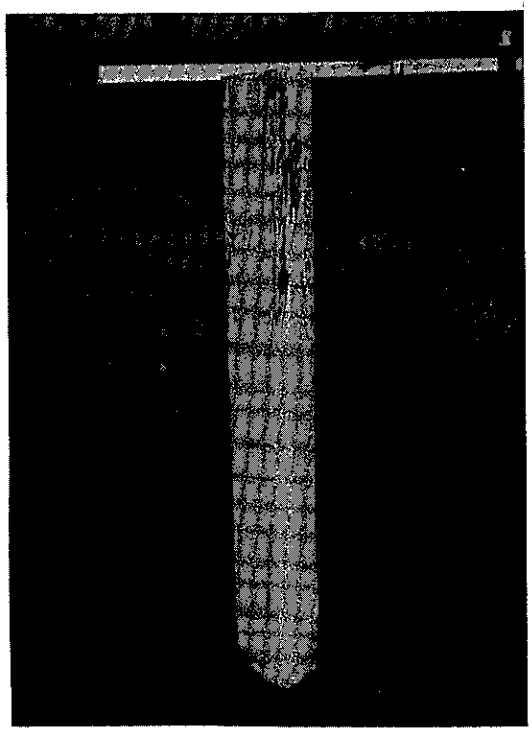
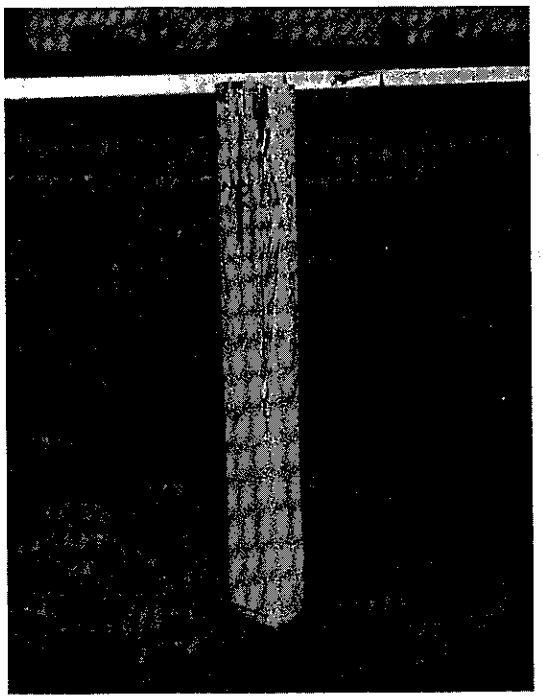
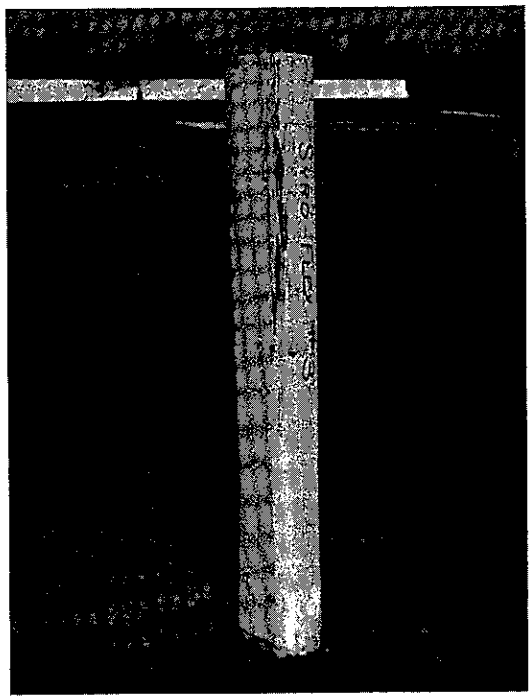
installations which have been made over the past years. We have a number of examples of extreme change in the plastic from outdoor weathering and sunlight exposure where the plastic loses its flexibility, becomes brittle and discolored. The weathered marker then fractures under vehicular impact. The evidence indicates that the long term serviceability of this marker as currently formulated is not acceptable. Presently we have outdoor exposure samples on the Transportation Laboratory roof and laboratory fadeometer tests underway to better estimate its durability.

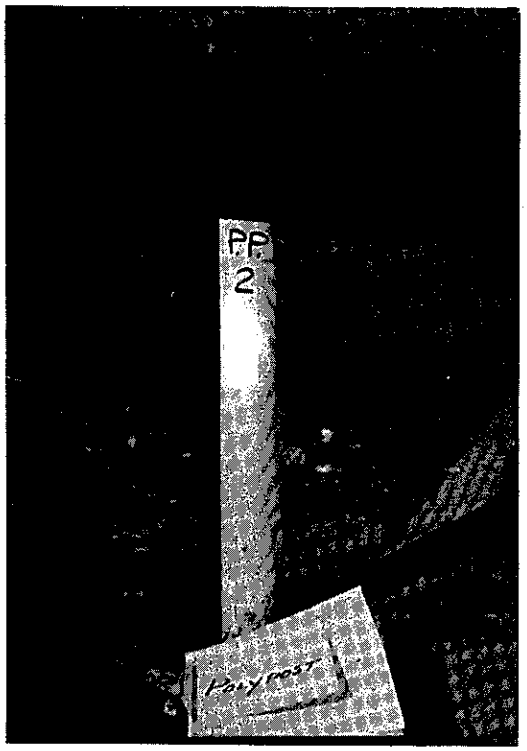
This post is fabricated out of white flexible plastic with a 10" long black flexible plastic top. It is circular in cross section with a 3 1/2" diameter. Details of the Polypost are shown in Figure 9. This hollow post is a non-driveable type which requires a hole in the ground and backfilling both inside and out up to ground level. The upper left photo in Figure 10 shows one of the three posts before impact and the other photos show all three posts after 10 vehicular impacts. The interior of all three posts was backfilled.

The second series of tests was conducted to verify the manufacturer's claim that the post would perform satisfactorily without interior backfilling. This installation was not successful. The guide marker post failed to return to vertical when the interior backfill was omitted.

It is recommended that this post with interior backfilling be considered acceptable at this time. Further evaluation of long term serviceability and general performance by trial field installations should be monitored. Our present specification for non-driveable flexible guide markers is appropriate and should be used in specifying the Polypost guide marker post.

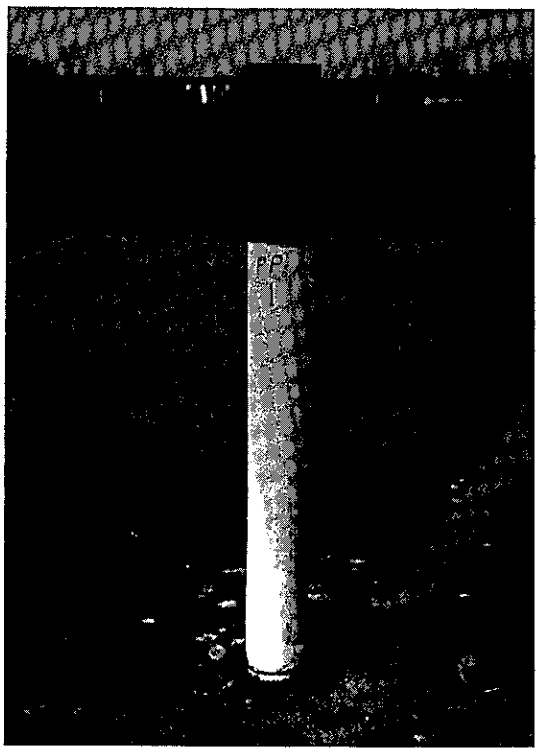
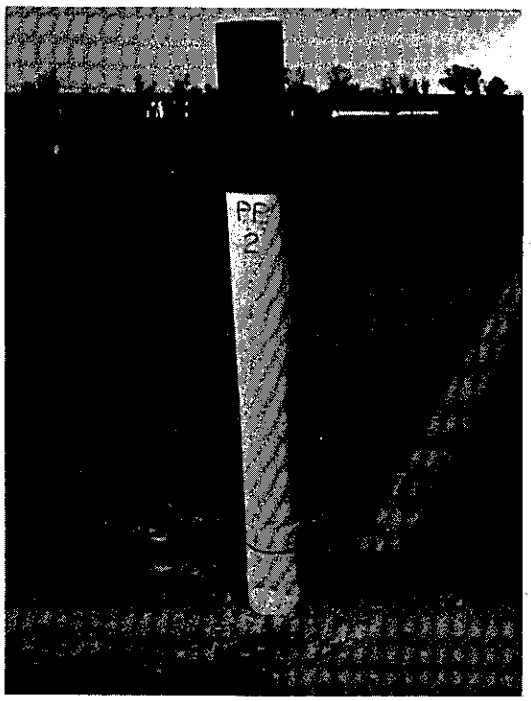
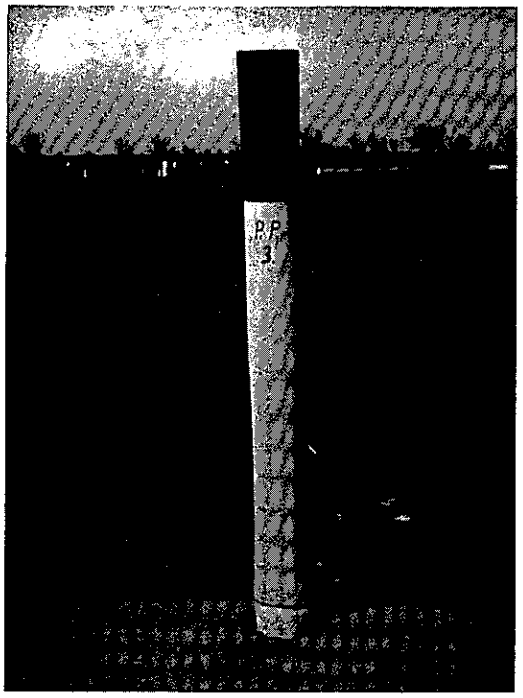
There was slight or no damage to the vehicle from the 55 mph impact with this backfilled guide marker post. The post was able to withstand the 10 vehicular impacts and return to a vertical position with little or no apparent damage. Care must be taken to insure that the backfill for this post is tightly compacted as anchorage depends entirely on friction between the post and the soil. Two of the three posts pulled out of the ground 4" to 6" from the impacts. The third post pullout was very minimal - approximately 1/2" or so.

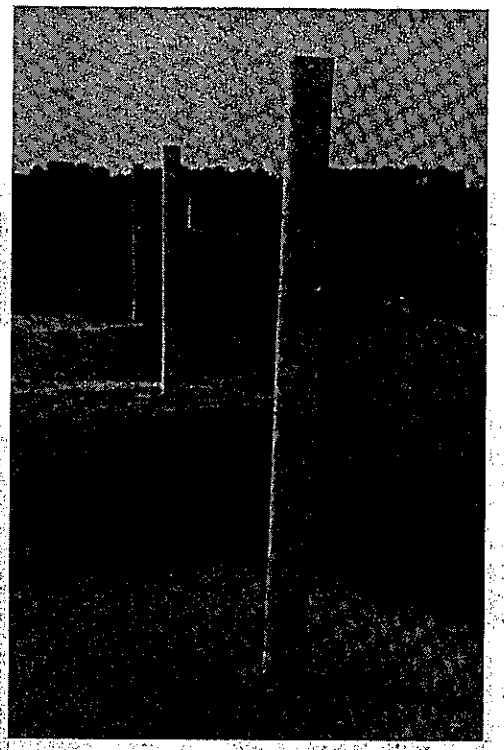
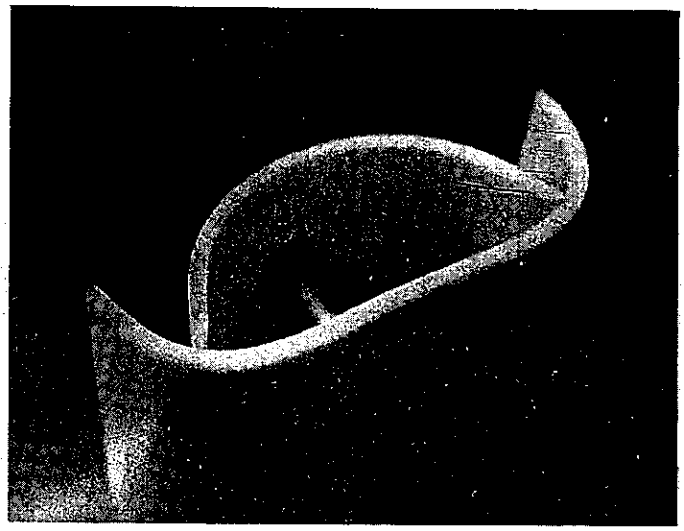
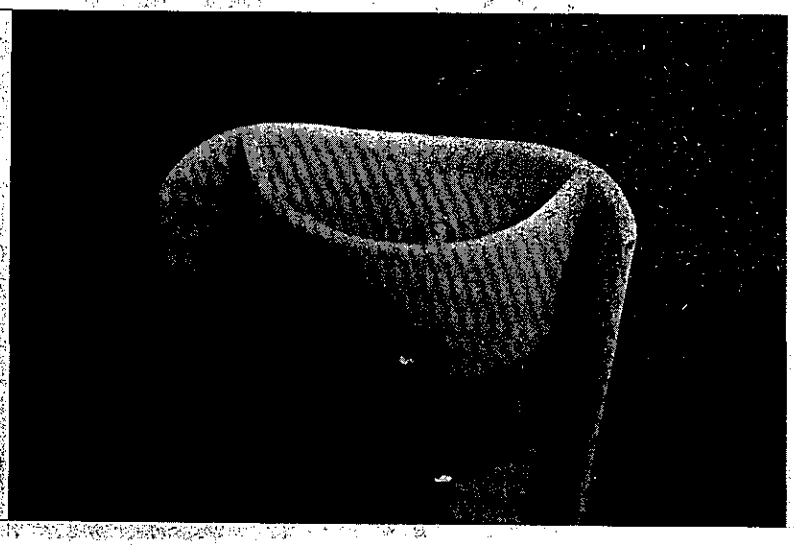
Figure 12

Damage to the vehicle at 55 mph by this guide marker was minimal to slight. However, the rivets which held the two sections of the post together separated upon the first impact of the vehicle. The top portion of the post cracked and subsequently broke apart from further repeated vehicle impacts. In its present design form we would not consider this post to be acceptable for installations in areas subjected to repeated vehicular impacts. However, the manufacturer of this post may be able to develop a better method of fastening the two pieces of this post together. Therefore, due to the fact that this polycarbonate flexible guide marker may have possibilities with design improvement, it is being further evaluated for weathering and the effects of ultraviolet

It is recommended that no further evaluation than mentioned above be conducted on this post unless design changes are made.

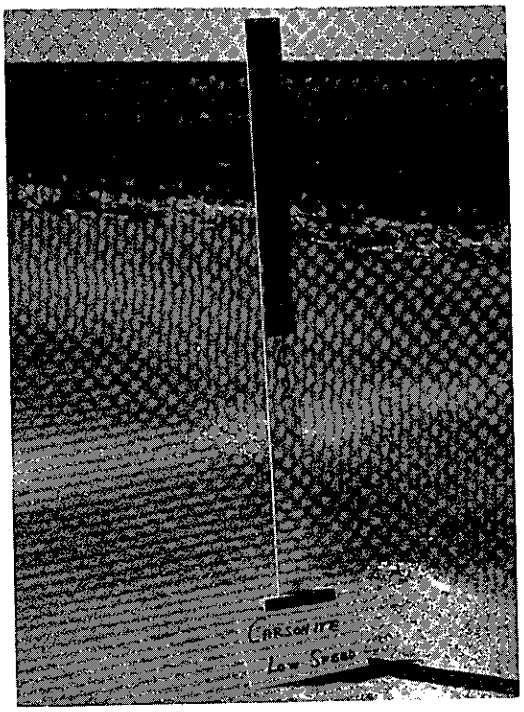
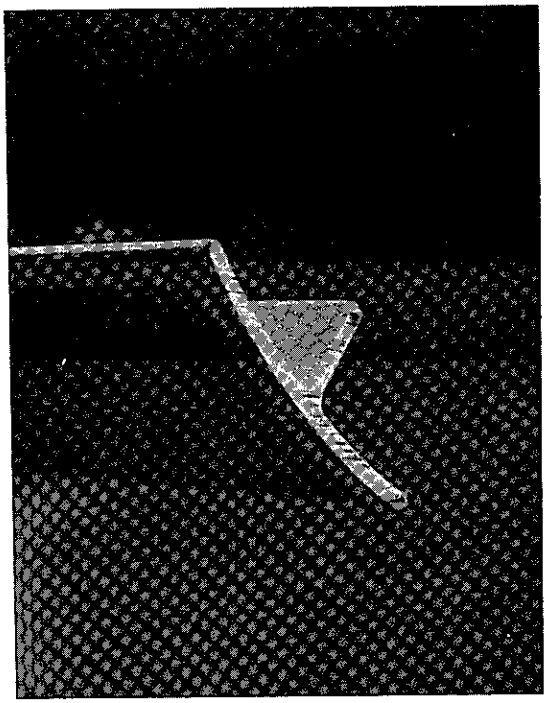
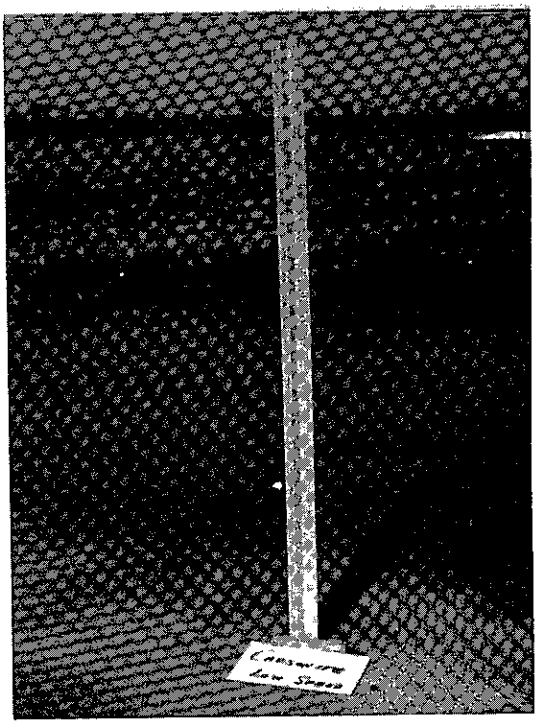
were two designs. The first consisted of a T section with a face width of 2 1/2" and a web width of approximately 3/4". Figure 13 shows the details of this post and Figure 14 shows photos. This model was developed from an earlier model that had a face width of approximately 1". The 1" wide model was never evaluated nor considered a likely candidate for a flexible guide marker.

split from the flange or face as shown in Figure 14. With this separation, the rigidity of the post was lost and its function in the field was questioned, particularly in high winds when both pieces are free to move and flop about. Objectionable as this was, the post could be impacted several times and still return to an upright position. After more than 5 impacts, the top of the guide marker began to fray and develop an objectionable and ragged appearance. It appeared that 5 impacts would be a reasonable limit to expect for this post, as compared to the 10 impacts withstood by the non-driveable flexible posts.

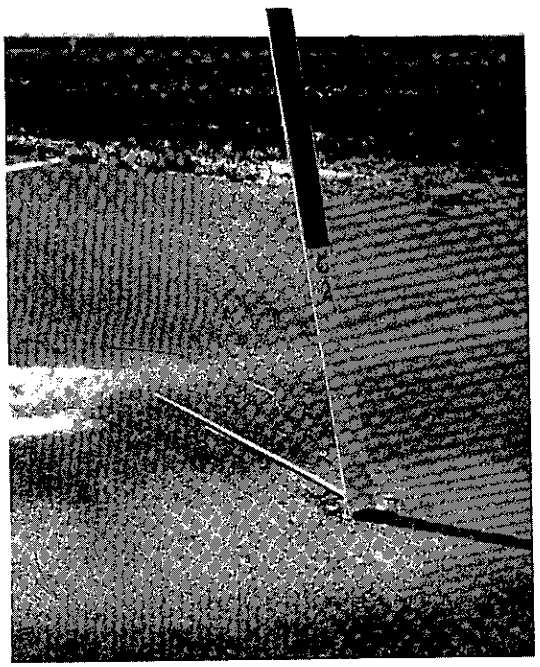
After 5 Impacts

During the entire vehicle impact test series, there was slight if any damage to the vehicle when encountering any of the posts at speeds up to 55 mph. The first Carsonite T-post design (2 1/2" face with 3/4" web) was considered by the manufacturer to be functionable only at slower impact speeds of 20-30 mph. Therefore, the first tests conducted by the Transportation Laboratory on this design were at a speed of 35 mph. When impacted, the spline or web section of the T separated or

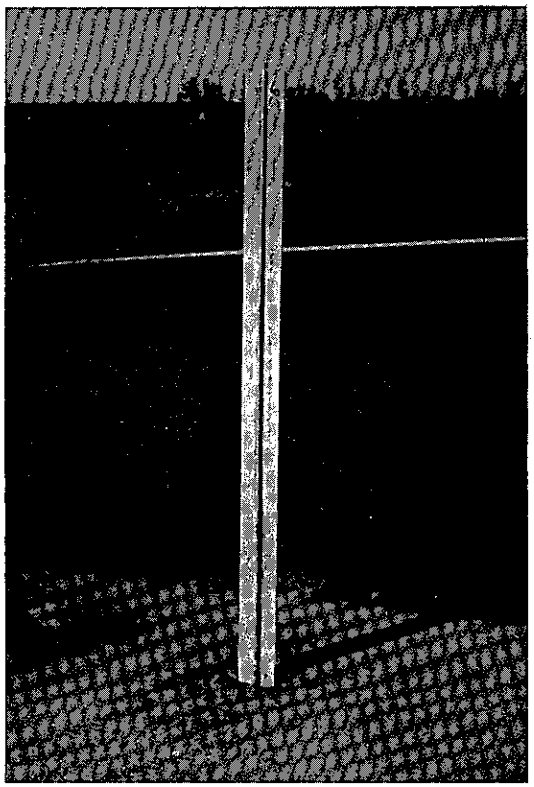
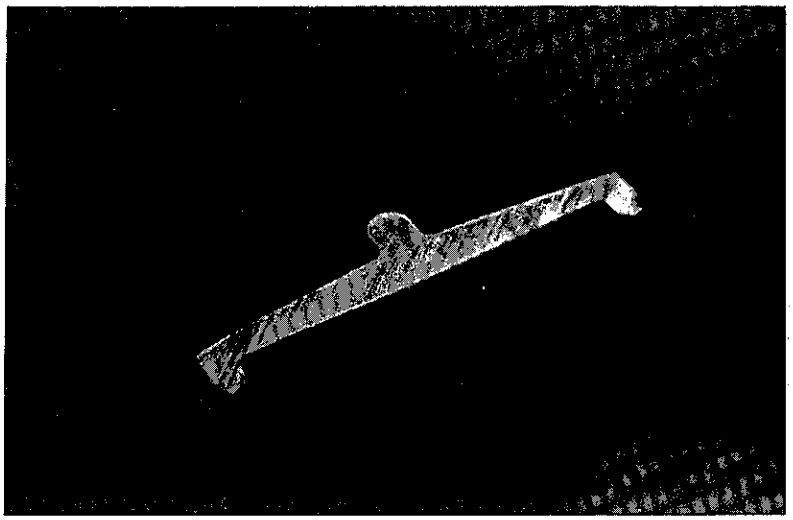
CARSONITE 2 1/2 INCH WIDE RIBBED POST Figure 16

The second design tested in the first series consisted of a flat 2 1/2" wide flexible guide marker with a rib for stiffness and strength along both edges as well as similar raised rib centered on the back of the marker. Figure 15 shows the details and Figure 16 shows photographs of this 2 1/2" wide ribbed post.

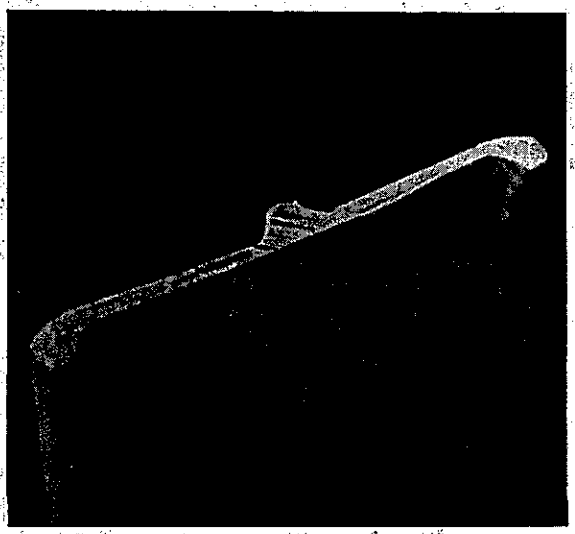
speed of 35 mph without any failures. Then the impact speed was increased to 55 mph which the posts also withstood. As in the tests on the 2 1/2-inch wide ribbed post, the tops of these posts also started to show significant damage after about 5 impacts with the damage progressing perceptibly during the next 5 impacts. The fraying of the post tops after 10 impacts was about the same as noted for the 2 1/2-inch wide post. Delamination also occurred in the region of the plastic hinge.

It is somewhat difficult to understand why the Carsonite post performs so poorly when driven in a prepared foundation hole in AC pavement. However, from the visual observation of the damage, the inadequate performance is possibly caused by the post being firmly confined by the AC surface as if it were installed in a vise. Thus the radius of flexure is so short the post fails by a combination of direct shear and flexure as the plastic hinge action cannot develop.

In summary, this 3 3/4 inch wide Carsonite flexible delineator post was easily driven in the soil at the test location. However, it could not be driven through the paved AC shoulder and underlying crushed rock base layer. The post appeared to be almost indestructible when impacted 10 times head-on at 35 mph. However, it could not withstand 10 head-on impacts at 55 mph, nor at 45 mph, and remain in serviceable condition. This Carsonite post suffered much greater impact damage, particularly in the plastic hinge region, when installed in pavement as compared to soil. This post appears to be able to withstand angle impacts better than head-on impacts from the standpoint of damage in the hinge region. The smaller strips of high intensity grade reflective sheeting appeared to resist impact damage better than the larger strips of engineering grade reflective sheeting. It is also significant to note that after 166 impacts by the test vehicle, the AMC Matador, no significant damage to the vehicle was noted. Ninety percent of these 166 impacts were made at speeds of 55 mph.

From the impact testing performed to date on the Carsonite flexible delineator post, it appears that for the post to reliably withstand 55 mph impacts without failure, a plastic hinge must be developed in the post at ground level. This can be accomplished by bending the post to the ground by a slow speed impact or by hand. Thus the installation instructions should include the requirement for the development of a plastic hinge in the post immediately above ground level.
