CRASH TEST OF CONE TRUCK FOR OPERATOR SAFETY

Federal Research Grant No. F82EQ07

1 REPORT NO FHWA/CAL 86-10	2 GOVERNMENT ACCESSION NO	3 RECIPIENT'S CATALOG NO
4 TITLE AND SUBTITLE Crash Test of Cone Truck for Operator Safety		5 REPORT DATE October 1986
		6 PERFORMING ORGANIZATION CODE
7 AUTHOR(S) Calvin Schiefferly		8 PERFORMING ORGANIZATION REPORT NO 32-609937
9 PERFORMING ORGANIZATION NAME AND ADDRESS California Department of Transportation Division of Equipment Maintenance and Development Sacramento, CA 95816		10 WORK UNIT NO
		11 CONTRACT OR GRANT NO F82EQ07
12 SPONSORING AGENCY NAME AND ADDRESS California Department of Tranportation Sacramento, CA 95807		13 TYPE OF REPORT & PERIOD COVERED Final Report
		14 SPONSORING AGENCY CODE

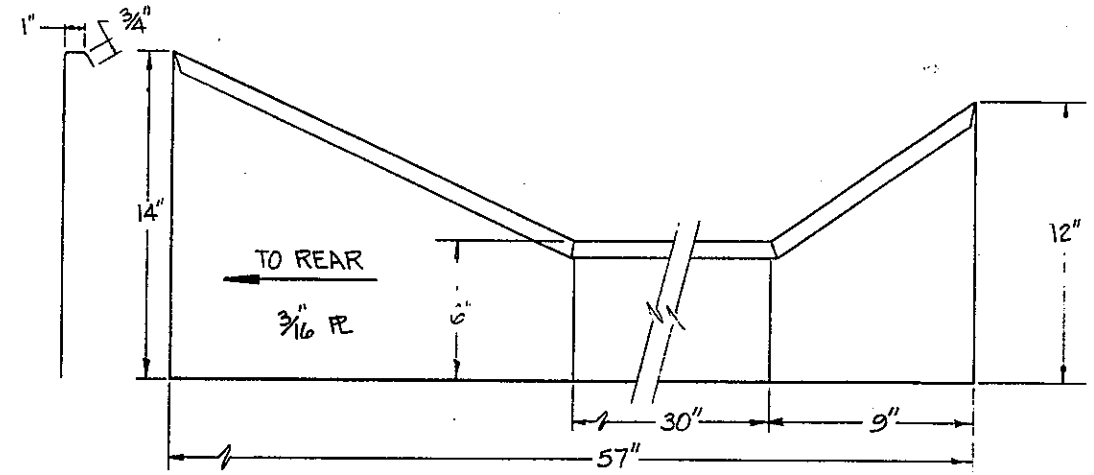
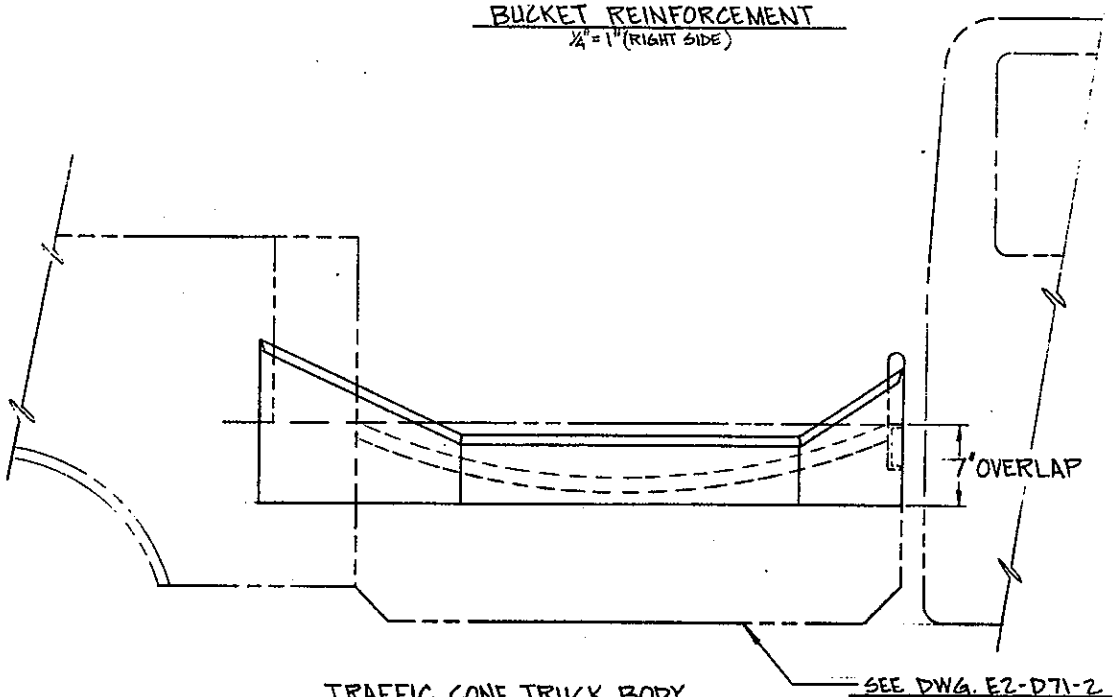
Figure 1

BUCKET SIDE REINFORCEMENT FOR TRAFFIC CONE TRUCK BODY

2. The attachment used in test 423 and 424 should be installed on a limited number of cone trucks for field evaluation. Attachment could result in hampering cone setting/retrieving process, entrance into body, etc.

3. If attachment hampers operation of cone truck, an alternate solution should be devised and field tested. If attachment does not hamper operation, all cone trucks should be retrofitted.

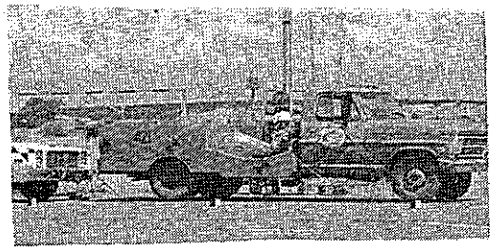
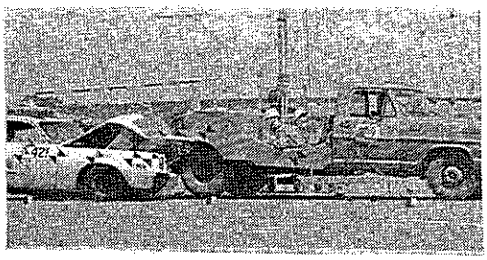
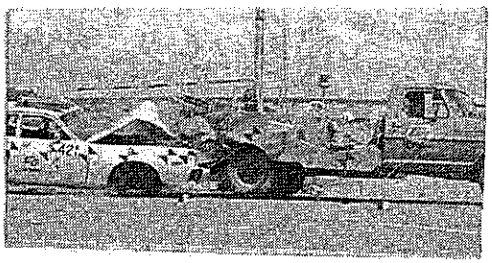
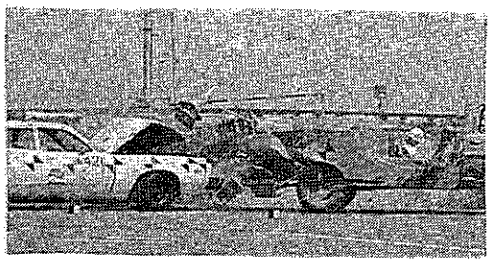
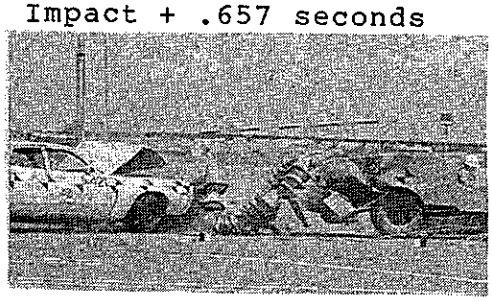
The rear sheet metal of the cone truck was severely crushed while leaving the operator's compartment damage free. Sam (dummy) was tossed about loosing his hardhat but remaining belted in his position. The cone truck was driveable after the test.

The car was severely damaged and undriveable.

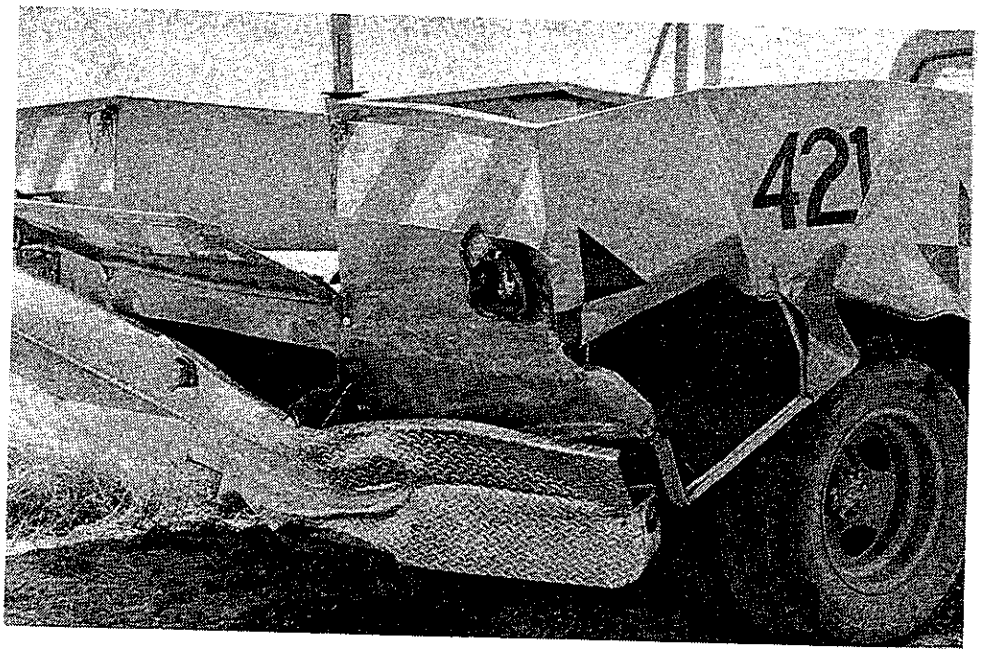
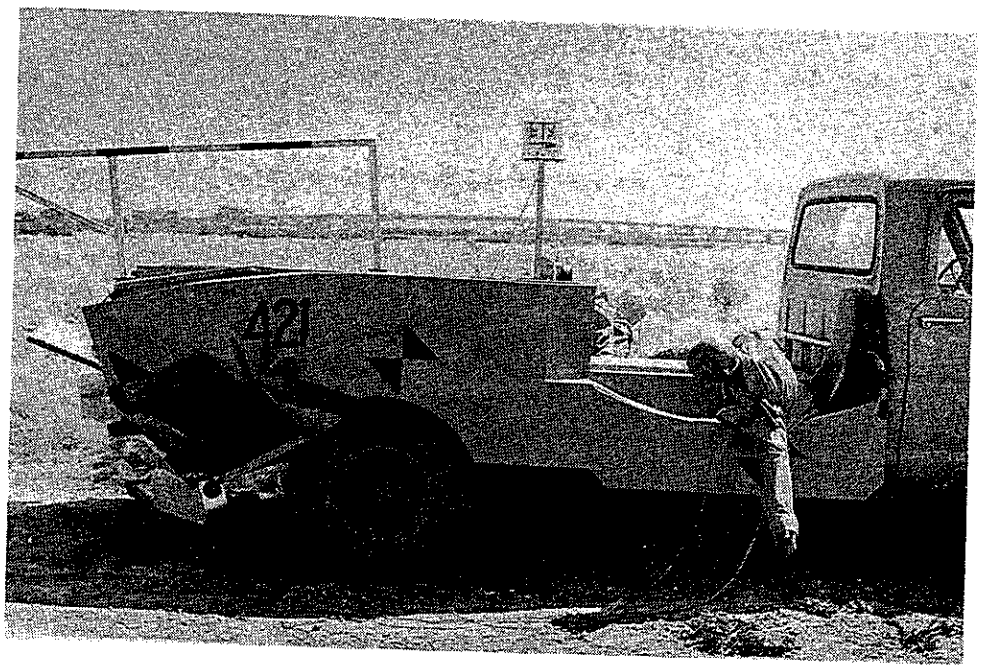
FIGURE 421-4

Although all four tests were severe, angle of impact and speed, there was no structural damage to the cone setter compartment of the cone truck. In test #421 (rear impact), the cone body sheet metal behind the rear axle absorbed the impact leaving the front half of the cone body damage free.

TEST VEHICLE
AFTER IMPACT

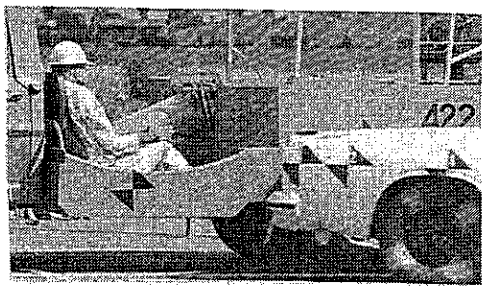
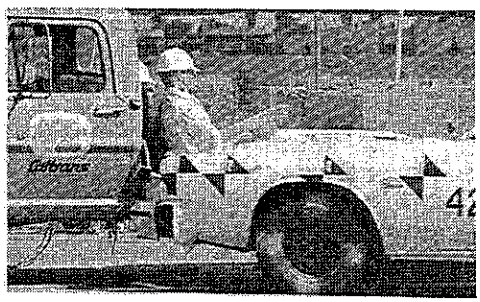
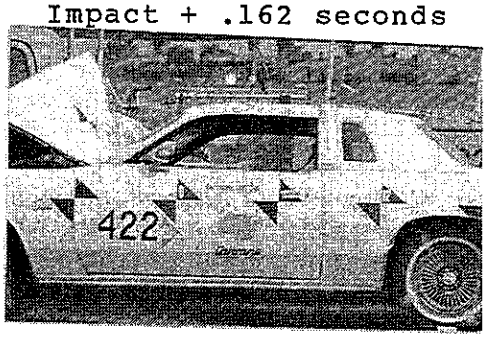
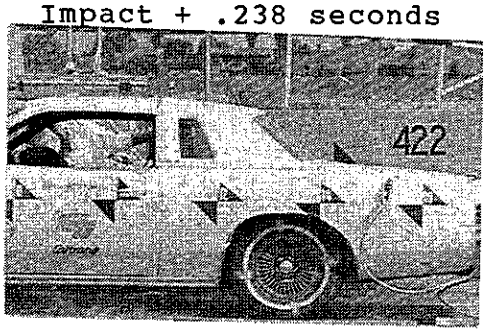
In test 422 (first 25° angle test), the front corner of the impacting car's hood rode over the rail of the cone setter compartment. This allowed the corner of the hood to penetrate and damage the dummy that was in the cone setters position. In the following two tests (423 and 424), an attachment (see Figure 1) was fabricated and installed as shown. Neither in test 423 nor 424 was it possible to repeat the circumstances that resulted in the hood penetrating the cone setter compartment of test 422. At re-evaluating test 422, it was concluded that impacting the cone truck at an angle produced an opening for penetration at 30 inches above ground level. Also as the impacting angle increases, the more likely the impacting vehicle's bumper system will prevent the hood from reaching into the compartment.

The operator's compartment was left undamaged, only scratched paint remained. The right front corner of the car's hood penetrated the operator's position and severely damaged the right arm and knee of Sam. Sam remained belted in the operator's position. The cone truck was driveable after the test.

The car was severely damaged and undriveable.

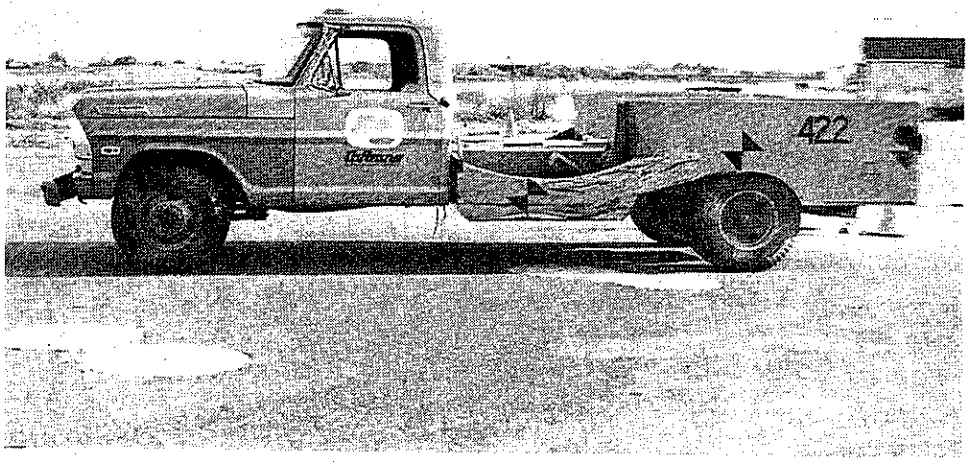
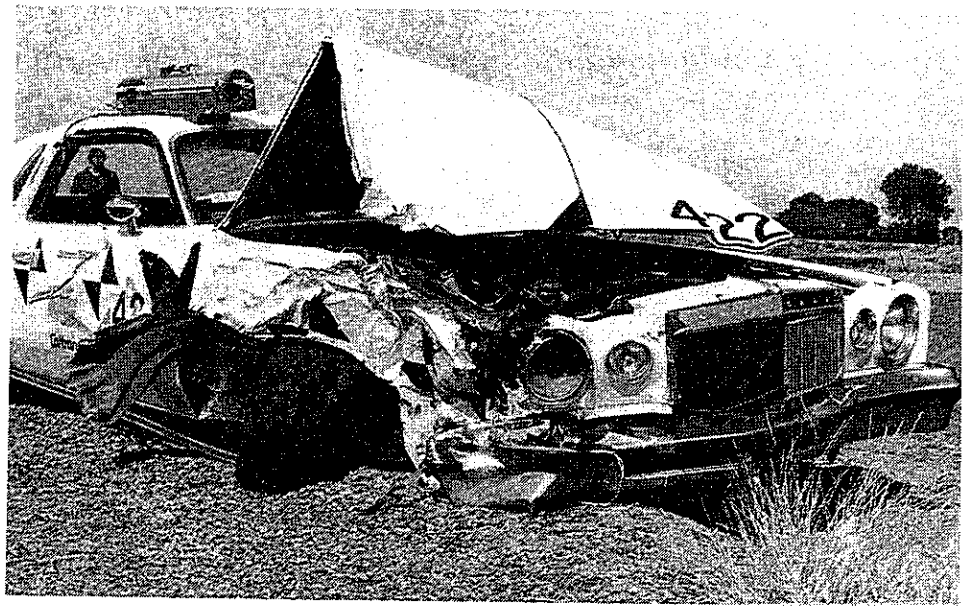
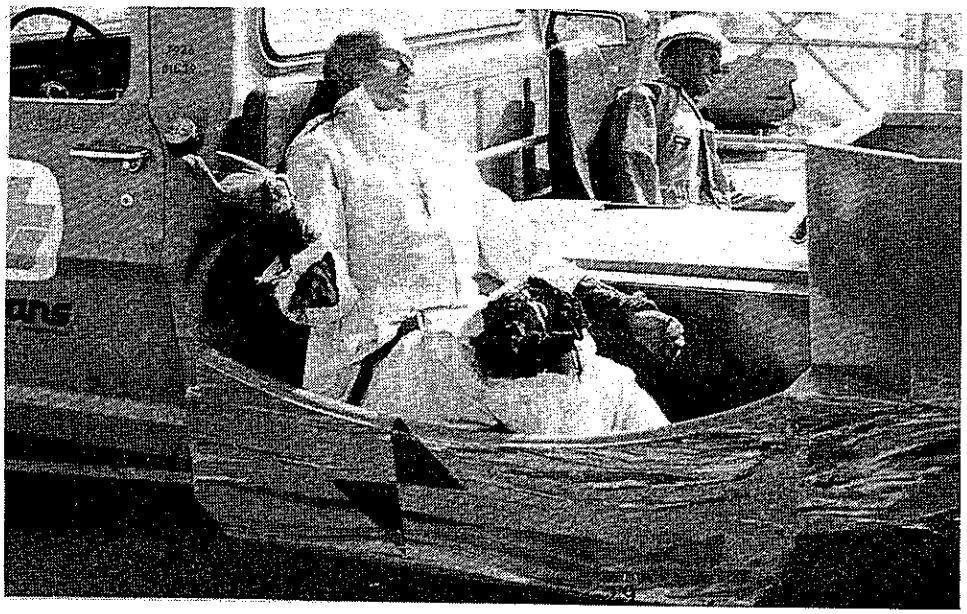
FIGURE 422-3

TEST VEHICLES
AFTER IMPACT

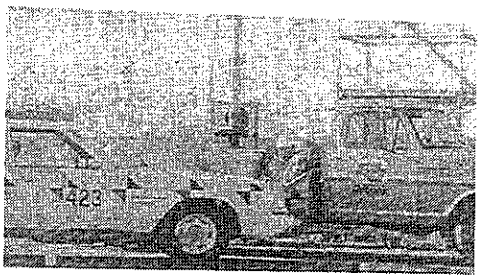
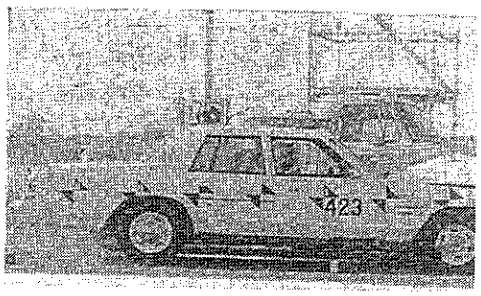
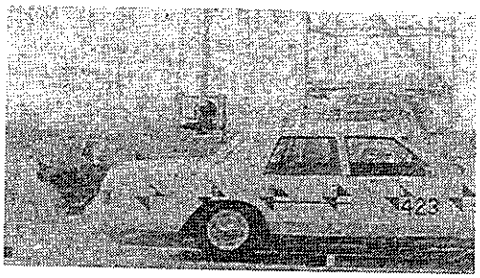
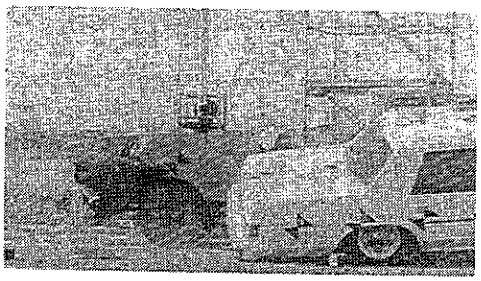
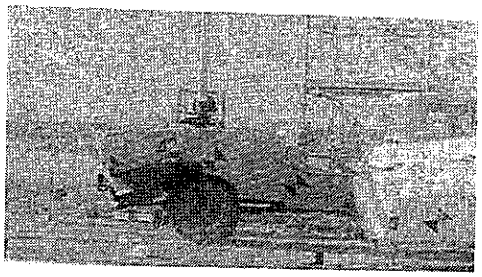
The operator's compartment was left undamaged, only scratched paint remained. Sam was tossed about but remained belted in the operator's position and was not damaged. The attachment appeared to reduce the possibility of the hood penetrating the operator's compartment. The right side of the cone truck cab and right front axle were damaged. The truck was not driveable.

The front left side of the car was severely damaged and undriveable.

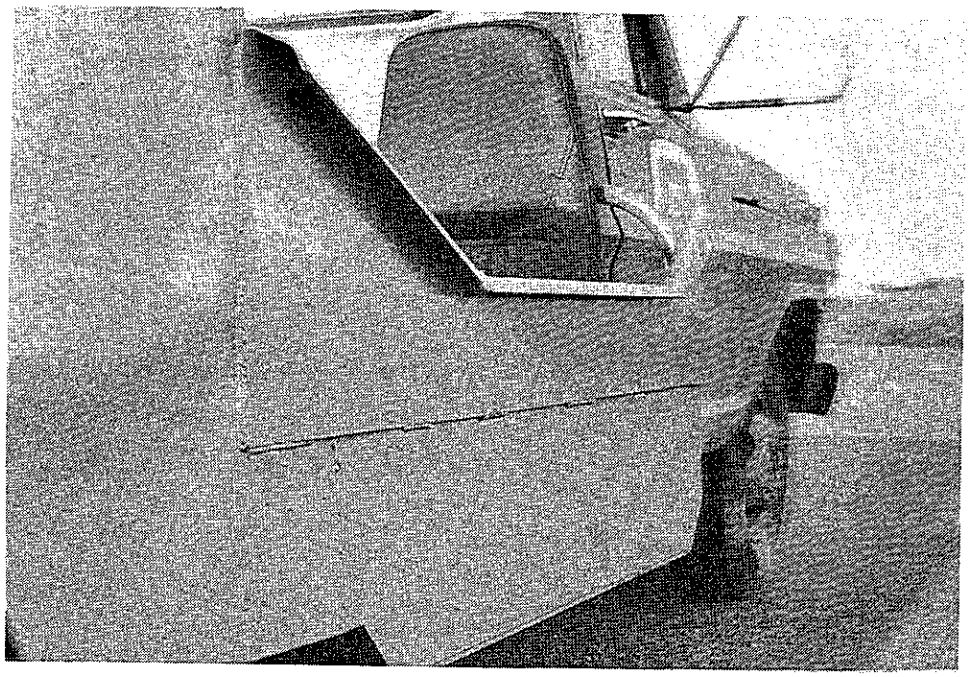
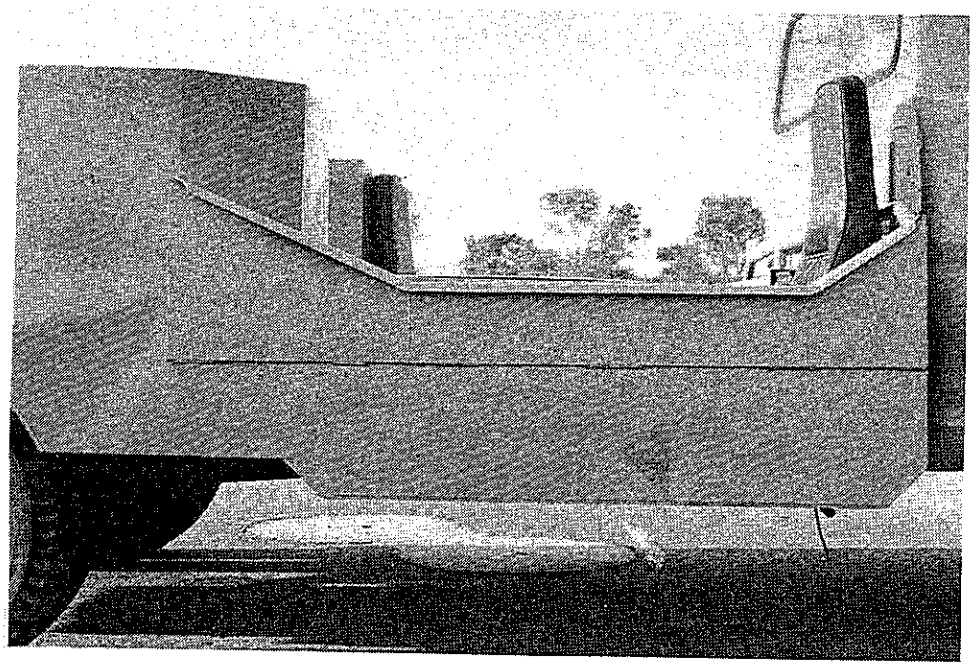
FIGURE 423-2

Test 423 was an angle impact of the cone truck body. This test was conducted to determine if an attachment to increase the height of the operator's compartment would prevent Sam from being damaged, as in Test 422.

ATTACHMENT ADDED
AFTER TEST 422

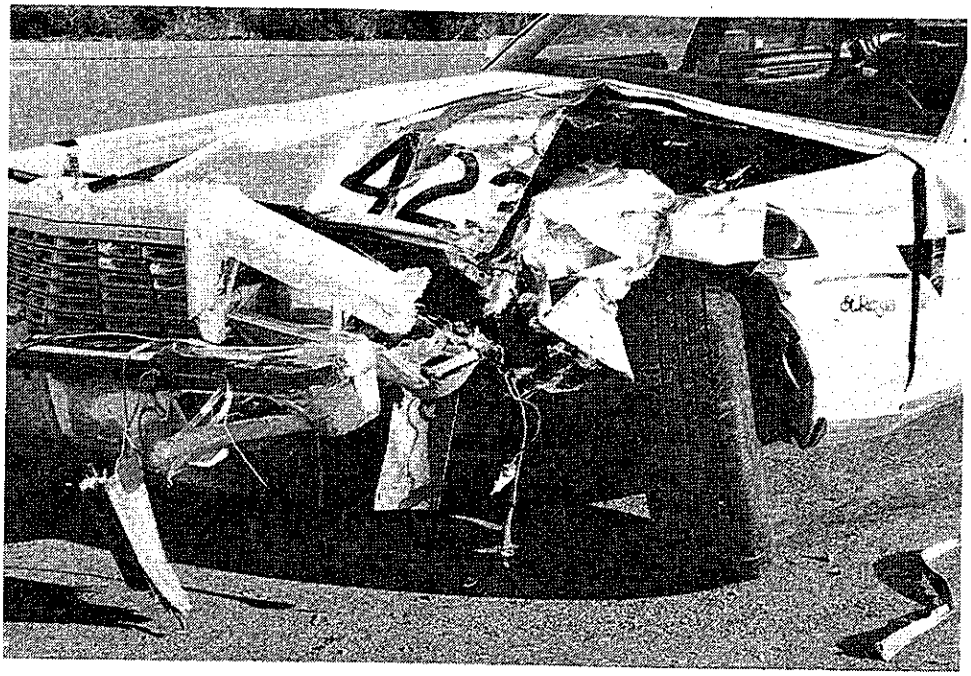
FIGURE 423-4

TEST VEHICLES
AFTER IMPACT

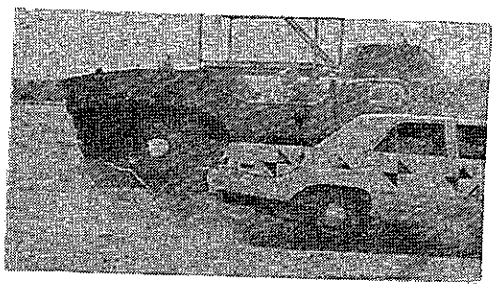
Impact + .535 seconds

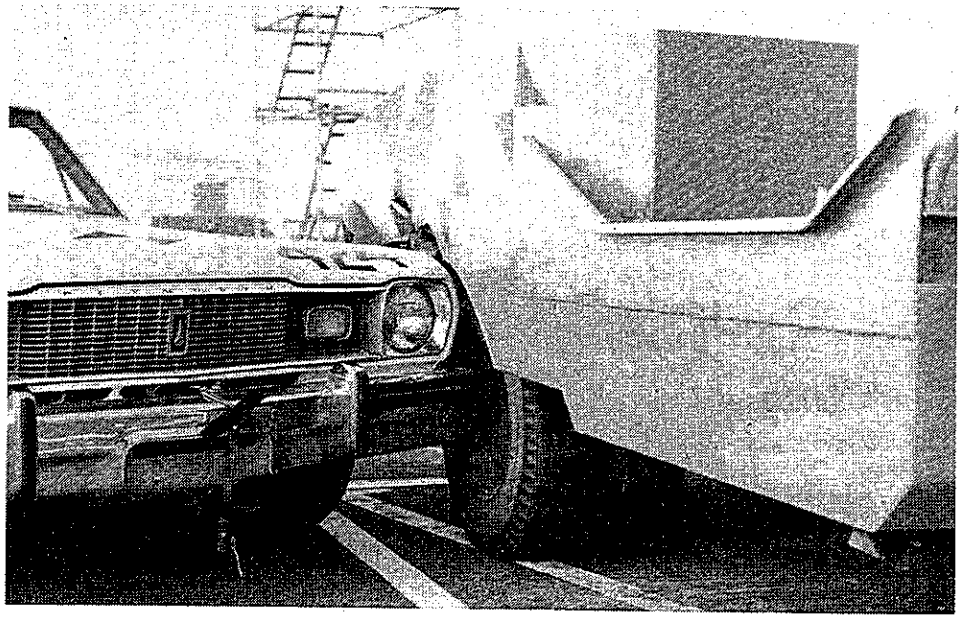
TEST 424

TEST VEHICLE
BEFORE IMPACT

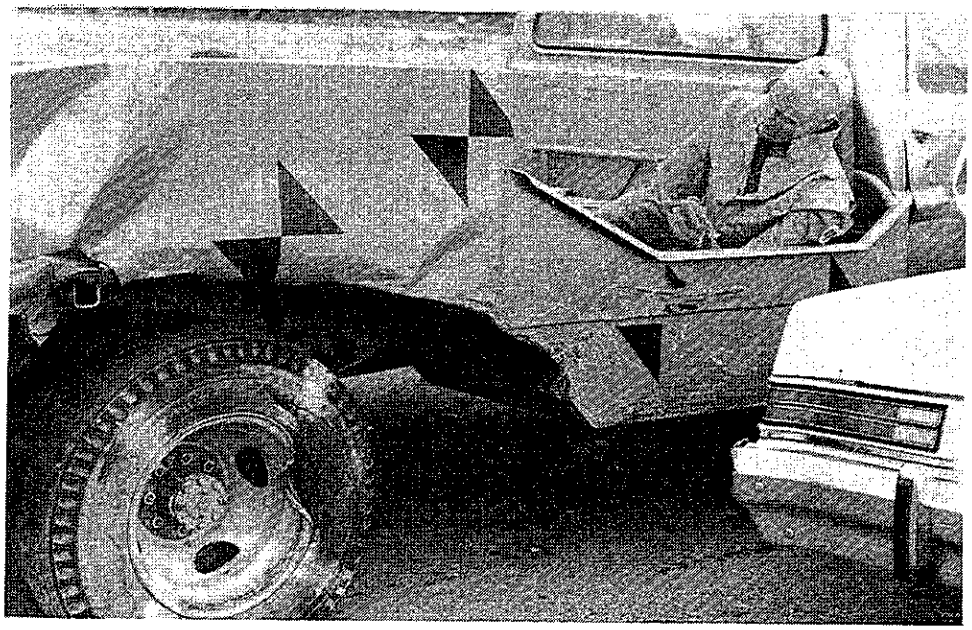
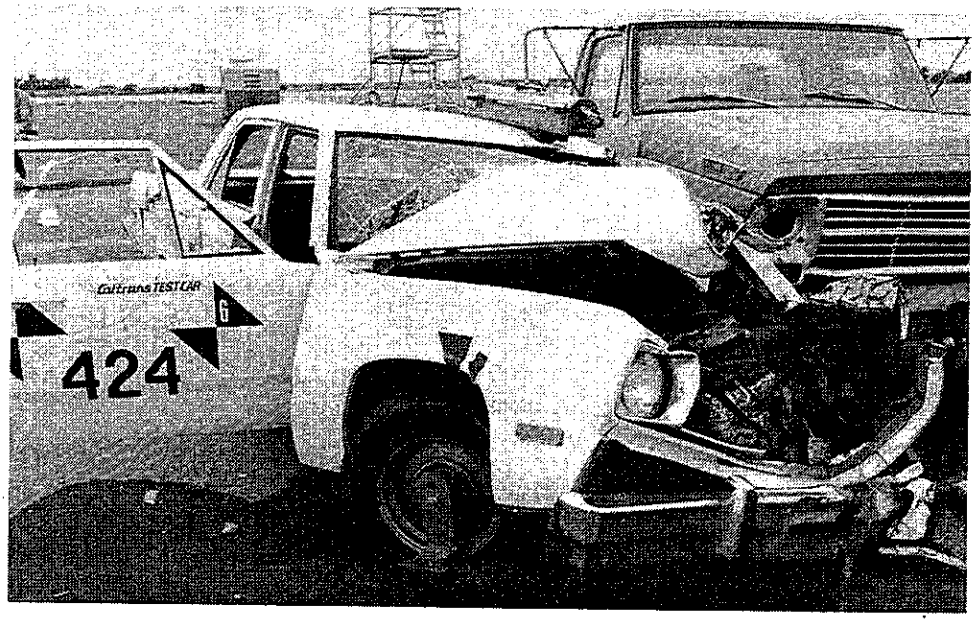
FIGURE 424-3

TEST VEHICLES
AFTER IMPACT

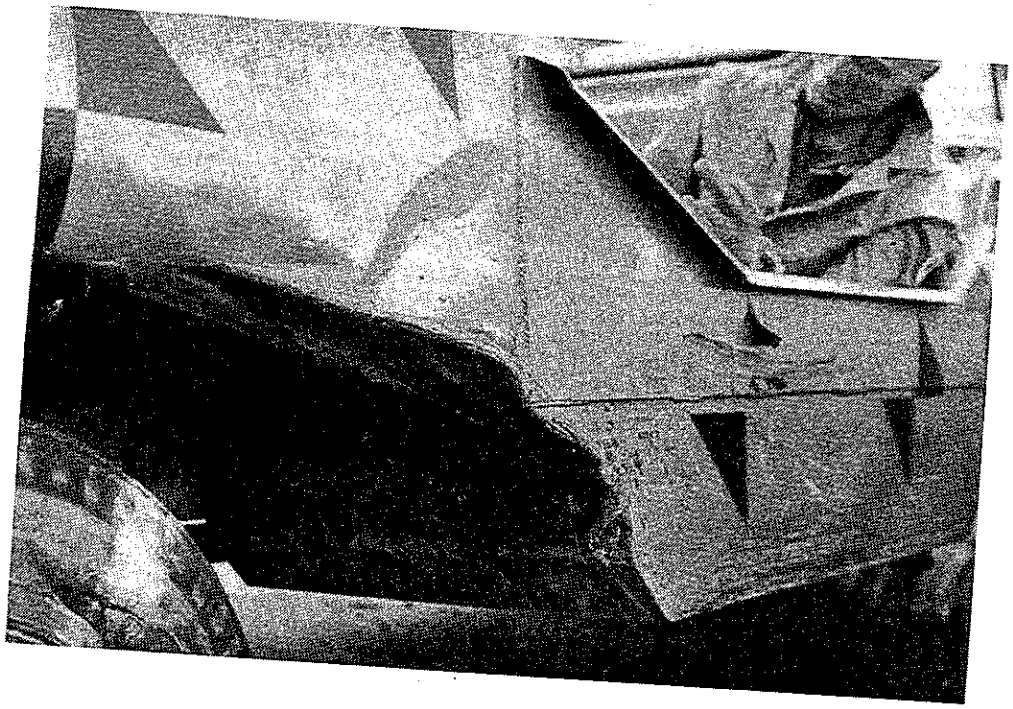
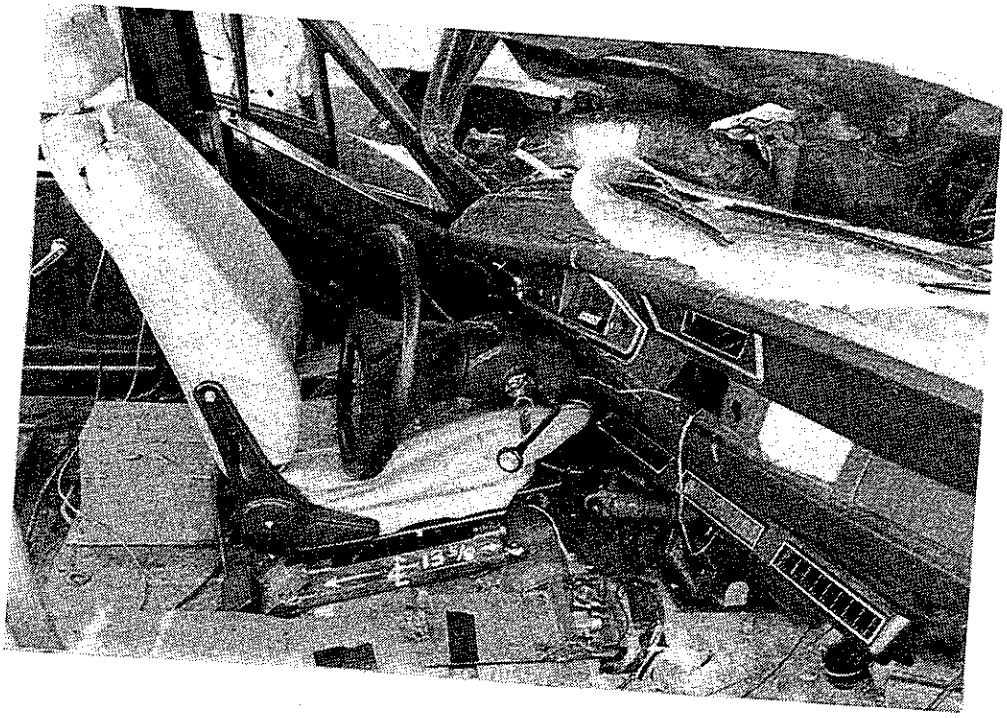
FIGURE 424-4

TEST VEHICLES
AFTER IMPACT
