SLOTTED CORRUGATED METAL PIPE DRAINS

71-04

RESEARCH REPORT

NO. M & R 636453

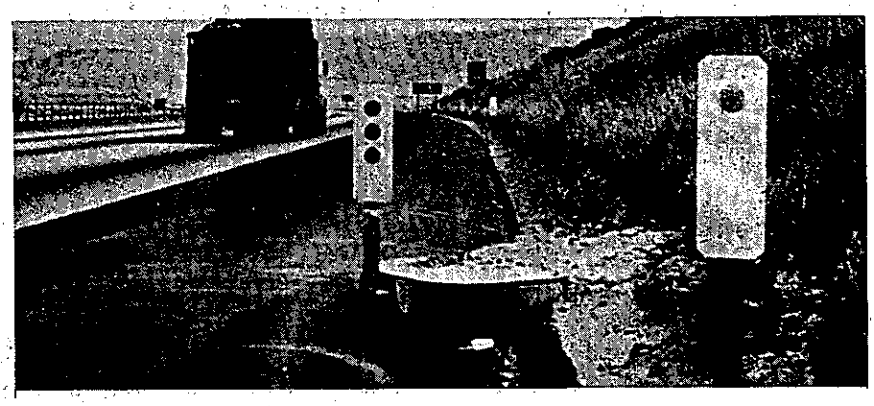
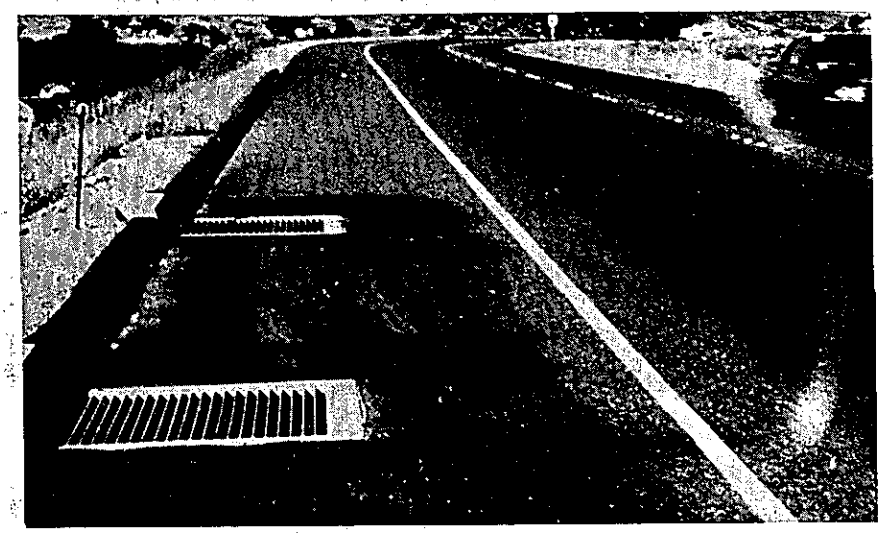
FIGURE 1

EXISTING DRAINAGE INLETS

Slotted drain pipe would improve the system.

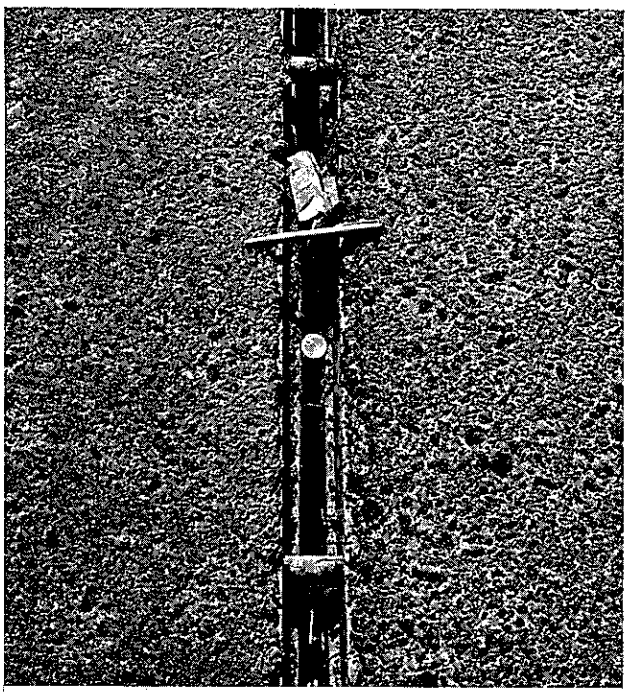
FIGURE 2

The most significant observations regarding design-fabrication-construction procedures were of an installation near Post Mile 13.5 on Route 60 in Los Angeles. This angle slot type slotted drain (similar to that shown in Drawing No. 1 of the Appendix) sustained approximately 15,000 vehicle loadings during a landslide repair detour operation. Few, if any, of these vehicles were trucks, however. Traffic related distress was not observed but an undesirable feature was found to exist at intermittent locations throughout the project. Slippage occurred between the angle and the flashing as shown in Figures 2 and 3. The slot width reduced to approximately 1 inch at several locations and

PIPE CLOSURE ON ANGLE SLOT TYPE SLOTTED DRAIN

in some places a quarter could be rested on the resulting ledge. This narrow opening reduces efficiency and establishes an undesirable hydraulic loss at the inlet. Also, the resulting shelf catches rocks and debris which will eventually clog the drain if not maintained periodically. To prevent this pipe slot closure, a recent design revision relocates the structural tubing spacer 3/8 inch lower so that it will restrain the pipe and flashing. This revised detail is shown in Figure 3 and in Drawing No. 2 of the Appendix (SD98-5 dated April 21, 1971).

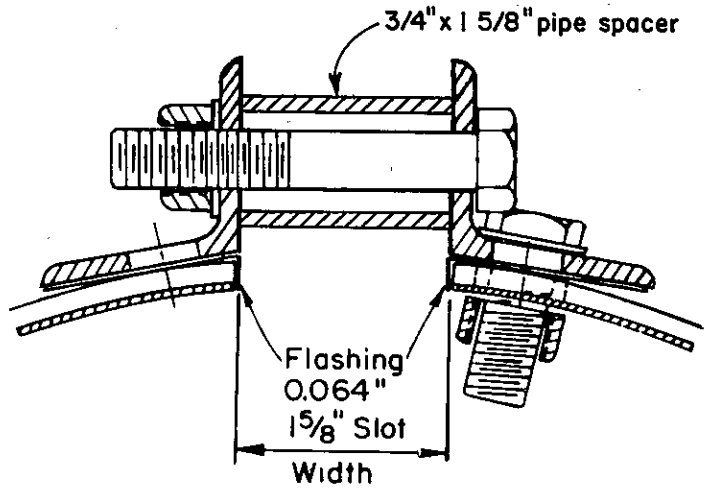
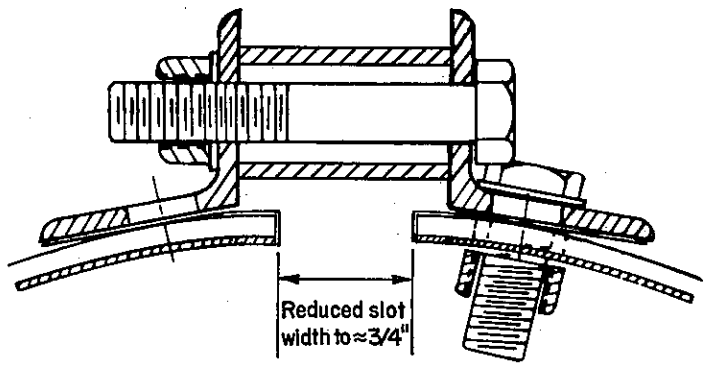
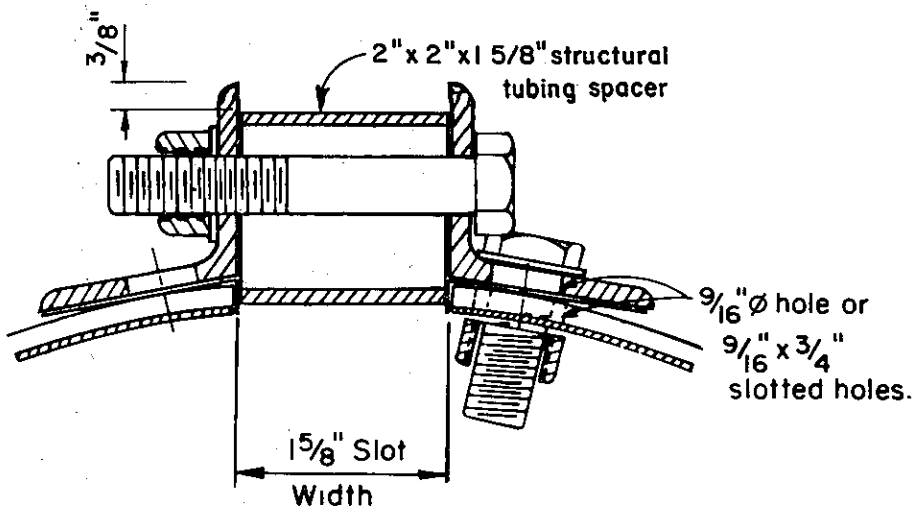
Figure 3

OBSERVED DISTORTION

REVISED DESIGN

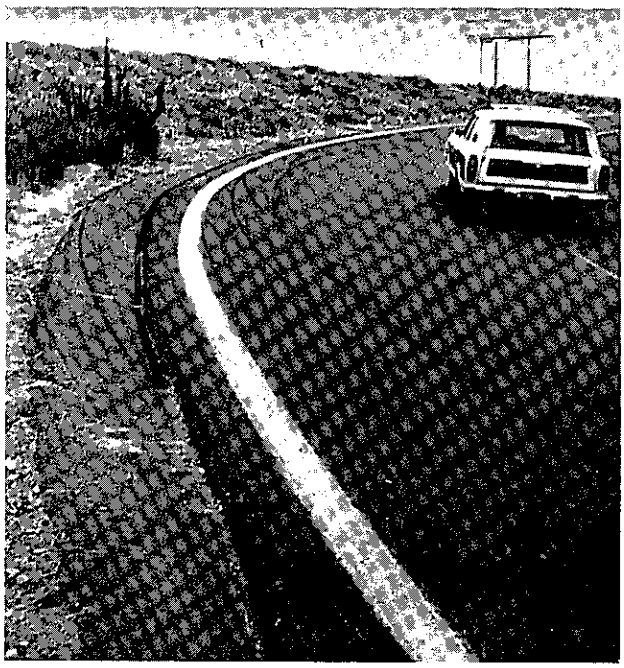
FIGURE 4

A very practical slotted drain pipe installation that intercepts runoff to an interchange ramp is shown in Figure 4. The AC surfacing adjacent to the drain inlet was observed to have several tire marks indicating that vehicles had crossed without any apparent distress to the pipe or the surfacing. It appears that most of these marks were made by passenger vehicles.

DRAIN INSTALLATION ON AN INTERCHANGE RAMP

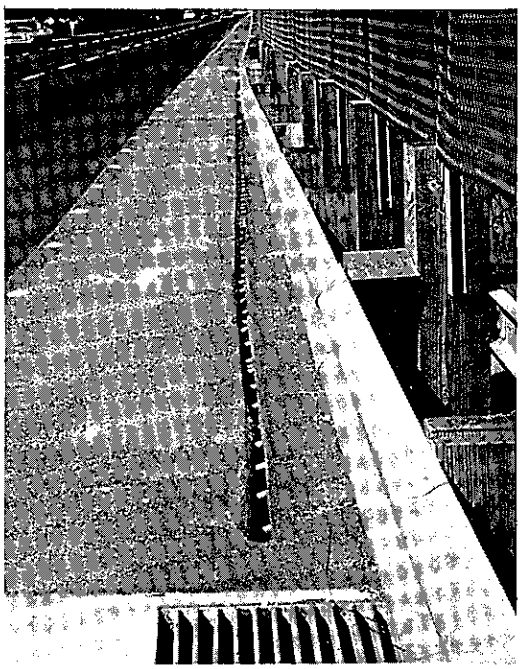
FIGURE 5

Figure 5 partially exhibits the twisting that occurred with an installation of slotted drain pipe utilizing the earlier flange slot type design. This design has been deleted from the Standard Plans because of the construction problems in maintaining alignment and for reasons of economy.

FLANGE SLOT TYPE SLOTTED DRAIN DESIGN
