STATE OF CALIFORNIA
DEPARTMENT OF PUBLIC WORKS
DIVISION OF HIGHWAYS

A REPORT ON FIELD EXPOSURE TESTS OF FIVE TYPES OF REFLECTIVE SHEETING MATERIAL

February 28, 1958

MATERIALS & RESEARCH DEPARTMENT

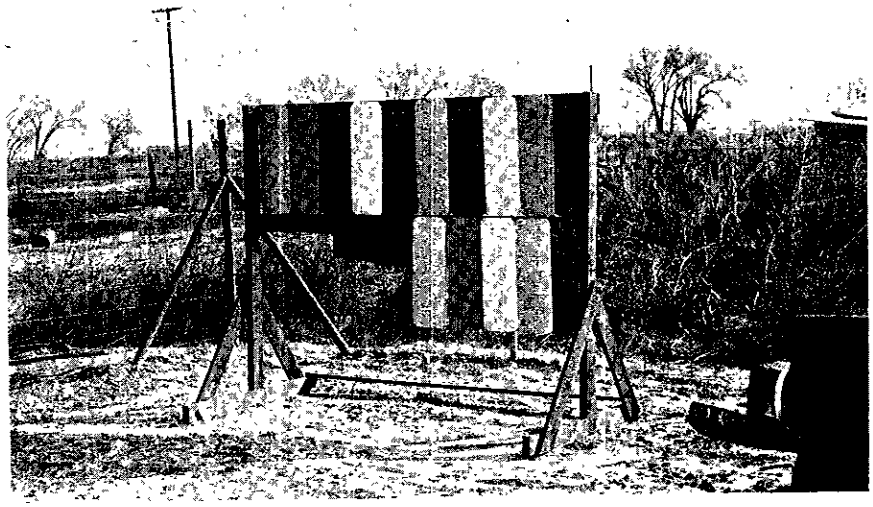
Figure 1 - Exposure Rack, District VI, Valley Area

The maintenance yard test site is located in the southern corner of the Lemoore Maintenance Yard in the town of Lemoore, 34 miles south of Fresno on State Sign Route 41. The test rack faces north and south. This installation (see Figure 1) was completed on June 13, 1955.

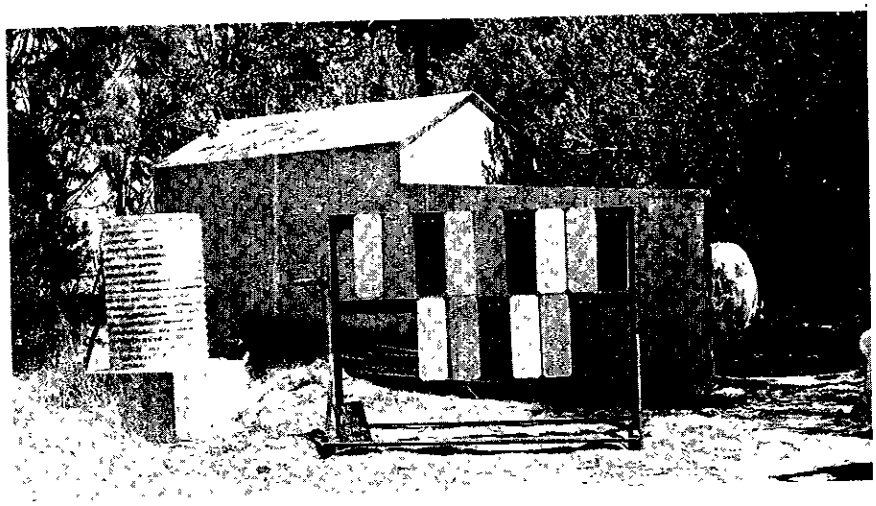
Figure 2 - Exposure Rack, District VIII, Desert Area

The maintenance yard test site is located in the northeast corner of the Palm Springs Maintenance Yard, five miles north of the city of Palm Springs on State Sign Route 111 (see Figure 2). The exposure rack, which faces north and south, was installed on June 16, 1955.

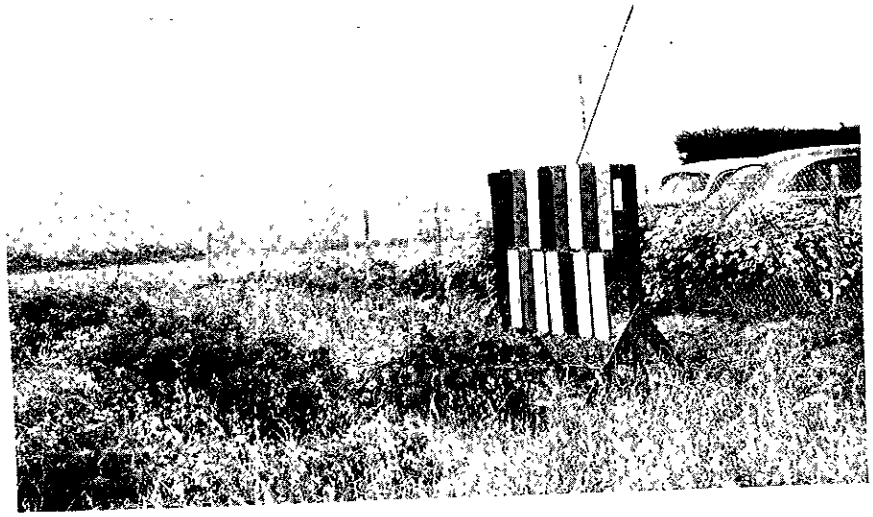
Figure 3 - Exposure Rack, District V, Coastal Area

The maintenance yard test site is situated in District V in the Cambria Maintenance Yard, one mile north of the city of Cambria on State Sign Route 1. The exposure rack (see Figure 3), 100 feet east of the highway and 300 feet from the ocean edge, was installed on June 21, 1955.

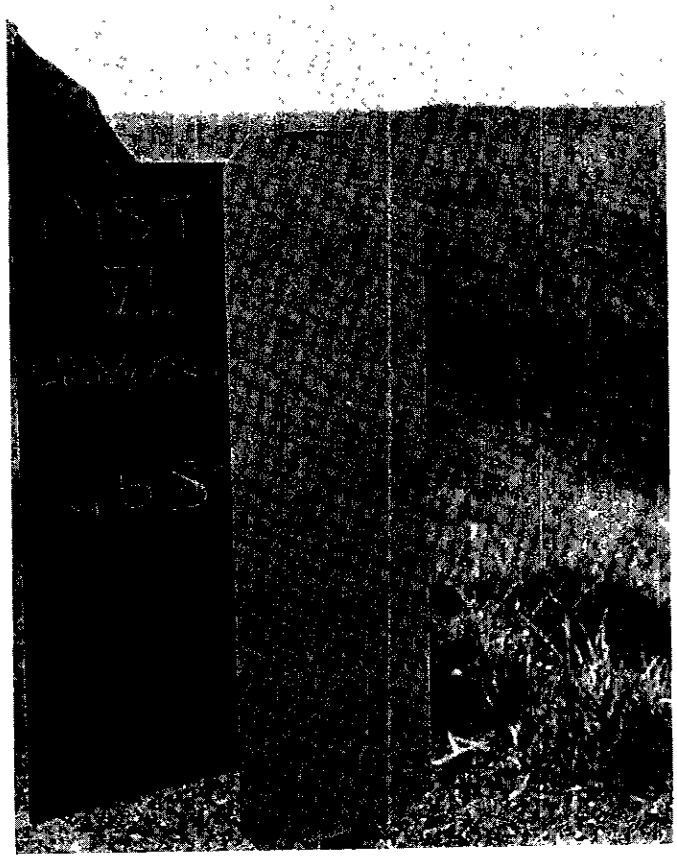
Fig. 4 Grote Silver Undamaged - Peeling on top edge after 8 months exposure.

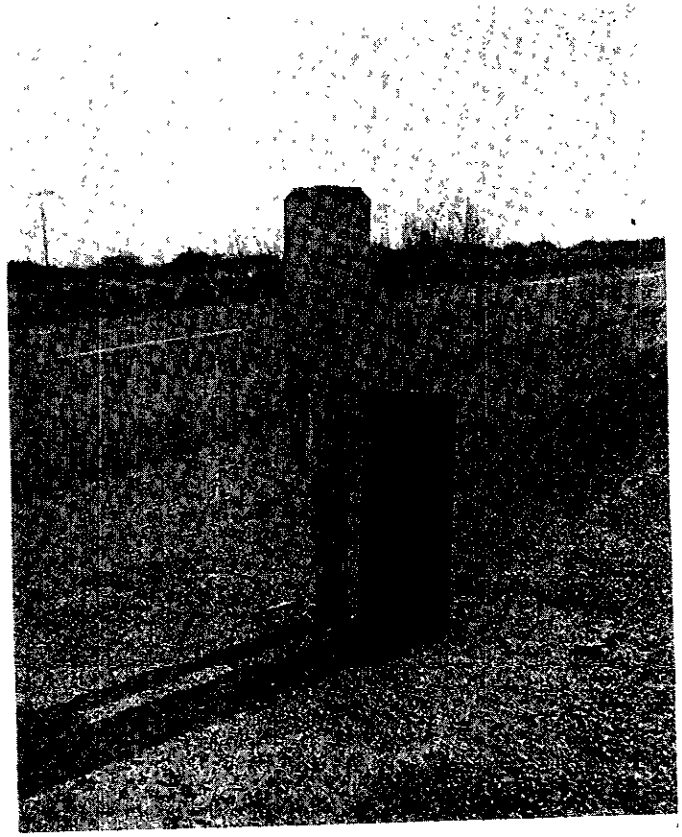
Fig. 5 Grote Silver, Damaged - Peeling on top edge after 8 months exposure.

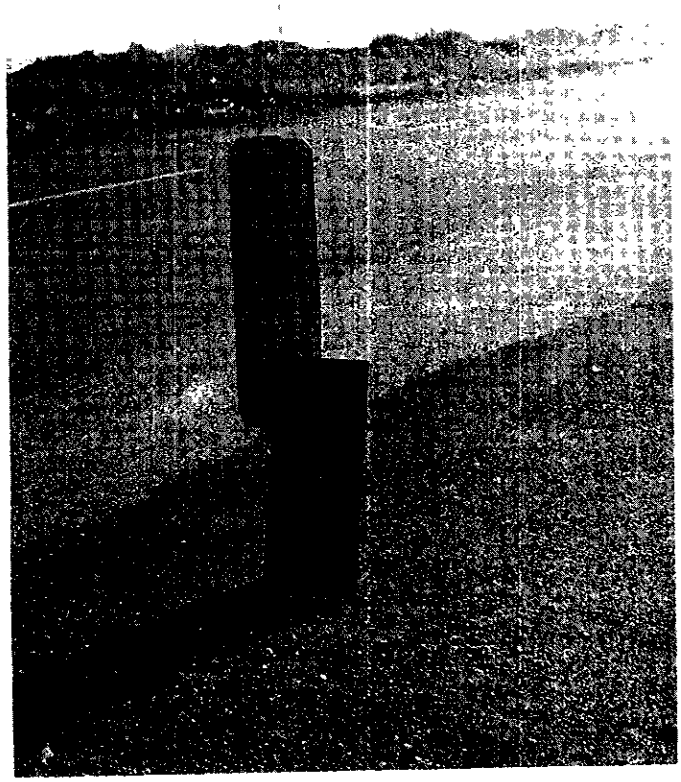
Inspection after nine months revealed that the panels at the valley roadway test site had been carved upon by vandals (see Figure 6); however, no peeling or further damage had resulted from this carving. The panels in the desert test site located on Palm Springs Highway 187-D were in good condition. They had not been subjected to the severe sandblasting prevalent in other desert areas. Signal Silver and red panels in the Coastal area had faded slightly.

Fig. 6 Example of Vandalism.

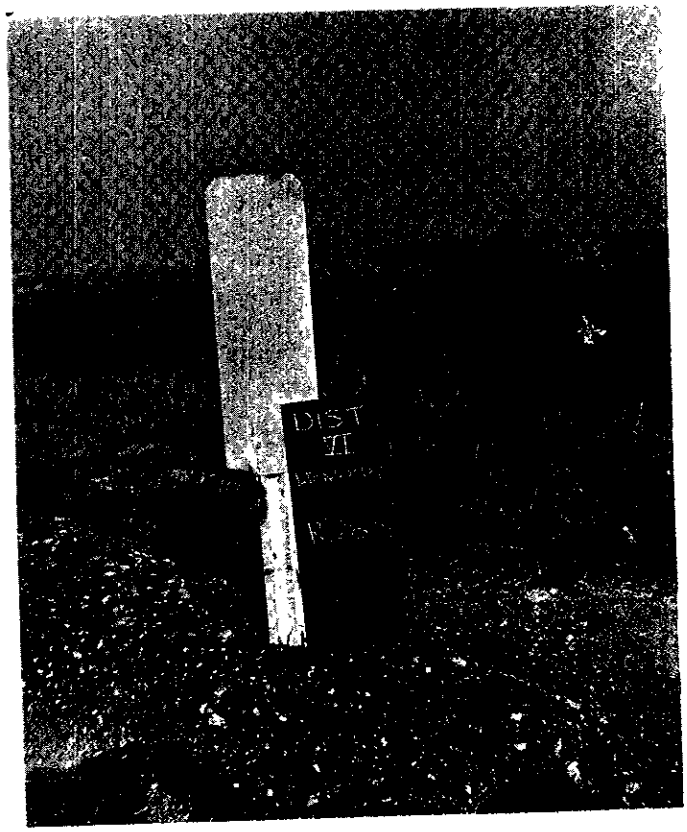
Reflexite panels in all areas were very brittle. They shattered easily when struck and were impossible to repair (See Figure 7).

Fig. 7 Reflexite Shattered from vehicle impact.

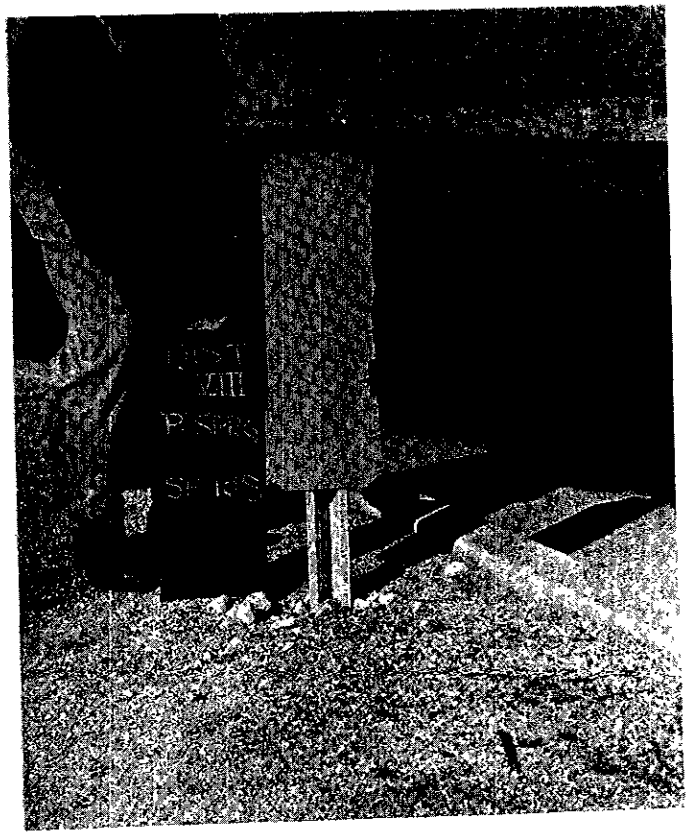
After nine months the south exposed panels at the desert test area were peeling along the edge (see Figure 9). The exterior layer of beading was peeling off the aluminum foil backing of the reflective sheeting. Panels in the coastal and valley test areas had weathered satisfactorily.

Fig. 9 Scotchlite Flat Top - Peeling along edge.

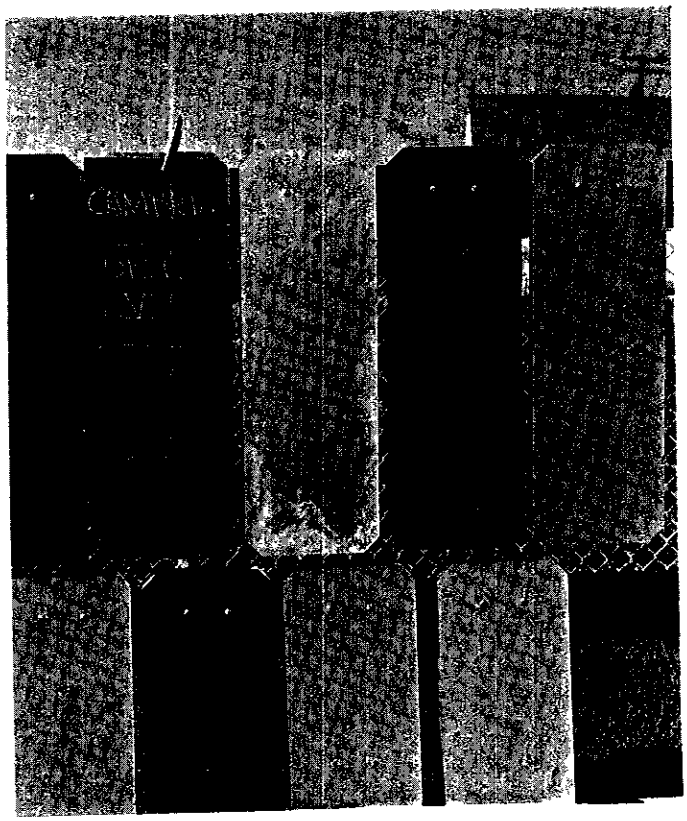
After nine months this reflective sheeting gave definite indications of failure due to exposure in all three locations. The panels had cracked and peeled between the plastic reflective surface and the aluminum foil backing. The exterior coating on the valley test area panels, particularly those in north exposures, had cracked and peeled (see Figure 4). The panels in the desert area had peeled and cracked slightly around the edges and along the bottom, apparently because of moisture. The reflective sheeting in the coastal maintenance yard had peeled off the aluminum base plate (see Figure 10).

Fig. 10 Grote Silver - Peeling severely.

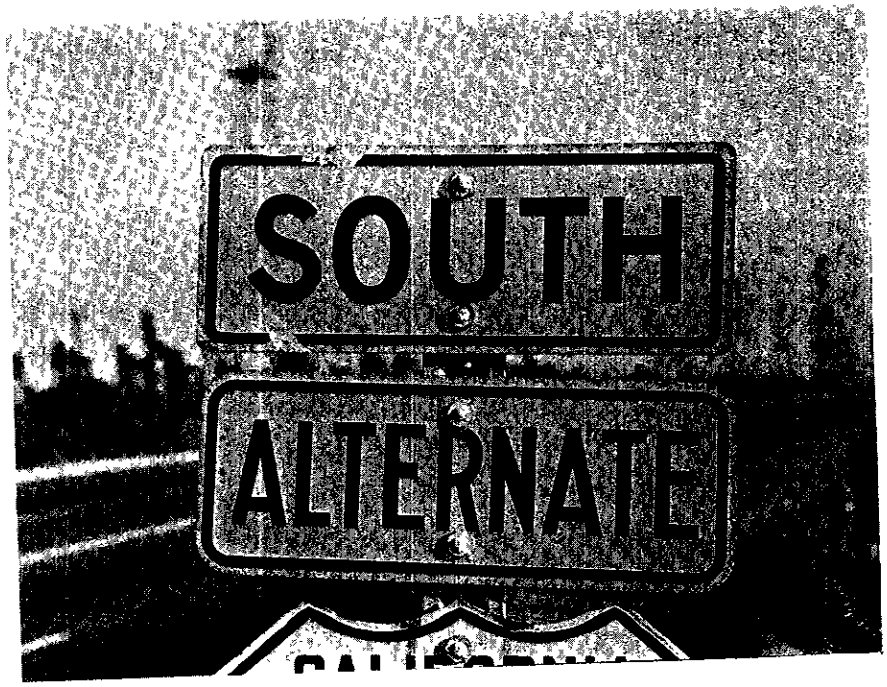
After nine months' exposure, the panels in the coastal maintenance yard had started peeling. Figure 12 indicates edge peeling which occurs on reflective sheeting in this area. Light corrosion was evident on the aluminum base plate. Panels had peeled and blistered more in the coastal area than in the other areas. The cause was primarily oxidation of the aluminum base plate under the sheeting rather than a deficiency in the reflective sheeting.

Fig. 12 Example of edge peeling of reflective sheeting.

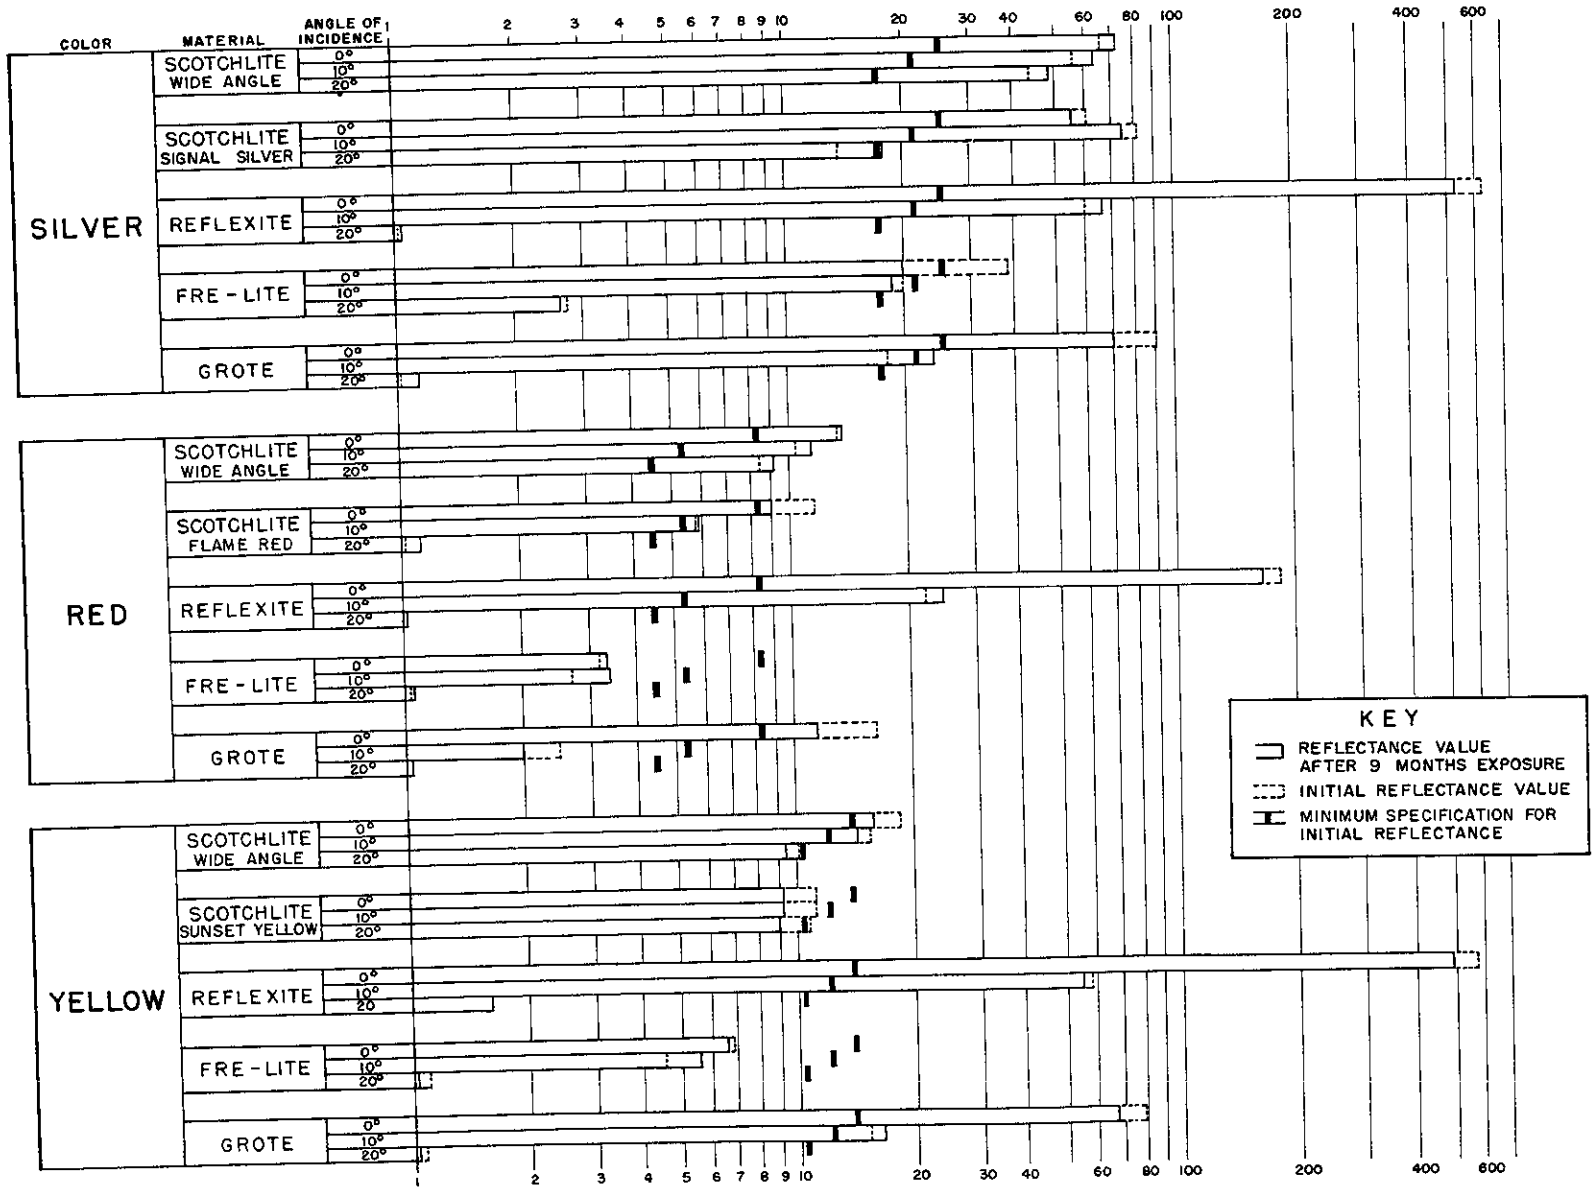
FIG. 14

Type R panels, though showing the greatest loss of reflectance, exhibited high initial and final reflectance values at angles of 0° and 10°. Reflectance values of Type R panels at angles of 20° were extremely low, at both initial and final measurements. Newly installed Type R panels were objectionably bright when viewed from a vehicle with headlights on high beams.

Type SF panels in the red color show an increase in reflectance value, indicating that some color change had occurred due to the physical characteristic of the matrix of the sheeting which increased the reflectance values of the red panels. Type SF silver white and yellow panels show a loss in reflectance.

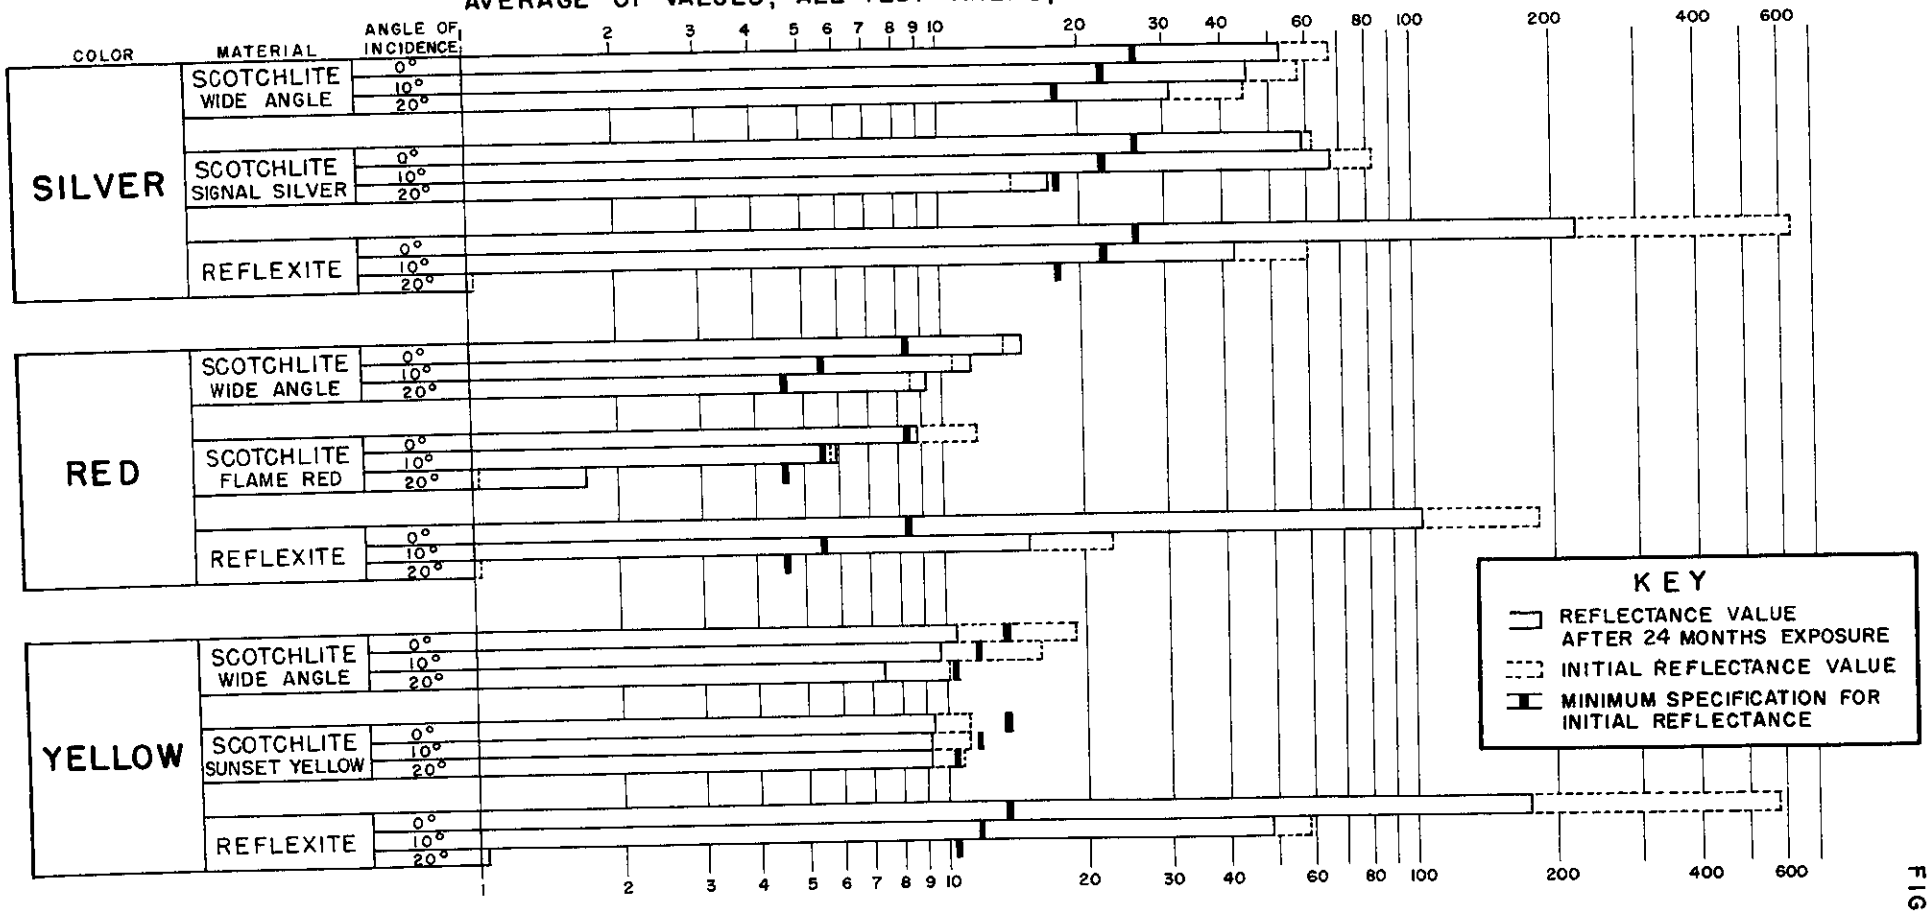
FIG. 15

Type SS signal silver panels show a loss in reflectance in all locations except the valley and coastal maintenance yard test sites. The wide angle characteristics of Type SS panels are retained after prolonged exposure, as shown in Figures 13 and 15.
