SLIDE INVESTIGATION AT EMERALD BAY

ROAD III-ED-38-B

STATION 243± TO 250±

December 17, 1957

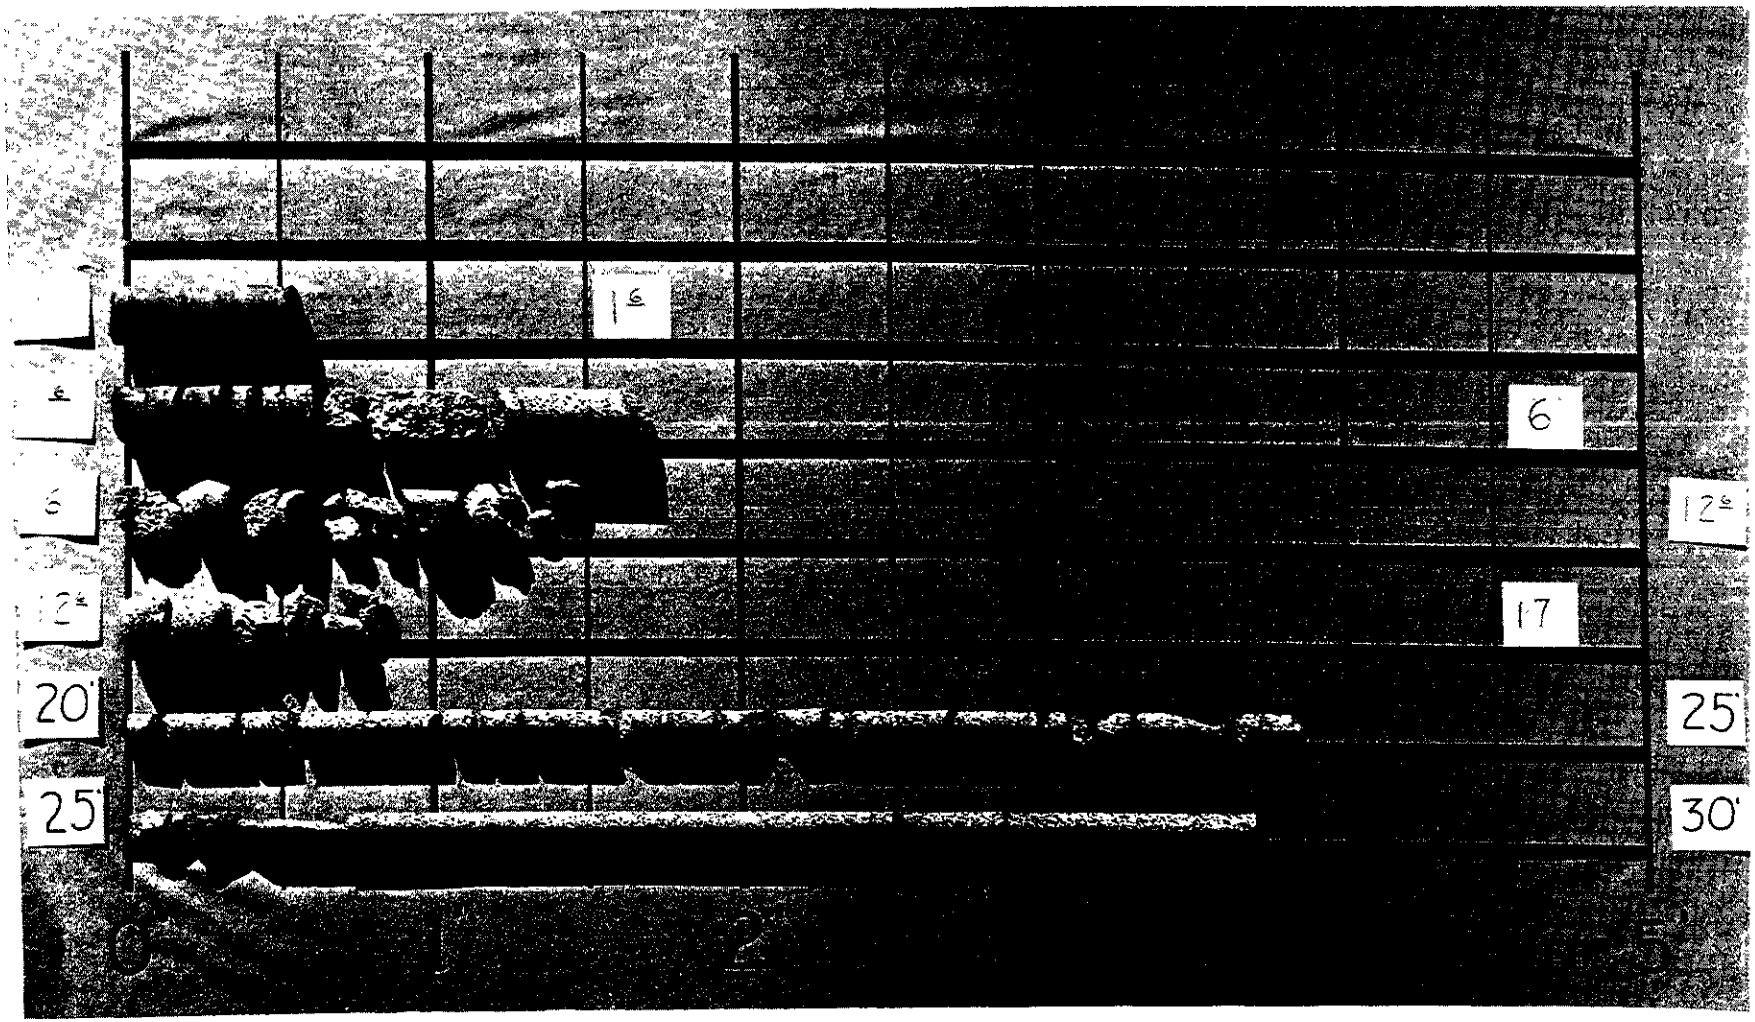
Emerald Bay Slide Investigation
Road III-ED-38-B
Boring R-1; 1' to 30'

Generally the upper sixteen feet of the material was badly broken or decomposed granite. The remaining fourteen feet was a moderately hard fractured and jointed granite.

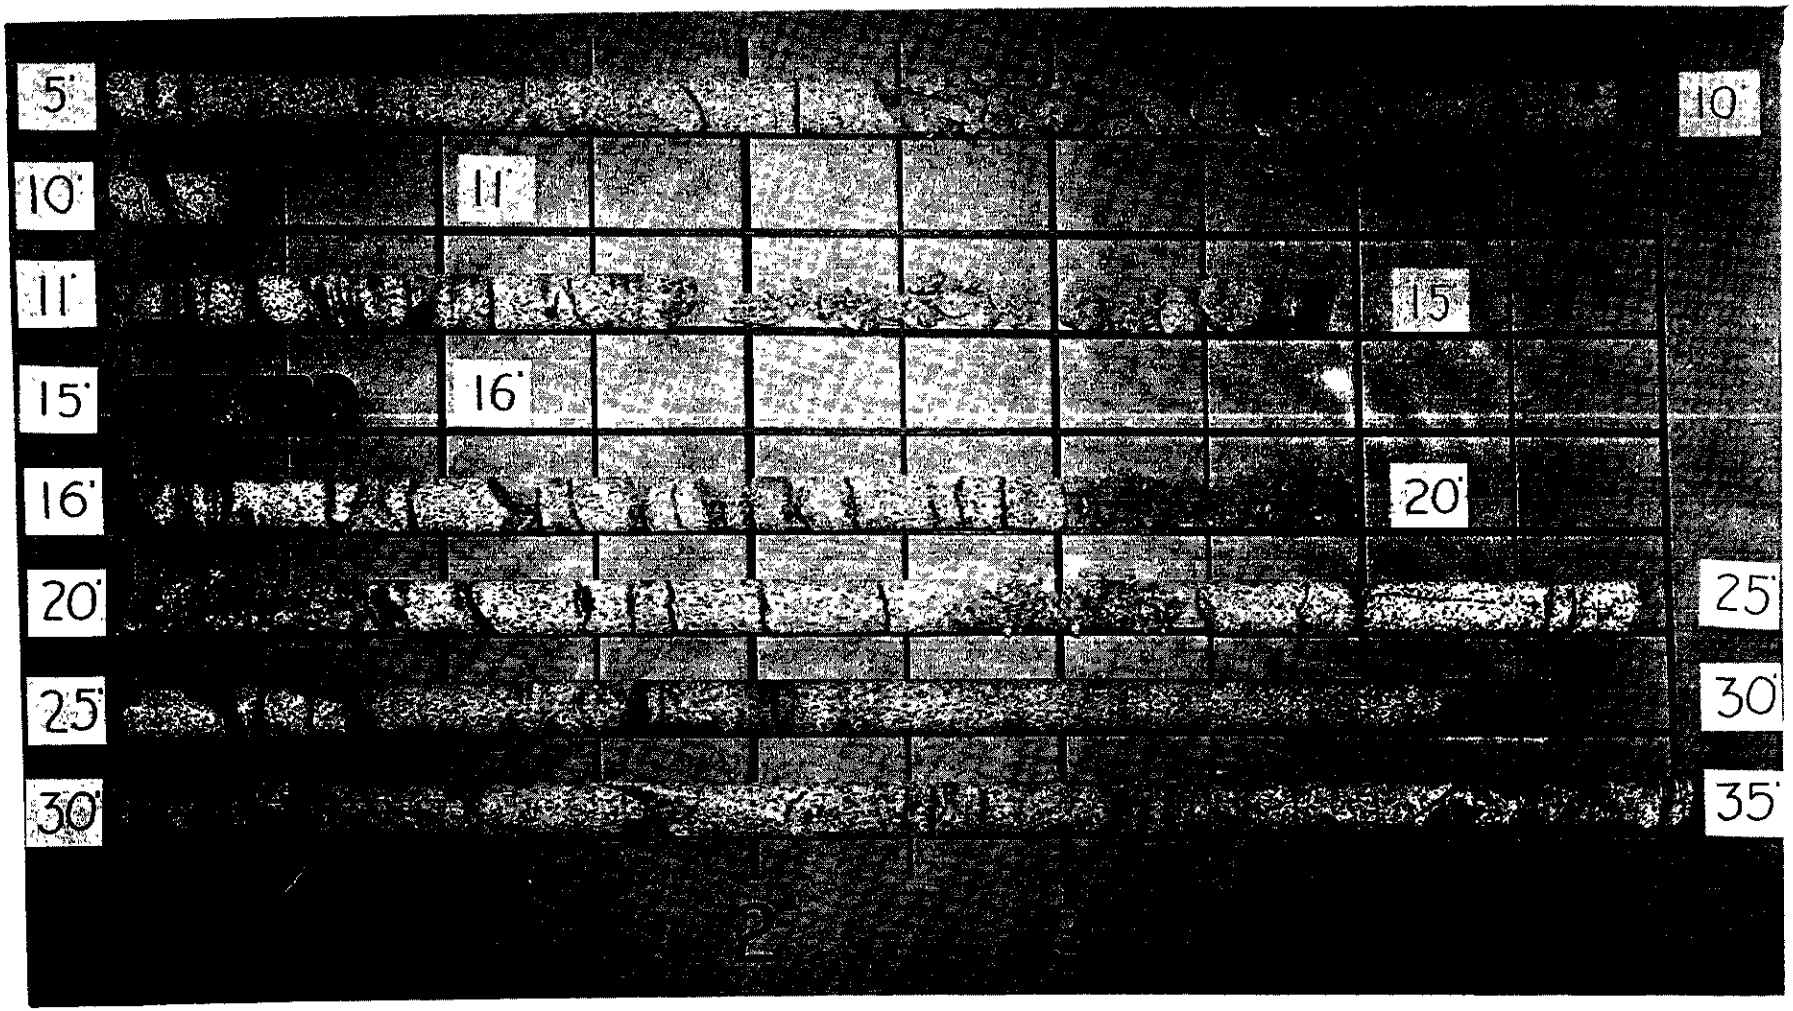
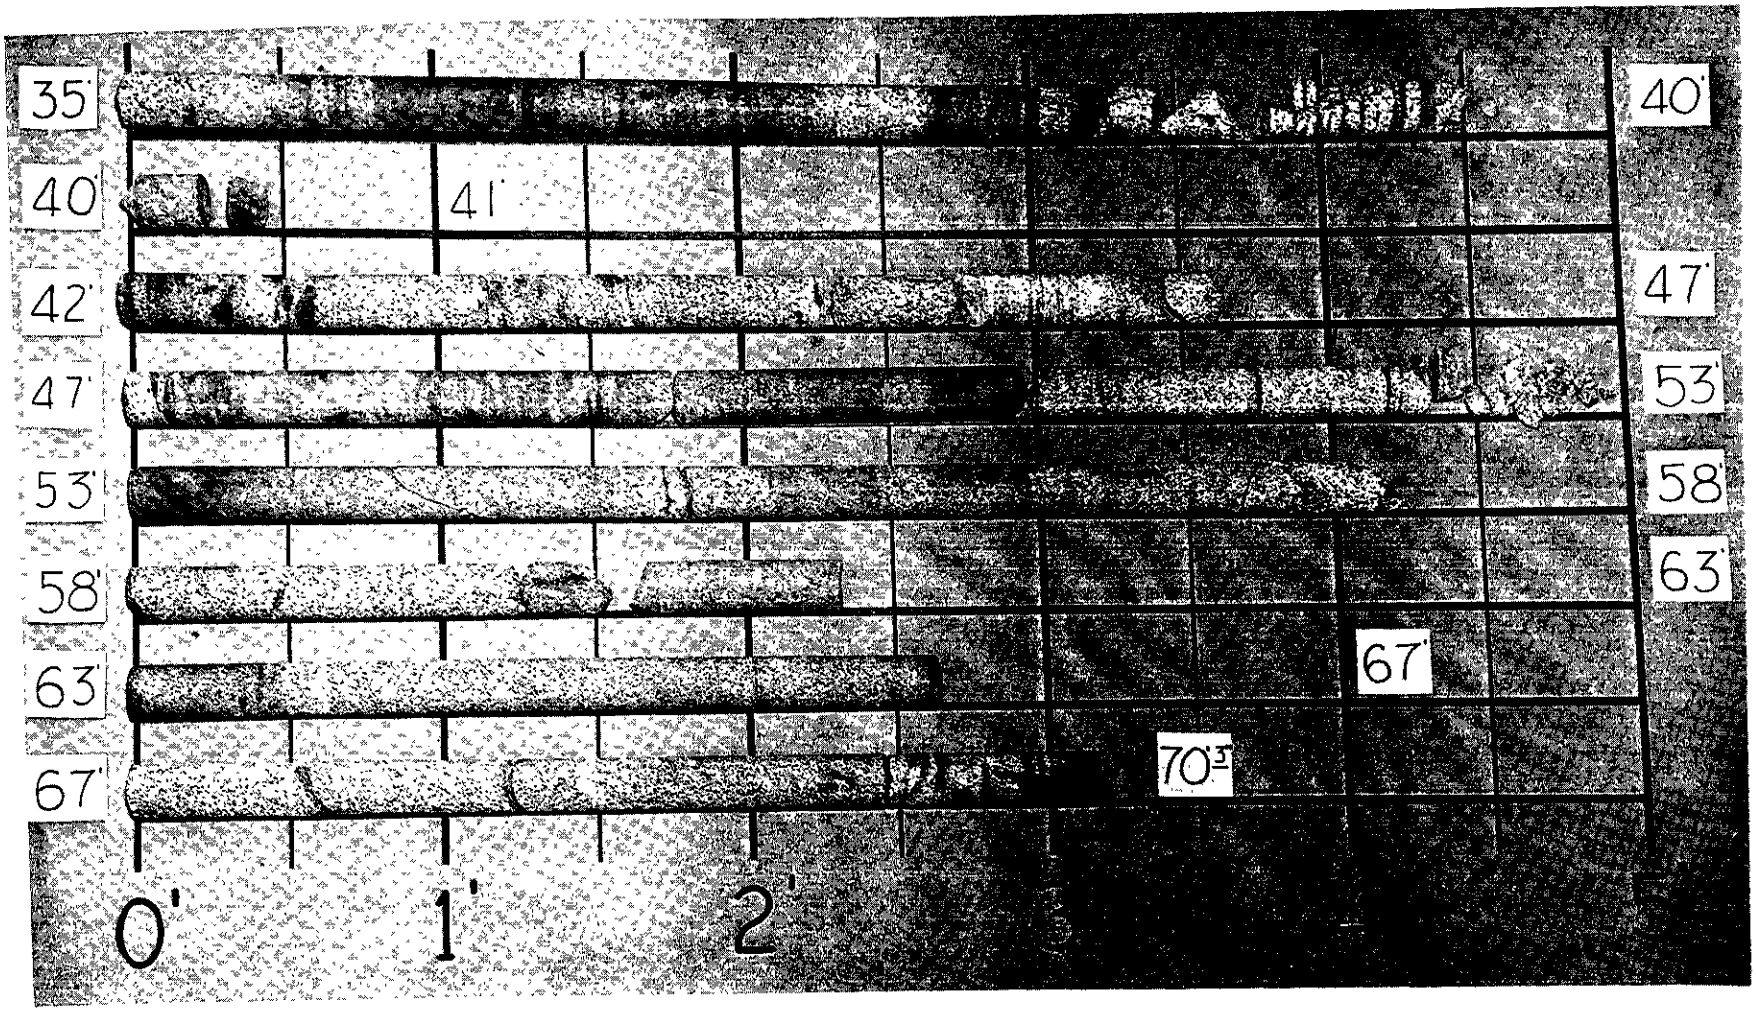
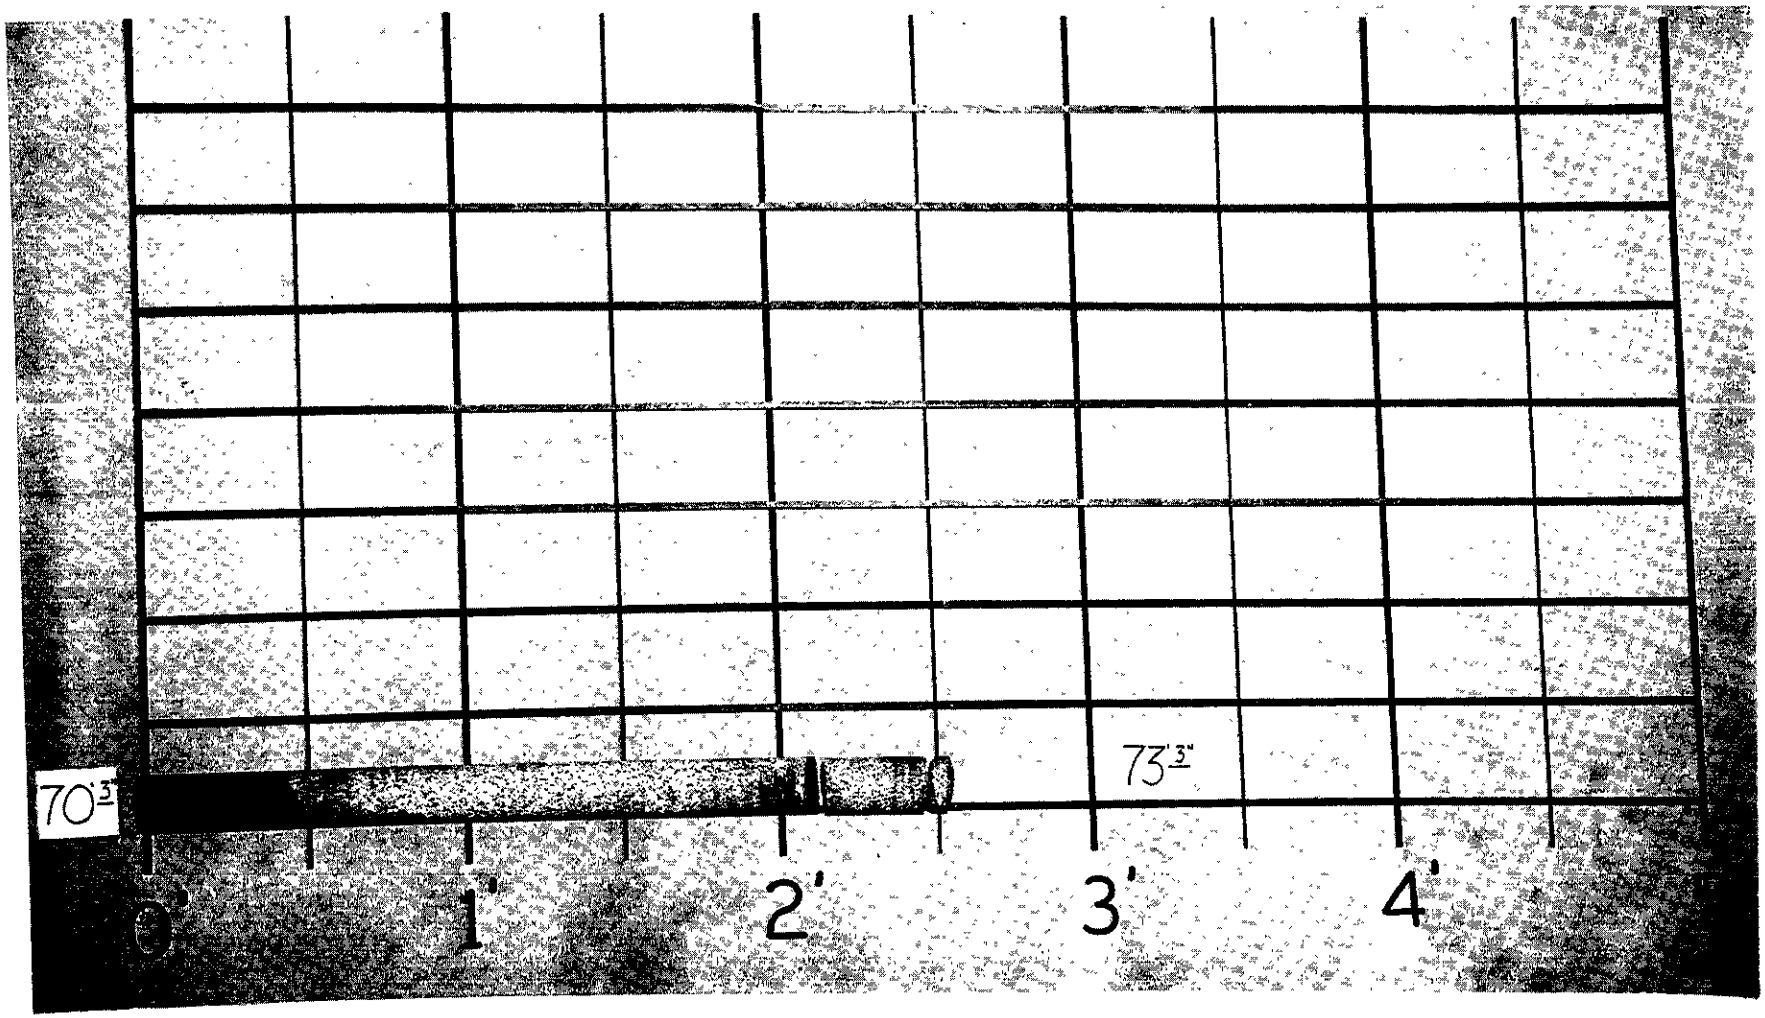
Emerald Bay Slide Investigation
Road III-ED-38-B
Boring R-3, 5' to 35'

The material appears in-place, being fractured and jointed with some weathering or decomposition in the first twenty-five feet.

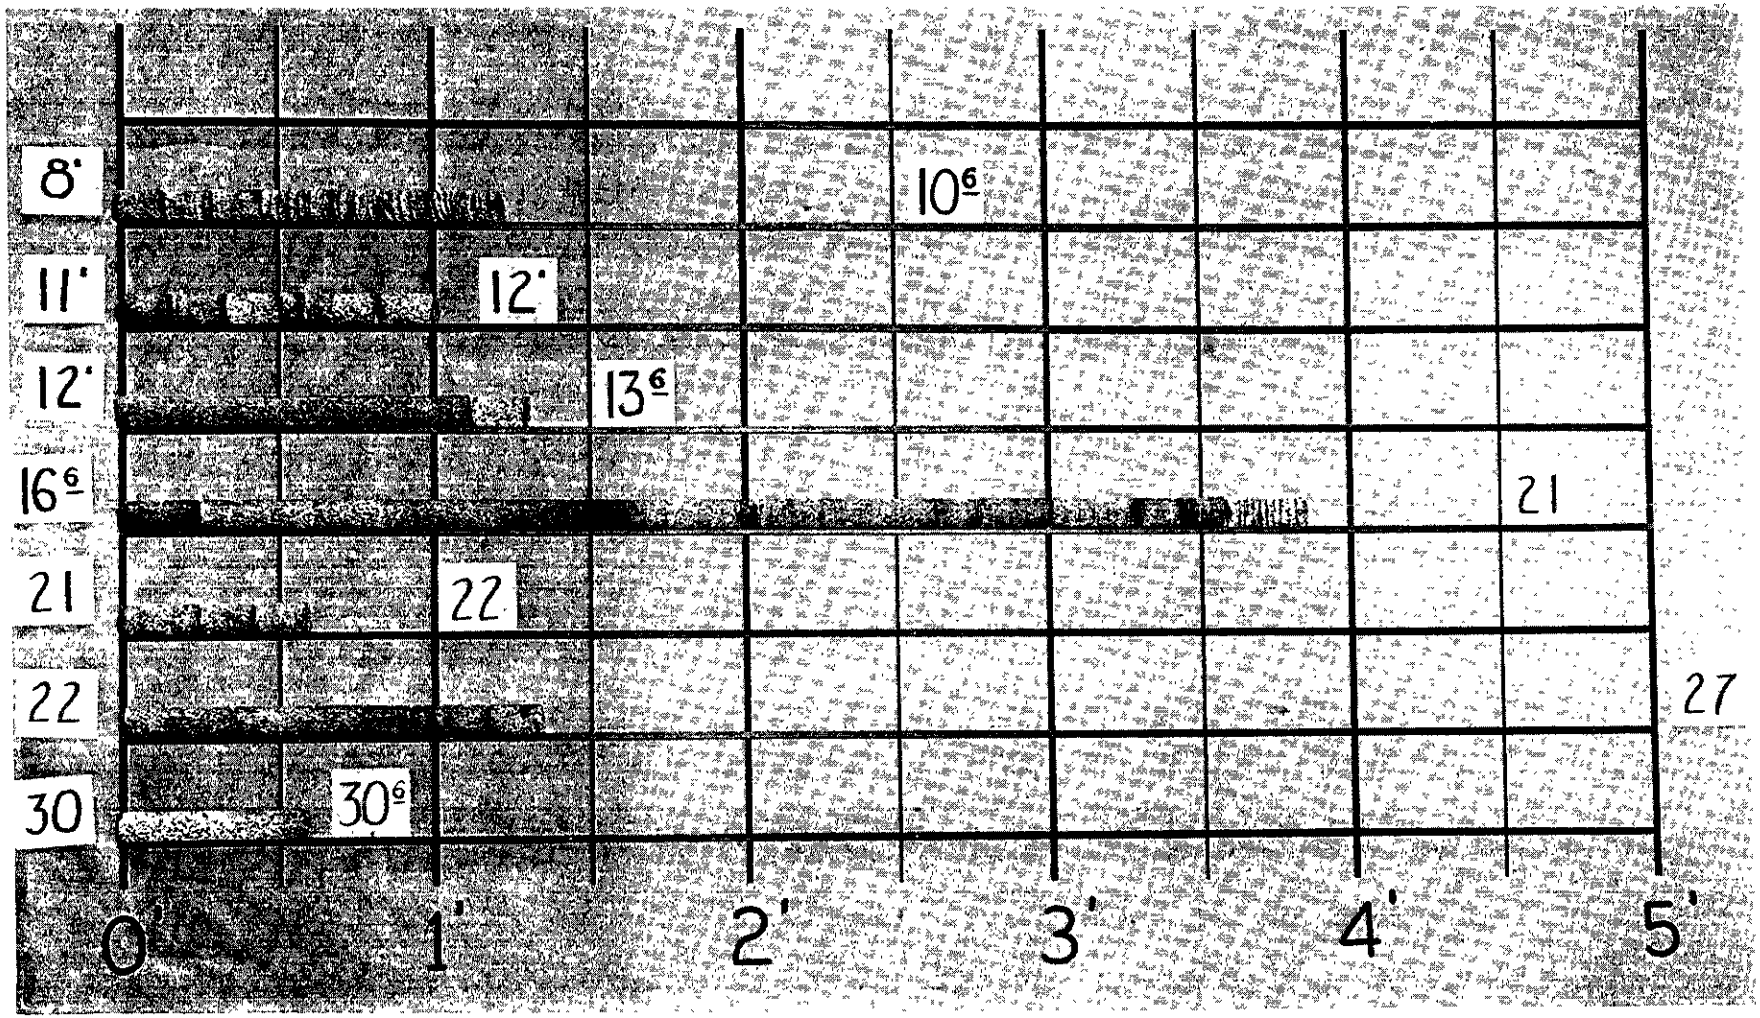
Emerald Bay Slide Investigation
Road III-ED-38-B
Boring R-4, 8'6" to 30'6"

The material varied from loose broken and decomposed granite to moderately hard fractured granite.

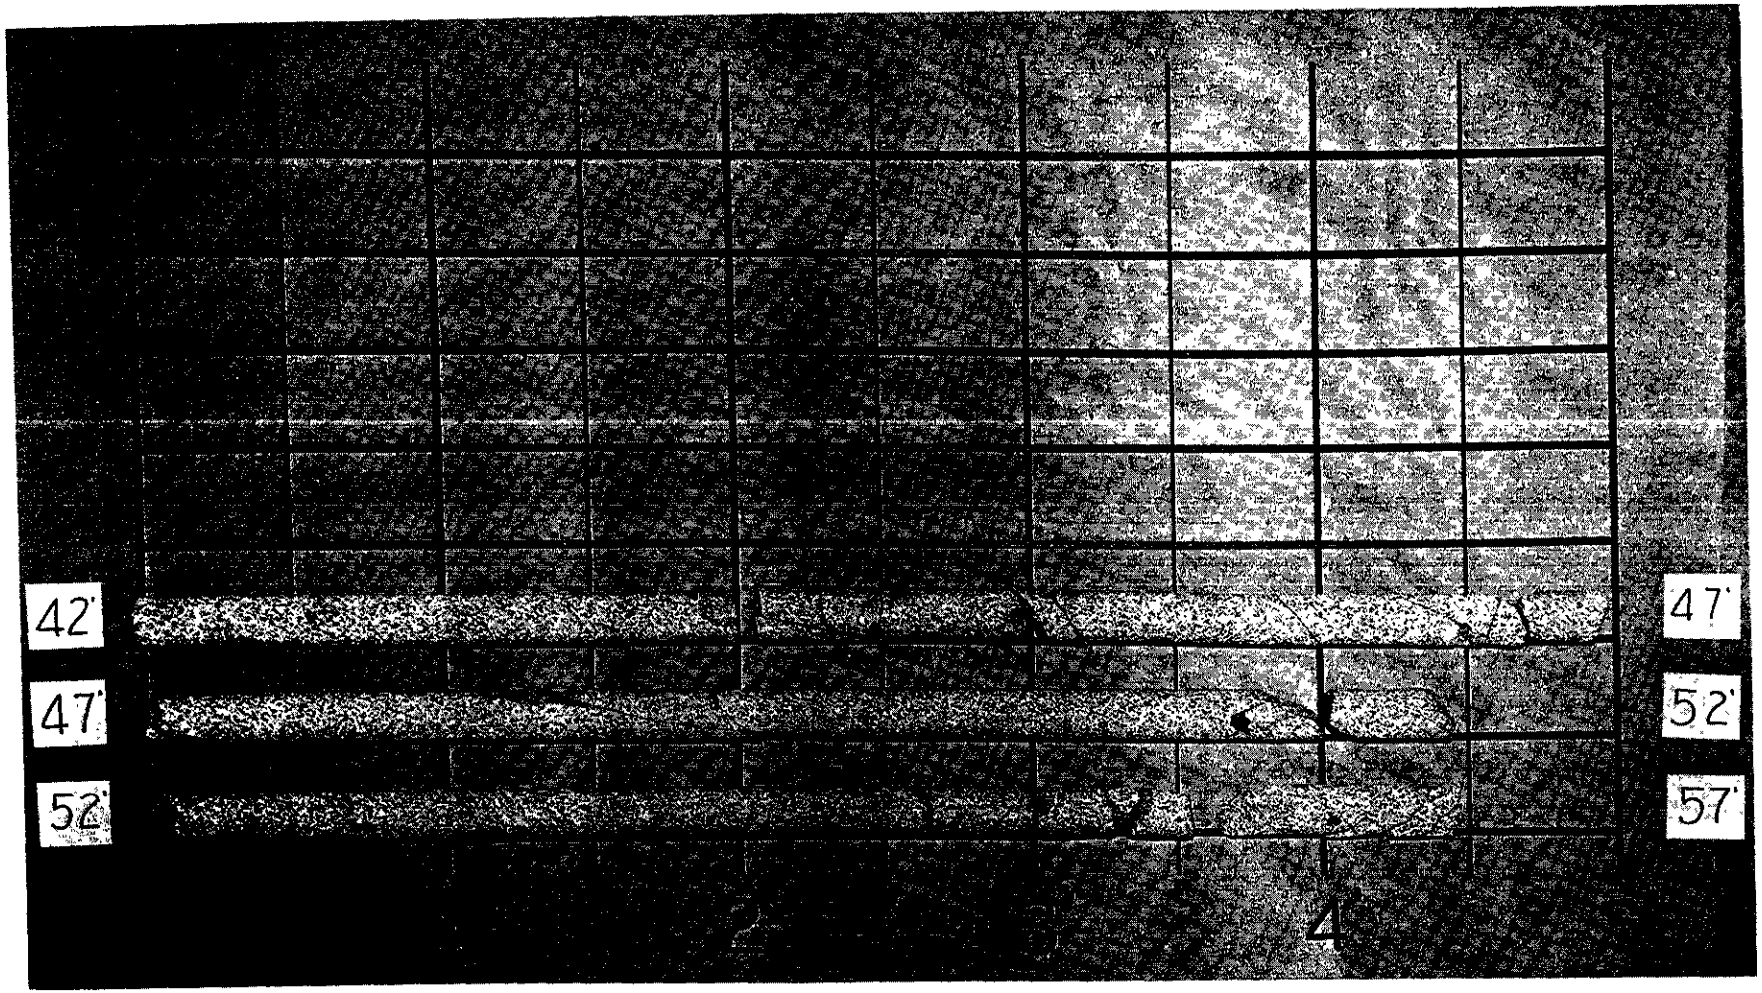
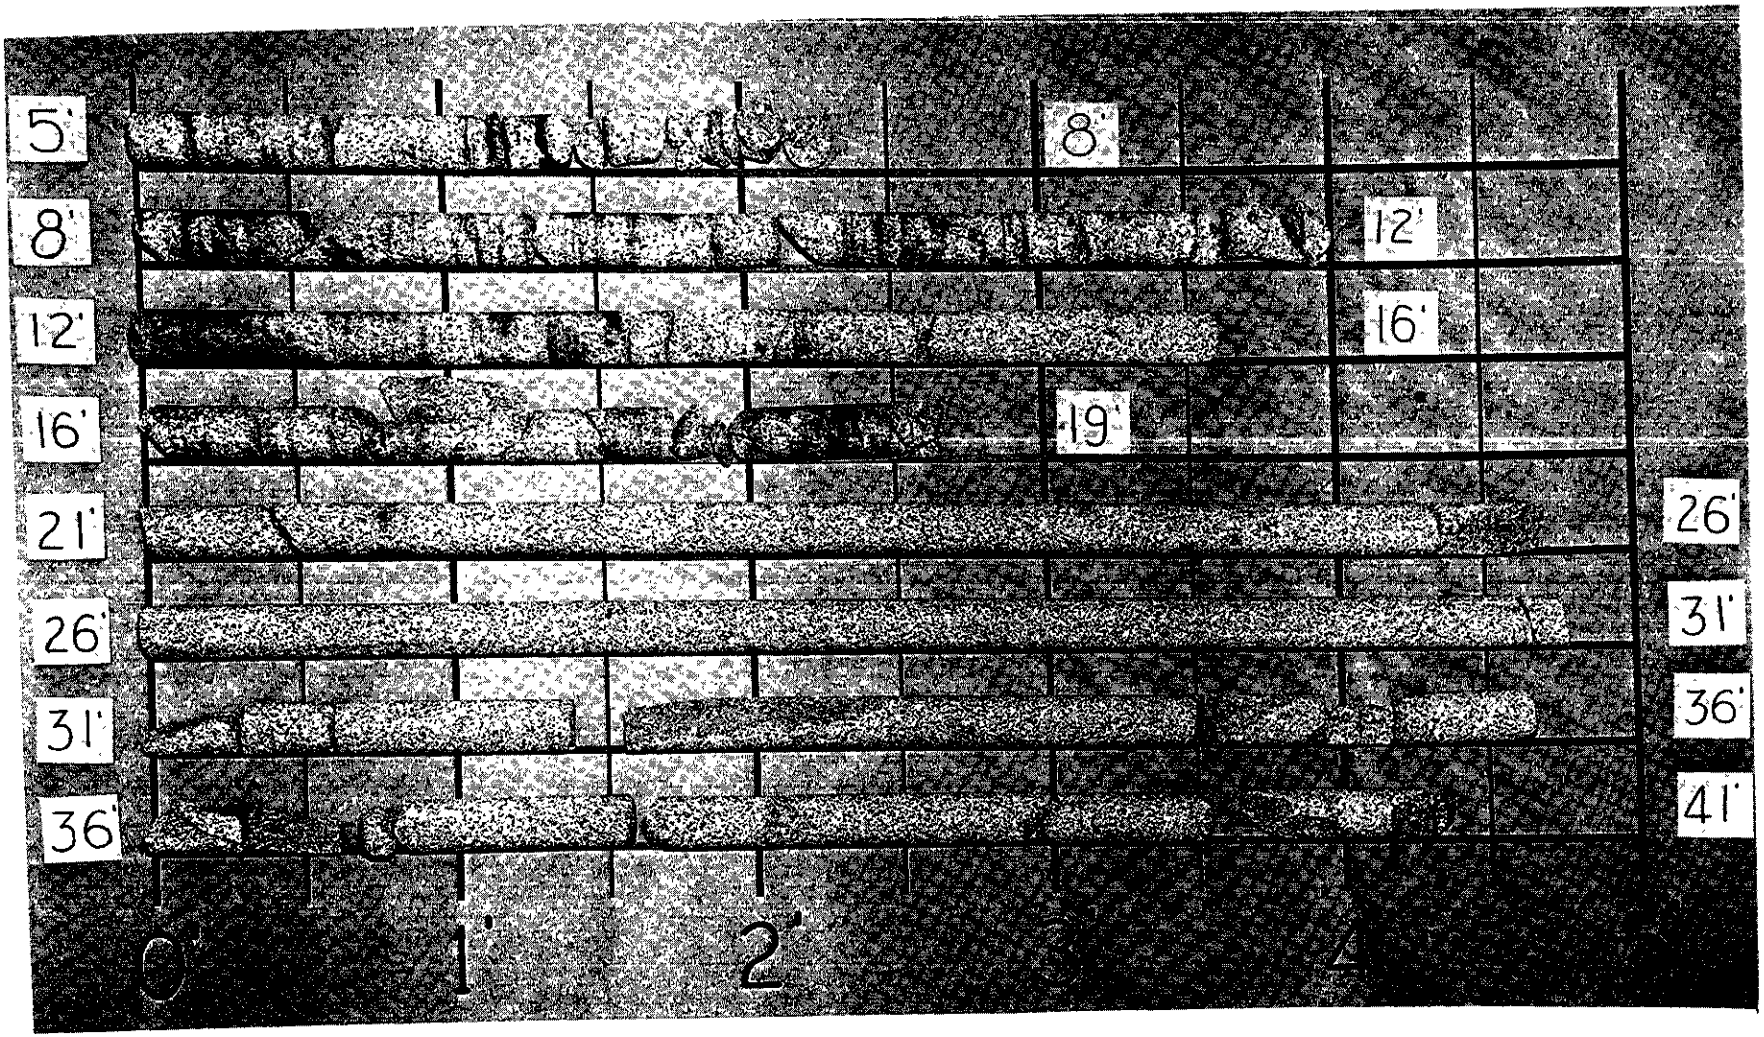
Emerald Bay Slide Investigation
Road III-ED-38-B
Boring R-5, 42' to 57'

The material from this boring appeared to be in-place fractured and jointed granite with layers of decomposed granite.

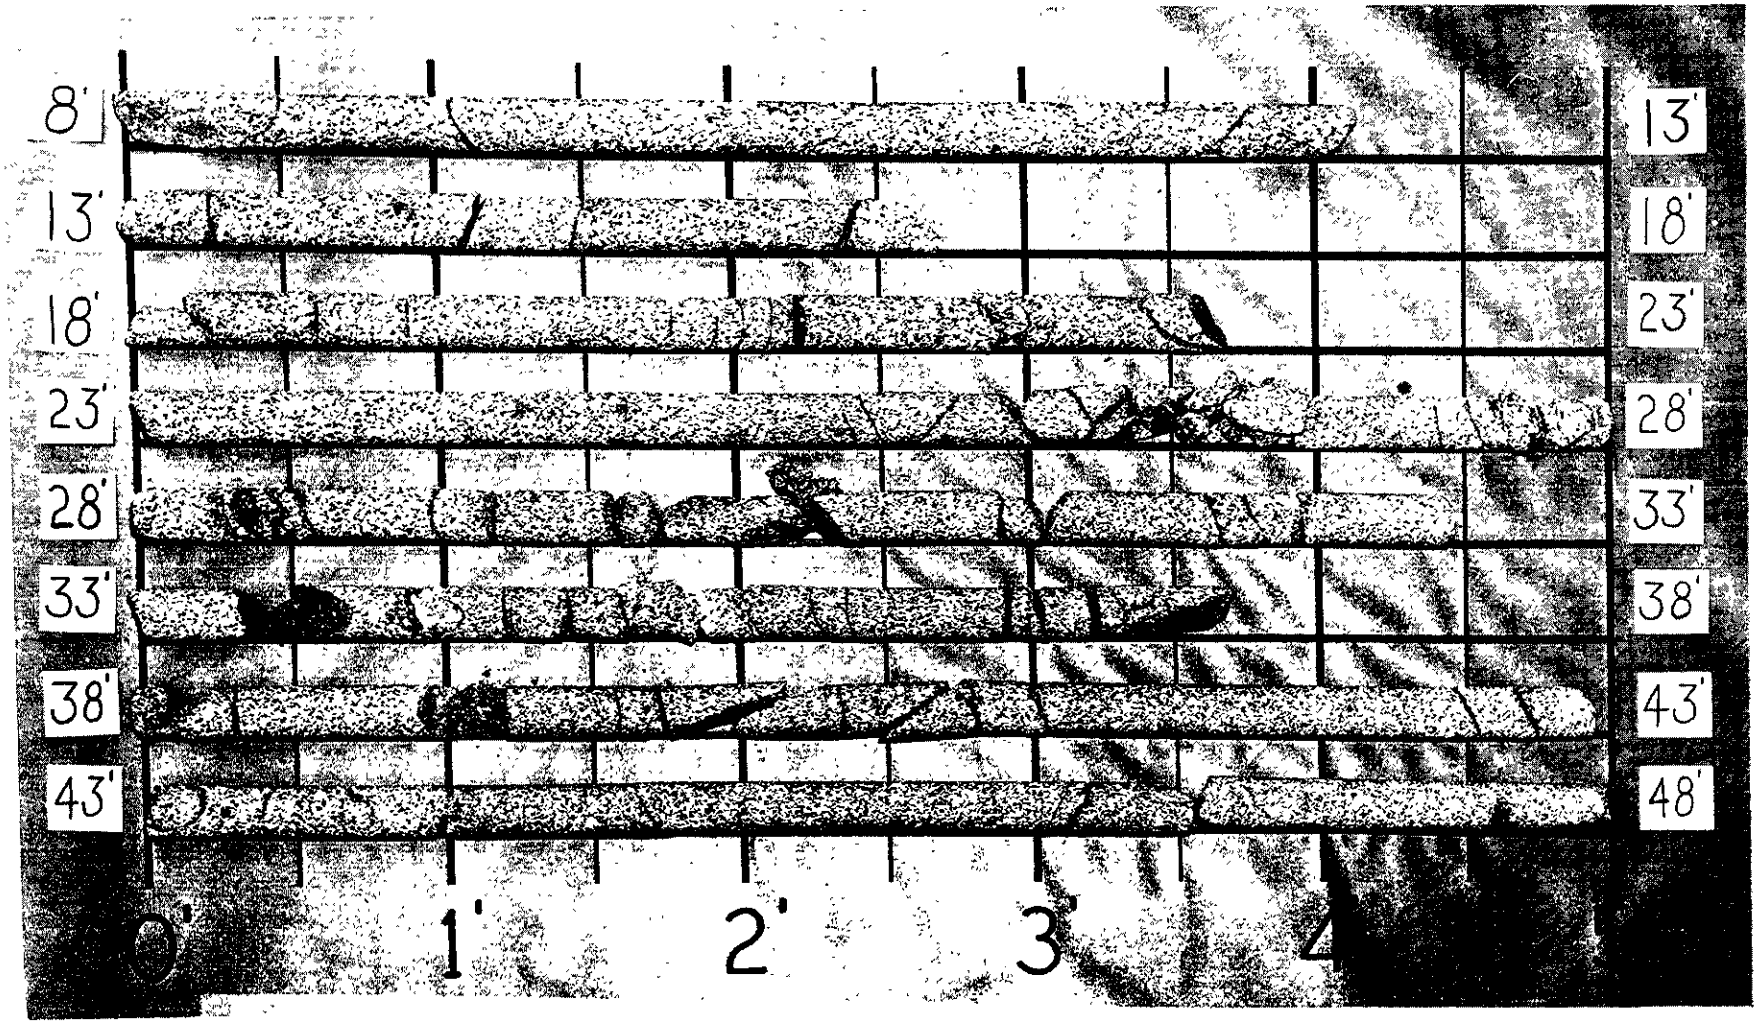
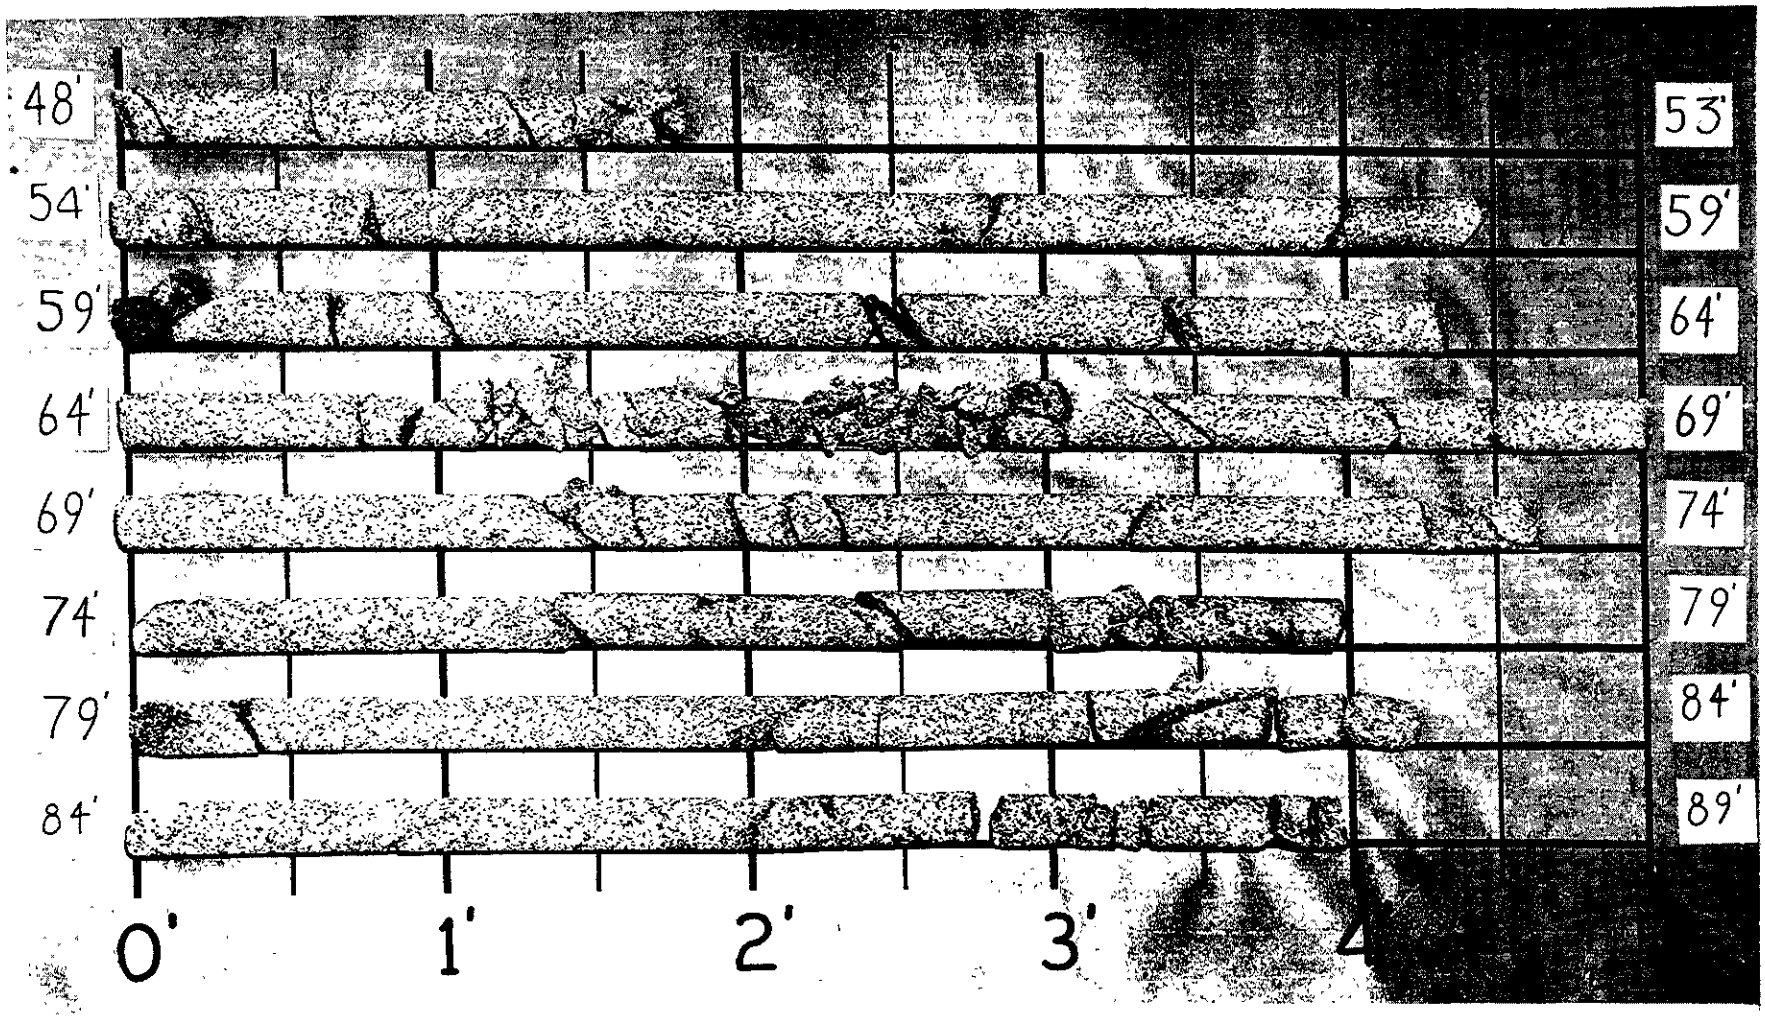
Emerald Bay Slide Investigation
Road III-ED-38-B
Boring R-9, 8' to 48'

The material from this boring was a moderately hard fractured and jointed granite with layers of decomposed granite. Slickensides were found on the fracture planes at approximate depths of twenty-eight and thirty-five feet. It appears that the magnitude of the displacement of material was slight.
