SLIDE INVESTIGATION AT EMERALD BAY

ROAD III-ED-38-B

STATION 243± TO 250±

December 17, 1957

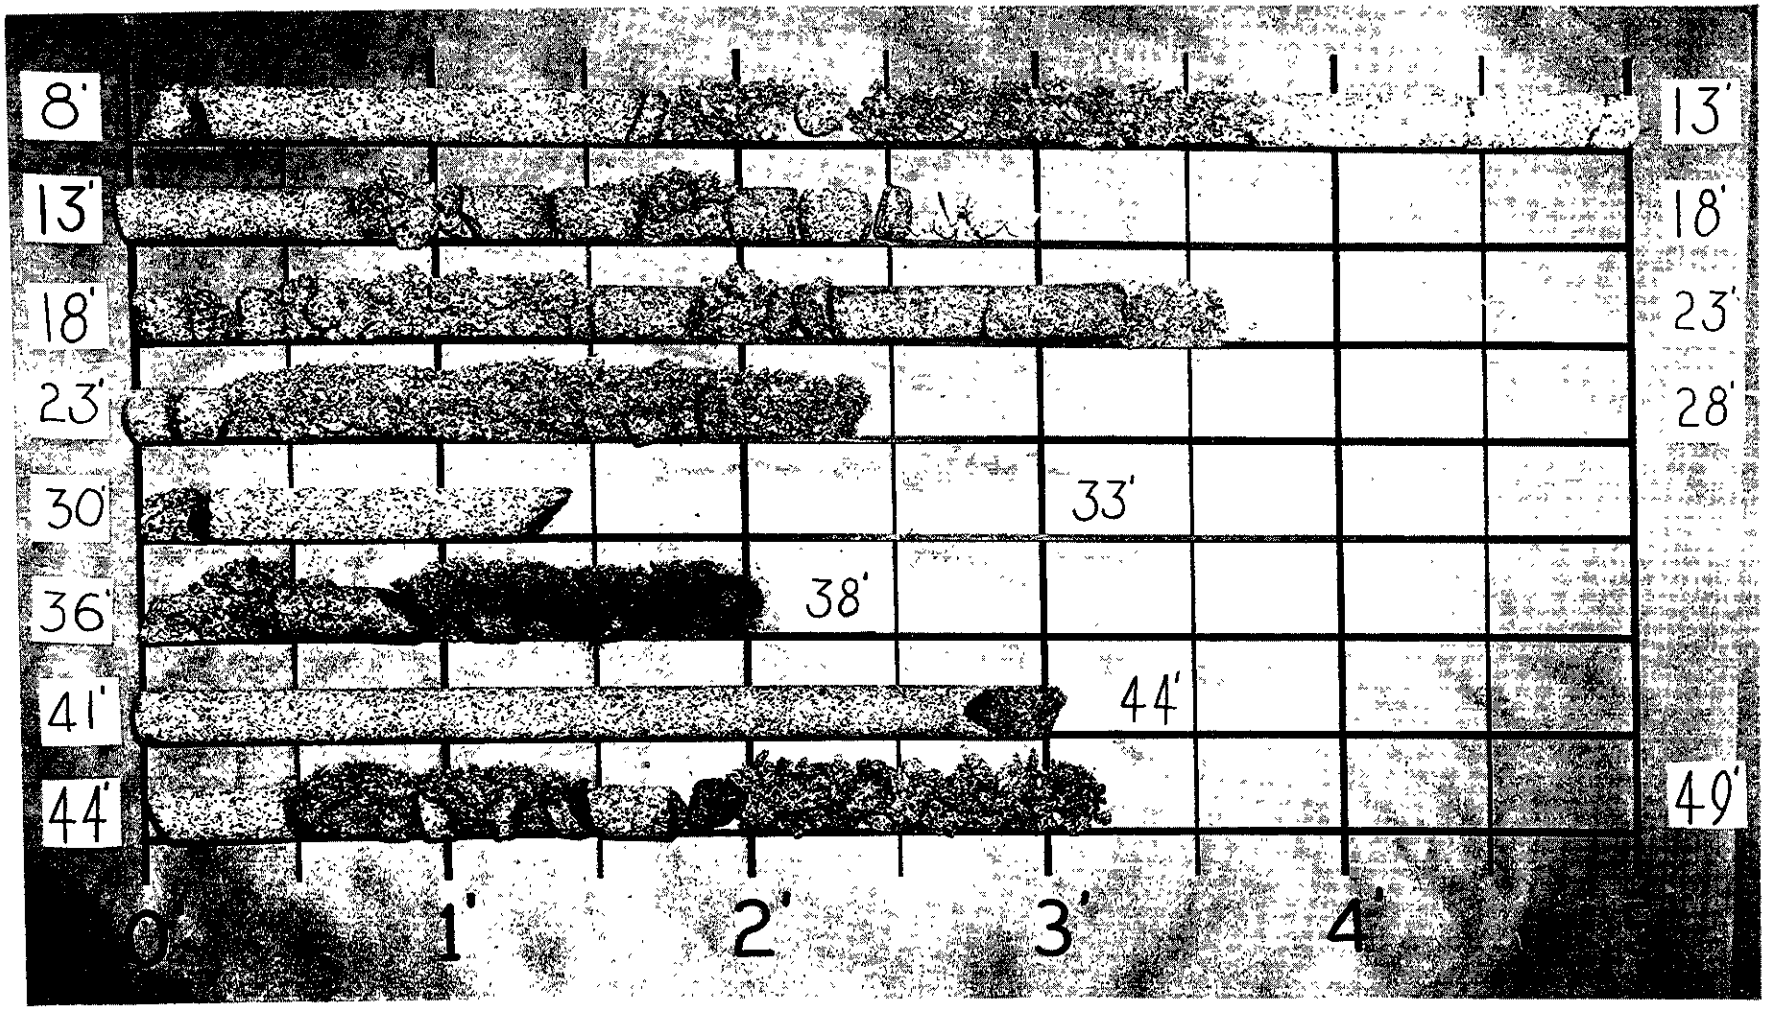
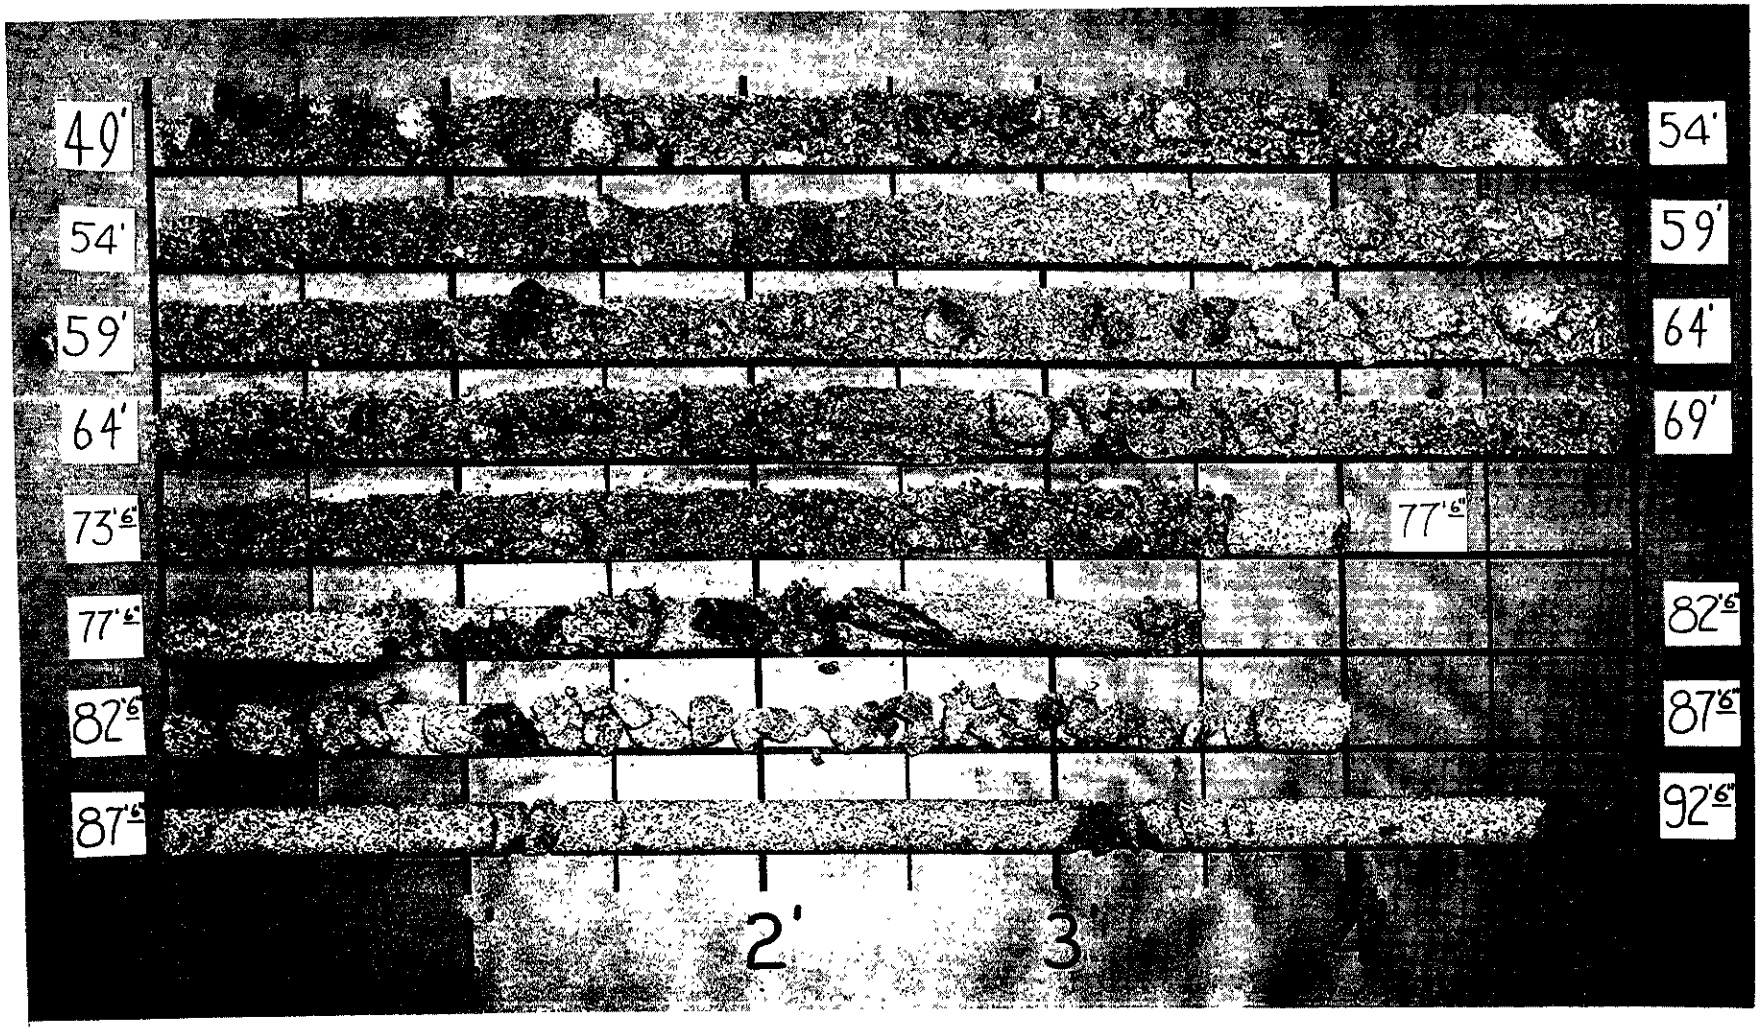
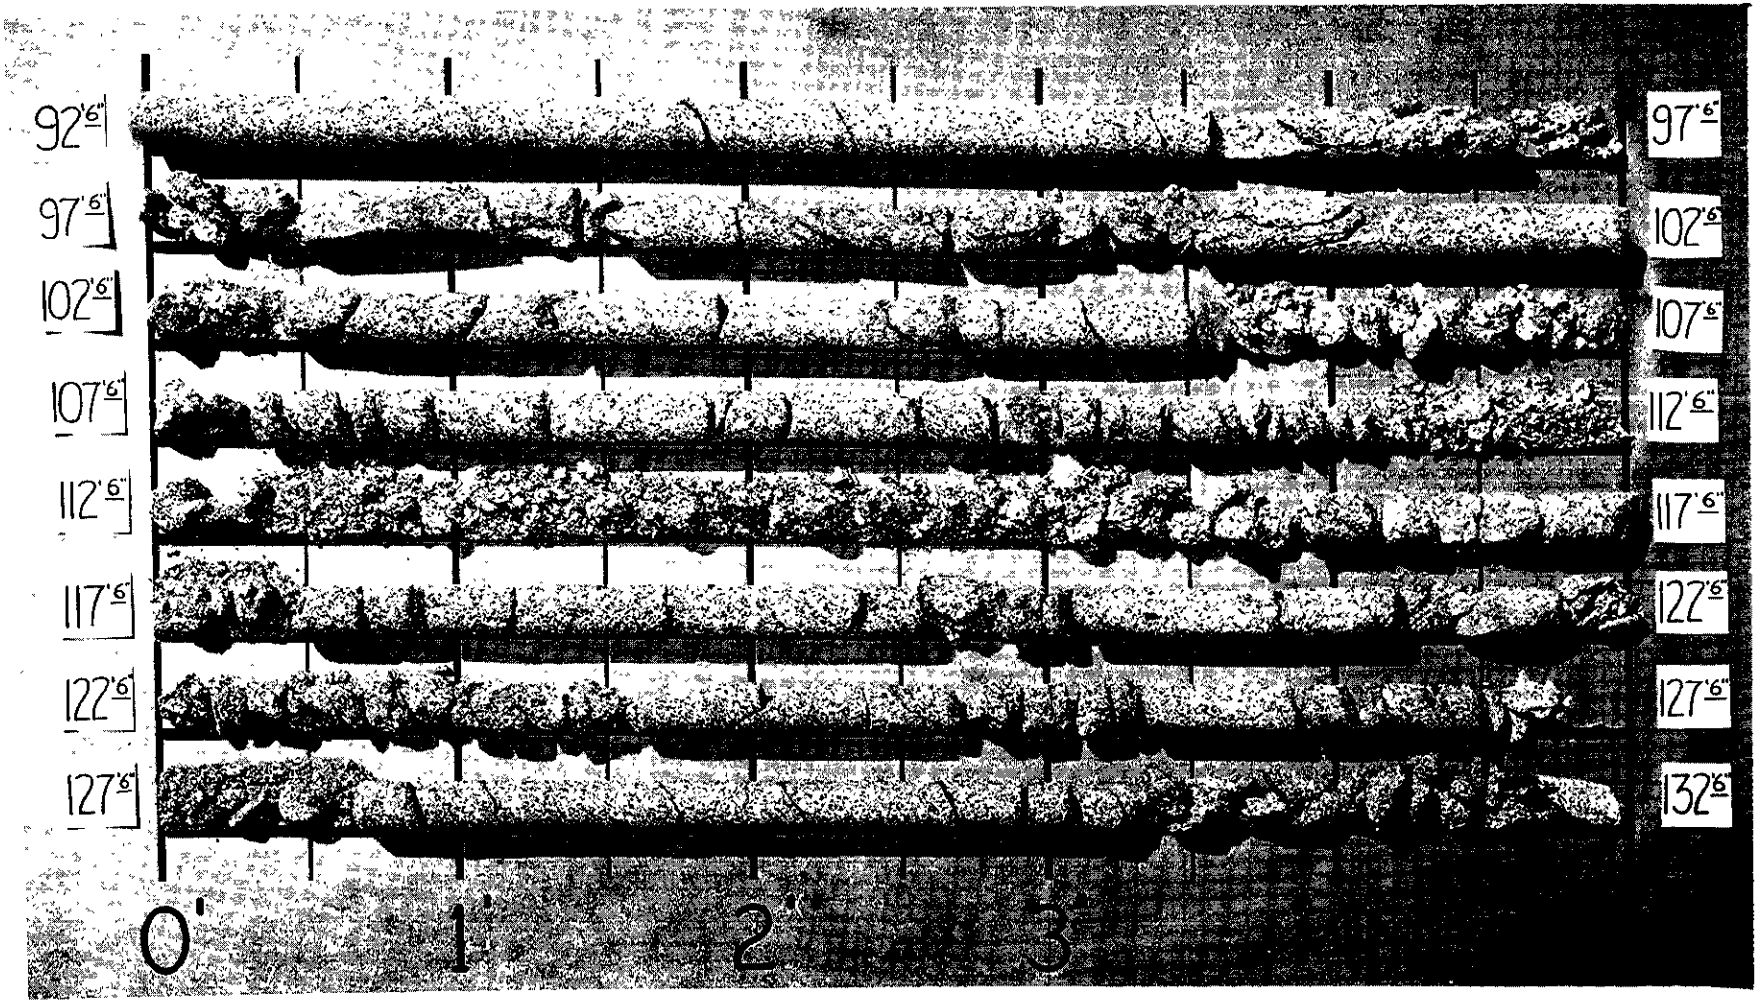
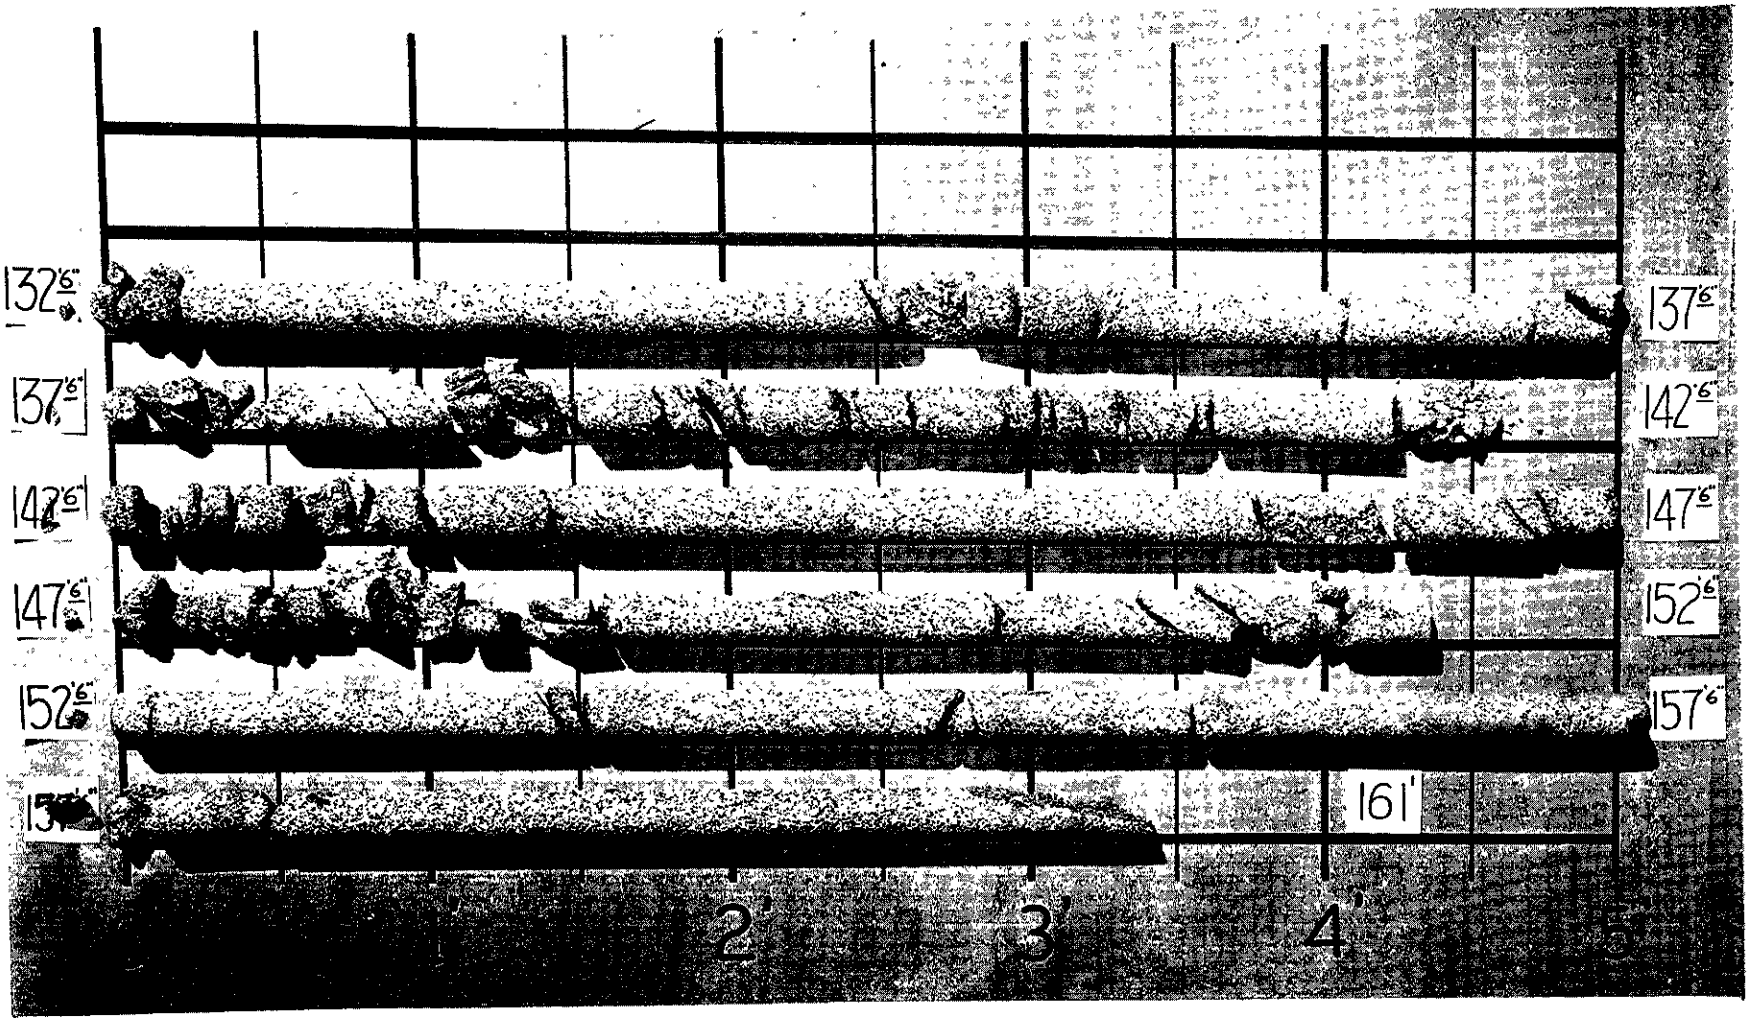
Emerald Bay Slide Investigation
Road III-ED-38-B
Boring R-10, 8' to 49'

The first fifty feet alternated between moderately hard granite and decomposed granite. From fifty to eighty feet the material was predominately decomposed granite of sand sizes. From 80' to 130' the material was a badly fractured granite with considerable degree of decomposition. In the remainder of the boring the granite was moderately hard fractured and jointed.

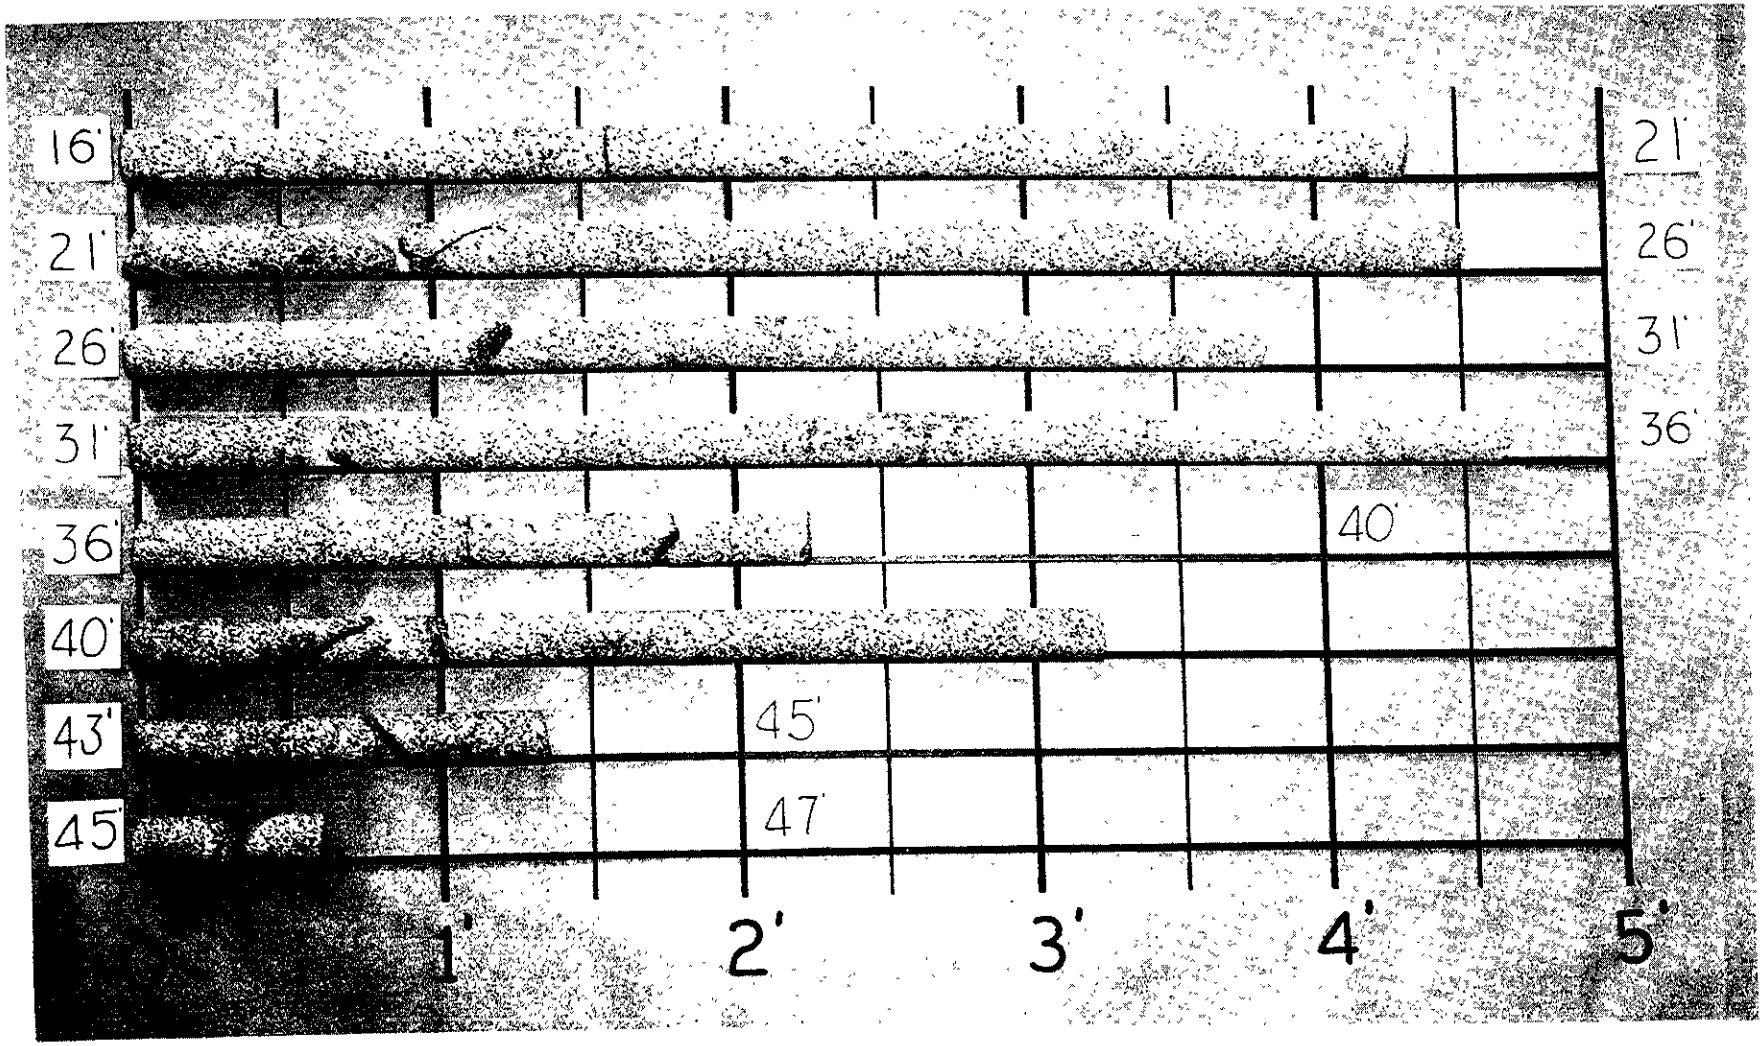
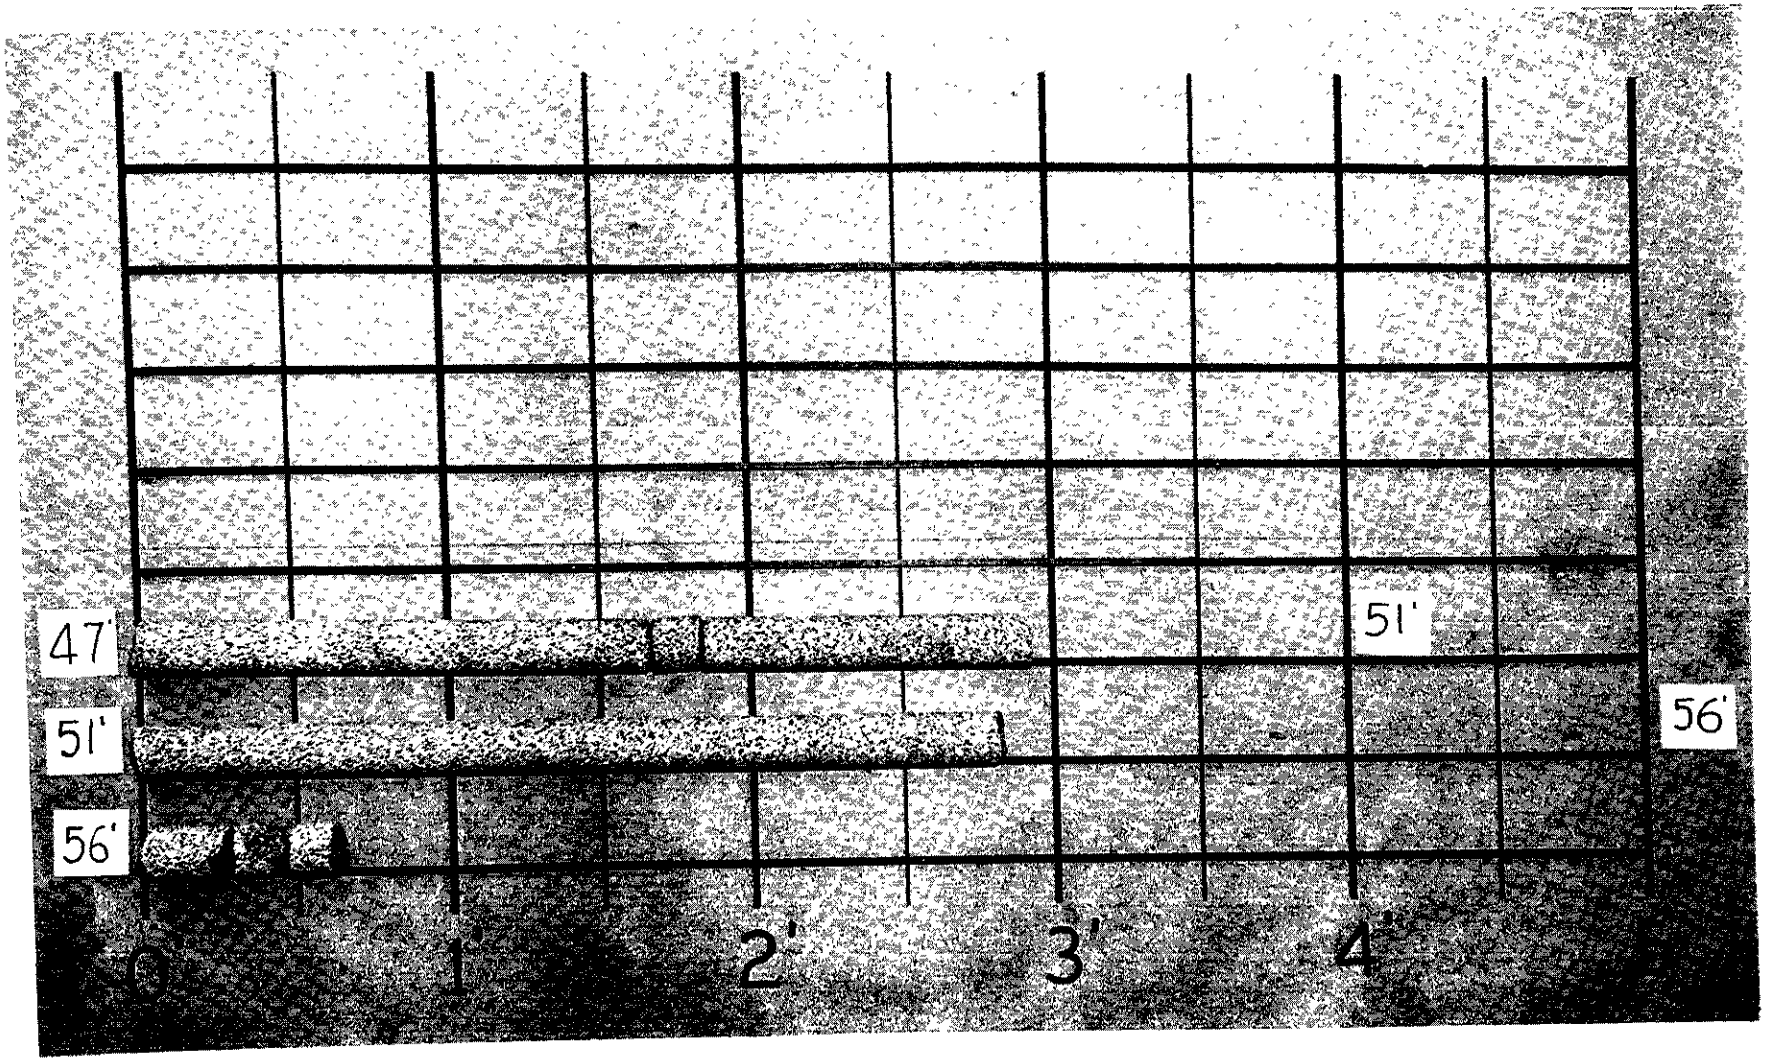
Emerald Bay Slide Investigation
Road III-ED-38-B
Boring R-12, 16' to 47'

Although this boring was only seventy feet south of boring R-10 the material was relatively fresh granite with some fractures and joints.

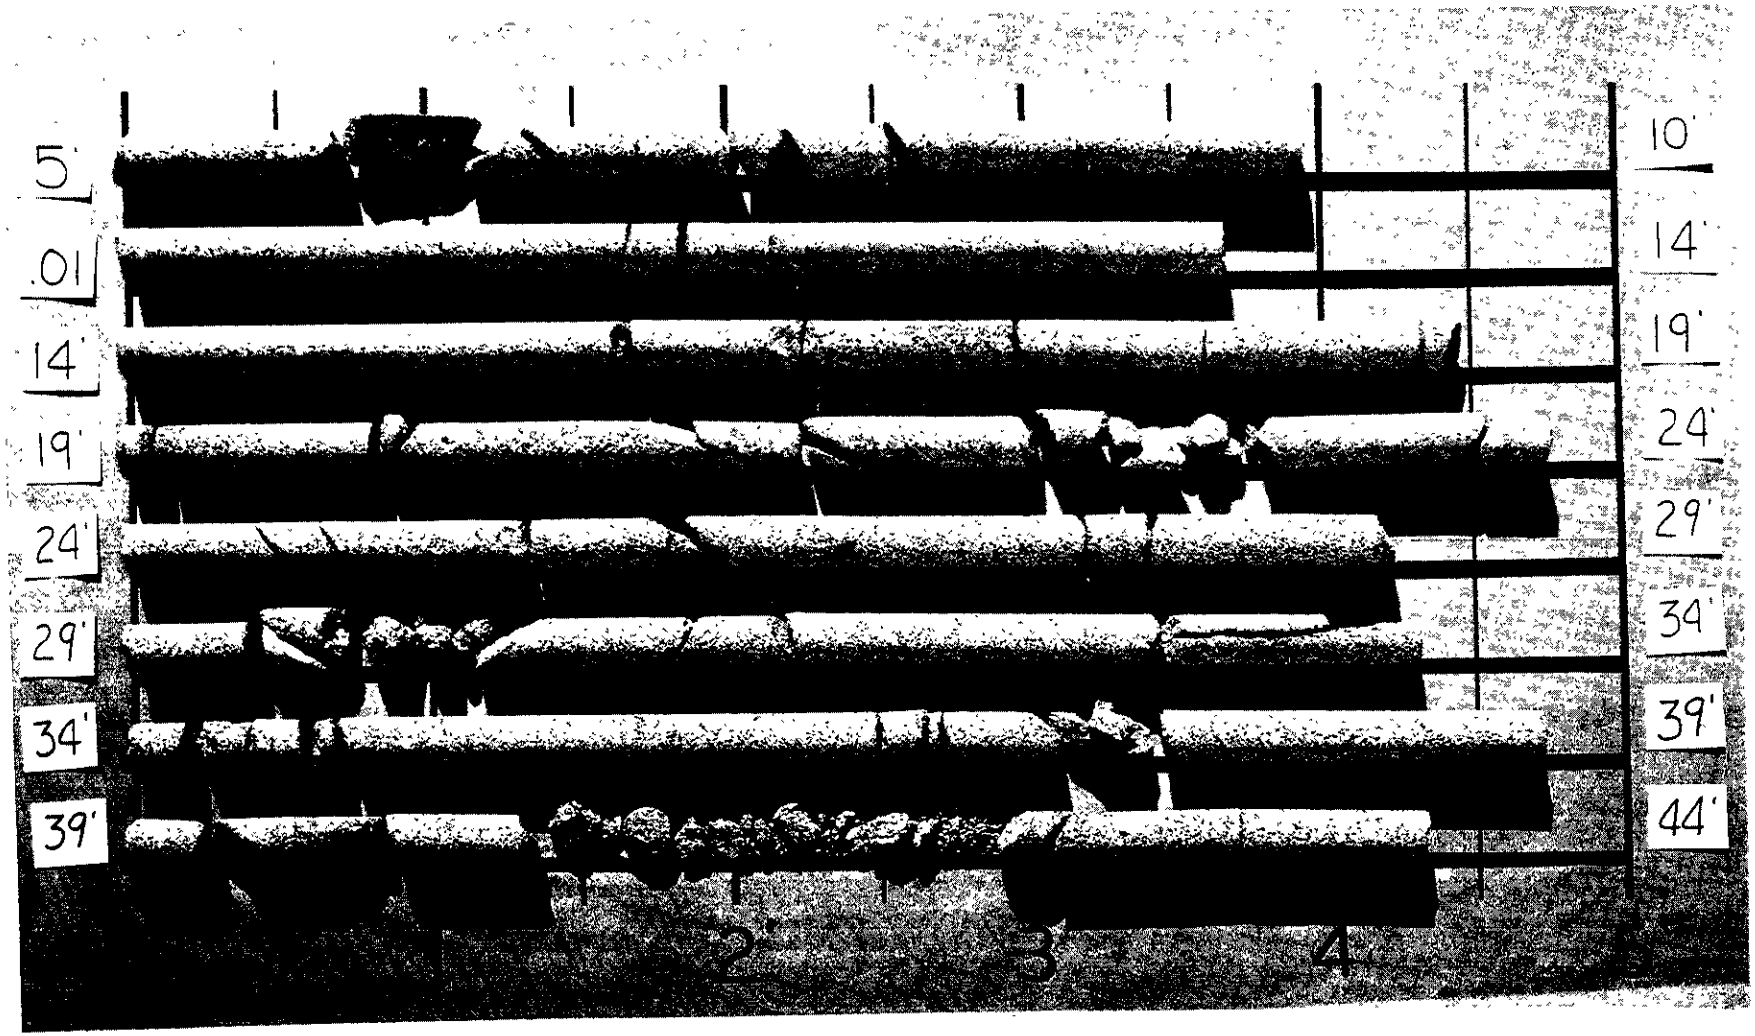
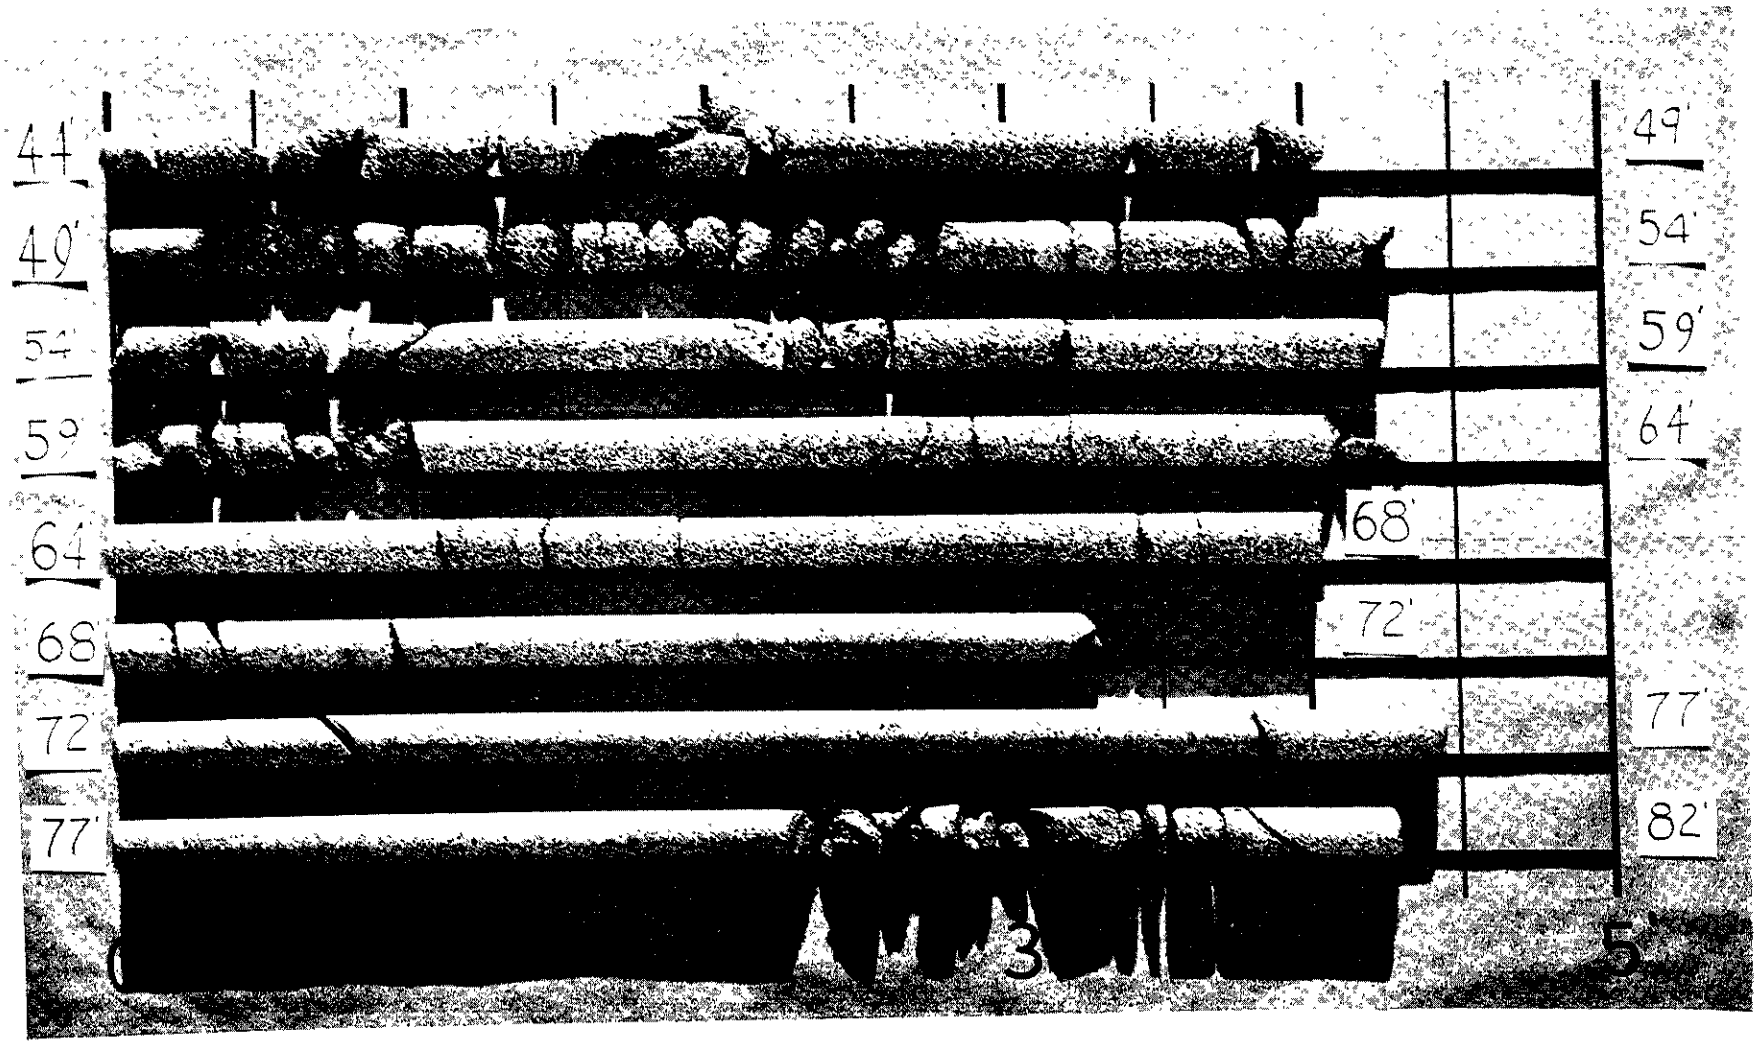
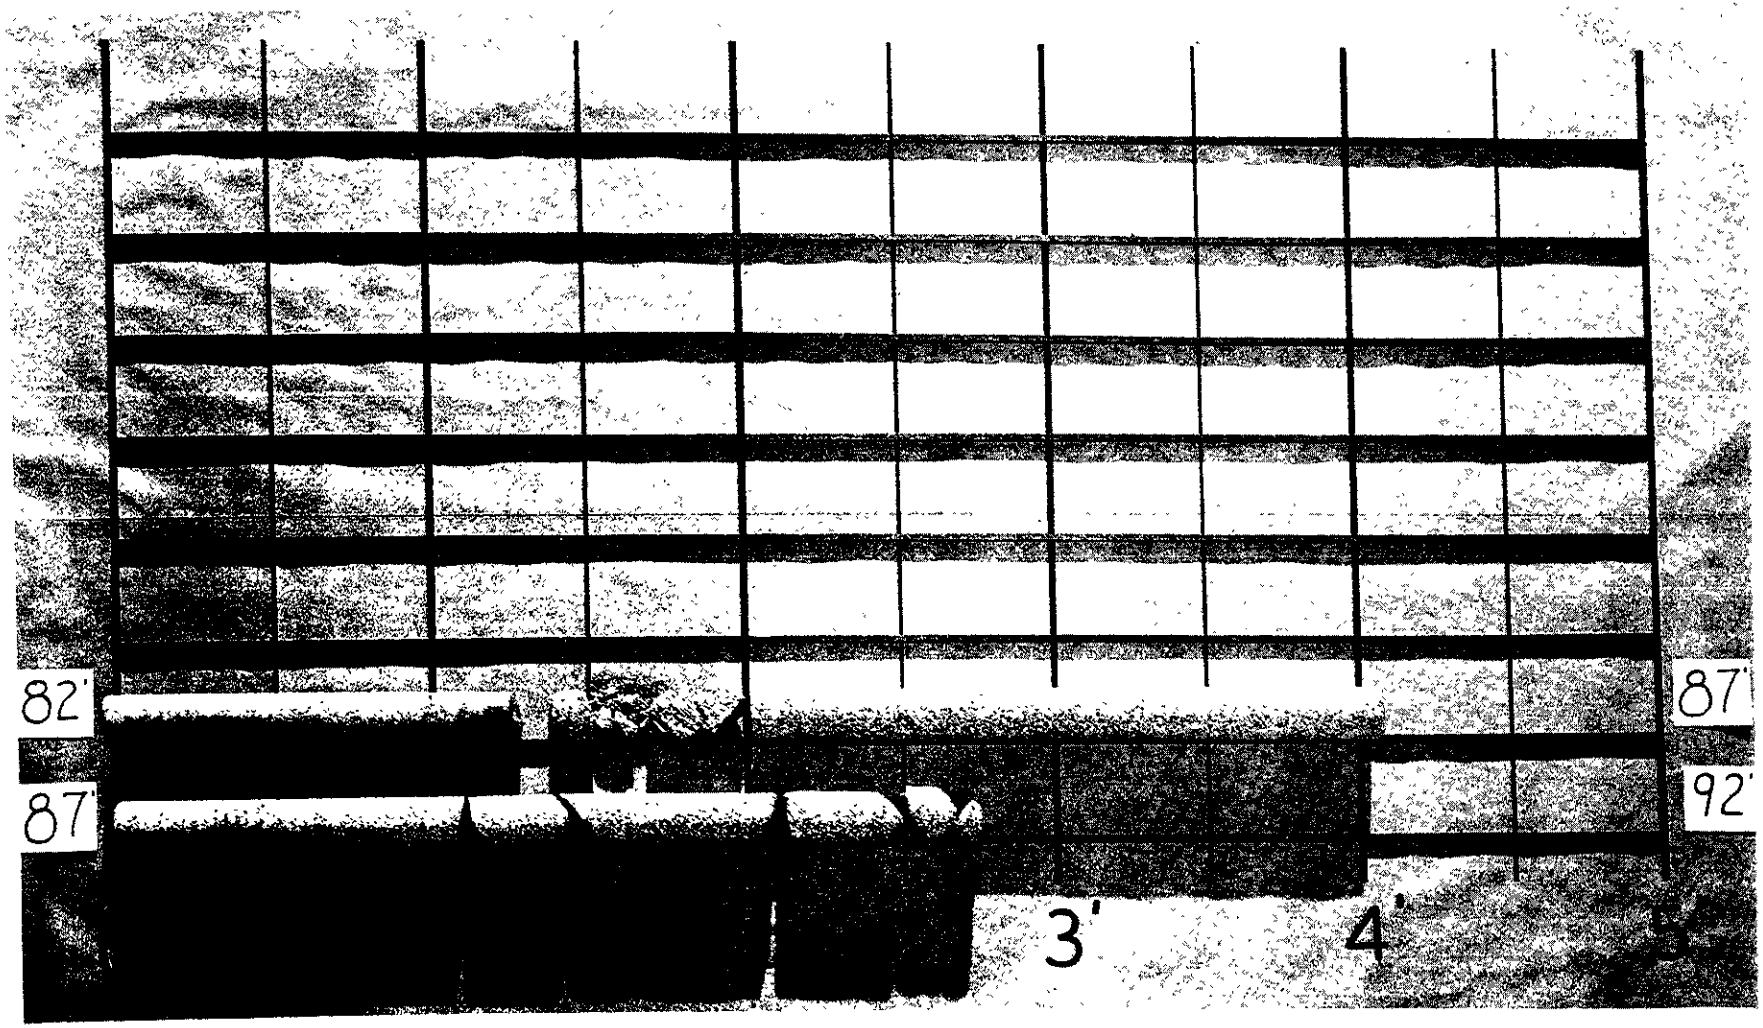
Emerald Bay Slide Investigation
Road III-ED-38-B
Boring R-13, 5' to 44'

The first forty and the last twenty feet of this boring was a moderately hard fractured and jointed granite with the intermediate material being badly fractured and moderately decomposed.
