MOVEMENT WITHIN LARGE FILLS

SAN LUIS RESERVOIR RELOCATION PROJECT

RESEARCH REPORT

NO. M & R 632509-1

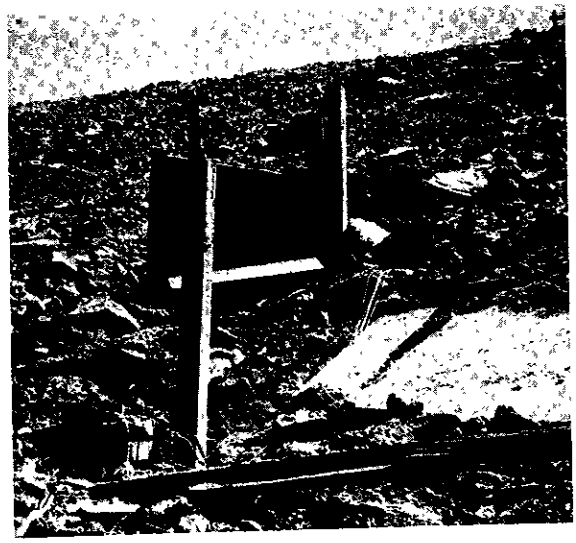
Figure 24. A typical example of the severe damage often inflicted on installations from large rocks rolling down the fill slope during construction. Compare with Figures 22 and 23. Note the almost complete destruction of the "protective" wingwall.

It is now apparent that the concrete "wing walls," provided on the San Luis project for protection of the exposed units, are totally inadequate. As a consequence, special instrument shelters have been devised and are presently being used on the "Ridge Route project" where horizontal and vertical movement devices are being installed.

The shelters are constructed of "ends" cut from steel "surplus" missile containers provided by the U. S. Navy. These sections are about 6 ft. in diamter and 6 ft. long. Due to space limitations it is necessary to provide a spring tensioning system for the cables rather than using dead weight, as was done on the San Luis project. Figure 29 illustrates the arrangement for the horizontal movement indicator and the general configuration of the shelter with a plywood door panel installed on the open end. Adequate space is available on the rear metal wall to mount settlement indicators and other devices, as shown in Figure 30. With the shelter bedded firmly in concrete and covered with fill, as illustrated in Figure 31, a safe housing for the indicator equipment is provided.

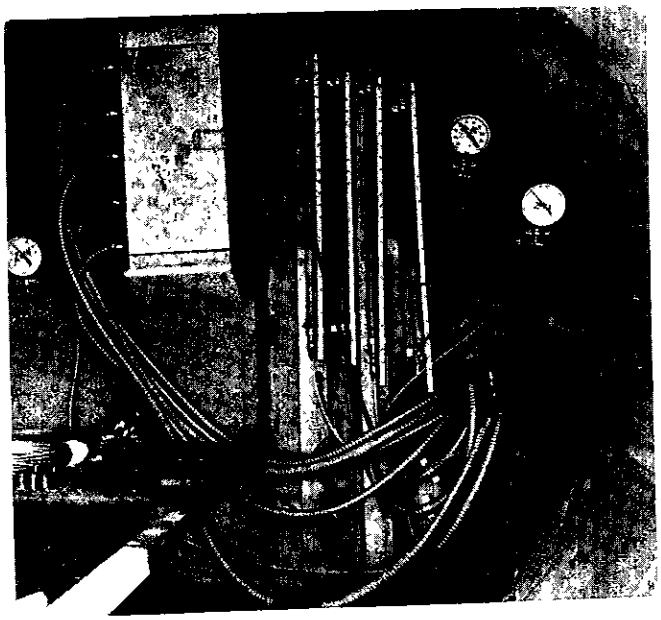
Figure 30. Settlement indicators and other instrumentation mounted on the back wall of the shelter.
