HIGHWAY RESEARCH REPORT

FULL SCALE DESTRUCTIVE TESTING OF TWO BOX BEAM OVERHEAD SIGN STRUCTURES

NO. M & R 36419

Prepared in Cooperation with the U.S. Department of Transportation, Bureau of Public Roads June, 1969

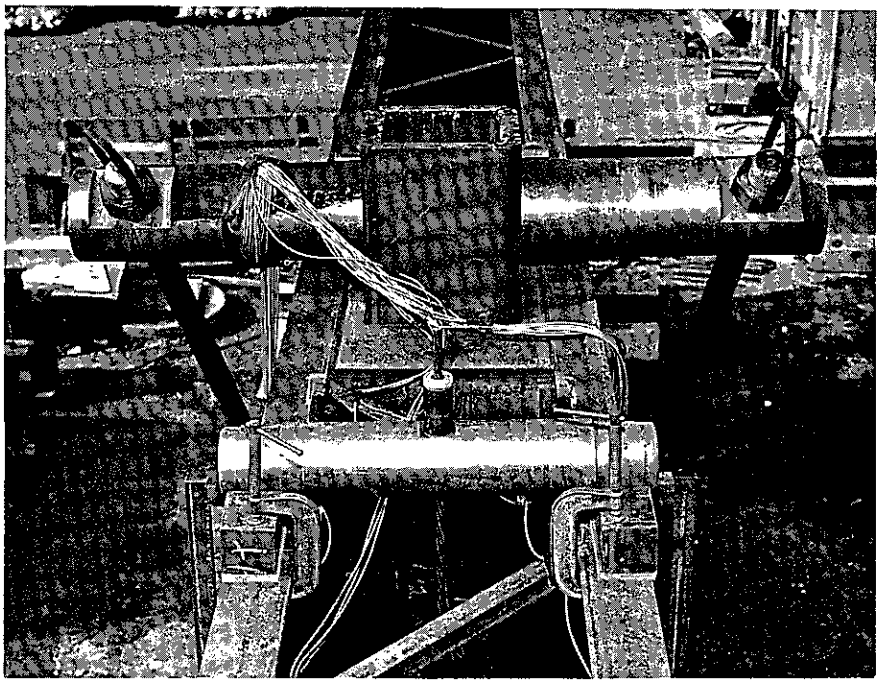
Figure 7

COLUMN TOP, UPPER BRACE CONNECTION AND ORIGINAL LOAD DISTRIBUTION MEMBERS

Originally, 3 in. x 3 in. x 12 in. bearing blocks were used in pairs to transmit testing loads from a 4½-in. diameter pin to the top flanges, as shown in Figure 7. However, the initial testing in October and November 1968 showed that significant local stress concentrations were being applied to the chord angles of the top flange and were inducing substantial outward buckling of the side webs even at low load levels. Consequently, the load distribution system was redesigned (see Figures 9 and 10 and Exhibit 2 in the Appendix). The number of bearing members was doubled, and the dimensions of the bearing surface per member was lengthened from 12-in. to 30-in. and narrowed from 3-in. to 1-in. The original bearing blocks were trimmed to a width of 2-in. and welded to the middle of 38-in. lengths of 5 I 10 bearing distribution beams. These in turn transmitted the load to the midpoint of 30-in. lengths of 14 B 17.2 bearing members by means of 2-in. x 3-in. pads of 1-in. thick layered fabric bearing material. The load was transmitted to the sign structure along the full 30-in. length of the 14 B 17.2 beam sections by 1-in. wide strips of 1-in. thick elastomeric bearing material. Figures 9 and 10 and Exhibit 2 in the Appendix show the arrangement of the members. Note that the 1-in. wide elastomeric bearing pads were located next to the outside edge of the chord angles. This placed the centerline of the load very close to the web-to-angle leg connection plane.

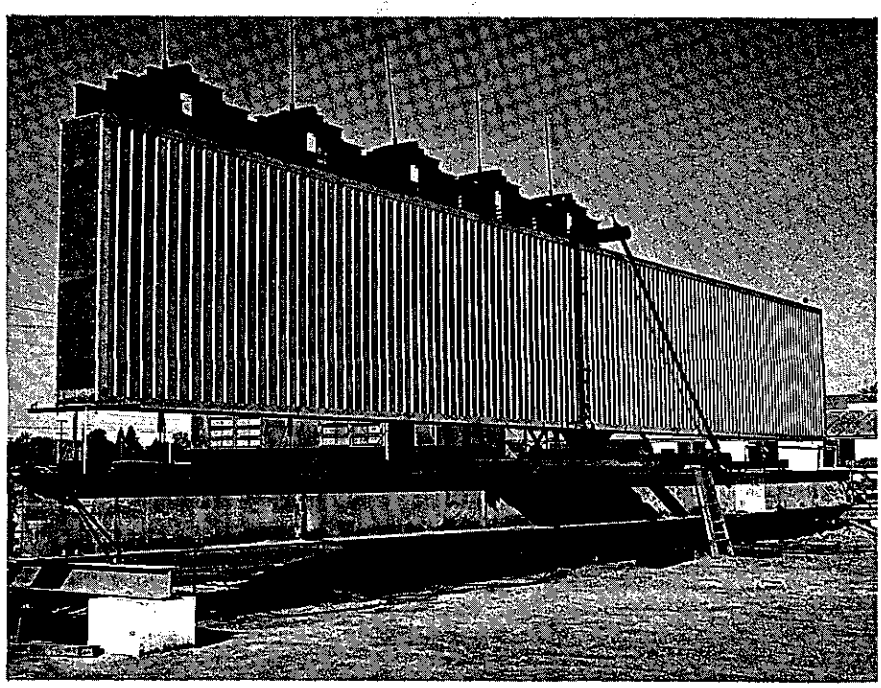
Figure 9

REVISED LOAD DISTRIBUTION APPARATUS FROM NORTH SIDE OF ALUMINUM SIGN STRUCTURE

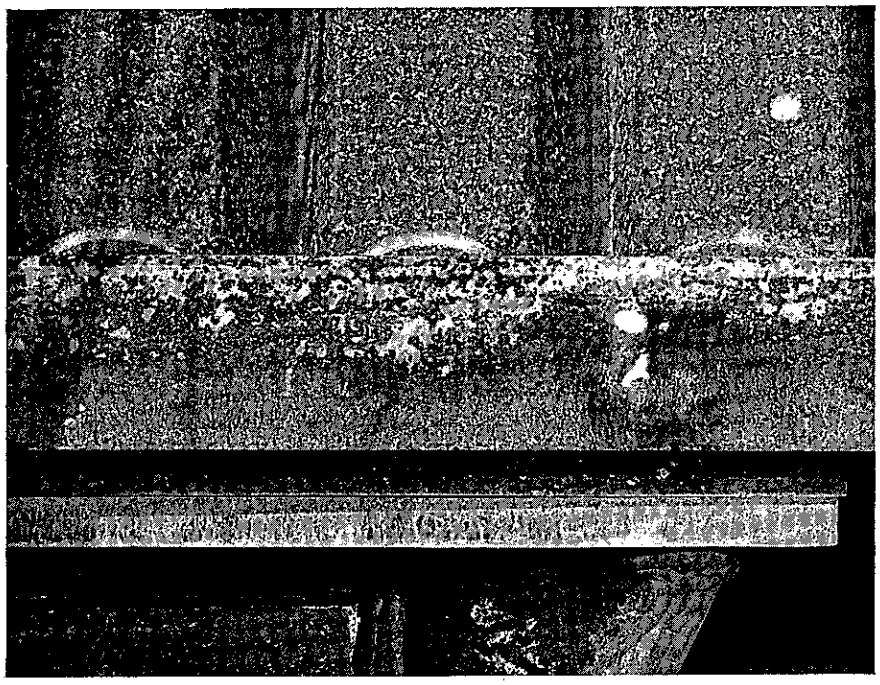
Figure 17

The first full test sequence was performed April 9, 1969, on the plug welded half of the steel sign structure. No significant indications of distress were evident until the load reached 1.8 kips per foot. Then vertical twisting of web face panels became visibly apparent, and the structure began emitting an occasional snapping or popping sound. The web twisting increased as more load was applied. At a load of 2.6 kips per foot, outward deflection of the vertical legs of the bottom chord angles was noticed above the support plate at the column. This deflection increased substantially as the load increased to 3.2 kips per foot. This was the maximum load applied to the structure since greater leg deflection might adversely affect the second half of the sign, which was yet to be tested.

When the load was withdrawn, a slight warp remained in the angles. The web material, at the connections to the twisted angles, sustained permanent deformation in the form of stress rings. These rings occurred at the first 7 connections out from the center line on both web faces and are shown in Figure 17.

STRESS RINGS AT PLUG WELDS WHERE VERTICAL LEG OF CHORD ANGLE ROTATED OUTWARD ON STEEL STRUCTURE

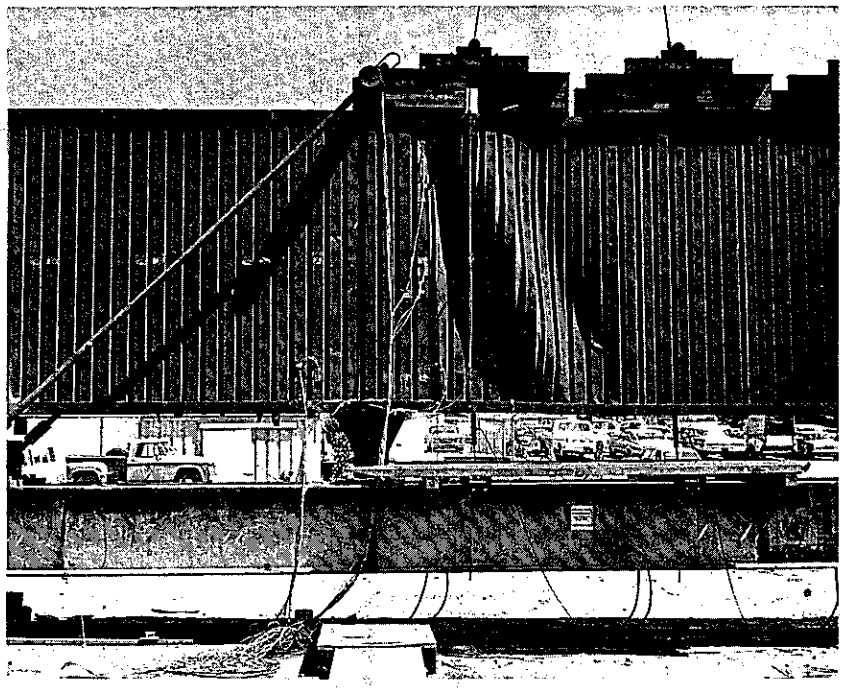
Figure 18

The Huckbolted end of the steel structure was tested on April 29, 1969. As this structure was loaded, cracking and drumming sounds were produced and severe vertical twisting of the web ribs occurred. At a load of 2.2 kips per foot, the chord angles of the lower flange deflected outward slightly, and the side web on both sides of the diaphragm deflected inward. While approaching a load of 3.6 kips per foot, a sever undulating buckling of one side web suddenly occurred next to the post diaphragm, and the structure deflection increased substantially. The structure continued to support a substantial load, although less than at failure; but efforts to increase it only increased the deflection and longitudinal rotation of the structure (see Figure 21). The buckling pattern remained on one side when the load was removed and consisted of a convex buckle between two nearly vertical parallel concave buckles (Figure 18) while the other side sustained negligible permanent deformation. Each of the three buckles had a maximum deflection of 5 in. At the point where the trough nearest centerline intersected the top flange, the web material was torn about one Huckbolt fastener.

WEB FAILURE
IN HUCKBOLTED
END OF STEEL
STRUCTURE

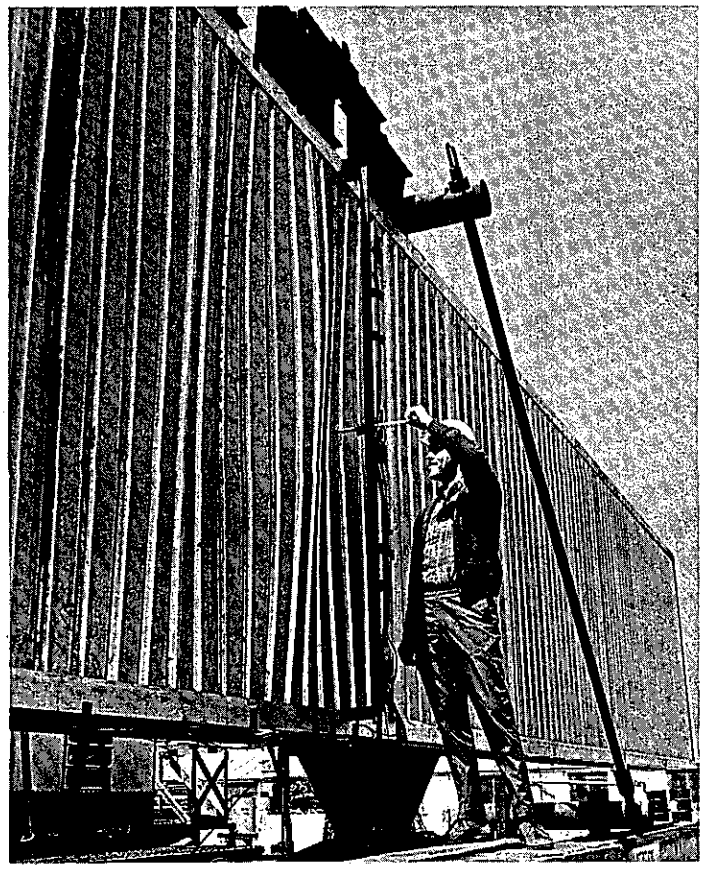
Figure 19

WEB DEFORMATIONS
OF PLUG WELDED END
ALUMINUM STRUCTURE
MAXIMUM LOAD PRIOR
TO FAILURE

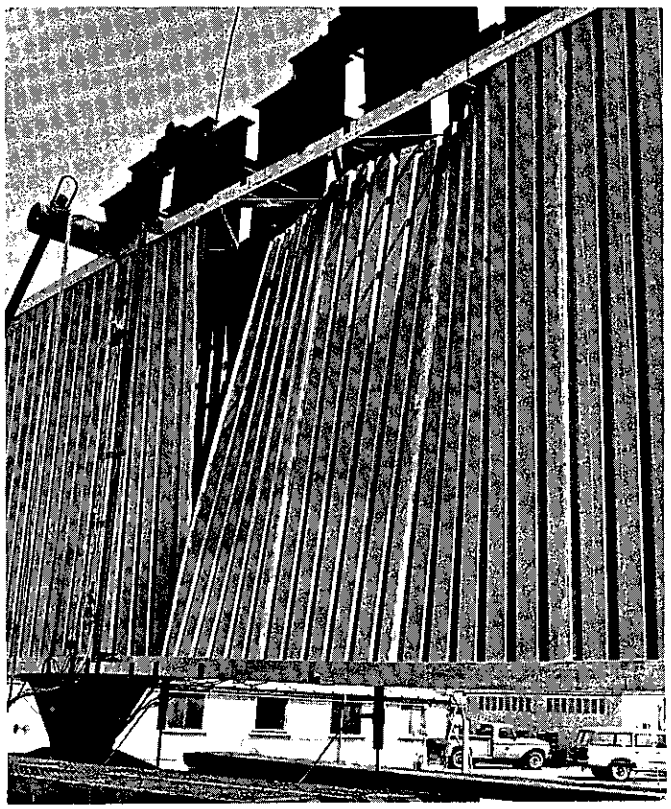
Figure 20

The plug welded portion of the aluminum structure was tested on May 13, 1969. Snapping and popping occurred more frequently as the load was increased. The web material on both sides of the post diaphragm bent inward and became more pronounced as loading increased. Vertical ripples in the web material were noticeable at a load of 0.8 kips per foot. The ripples grew to large slanted buckles which are shown in Figure 19. At a load of 1.7 kips per foot, a vertical welded web seam, located 4 ft from the centerline on one side of the sign structure, failed by cracking open 6 in. down the seam from the top of the web. The load was then released from the sign structure, which then appeared to sustain little permanent deformation. To reproduce the large buckles so that they might be photographed, the sign was again loaded to the same load level (1.7 kips per foot). The buckles regained their full depth of 2 in. (Figure 19); the tear in the web weld seam lengthened 2 in.; and a second seam 7 ft from centerline opened 4 in. down the seam at the top of the web. While holding a load of 1.7 kips per foot, the seam 4 ft from centerline failed completely, All of the plug welds connecting the top of the web to the upper chord angles failed between the failed vertical seam and a point 12 ft from centerline, and the welds connecting the bottom of the web to the lower chord angles failed from the failed vertical seam to a point 1.5 ft from the center. Intermittent weld separations occurred along the bottom flange from 4 ft to 11.5 ft from centerline. The sign deflected downward and twisted about its longitudinal axis. The sign, as it appeared after this failure, is shown in Figure 20.

WEB FASTENER AND SEAM FAILURE OF PLUG WELDED END OF ALUMINUM STRUCTURE

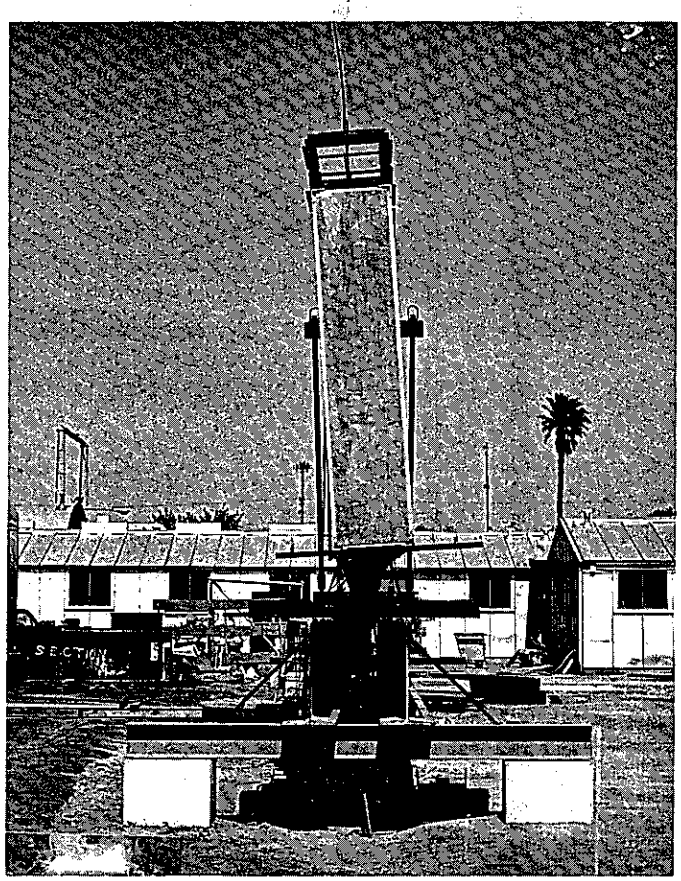
Figure 21

HUCKBOLTED END
OF ALUMINUM
STRUCTURE
AFTER TESTING

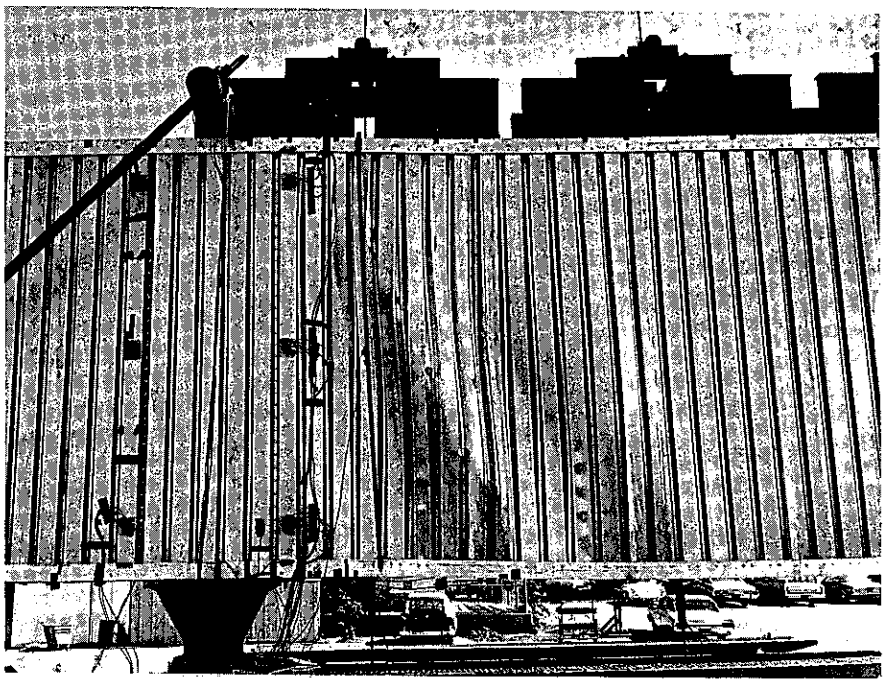
Figure 22

The Huckbolted half of the aluminum sign structure was tested on May 23, 1969. The sign was loaded to 1.2 kips per foot before any significant indications of distress were evident. Ripples then appeared in the web and grew into large buckles. At a load of 1.65 kips per foot, the load began to drop and the sign structure continued deflecting downward. The failure occurred quietly and gradually. The sign was then unloaded to determine the structure's ability to regain its original shape. One web sustained permanent deformation in the form of shallow buckles. The load was again applied, but only a magnitude of 1.35 kips per foot could be attained. The buckles on the failed side deepened, and the sign twisted further about its longitudinal axis as shown in Figure 21. The buckles consisted of two convex and two concave troughs as shown in Figure 22. The two major buckles in the middle were 6 in. deep and the other two were 3 in. deep, measured from a reference plane at the face of the chord angles.

FAILED SIDE OF HUCKBOLTED END OF ALUMINUM STRUCTURE
