STATE OF CALIFORNIA
DEPARTMENT OF TRANSPORTATION
DIVISION OF CONSTRUCTION AND RESEARCH
TRANSPORTATION LABORATORY

November 1974

EVALUATION OF ASPHALT CONCRETE

PRODUCED BY THE DRYER-DRUM MIXING PROCESS

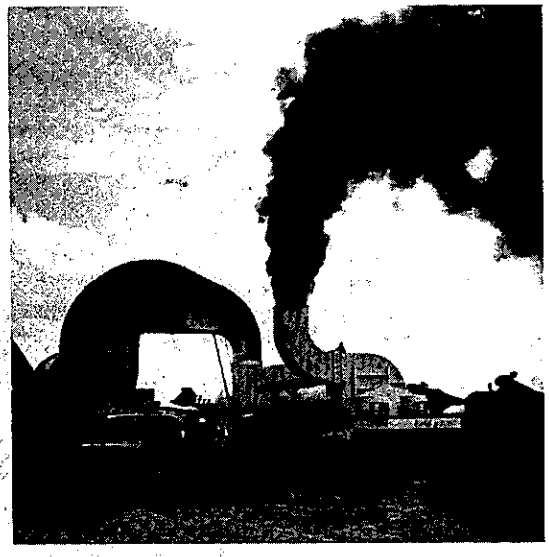
Figure 1

Dryer-Drum Mixing Plant During
First Week of Operation

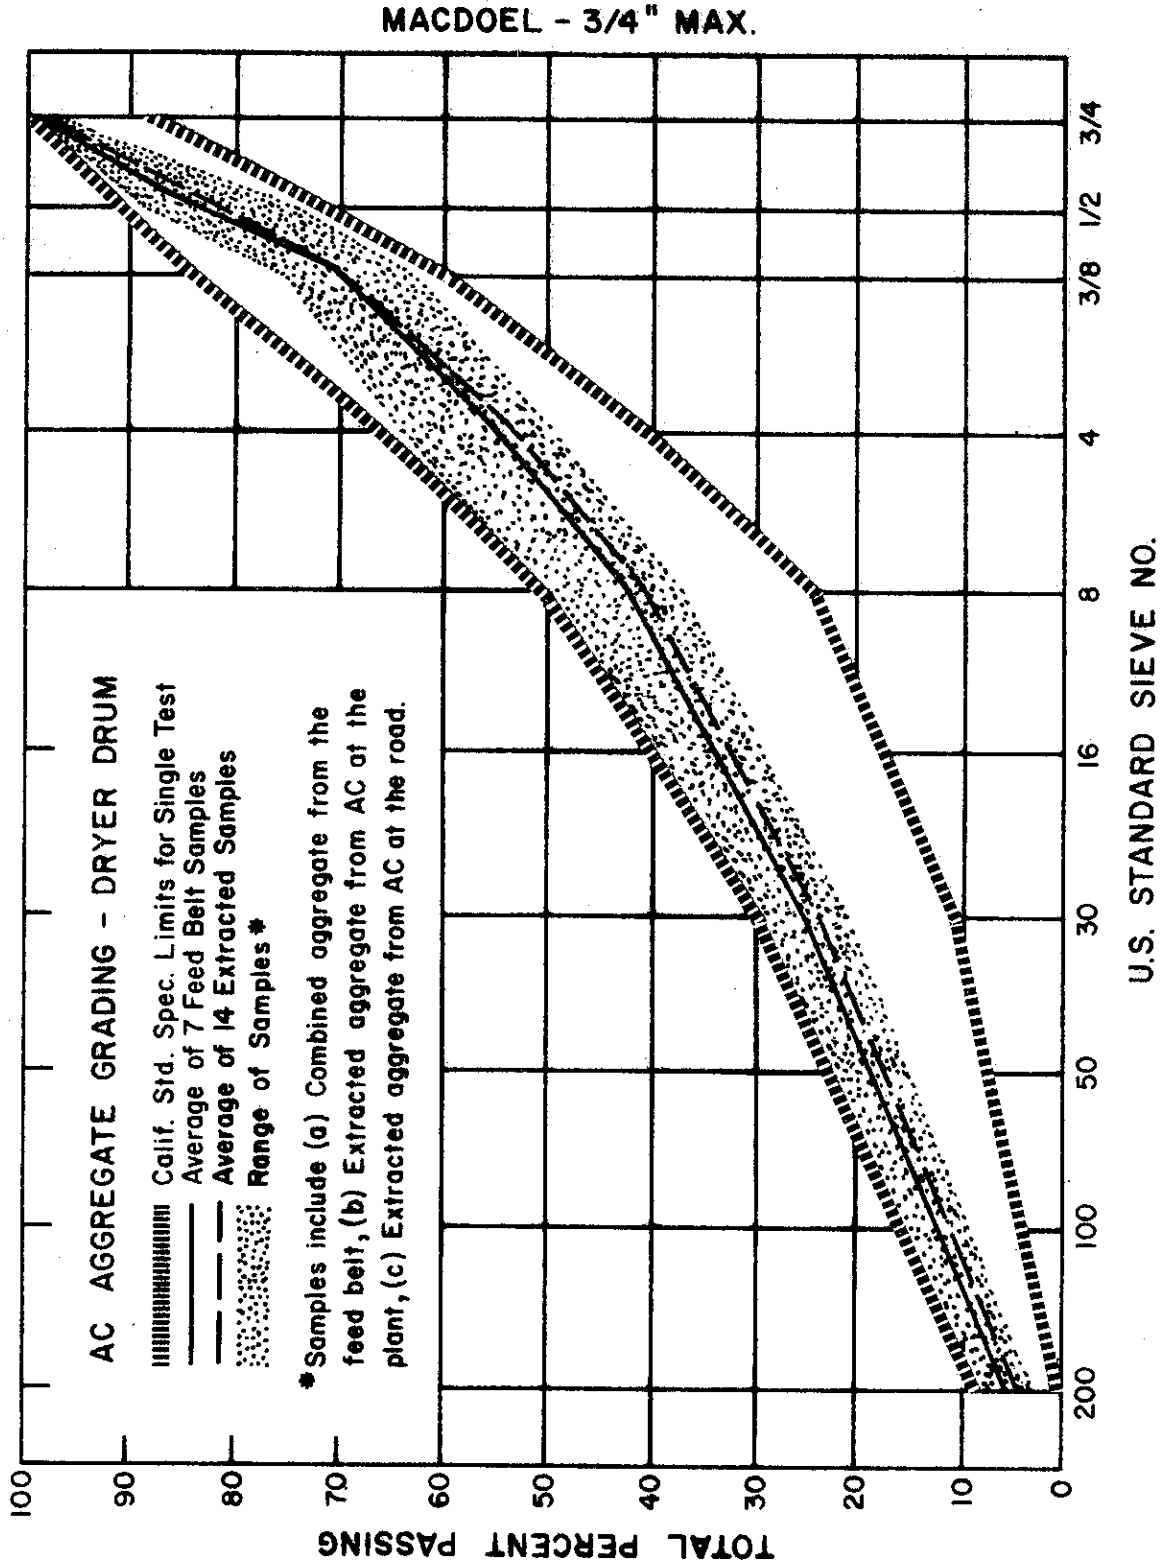
The results of the aggregate gradation tests indicated that the aggregate combination obtained by the multi-hopper/conveyor-belt system was reasonably uniform and within the California Standard Specification limits. Figure 2 indicates the range of gradation evident in the aggregate and A.C. samples. The exhibited bias towards the upper limits of the gradation curve was attributed to the characteristic grading of the stockpile used for each cold feed hopper rather than to any fault of the system.

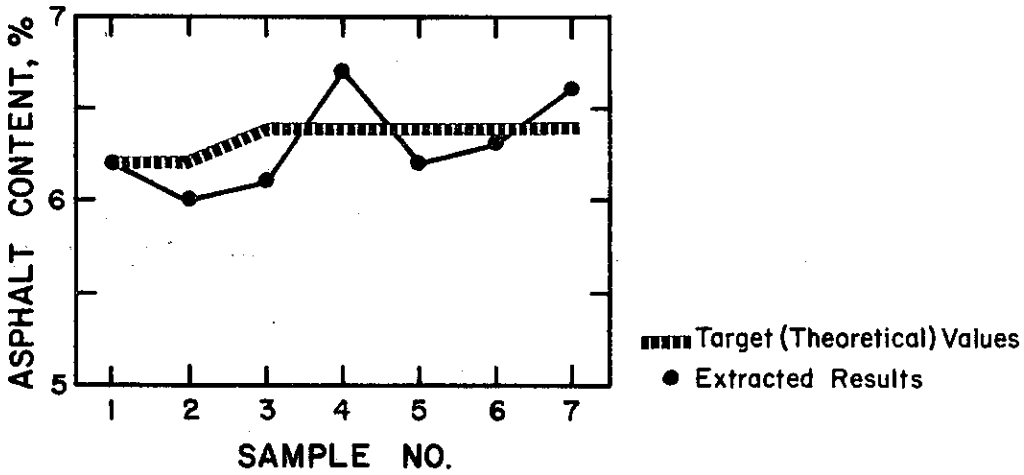
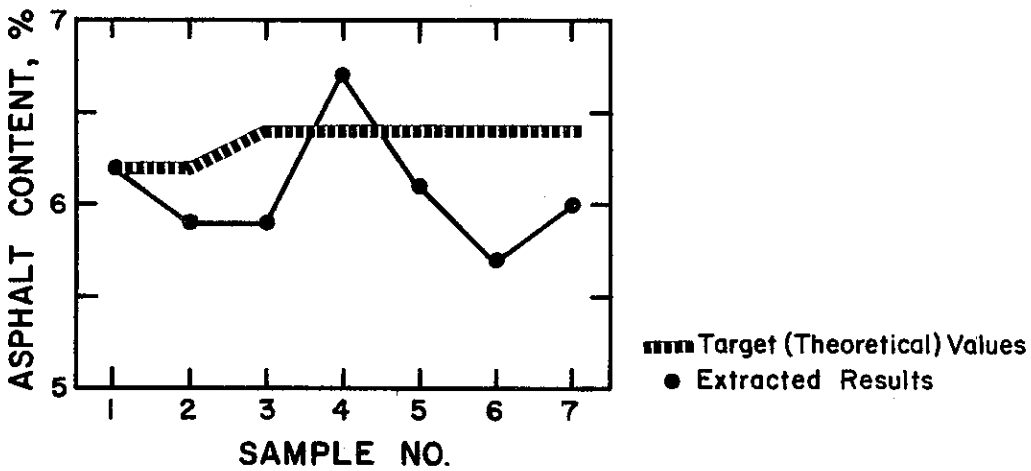
Figure 3

ASPHALT CONTENT VARIATION MACDOEL

3A- Asphalt content of AC sampled at the plant

3B- Asphalt content of AC sampled at the street

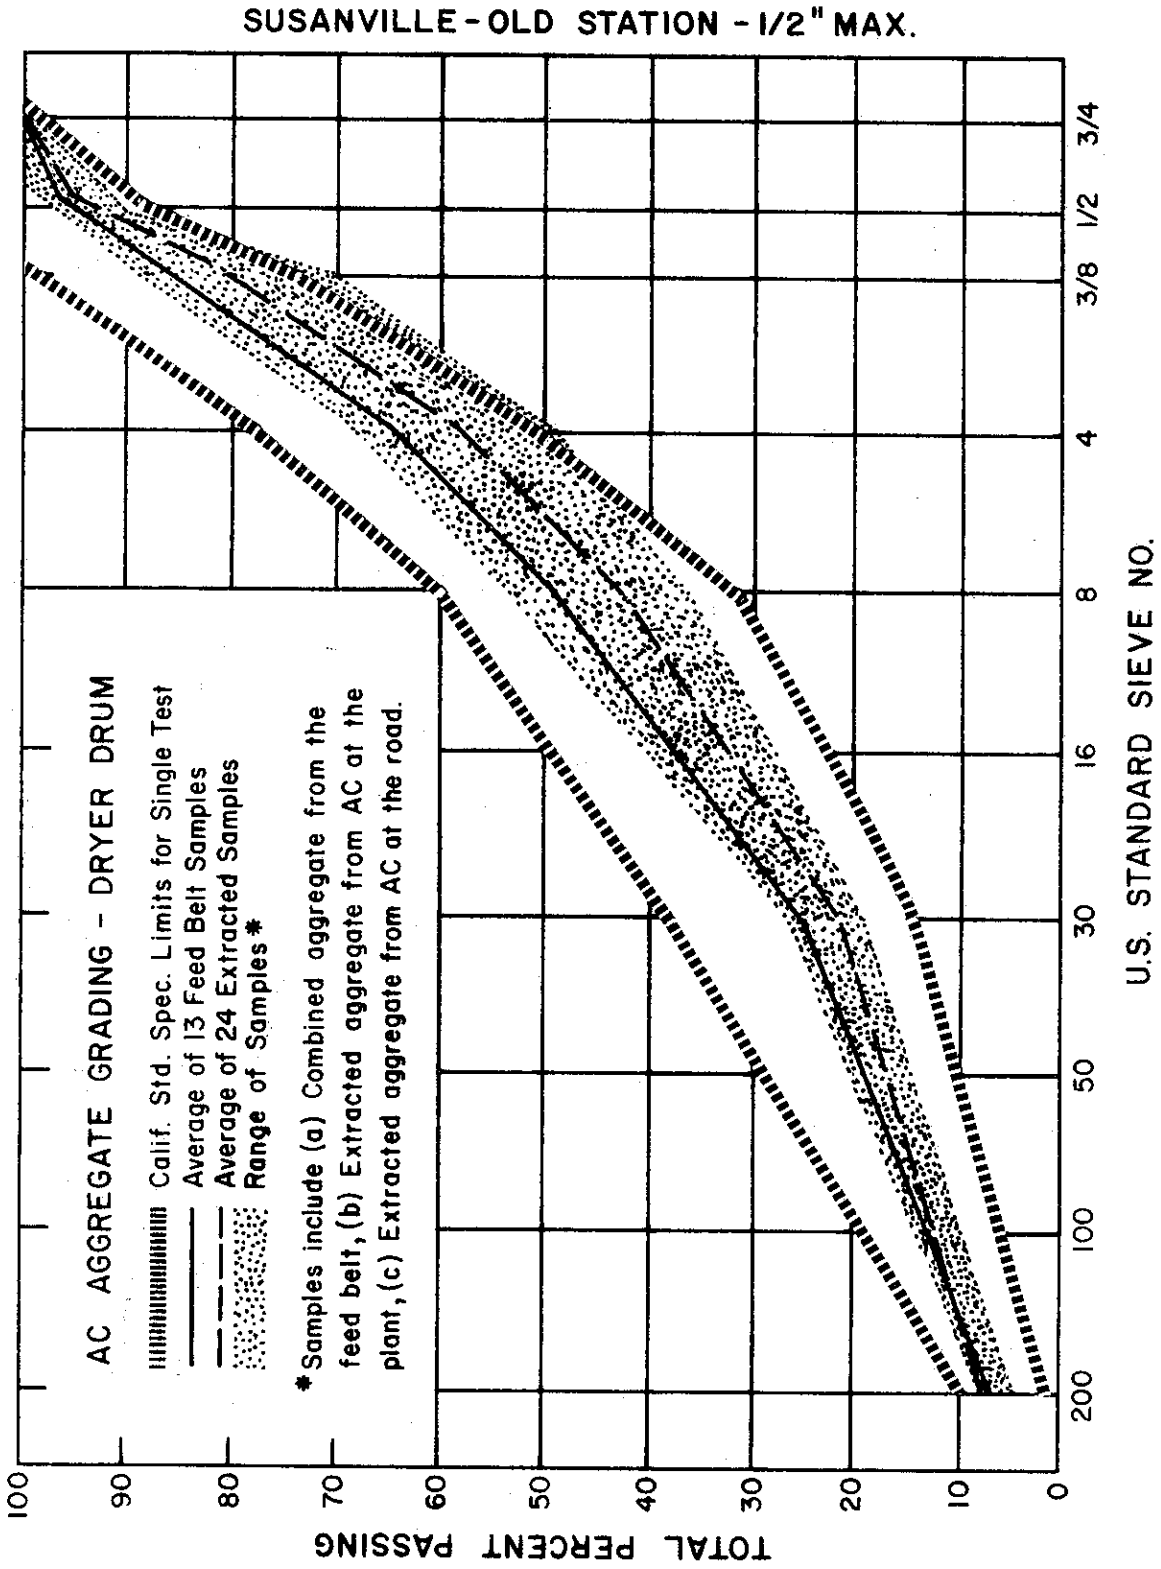
Figure 5

Results of the second project again indicated that the aggregate gradation obtained by the system was reasonably uniform and within specification limits. Because the mat thickness varied from 0.1 ft. to 0.2 ft. two mixtures were used for the project, a 1/2-inch maximum and a 3/4-inch maximum aggregate grading. Figures 5 and 6 indicate the range of gradation measured. Part of the variation was due to adjustments by the contractor when apparently attempting to use a maximum amount of natural fines for economic reasons.

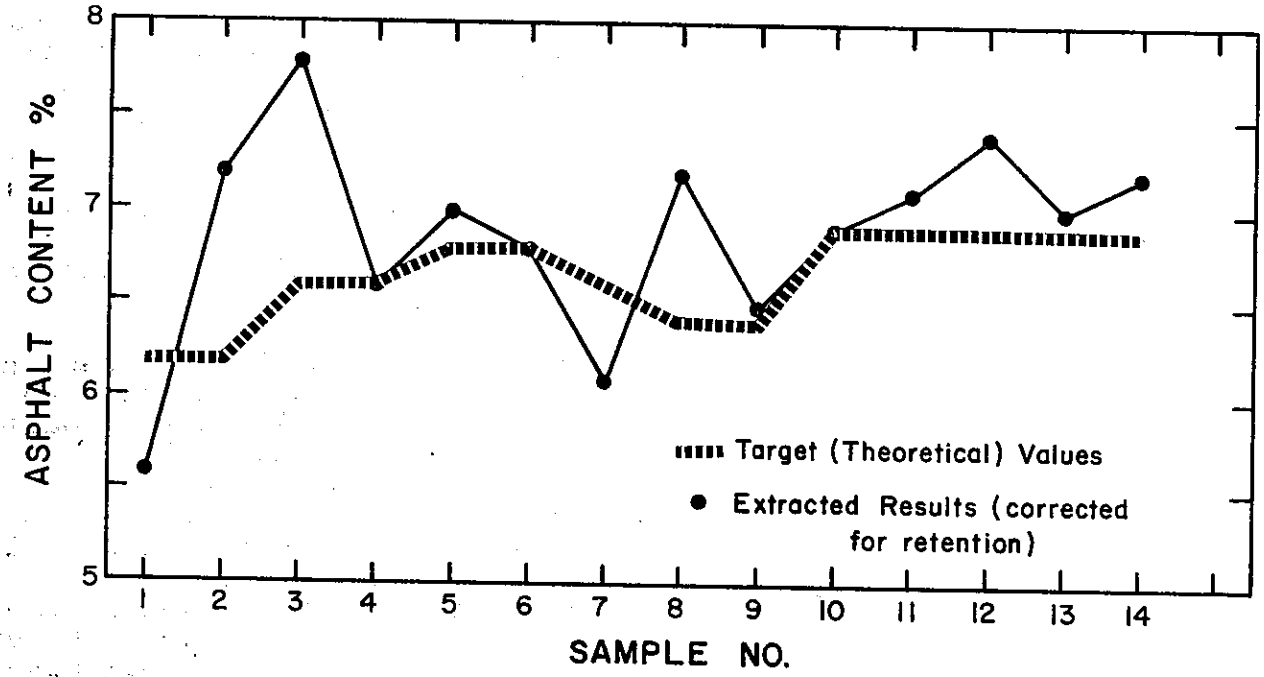
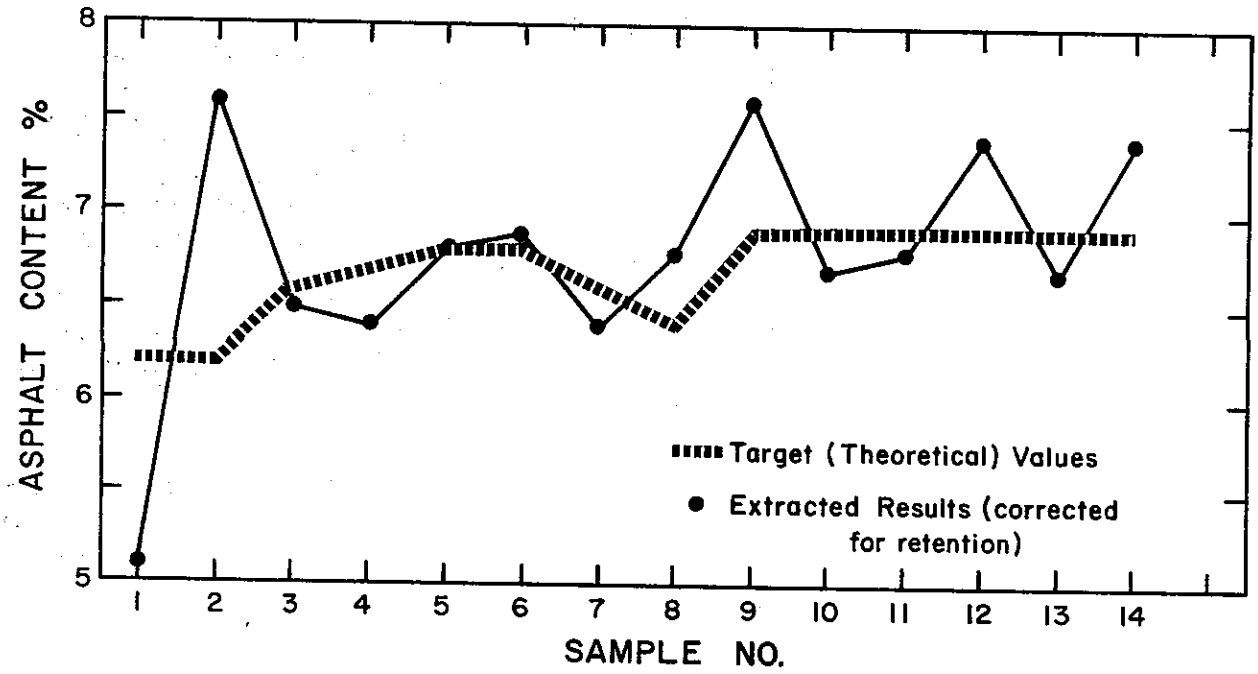
samples. (This was not done for the Macdoel project.) The results of these tests, shown in Figure 7 and Table 5, indicate that the asphalt content variation obtained did center about the target value, with a standard error of ± 0.3 percent asphalt (this magnitude is ± 4.5 percent of the target value). This uniformity matches the capabilities of many conventional batch plants as reported by Granley and Olsen in the September, 1973, issue of "Public Roads". Figure 8 is reprinted from this publication and the standard error of the samples from the Susanville-Old Station project is superimposed on their bar graph.

ASPHALT CONTENT VARIATION
Susanville - Old Station

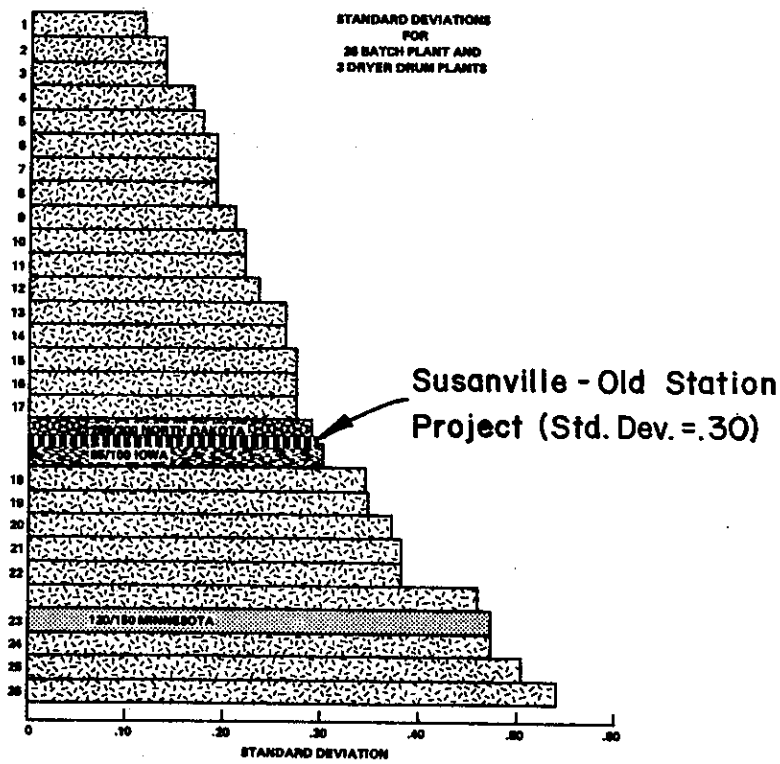
Figure 8

STANDARD DEVIATIONS FOR ASPHALT CONCRETE PLANTS
(26 Batch Plants and 3 Dryer Drum Mixing Plants)

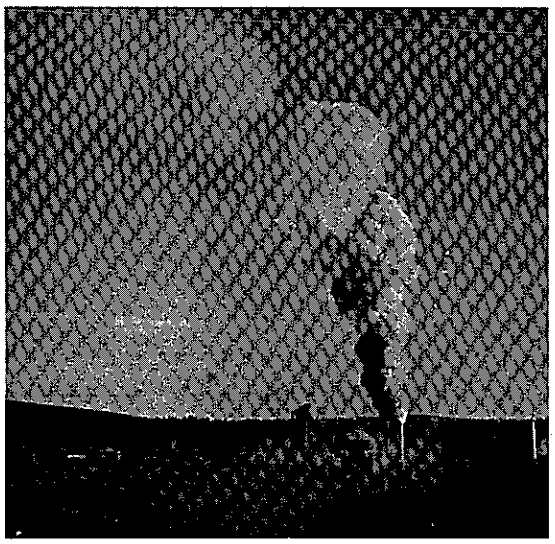
Figure 9

The exhaust stack emitted billowing clouds of dust despite the built-in cyclone collector. Consequently, the contractor erected a water-scrubber on the stack on October 9, 1973. The water-scrubber emitted a substantial quantity of steam, and necessitated the creation of a settling pond for the effluent, but was successful in trapping the majority of the dust. The resulting opacity, as checked by Lassen County Air Pollution Control District officials, was improved from 80 percent to an acceptable 5 percent or less (Figures 9 and 10).

Steam Emitted by Water-Scrubber at the Susanville-Old Station Project

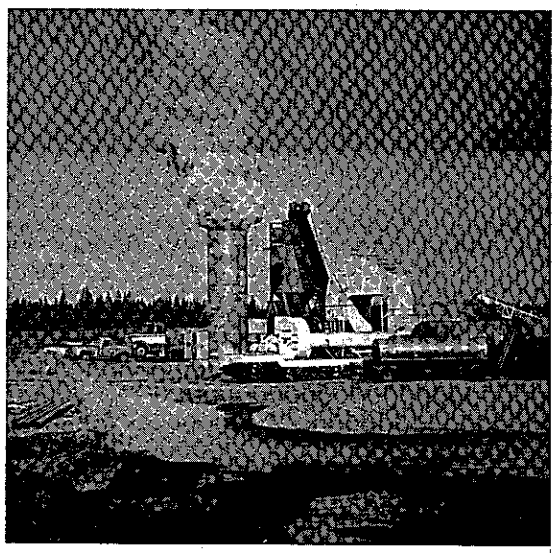
Figure 10

Plant in Operation, with the Settling Pond of Scrubber Effluent in the Foreground. The Discharge Line of Still-Steaming Effluent is Visible at the Bottom of the Stack.

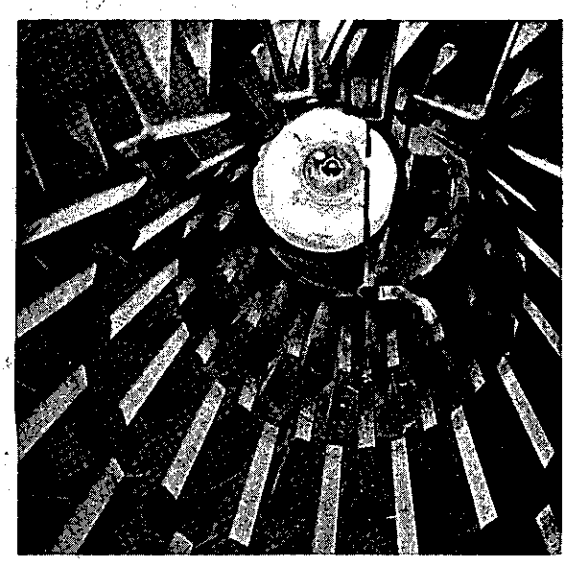
Figure 20

The internal configuration (baffles) for this particular plant is shown in Figure 20. The asphalt concrete mixing time (as per the manufacturer's representative) was 2-1/2 to 3 minutes. The temperature of the mix at discharge varied for both projects, but the range of the majority of the mix was between 220°F and 250°F.

Interior of Drum Looking Toward Burner. Note Internal Baffle Arrangement and Asphalt Discharge (Arrow).

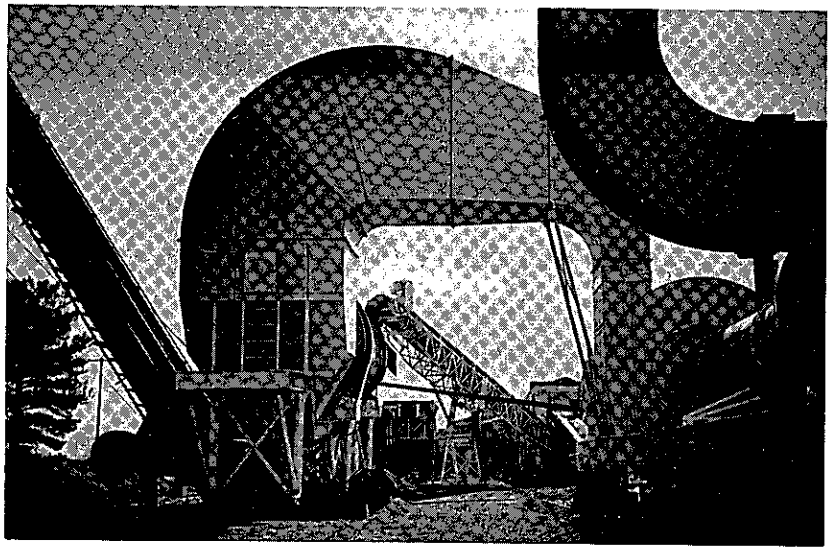
Figure 21

The dust-collection system used initially consisted of a cyclone collector (Figure 21). The collected fines were then returned via conveyor-belt onto the main feed belt, and thus back into the dryer-drum mixer. Smoke and suspended fines were carried to the exhaust stack. During the project, a water-scrubber tower was erected around the exhaust stack to trap the suspended fines and thus meet pollution control requirements (Figure 22).

Intake Duct Carrying Smoke and Dust to the Cyclone Collector at Right. The Exhaust Stack is at Upper Foreground.

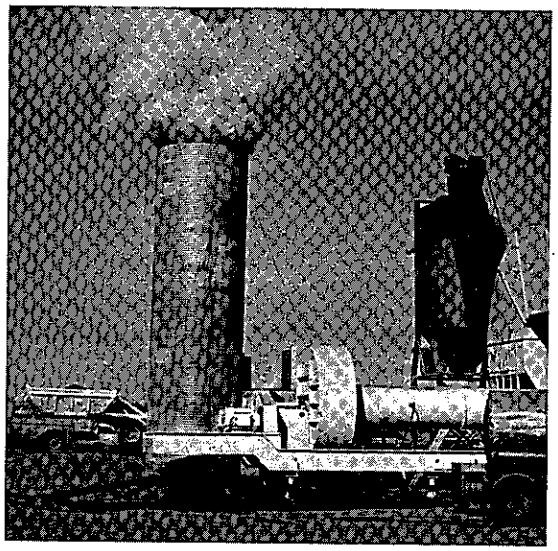
Figure 22

Water-Scrubber Attached to the Exhaust Stack
