Damage To Pavement Due To Axle Loads

FINAL REPORT

CA-DOT-TL-3158-1-76-64

DECEMBER 1976

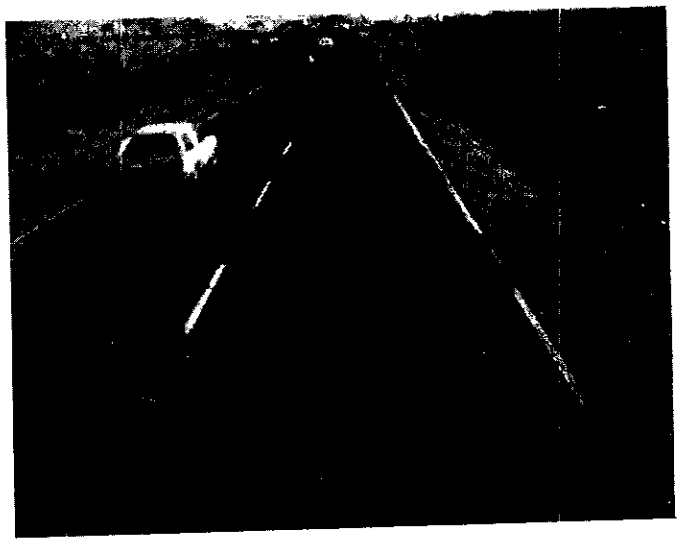
FIGURE 7

Several photos of asphalt concrete pavement, Figures 7 and 8, show the prevalence of damage in the outside freeway lane, which generally takes over 80% of heavier truck traffic for 6-lane freeways and about 90% on most 4-lane freeways. These pictures graphically illustrate the damage done by the heavier loads. The type of failure illustrated is called "alligator cracking" and is due to fatigue, or failure due to repetition of loads and consequent stresses and strains that cumulatively cause failure.

Typical Structural Failures on 4-Lane Freeways

The first signs of failure on multilane highways invariably occur in the outside lanes which generally handle about 85% of the truck traffic. Structural overlays are applied as a repair when needed. The overlay must be carried across the full width of the travelled way because a "step off" at the lane edge is intolerable from a traffic safety standpoint. This adds considerably to the cost of pavement rehabilitation.

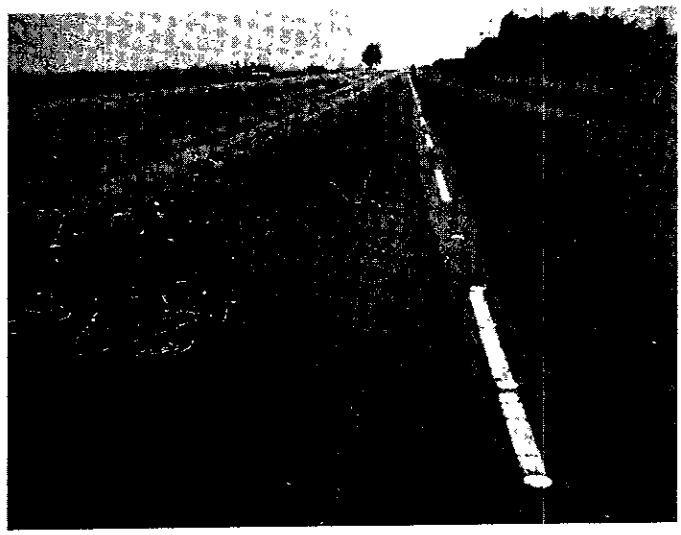
FIGURE 8

Typical Structural Failures on 4-Lane Freeways

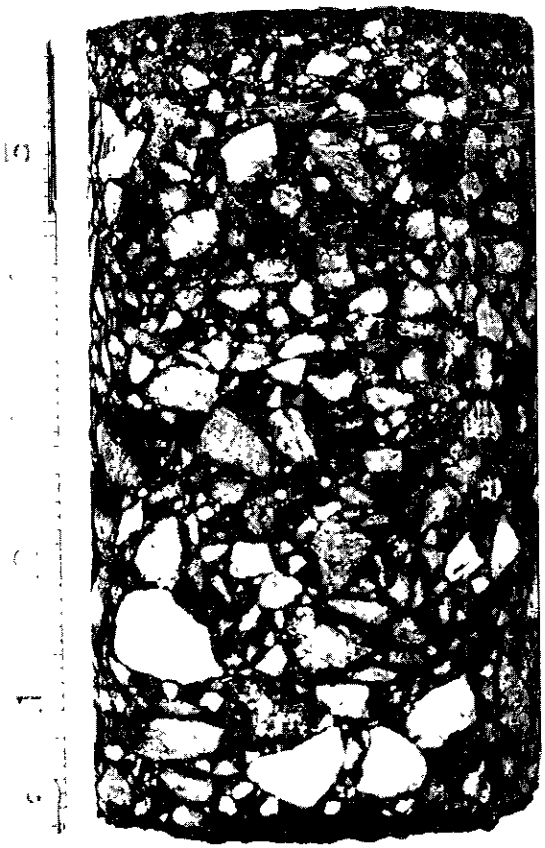
Photos (Figure 9) show the present condition of the AC inner lanes of the Arroyo Seco Freeway. A picture of a pavement core extracted from this roadway is also shown. As previously noted, this pavement was placed about 1940 with no subsequent structural overlay. Figures 10, 11, and 12 show the present condition of pavements at three locations on Route 99, including pictures of pavement cores taken for comparison purposes. It should be noted that while no overlay repairs were required to carry only passenger car traffic on Arroyo Seco Freeway for 35 years, substantial overlays were required at all three Route 99 locations to accommodate the heavier loadings of trucks for about the same period of time.

OLD ARROYO SECO FREEWAY

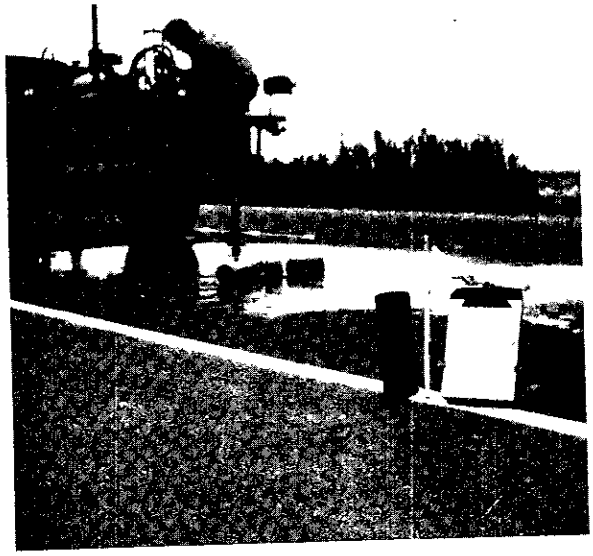
FIGURE 10

0.60'-0.75' A.C. (Avg. 0.68' A.C.) 1941
Opened to traffic 1941. Has been carrying trucks, buses, and autos since 1941

1.04' A.C. Total Depth

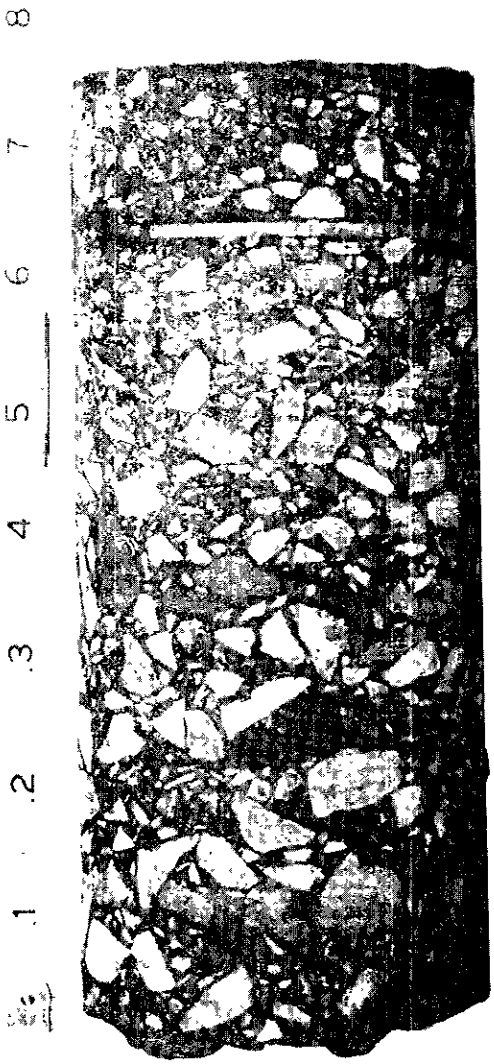
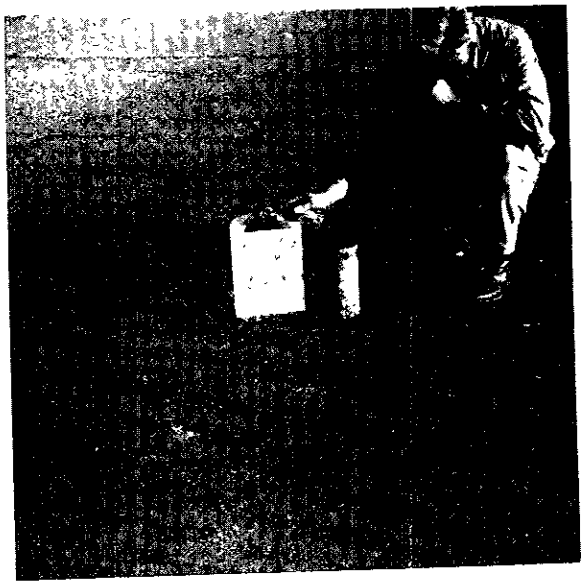
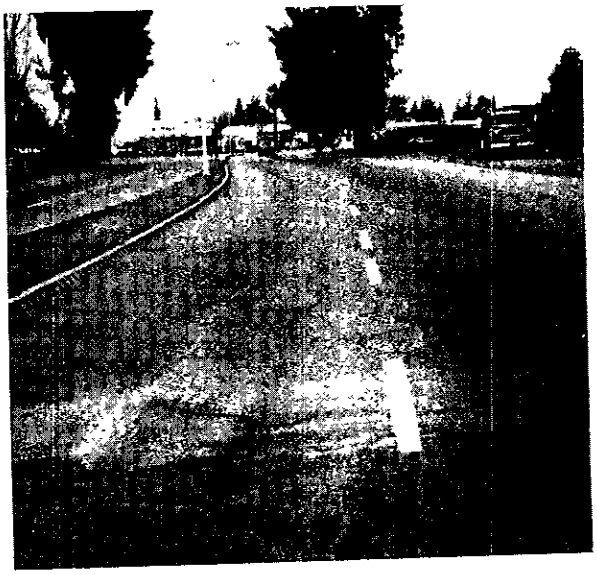
FIGURE 11

truck traffic, is about twice the original pavement thickness at Arroyo Seco, which has carried only passenger car traffic. The third location, represented by Figure 11, is old Route 99 through the City of Selma. This roadway was relinquished from the State to the City in 1965 and it has been carrying lighter traffic loadings for the past ten years. It also has much more stable subgrade support and therefore requires less pavement thickness than at the other locations.

0.15 A.C. Relinquished to Selma in 1965 - 1964 ADT = 20,000

0.60' A.C. 1938
Opened to traffic 1938
Has been carrying trucks, buses and autos since 1938

0.75' A.C. = Total Depth
