TRANSPORTATION LABORATORY

LANDSLIDE INVESTIGATION NEAR FOREST GLEN

01-Tri-36

REPORT
OF
LANDSLIDE INVESTIGATION
NEAR
FOREST GLEN, CALIFORNIA
01-TRI-36

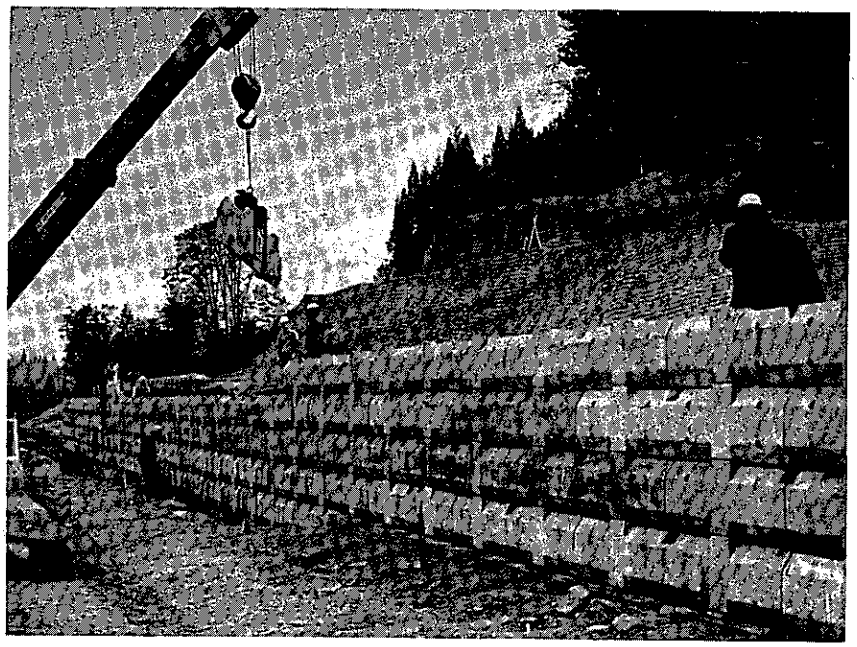
Two other experimental projects designated as "Mechanically Stabilized Embankment" with concrete beam facing and bar-mesh reinforcements were also constructed on Interstate Highway 5 at Dunsmuir, California, in September 1975 and May 1976, respectively, (Photo 1-a and 1-b). These experimental projects were designed and constructed by the California Department of Transportation under an agreement with the Reinforced Earth Company of Washington, D.C. Future construction using this system will be under their license.

PHOTO 1-a: Concrete Beam Facing of the Mechanically Stabilized Embankment on Interstate Highway 5 at Dunsmuir, California.

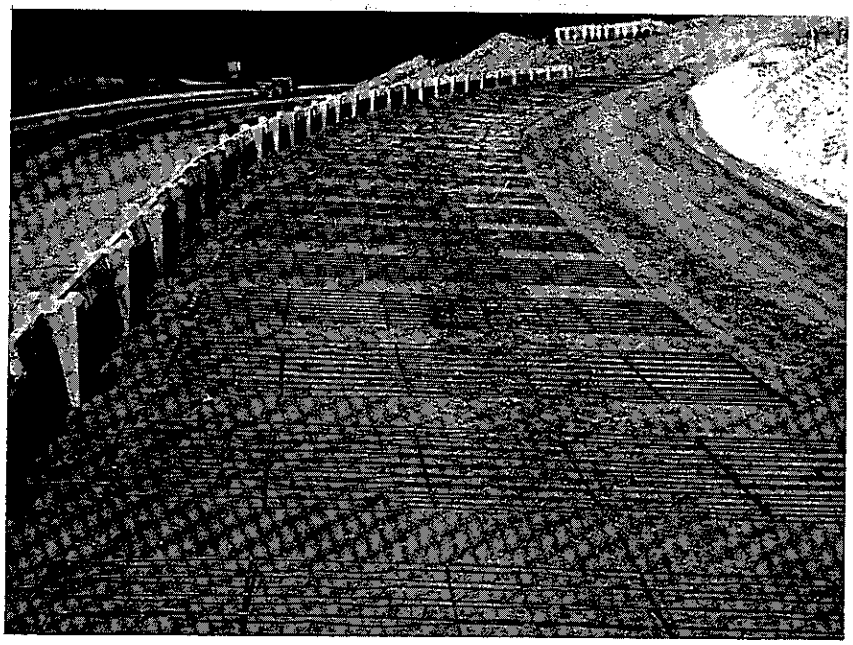
PHOTO 1-b: Reinforcing Bar-mesh in the Mechanically Stabilized Embankment on Interstate Highway 5 at Dunsmuir, California

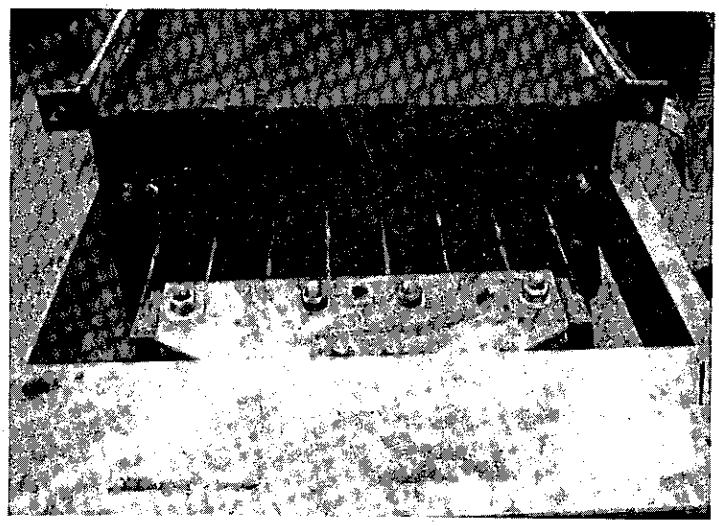
PHOTO 4: Failure Mode exhibited in specimen with 8-longitudinal bar (Test Run No. 5).

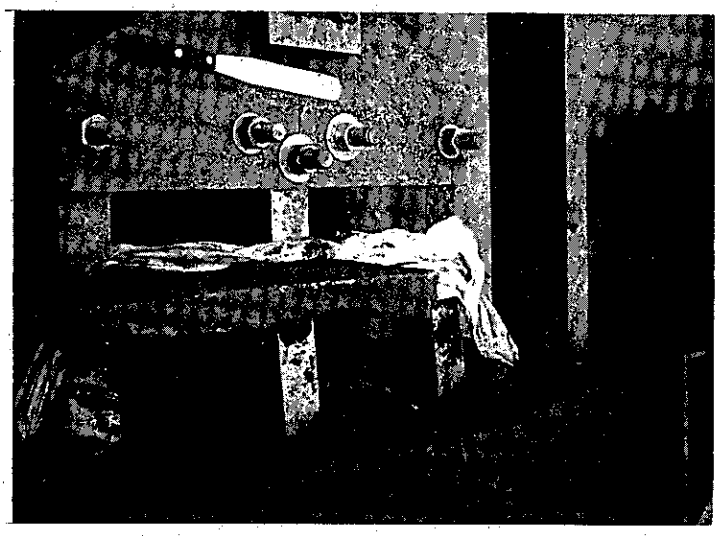
PHOTO 5: View of failure mode in specimen with three steel strips (Test Run No. 10).

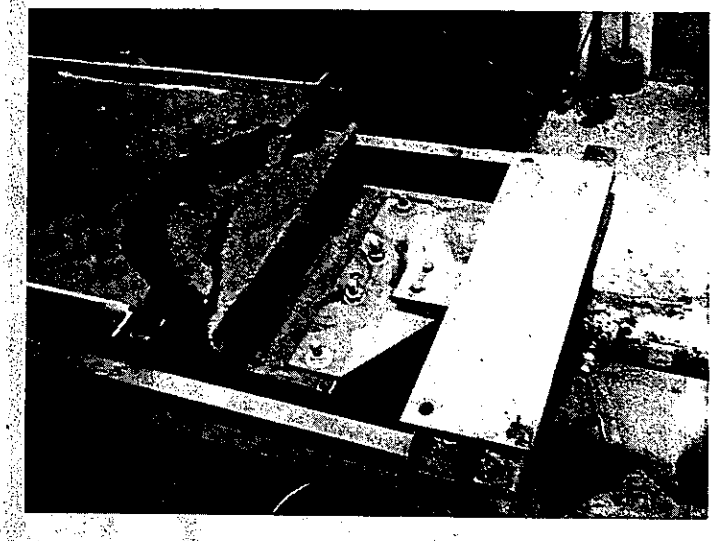
PHOTO 6: Cone-shaped failure mode exhibited in specimen with solid steel plate (Test Run No. 7).
