STATE OF CALIFORNIA

DEPARTMENT OF TRANSPORTATION
DIVISION OF NEW TECHNOLOGY,
MATERIALS AND RESEARCH

CATHODIC PROTECTION OF A REINFORCED CONCRETE BRIDGE DECK AND SOFFIT USING METALLIZED ZINC

FINAL REPORT # FHWA/CA/TL-91/05
CALTRANS STUDY # F84TL04

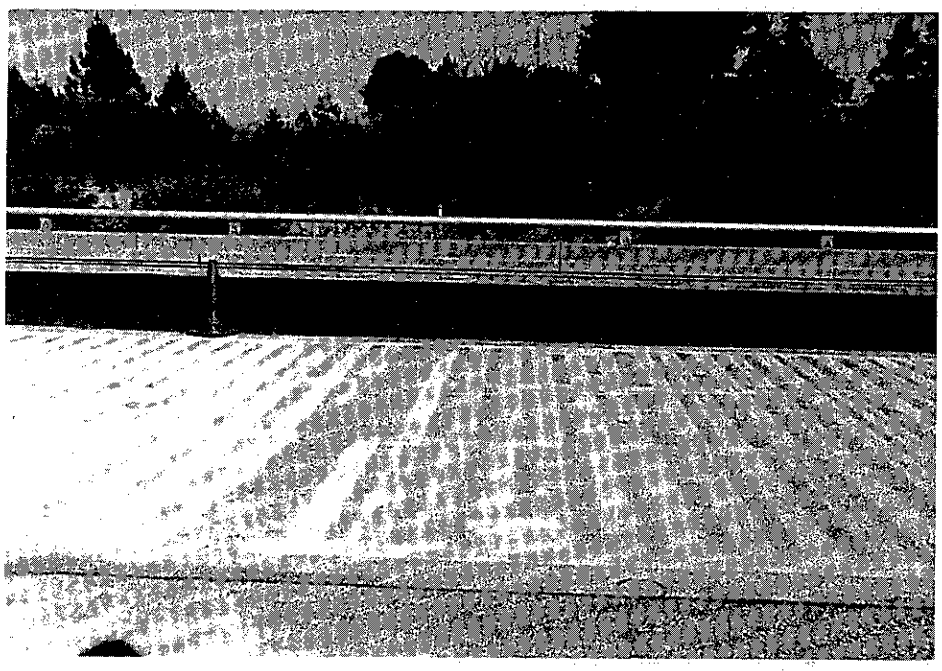
Figure 5-4, DECK METALLIZING GRID PATTERN, EAST CAMINO UNDERCROSSING

Since the resulting additional thickness of zinc on each stripe, due to the increased spacing, caused the metallized zinc to disbond from the concrete surface, the spacing was reduced to 10" O.C. and three spraying passes per stripe were used. These corrections reduced the amount of disbondment but did not eliminate it altogether. Partial disbondment was due in part to the slow traversing speed of the truck mounted equipment supporting the metallizing gun.

stripes were contained within each quadrant and did not bridge any of the one-foot-wide clear areas between quadrants. The result was a grid pattern of zinc stripes (Figure 5-4). The zinc stripes also traversed each exposed brass primary anode pad previously placed in the deck surface in order to make the necessary electrical connection to the CP rectifier.

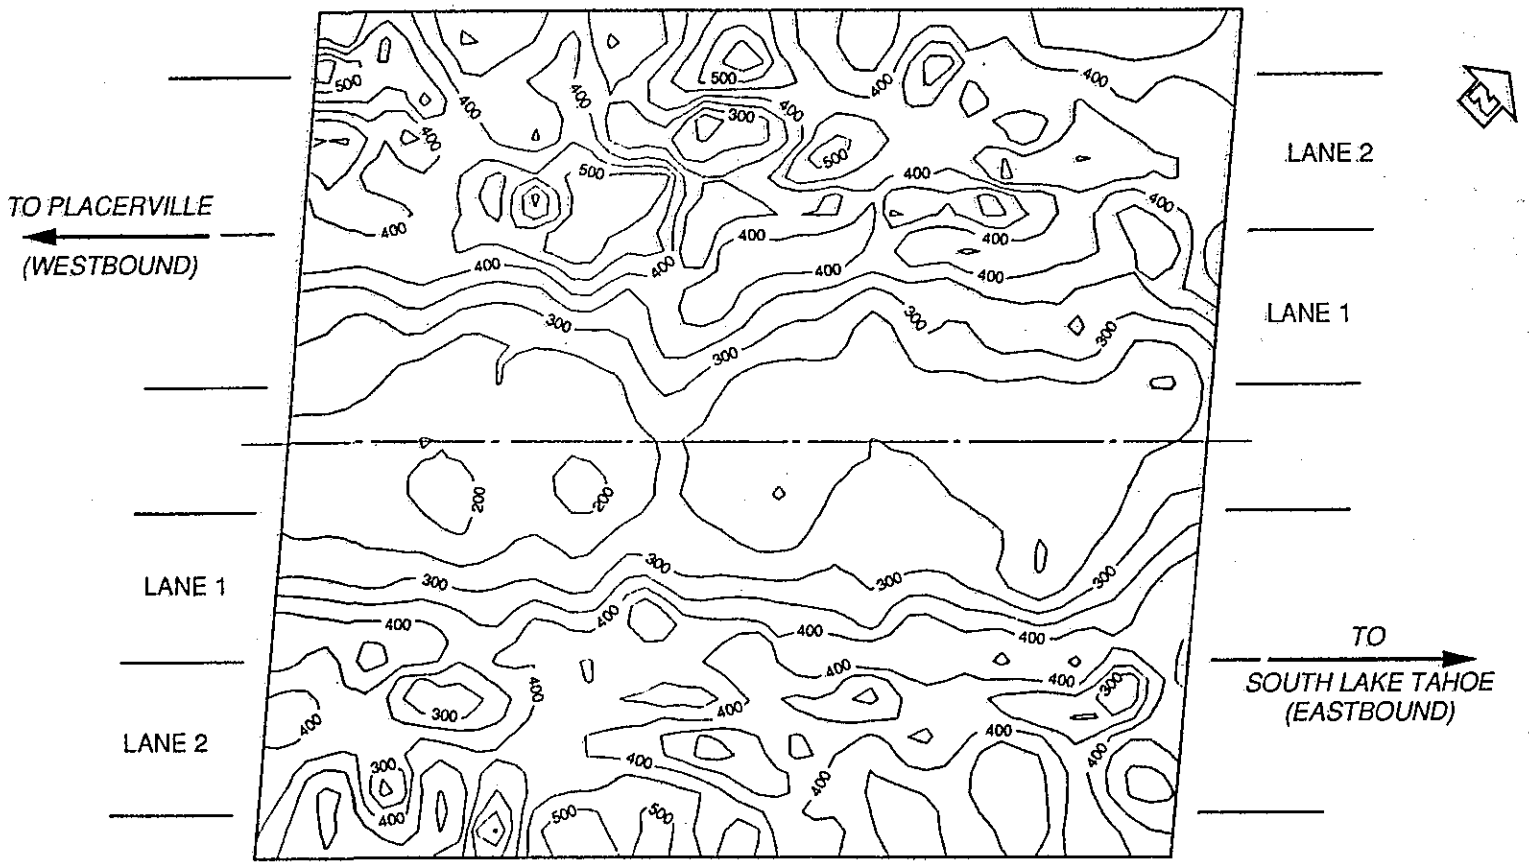
Figure 9-1, EAST CAMINO UNDERCROSSING DECK CORROSION POTENTIALS (NEGATIVE VALUES vs Cu-$CuSO_4$), APRIL 1985

LOCATION	Percent of Total Area of Deck vs Potential (Cu-$CuSO_4$)		
	< 200 mV (%)	200 to 350 mV (%)	> 350 mV (%)
EB Side	1.7	44.8	53.5
WB Side	0.1	44.7	55.2
Total Deck	0.9	44.7	54.4

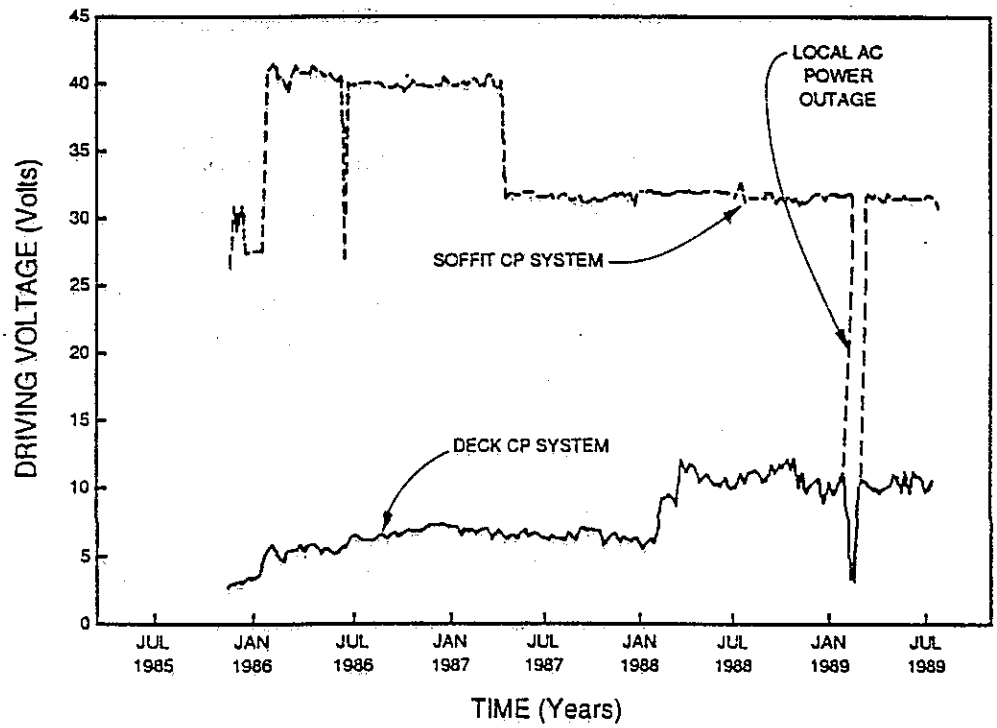
Figure 9-3, VARIATION OF DRIVING VOLTAGE VS TIME, DECK AND SOFFIT CP SYSTEMS

Driving Voltage: The driving voltage of the deck system was initially set at 3.0 volts (nominal) while the driving voltage of the soffit system was set at 26 volts. A graph showing the variation in the driving voltages during their CP operation is given in Figure 9-3.

The driving voltage was increased in January 1986 to 5 volts on the deck system and to 40 volts on the soffit system in order to maintain the design current density criteria of 2 milliamps per square foot of steel surface area. This was achieved on the deck CP system, but the current density of the soffit CP system increased only to 1.2 mA/sq ft.

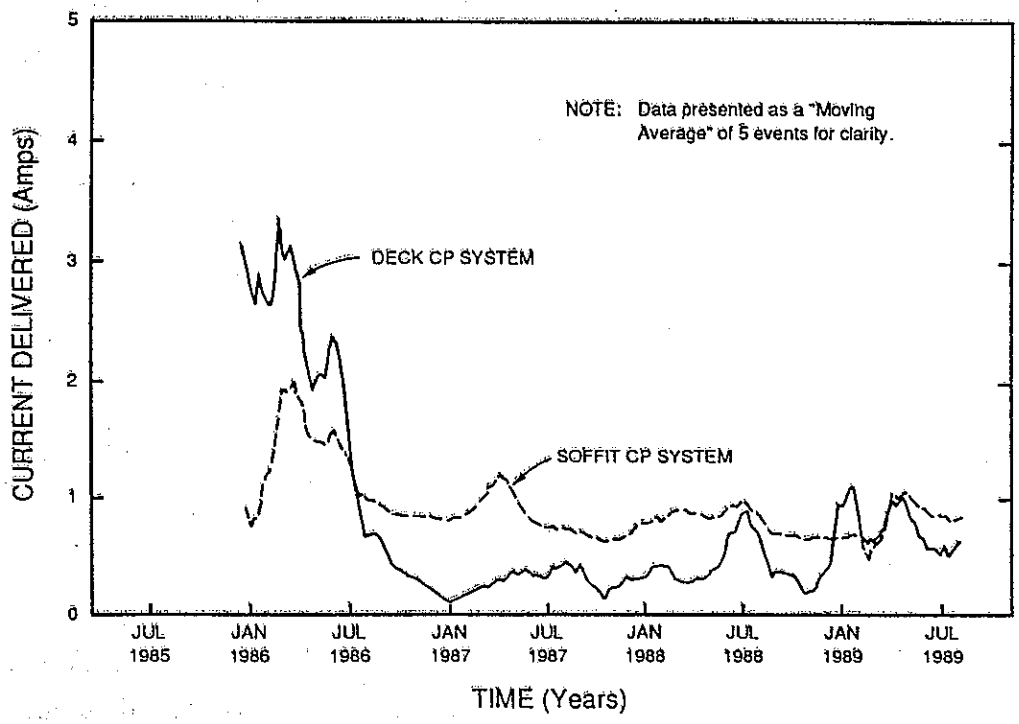
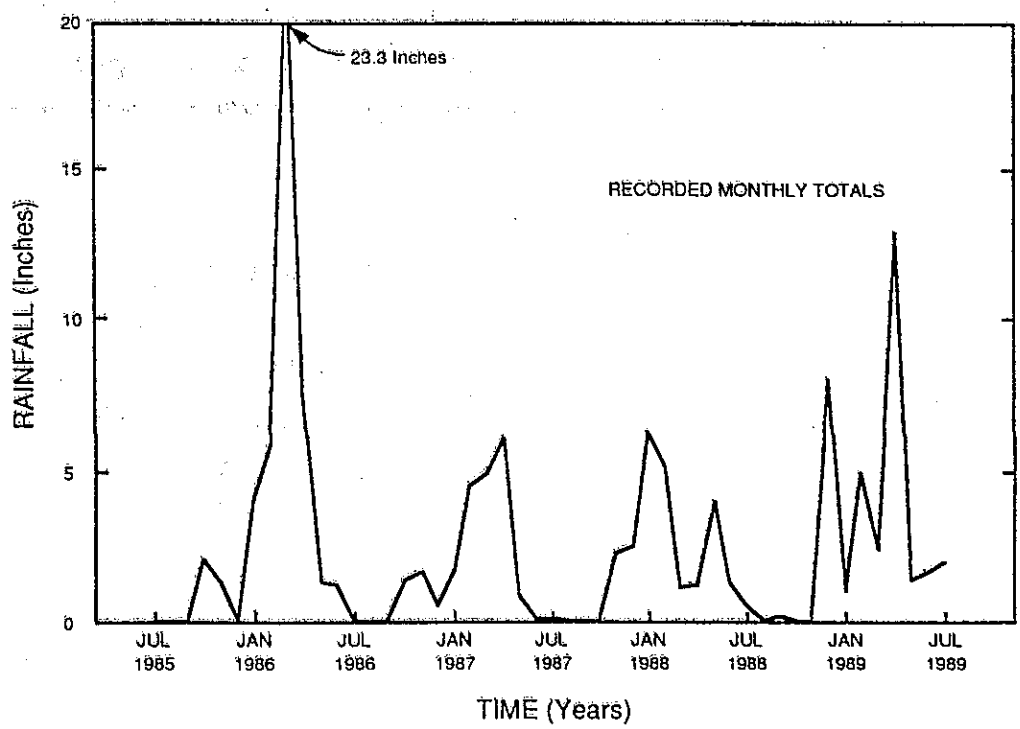
Figure 9-4, CP CURRENT AND PRECIPITATION VS TIME, DECK AND SOFFIT CP SYSTEMS

In January 1988, to compensate for the recorded reduction in the delivered CP current, the driving voltage of the deck CP system was increased to a nominal 9 volts. This increase in driving voltage increased the average current density of the deck CP system from 0.09 to 0.22 mA/sq ft of steel. Since we were still experiencing below normal precipitation, we felt that was the primary cause of the low current density readings. No further voltage adjustments were made to the system at this time. It was felt that when the expected rainfall increased, and the circuit resistance dropped, the current density could be excessive.

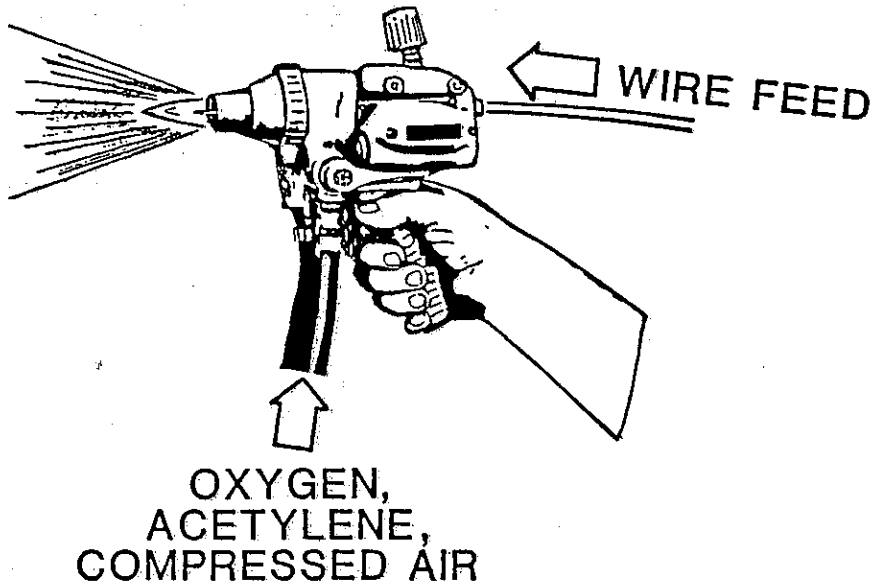
Figure 12-17, FLAME SPRAY METALLIZING GUN

The flame-spray process utilized a hand-held "gun". A single wire (in this case, zinc) is automatically fed through the back of the gun (powered by an air driven motor), and melted by the oxygen/acetylene gas flame. The resultant molten zinc is propelled out the nozzle by compressed air (Figure 12-17).
