CONSTRUCTION EVALUATED RESEARCH REPORT:

CATHODIC PROTECTION SYSTEMS INSTALLED ON SUBSTRUCTURE SURFACES

CA-92-02
03-NEV-80 PM 59.44
03-377601
Yuba Pass Overhead and Separation
Bridge No. 17-23L/R

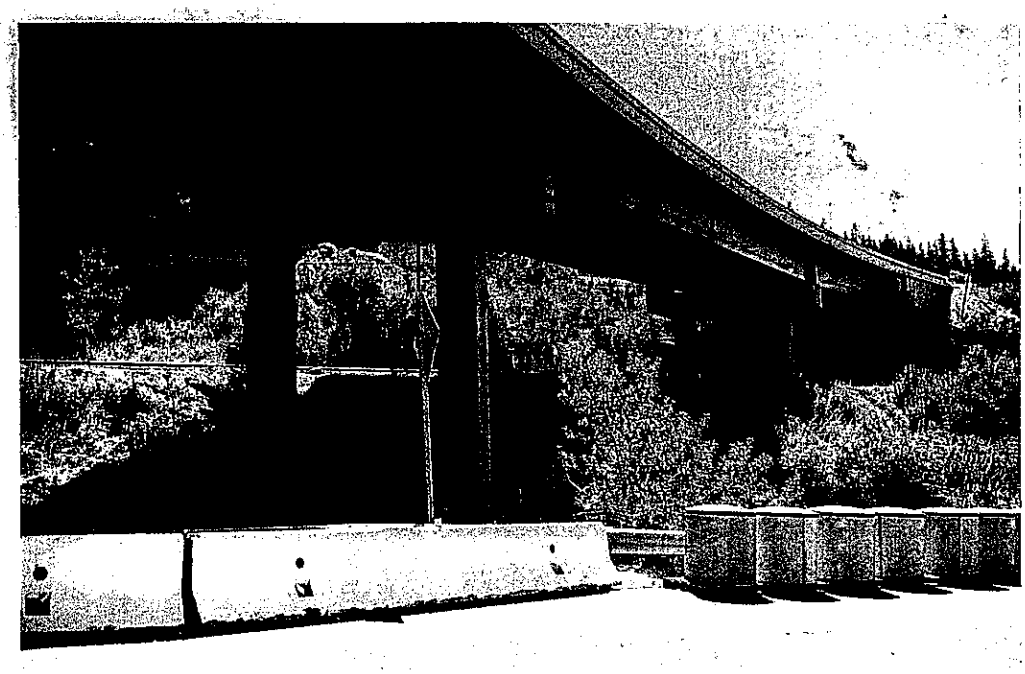
Figure 3. Yuba Pass Overhead and Separation (Bridges 17-23L/R). View facing Southeast. The left bridge is in the foreground.

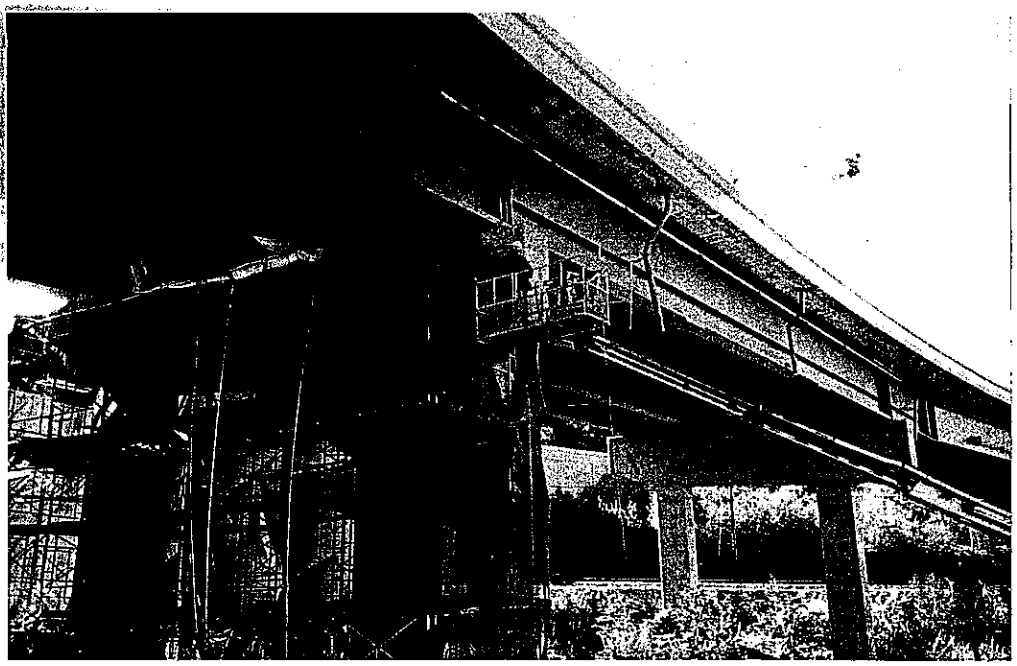
Figure 5. View of Bent 4L showing netting in-place to prevent construction debris from entering the roadway and creek.

Figure 6. View of Bent 4R showing corrosion damage to the No. 4 confinement reinforcing steel and No. 11 vertical reinforcing steel. Corrosion resulted in a loss of nearly 75% of the cross-sectional area of some No. 4 rebars. Although some of the vertical No. 11 rebars experienced corrosion, there was virtually no loss of rebar cross-section.

The confinement reinforcing steel was replaced by either replacing an entire segment (hoop), or by cutting out the corroded section and lap-splicing replacement reinforcing steel of appropriate length to the remaining portion of reinforcing steel. Lap splices were welded with a minimum 300 mm (12 inch) splice overlap. All welding was performed by certified welders in accordance with Sections 4-103, 4-1103D, and 9-1.03 of the Caltrans Standard Specifications. The replacement reinforcing steel was tied onto the vertical column steel to maintain the original 300 mm (12 inch) confinement steel spacing.

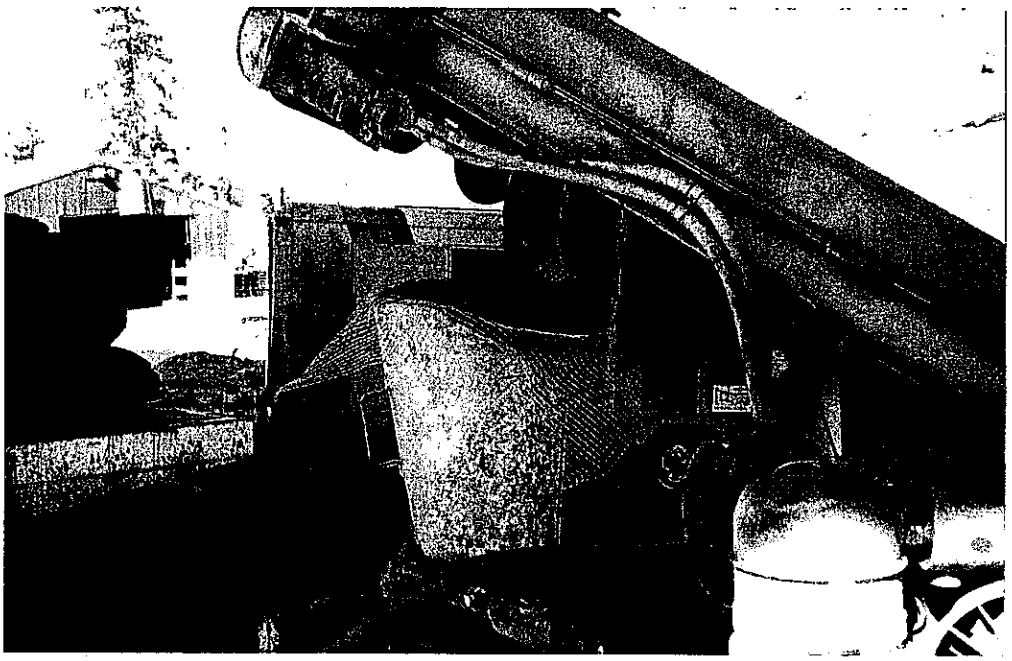
Figure 10. Close-up view of the shotcrete pump showing the cement hopper and spiral mixing blade.

Chipped concrete areas were repaired with shotcrete. The shotcrete was applied using a dry mix shotcrete pump (Figures 9 and 10). Sand and cement were added to a mixing hopper and pumped dry through the delivery hose to the shotcrete nozzle where water was added through a pressure ring. The amount of water added to the mix was controlled by the nozzle operator. The shotcrete mix design was in accordance with Section 53 of the Caltrans Standard Specifications.

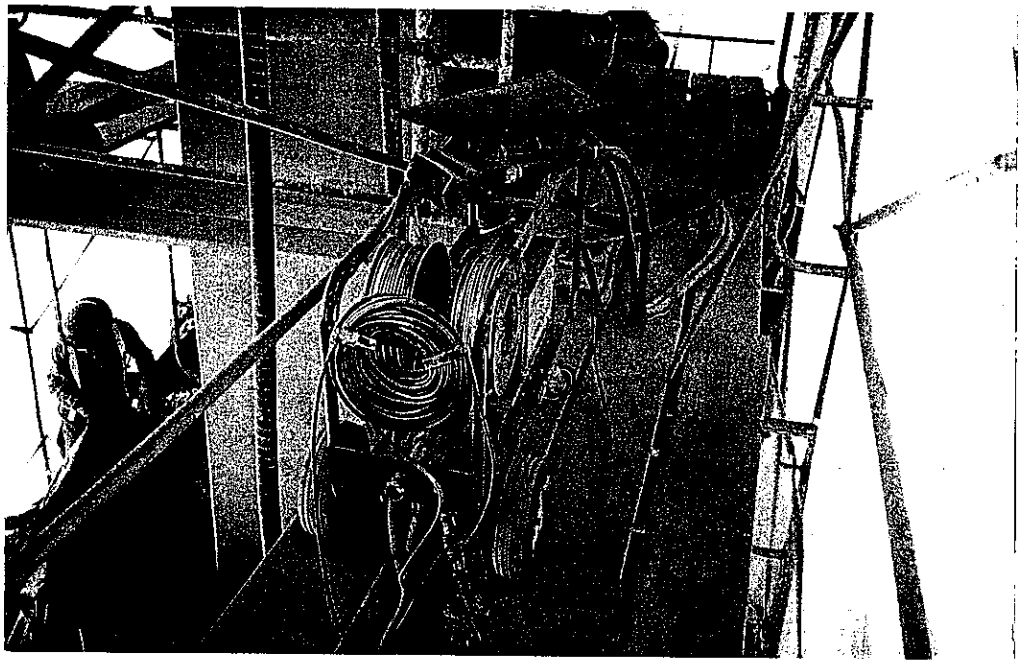
Figure 11. Photograph showing the metallizing equipment. Metallizing was performed with an electric arc gun.

The metallized zinc was applied using an arc spray system. This equipment consisted of an arc spray gun, an air compressor, an electric power unit, and an electrical short detection device. The electrical short detection device was used to monitor the electrical resistance between the metallized zinc and the reinforcing steel (embedded in the concrete). The metallizing process was automatically interrupted if a direct electrical connection was made between the metallized zinc and the reinforcing steel. Figures 11 through 13 show the zinc metallizing equipment, the metallizing operation, and a view of the metallized concrete surface. Figures 14 and 15 show the brass anode pads before and after zinc metallizing was applied.

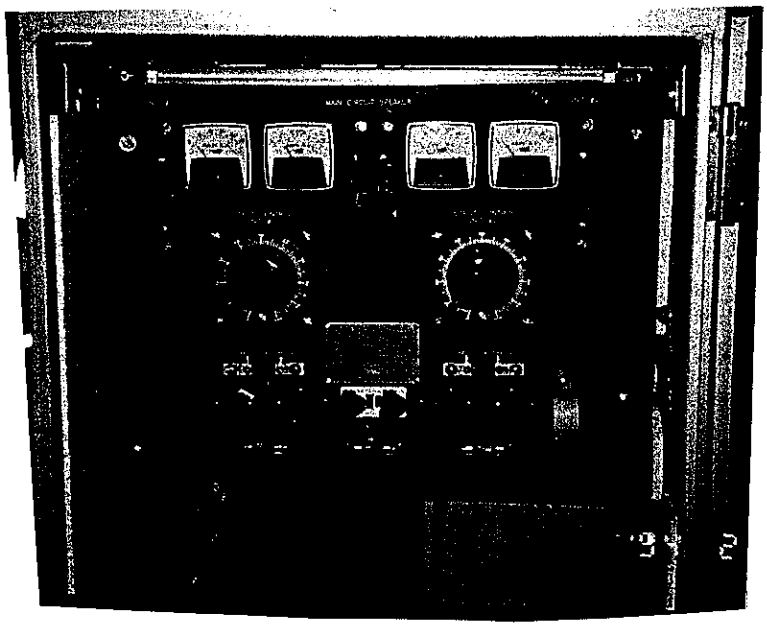
Figure 18. View of the CP control rectifiers. The rectifiers are mounted inside a standard traffic control cabinet. The cabinet contains the CP rectifiers, remote datalogger, and cellular telephone unit. The cabinet is located at Abutment 5 of bridge 17-23L.

The remote monitoring system is composed of a Campbell Scientific 21X Datalogger, a telephone modem, and a Telular 4-line cellular phone unit. These components are housed in a traffic control cabinet with the DC rectifiers. The traffic control cabinet provides a water tight enclosure to house the CP systems and remote monitoring system and permits easy access to all components during system checks. Figures 18 and 19 show the CP cabinet and CP system components.

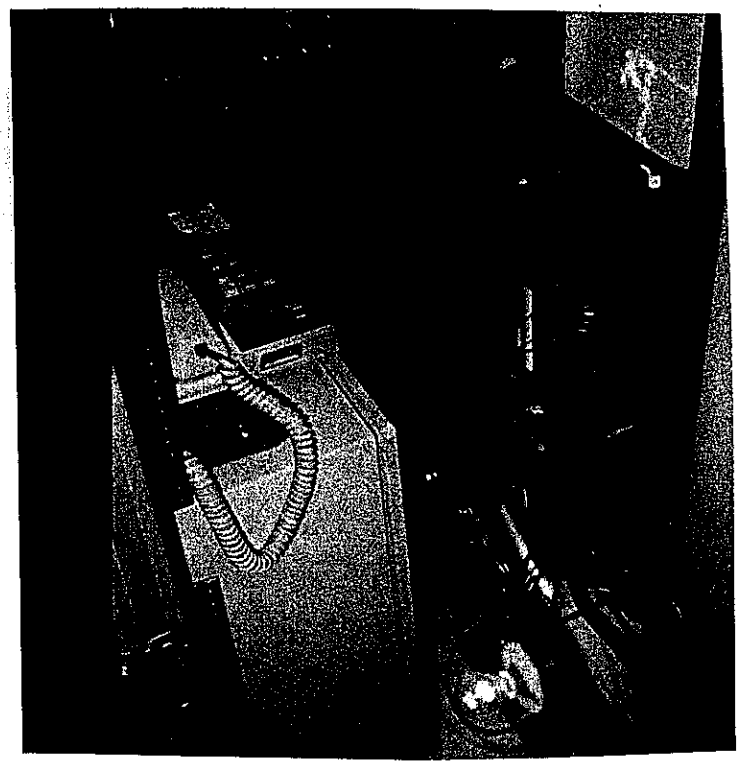
Figure 19. Close up view inside the CP control cabinet showing the CP system components.

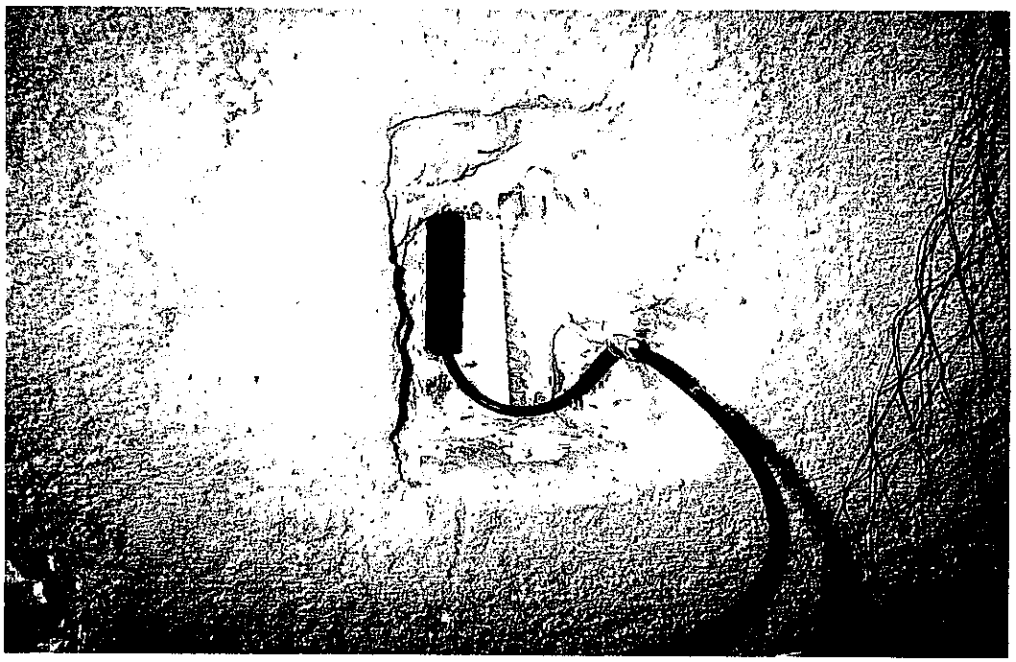
Figure 20. View of a graphite reference cell. The reference cells were grouted in-place next to the reinforcing steel. The reference cells will be used to monitor the electrical potential of the reinforcing steel. This will give an indication of the level of protection provided to the steel.

A pair of graphite reference cells were installed at separate locations for the Metallized Zinc and Elgard CP systems. These reference cells can be used to measure the electrical potential of the embedded reinforcing steel. Graphite reference cell locations were chosen based on an electrical potential survey that indicated where the most corrosive areas were located. When the CP systems are supplying current to the structure, the shift of the reinforcing steel in these areas can be monitored with the graphite reference cells. The graphite reference cells were backfilled with a portland cement grout containing 2.4 kg/m^3 (4 lbs/cy) of salt. Figures 20 and 21 show a graphite reference cell being placed and grouted.

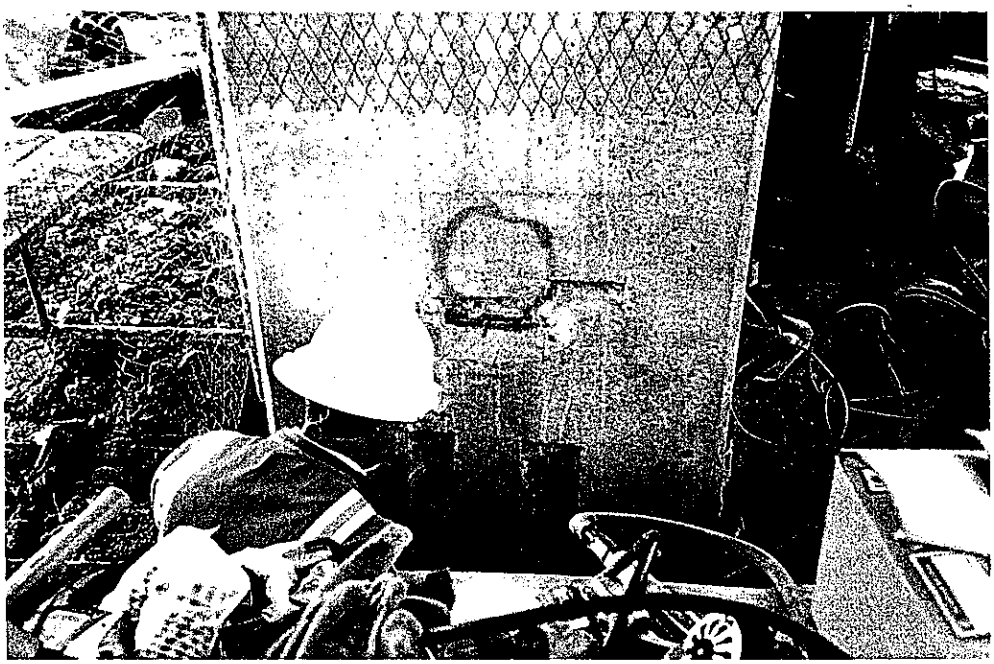
Figure 23. Worker installing a corrosion null probe. The corrosion null probe is an experimental Strategic Highway Research Program (SHRP) product. The probe can be used to monitor the amount of CP current delivered to the probe location.

In addition to the graphite reference cells, four corrosion null probes were installed at the most corrosive areas (two probes per CP system, installed as a contract change order). Corrosion null probes are an experimental Strategic Highway Research Program (SHRP) product used to evaluate the effectiveness of reinforced concrete CP systems. The null probes are segments of existing reinforcing steel (located in one of the most anodic locations) that are cut to isolate them from the rest of the reinforcing steel (Figure 23). CP current can be monitored through a resistor connected to the probe and adjoining reinforcing steel. By knowing the location and surface area of the probe, the current density (amount of CP current per steel surface area) for a particular location can be calculated. The two corrosion null probes at Bent 4R were constructed from separate segments of No. 4 confinement steel. One corrosion null probe at Bent 4L was constructed from a segment of No. 4 confinement steel, and the second probe was constructed from a segment of No. 5 rebar located in the bent cap.

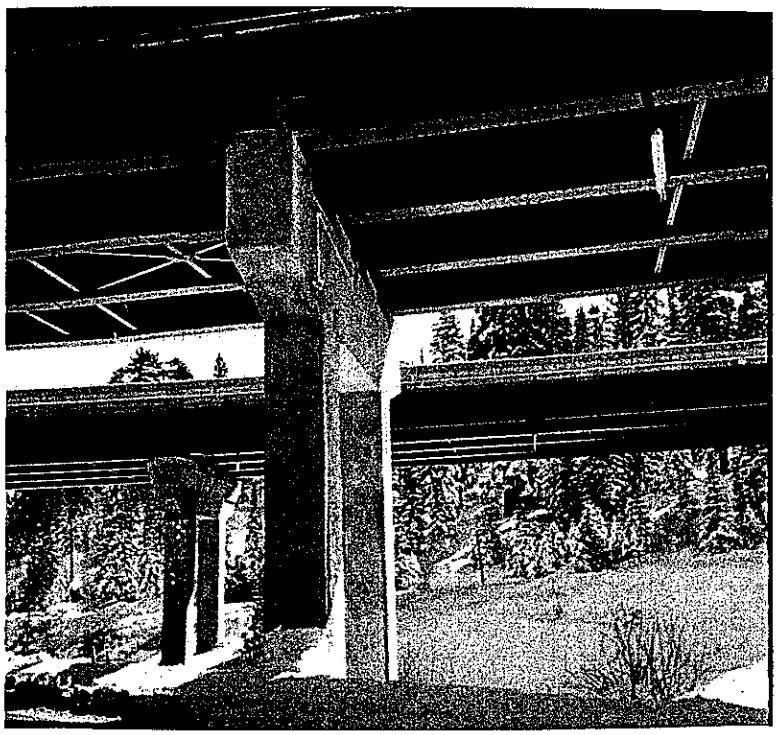
Figure 26. View of Bent 4L (Elgard Mesh CP system) showing the finished shotcrete surface over the Elgard mesh.

By February, 1994, all work was completed and the CP systems were operating satisfactorily. No contractor claims were filed against Caltrans for this project. Figures 25 and 26 show the completed project.

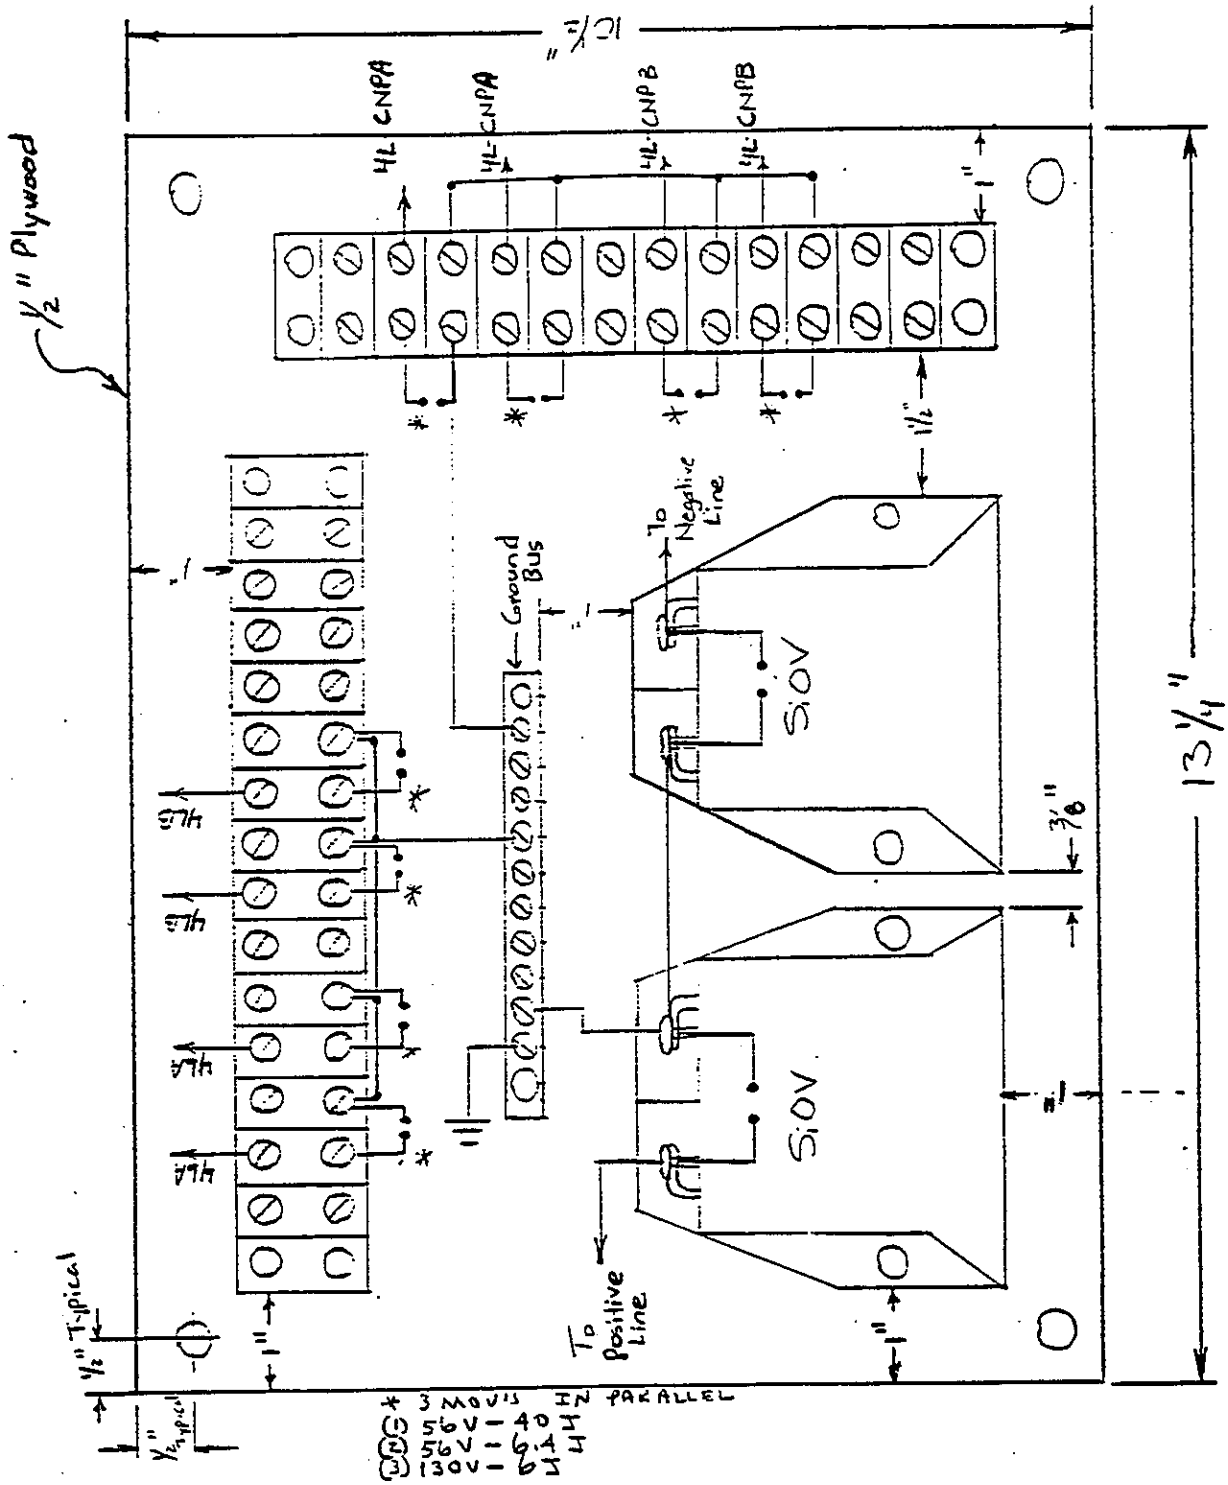
On March 10, 1994 lightening damaged the Campbell datalogger and the Metallized Zinc CP rectifier. The CP rectifiers had DC lightening protection devices across the positive and negative rectifier output leads and an AC lightening protection device across the AC power input lines to the CP system. The electrical ground for the CP systems as originally connected was provided through a third wire ground lead connection (from the AC power input lines) to an existing ground rod for the nearby Caltrans fuel and maintenance work building located approximately 90 meters (300 feet) from the rectifier location.

Figure 27. Schematic diagram of metal oxide varistor (MOV) board used for lightening protection of the power leads, reference cell leads, and corrosion null probe leads to Bent 4L (Elgard CP system). The MOV's provide a shunt to ground if large spikes or surges occur due to electrical storms. Three MOV's with different energy level ratings were used in parallel to protect against a wide range of electrical and/or surges. The board was mounted at the CP control cabinet.

Repairs were made to the damaged components and additional lightening protection devices were added after reviewing the latest available literature regarding lightening protection for electrical components and consulting with members of the Caltrans Electrical and Commodities Testing Section. Metal oxide varistors (MOV's) were added to all input and output lines of the Elgard and Metallized Zinc CP systems for additional lightening protection. These devices provide a shunt to ground if large transient spikes or surges occur in the CP system wiring and components during storm events. MOV's with different energy ratings were stacked in parallel on input and output lines of the CP systems to provide lightening protection against a wide range of transient responses. Figures 27 through 29 are schematic diagrams that show the added MOV's.

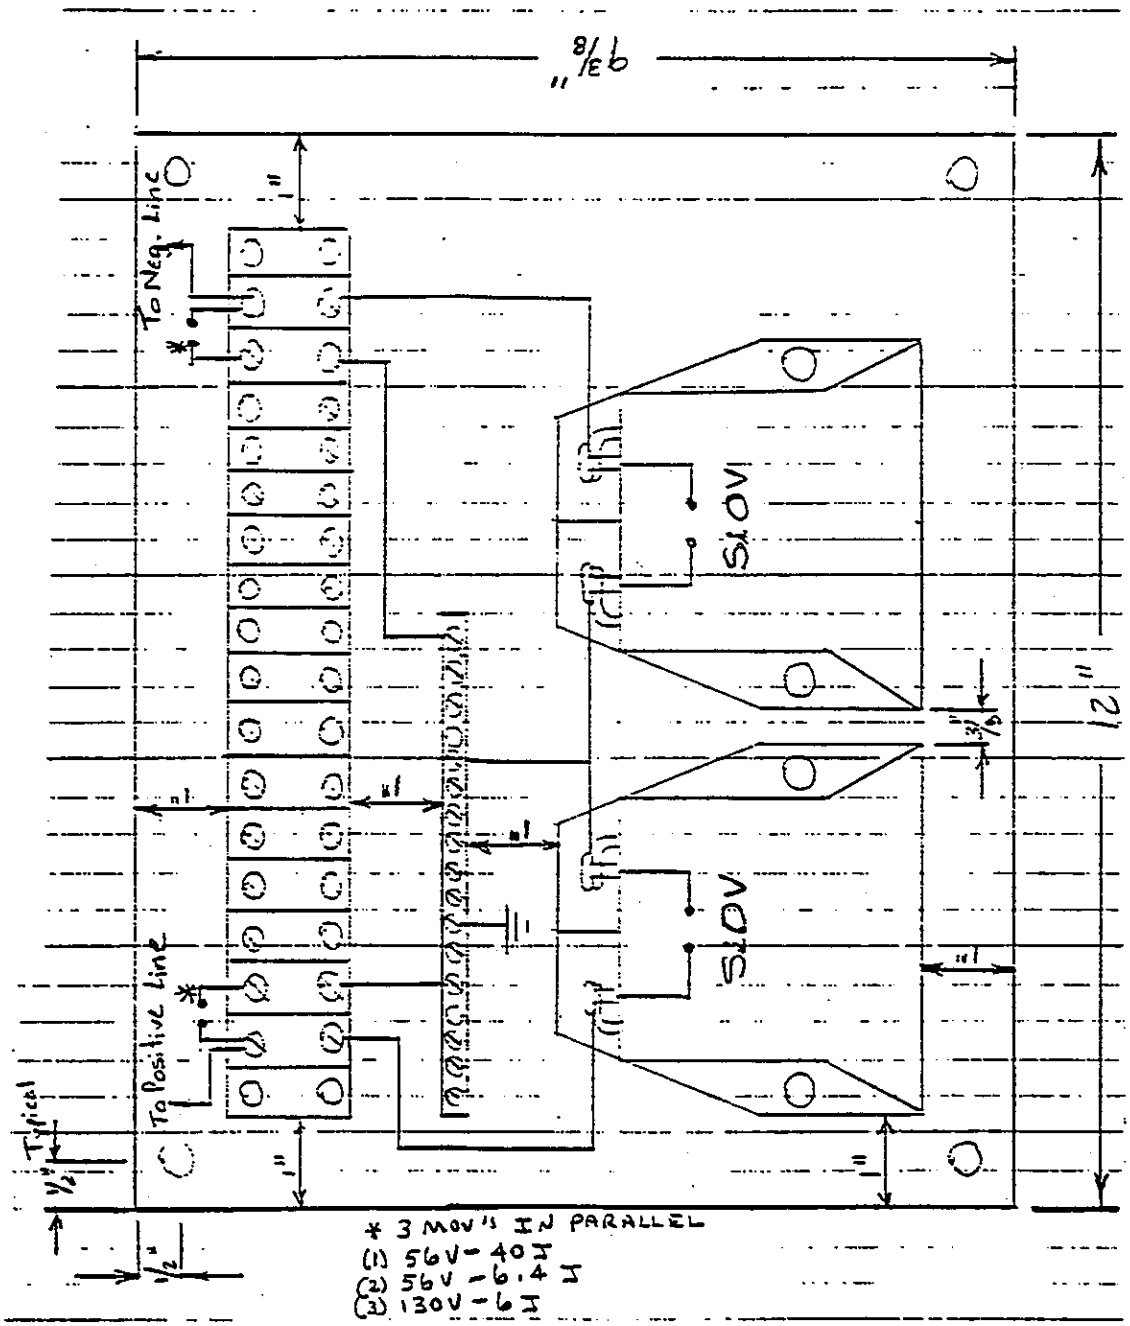
Figure 28. Schematic diagram of metal oxide varistor (MOV) board used for lightening protection of the power supply leads to Bent 4R (Metallized Zinc CP system). The MOV's provide a shunt to ground if large spikes or surges occur in the wiring due to electrical storms. Three MOV's with different energy level ratings were used in parallel to protect against a wide range of electrical spiking and/or surges. The board was mounted in a pull box at Abutment 5R. This location provided the shortest path to ground if electric charge is collected on the metallized zinc surface during an electrical storm event.

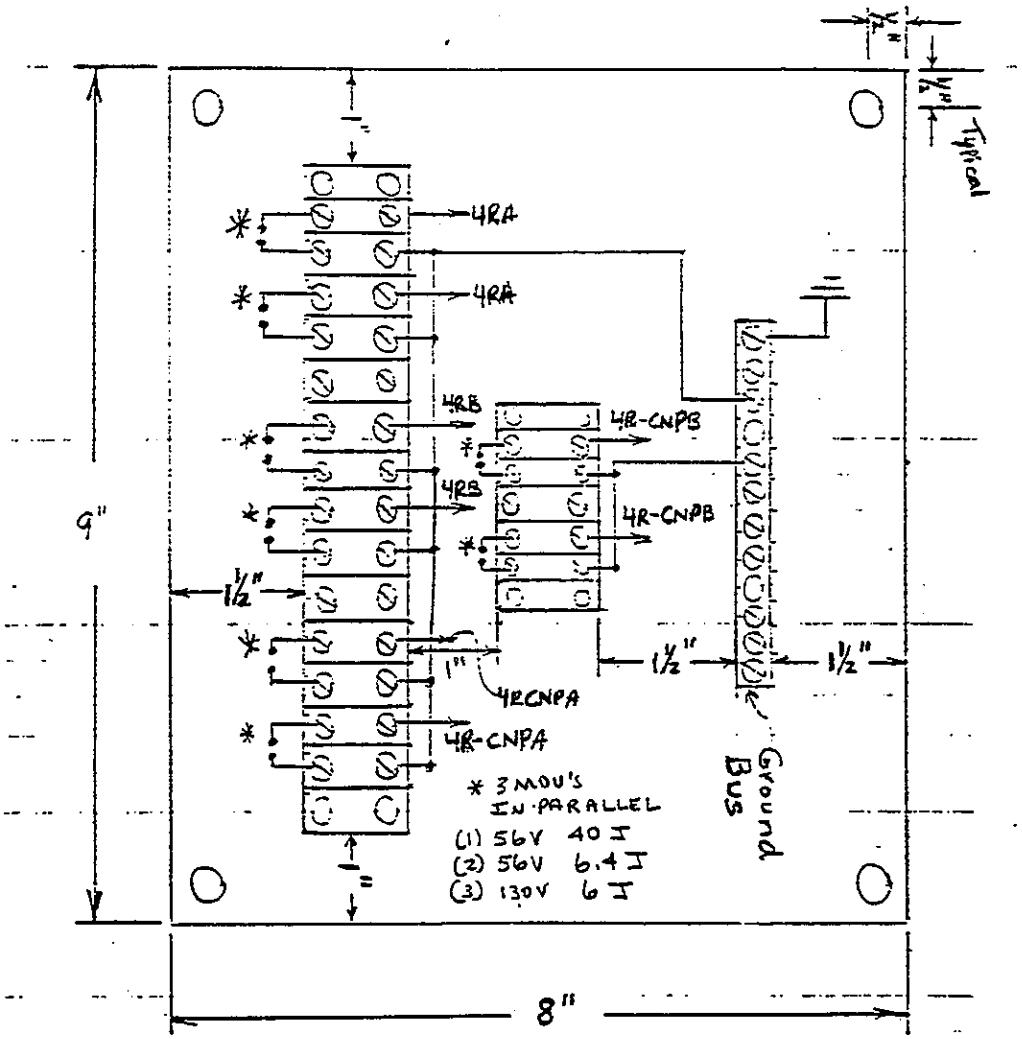
Figure 29. Schematic diagram of metal oxide varistor (MOV) board used for lightening protection of the reference cell leads and corrosion null probe leads to Bent 4R (Metallized Zinc CP system). The MOV's provide a shunt to ground if large spikes or surges occur due to electrical storms. Three MOV's with different energy level ratings were used in parallel to protect against a wide range of electrical spiking and/or surges. The board was mounted in a pull box at Abutment 5R. This location provided the shortest path to ground if electric charge collected on the metallized zinc surface during an electrical storm event.
