USE OF ASPHALT-LATEX EMULSION IN THE CONSTRUCTION OF THIN WEARING SURFACES FOR STEEL BRIDGES AND STRUCTURES

Ernest Zube

Presented at the 34th Annual Meeting
of the Highway Research Board
Washington D.C., January 11-14, 1955

December 15, 1954

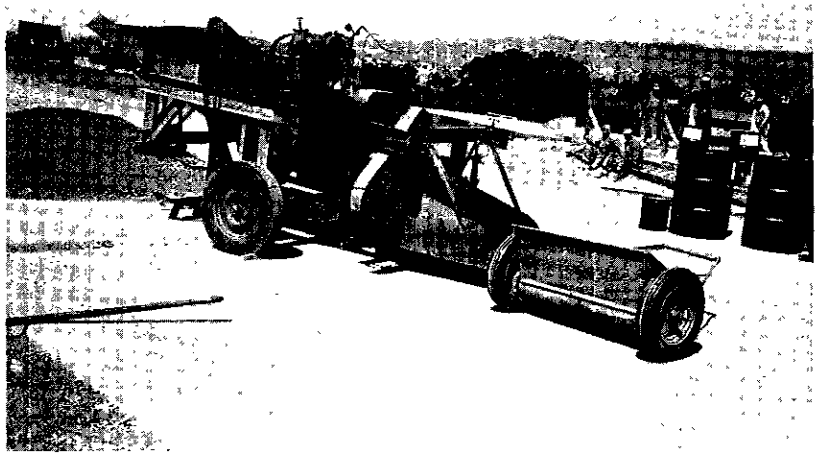
To spread the screenings a small hand operated fertilizer spreader, Figure 12, which consisted of a "V" shaped hopper mounted between two small rubber tired wheels was brought to the job. However, it did not work too successfully and the screenings were finally spread by hand.

Fig. 12
Heater and Spreader for Screenings

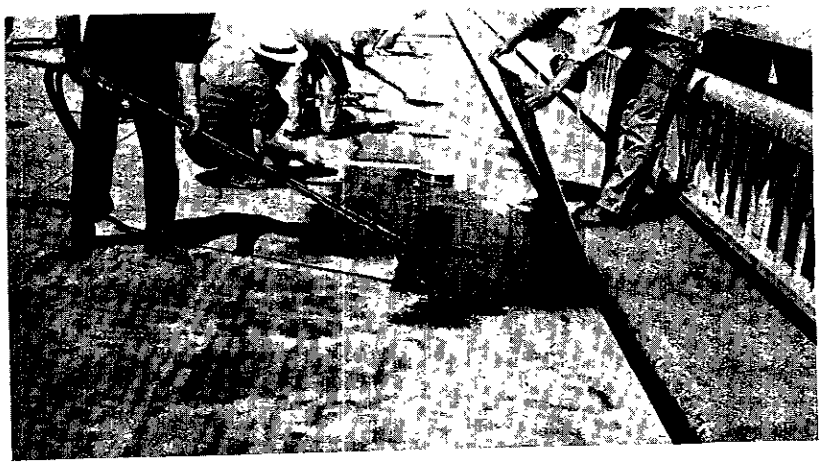
The asphalt-latex binder was spread under pressure through a fan shaped spray, Figure 14. On the raised surface deck it was found somewhat difficult to determine the spread. The material formed a skin almost immediately so that it could not be satisfactorily gauged. The most satisfactory method found was to mark off an area on the deck and by gauging the drum, the coverage was calculated. About 0.45 gallons per sq. yd. was applied to both bridges. No significant flow of the emulsion due to the 3% grade of the deck was noticed.

An 8 in. diameter 100 mesh sieve was mounted on a 3 ft. handle and the powder was sifted over the emulsion. However, it required considerable care to obtain uniform distribution by this method, Figure 14.

Fig. 14
Applying Asphalt-Latex Emulsion
Sifting Sodium Fluosilicate on Emulsion

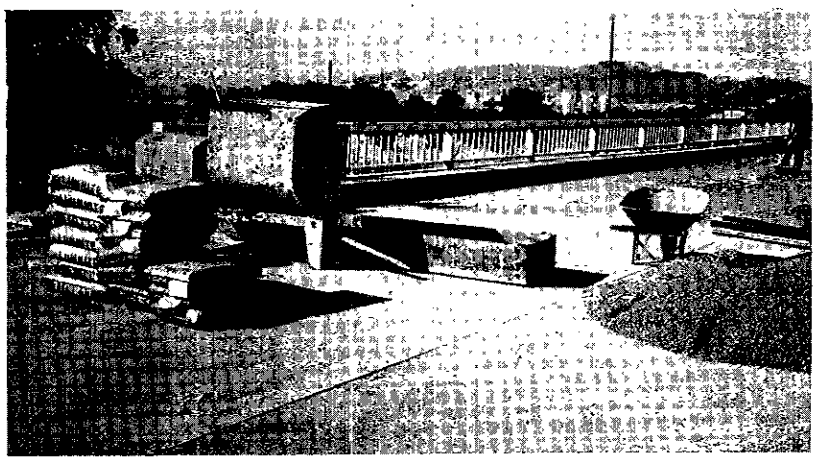
The neoprene-latex and lumnite-cement were mixed in a three sack plaster mixer, Figure 15. The cement was proportioned by

Fig. 15
Plaster Mixer for Mixing
Neoprene-Latex and Lumnite Cement

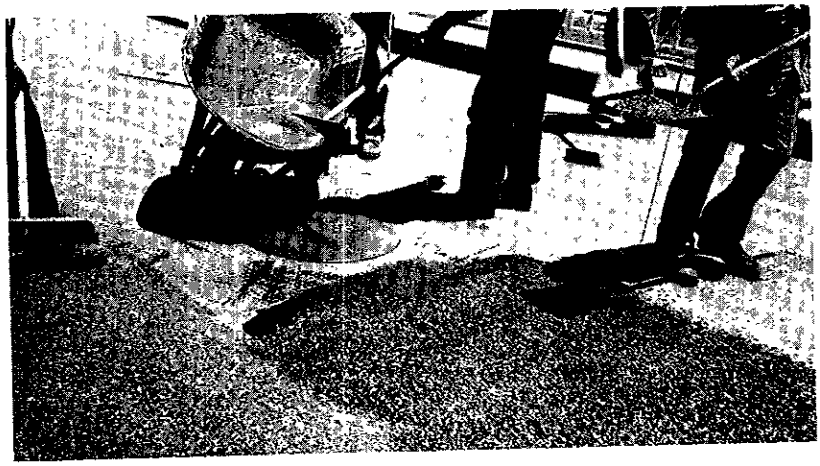
Fig. 17
Latex-Lumnite Cement
Mixture and Screenings

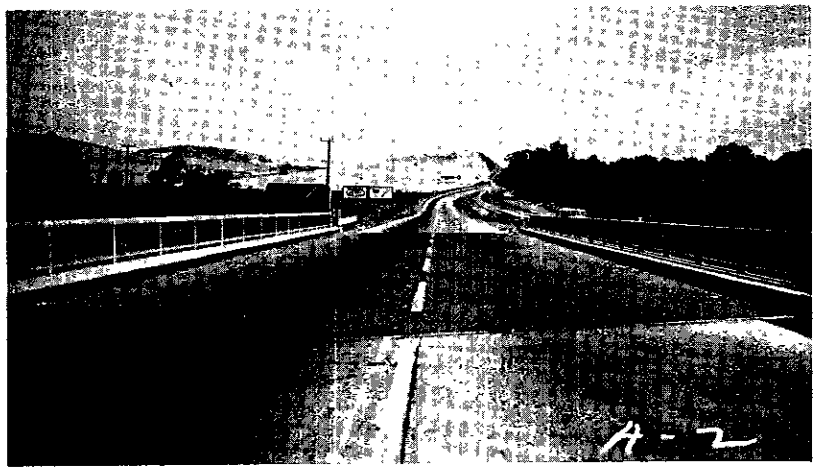
After spreading, the screenings were immediately hand broomed lightly to a uniform thickness. They were then rolled about three passes with a dual wheel flat rack truck. This rolling embedded the screenings very thoroughly into the asphalt-latex emulsion. Since an excess (about 25%) of screenings was used no excessive pick-up on the truck tires was noted. The general appearance after rolling was very good, Figure 18.

Fig. 18
Smooth Deck, Asphalt-Latex Seal Coat in Foreground
Latex-Lumnite Cement Seal Coat Background, July 1952

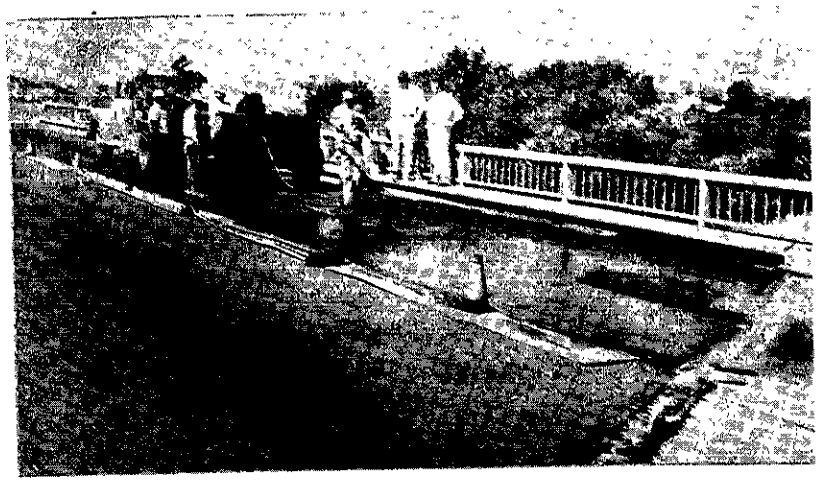
By the summer of 1953, considerable distress was noted in the wheel tracks of the west bound (up grade) traffic lane (smooth deck) in the asphalt emulsion seal coat. The passing lane appeared in good condition. On the checkered deck, which is on the down grade, both traffic lanes appeared in satisfactory condition.

In the summer of 1954, the travel lane only on the north bridge (containing the asphalt emulsion seal) was repaired. The area repaired was 65 ft. long and 9 ft. wide, the inner edge of the area being very close to the centerline stripe, Figure 21.

Fig. 21
Applying Asphalt-Latex in Travel Lane to Smooth Deck, July 1954. Asphalt-Emulsion Seal Coat on Left. Asphalt-Latex Seal Coat Placed in June 1952 in Background.

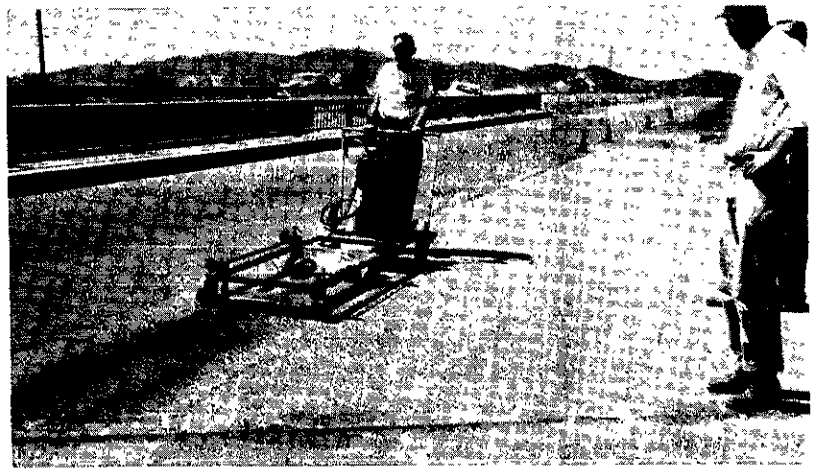
As soon as the screenings were rolled the surface was heated with the weed burners. Heat was applied until the asphalt-latex boiled up around the aggregates. A portion of the area was heated by using the weed burners on our small pavement heater, Figure 22. Two large size weed burners were arranged on the carriage so that the flame would be discharged under the flat hood and spread over a larger area of the surface and also to conserve heat. The hood is mounted on a carriage so that it may be pulled along over the surface. However, the small metal wheels on the carriage tended to loosen and pick up the screenings and therefore, the remaining

Fig. 22
Heating Screenings with Pavement Heater

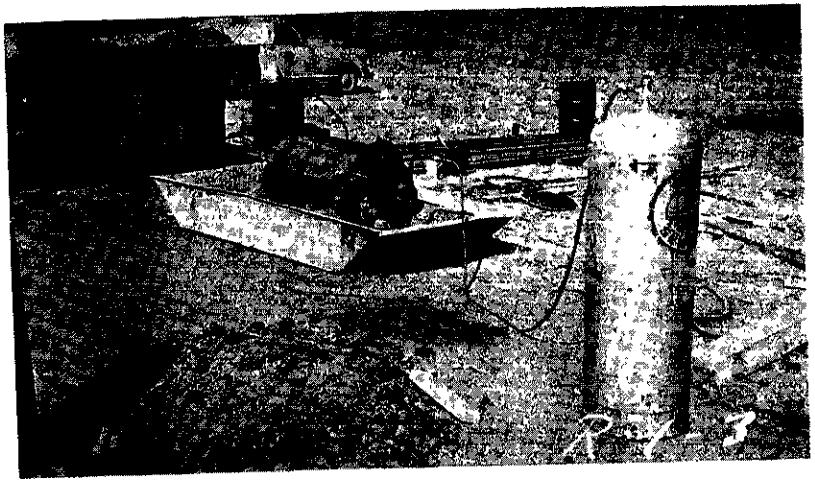
The screenings were spread at a rate of about 15 pounds per sq. yd. after the asphalt-latex and demulsifier had been placed on the deck, Figure 27. Prior to spreading, the screenings were heated to between 250 and 350 F. in a homemade heater, Figure 25, consisting of a 50 gallon drum with a hinged lid and butane heater attached.

Fig. 25
Drum Heater for Heating Screenings

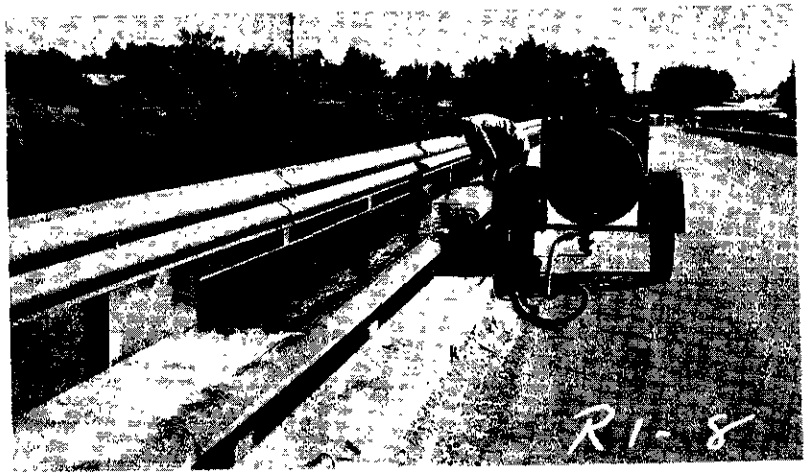
The asphalt-latex was placed at the rate of 0.5 gallons per sq. yd. by hand spraying from a pressurized tank, Figure 26. A light application of sodium fluosilicate was immediately sprinkled on the surface of the asphalt-latex using a 100 mesh 10 in. diameter sieve.

Fig. 26
Applying Asphalt-Latex Emulsion
Foreground Sodium Fluosilicate
Sifted on Top of Emulsion

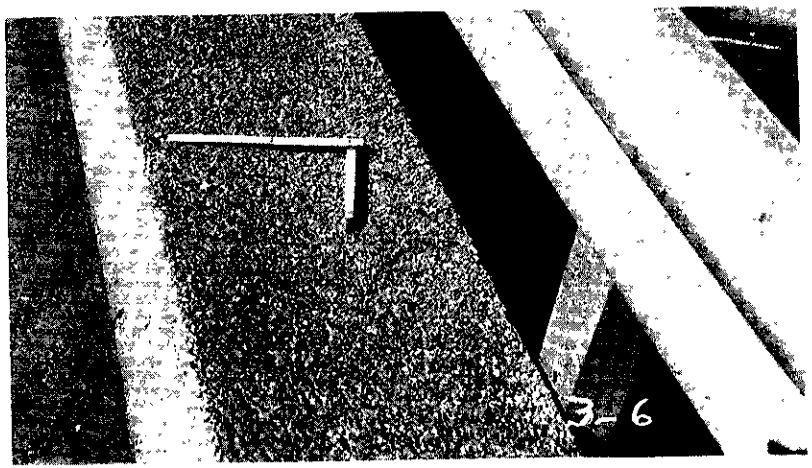
When inspected on numerous occasions, the seal coat on the walkway was found to be in excellent condition with the asphalt-latex emulsion well bonded to the deck, Figure 28.

Fig. 28
Appearance of Walkway After $1\frac{1}{2}$
Years of Service, 1954

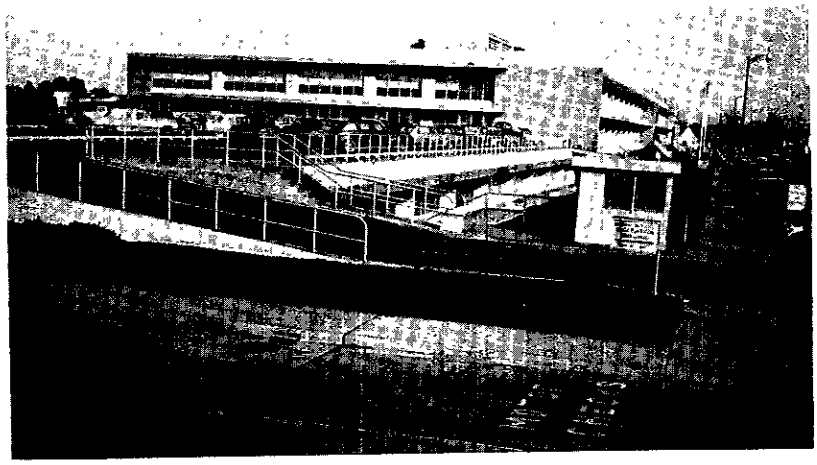
When last inspected in December 1954, the deck appeared to be in satisfactory and serviceable condition with the exception of a few local spots.

Fig. 30
Appearance of Parking Deck After
One Year of Service, December 1954
