CRACKING OF ASPHALT CONCRETE PAVEMENTS ASSOCIATED WITH ABSORPTIVE AGGREGATES

Ernest Zube

RESEARCH REPORT

NO. M & R 231138-2

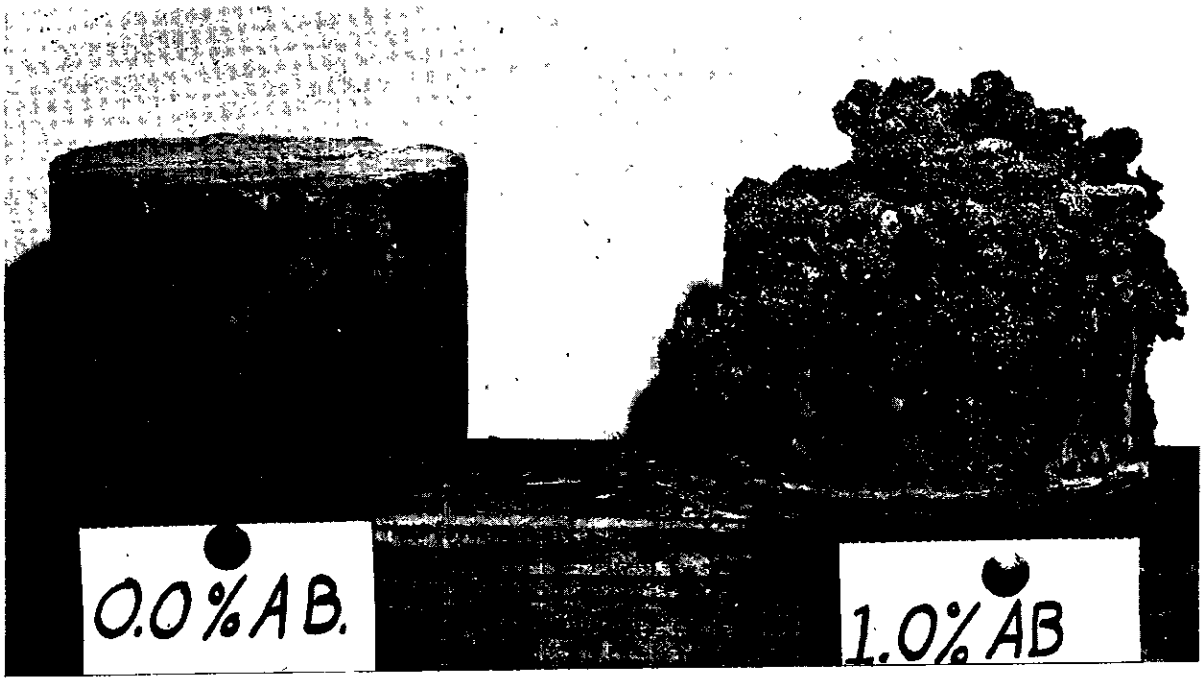
After one year's exposure the highly absorptive specimens had completely ruptured the epoxy coating, while the nonabsorptive capsulated specimens remained in excellent condition (Figure 1).

Fig. 1 - Epoxy coated specimen after 1 year exposure on roof.
Left - Nonabsorptive aggregate.
Right - Absorptive aggregate.

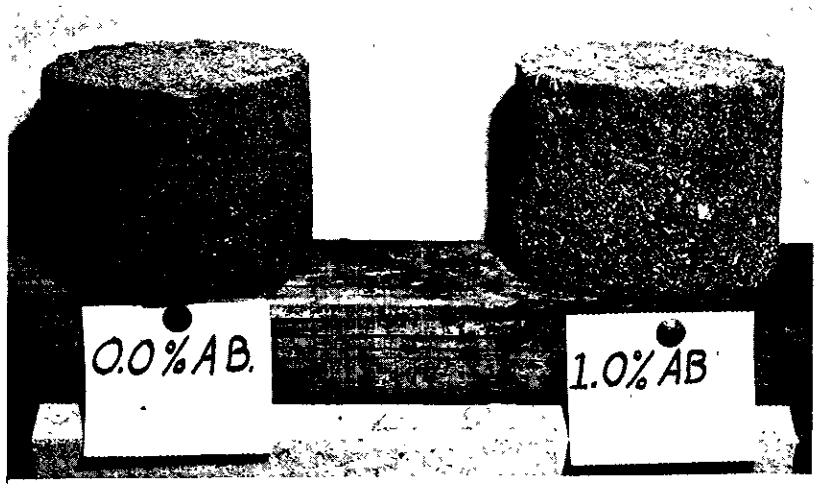
trend. The absorptive briquettes had cracked over their entire exposed surface, whereas the nonabsorptive briquettes showed no signs of distress (Figure 2).

Fig. 2 - Noncapsulated specimen exposed on roof after 6 months.
Left - Nonabsorptive aggregate.
Right - Absorptive aggregate.

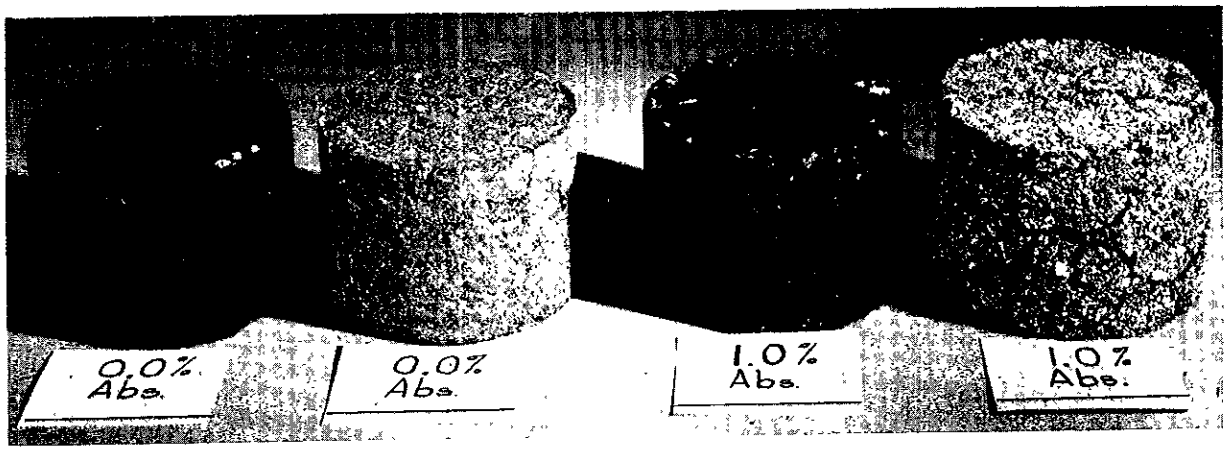
The absorptive and nonabsorptive aggregate specimens stored in a cabinet at room temperature in the laboratory building free from sunlight and moisture for a period of six years remained in excellent condition. In comparison, identical specimens stored on the roof are shown in Figure 3.

Fig. 3 - Absorptive and nonabsorptive AC briquettes.
Dark colored specimen stored in cabinet for 6 years.
Light colored specimen exposed on roof for 6 years.

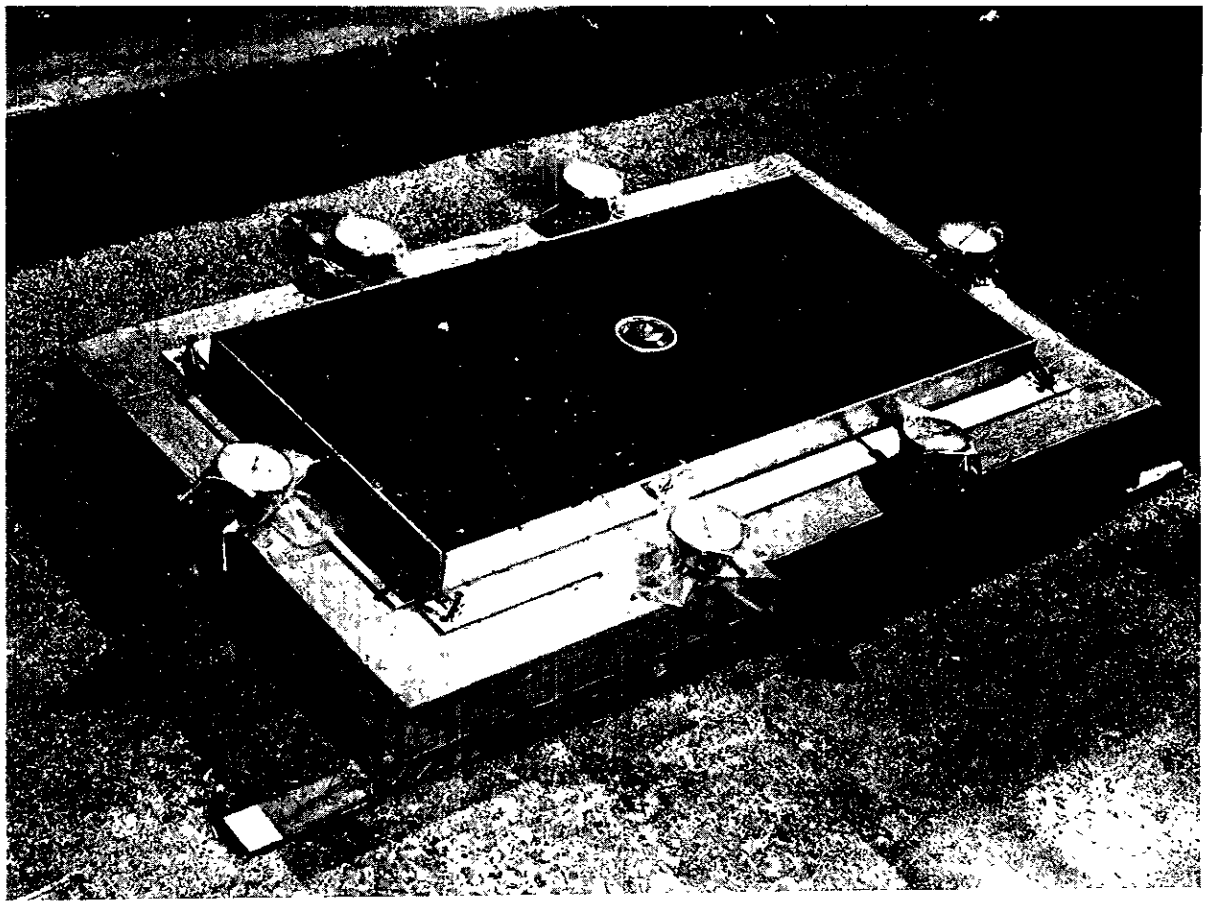
The test slab was compacted in a heavy wooden frame. After compaction, the top portion of the sides was removed and replaced with free moving aluminum sides which permitted unrestrained expansion and contraction of the specimen. The unrestrained movement was recorded by six dial indicators (reading to the nearest .001") located around the surface as shown in Figure 4.

Fig. 4 - Slab specimen 1' x 2' x 3". Note springs holding aluminum sides surrounding surface course.

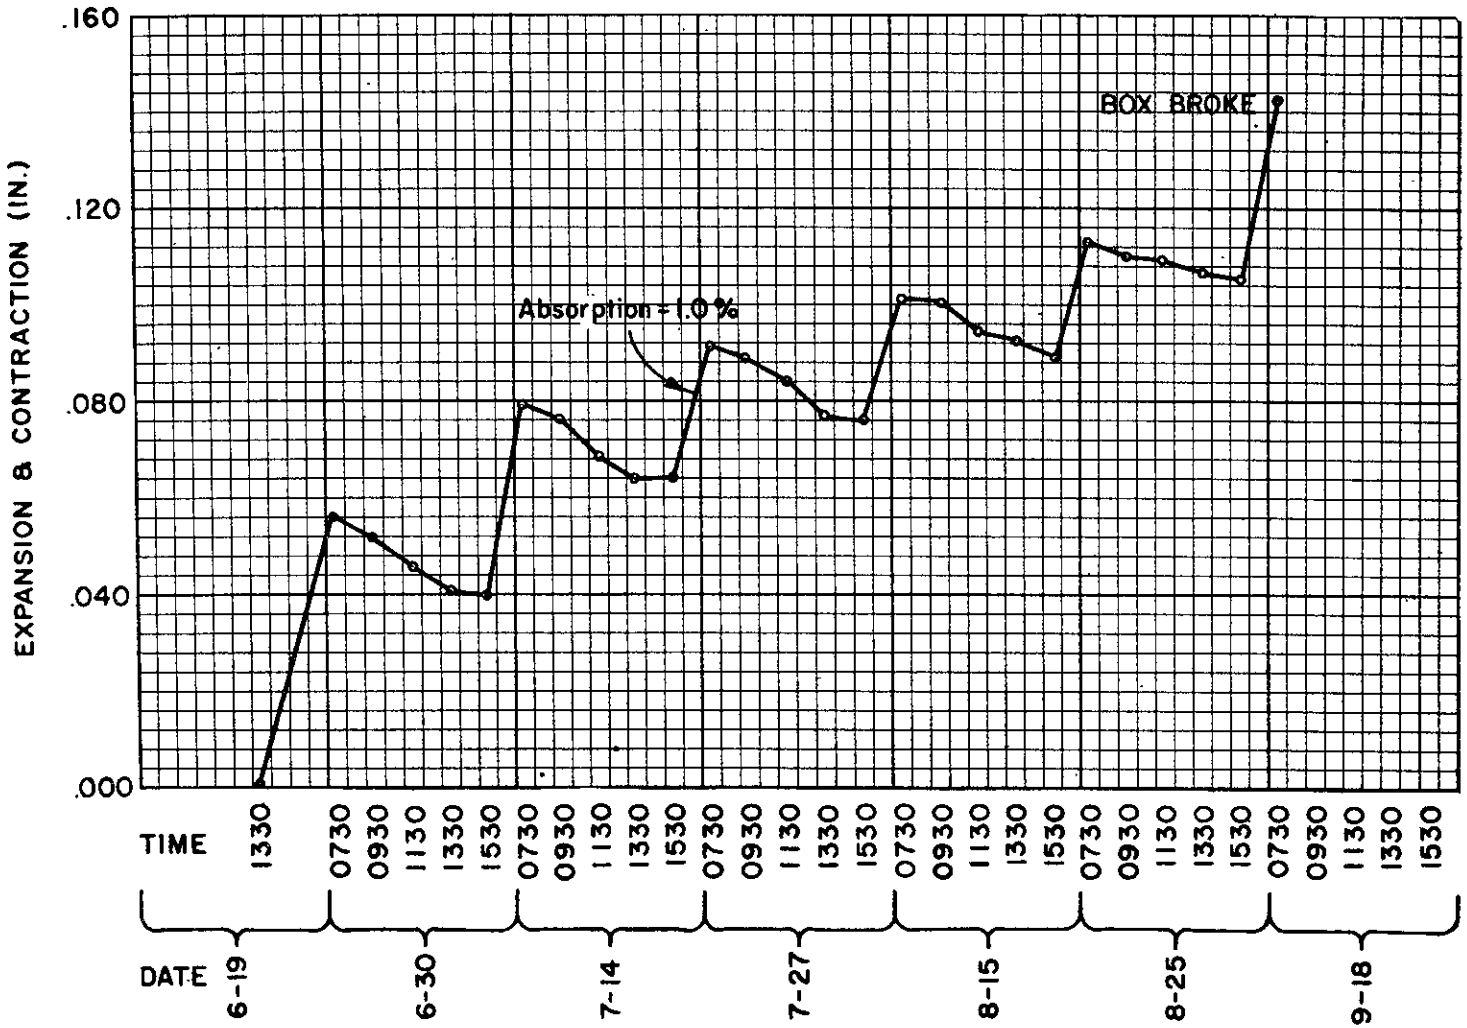
FIGURE 5

This slab was exposed to the outside atmosphere in the early summer of 1961. Dial readings and temperature measurements were made five times daily. Figure 5 shows the expansion that occurred in a three month test. The cyclic pattern shows that maximum expansion occurs during the early morning hours when there is a considerable amount of moisture in the air. Maximum contraction occurs during the warmest hours of the day. It is noteworthy that the specimen failed to return to its original dimension during the contraction period, possibly due to aggregate breakdown during the moisture cycle. The maximum expansion of 0.142" generated sufficient force to break the frame. This occurred soon after an early unseasonable rainstorm.

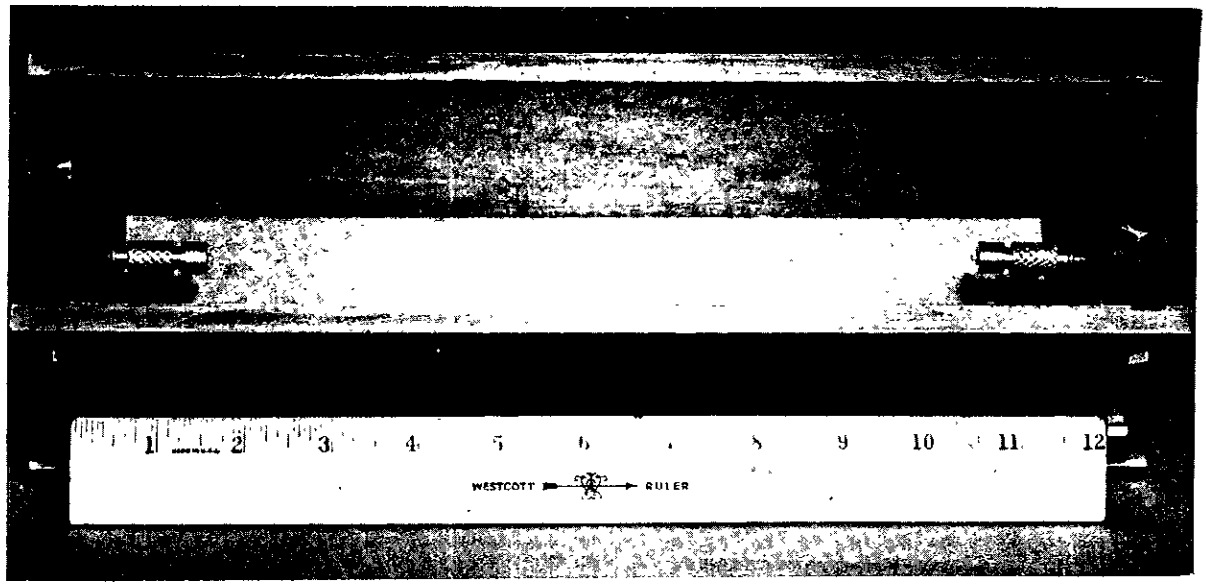
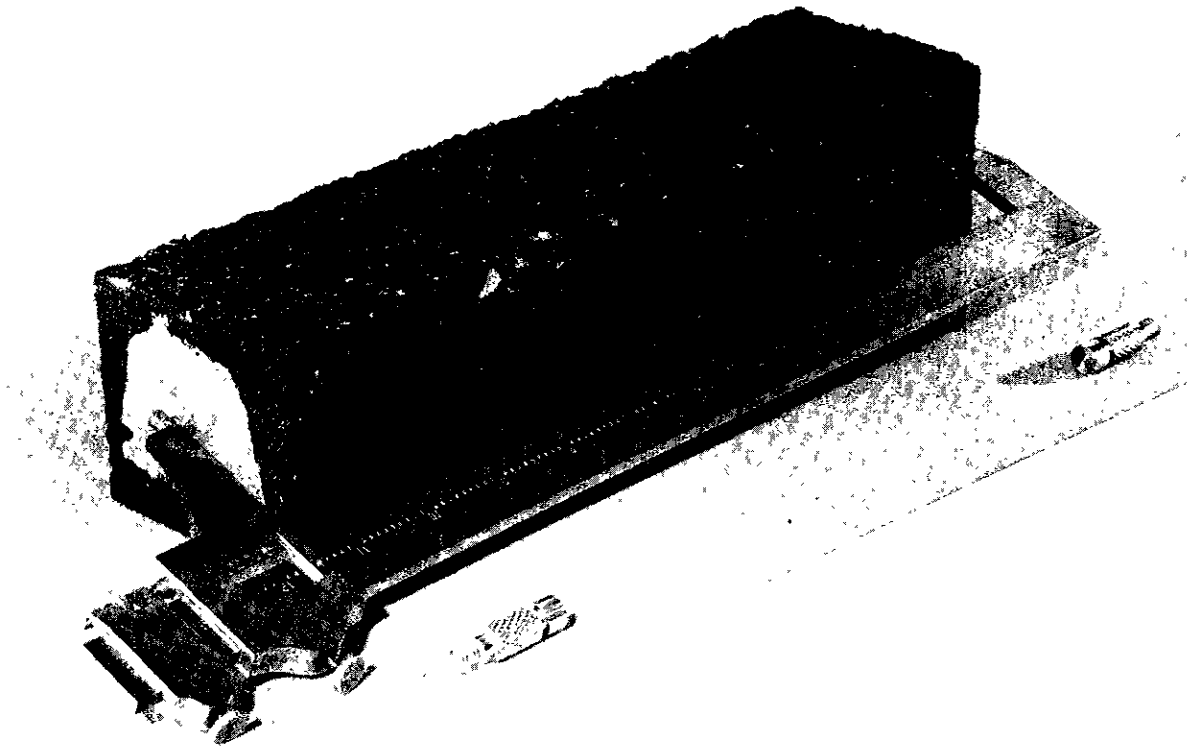
Fig. 6

Because of the expense and time involved in fabricating the large slab specimens, a new method, still currently in use, was adopted. It consists of compacting the AC mix into 3" x 3" x 11.25" long steel molds (Figure 6) using our kneading compactor. (For details of fabrication see Reference 1.) After cooling, the mold is stripped and the steel pins at the ends of the compacted bar are fastened with epoxy. The bars are then cured at 100°F for three days before being subjected to the weathering cycles. Each weathering cycle consists of seven days in the moisture room followed by seven days drying in a 100°F oven. The specimens are subjected to from three to six weathering cycles during which daily measurements and observations are made. The measurements are made with a micrometer to the nearest 0.001" as shown in Figure 6.

Steel molds 3" x 3" x 11.25" used for fabricating bars.
Note steel pins in end of plates for measuring AC bars.

Bar after being stripped, ready for measurement.

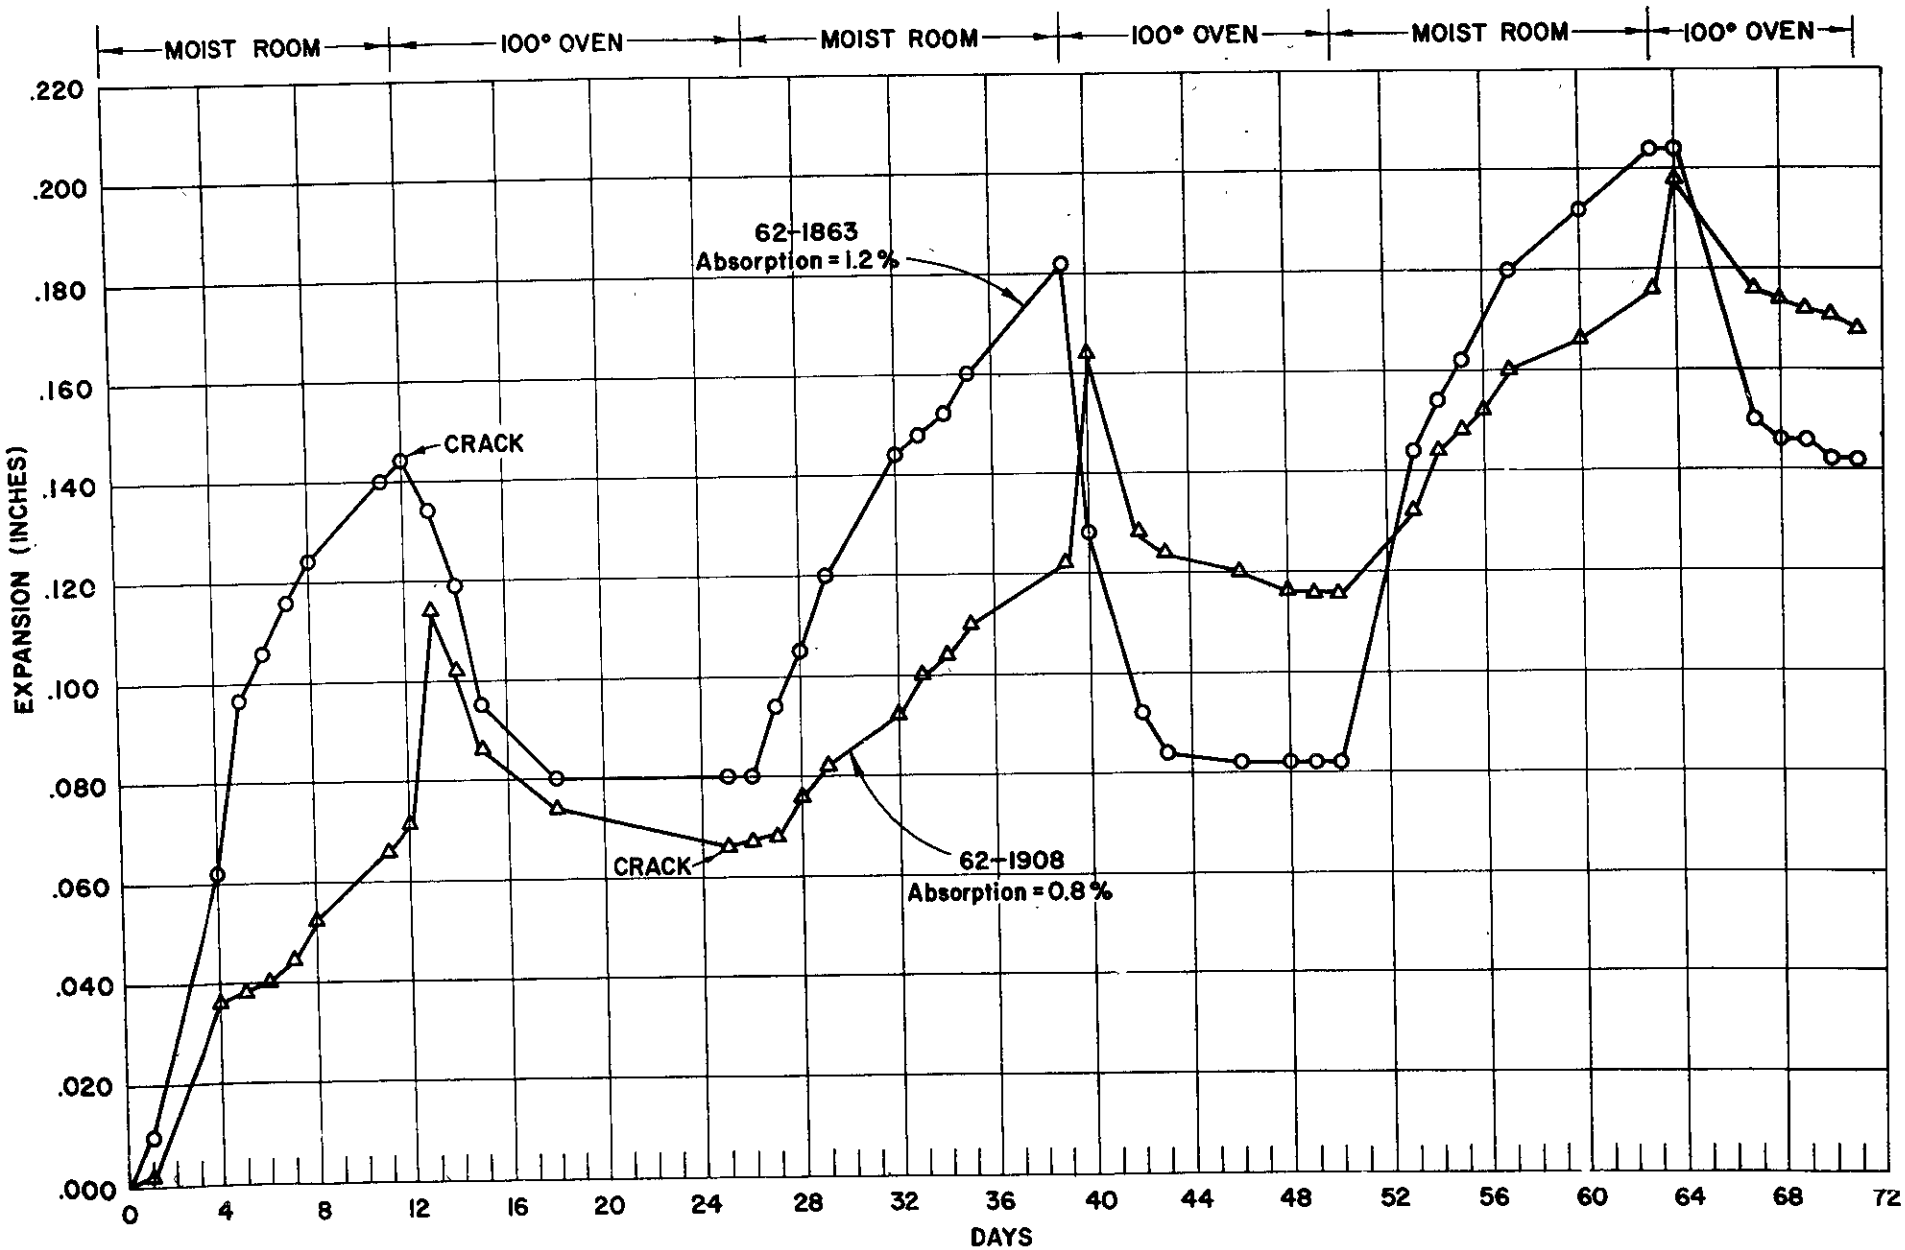
FIGURE 7

Cracks appeared in Sample #62-1863 during the drying period of the first cycle. During the third cycle the sample had expanded over 0.2" and was cracked throughout its entirety. This expansion (0.2" in a 11.25" bar or 1.8%) is the maximum longitudinal increase recorded to date for AC bars. This condition was reached after 64 days' (Figure 7) exposure to wet and dry periods.

Transverse cracks were visible on Sample #62-1908 at the end of the first cycle (Figure 8). Rapid expansion (0.045") at the beginning of the drying cycle would indicate that this specimen was susceptible to moisture in the vapor state. Subsequently, several transverse cracks were observed at the end of the third cycle. This specimen required 13 days in the 100°F oven before contraction became constant which, as stated, was probably due to its susceptibility to moisture vapor. Our data indicate that the average time required for maximum expansion and contraction is approximately seven days for each wet and dry cycle.

AC pavements constructed with aggregates from the same source as Sample #62-1863 have shown considerable distress in the form of cracking even though this material generally passes all routine physical laboratory tests. At the end of the third cycle the bar was completely cracked.

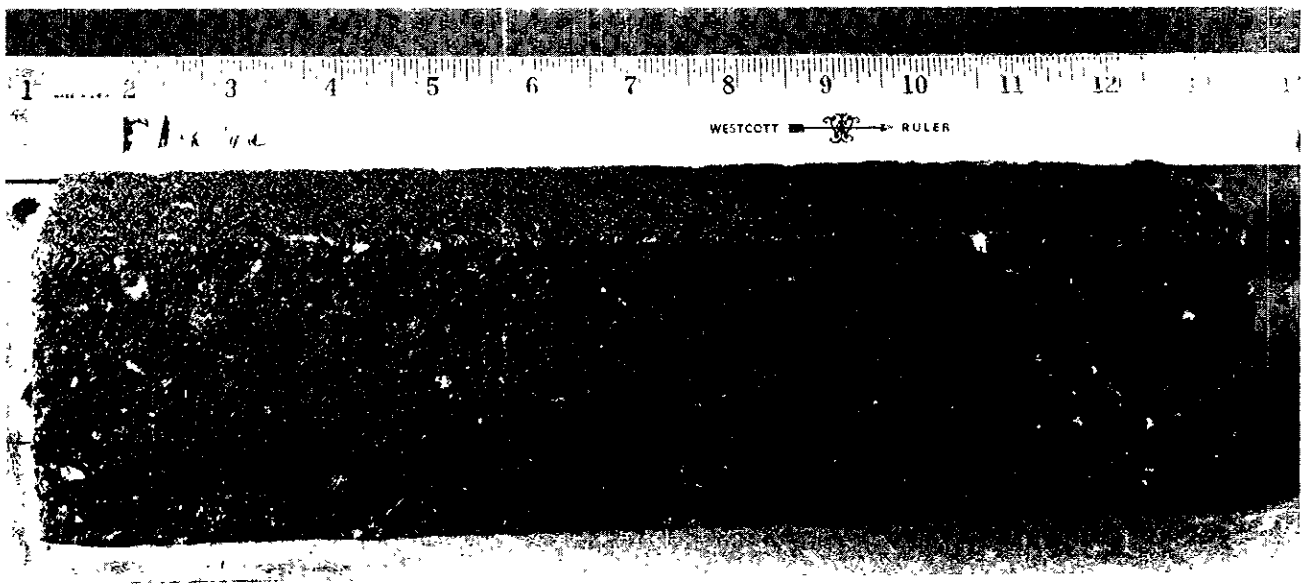
Fig. 8 - Test bar 62-1908.
Transverse cracks appeared after the first cycle.

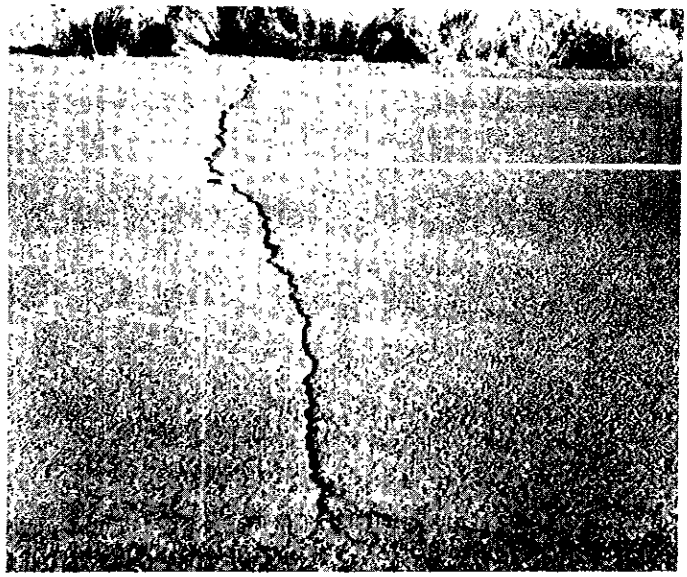
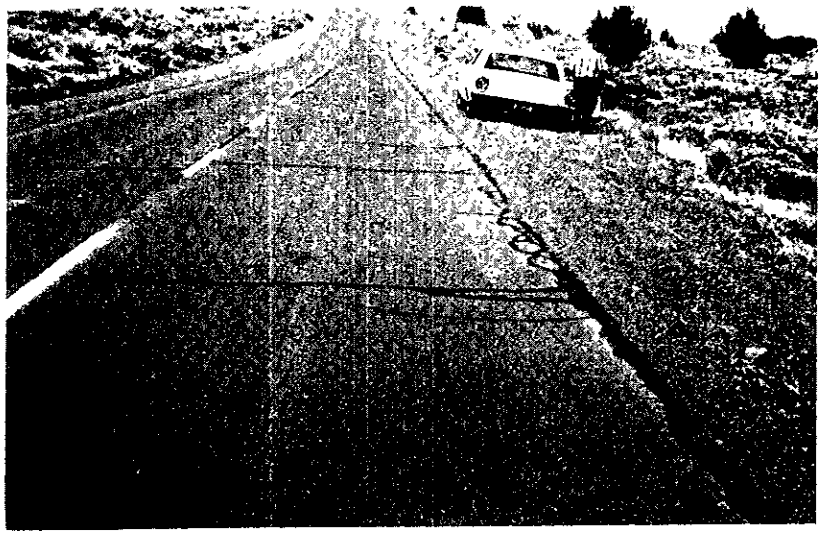
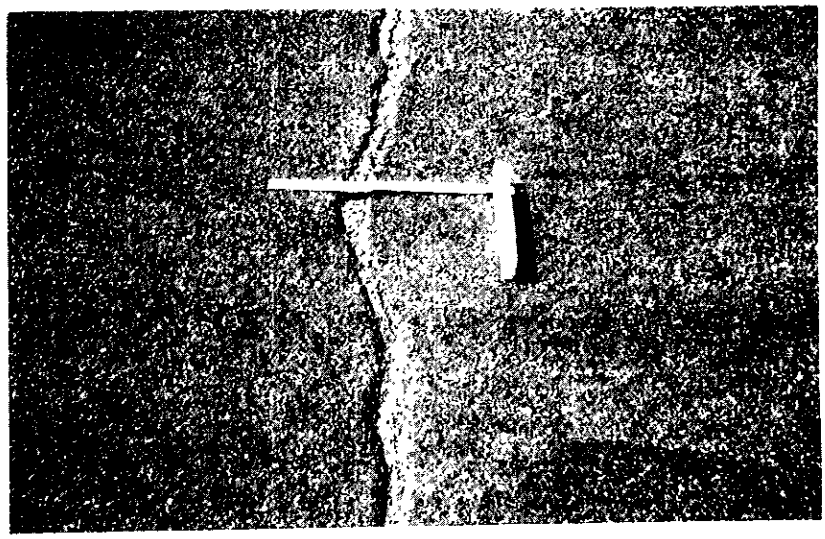
Fig. 9

The transverse cracks in the surfacing (Figure 9) vary in width from 3/4" to 1½" and were found at intervals ranging from 10 to 20 feet throughout the entire project. The pavement was constructed from aggregates obtained from a local pit.

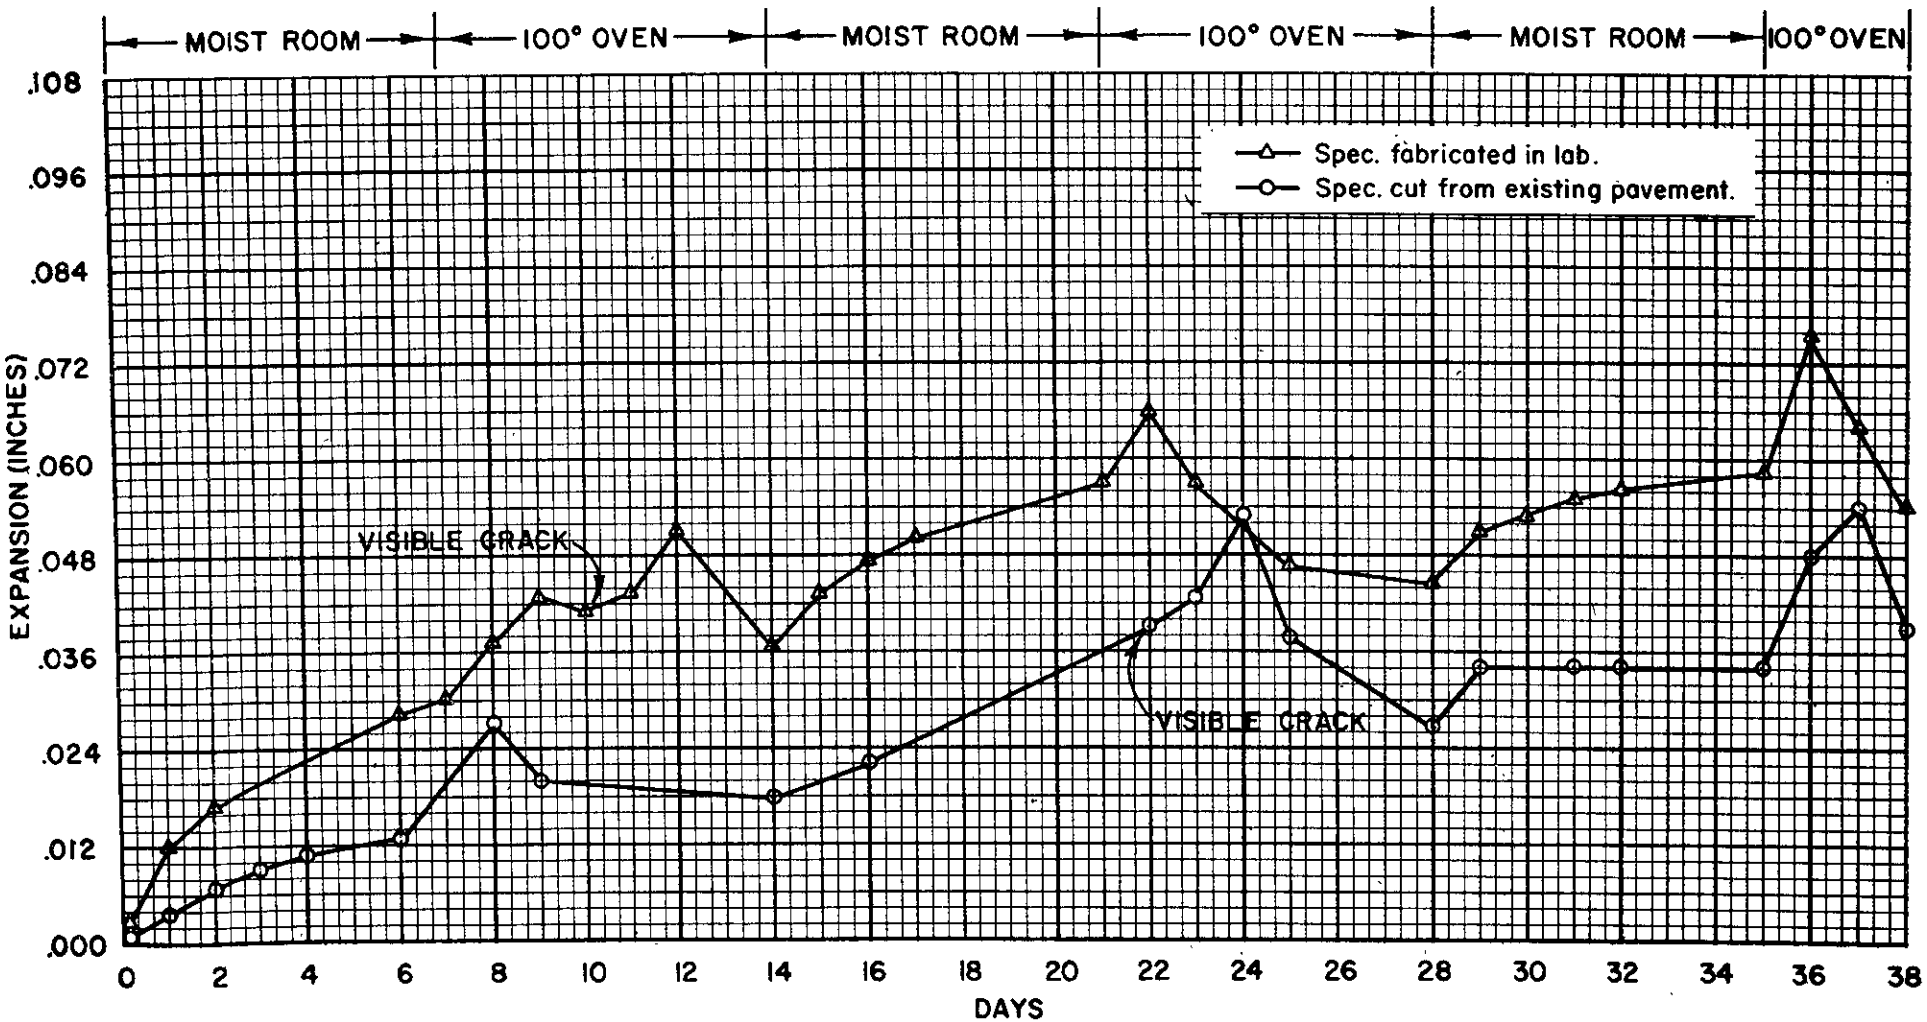
FIGURE 10

A record of the expansion and contraction occurring in the laboratory-fabricated specimen and the AC sample bar sawed from existing pavement is presented graphically by Figure 10. Both AC bars showed approximately the same rapid expansion in the first few hours of the dry cycle. However, the laboratory-prepared bar expanded more during the wet cycle, probably due to the fact that the asphalt in the specimen from the existing pavement had a longer time to be absorbed by the absorptive aggregates (both fine and coarse). This added depth of penetration of asphalt into the aggregates partially sealed off the pores of the aggregates and prevented it from absorbing water thus reducing expansion during the wet cycle.

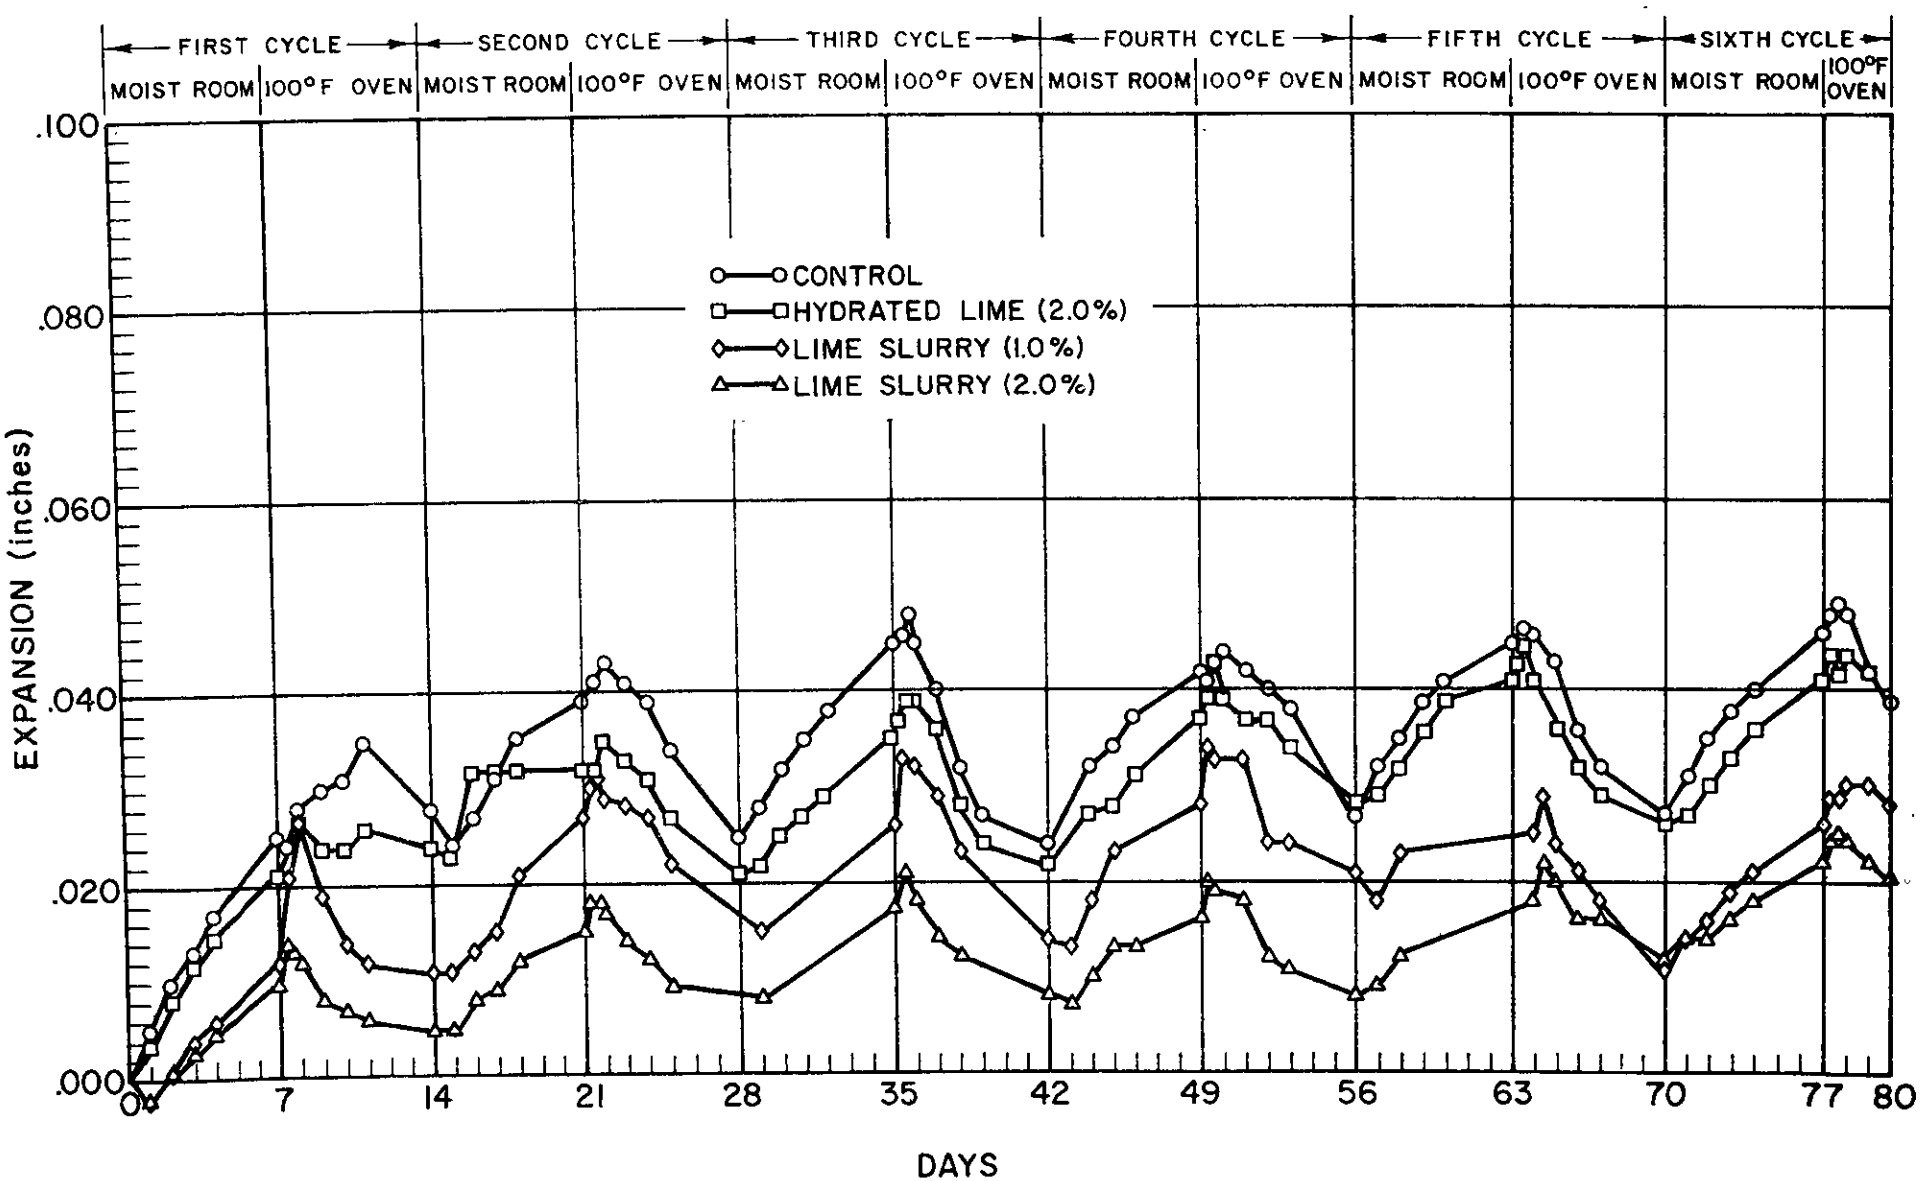
FIGURE 11

The hydrated lime, when added as a filler, did not prove beneficial for this particular aggregate. However, when applied in a slurry form, a marked reduction in expansion was noticed (see Figure 11).

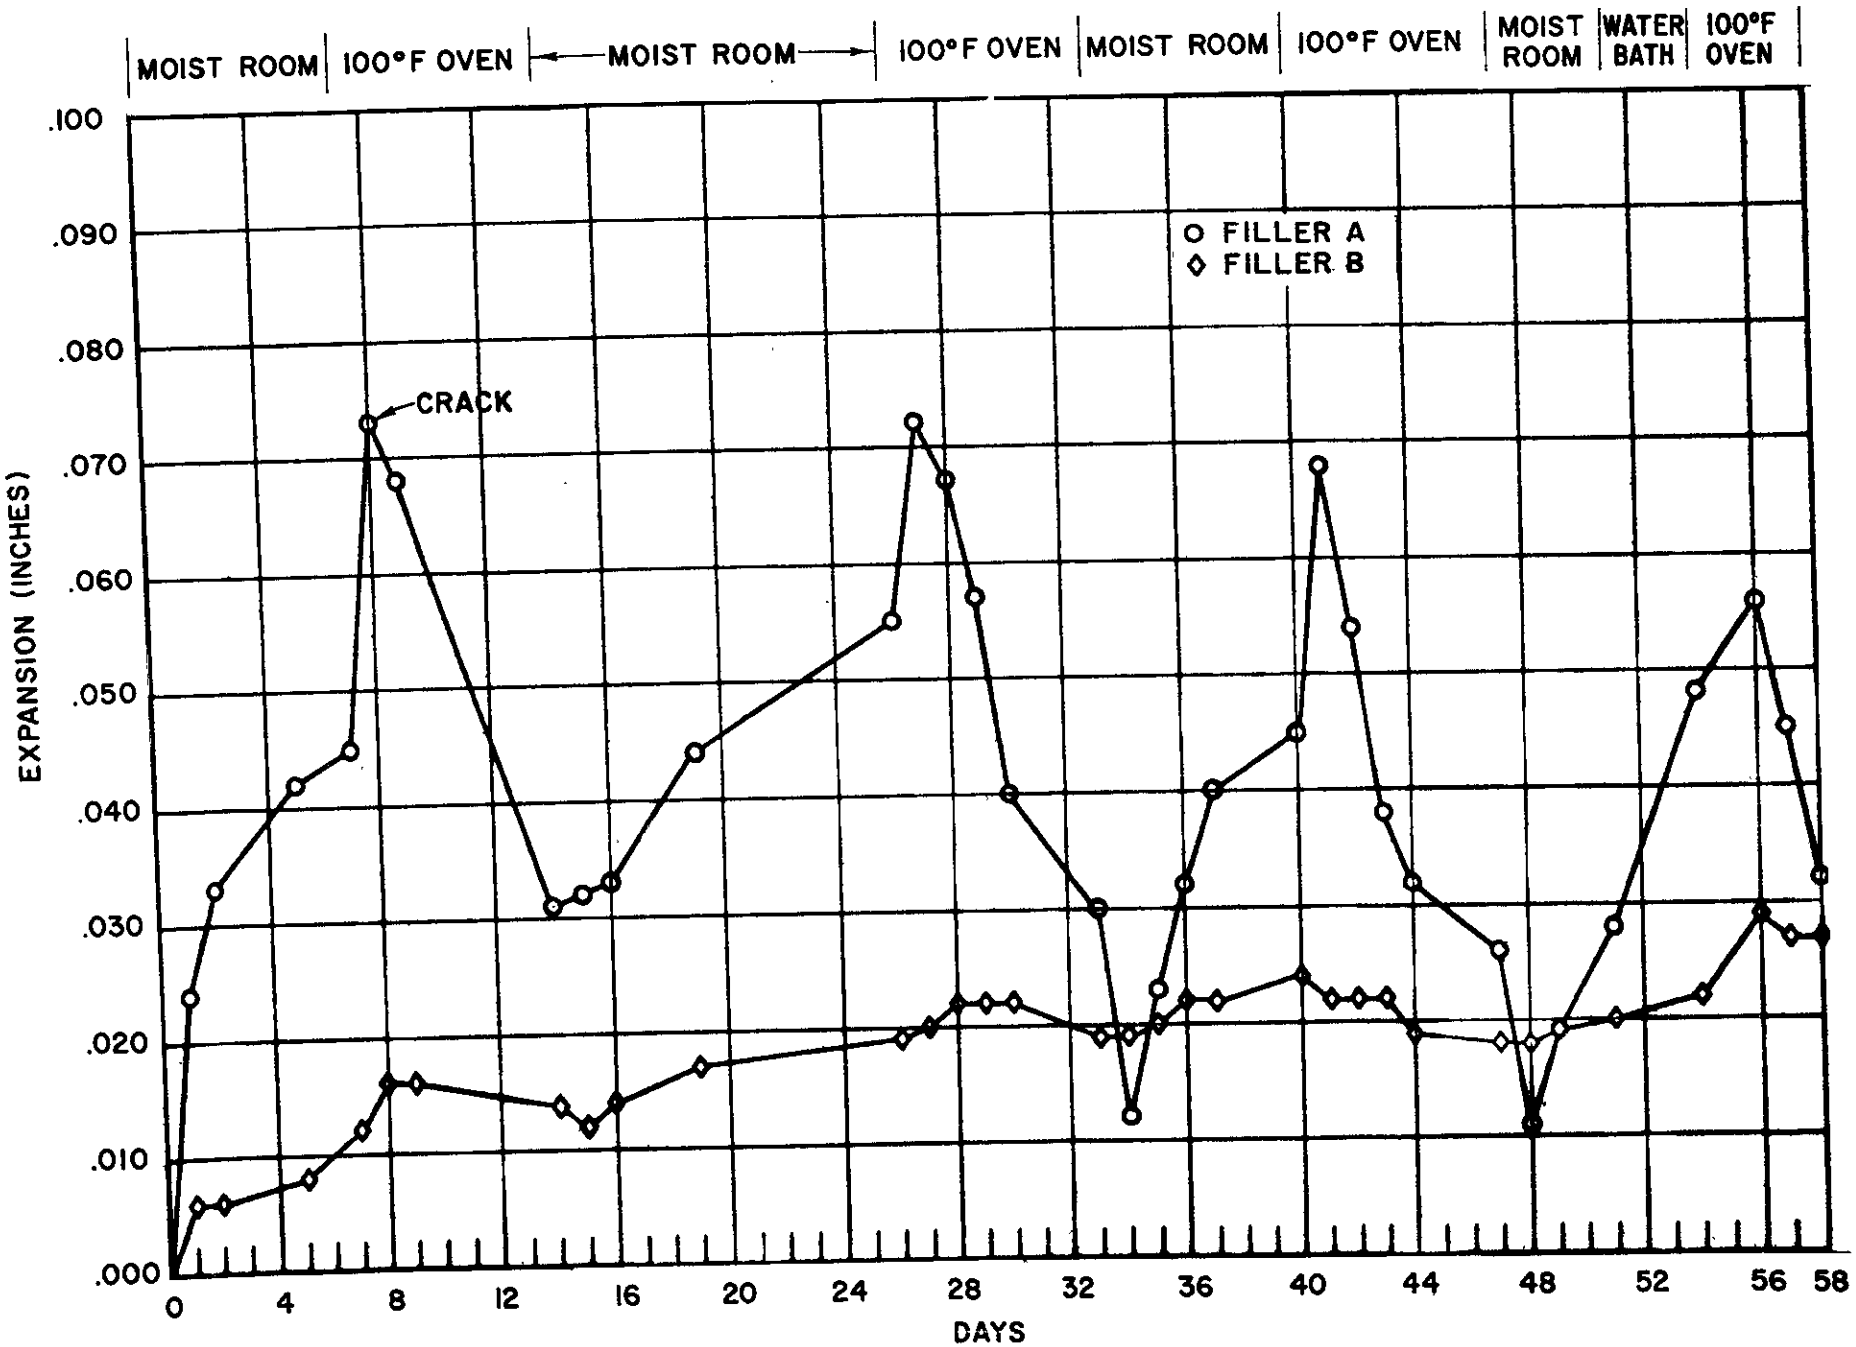
FIGURE 12

To summarize the results of this investigation, we feel that Filler B was effective in reducing expansion and contraction of the pavement. However, this phenomenon may not necessarily hold true for other aggregates. Figure 12 shows the cyclic expansion-contraction for Fillers A and B for a period of 58 days.

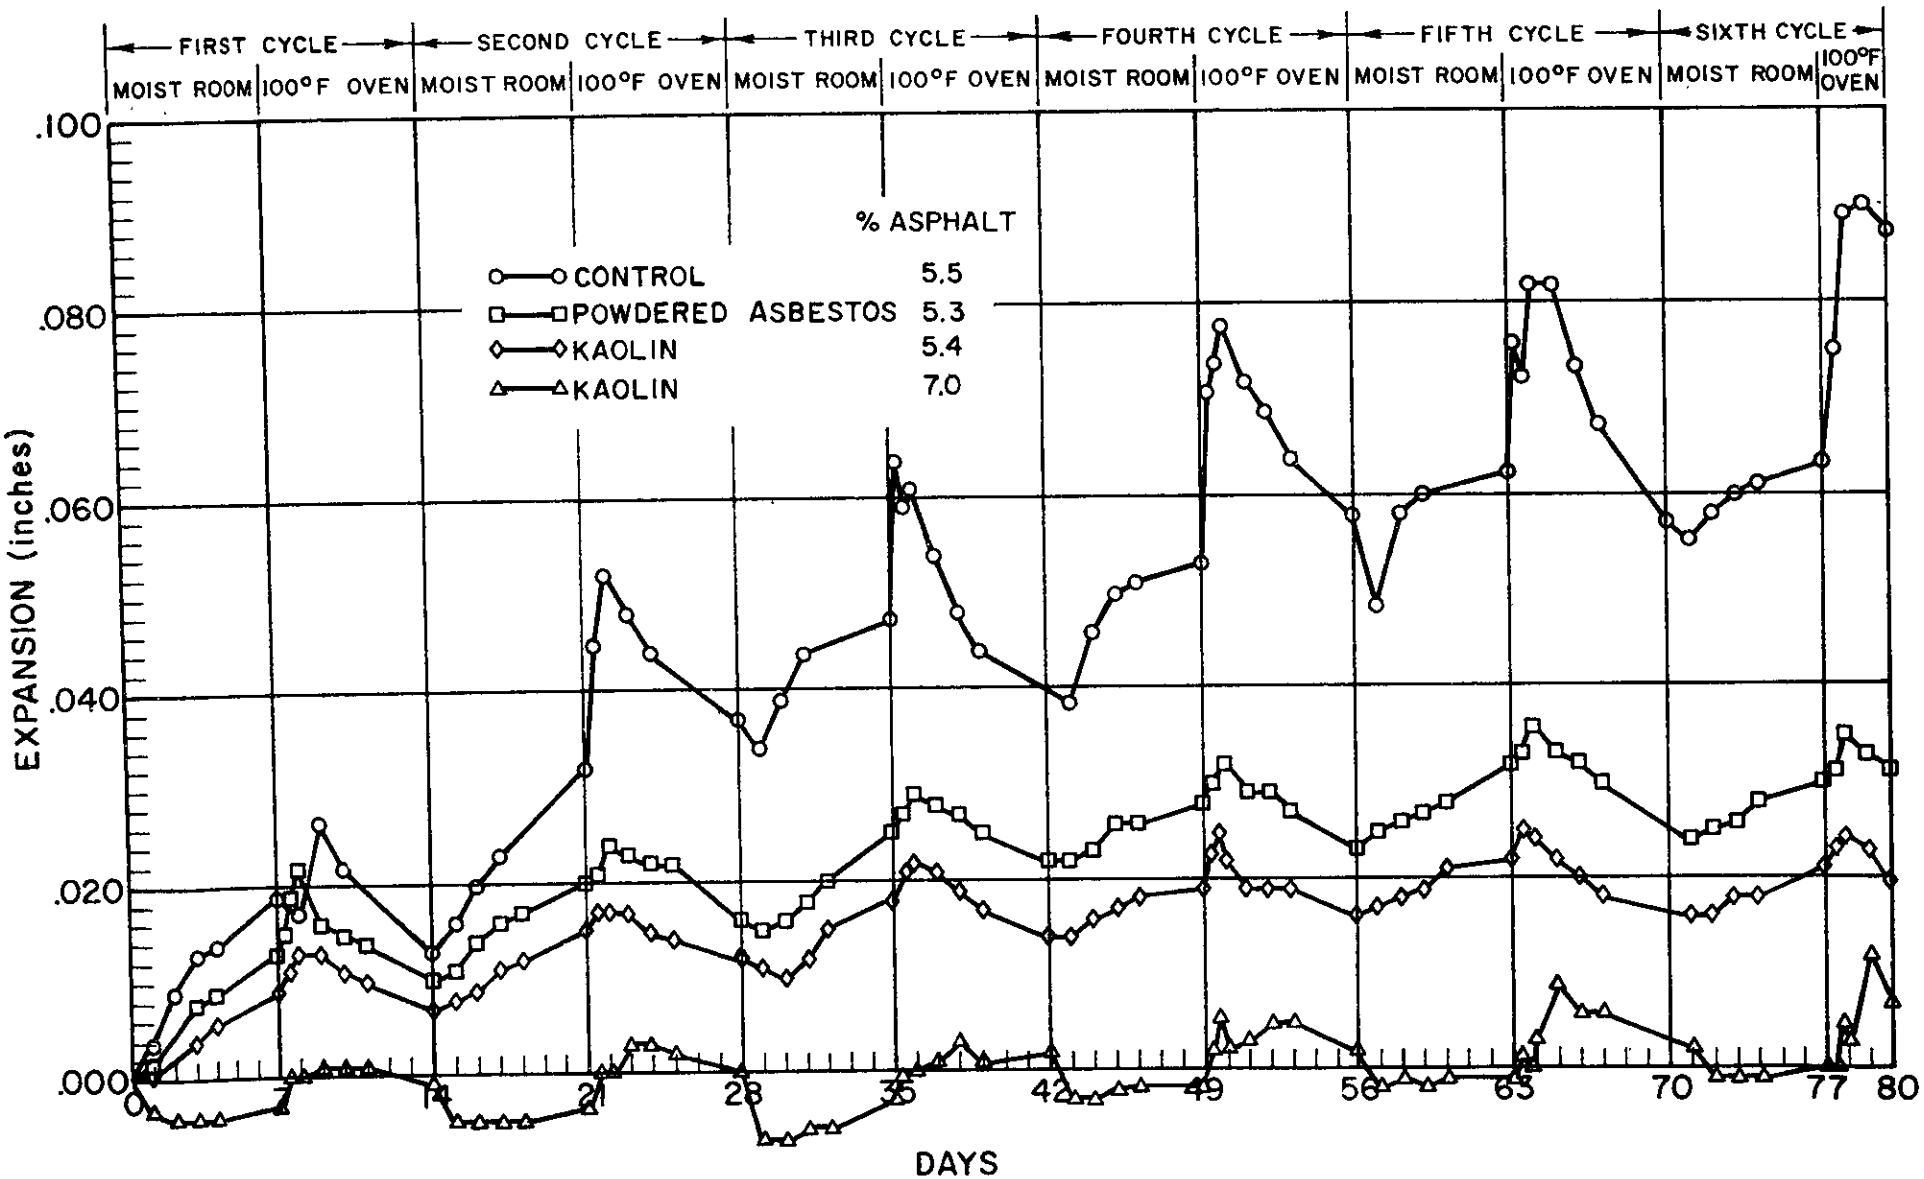
FIGURE 14

Considerable reduction in expansion occurred with the fillers added (Figure 14). No cracks were visible in these specimens. Although the Kaolin filler with 7.0% asphalt reduced the maximum expansion to 0.012", the amount of asphalt was excessive
