CRACKING OF ASPHALT CONCRETE PAVEMENTS ASSOCIATED WITH ABSORPTIVE AGGREGATES

Ernest Zube

RESEARCH REPORT

NO. M & R 231138-2

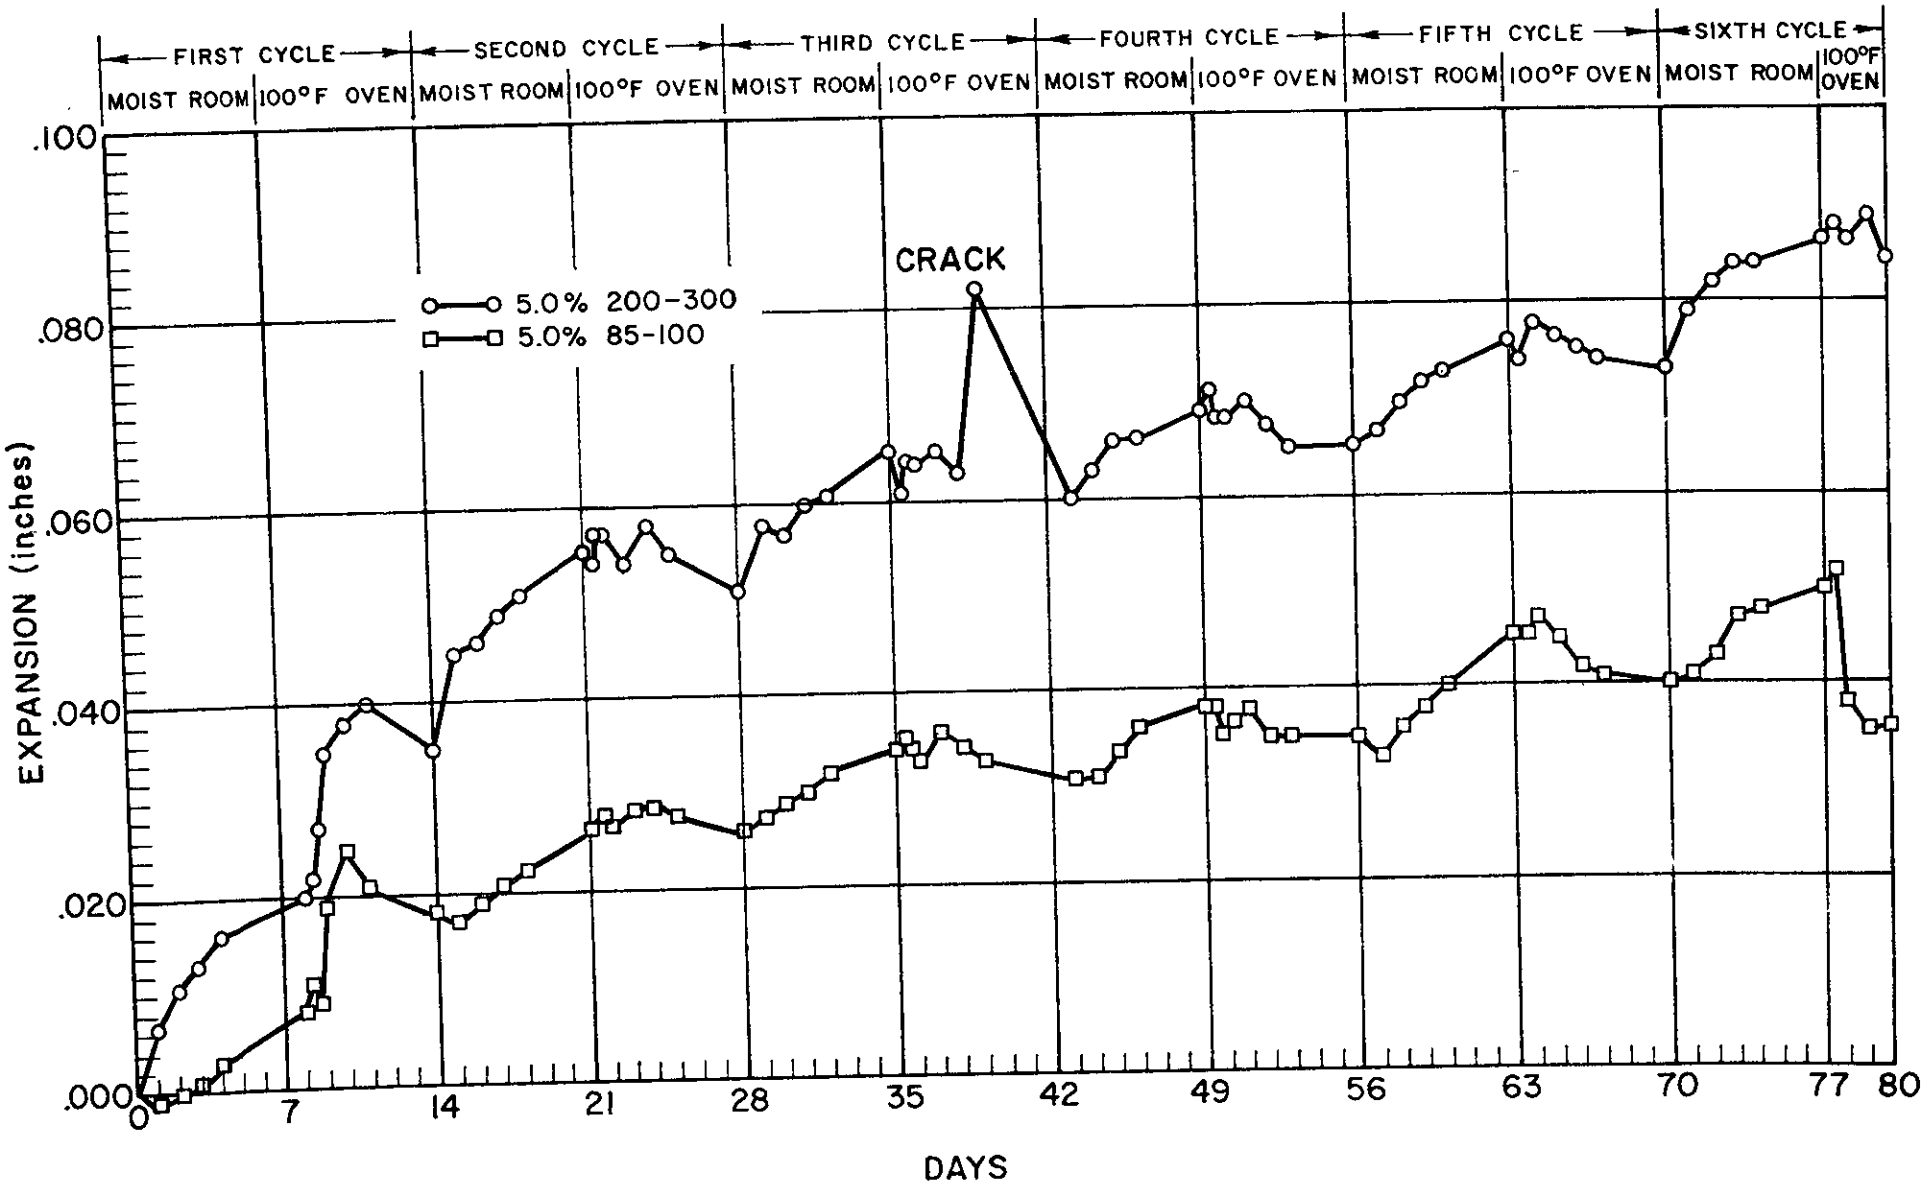
FIGURE 15

In another example (Test #65-1401) we used 200-300 and 85-100 penetration asphalt. The aggregate showed 0.5% absorption. By using 5.0% asphalt the following maximum expansion was obtained after 6 test cycles:

200 - 300 penetration = 0.089" expansion

85 - 100 " = 0.052" "

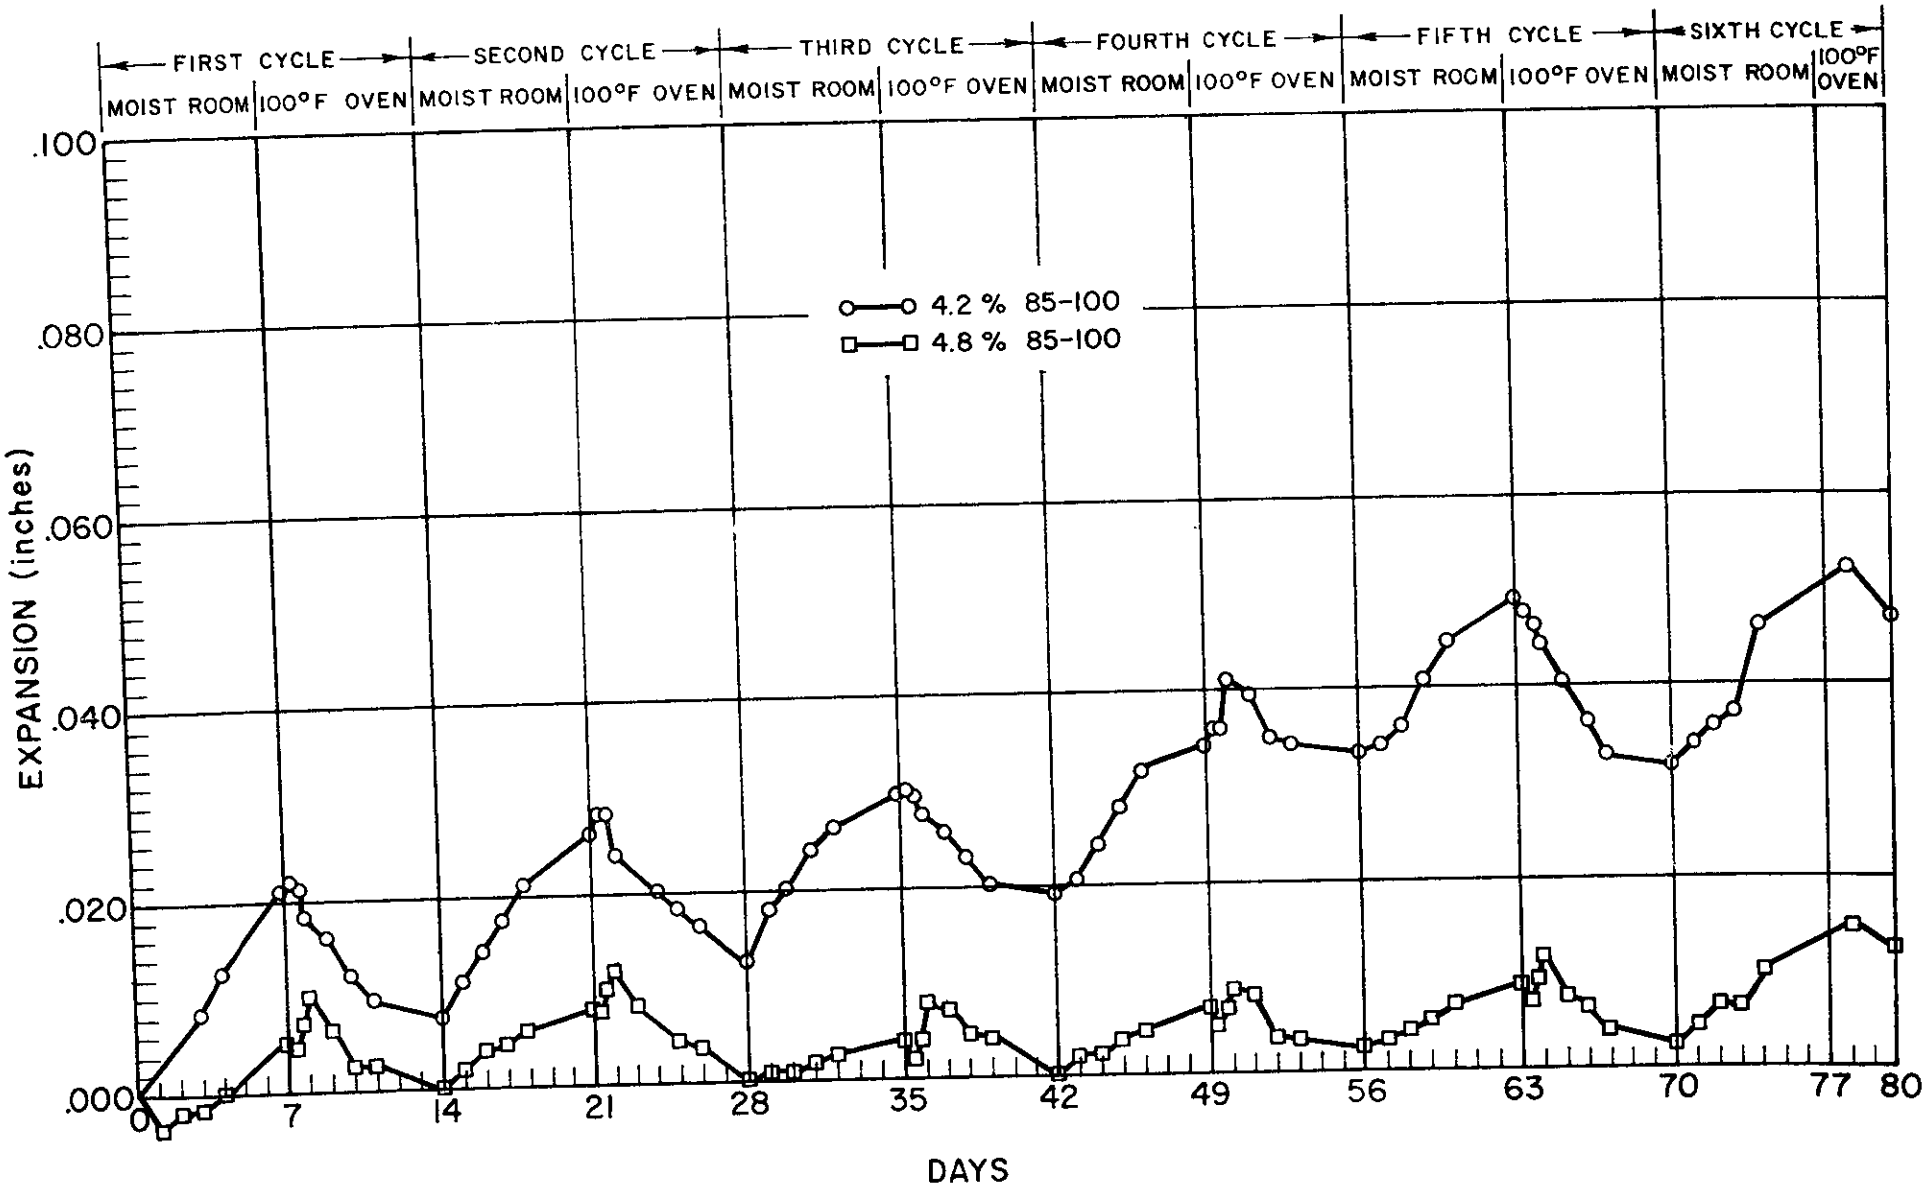
FIGURE 16

It is the policy of the California Division of Highways to recommend the highest possible asphalt content for asphalt concrete mixes, consistent with other specification requirements such as stability. This is particularly important when using absorptive aggregates. Figure 16, representing a moderately high absorptive aggregate, shows that the maximum expansion has been decreased from 0.052" to 0.014" by increasing the average asphalt film thickness by one micron. The same increase in film thickness of a nonabsorptive or slightly absorptive aggregate will only reduce the expansion slightly, as i.e. from 0.014" to 0.012" after 3 exposure cycles.
