DYNAMIC TESTS
of
CORRUGATED METAL BEAM GUARDRAIL

MATERIALS AND RESEARCH DEPARTMENT

NO. M & R 636392

State of California
Department of Public Works
Division of Highways

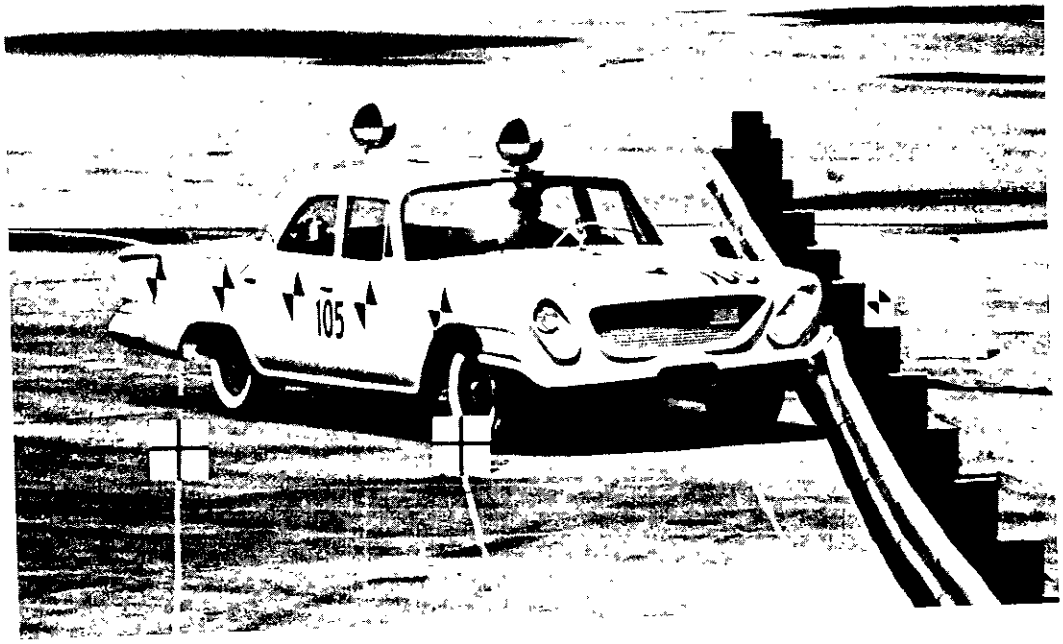
Figure 3

Analysis of the data from Test 105 indicated that the vaulting problem on the 24-in-high blocked-out corrugated steel beam guardrail was compounded by the front bumper geometrics of the 1962 Chrysler test vehicle (see Figure 3).

Investigation of bumper geometrics revealed that a majority of the U. S. manufactured vehicles for the years 1962-65 were equipped with bumpers having characteristics similar to those of the 1962 Chrysler test vehicle (Plate 1). It is possible that this feature of the newer vehicles has contributed to the high incidence of guardrail vaultings reported by our operational departments. It may be noted in Plate 1 that the bumpers of the newer automobiles from the four leading manufacturers would strike a 24-in.-high guardrail above the center of the beam. This point of impact, in conjunction with the curved, sloped-back bumper design, increases the possibility of vaulting due to the eccentric loading about the beam's longitudinal axis of rotation.

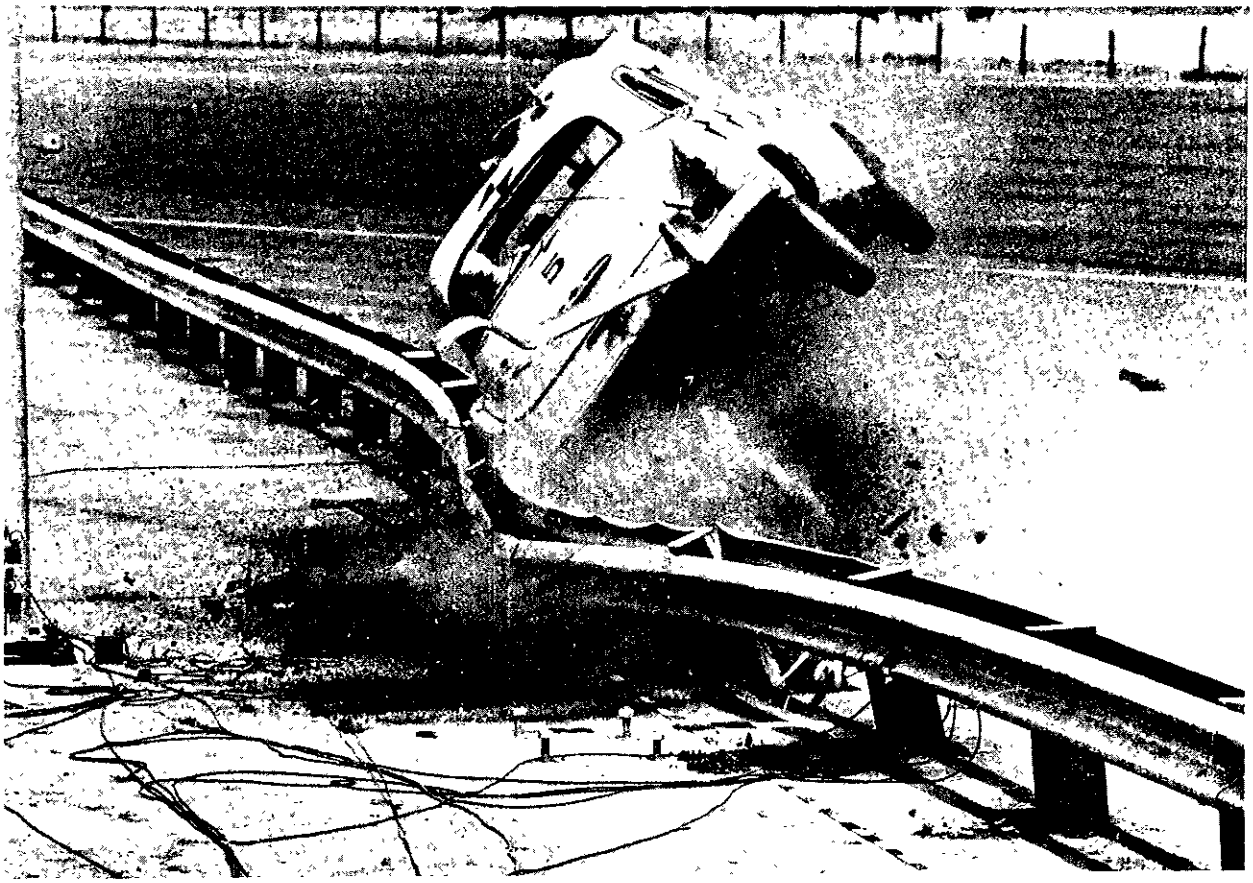
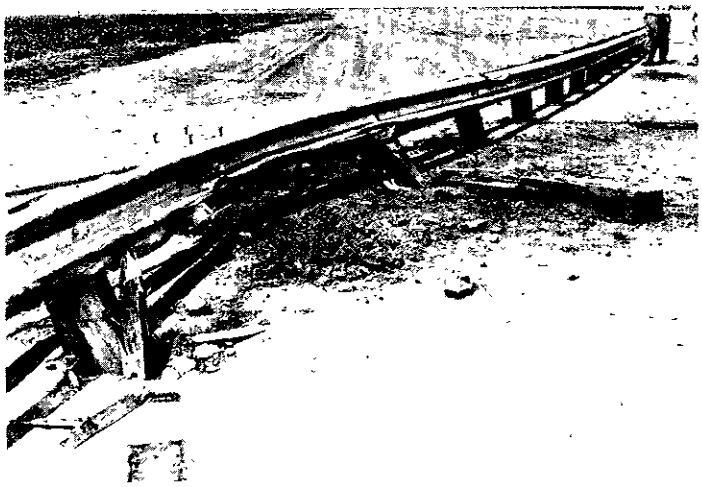
PLATE 2

The relative effectiveness of the blocked-out barrier design in preventing excessive vehicular roll may be seen by comparing Test 505 conducted in 1958 (see Plate 2) with Test 108 (Plate C). Even with the additional rigidity provided by the double beam, the design used in Test 505 was ineffective in preventing vehicle roll-over. During contact with any semi-rigid beam-type barrier, an impacting vehicle tends to roll toward the barrier. Resistance to this roll is provided by the weight of the vehicle acting downward and is either helped or hindered by the moment couple between the horizontal center of gravity of the car and the center of gravity of the beam. Since the most critical time of any barrier collision occurs during the first few hundredths of a second after impact as the beam is being deflected but before axial tension has become effective, it is important that the beam height be maintained or increased slightly as the post rotates, as shown in Figure 4. The effect of blocking-out the beam is to minimize vehicular roll by providing restraining forces above the center of gravity of the vehicle during the early and most critical time of collision. In contrast, the height of the nonblocked-out beam immediately decreases during post rotation thereby decreasing the effectiveness of the barrier's restraining forces. This can result in the beam acting as a ramp before it has an opportunity to start resisting axially.

TEST 505 1958

Double Metal Beam Median Barrier with galvanized steel corrugated beam mounted on 8- by 8-in. D. F. posts spaced 6-ft 3-in. on centers.

Impact Speed	58-mph
Impact angle	31°
Beam Height	25-in.

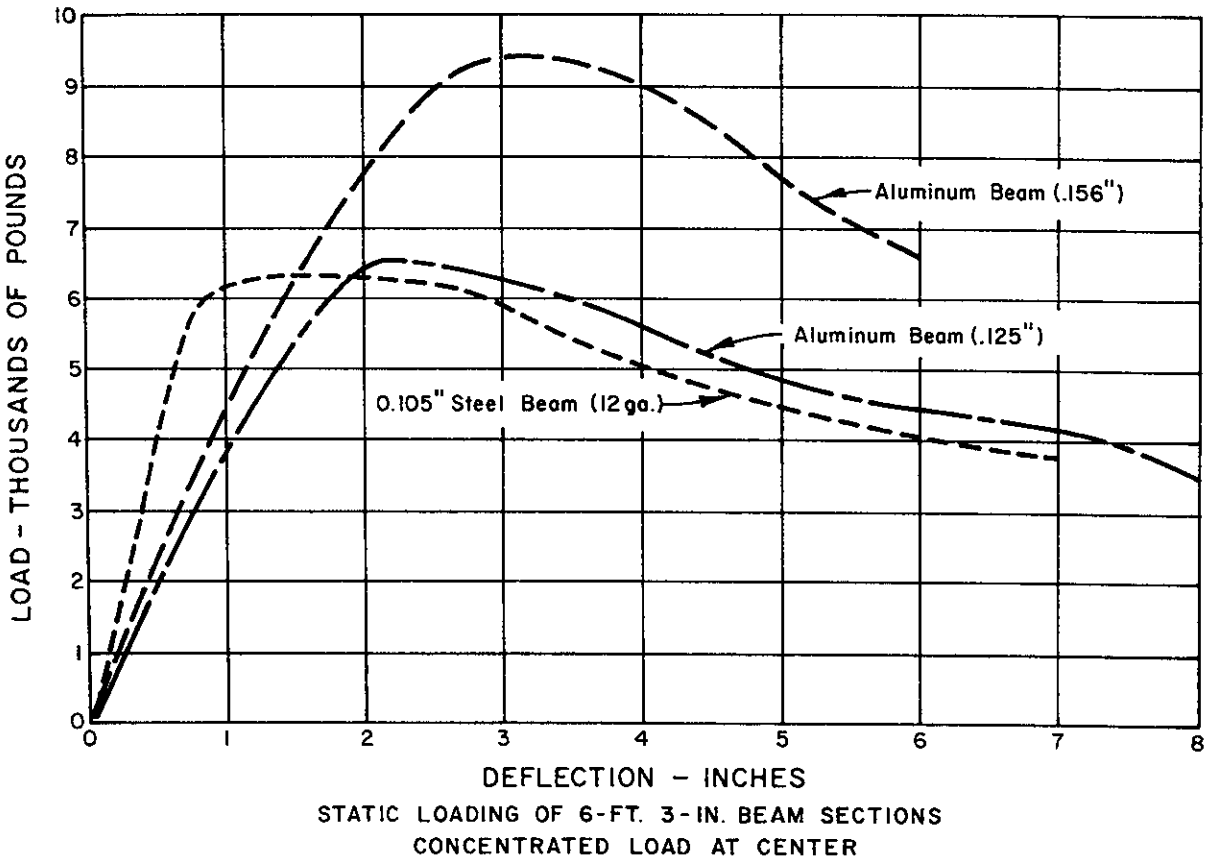
FIGURE 5

to high dynamic stress concentrations. These bending stresses, present with large beam deflections, cause local buckling at the top and bottom of the beam. The buckled areas, appearing as ripples, are more apparent in steel sections although they do not cause tears as in the aluminum. The difference in performance of steel and aluminum appears to stem from the difference in stress-strain relationships and ductility of the two materials (see Figure 5 and Table 2).

BEAM DEFLECTIONS

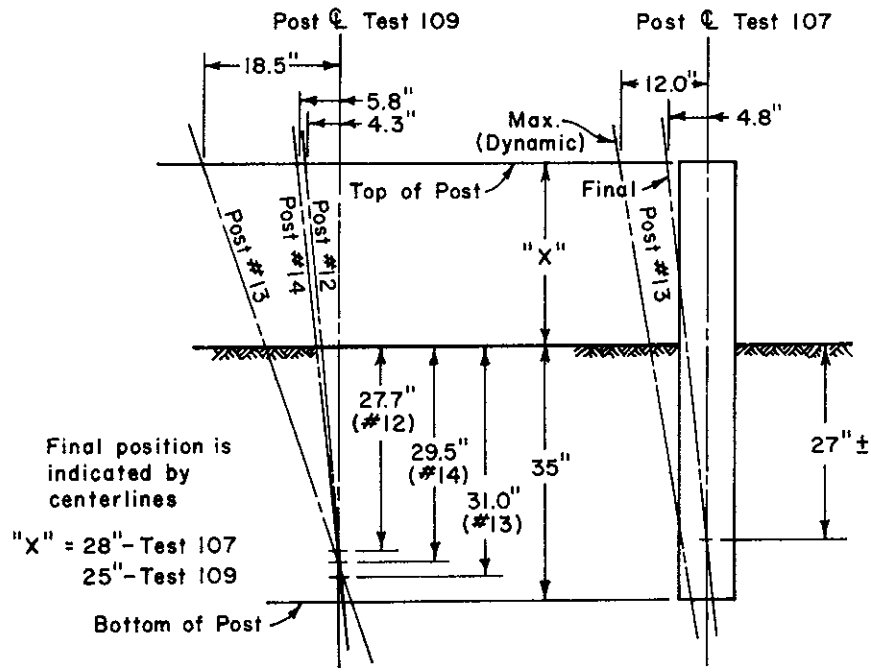
Figure 7

vertical axes. As the lateral deflections of the post tops increased, the centers of rotation moved down along the post axes. For very large deflections the rotation center appeared to be very near the bottom of the post, which is in agreement with previous findings[14] for rigid posts (see Figure 7).

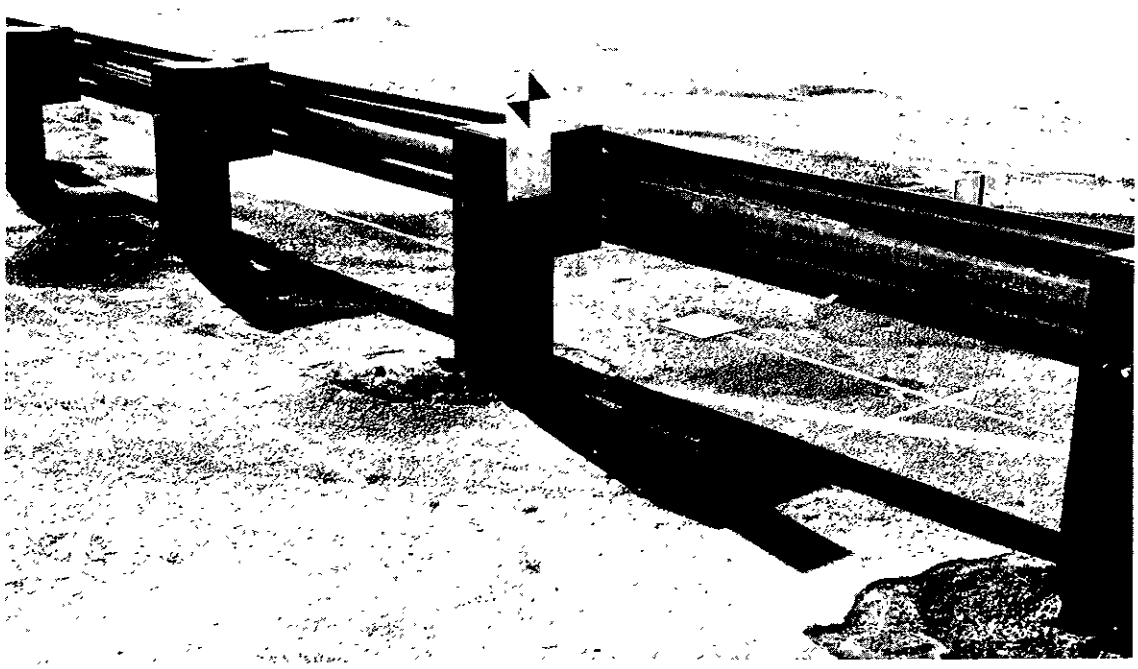
Figure 8 shows soil heave after one of the latter tests and illustrates the need for adequate set-back from the hinge-point, or deeper post embedment, for guardrail installations on fill slopes.

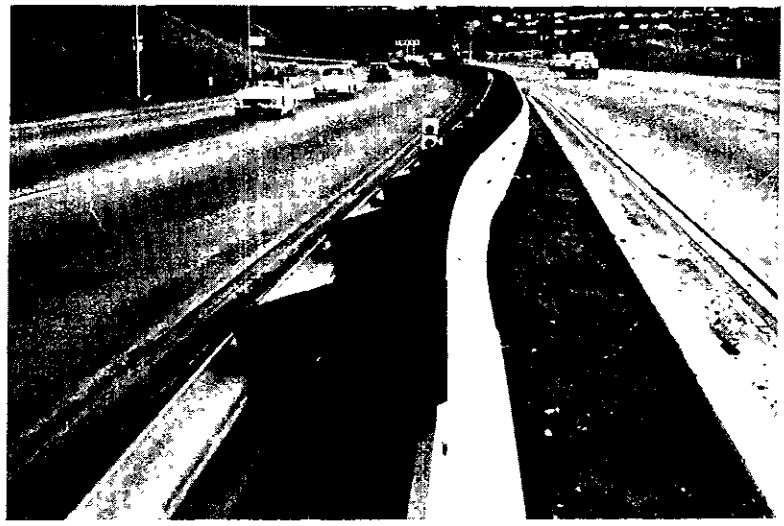
Figure 9

The blocked-out beam barrier concept has been supported consistently by satisfactory performances of single and double blocked-out corrugated steel beam barrier field installations. Investigations of in-service barriers at accident locations revealed barrier behavior patterns almost identical to those exhibited by successful test barriers. Double blocked-out

median barriers have performed exceptionally well as illustrated by Figures 9 and 10.

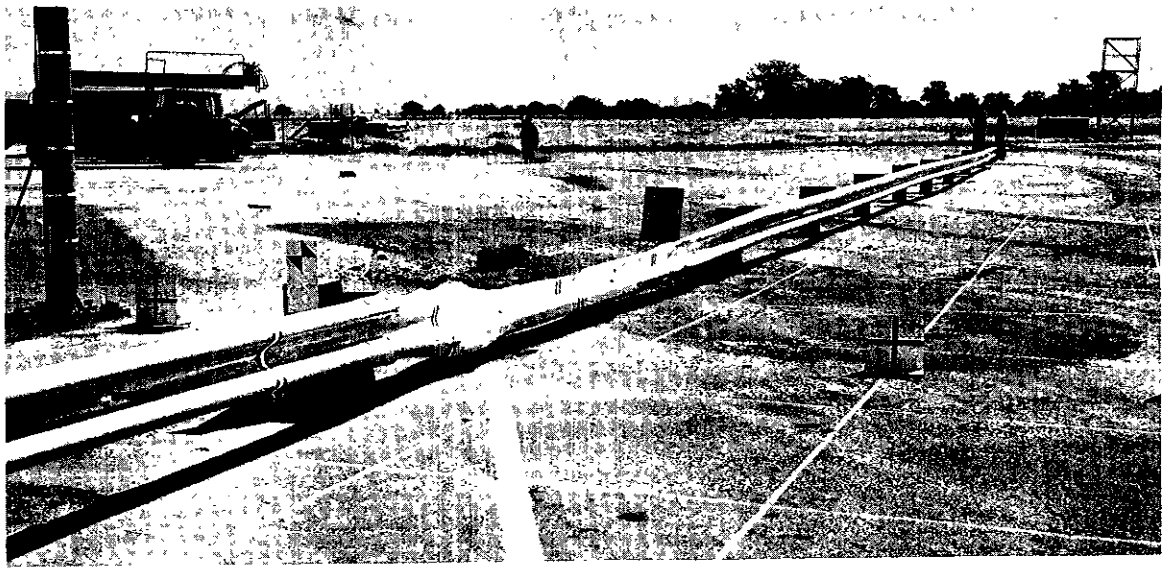
TEST 105 PLATE A

BARRIER DAMAGE: Two sections of beam were damaged. Three posts were knocked out of alignment, one of which was shattered. One block-out block was splintered and one was split.

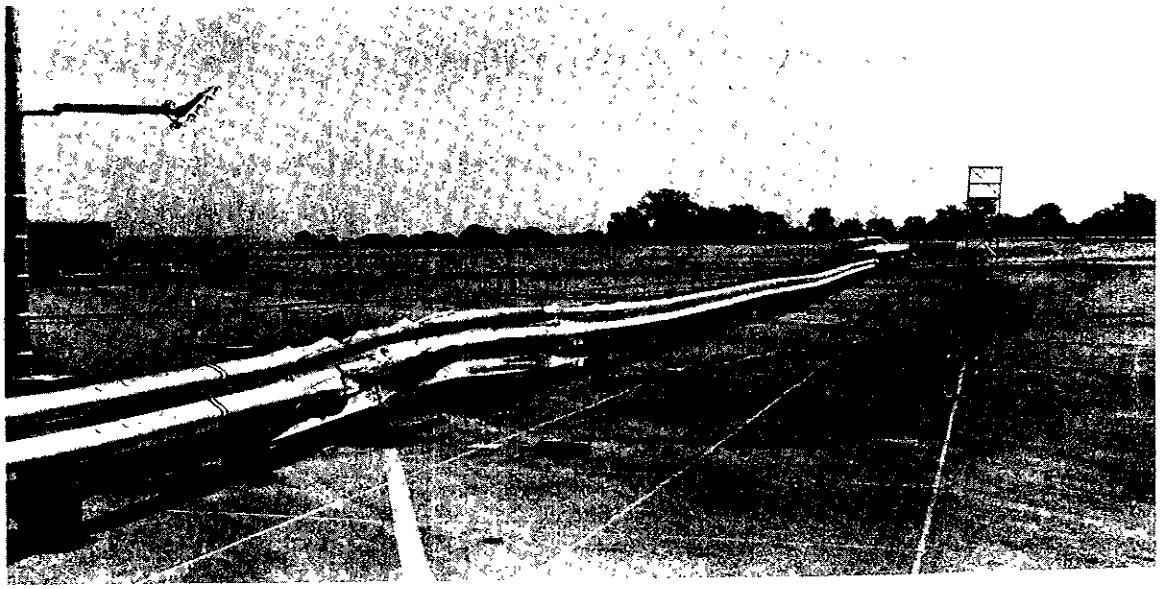
TEST 106 PLATE A

BARRIER DAMAGE: Three sections of beam and two sections of rubbing rail were damaged. Six posts were knocked out of alignment, one of which was broken and one was split. Three block-out blocks were splintered, and two were split.

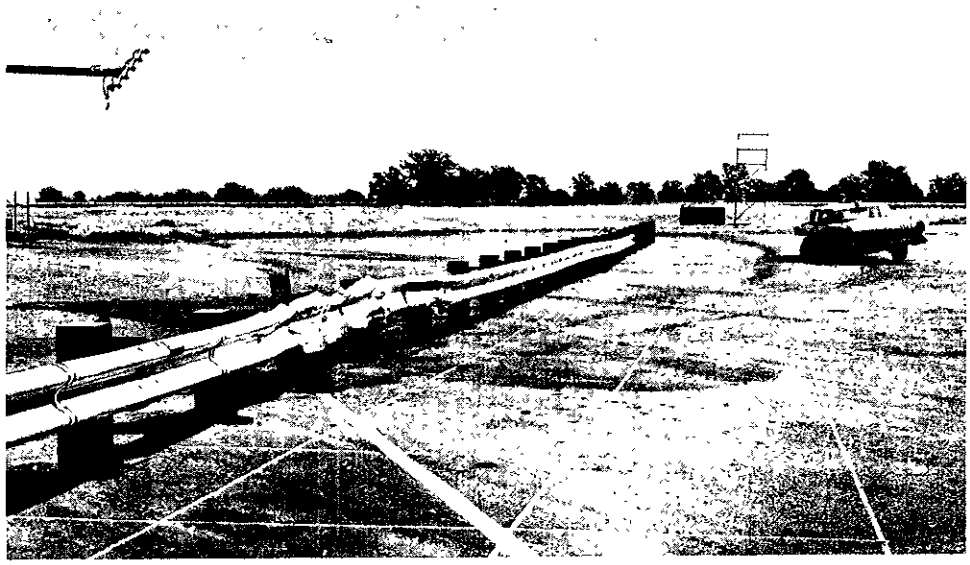
TEST 107 PLATE A

BARRIER DAMAGE: Three sections of beam were damaged. Four posts were knocked out of alignment and two were split. Two block-out blocks were splintered and three were split.

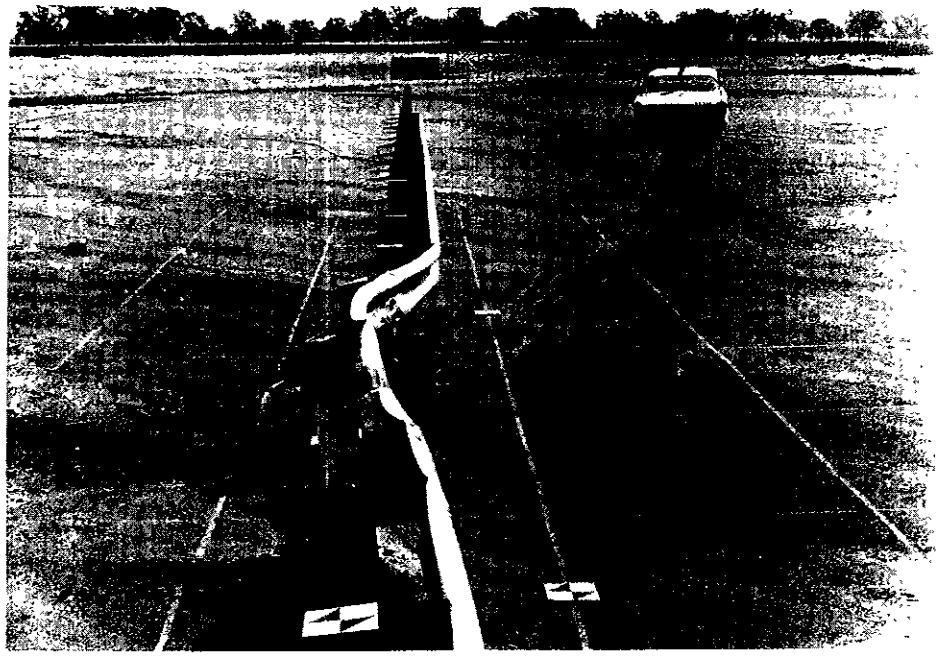
TEST 108 PLATE A

BARRIER DAMAGE: Three sections of beam were damaged. Five posts were knocked out of alignment and five were split. Two block-out blocks were splintered and four were split.

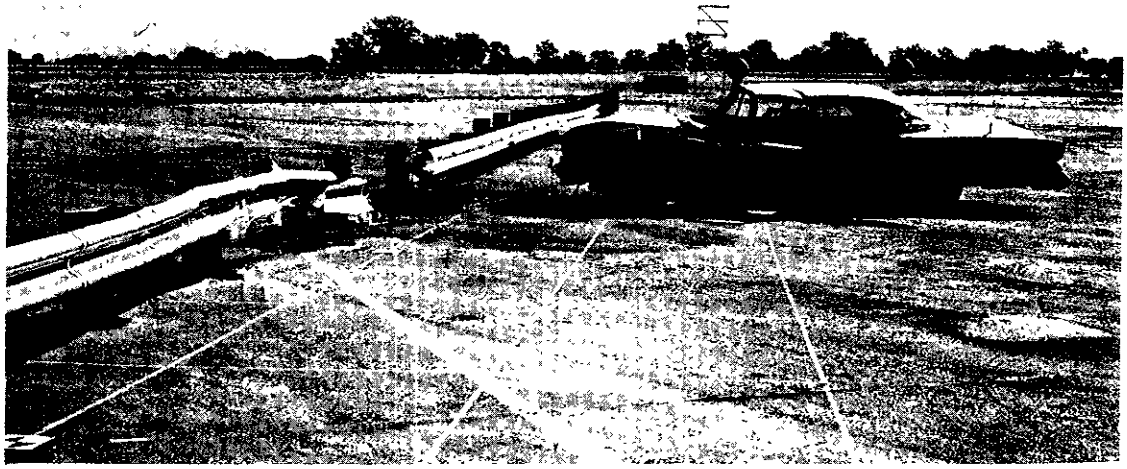
TEST 109 PLATE A

PERFORMANCE: The vehicle impacted the guardrail between posts at a speed of 60-mph and remained in contact for approximately 12-ft before the beam separated. The vehicle snagged the separated beam, resulting in a violent 100° spin-out. The vehicle's momentum, as it snagged, caused the failed beam to penetrate the wheel well and floor boards and impale the dummy. As the vehicle spun-out, 8-ft of the beam broke off near the wheel well and remained in the vehicle.

BARRIER DAMAGE: Two sections of beam were destroyed. The beam failed completely in three places. Five posts were knocked out of alignment, three of which were split. Three block-out blocks were splintered and six were split.

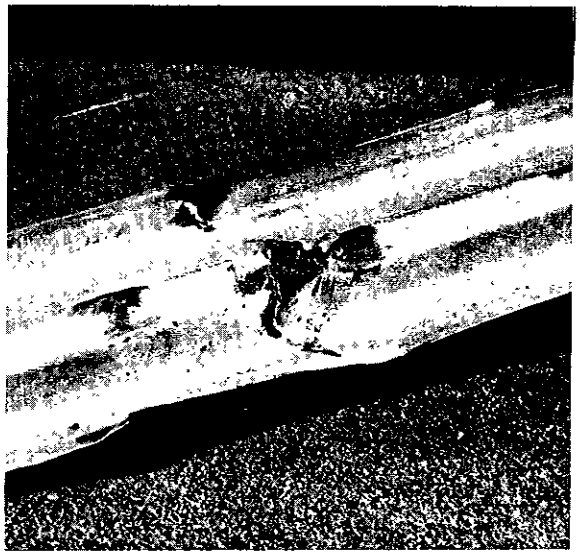
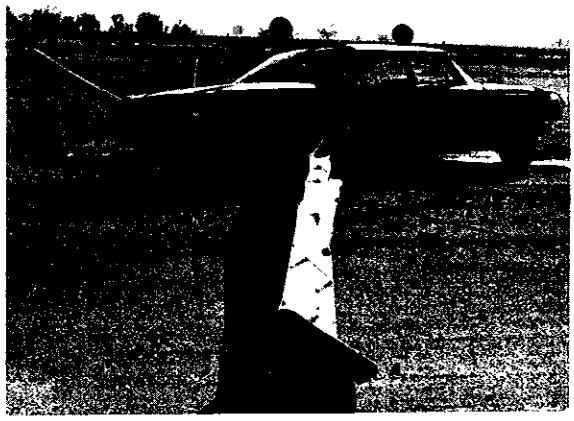
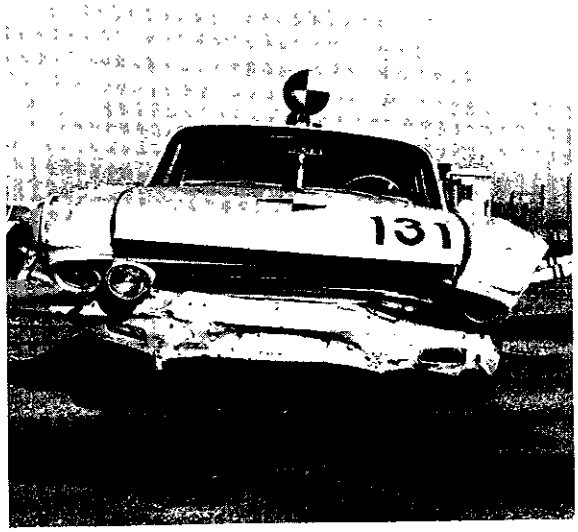
131

BARRIER DAMAGE: All three beam sections and all seven posts and blocks were damaged. Posts one, two, three, four, and seven were split as the bolts were pulled through the post by the beam. Post six split but partially retained the bolt, causing the beam to pull free of the bolt. Post five pulled out of the ground and remained attached to the beam. One post bolt failed at the beam bearing point. There was no indication of failure at the beam splices.

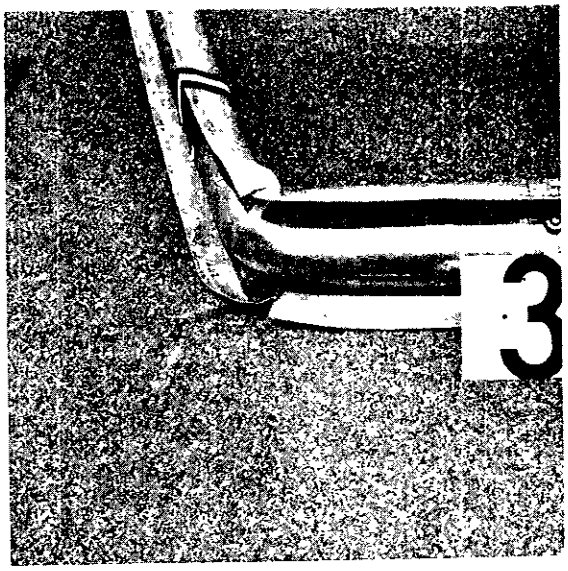
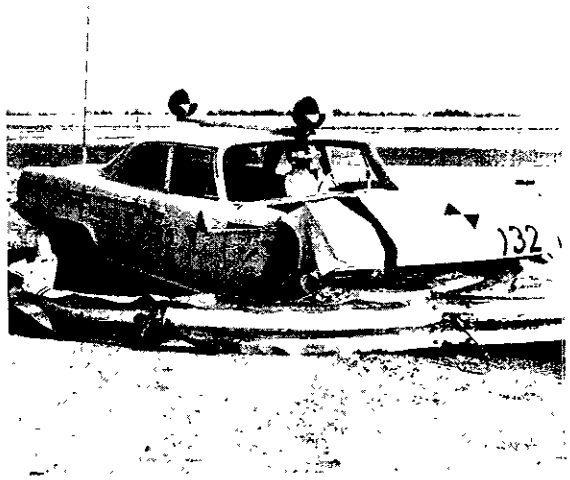
132

BARRIER DAMAGE: All five beam sections, ten of eleven posts and eight of nine blocks were damaged. Posts one, three, five, nine, ten, and eleven were split as the bolts were pulled through the posts by the beam. Posts six and seven were shattered to ground level. Posts two, four, and eight retained the bolt causing it to pull through the beam. Extreme bending caused three cracks to occur in the beam. There was no indication of failure at the beam splices.
