Bridge Painting

FINAL REPORT

PROTECTIVE COATINGS USED IN THE EXPERIMENTAL PAINTING of the LEFFINGWELL CREEK BRIDGE

January, 1959

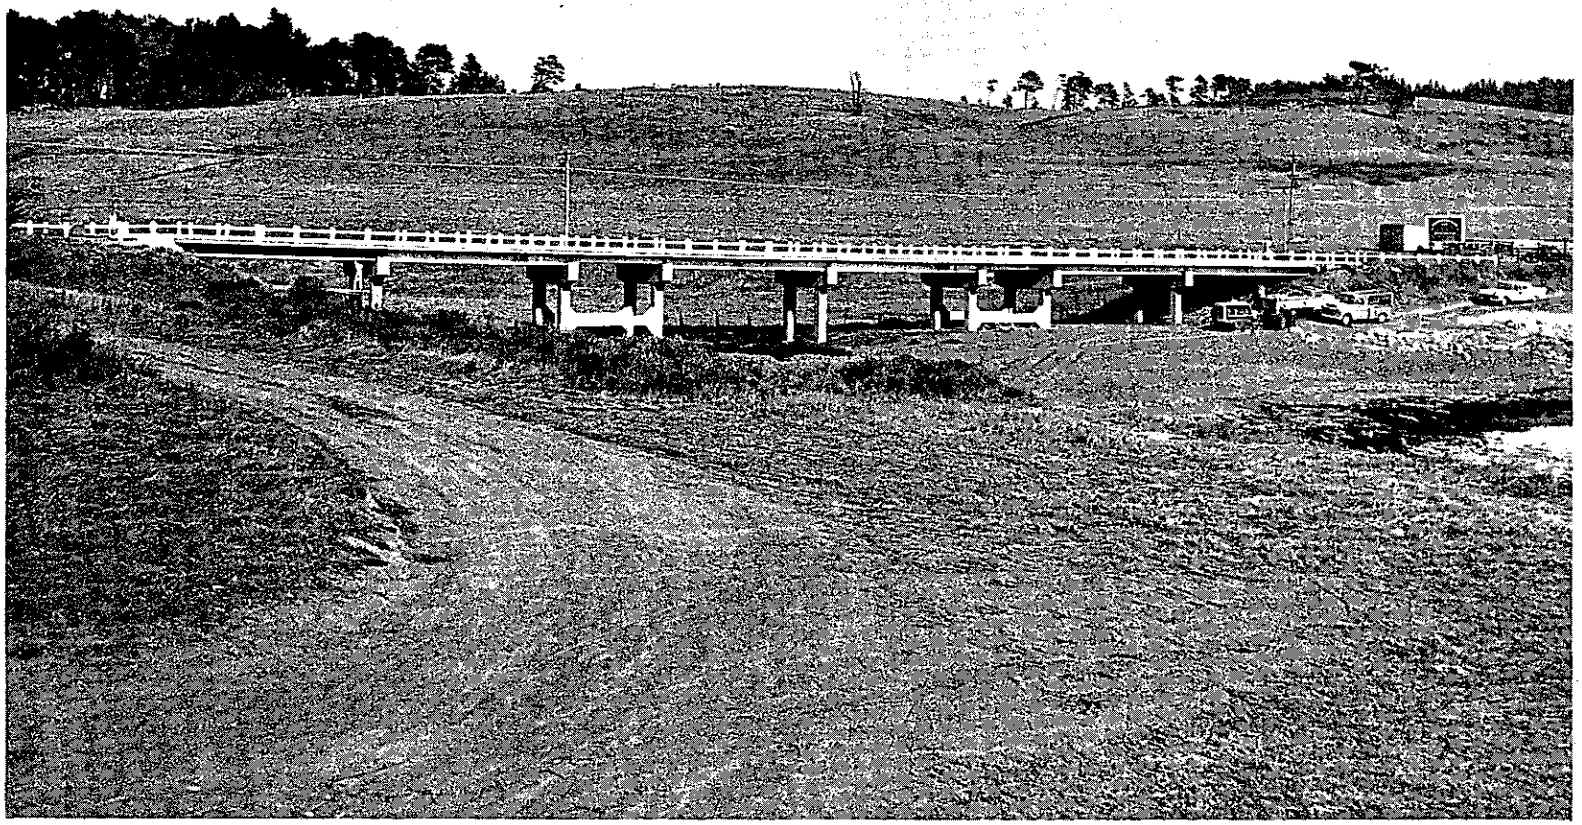
Fig. 1. Leffingwell Creek Bridge as viewed from near the Pacific Ocean surf line. This picture was taken in October 1958, just at the beginning of sandblasting operations for repainting.

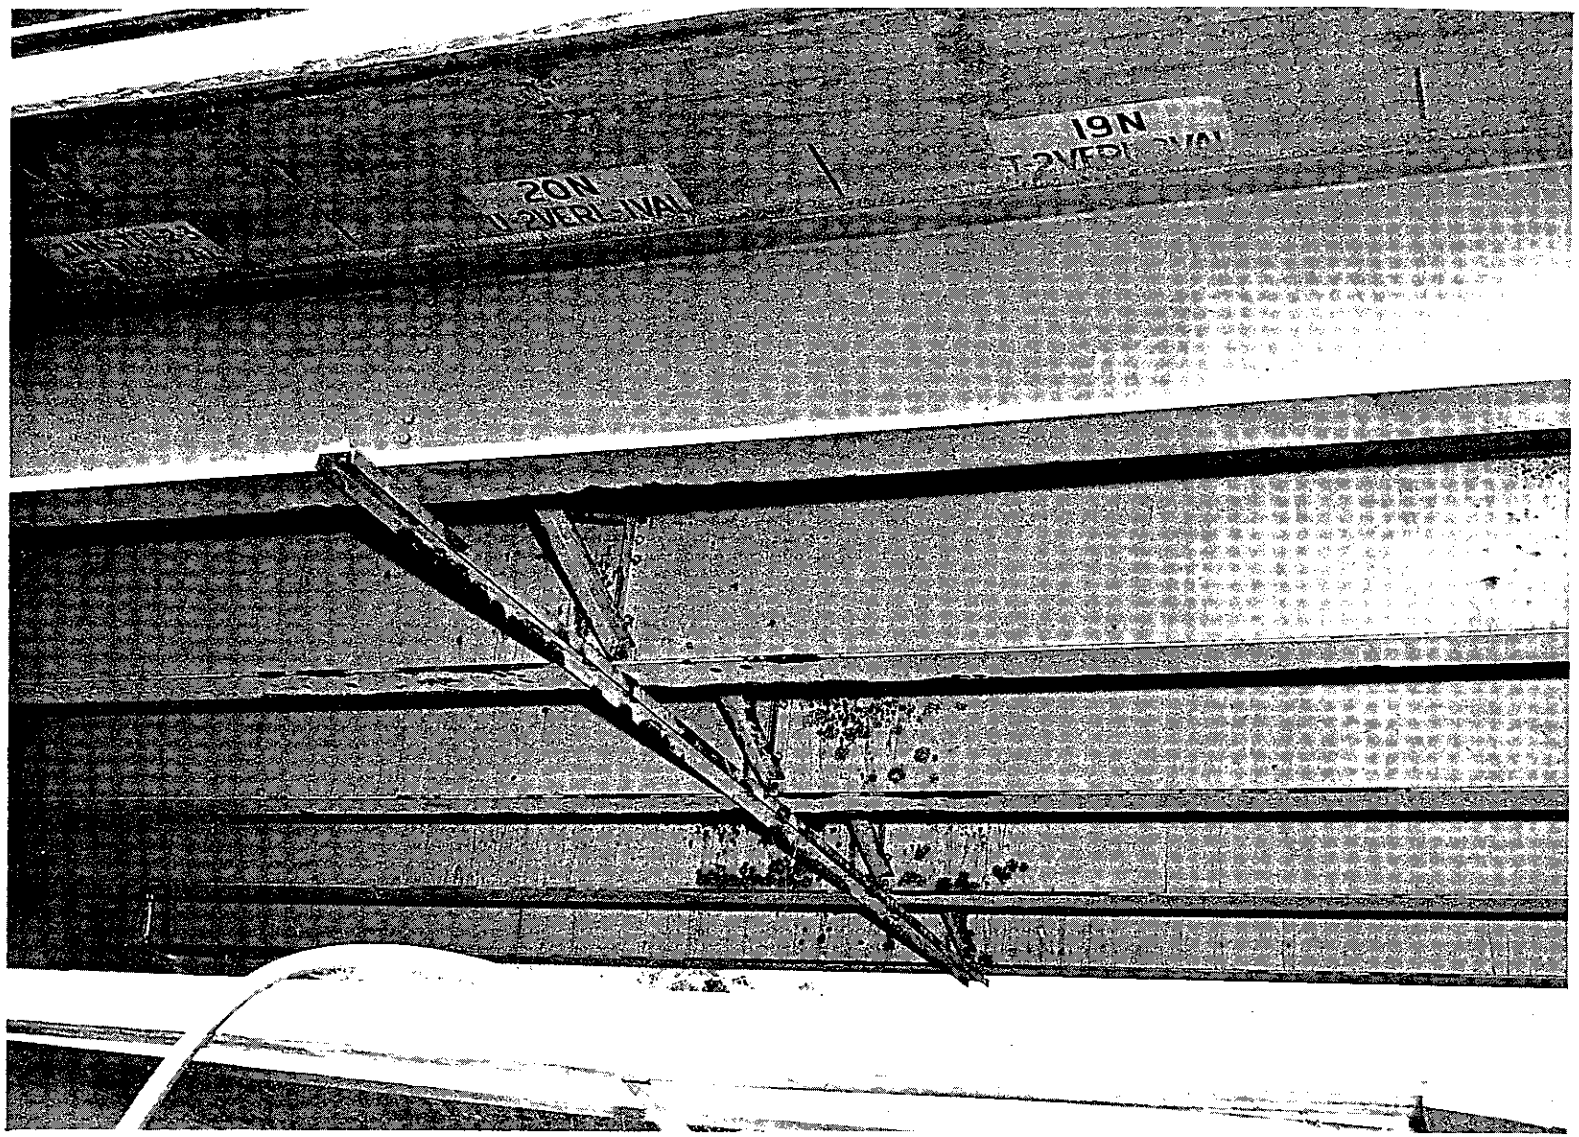
Fig. 2. The legend shown on the underside of the bridge deck describes the coating and whether steel was treated or not, e.g., Panel 20N indicates bare sandblasted steel was painted with two coats of Vinyl Epoxy Red Lead and one coat Vinyl Aluminum. Panel 19N steel treated with phosphoric acid, two coats of Vinyl Epoxy Red Lead - two coats Vinyl Aluminum.

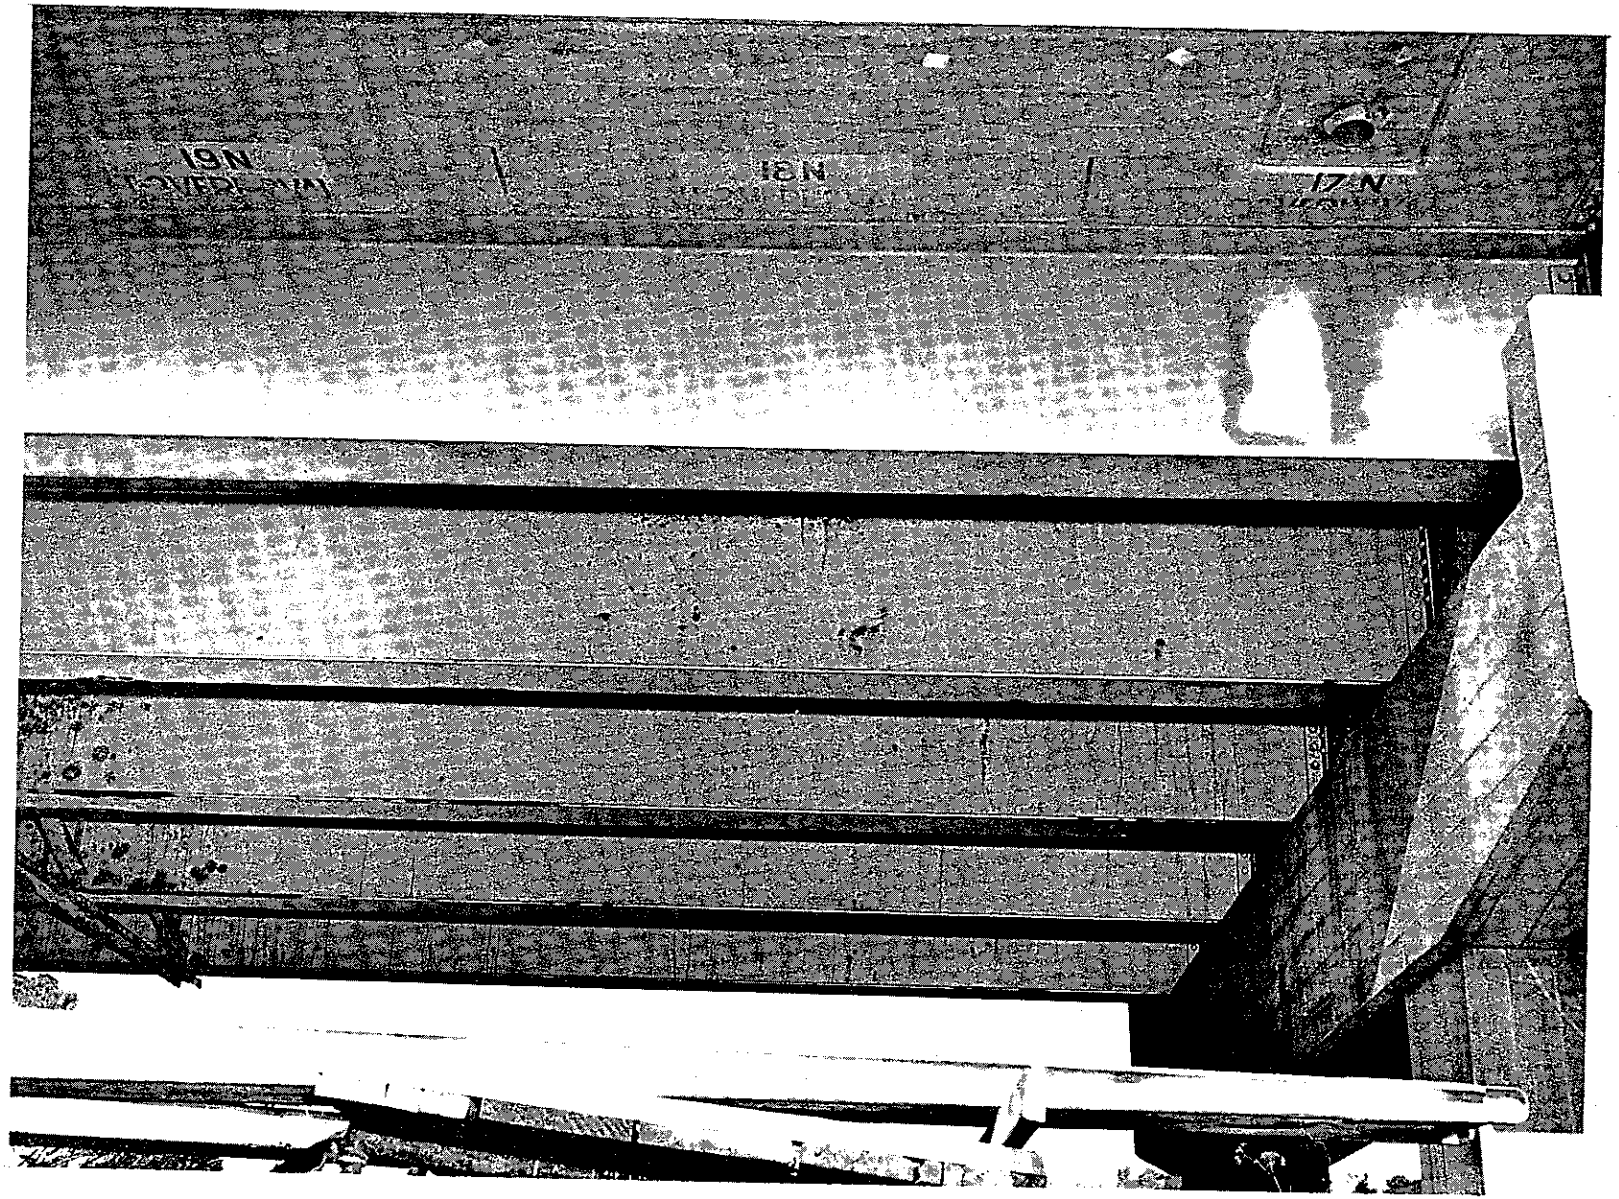
Fig. 4. Panels 19N and 18N were presumably given identical coatings except that 19N had the acid treatment, 18N none. Note the general better appearance of 19N.

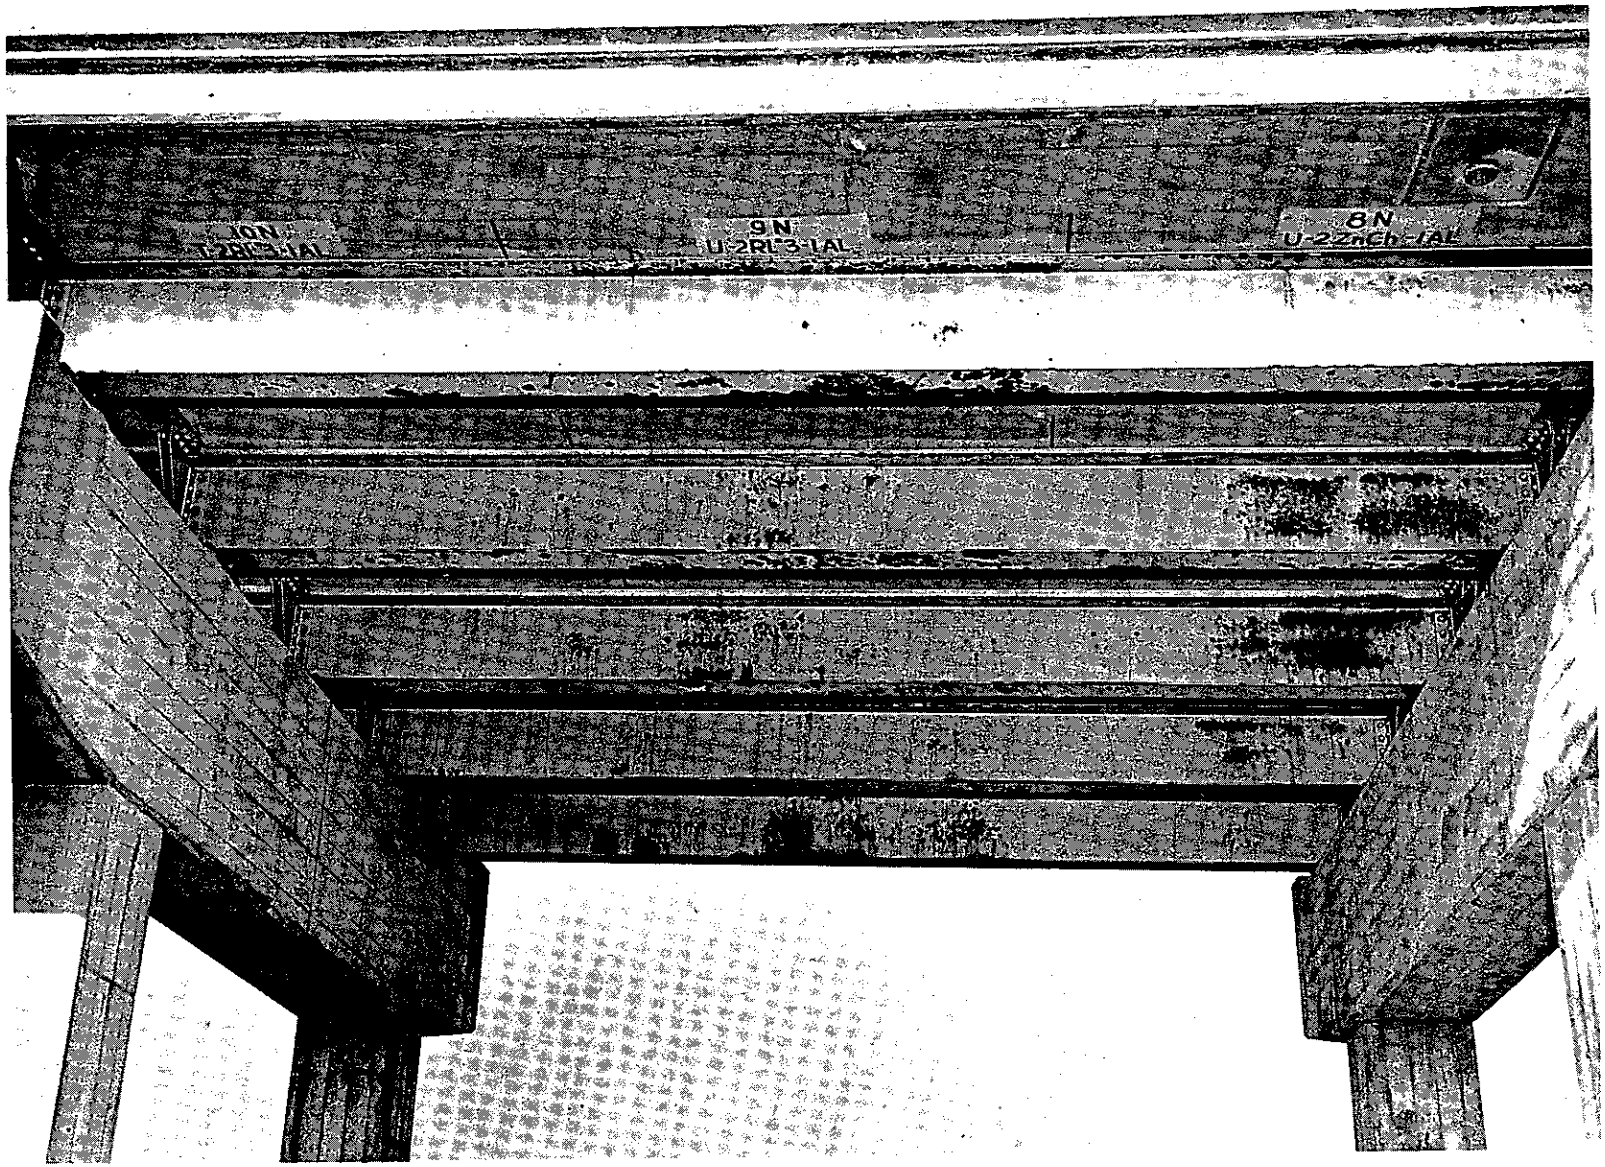
Fig. 7. Panels 10N and 9N seem to show the benefit of treatment in Panel 10N, although the effect of the pier alongside this panel is unknown.

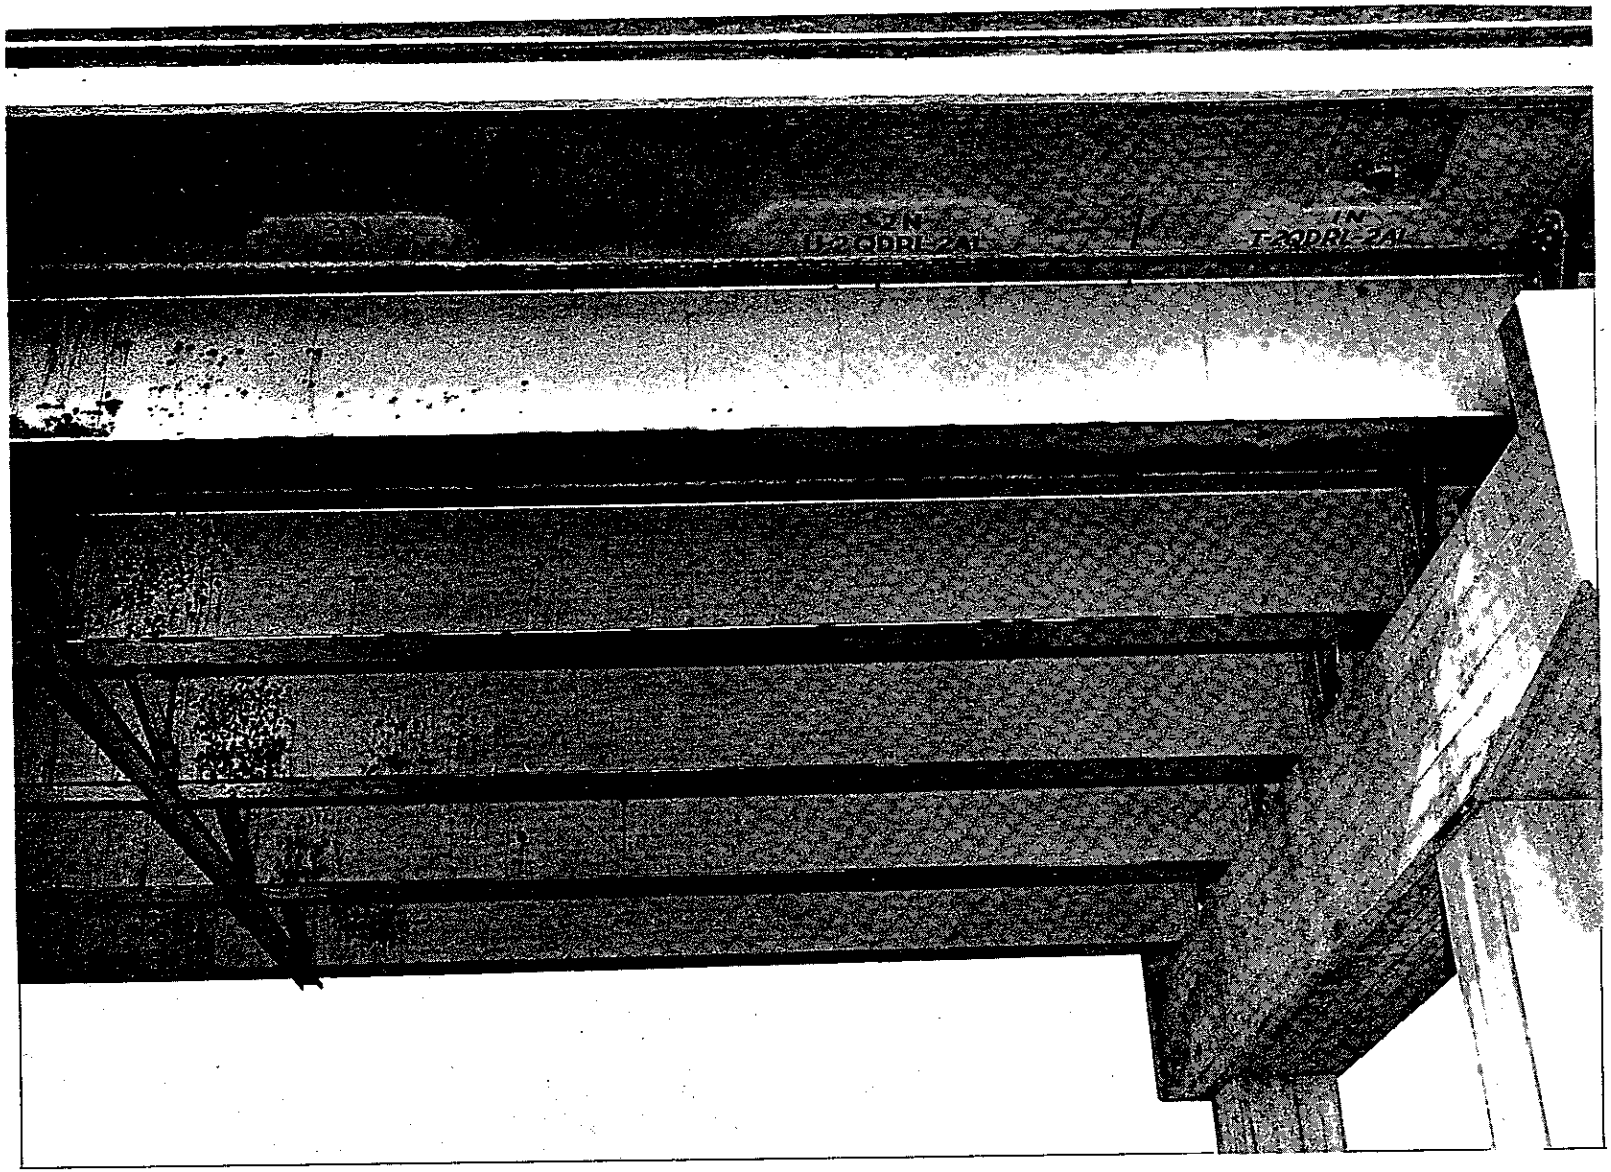
Fig. 9. Flanges in Panels 2N and 1N are badly corroded but there is little evidence of difference between the treated and untreated sections.

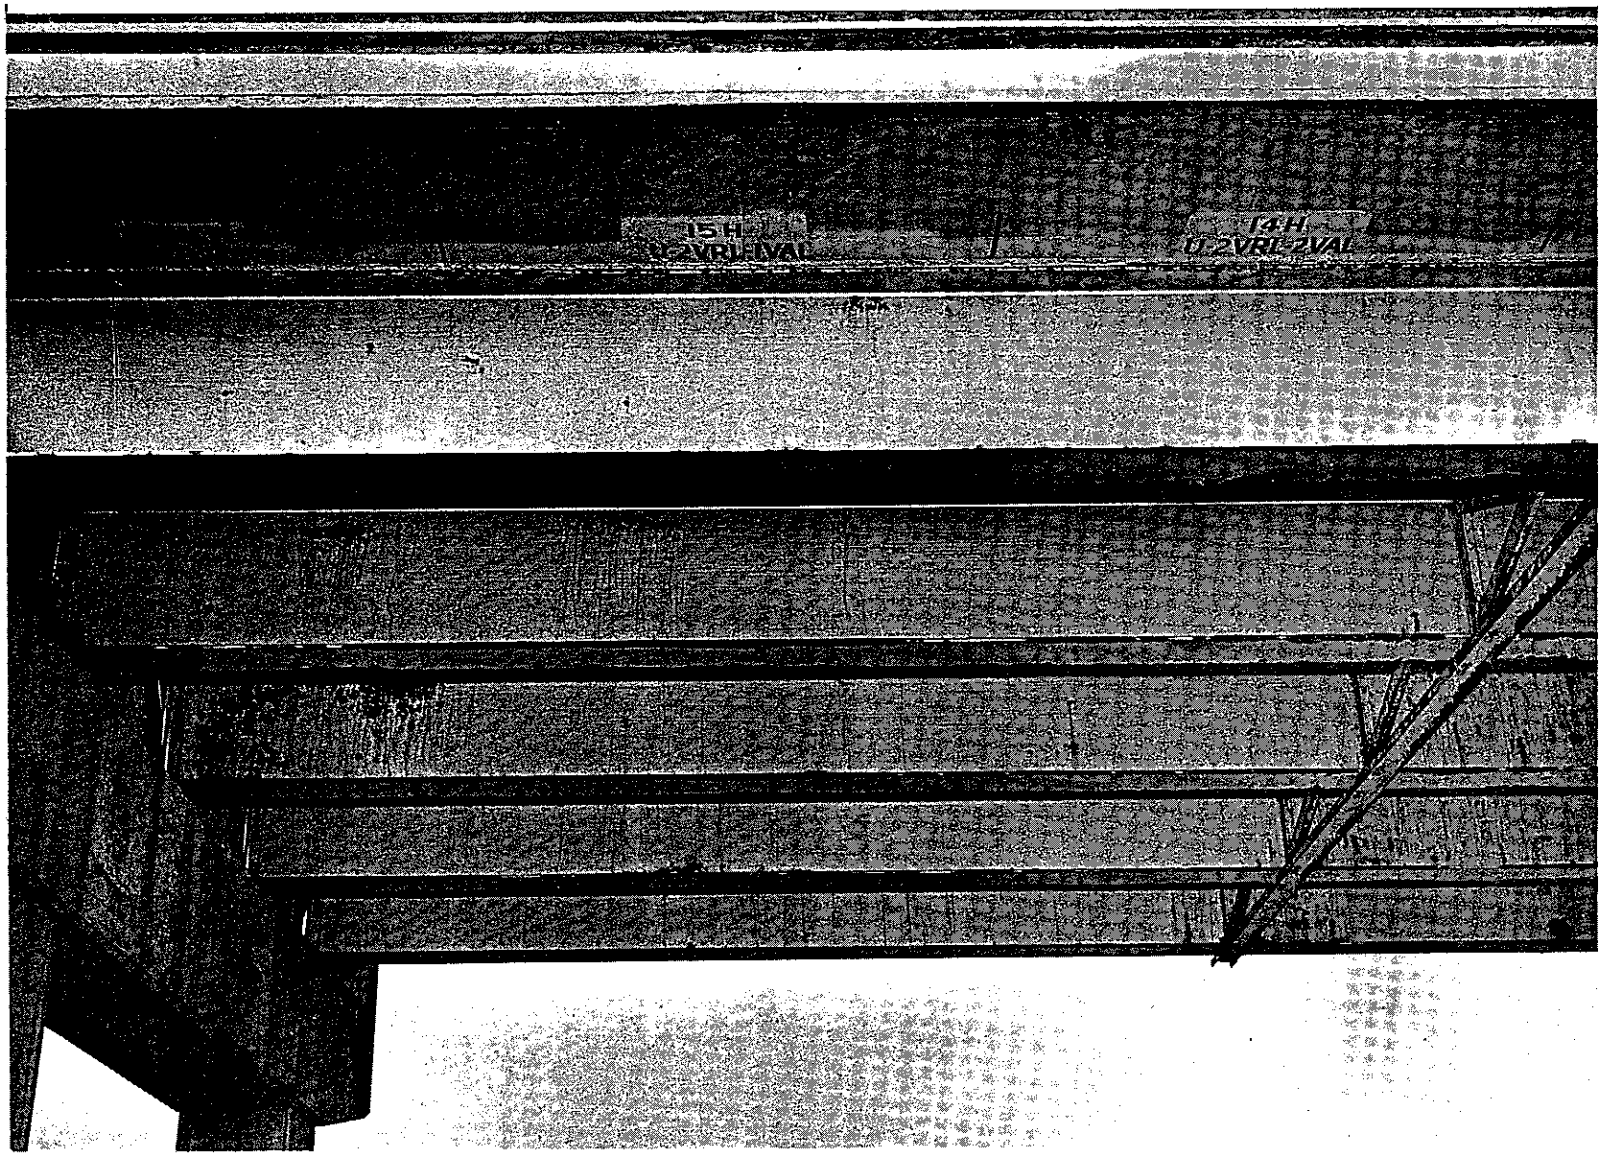
Fig. 10. The pretreatment of Panel 16H does not show to advantage here. The advantage appears to lie in the extra coat of Aluminum Finish in Panel 14H. Pier and brace probably alter the course of corrosion.

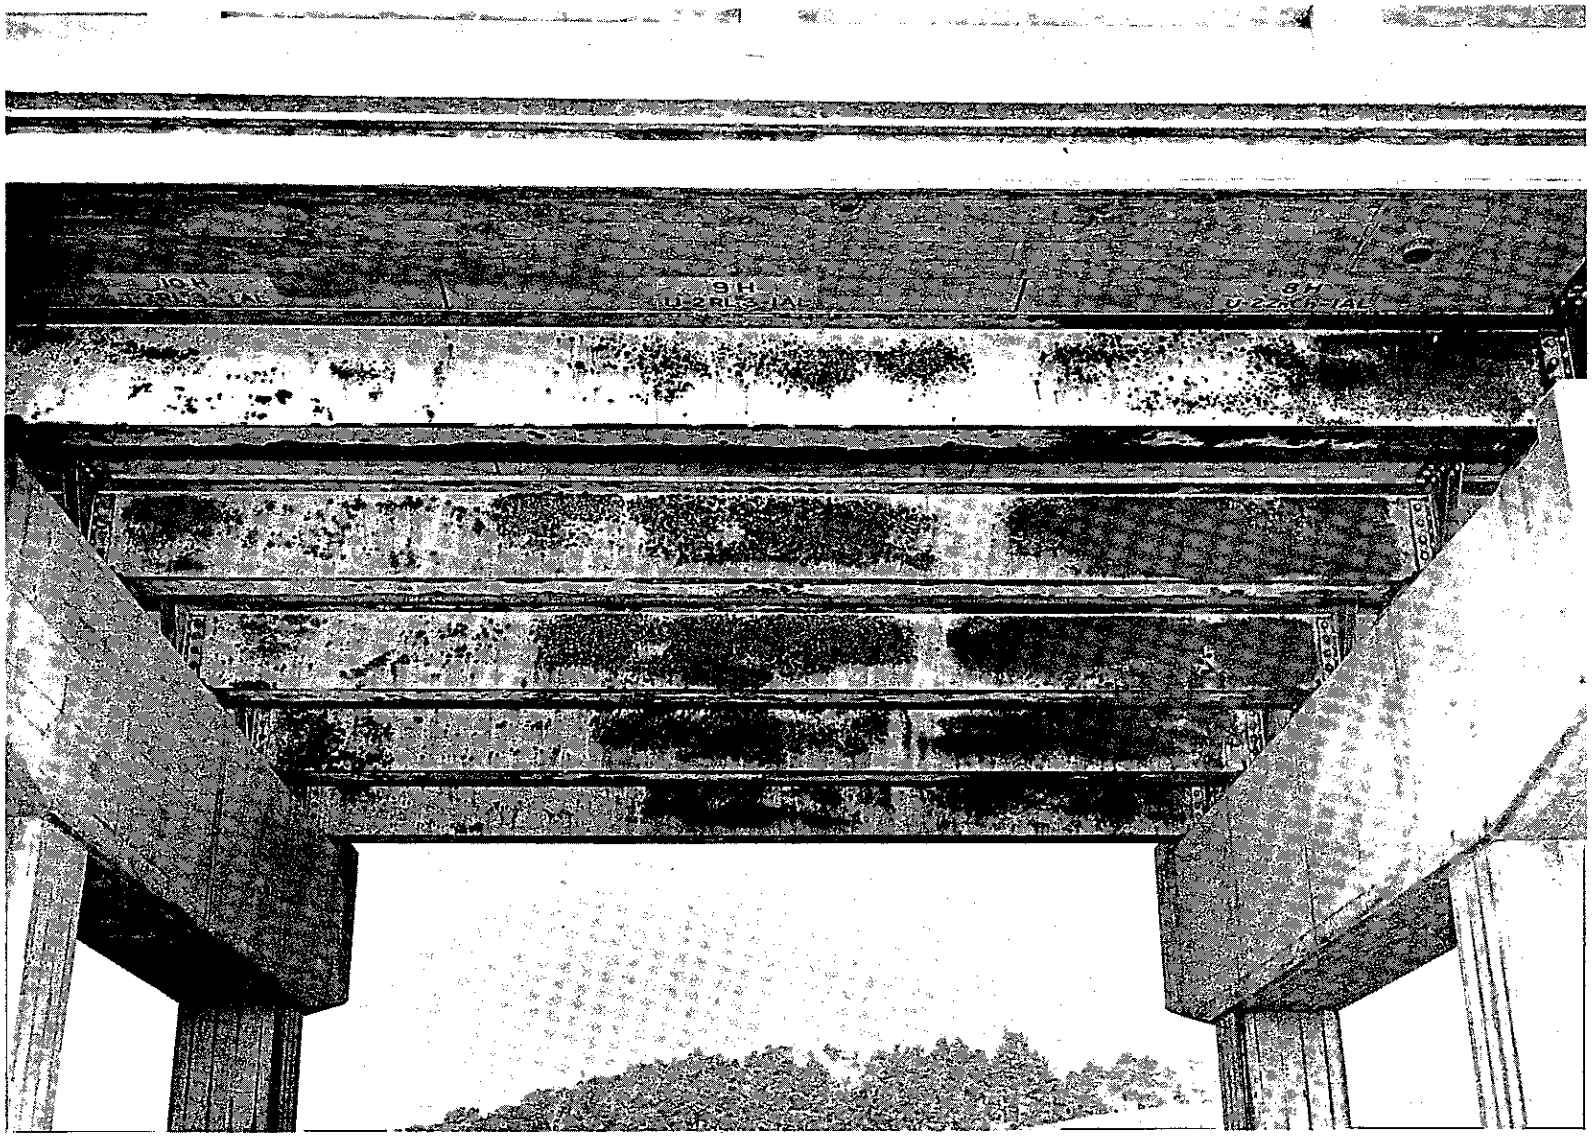
He may notice, also, some features which are very revealing. Specifically, examine Panels 8H and 9H, Fig. 12 — the boundary between them. Note that an area six or eight inches in width extending across the entire span is relatively well protected. This must be due to overlapping of the two coatings. Individually,

both of these coatings have failed miserably, but where they have been piled up on each other extra coats and probably extra thickness have afforded protection. Other panels may show a similar effect.

Fig. 12. Eliminating the first stringer which is subject to fresh rain and little of pier's wind diversion, note the regressing width of heavy corrosion on successive stringers. Probably due to sustained diversion by pier of salt carrying winds.

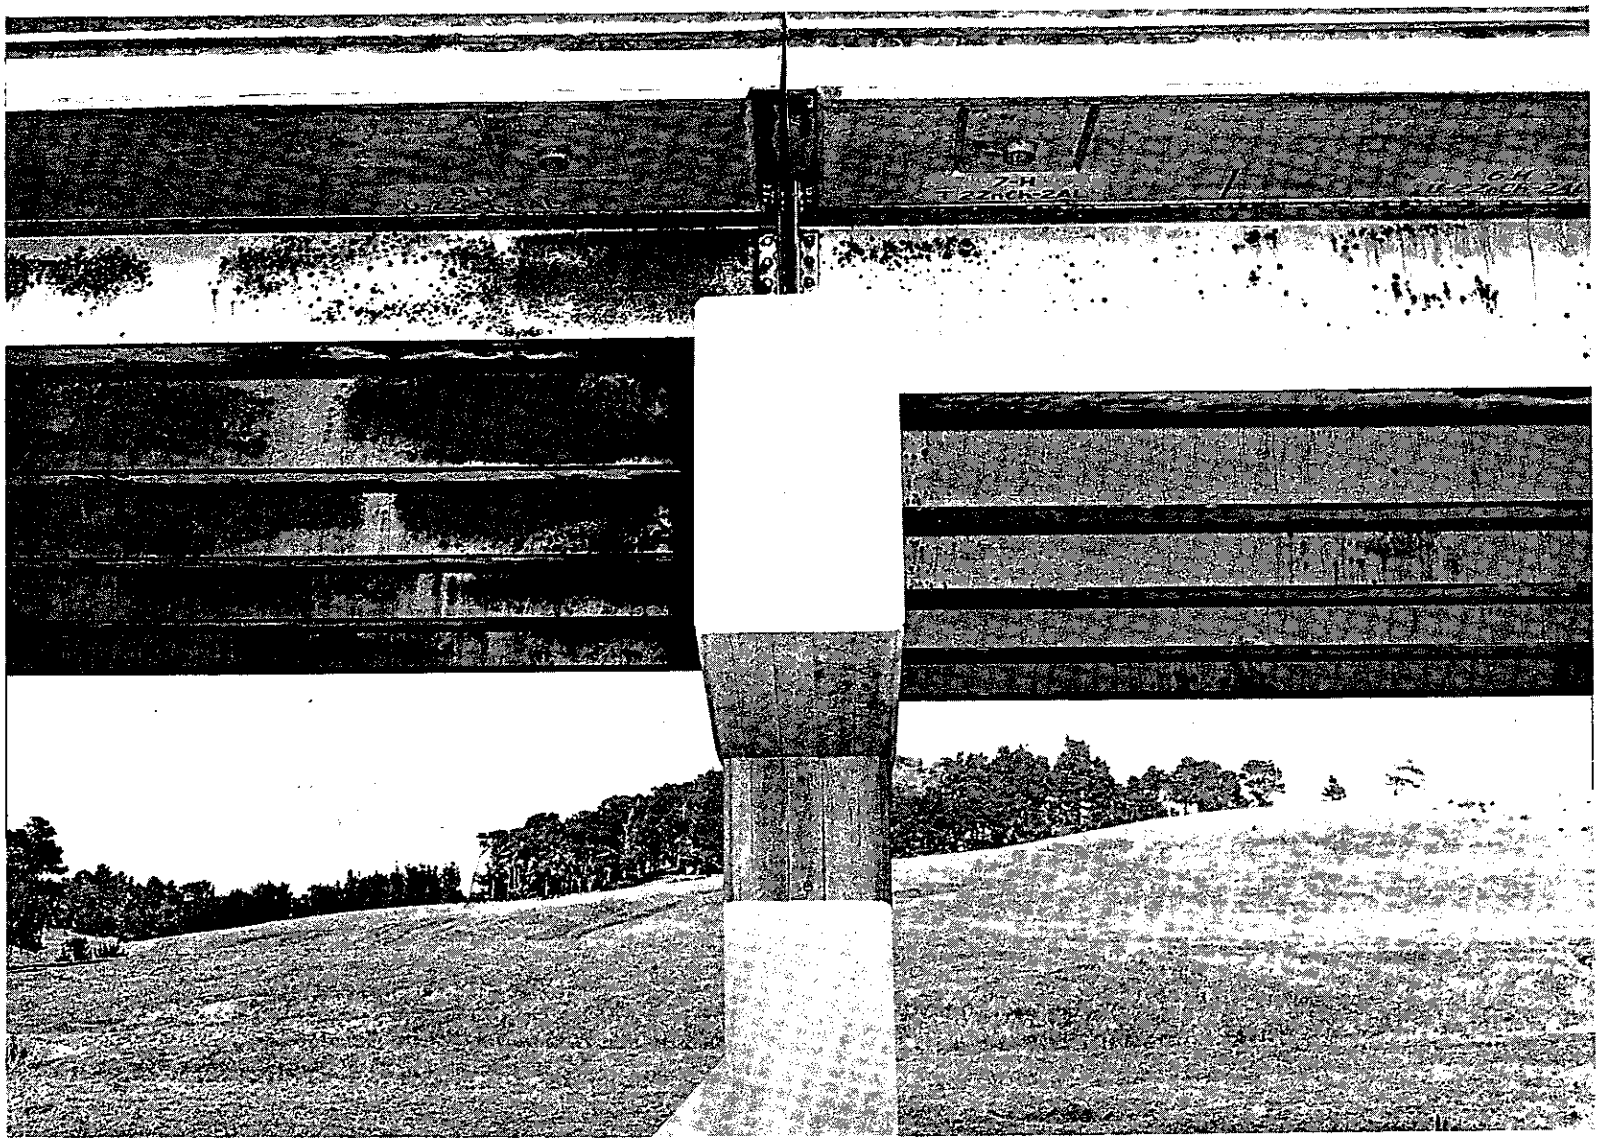
Fig. 13. Panels 8H, 7H and 6H, all given two coats of Zinc Chromate have performed here in accordance with what would be predicted, qualitatively.

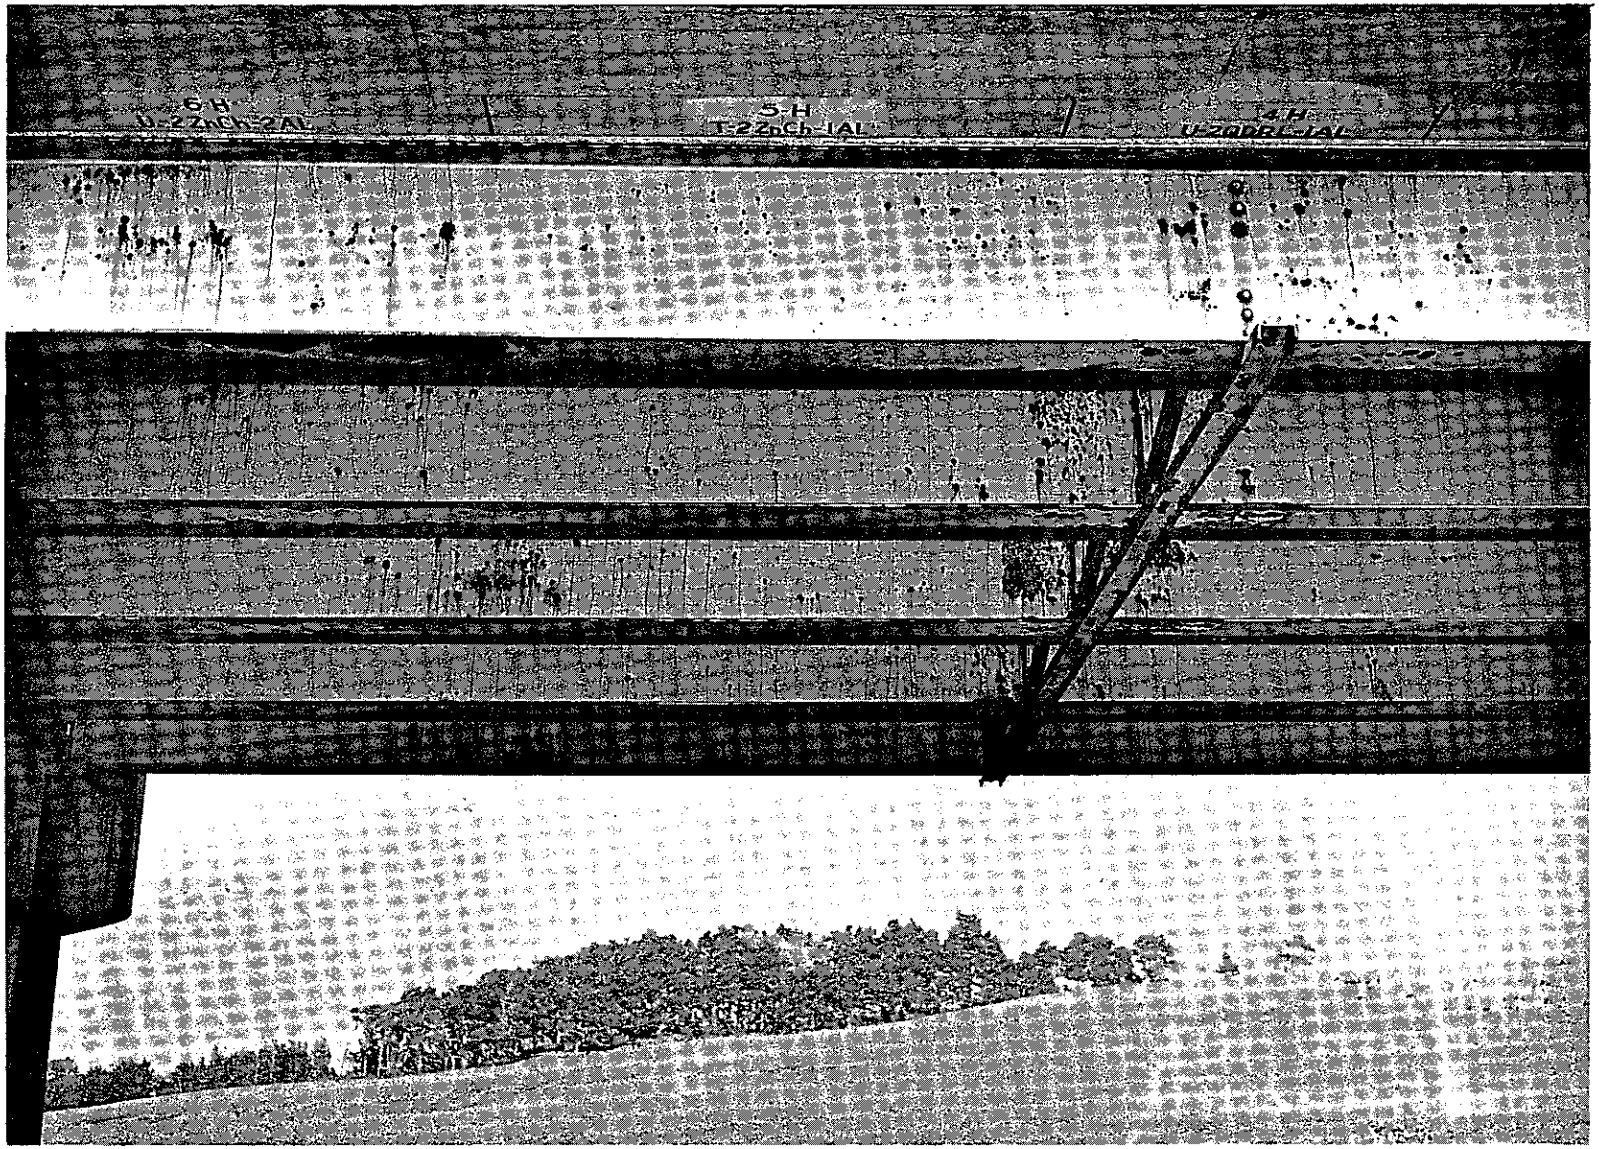
Fig. 14. Normal expectancy continues into Panel 5H. This treated panel with one coat of Aluminum Finish is about a stand-off with Panel 6H, untreated but with two coats of Aluminum Finish.

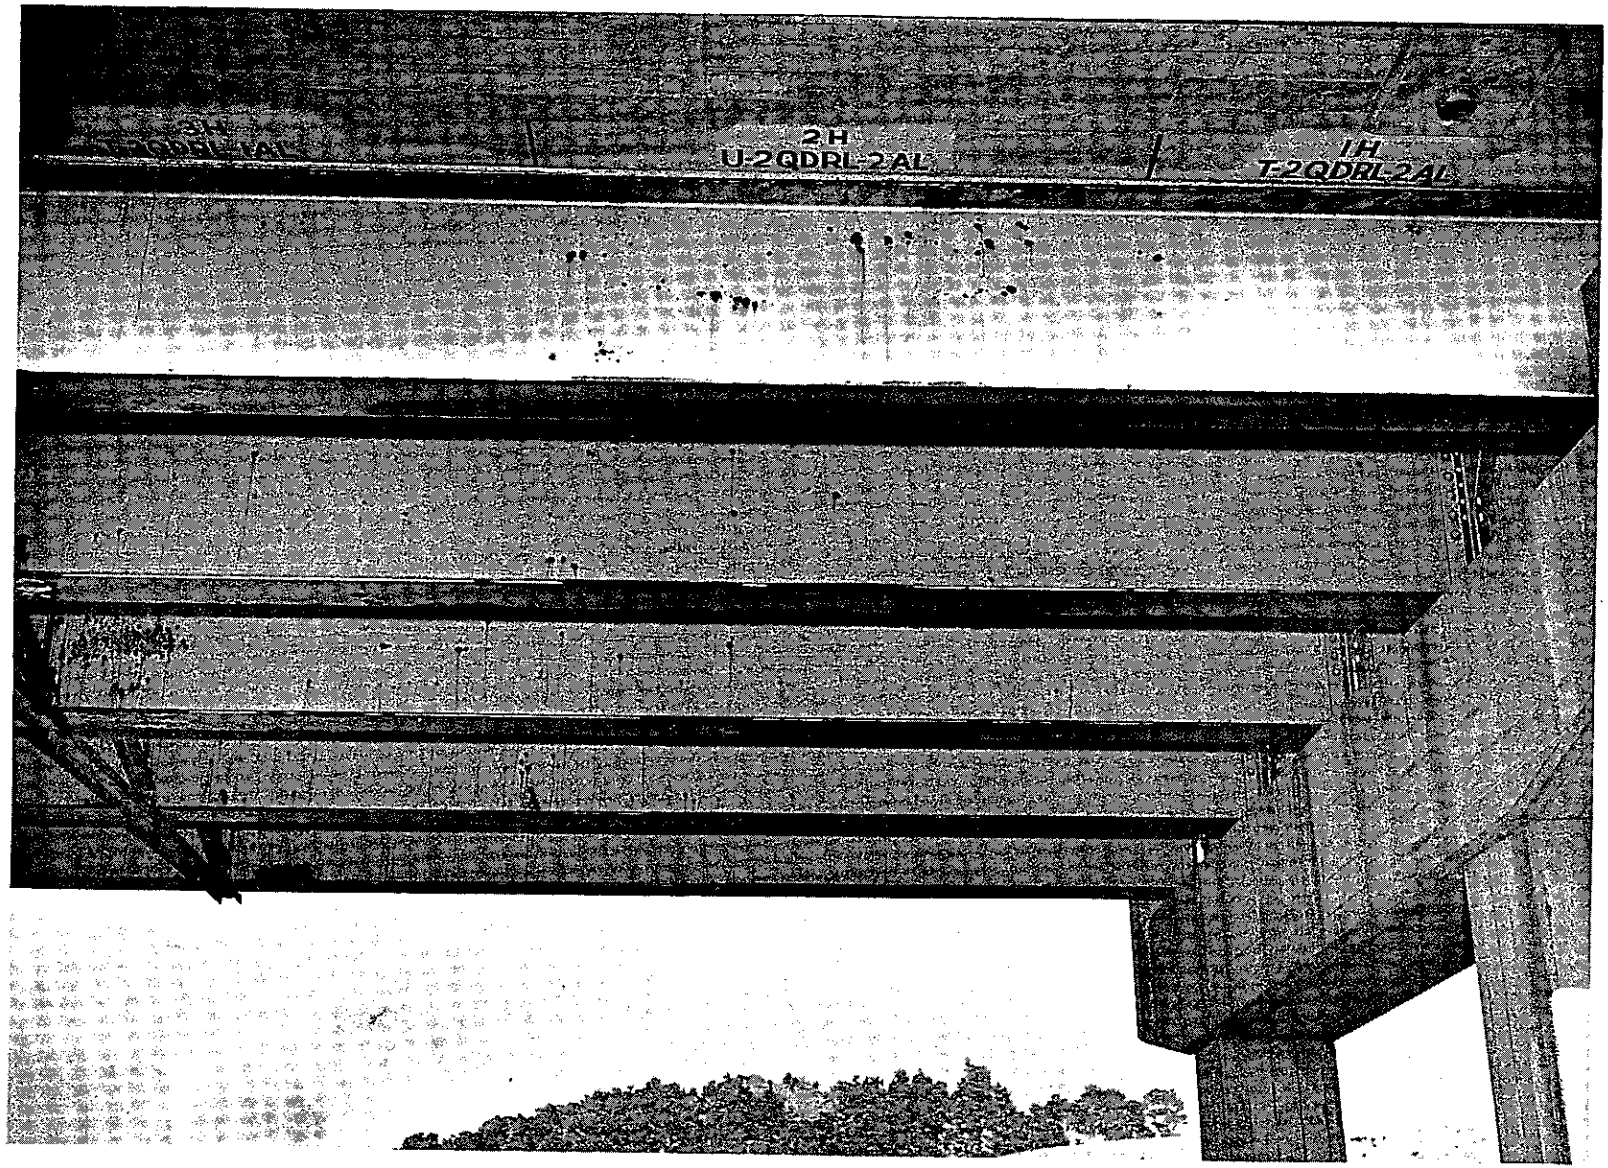
Fig. 15. This series of Semi-Quick Dry Red Lead also follows normal performance expectancy. Panel 3H, pretreated with one coat of Aluminum Finish seems to have an edge over Panel 2H with two coats of Aluminum Finish.

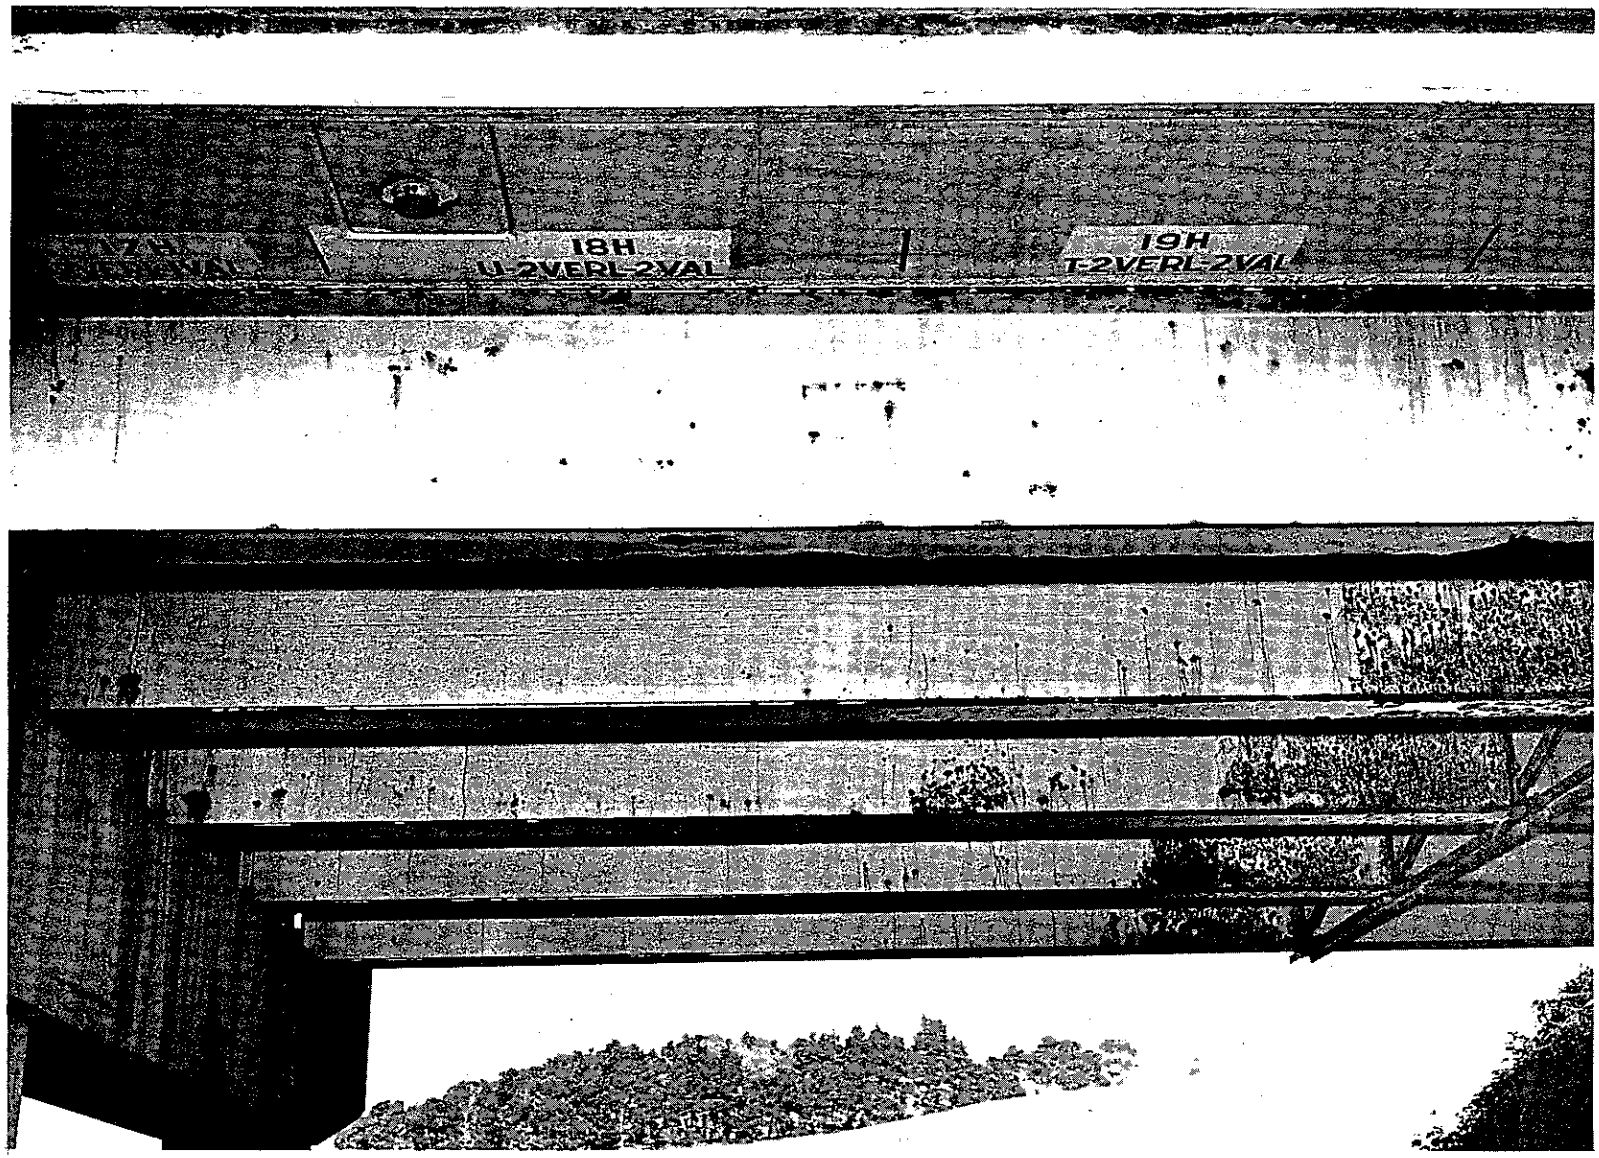
Fig. 16. This series of Vinyl Epoxy Red Lead coatings does not entirely conform to expected results. However, note the vast superiority of Panel 19H over 20H as indicated by the sharp dividing line between the two.

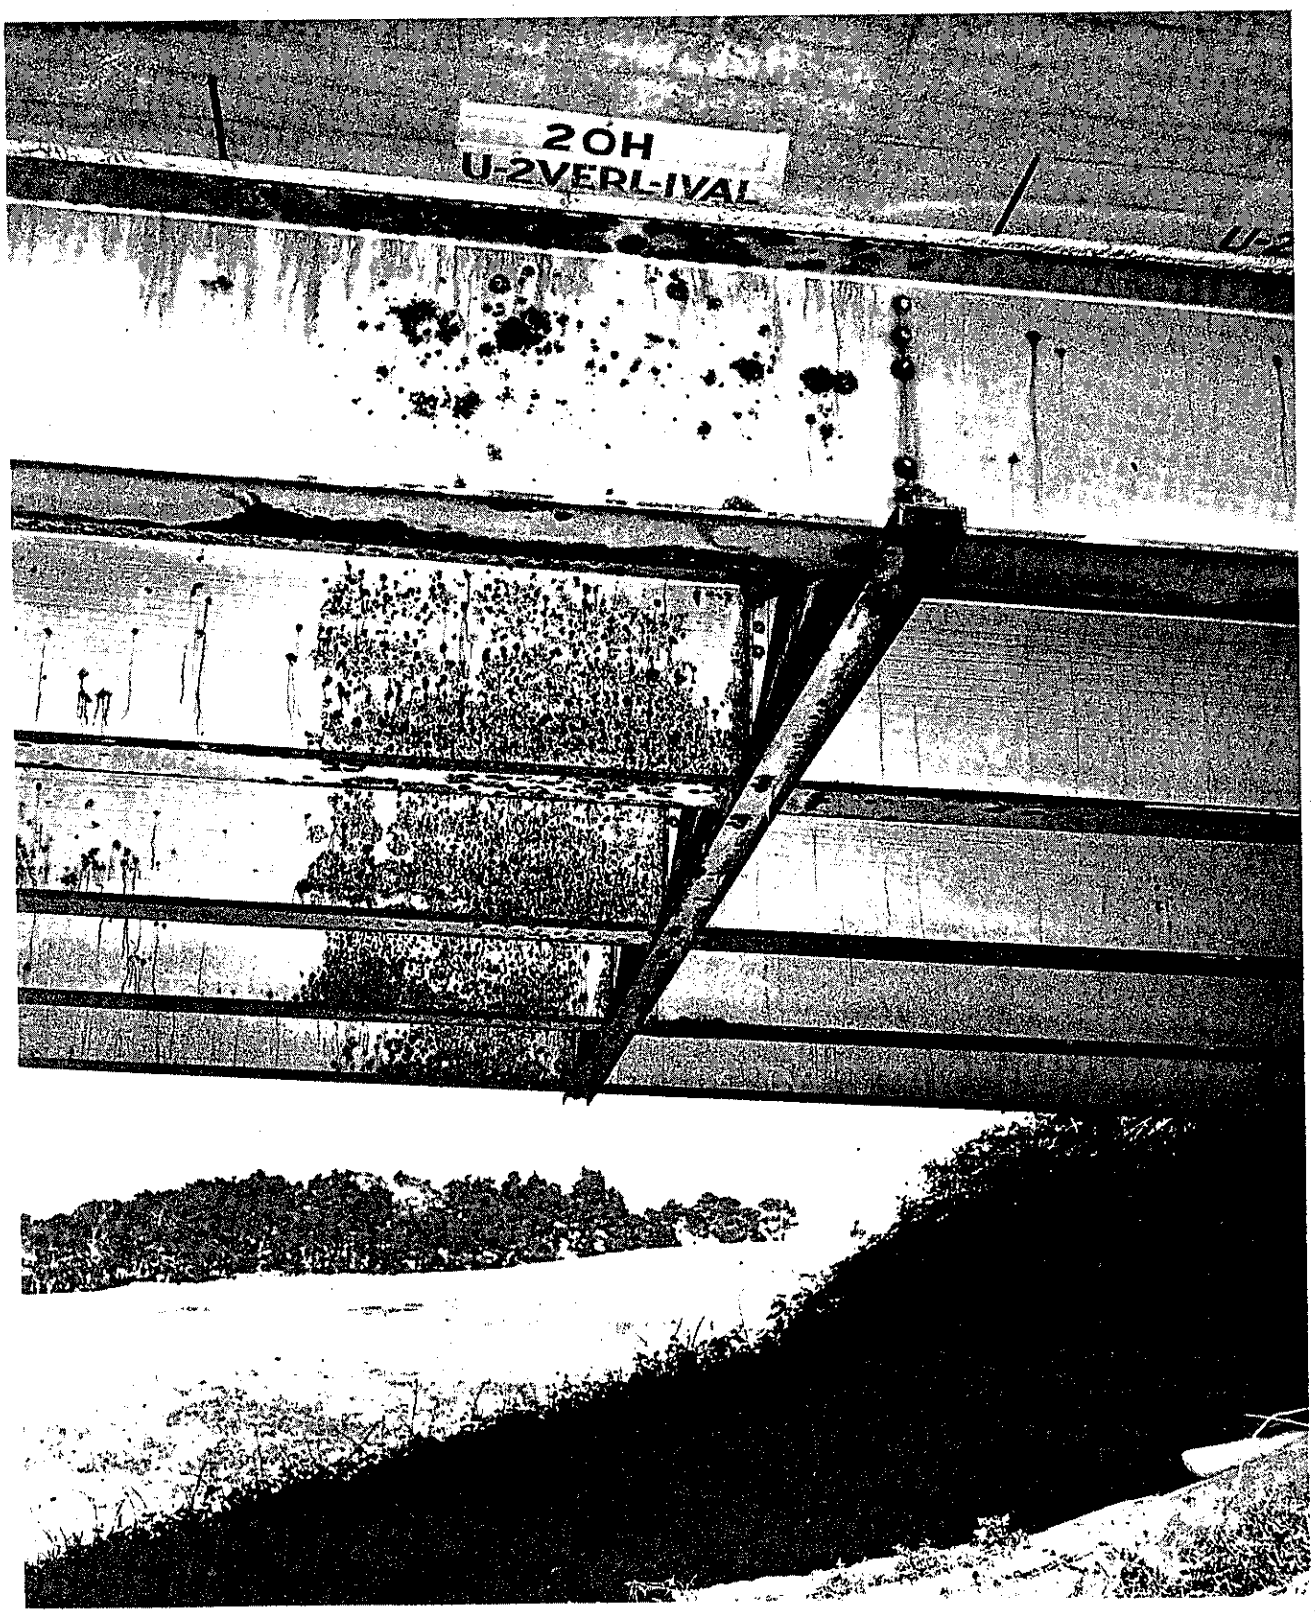
Fig. 17. The effect of the brace on corrosion areas is very marked in Panel 20H.
