Bridge Painting

FINAL REPORT

PROTECTIVE COATINGS USED IN THE EXPERIMENTAL PAINTING of the LEFFINGWELL CREEK BRIDGE

January, 1959

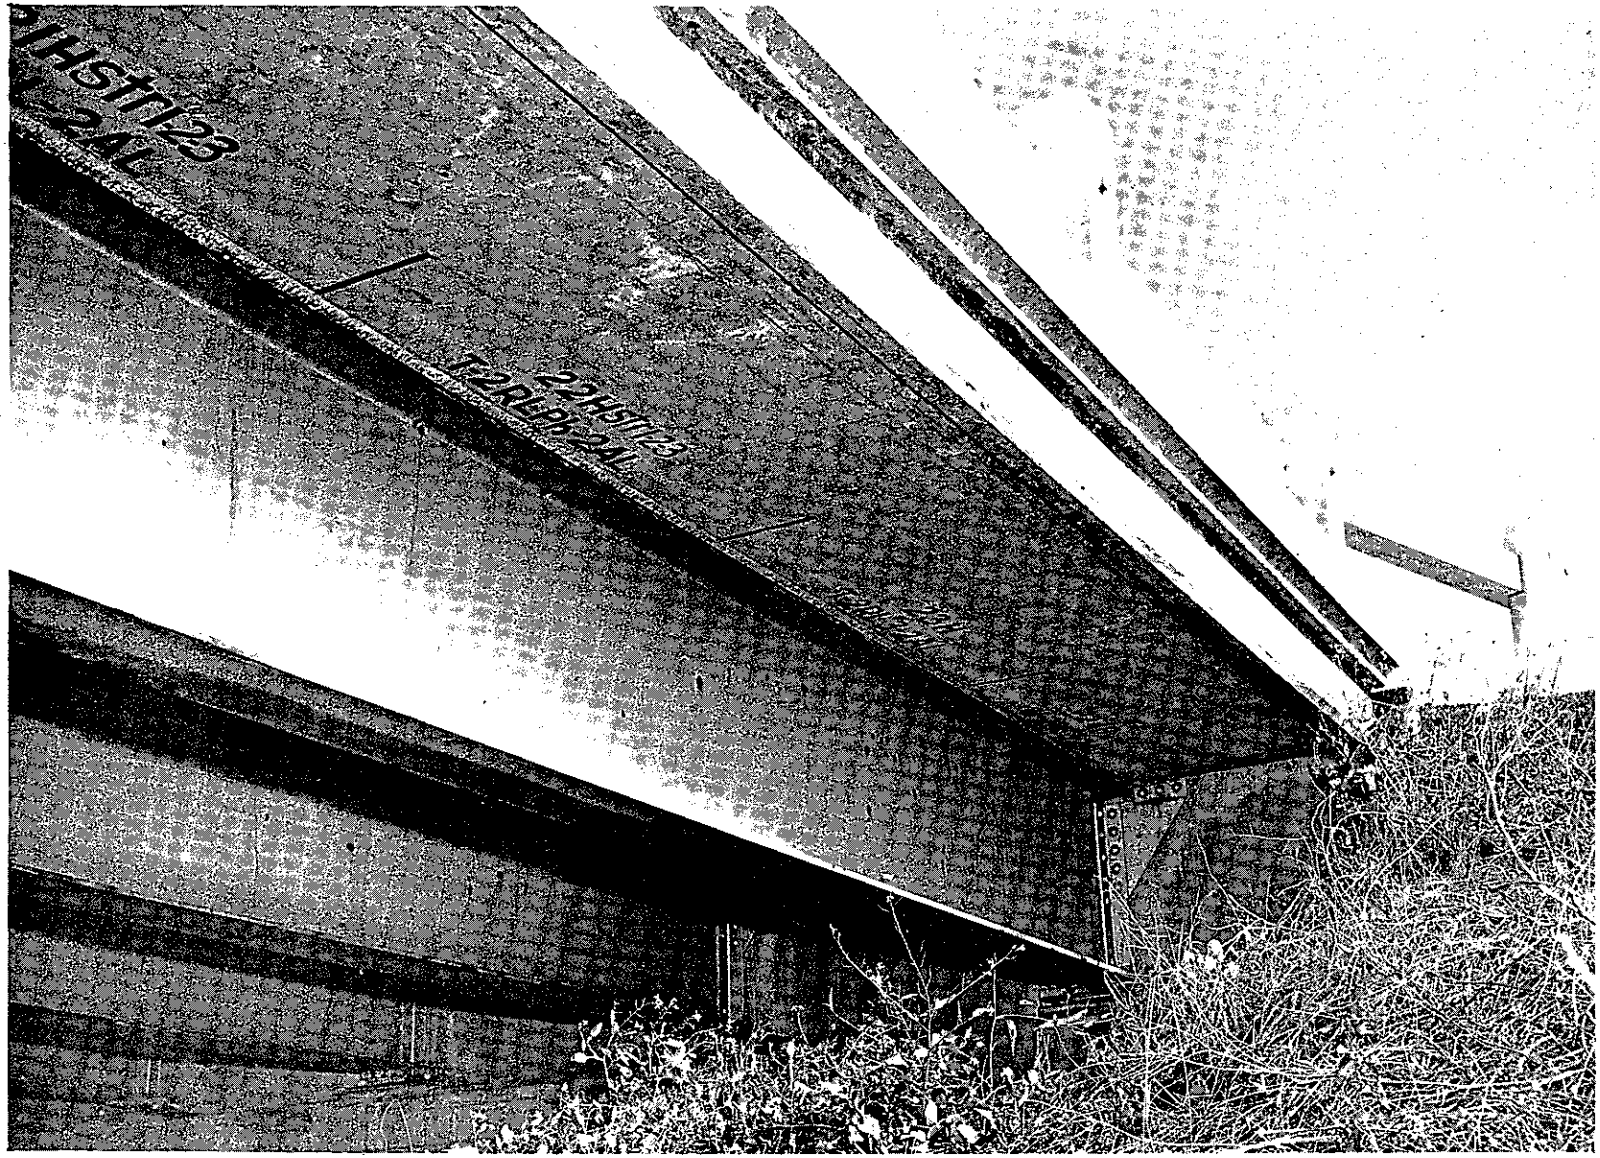
The Red Lead Phenolic used on Panel 21N, Stringers 1,2,3, Fig. 2, and on Panel 22H, Stringers 1,2,3, Fig. 19, should have been labeled RLPh - X6. This formulation is a variation of the coating frequently used by the San Francisco-Oakland Bay Bridge and consists of Red Lead in linseed oil reinforced with the State Specification Aluminum Varnish. The vehicle is not greatly different from that used in the other RLPh series but the performance — so far as we can judge from its limited trial — seems to be better. Of course, the location in each instance cited is recognized as more favorable generally than most of the RLPh series of panels.

Fig. 19. The Red Lead Phenolics shown here in Panels 21H and 22H seem to have performed better than the old Red Lead and Metallic Lead formulation.
