THE CORROSION OF CORRUGATED METAL CULVERTS IN CALIFORNIA

J. L. Beaton

R. F. Stratfull

A paper to be presented at the Annual Meeting of the Highway Research Board January 1959.

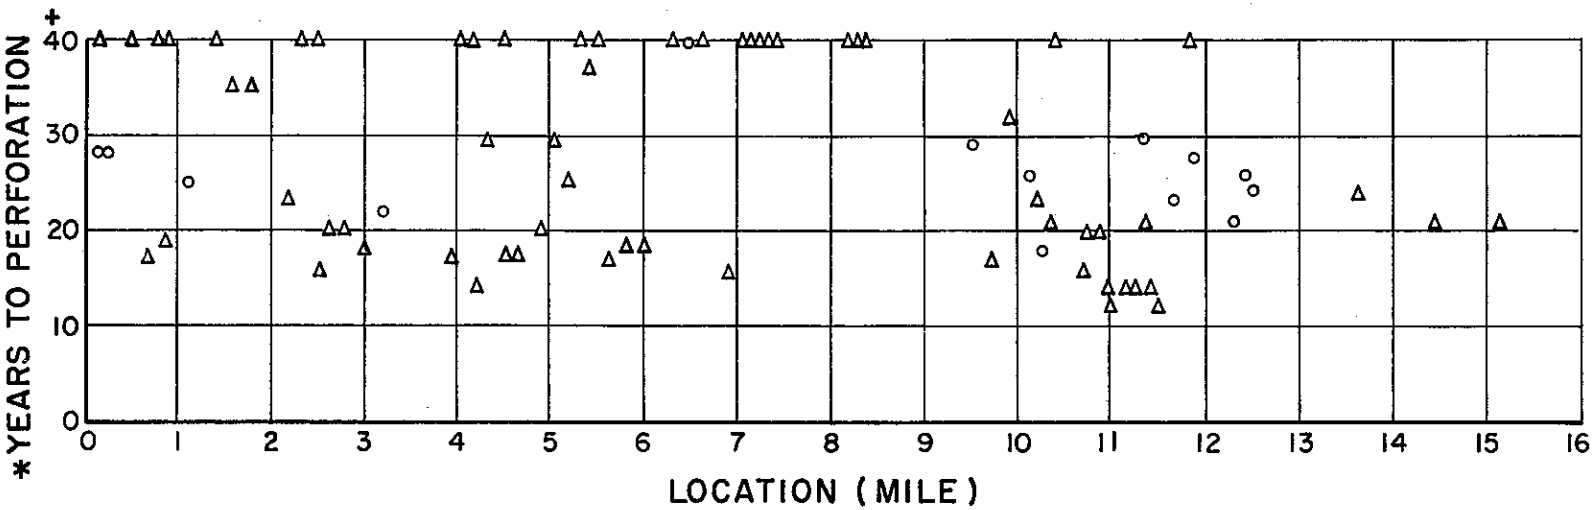
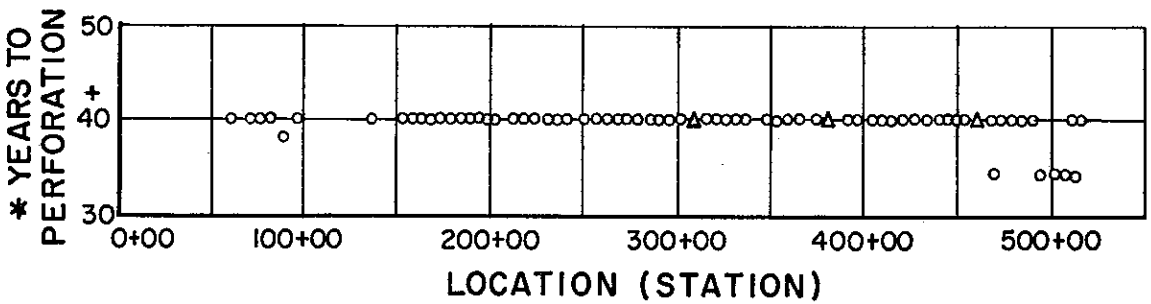
Exhibit 7. Comparison of Culvert Corrosion Rates

As will be noted in Exhibit 7, the corrosion rate of a number of culverts can be plotted for a highway section or a geo-

A Typical Comparison of Culvert Corrosion Rates Used for Corrosion Area Designation

HIGHWAY SECTION LOCATED IN AREA OF ORGANIC REDUCING WATERSHEDS

HIGHWAY SECTION LOCATED IN AREA OF INORGANIC OXIDIZING WATERSHEDS
