State of California
Department of Public Works
Division of Highways
Materials and Research Department

FINAL REPORT ON

CONSISTENCY OF PAVING GRADE

ASPHALTS AT VARIOUS TEMPERATURES

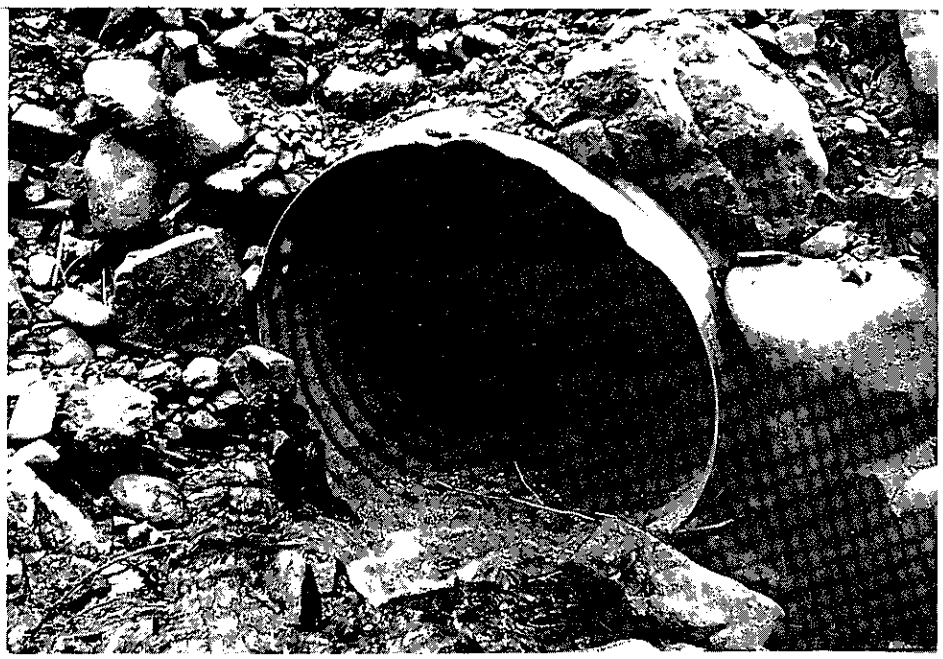
Field Test Site
I-Hum-35-C, Mile 1.19

Inlet of test pipe - aluminum section

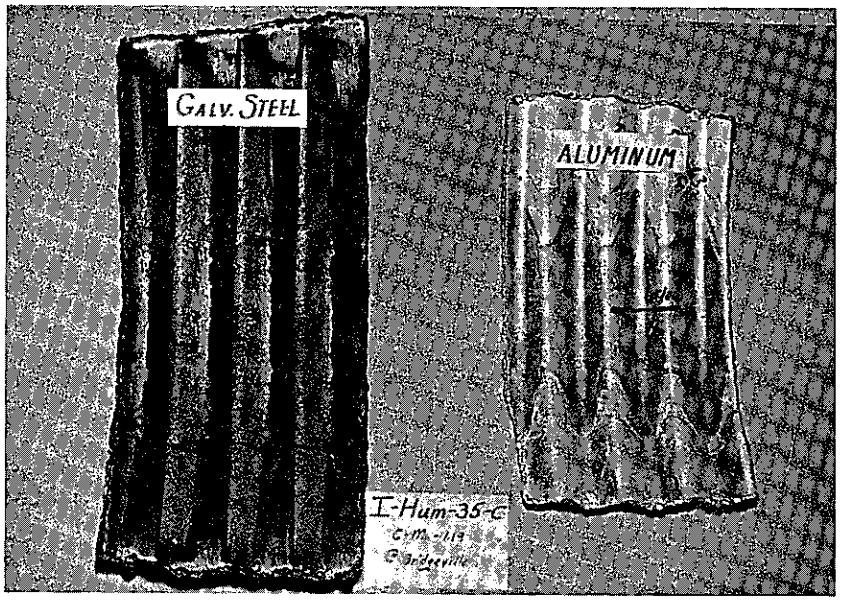
Samples removed from invert after 2-year exposure

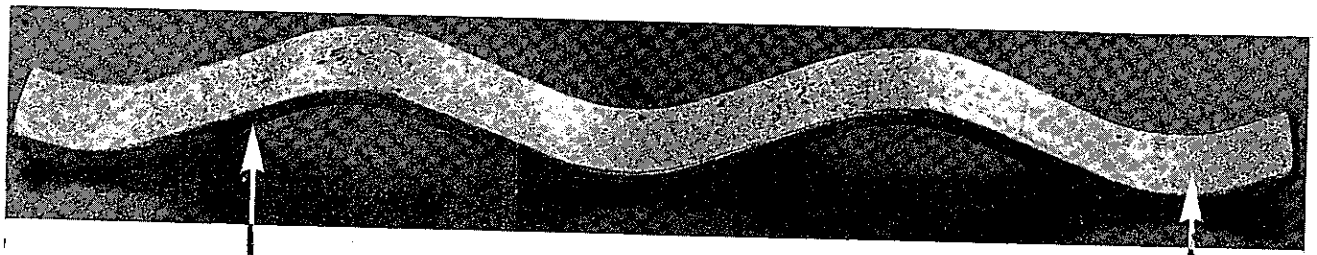
Field Test Site
I-Hum-35-C, Mile 1.19

Sample from invert of aluminum culvert

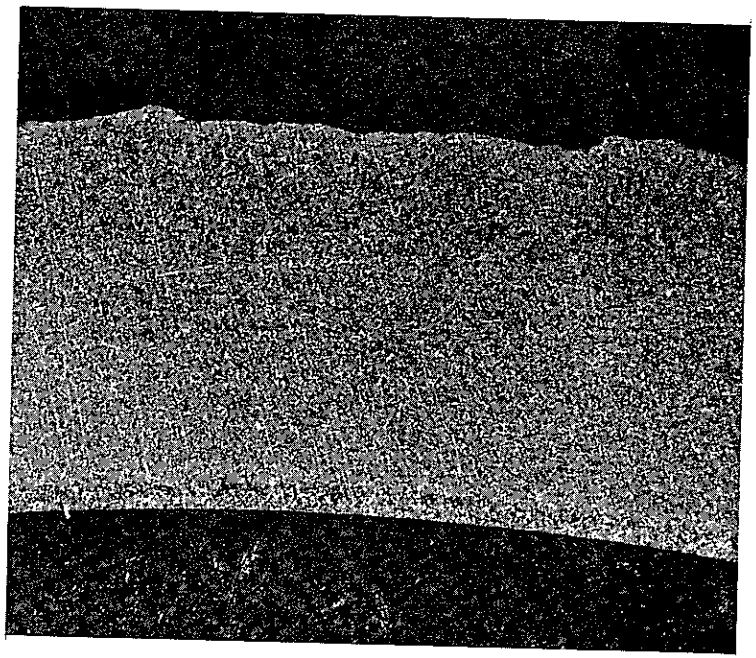
20±X

Typical loss of cladding at abrasion surface - 2 years

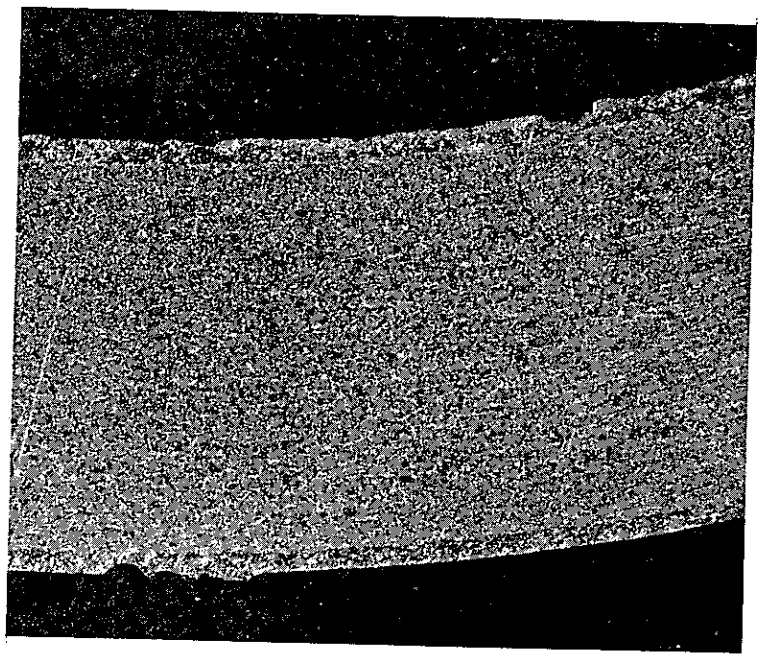
20±X

Cladding intact - 2 years

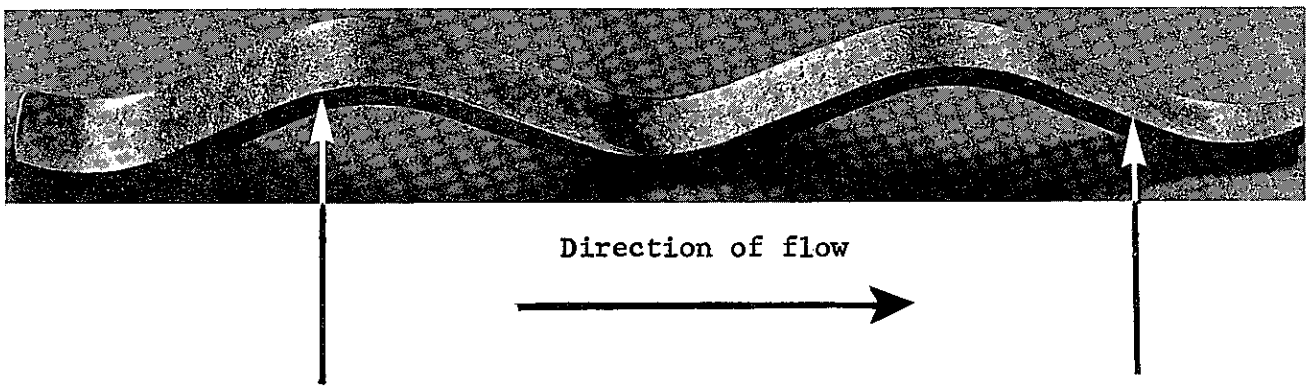
Field Test Site
I-Hum-35-C, Mile 1.19

Sample from invert of galvanized steel culvert

Direction of flow

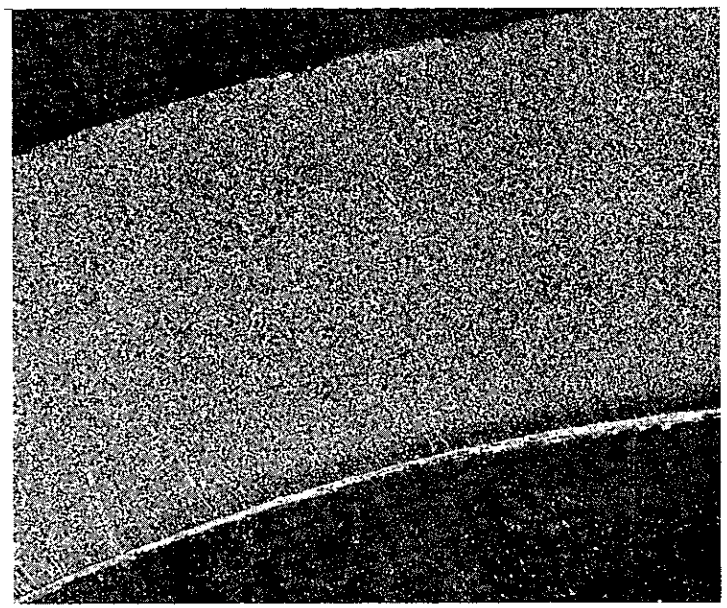
20±X

Note loss of zinc and minor loss of steel at abrasion surface - 2 years

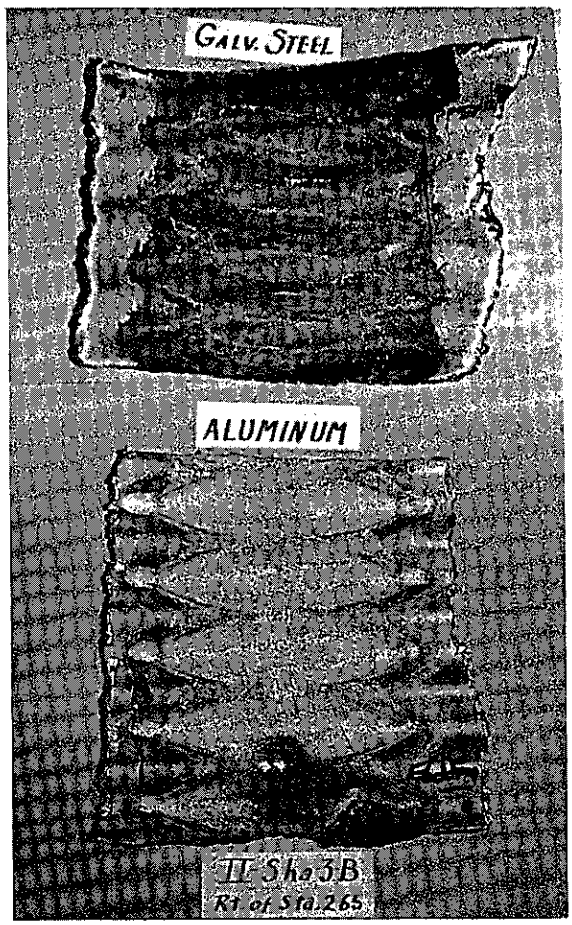
II-Sha-3-B
Right of Station 265±

Typical invert samples removed after approximately 1.5 years of test

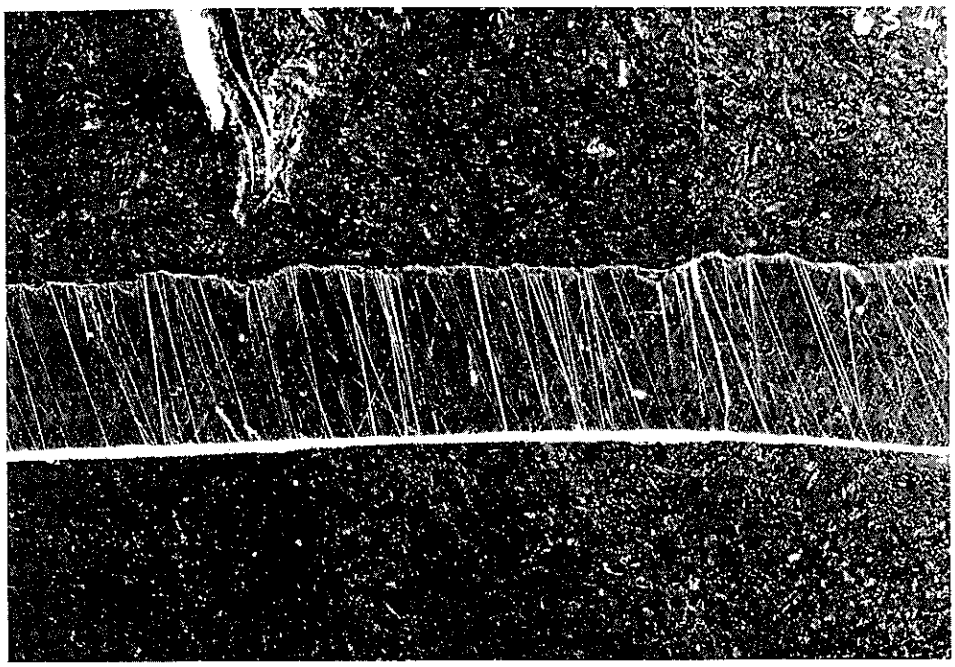
20±X

Cross-section of steel after 1.5 years of test

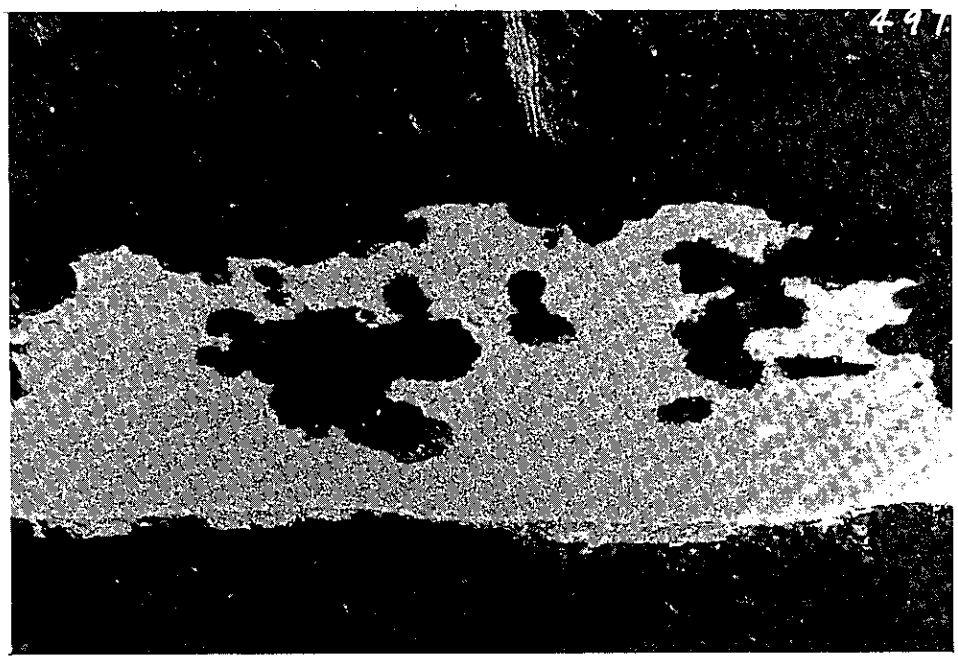
Cross-section of aluminum

20±X

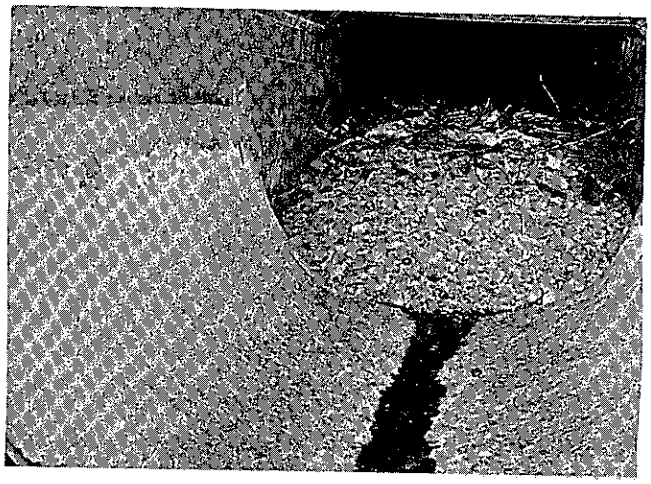
The reader should be aware that the test results of erosion are exceedingly difficult to explain and objectively formulate to a mathematical certainty. For instance, the severly damaged test pipe located at IV-SC1-5-C may have had a calculated flow velocity in the range of 25 - 30 feet per second with a bed load of shattered rocks. The minor abrasion damaged culvert near Redding, California, (II-Tri-20-A, Sta. 582+73) has a calculated flow velocity in the range of 20 to 25 feet per second, and has a bed load of rounded boulders. Therefore, it is obvious that even though flow velocities are highly important, the size and shape (rounded or shattered) and hardness of the bed material may be of greater consequence in the subsequent degree of abrasion of a culvert.

View showing loss of approximately 1/2-inch of concrete in the concrete test section at the outlet

Note deposit of debris at grade change of culvert

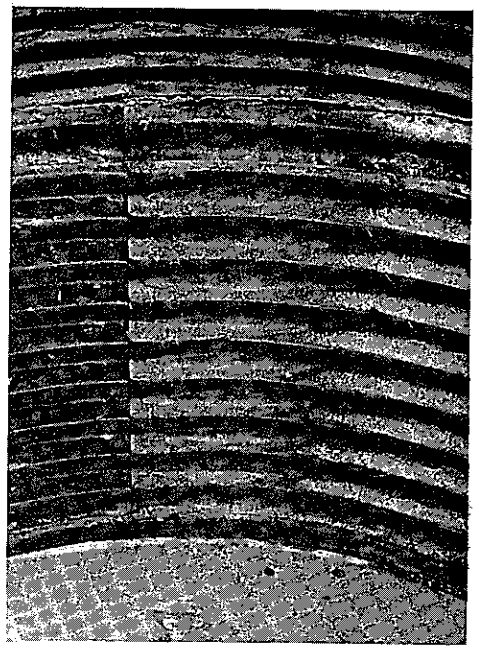
Samples of the invert galvanized steel section. Note wear of rivet heads.

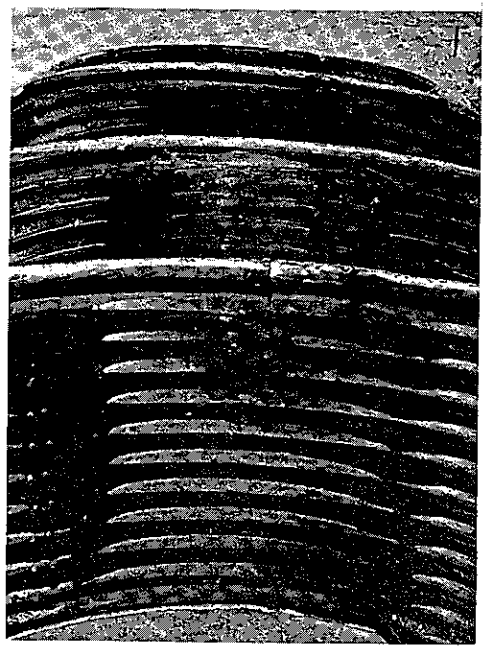
Samples of the invert from the A.D.P.I. section. Note loss of rivets at the joint.

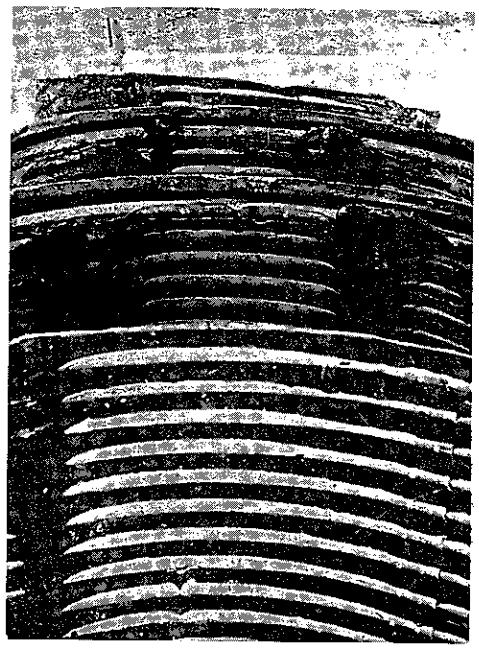
Figure 9

Samples of the invert from A.B.A.D.P.I. section.

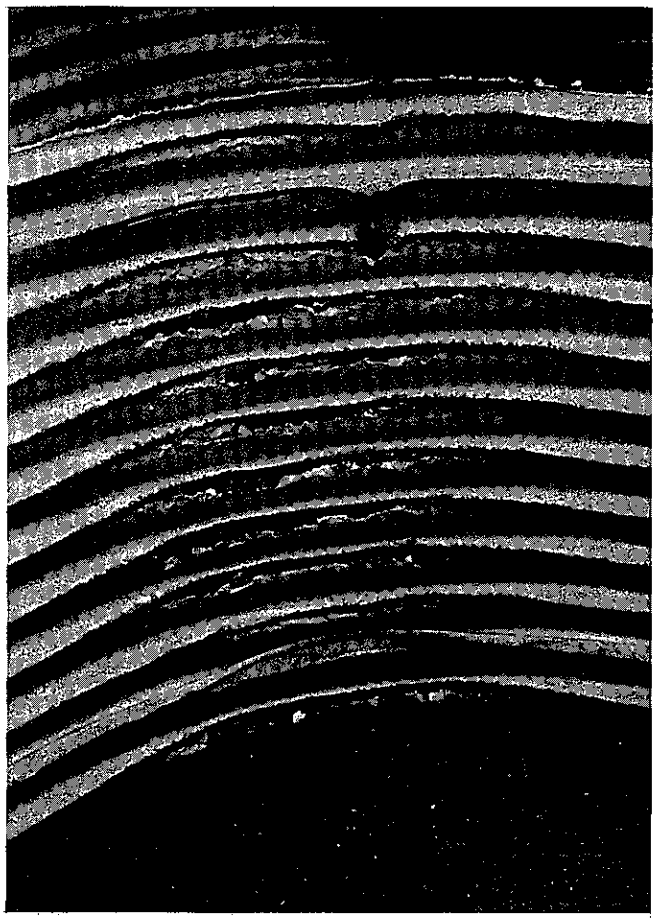
IV-SC1-5-C Sta. 250+25
Bridge No. 37-165

Severe abrasion of aluminum after 1.4 years of service

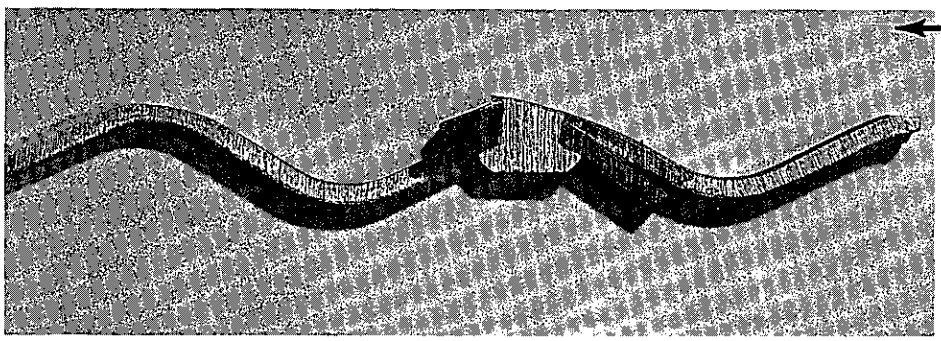
Severe abrasion of galvanized steel after 1.4 years of service. Note loss of head of rivet.

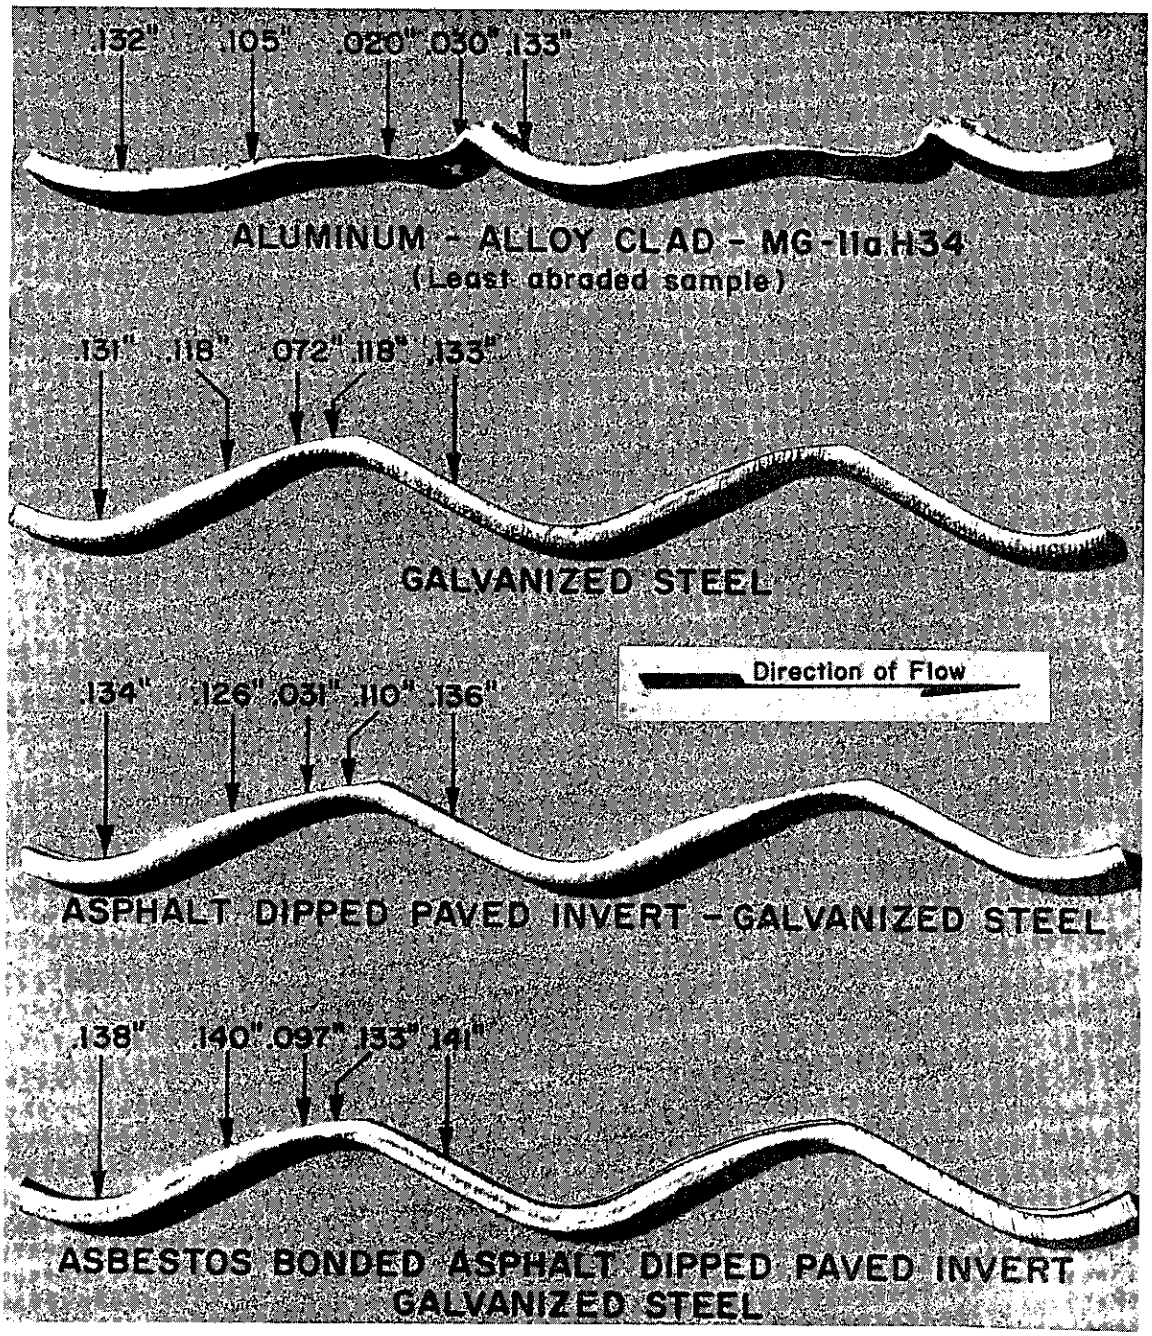
Typical cross-sections of pipe invert after test exposure.

Note: All C.M.P. samples were 10 gage (0.140+)
Steel samples are typical of the most abraded pipe sections

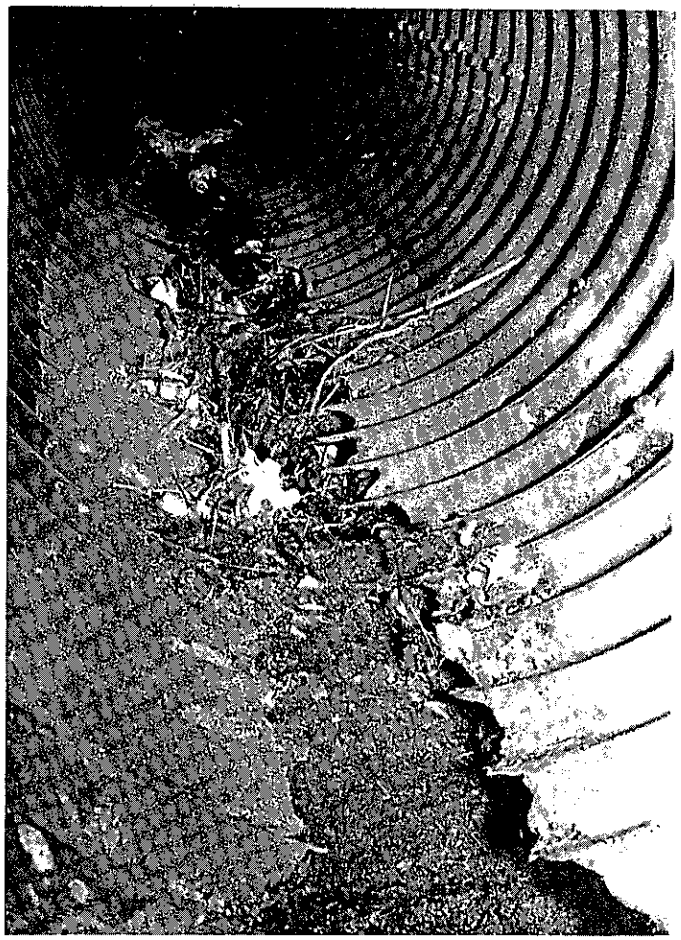
IV-SCr-5-A
Right of Station 530±

Existing galvanized C.M.P. Approximately 2 years of service. (Not placed as part of test program.)

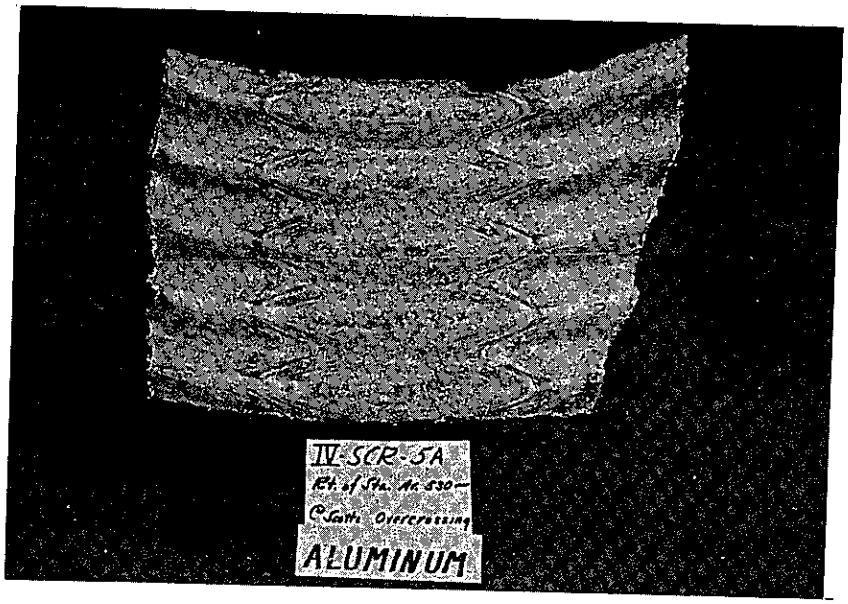
IV-SCr-5-A
Right of Station 530±

Aluminum invert sample after approximately 0.8 years of test.

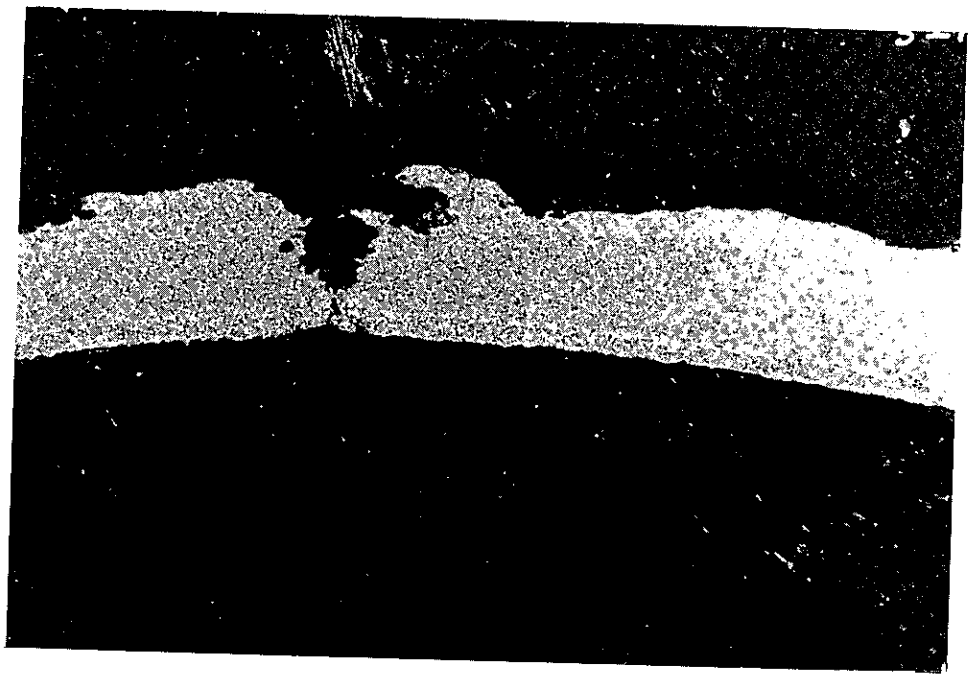
20±X

Cross-section of aluminum. Non-perforated section.

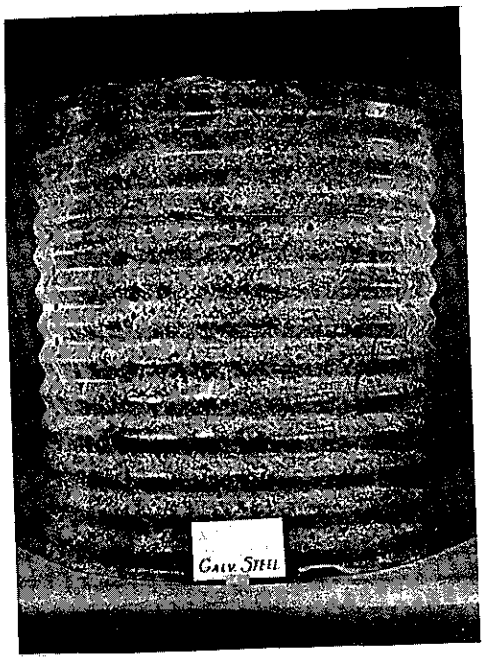
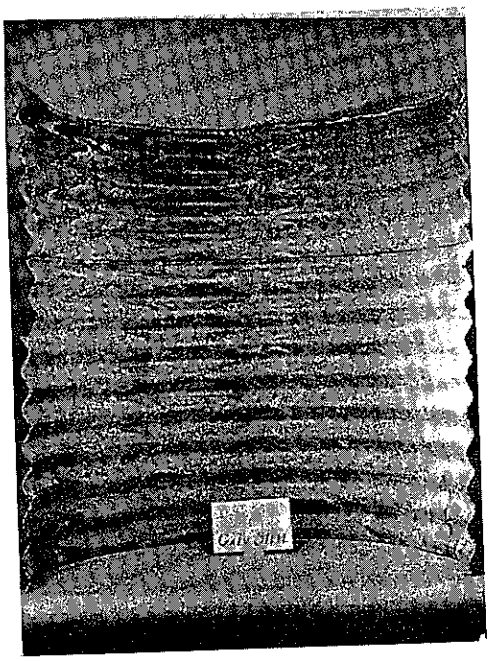
X-S.J-53-C
Right of Station 6±

Appearance of cleaned galvanized steel samples after 2.4 years of test.
