SERVICE PERFORMANCE OF CEMENT TREATED BASES AS USED IN COMPOSITE PAVEMENTS

Presented at the 48th Annual Meeting
of the Highway Research Board
January, 1969

MATERIALS AND RESEARCH DEPARTMENT
RESEARCH REPORT
NO. M & R 633208

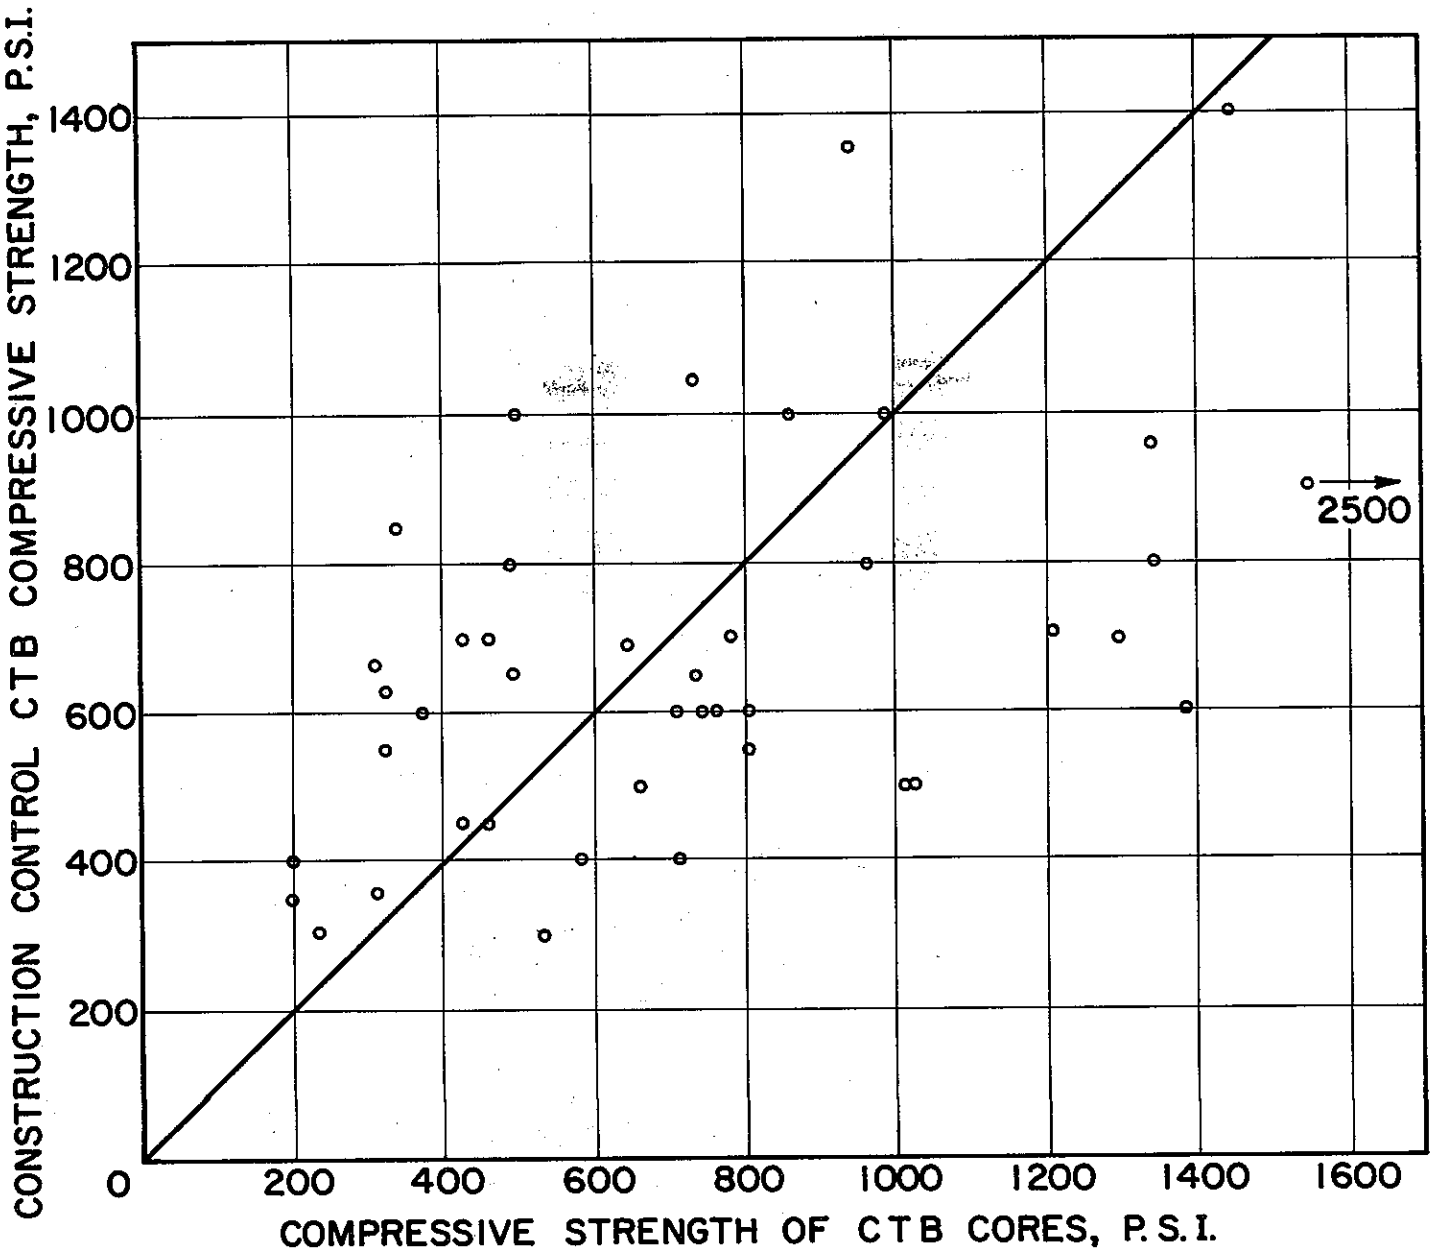
Figure 2

COMPARISON OF COMPRESSIVE STRENGTH OF CONSTRUCTION CONTROL SAMPLES WITH THAT OF THE FIELD CORES

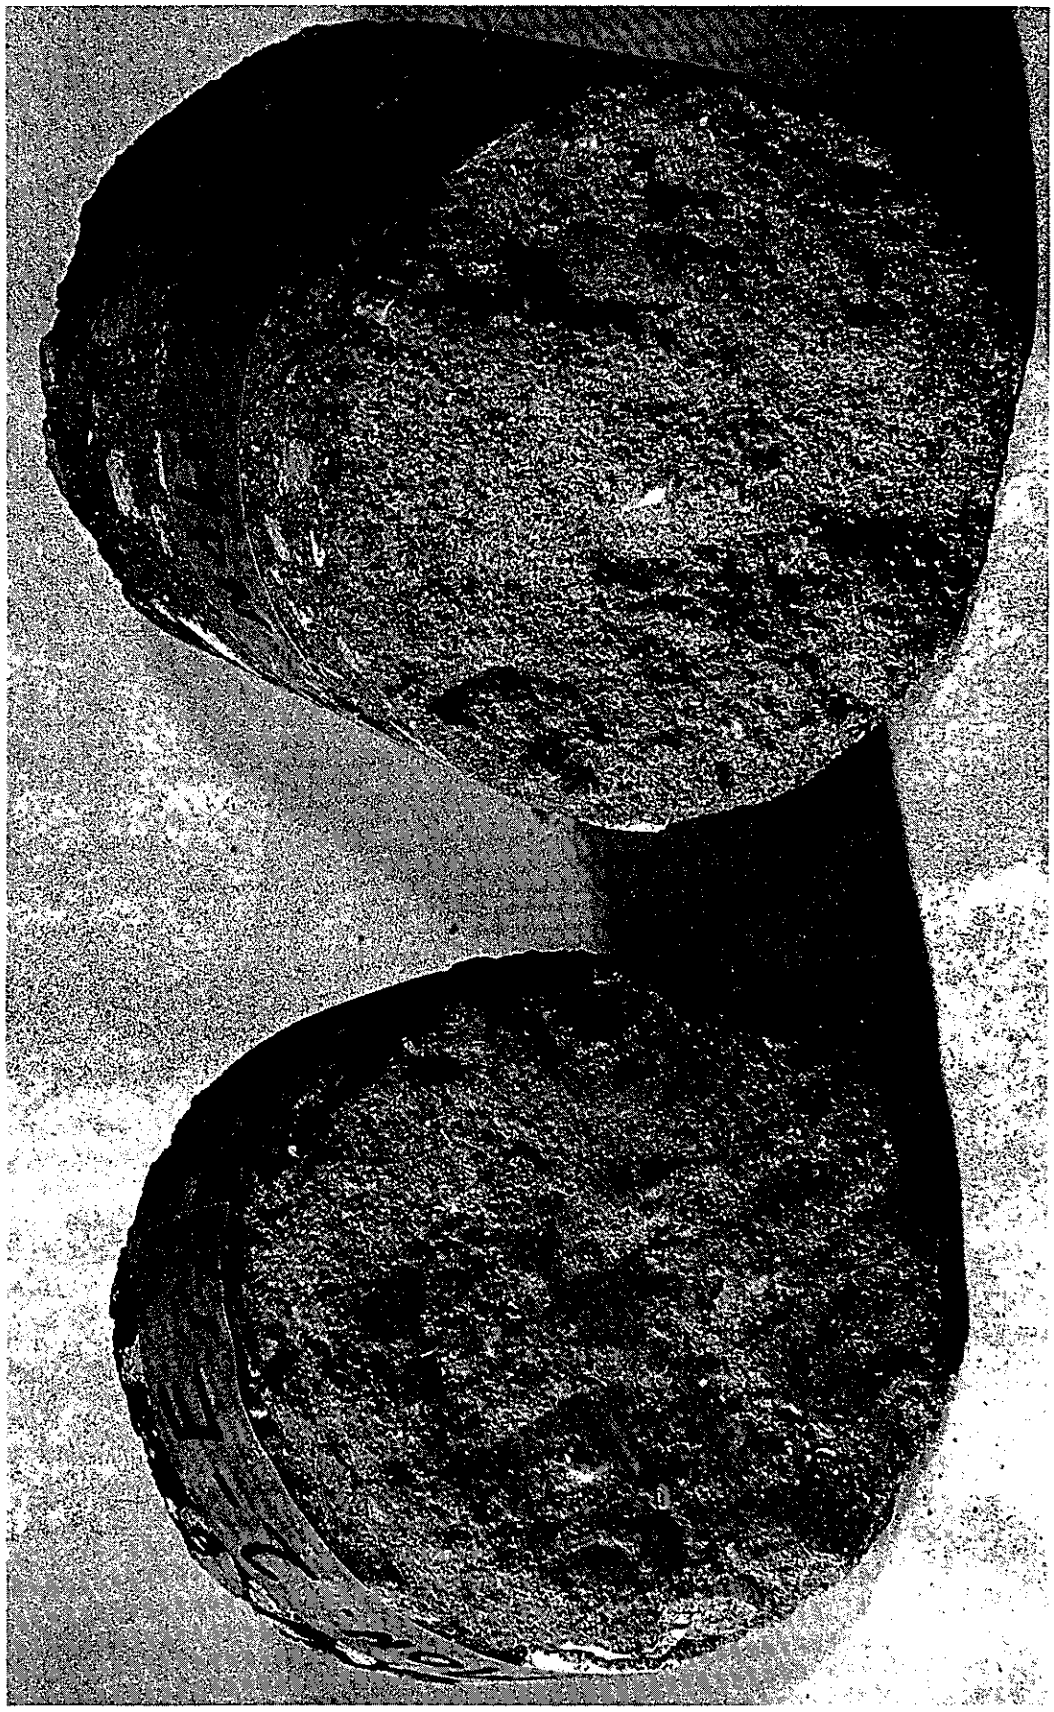
A thin layer of CTB was known to have been placed on another of these projects in order to bring it to design grade. Figure 4 shows the smooth separation of these two layers of CTB and that the thin layer remained bonded to the AC surfacing. This core was cut from the center of the lane. The thin layer of CTB was pulverized in the wheel tracks at this location and had caused extensive cracking and pumping of the pavement. Figure 5 shows how the thin layer of disintegrated CTB in the outer wheel track at this location was washed out from beneath the AC by the drill water. Since it is difficult to spread and compact a thin layer of CTB and it is unlikely that this layer would bond to the underlying CTB, it is easy to see how it could be pulverized between the underlying CTB and the AC surfacing by the action of heavy wheel loads.

COMPACTION PLANE BETWEEN TWO LIFTS OF CLASS "B" CTB.

Project 05 – Mon – 101 – 43.9/51.7

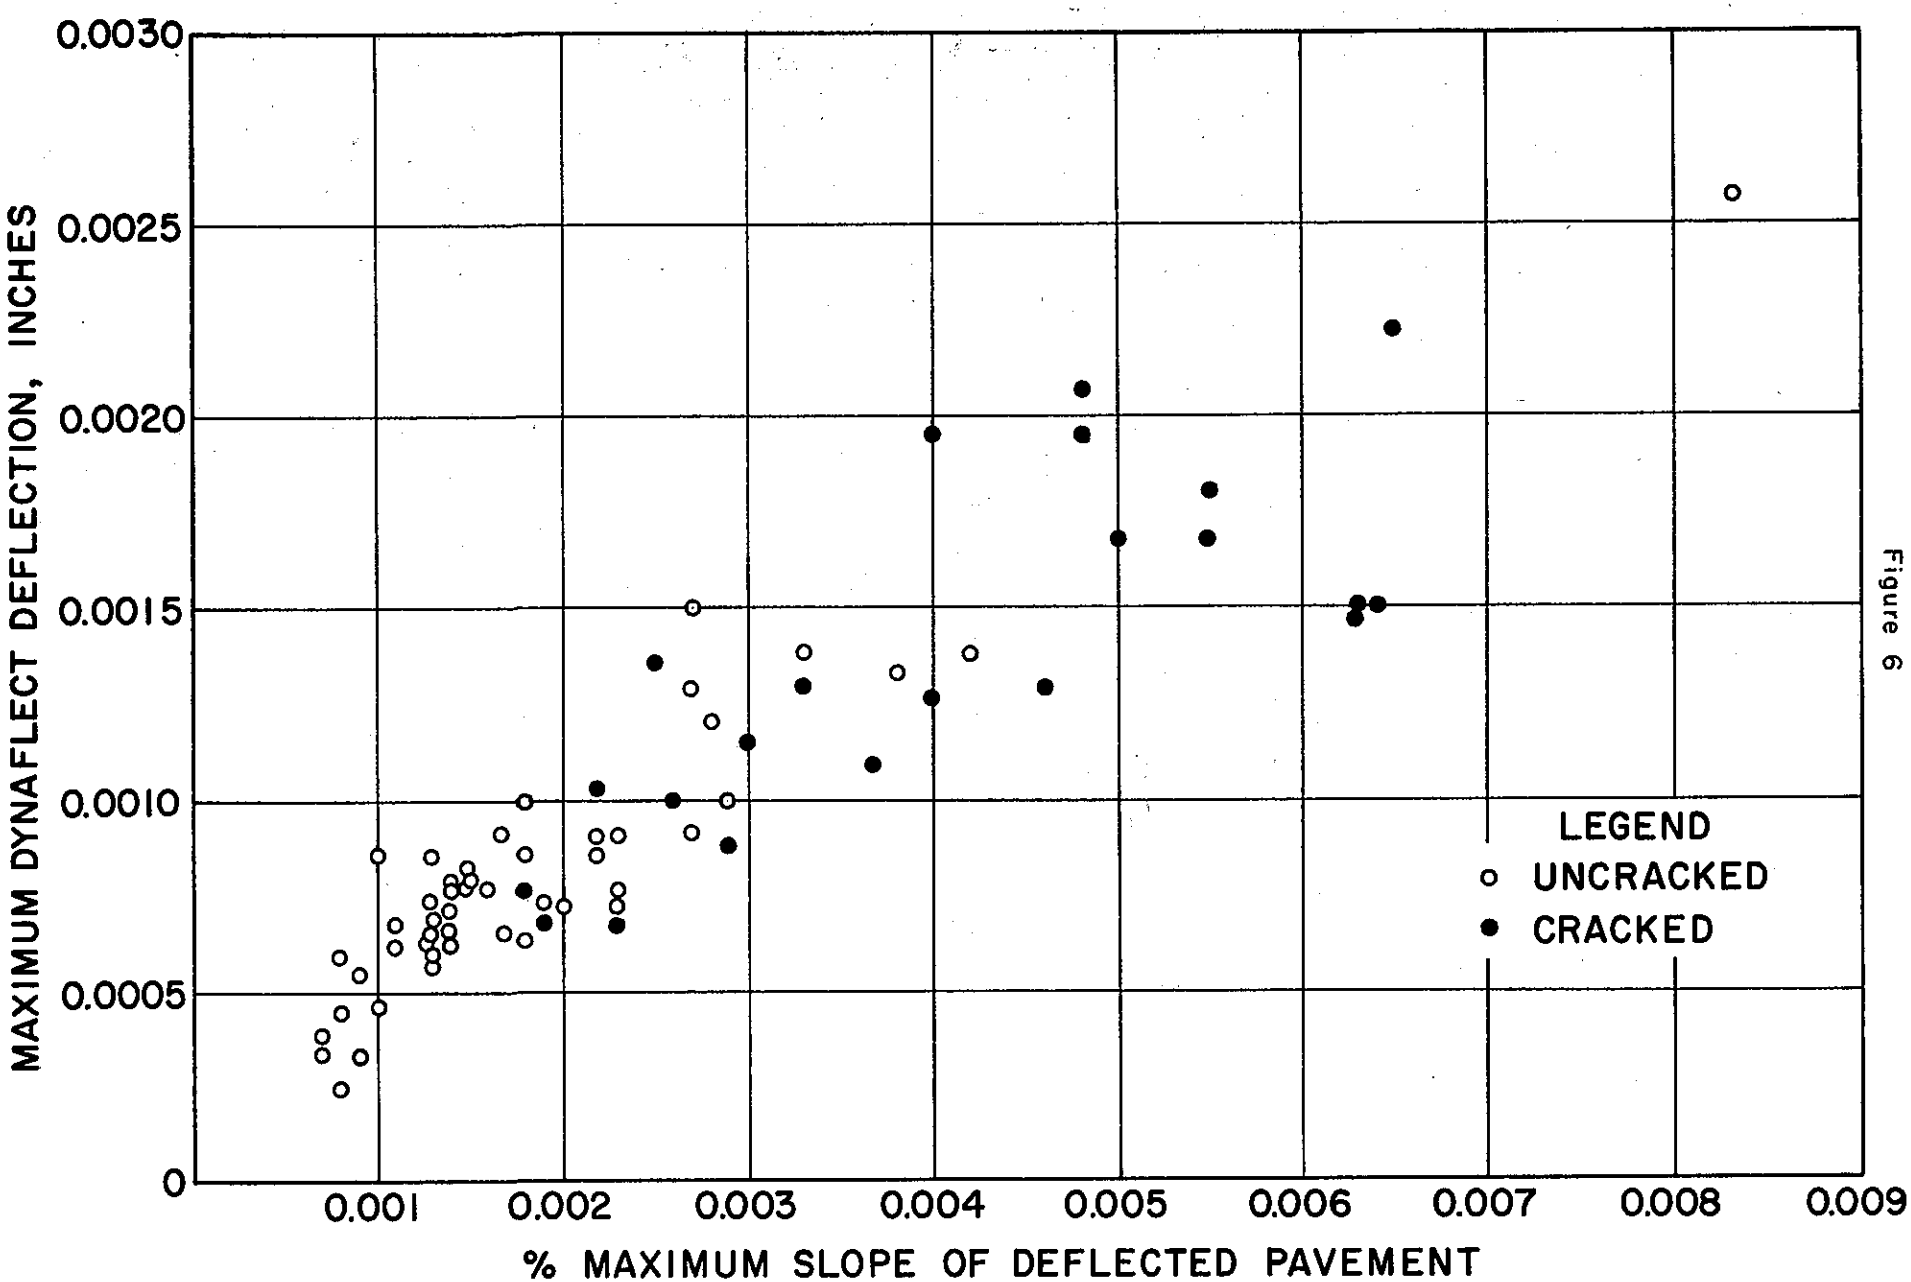
Figure 6 shows a plot of the maximum Dynaflect deflection versus the maximum slope of the deflected pavement between any two of the five geophones for both cracked and uncracked locations. Although both deflection and slope seem to indicate a maximum tolerable value, it is apparent from this plot that the maximum slope of the deflected pavement provides a more sensitive break between cracked and uncracked locations than does the maximum deflection. This data indicates the maximum tolerable slope to be about 0.002 percent. Fifty-nine percent of the locations with a greater slope were block cracked and many of those that have not cracked will probably do so before their design lives are exceeded.

MAXIMUM DEFLECTION VERSUS MAXIMUM SLOPE OF DEFLECTED PAVEMENT FROM DYNAFLECT READINGS

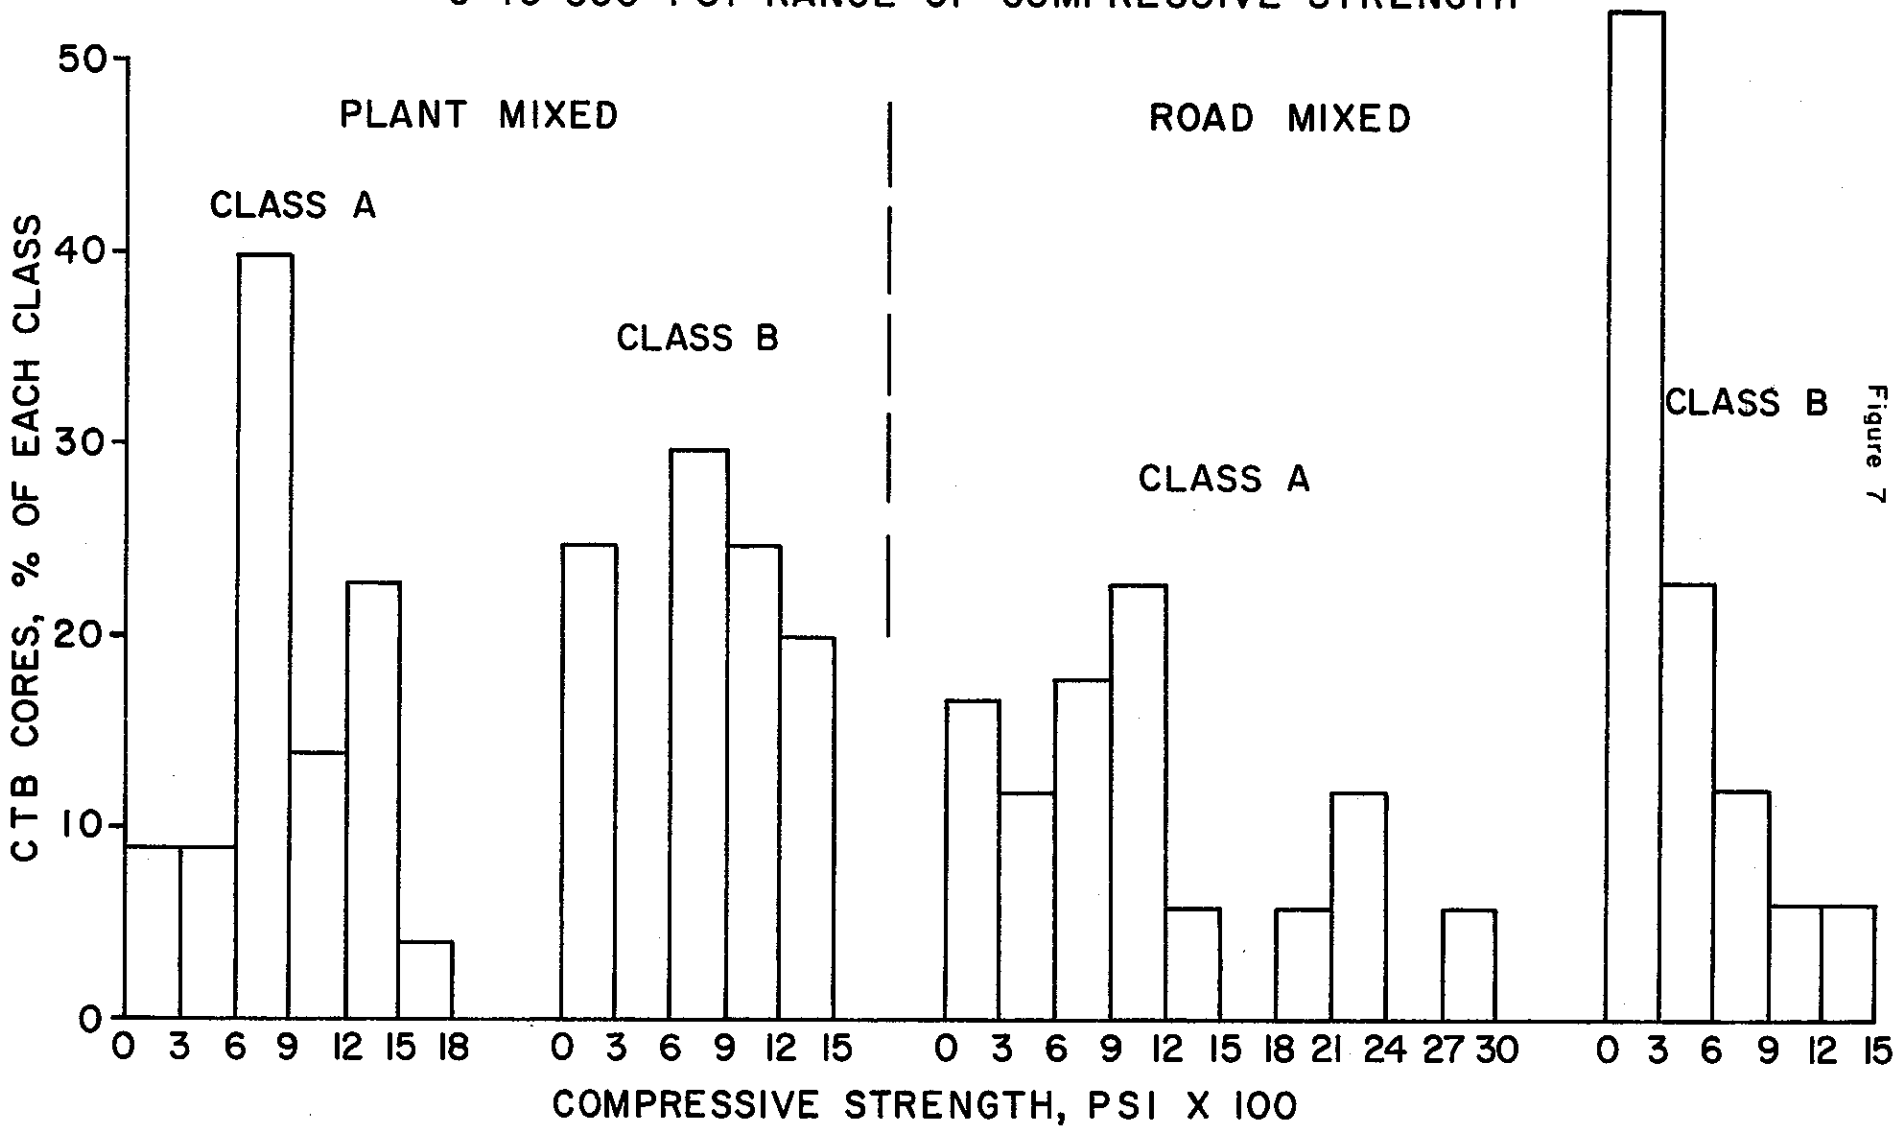
Figure 7 shows the compressive strength frequency distribution of the CTB cores for each type of mixing and class of CTB. The plant mixing produces more of a normal frequency distribution whereas road mixing produces a distribution which is skewed toward the low compressive strength range. Also, the Class "A" road mixed CTB cores produced a broad range of compressive strengths indicating poor uniformity very likely caused by a poor distribution of cement. Twenty-five percent of the Class "B" plant mixed projects had CTB compressive strengths of less than 300 psi whereas 53 percent of the Class "B" road mixed projects were in that range of compressive strength. Eighteen percent of the Class "A" plant mixed projects had CTB compressive strengths of less than 600 psi whereas 29 percent of the Class "A" road mixed projects were in that range of compressive strength. This data clearly demonstrates the superiority of plant mixing over road mixing and the disadvantage of specifying a cement content which is too low.

COMPRESSIVE STRENGTH FREQUENCY DISTRIBUTION OF CTB CORES BY CLASS OF CTB AND TYPE OF MIXING
