STATE OF CALIFORNIA
DEPARTMENT OF PUBLIC WORKS
DIVISION OF HIGHWAYS

# REPORT ON STRENGTH AND DEFLECTION TESTS OF VARIOUS MATERIALS USED AS GUARD RAIL POSTS

57-19

May 10, 1957

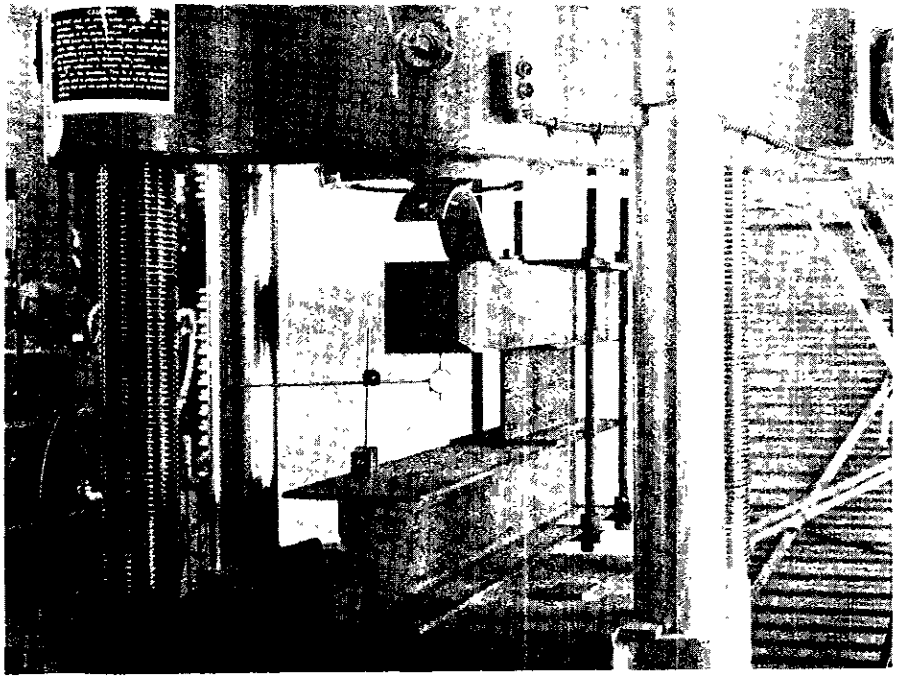
Figure 1

Redwood post in place for testing.

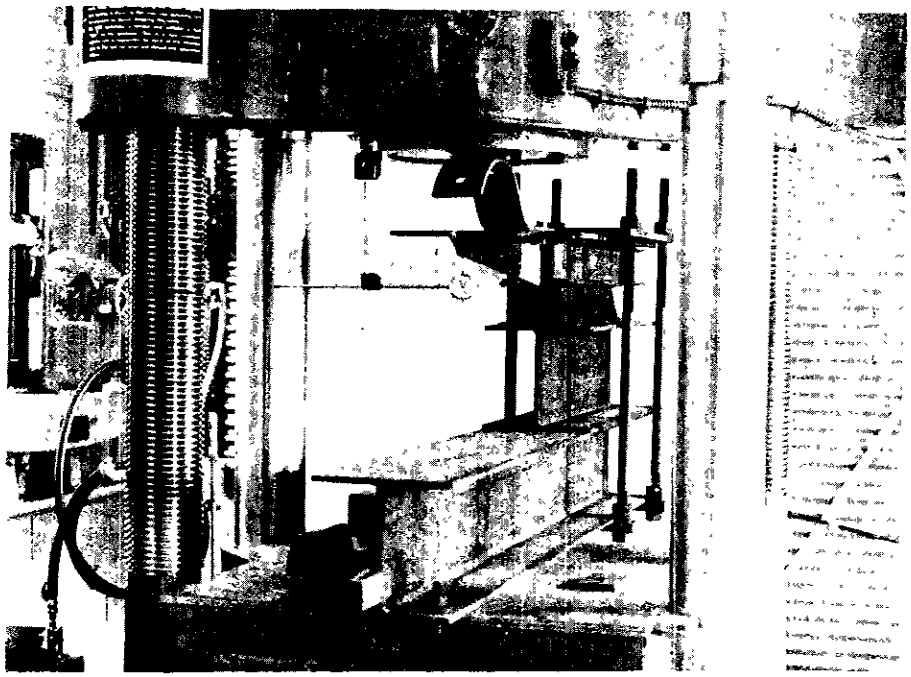
3. The split H-beam showed comparatively low ultimate strength and high deflections.

Figure 3
Split steel post in place for testing.

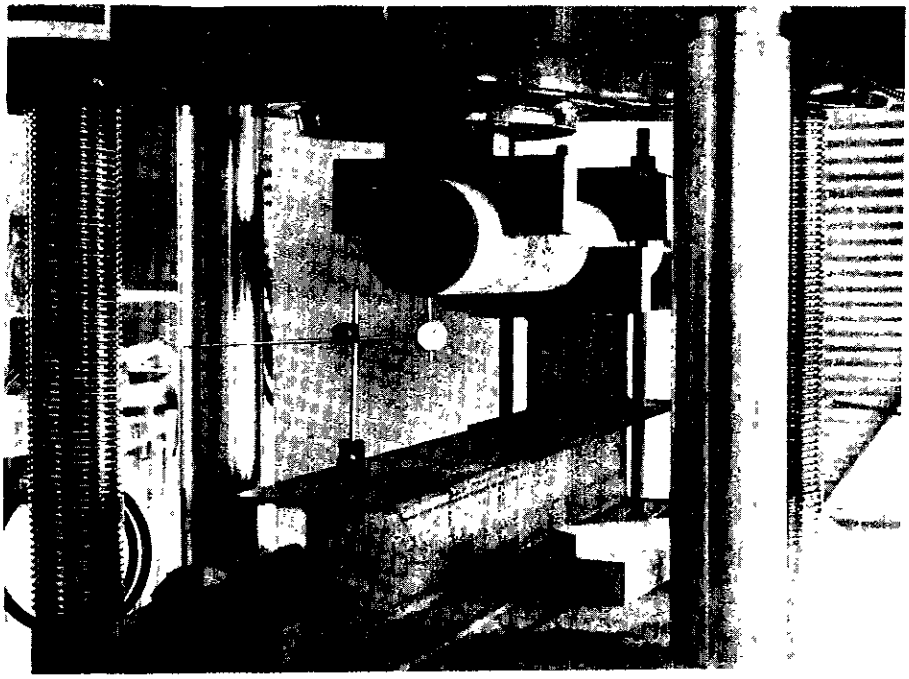
Figure 5
Concrete post in place
for testing.

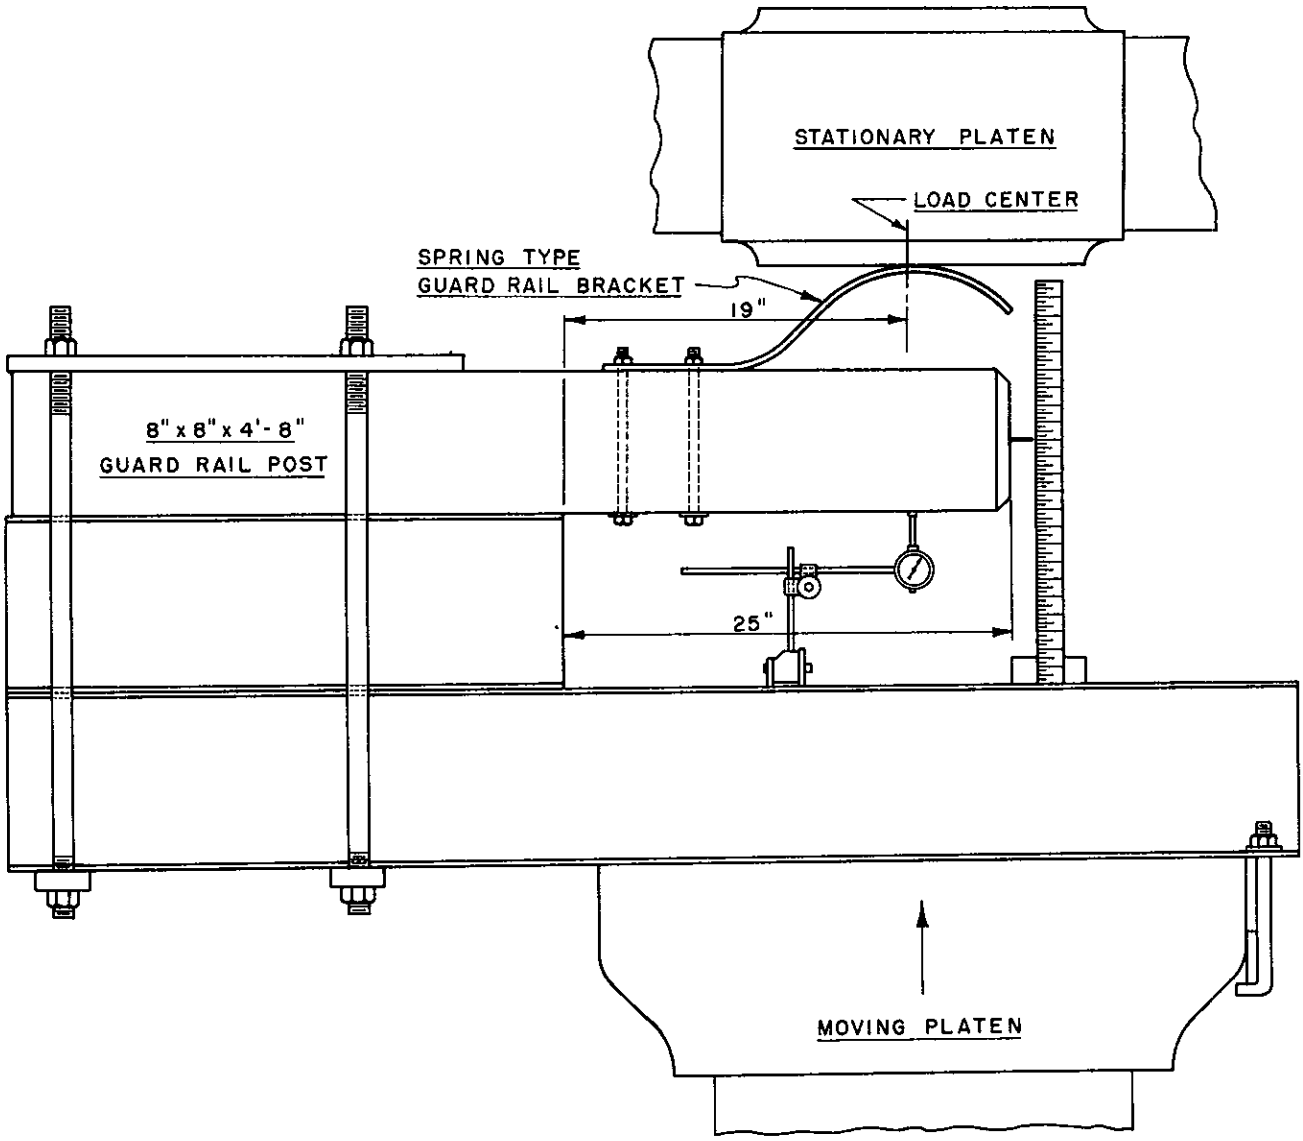
Figure 8 is a diagram of the apparatus and position of the posts. Figure 9 shows the numbering system used to identify each type of specimen.

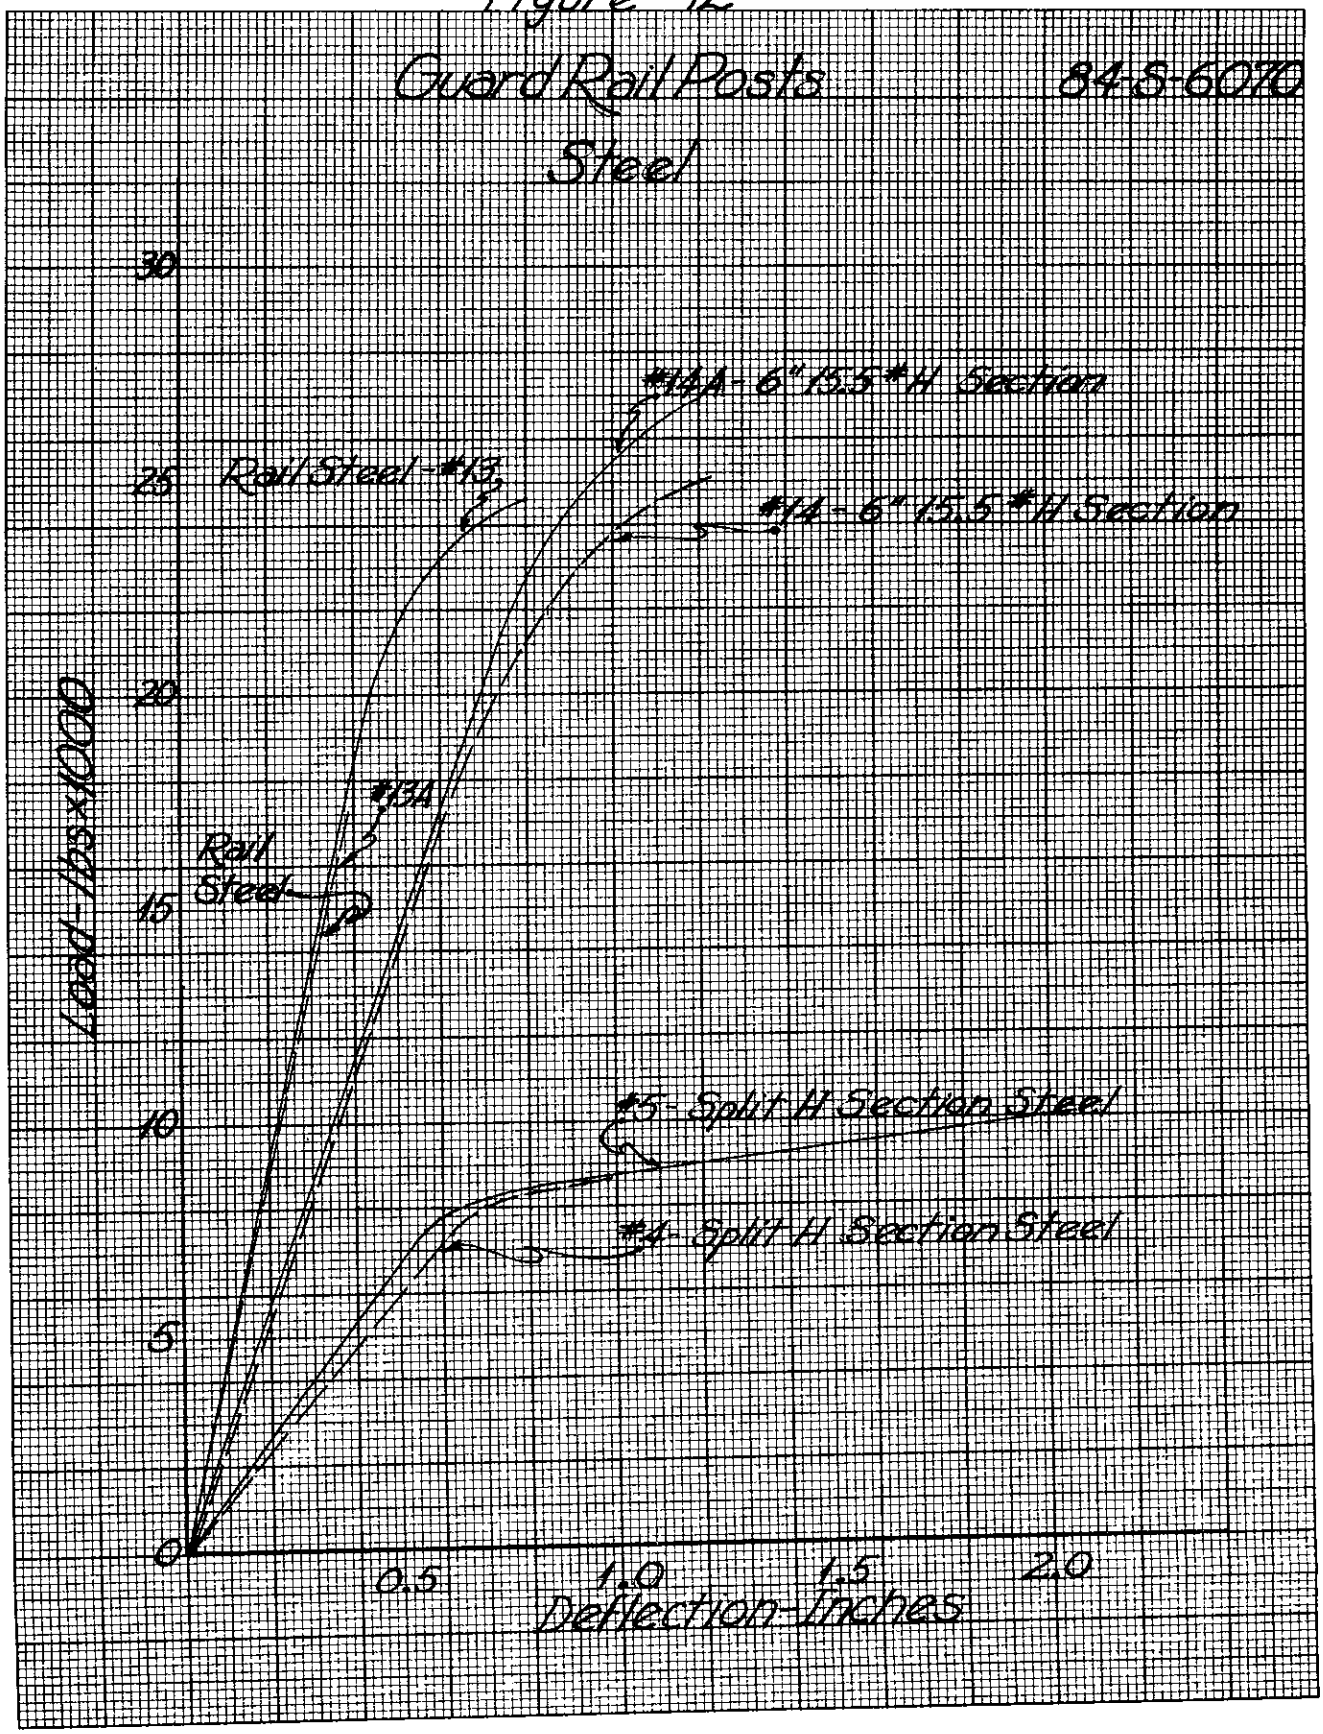
Figure #12

| Figure 12 | Stress - Deflection graphs of steel posts. |

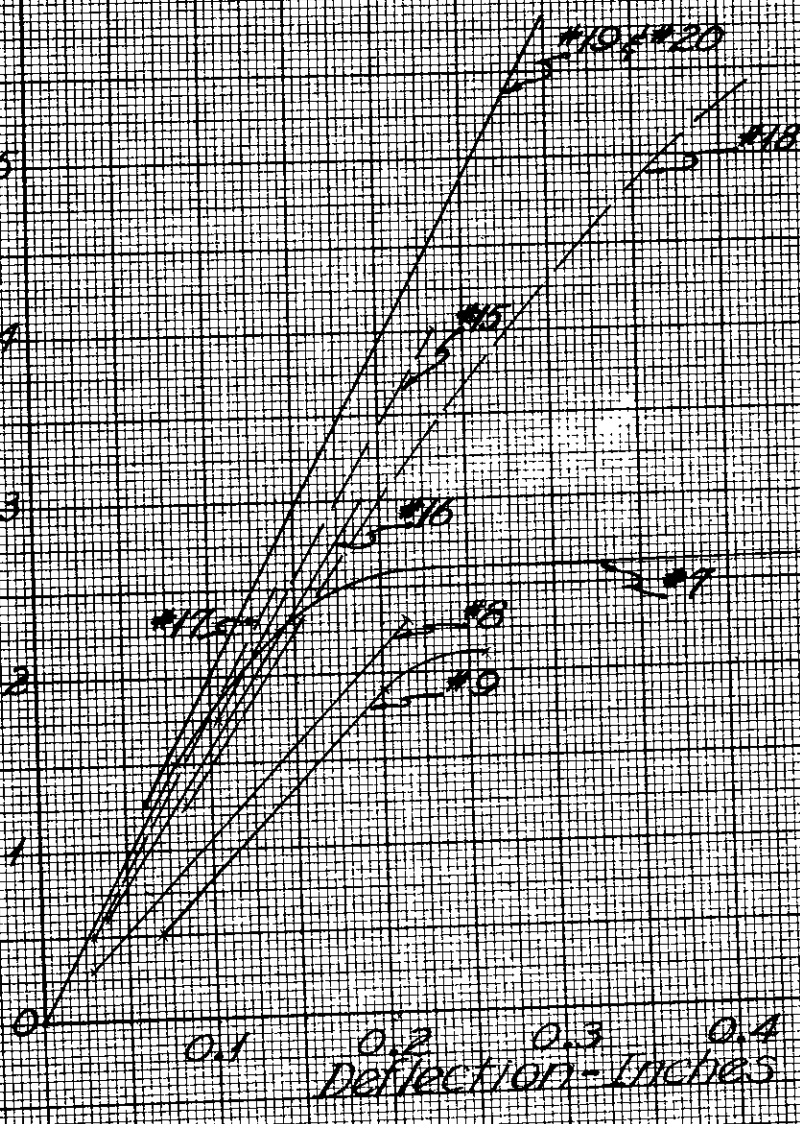
Figure #13

poured in 7" pipe and reinforced with #4 bar showed comparatively high deflections in addition to the lowest ultimate value of the series. It would appear that the concrete posts would have to be made in larger sections and have considerably more reinforcing in order to be structurally comparable to the other types. Any economic advantage would be correspondingly reduced.

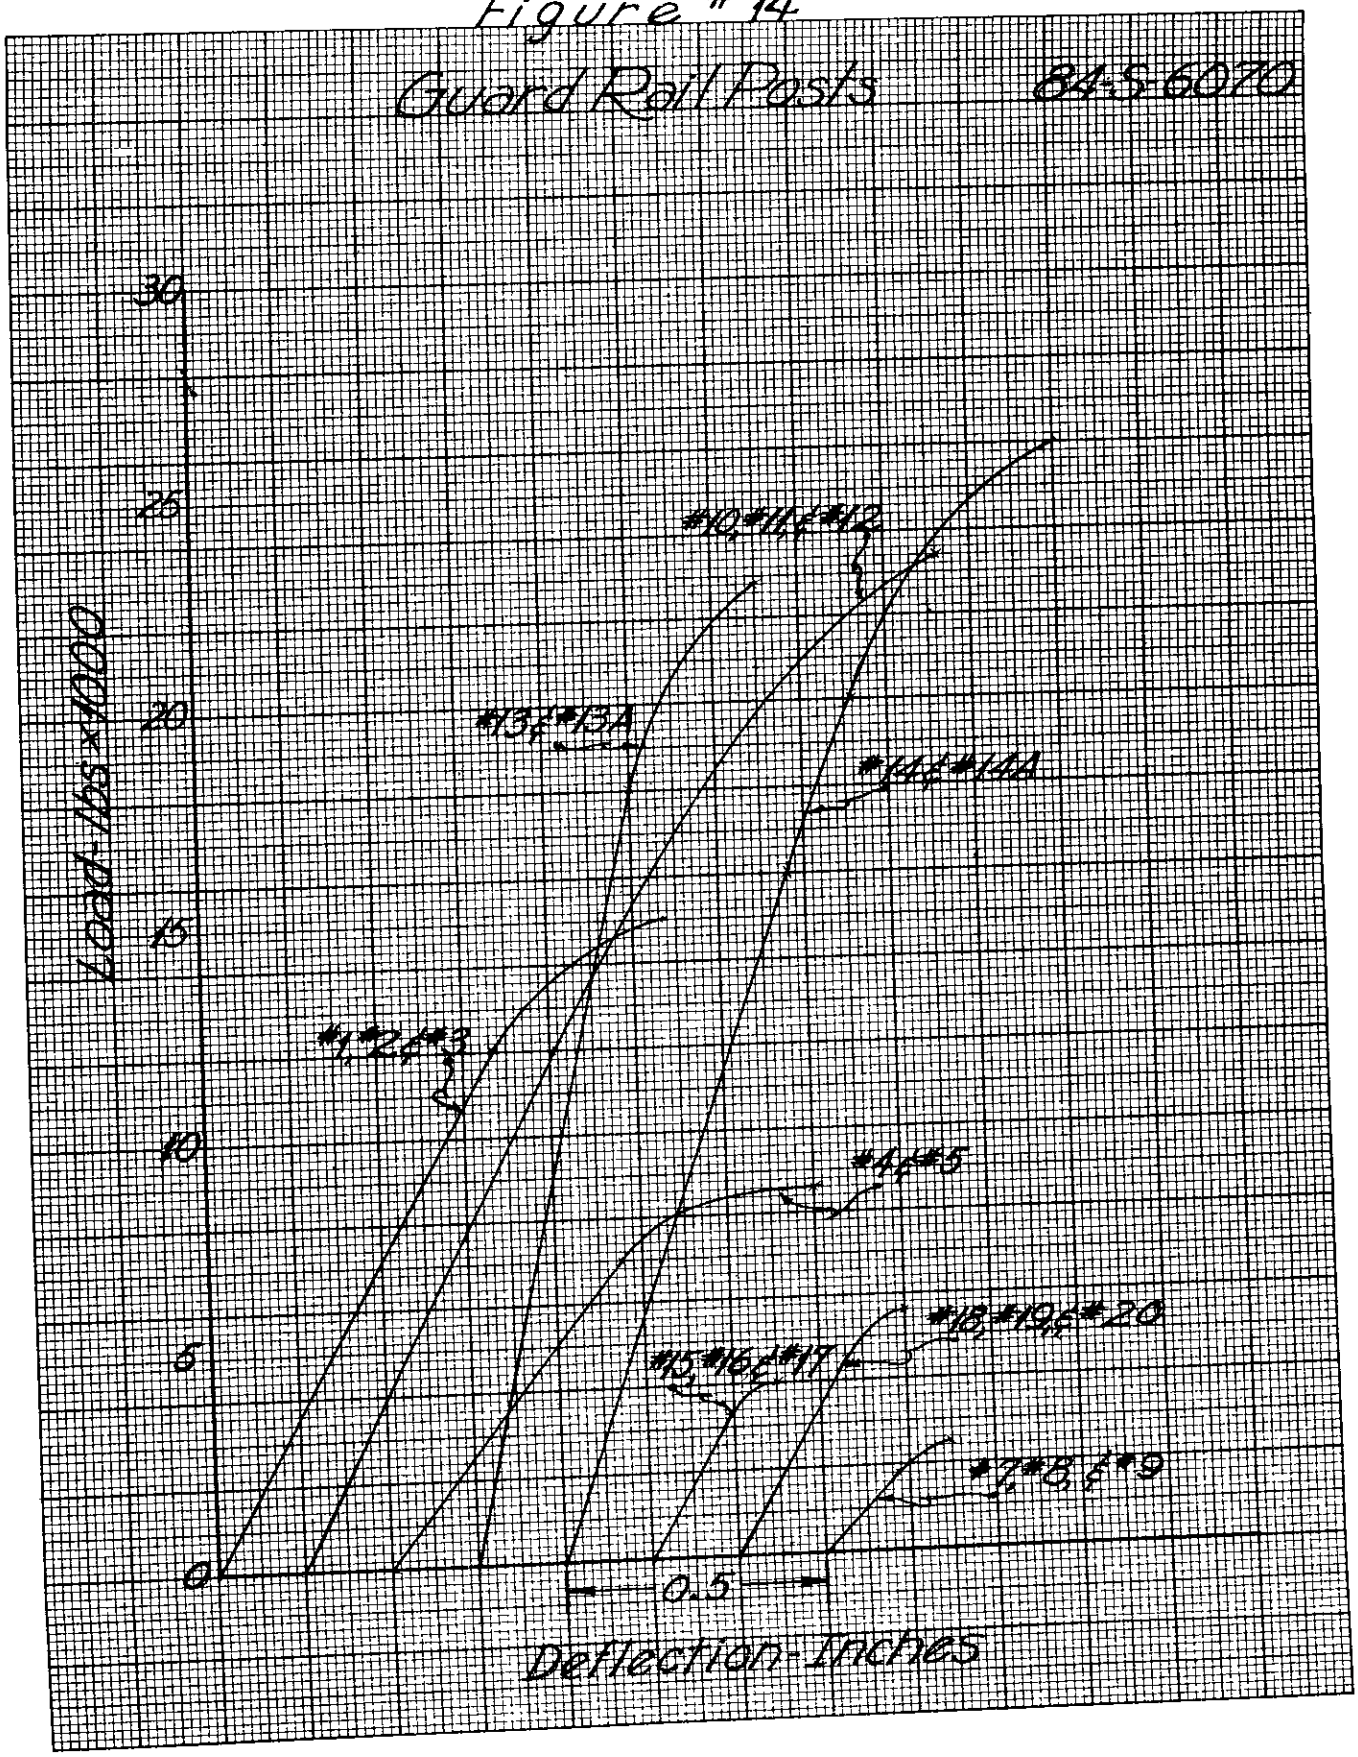
Figure #14

A review of the tabulation of results (Figure 10) and of the composite deflection graph (Figure 14) shows the following:

4. The tests indicated the railroad rail to be structurally comparable to the standard timber and WF beam sections.
