FULL SCALE TESTING OF HIGHWAY BRIDGE RAILS AND MEDIAN BARRIERS

F. N. HVEEM
Materials and Research Engineer

J. L. BEATON
Supervising Highway Engineer

State of California
DEPARTMENT OF PUBLIC WORKS
Division of Highways
Materials and Research Department
Sacramento, California

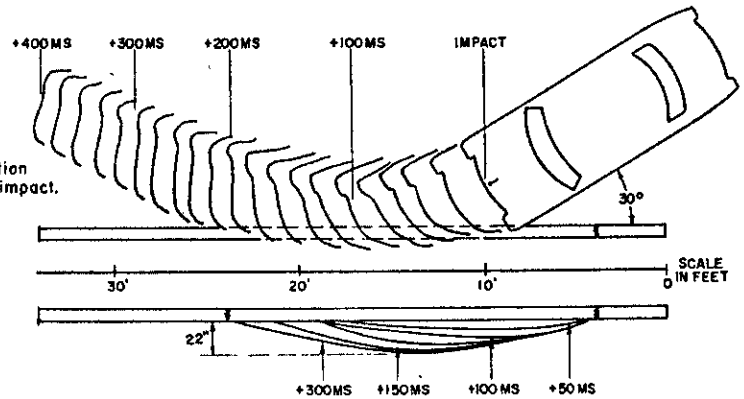
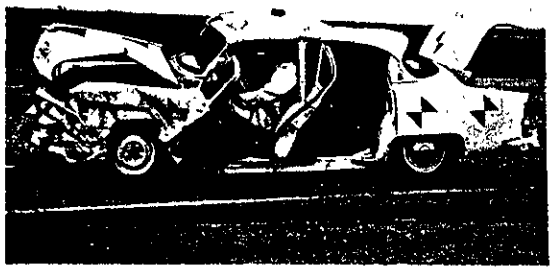
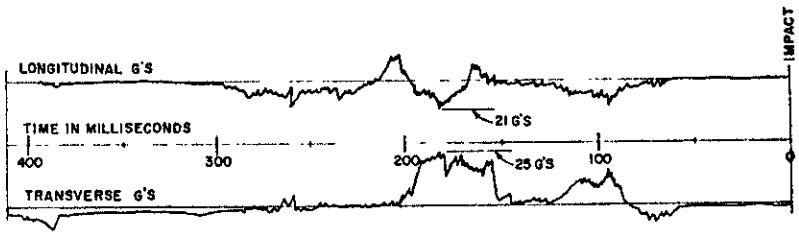
FIG. 2

An examination of the sequence photographs of Test No. 22 (Fig. 2) reveals that the rail retained only the lower part of the door and allowed the top of the door to be forced open as much as one foot. In cases where the head of the dummy protruded from the vehicle, skull injuries usually resulted.

Final Position 124' from impact. After one roll over.

DUMMY INJURY . . . . . Concussion, severe shoulder & chest injuries
GUARDRAIL DAMAGE . . . . . 20' Wall broken
VEHICLE DAMAGE . . . . . Beyond economic repair.
MAX. DYNAMIC DEFLECTION OF RAIL . . 22"
TIME FROM IMPACT TO STOP . . . . . 3000 Milliseconds.

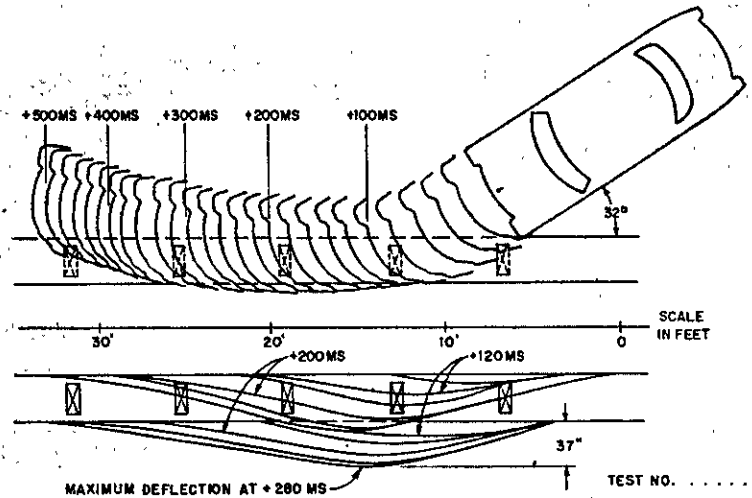
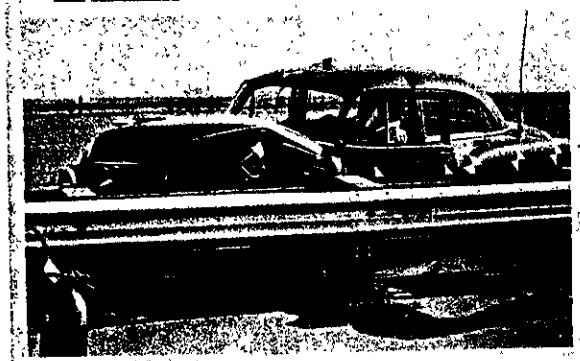
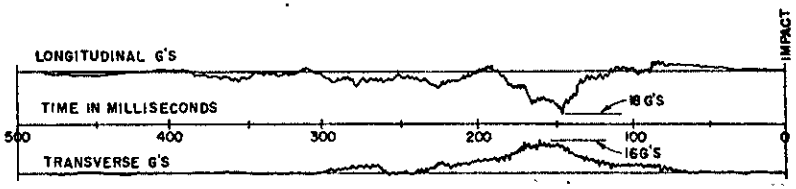
FIG. 3

In all semi-rigid and rigid barrier tests where the vehicle was not trapped by the posts, the dummy was subjected to high transverse decelerations. It was forced against the left door with sufficient pressure to break the latching mechanism. In tests where relatively high transverse decelerations were sustained after the vehicle left the barrier, the dummy probably would have been ejected from the vehicle had it not been restrained with a lap belt as the door usually flew open. However, in cases where the dummy was in contact with the door and the door in turn was against the barrier throughout the period of transverse G loading, (as exemplified by the tests on the blocked-out barrier, Fig. 3), the rail prevented the door from opening.

Final Position 94' from impact.

DUMMY INJURY ..... Possible shoulder and head injuries.
GUARDRAIL DAMAGE ..... 4 Sections damaged beyond repair.
CHANNEL DAMAGE ..... 4 Sections damaged beyond repair.
POST DAMAGE ..... 3 Posts damaged beyond repair.
VEHICLE DAMAGE ..... $ 900
MAX. DYNAMIC DEFLECTION OF RAIL .... 37"
TIME FROM IMPACT TO STOP ..... 3100 Milliseconds.

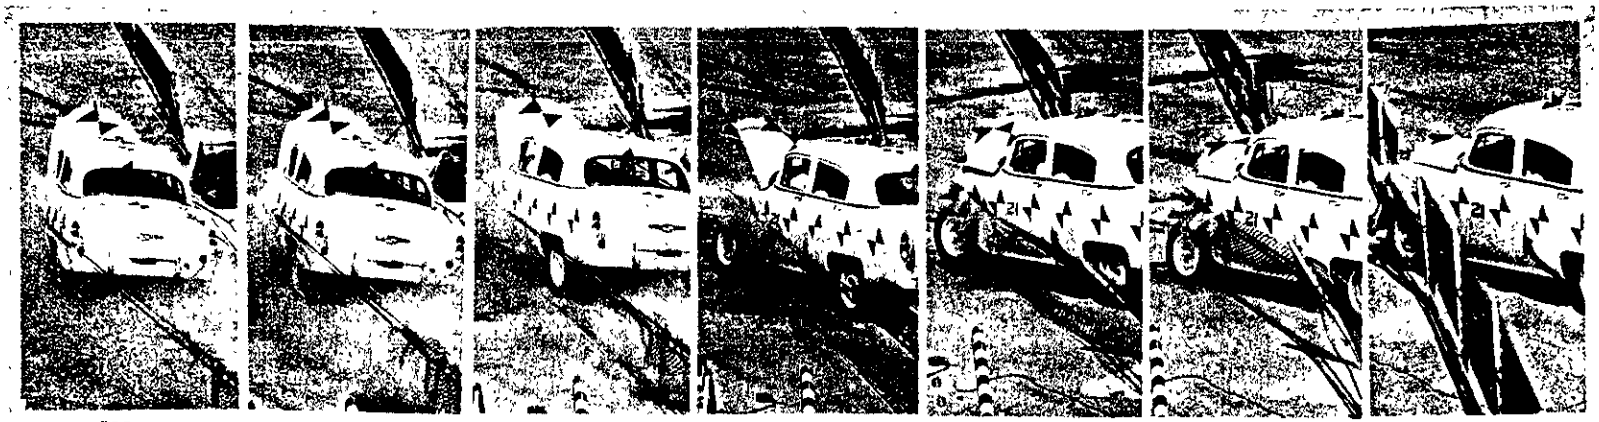
A barrier that deflects appreciably but within limits so as to form a smooth "pocket" under the condition of oblique collision loading is defined as a semi-rigid barrier. The resultant vehicular decelerations sustained during a heavy oblique collision with a semi-rigid barrier will be moderately high in both longitudinal and transverse axis and of appreciable duration, the decelerations being slightly higher in the transverse than in the longitudinal axis. This type of barrier is illustrated by Fig. 3.

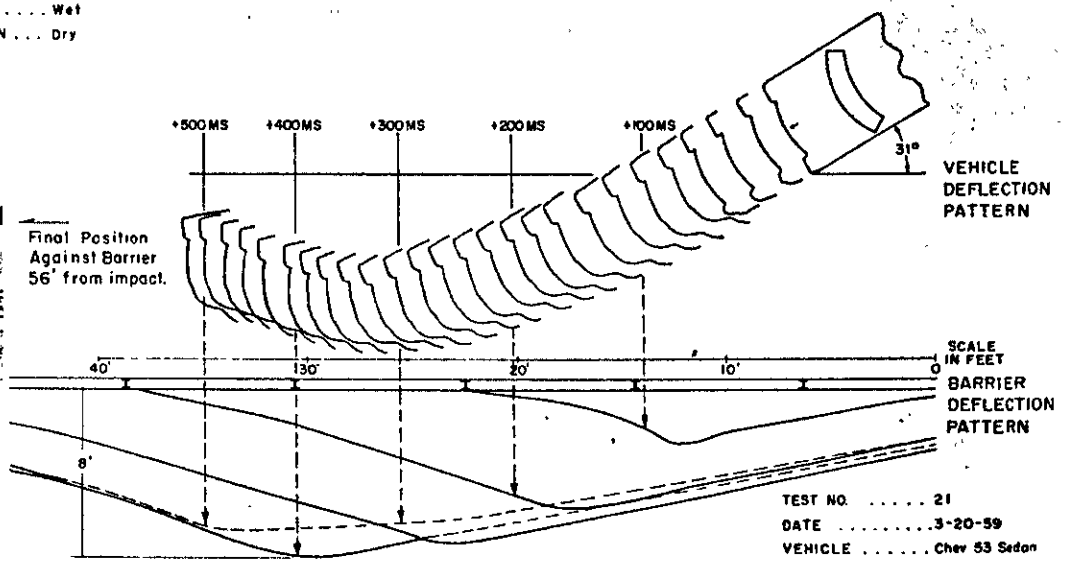
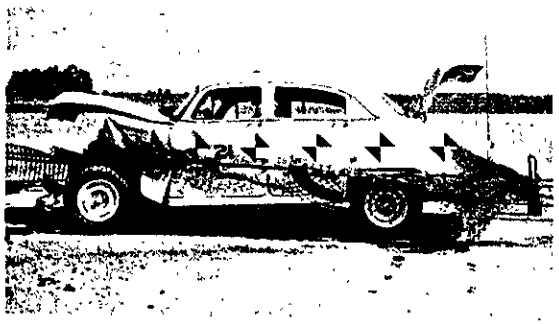
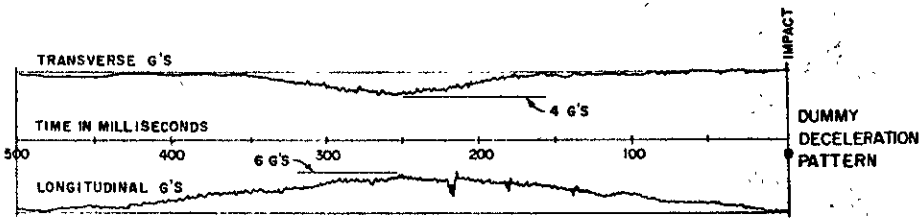
FIG. 4

Dummy deceleration data from all tests of cable-chain link (Fig. 4) barriers show very low transverse decelerations (2-9 Gs) and low longitudinal decelerations (3-7 Gs). If the dummy did impart a loading great enough to spring the door latching mechanism, the door did not open because the vehicle was firmly against the upper cables when peak transverse decelerations occurred.

DUMMY INJURY . . . . . Minor scalp lacerations.
BARRIER DAMAGE . . . . . 56' of fence knocked out. No damage to cables.
POST DAMAGE . . . . . 12 Posts damaged beyond repair.
VEHICLE DAMAGE . . . . . Beyond economic repair.
MAX. DYNAMIC DEFLECTION OF CABLES . . 8'
TIME FROM IMPACT TO STOP . . . . . 1450 Milliseconds.

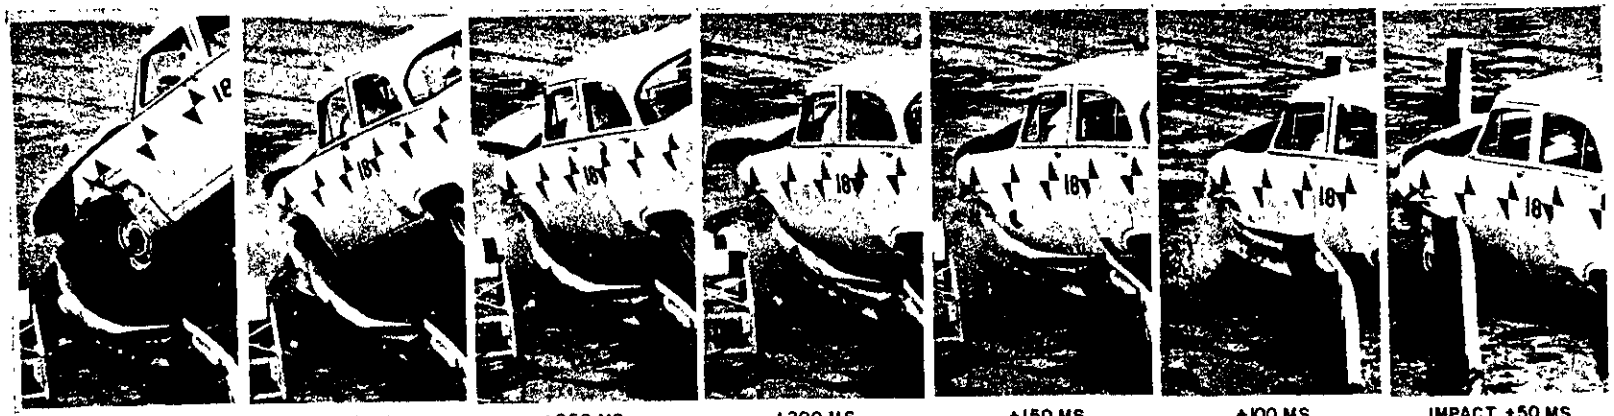
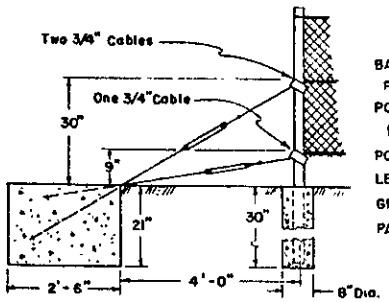
BARRIER . . . . . 36" Chain Link Fence W/ 3/4" cables 9" & 30" above pvmt.
POST . . . . . 2 1/4"-4.1#
H Section Fence Post
POST SPACING . . . . . 8' O. C.
LENGTH OF INSTALLATION . 600'
GROUND CONDITION . . . . . Wet
PAVEMENT CONDITION . . . Dry

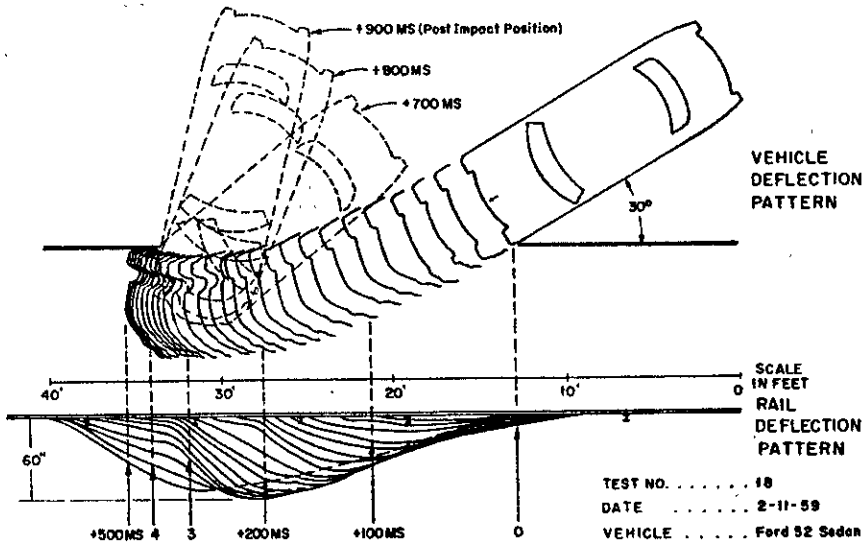
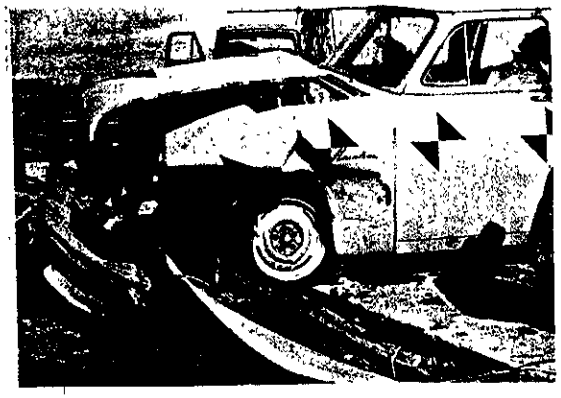
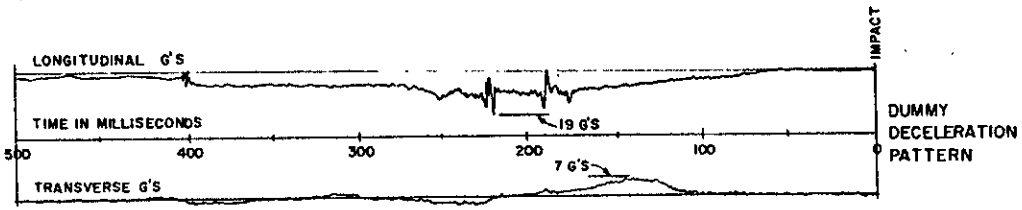
FIG. 5

When the dummy experienced excessive longitudinal decelerations, such as in Test No. 18 (Fig. 5), the dummy was thrown forward and the the left, striking the chest violently against the steering wheel and column, the skull impacting the header area. This action was typical of all tests where the front wheel assembly was trapped by the posts. A detailed analysis of steering wheel deformation with related injuries was not attempted due to the resistance offered the steering wheel by the remote steering pulley bracket.

DUMMY INJURY . . . . . Possible head & shoulder injuries.
BRIDGERAIL DAMAGE . . . . . 3 Sections damaged beyond repair
POST DAMAGE . . . . . 5 Posts damaged beyond repair.
VEHICLE DAMAGE . . . . . Beyond economic repair.
MAX. DYNAMIC DEFLECTION OF RAIL . . 60"
TIME FROM IMPACT TO STOP . . . . 1050 Milliseconds.
