State of California
Department of Transportation
Division of New Technology, Transportation Materials & Research
Office of Transportation Materials & Research

ABRASION EVALUATION OF COATED & UNCOATED C.M.P. INVERT PROTECTION USING DIFFERENT FLOW RATES

1. REPORT NO. CA/TL-90/01	2. GOVERNMENT ACCESSION NO.	3. RECIPIENT'S CATALOG NO.
4. TITLE AND SUBTITLE Abrasion Evaluation of Coated and Uncoated C.M.P. Invert Protection Using Different Flow Rates		5. REPORT DATE January 1990
		6. PERFORMING ORGANIZATION CODE
7. AUTHOR(S) R. L. Hickman and R. E. Edwardes		8. PERFORMING ORGANIZATION REPORT NO. 646985
9. PERFORMING ORGANIZATION NAME AND ADDRESS Office of Transportation Materials and Research California Department of Transportation Sacramento, California 95819		10. WORK UNIT NO
		11. CONTRACT OR GRANT NO. F87TL69
12. SPONSORING AGENCY NAME AND ADDRESS California Department of Transportation Sacramento, California 95807		13. TYPE OF REPORT & PERIOD COVERED Final
		14. SPONSORING AGENCY CODE
15. SUPPLEMENTARY NOTES

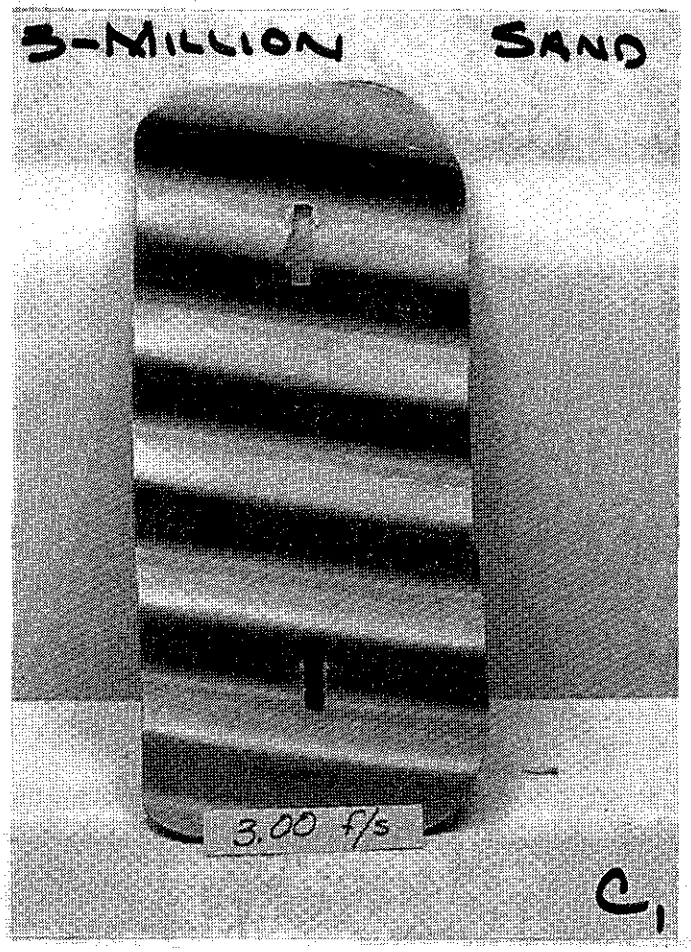
3-MILLION SAND
3.00 f/s
C1

After 3 million revolutions with the sand charge, the overall appearance of the sample looked good despite having twice the loss of galvanized steel. The cladding on the leading slopes of the corrugations was worn off in less than 500,000 revolutions. Total material loss due to the sand was 10 grams per million revolutions or 1.85%.

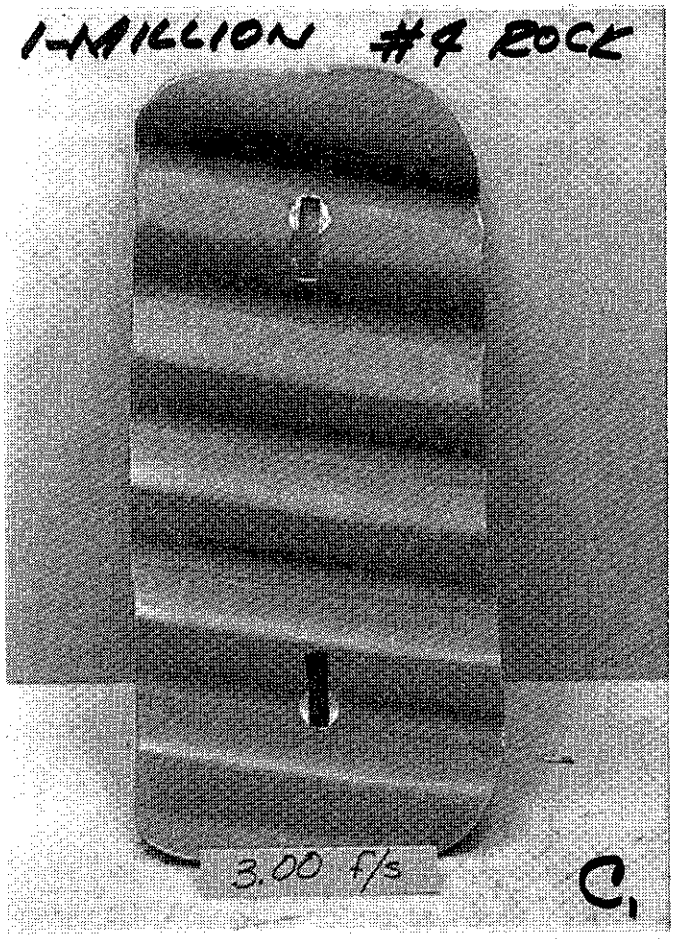
1-MILLION #4 ROCK
3.00 f/s
C1

After 1 million additional revolutions with the 1/2" x #4 aggregate, the sample showed visible signs of wear. The right outside edge had started to lose some material at the "most critical" points. The wear on the impact faces caused the corrugated ridges to become pointed in the middle, but not on the right or left sides of the ridge. Total material loss due to the

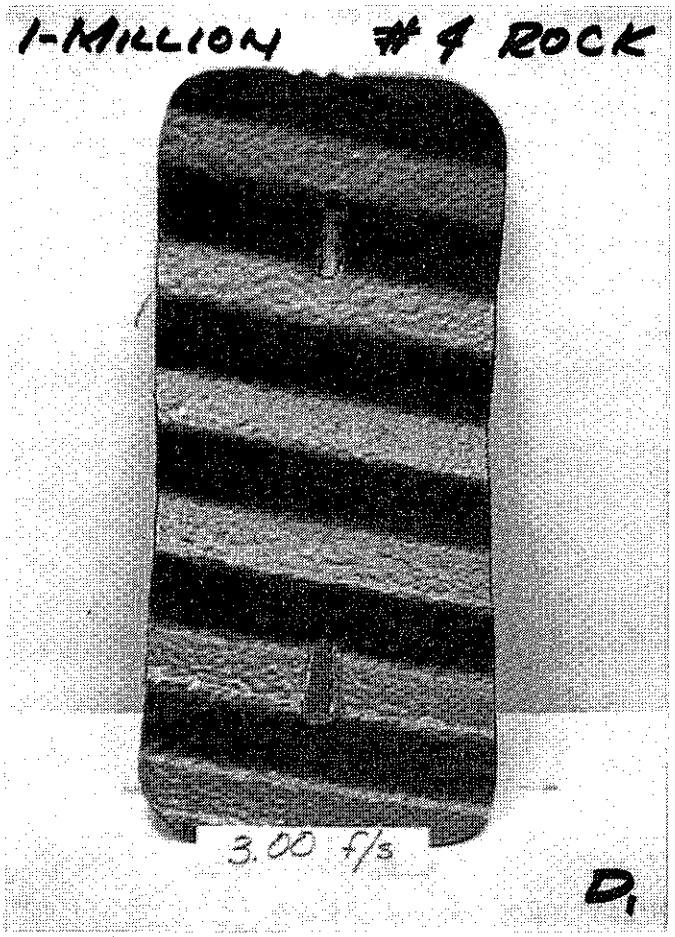
1-MILLION #4 ROCK
3.00 f/s
D1

After 1 million additional revolutions with the 1/2" x #4 aggregate, the sample showed no visible signs of wear and the overall appearance continued to be very good. Average loss at the "most critical" locations was only one-third of other samples. Total material loss due to the 1/2" x #4 was 1.9 grams per million revolutions or 0.20%. This loss was almost the same as that due to sand and was less than 10% of the loss to the galvanized steel sample.

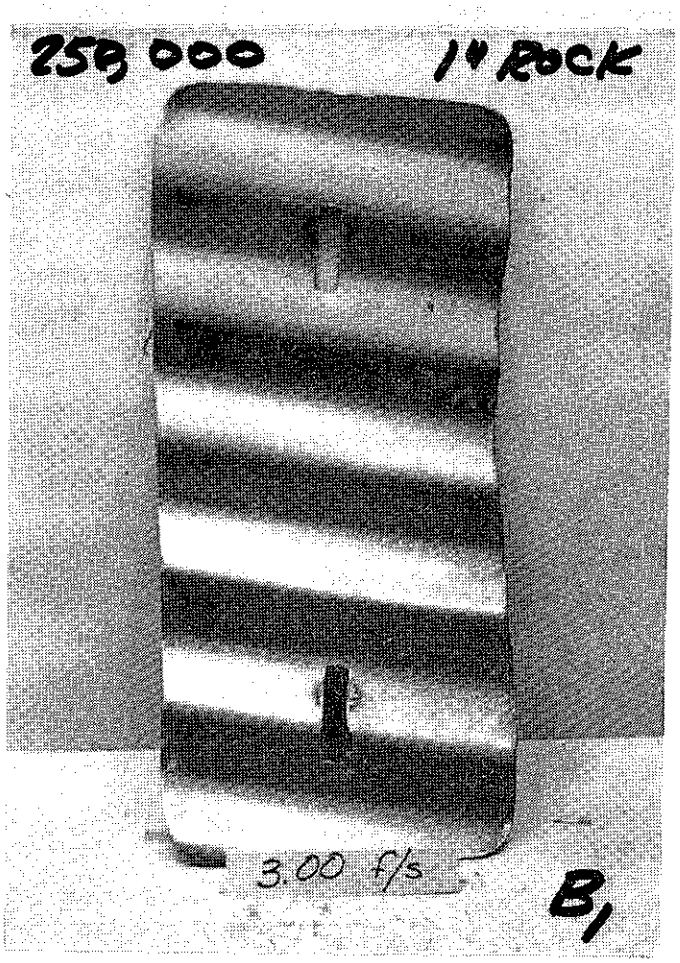
250,000
1" ROCK
3.00 f/s
B1

After an additional 1/4 million revolutions with the 1-1/2" x 1" aggregate, the sample was showing signs of heavy wear. Almost all of the original coating was gone. The ridges that were forming into points had become rounded again. All edges were intact, but some thinning at the outside edges could be seen. The surface was pitted and felt like fine sandpaper. Total material loss due to the 1-1/2" x 1" was 100 grams per million revolutions or 13.20%.

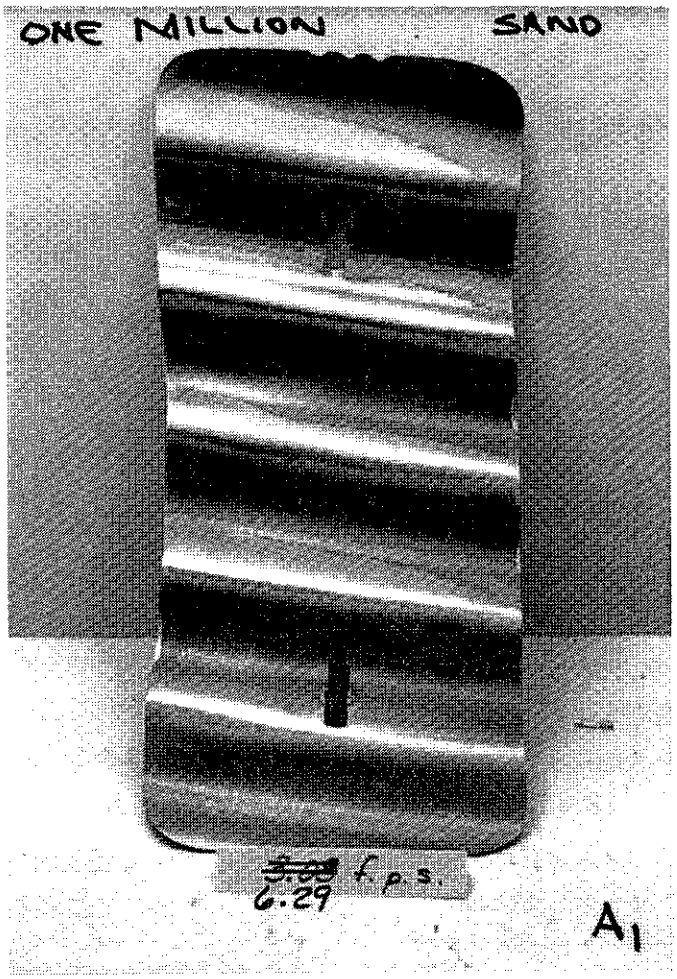
ONE MILLION SAND
6.29 f.p.s.
A1

After 1 million revolutions with the sand charge, the sample showed some wear, but the overall appearance was good. Total material loss due to the sand was 11 grams per million revolutions or 1.35%. For reasons unknown, this loss was only half that of the galvanized steel sample.

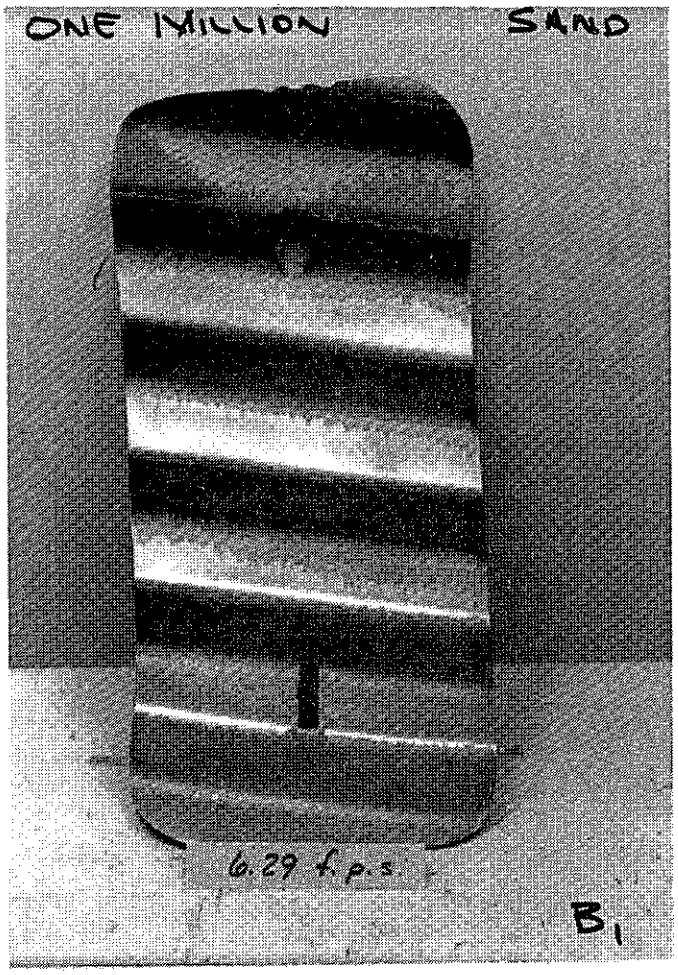
ONE MILLION SAND
6.29 f.p.s.
B1

After 1 million revolutions with the sand charge, the sample showed some wear, but the overall appearance was good. Total material loss due to the sand was 17 grams per million revolutions or 1.94%.

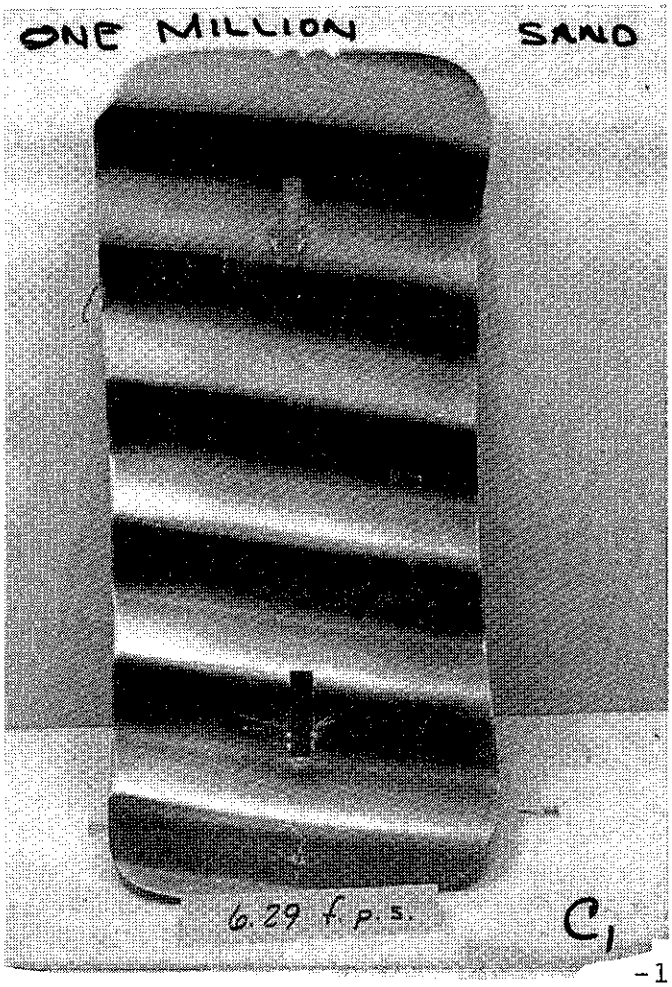
ONE MILLION SAND
6.29 f.p.s.
C1

After 1 million revolutions with the sand charge, this sample showed the most wear. The weight loss was the same as the galvanized steel sample, but represented a larger percentage of the sample weight. Extremely heavy wear could be seen on all leading edges. The right outside edge was worn round. The corrugated ridge was no longer round, it had become somewhat of a sharp ridge. The aluminum cladding on the leading slopes of the corrugations was worn off in less than 150,000 cycles. Total material loss due to the sand was 17 grams per million revolutions or 3.23%.

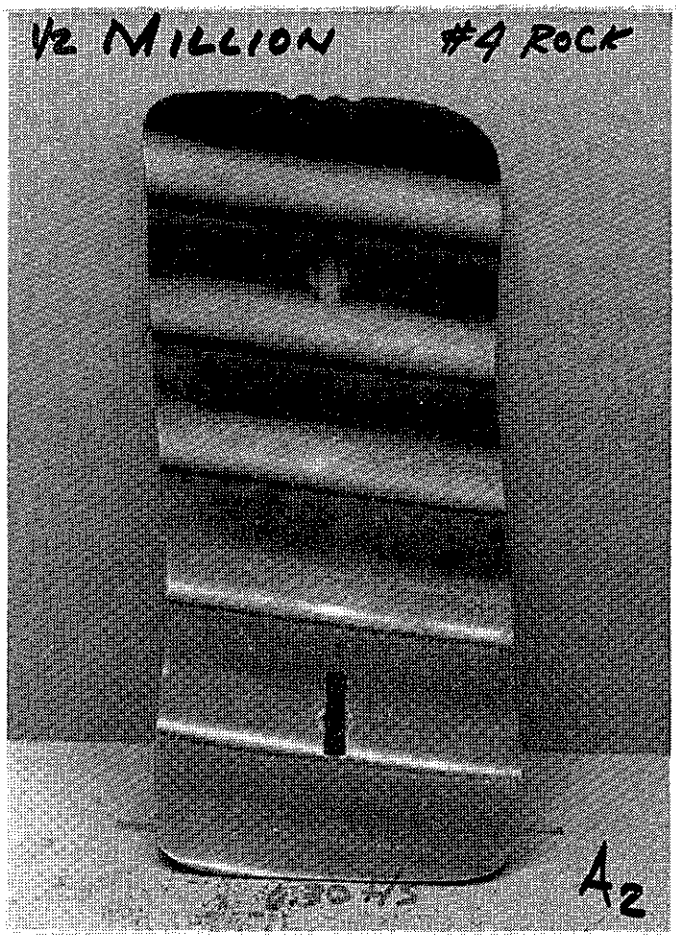
1/2 MILLION #4 ROCK
6.30 F/S
A2

After 1/2 million revolutions with the 1/2" x #4 aggregate, the sample showed visible signs of wear. The left outside edge was worn round. Total material loss due to the 1/2" x #4 was 46 grams per million revolutions or 5.74%. Again, this was 12 grams less than that of the galvanized steel sample.

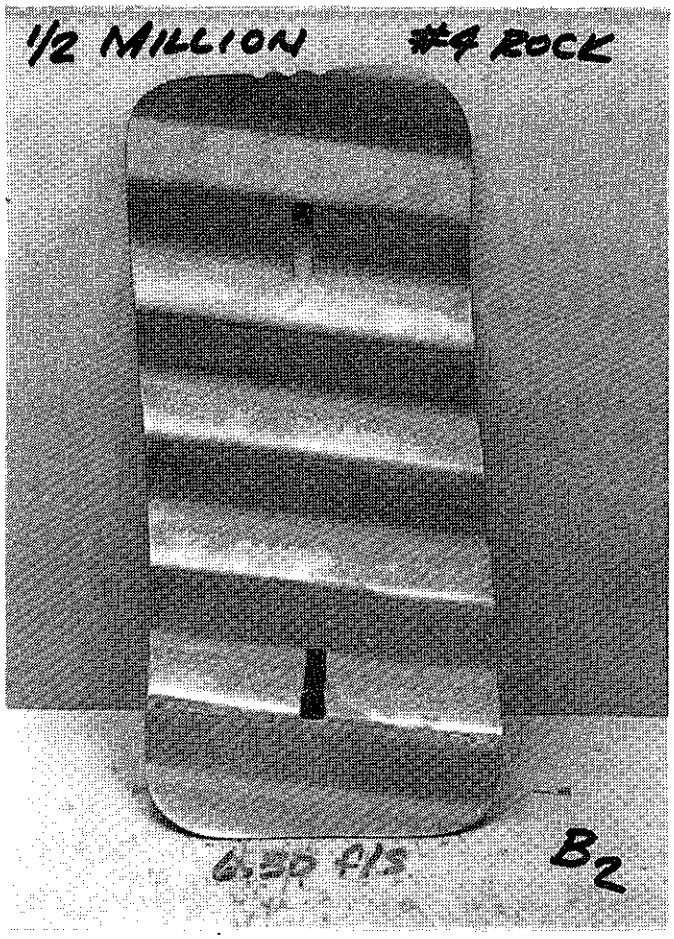
1/2 MILLION #4 ROCK
6.30 F/S
B2

After 1/2 million revolutions with the 1/2" x #4 aggregate, the sample showed some visible signs of wear. The left outside edge was worn to the point of being rounded. Total material loss due to the 1/2" x #4 was 58 grams per million revolutions or 6.72%.

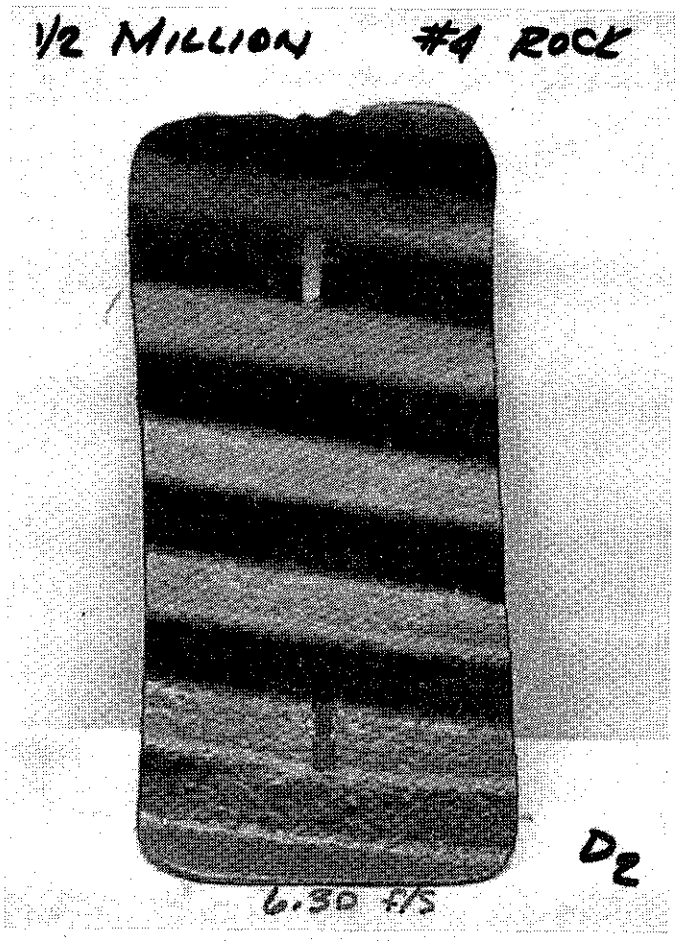
1/2 MILLION #4 ROCK
6.30 F/S
D2

After 1/2 million revolutions with the 1/2" x #4 aggregate, the sample showed no visible signs of wear and the overall appearance continued to be very good. Average loss at the "most critical" locations was only one-third that of other samples. Total material loss due to the 1/2" x #4 was 6 grams per million revolutions or 0.60%. Again, this loss was only 10% that of the galvanized steel sample.

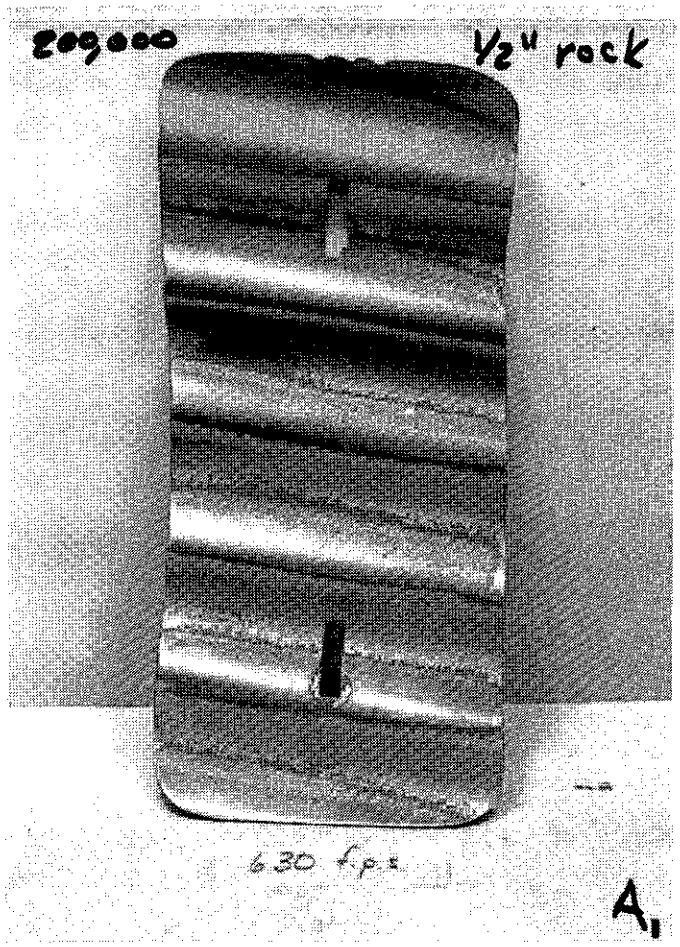
200,000
1/2" rock
630 f.p.s.
A1

After an additional 1/5 million revolutions with the 3/4" x 1/2" aggregate, the sample showed signs of heavy wear. The outside on the right was now losing material at the "most critical" points. The right side was wearing round and beginning to flatten. Total loss due to the 3/4" x 1/2" was 100 grams per million revolutions or 12.80%. This loss was slightly more than that for the galvanized steel sample.

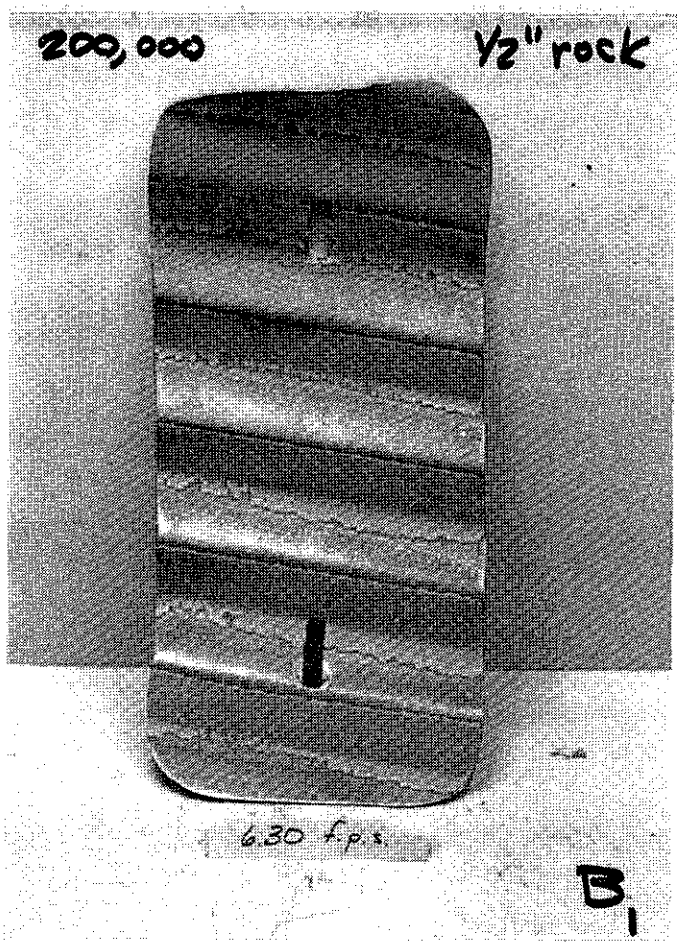
200,000
1/2" rock
630 f.p.s.
B1

After an additional 1/5 million revolutions with the 3/4" x 1/2" aggregate, the sample was showing heavy wear. The right outside

edge had lost material at the "most critical" points. The right side was worn round and the leading edges on all of the right side had some material missing. Total loss due to the 3/4" x 1/2" was 95 grams per million revolutions or 11.35%.

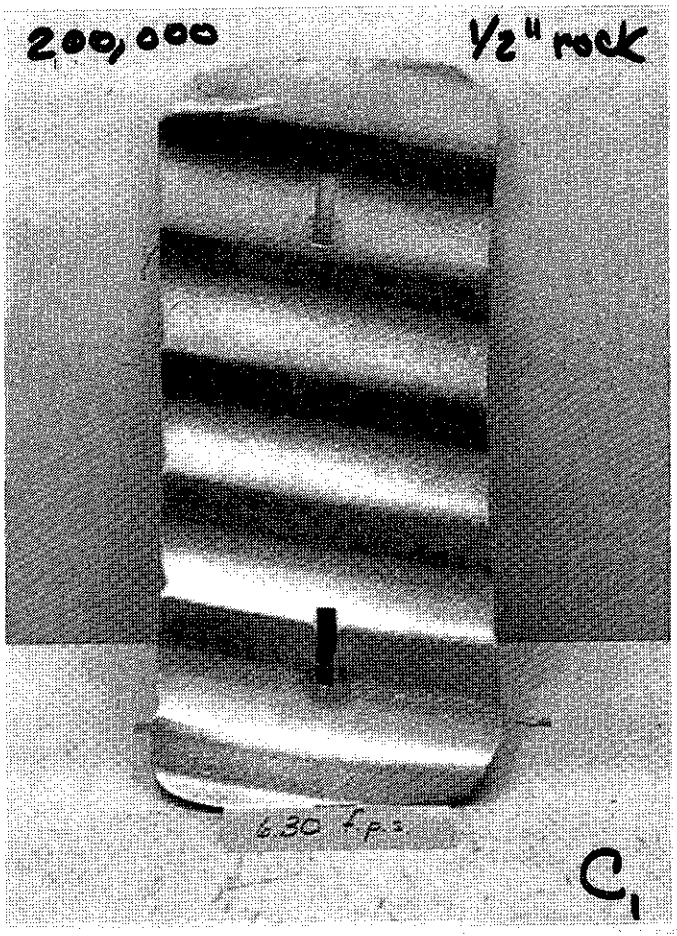
200,000
1/2" rock
630 f.p.s.
C1

After an additional 1/5 million revolutions with the 3/4" x 1/2" aggregate, the sample continued to show signs of heavy wear. The overall appearance had a pitted look. The leading edge on the right top and side was missing. The pointed ridges had again become somewhat rounded on the left side, but not on the right. The first ridge was buckled over and bent downward on the left side. Total loss due to the 3/4" x 1/2" was 80 grams per million revolutions or 16.65%. This was nearly twice the loss of the previous run of 1/2" aggregate, but less than that for the galvanized steel sample.

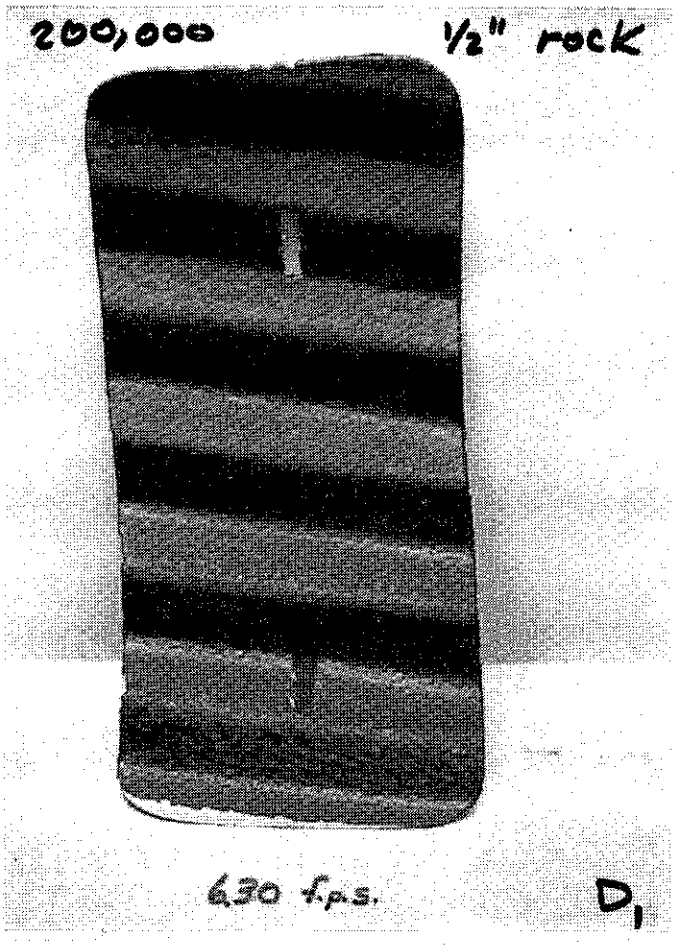
200,000
1/2" rock
630 f.p.s.
D1

After an additional 1/5 million revolutions with the 3/4" x 1/2" aggregate, the sample looked good except for the trailing edge. The coating had started to wear off at that point. There was a small hole about 1/8" in diameter starting to show up 4/5 of the way back from the front on the left side. Some wear in the impact faces could be seen, also scuffing, pitting and roughness, all very small but visible. The coating seemed to be moving around because some to the thickness measurements were greater than before. Total loss due to the 3/4" x 1/2" was 15 grams per million revolutions or 1.50%. The loss was only about 16% of that of the galvanized steel, but it is obvious that the failure mode will be quite different.

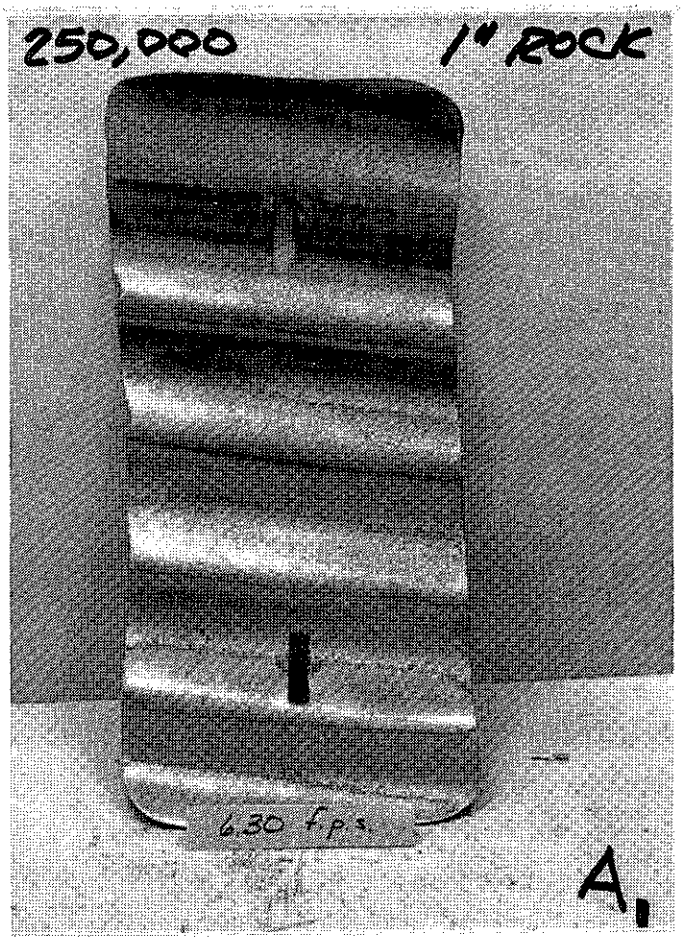
250,000
1" ROCK
630 f.p.s.
A1

After an additional 1/4 million revolutions with the 1-1/2" x 1" aggregate, the sample was still showing signs of heavy wear, especially on the right outside edge and the leading edges. The skipping of the aggregate also happened with this sample. Total material loss due to the 1-1/2" x 1" was 108 grams per million revolutions or 14.24%. This loss was slightly less than that for the galvanized steel sample.

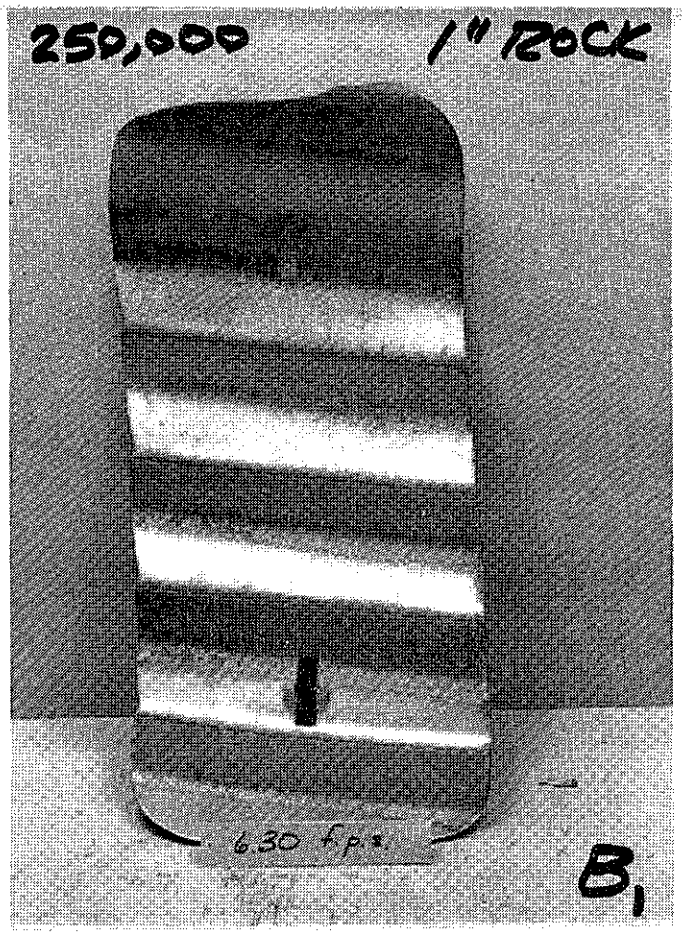
250,000
1" ROCK
630 f.p.s.
B1

After an additional 1/4 million revolutions with the 1-1/2" x 1" aggregate, the sample continued to show signs of heavy wear. The front leading edge looked about the same as after the 1/2" aggregate, but was missing more material. It appeared that more material loss had occurred at the "most critical" points, but this was not so. The measured loss at these points was less than that for the 1/2" aggregate. It appears that with this size of aggregate and this speed, the rocks skip over the tops of the corrugations and only hit part of the time. Total material loss due to the 1-1/2" x 1" was 116 grams per million revolutions or 14.20%.

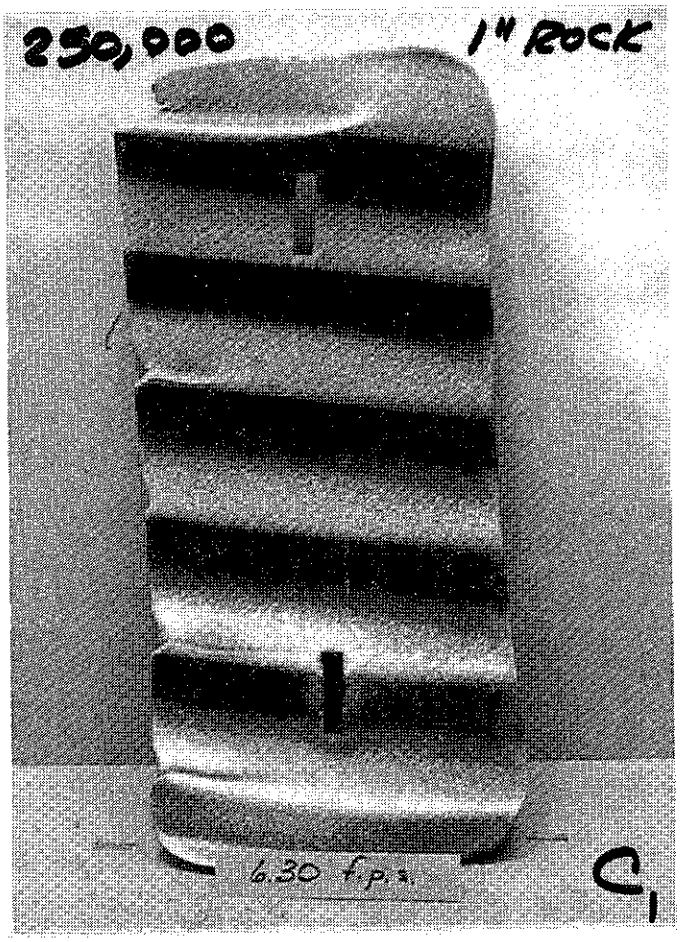
250,000
1" ROCK
630 f.p.s.
C1

aggregate, the sample showed signs of extremely heavy wear. The overall appearance was rough with heavy pitting and torn edges.
