STATE OF CALIFORNIA
DEPARTMENT OF PUBLIC WORKS
DIVISION OF HIGHWAYS

DYNAMIC FULL SCALE TESTS OF BRIDGE RAILS

December 1960

State of California
Department of Public Works
Division of Highways
Materials and Research Department

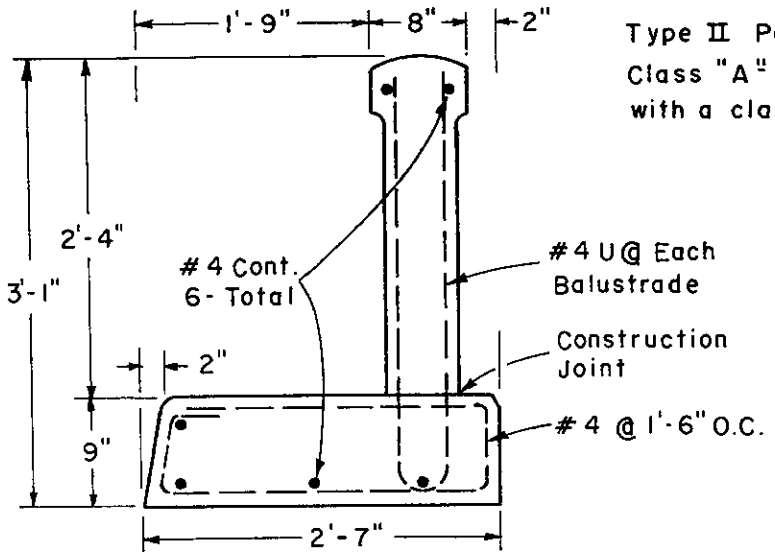
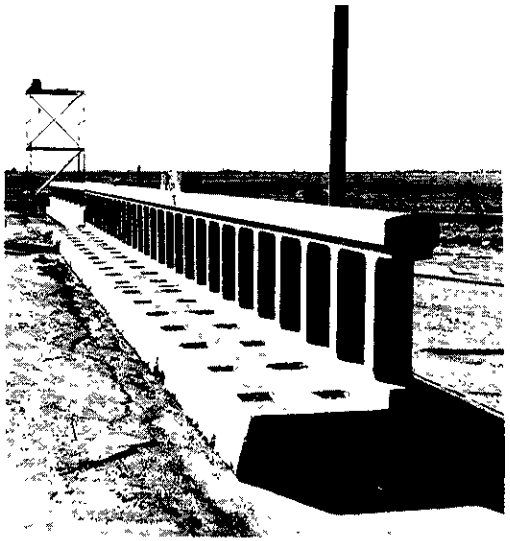
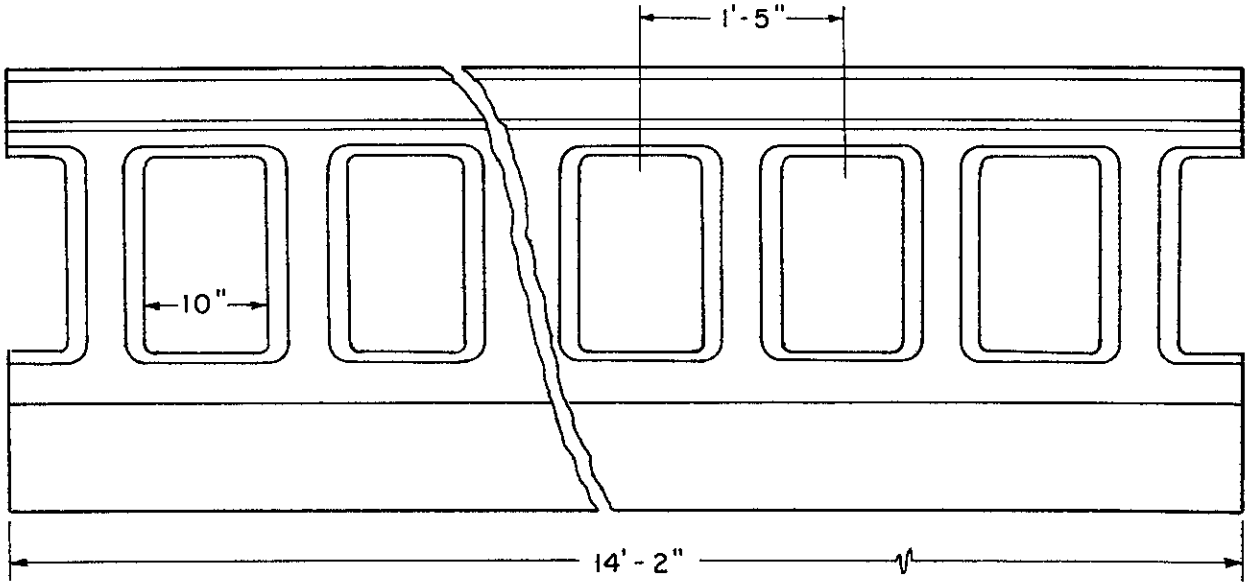
REINFORCED CONCRETE BRIDGE RAIL - DESIGN I

1. Design I (Exhibit 2) proved inadequate to retain a heavy passenger car collision.

Two rigid rail designs were tested. Design I (Exhibit 2) did not meet the above requirements in that it did not retain the vehicle due to structural failure of the rail element as shown in Exhibit 5.

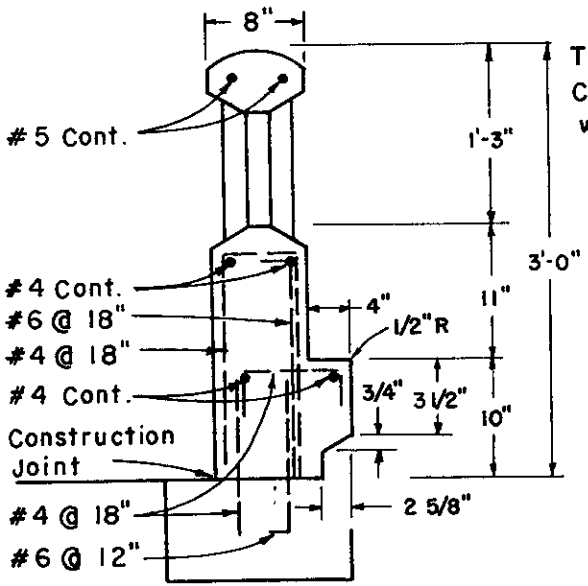
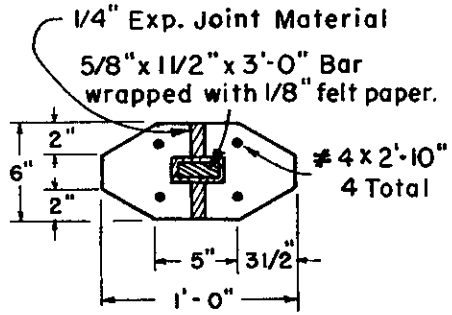
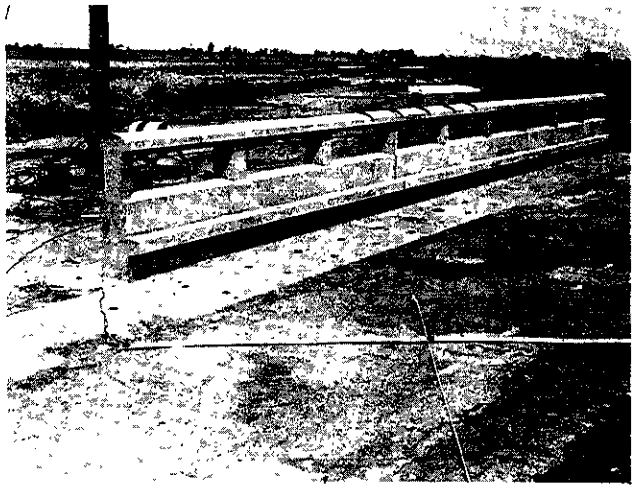
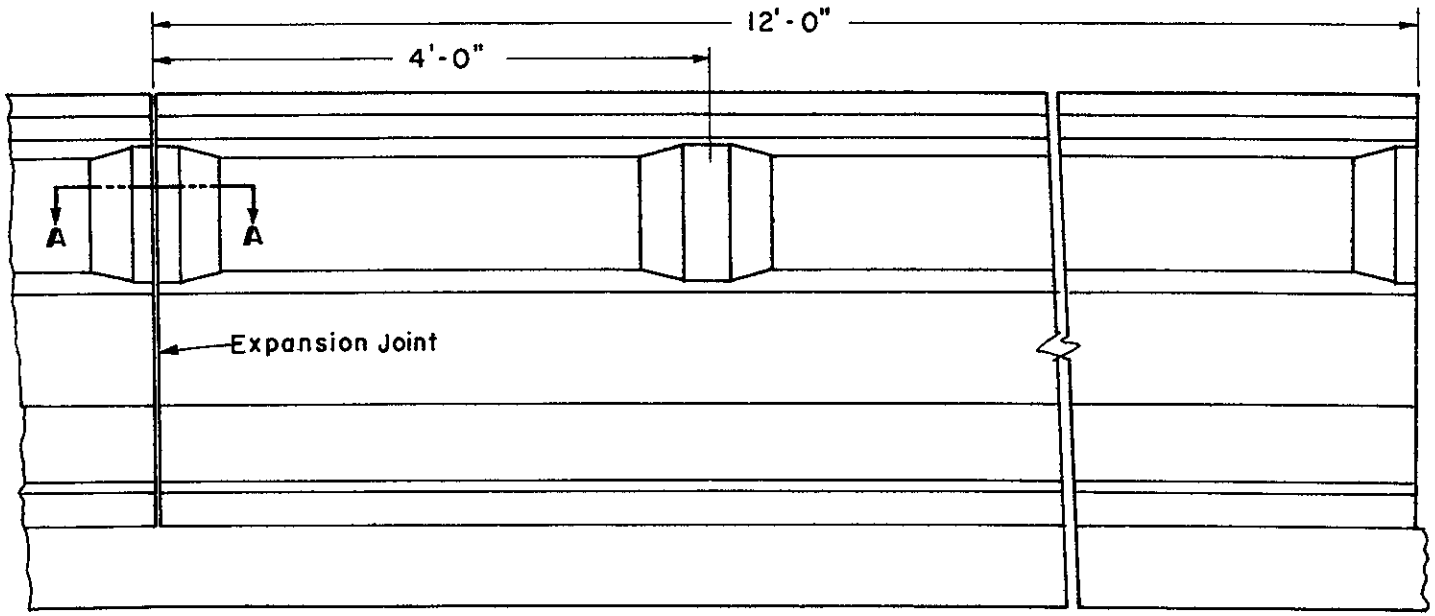
REINFORCED CONCRETE BRIDGE RAIL - DESIGN II

Design II (Exhibit 3) met all the requirements for a rigid rail when tested with passenger cars as shown in Exhibits 6 and 7. However, due to structural failure it did not retain the 17,000 pound bus at an impact velocity of 40 mph (Exhibit 9).

Analysis of this latter failure indicates that the position of the horizontal openings in this rail were the primary contributors to failure. These openings permitted the framing members of the bus to contact the balusters so that the full collision force was accepted by one post. The post failed, permitting further baluster failures and "topping of the rail" by the vehicle. There were no failures of the lower solid portion of this railing. It is our opinion (based on previous test results) that, had this solid wall portion been at least 27" high, the railing would have functioned as desired.

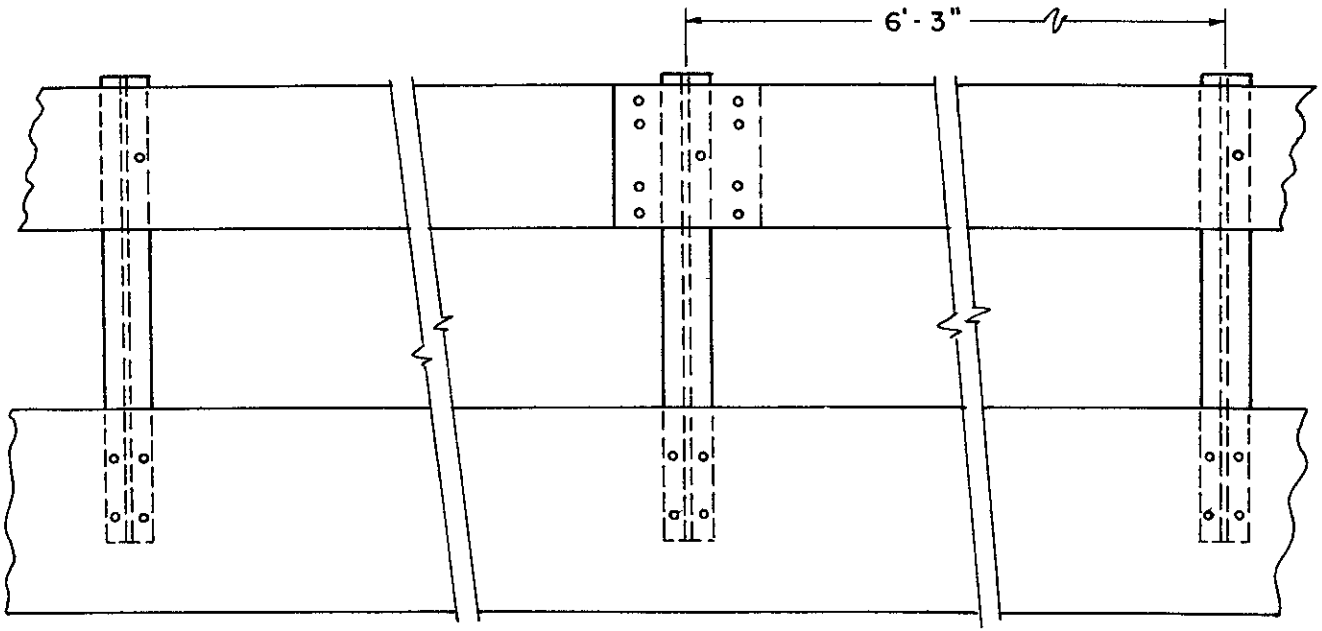
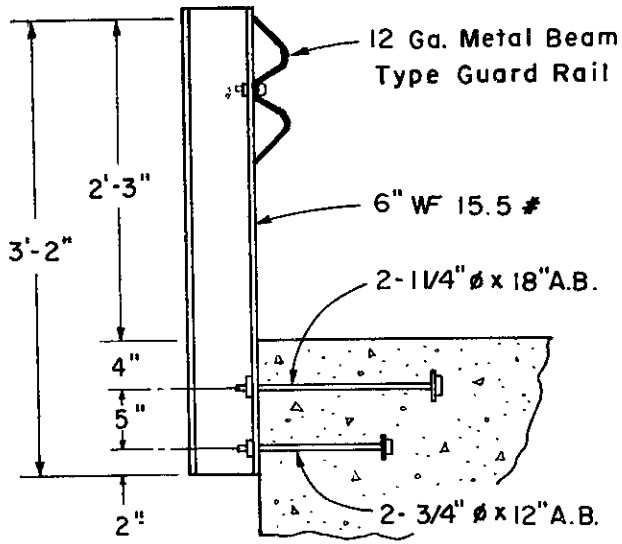
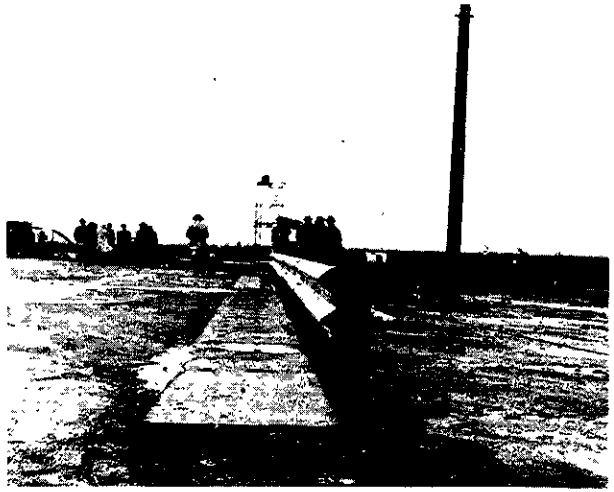
EXHIBIT 4

3. Design III (Exhibit 4) deflected excessively under collision load, and if the front wheels had not had support (as they would not over the edge of a bridge), the car probably would have cartwheeled over the rail. This design could probably be strengthened to restrict the deflection to a reasonable amount. It also probably could be considered adequate in those areas where only low angle oblique collisions would be expected.

Only one design of this type was submitted by the Bridge Department for evaluation. This design (Exhibit 4) consisted of 6" - 15.5 lb. H-Beam posts mounted on the side of the bridge deck at 6' 3" centers (using two 1 1/4" and two 3/4" bolts for each post) with a 12 gage corrugated metal beam type guard rail mounted on the posts at a height of 27" above the deck.

Upon vehicle impact with this design the connecting device between the bridge deck and the post failed, allowing excessive deflection of the rail, thus forming a pocket which entrapped the automobile. Had this occurred on an actual bridge, the vehicle would probably have gone through the rail because of lack of support beyond the edge of a bridge. The vehicle was retained during this test only because of the earth fill behind the simulated structure.

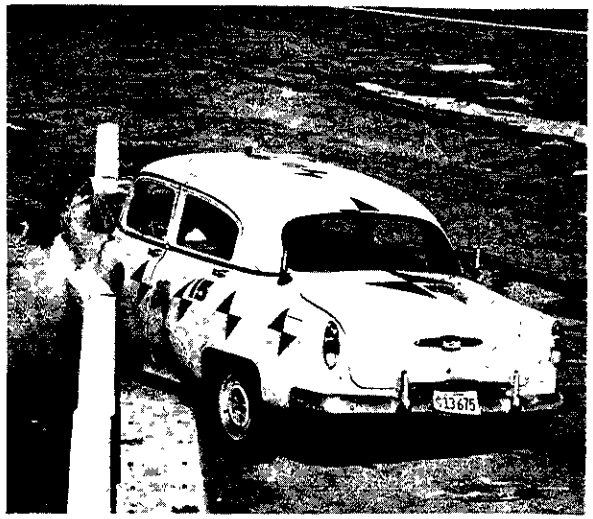
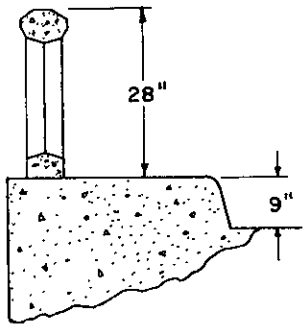
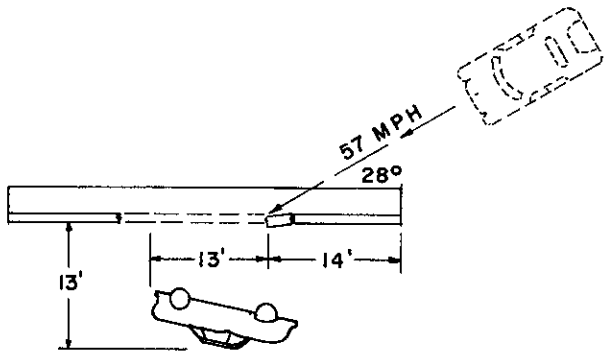
EXHIBIT 5

A close study of the data film from Test No. 15 (Exhibit 5) shows that the nine inch high curb imparted a rise of about 9 inches to the vehicle before it crashed into the rail. This action verifies the findings from earlier tests (Reference 1).

DUMMY INJURY ..... Left side, chest & head injuries.
BRIDGE RAIL DAMAGE ..... 14' Demolished
VEHICLE DAMAGE ..... Total Loss
DUMMY DECELERATION (PEAK) .... Long. ... Transv. 13 G

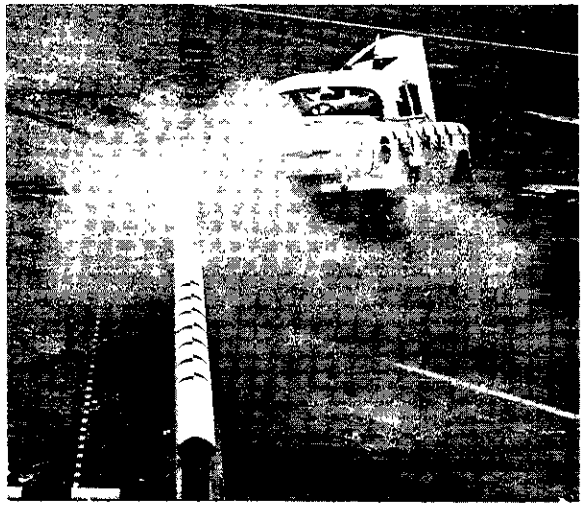
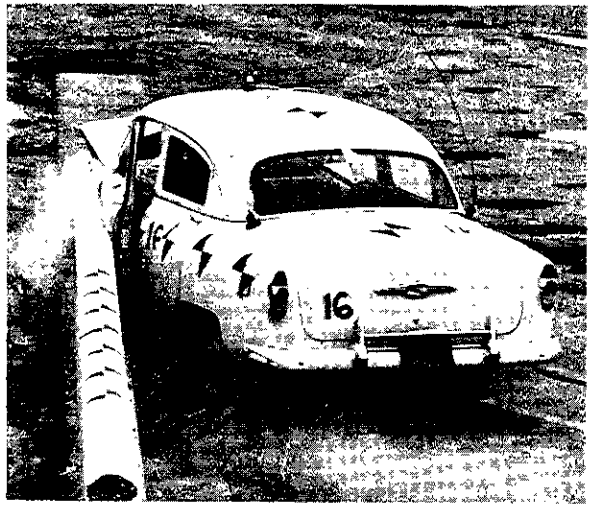
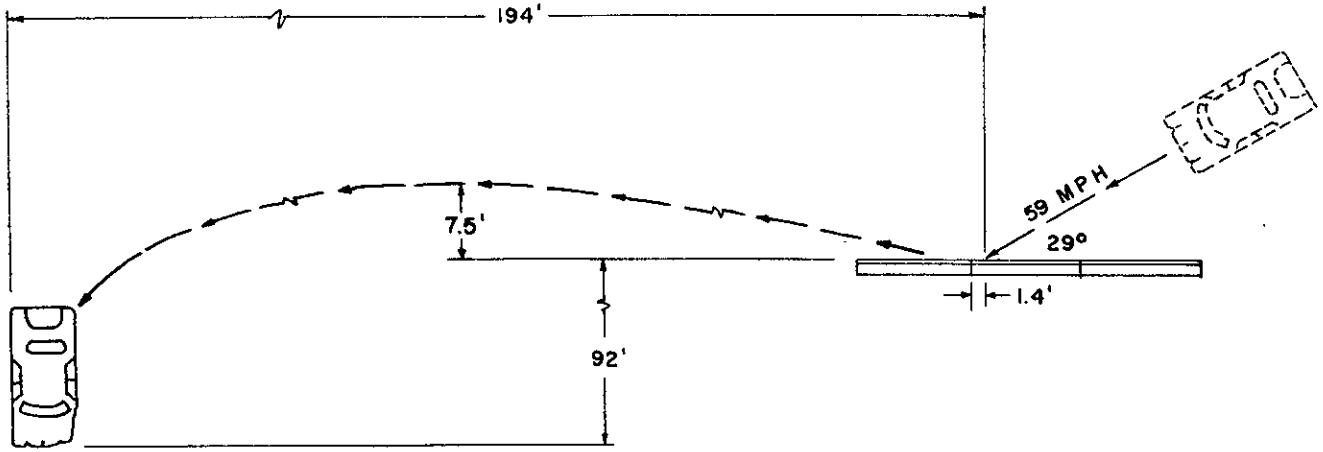
EXHIBIT 6

DUMMY INJURY ..... Severe left shoulder, side & internal injuries (Possible Fatality)
BRIDGE RAIL DAMAGE ..... Slight chipping & scratching
VEHICLE DAMAGE ..... Total Loss
DUMMY DECELERATION (PEAK) .... Long. 11 G ... Transv. 34 G

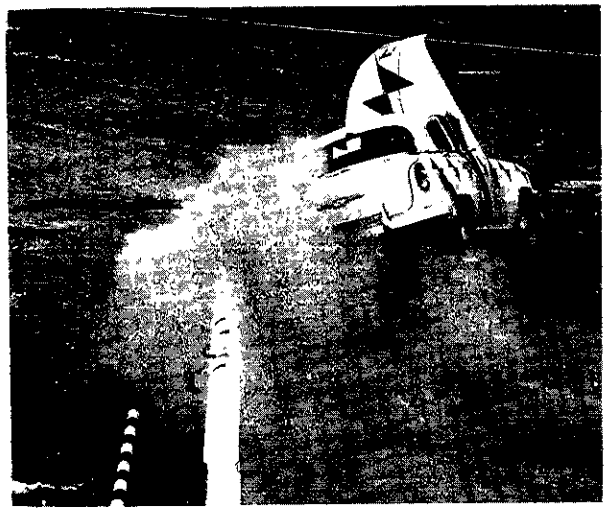
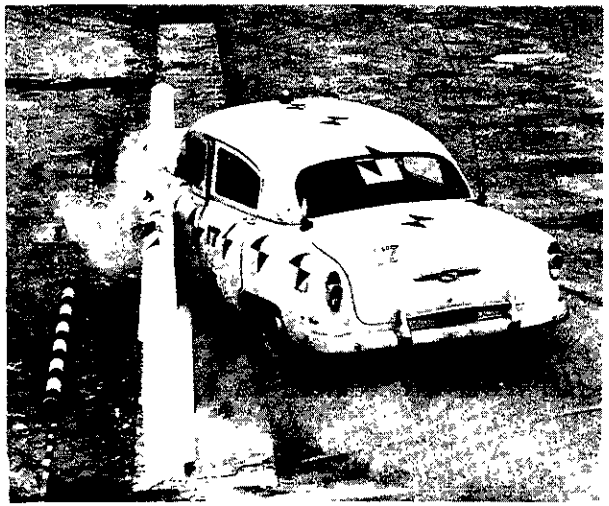
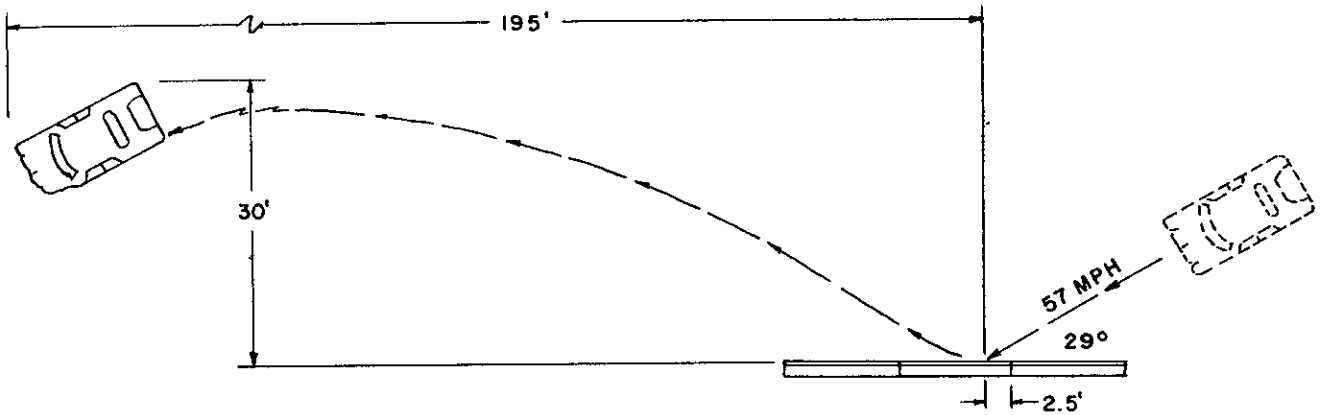
EXHIBIT 7

DUMMY INJURY ..... Severe left shoulder & side injuries. (Possible Fatality)
BRIDGE RAIL DAMAGE ..... Minor chipping & scratching.
VEHICLE DAMAGE ..... Total Loss
DUMMY DECELERATION (PEAK) .... Long. 26G ...Transv. 35G

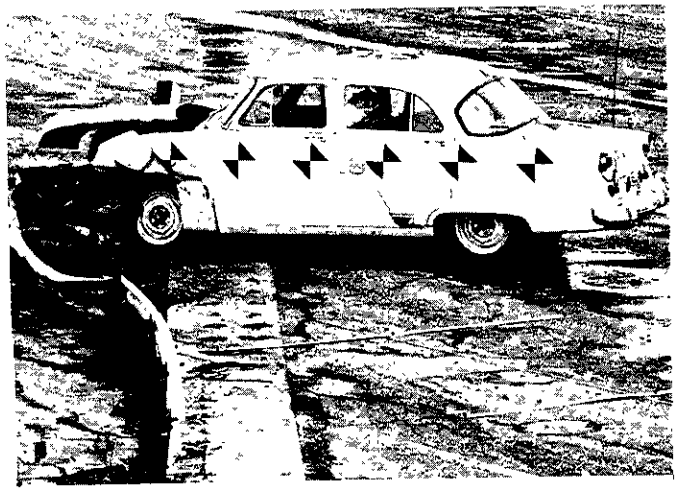
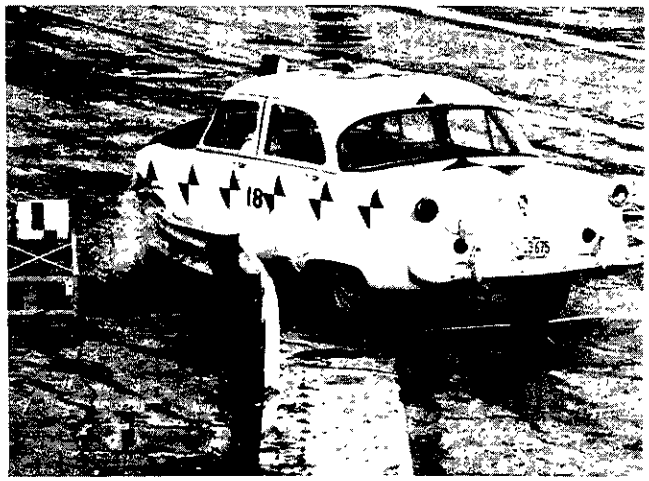
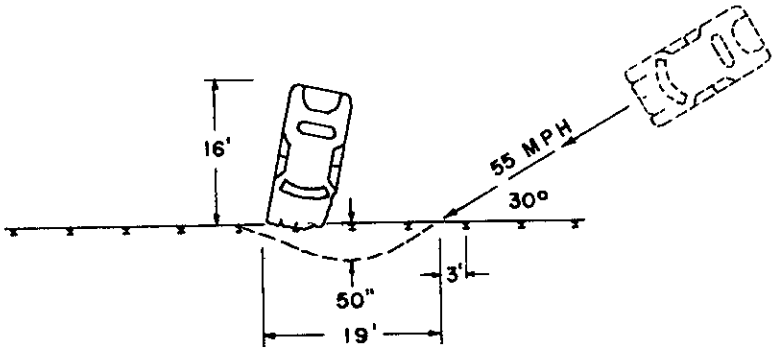
EXHIBIT 8

BRIDGE RAIL	Single W Section	DUMMY INJURY	Severe head & shoulder injuries.	TEST NO.	18
BRACKET	None	BRIDGE RAIL DAMAGE	3 Sections damaged beyond repair.	DATE	2-11-59
POST	6" WF 15.5 #	POST DAMAGE	5 Posts damaged beyond repair	VEHICLE	Ford 52 Sedan
POST SPACING	6'-3" O.C.	VEHICLE DAMAGE	Total Loss	SPEED	55 MPH
LENGTH OF INSTALLATION	62.5'	MAX. DYNAMIC DEFLECTION OF RAIL	60"	IMPACT ANGLE	30°
GROUND CONDITION	Wet	DUMMY DECELERATION (PEAK)	Long. 19G ... Transv. 7.1G	VEHICLE WEIGHT (W/DUMMY & INSTRUMENTATION)	4000

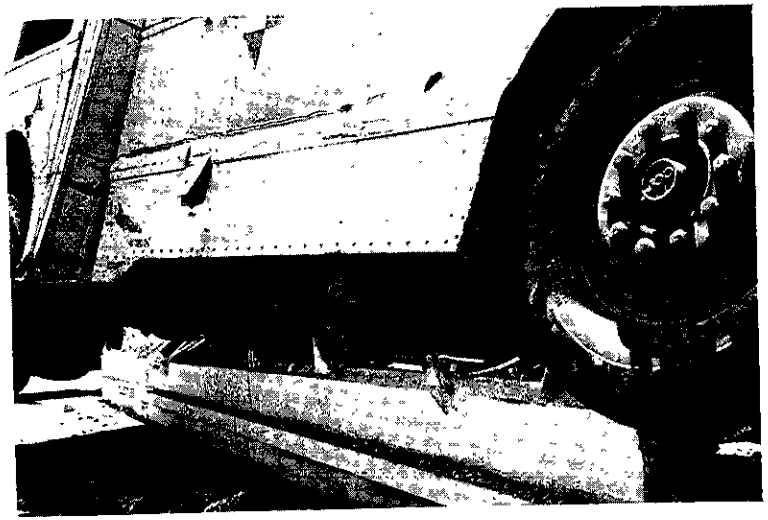
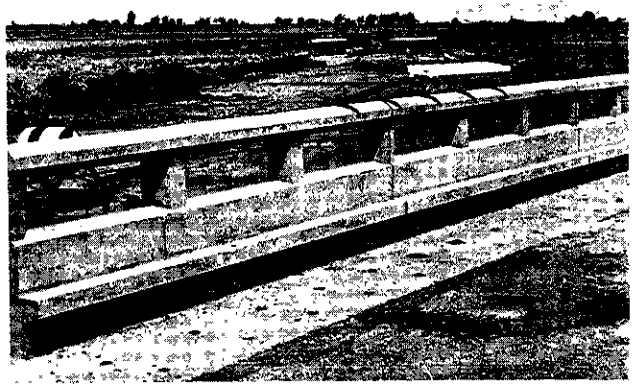
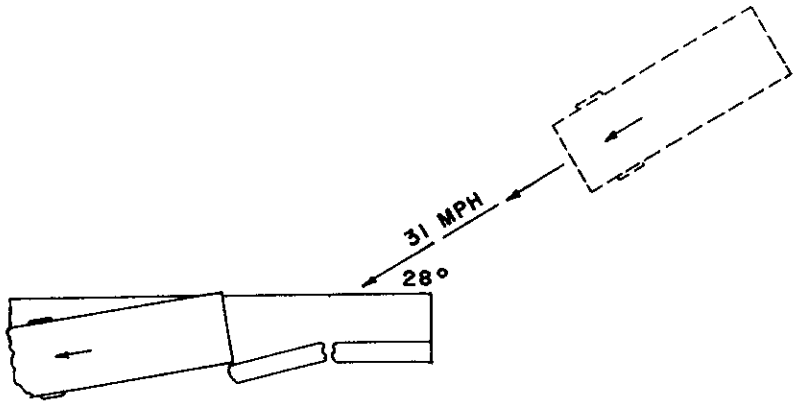
EXHIBIT 9

DUMMY INJURY ..... Severe head, left shoulder & side injuries.
BRIDGE RAIL DAMAGE ..... 32' demolished
VEHICLE DAMAGE ..... Total loss

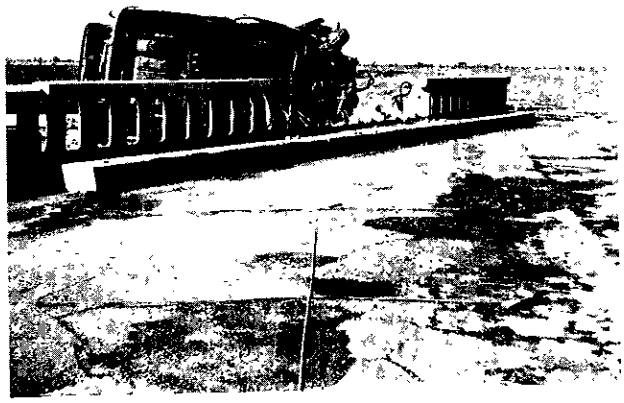
View showing post impact position of vehicle and extent of rail damage.

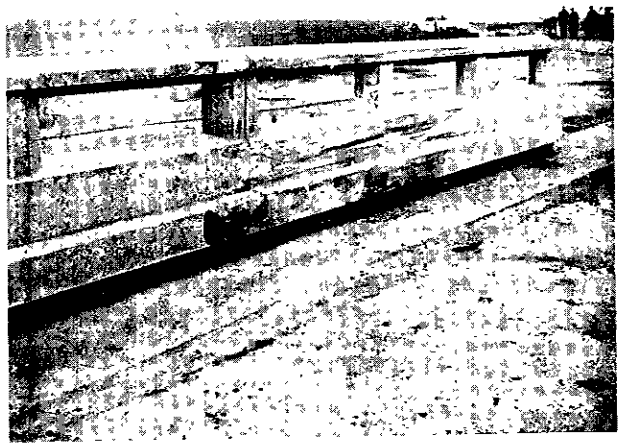
View showing damage to rail and post impact position of vehicle.
