FIELD EVALUATION of a TELEVISION BORE HOLE TELESCOPE

RESEARCH REPORT

NO. M & R 226468

Prepared in Cooperation with The U.S. Department of Commerce, Bureau of Public Roads July, 1966

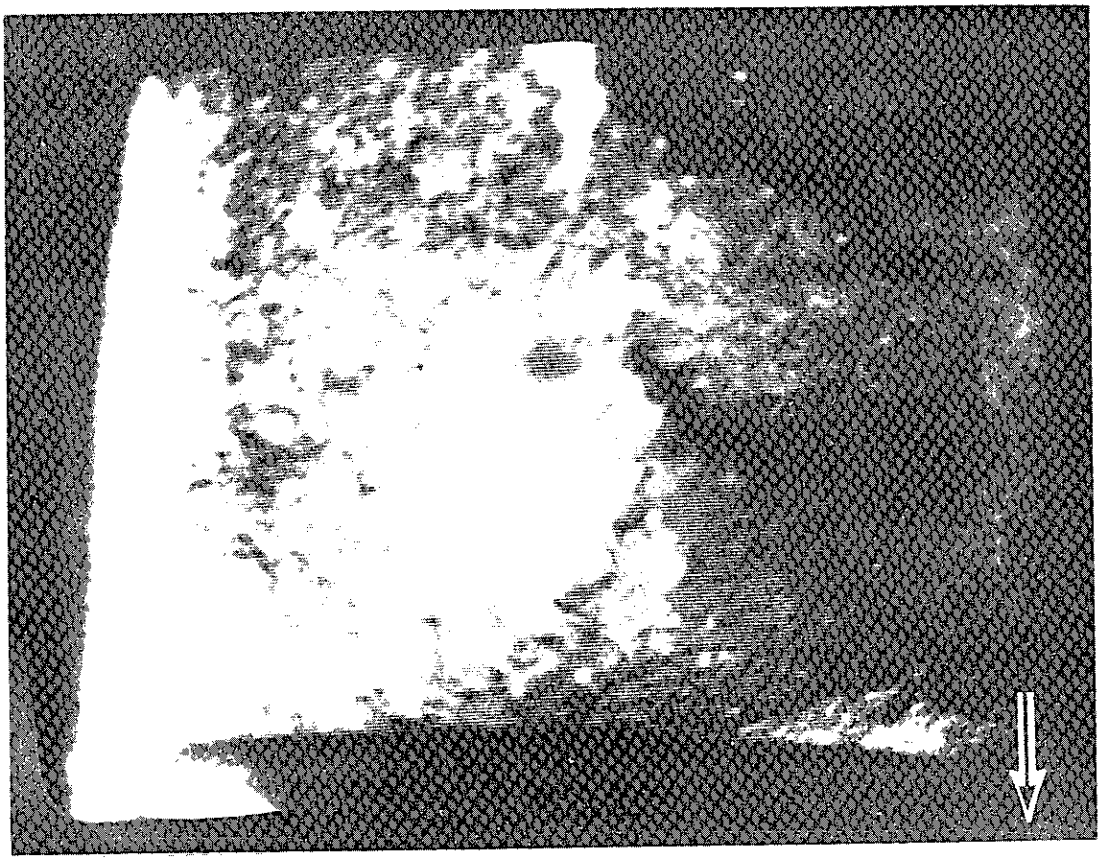
Photo 11 - Boring R-8 Santa Susana Pass 48.3 ft. Large void in sandstone.
