MATERIALS AND RESEARCH DEPARTMENT

TO DETERMINE CAUSES FOR DISPLACEMENT AND FAULTING

AT THE JOINTS IN PORTLAND CEMENT CONCRETE PAVEMENTS

May 17, 1949

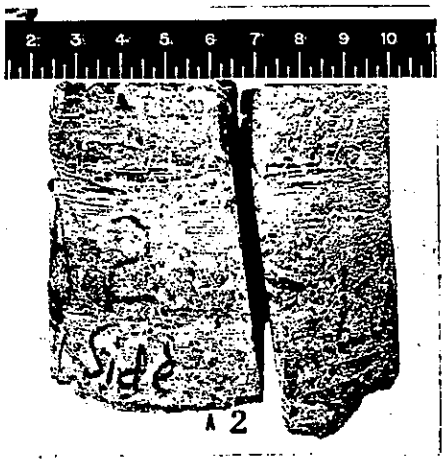
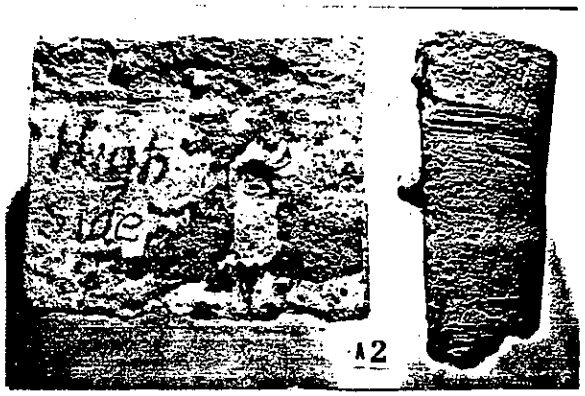
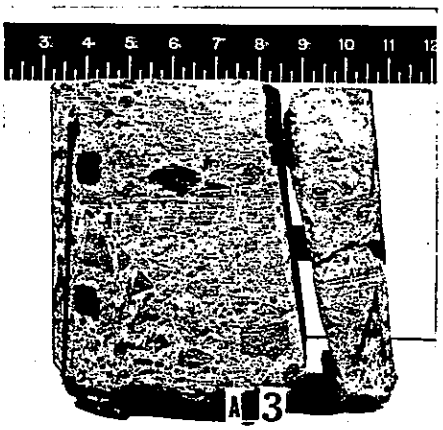
CONDITIONS OF DOWELS AND JOINT ALIGNMENT
AS INDICATED BY CORE SPECIMENS

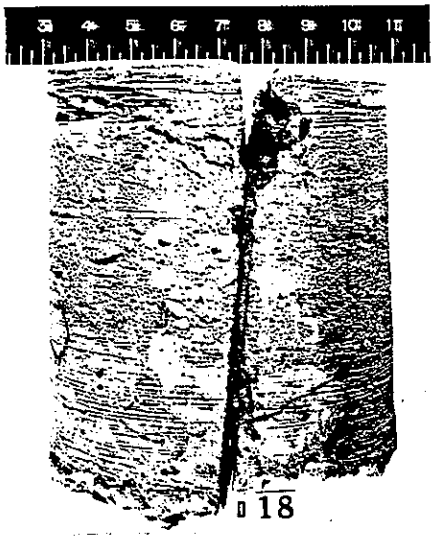
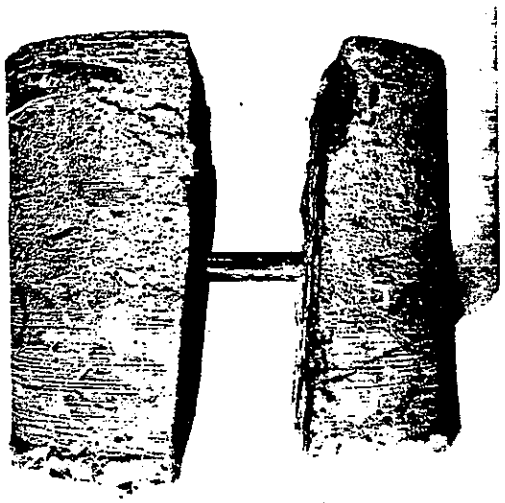
Reference No. 20 - b Cores cut through joints

CONDITIONS OF DOWELS AND JOINT ALIGNMENT
AS INDICATED BY CORE SPECIMENS

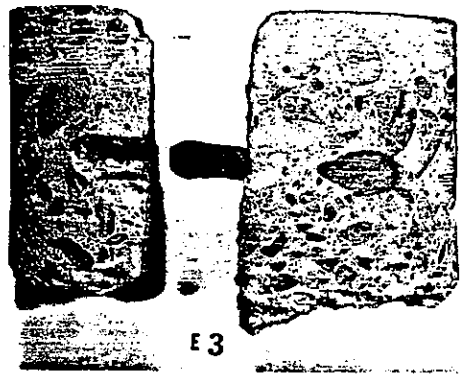
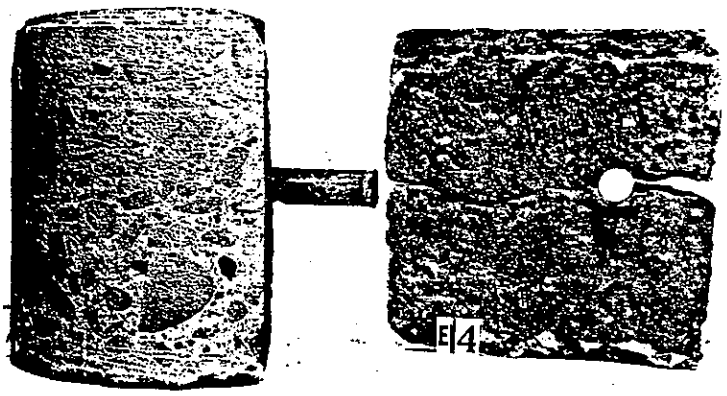
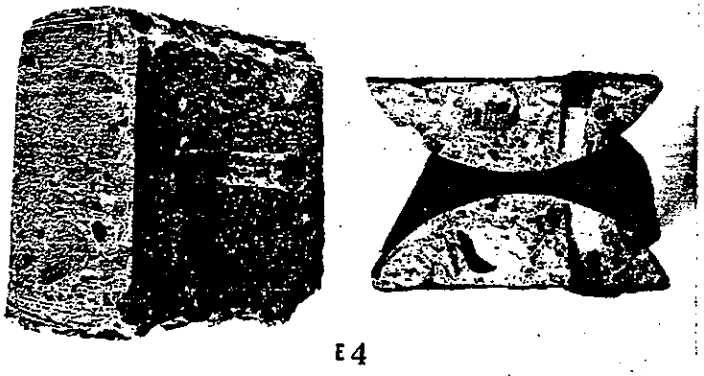
Reference No. 20 - c Cores cut through joints

CONDITIONS OF DOWELS AND JOINT ALIGNMENT
AS INDICATED BY CORE SPECIMENS
