November 14, 1958

Subject: Progress Report on Median Barrier Test Program

1958 MEDIAN BARRIER & BRIDGE RAIL IMPACT TESTS

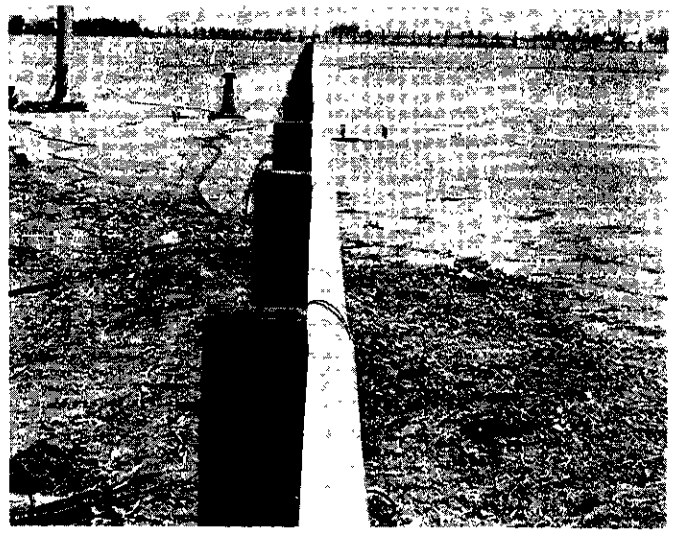
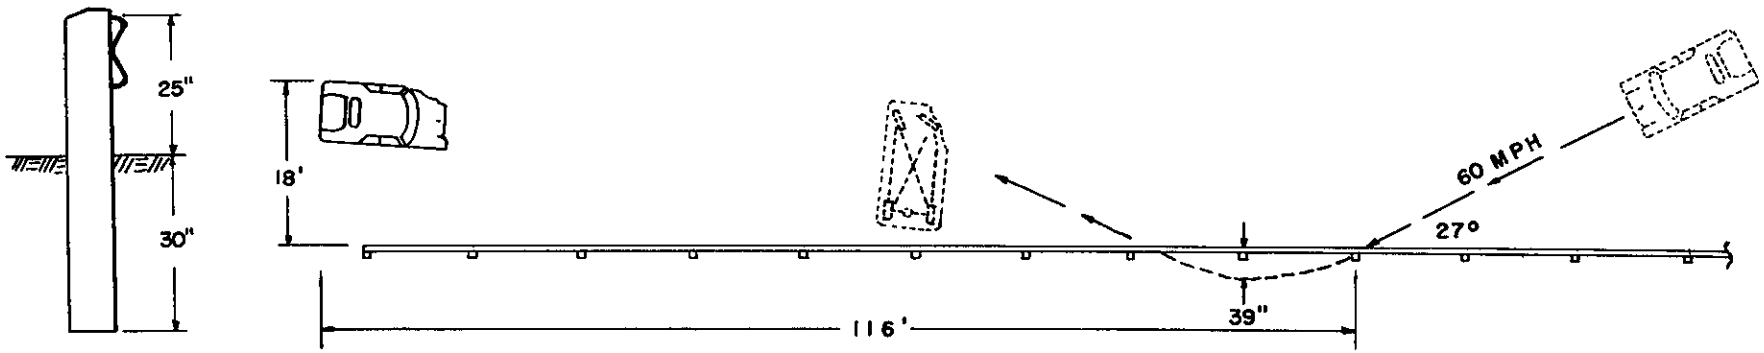
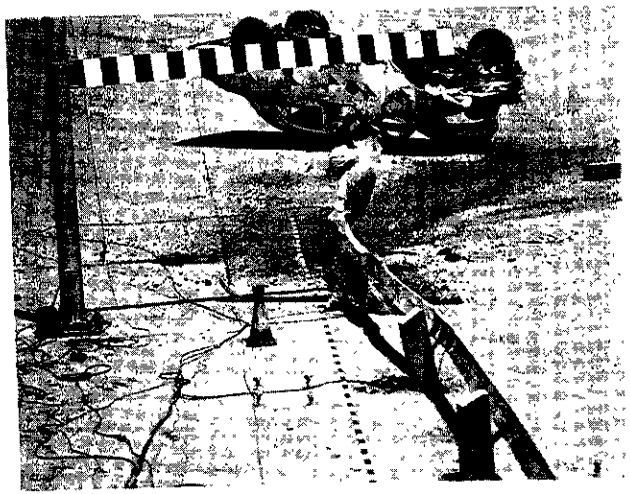
GUARDRAIL	W Section	DUMMY INJURY	Multiple scalp lacerations.	TEST NO.	1
BRACKET	None	GUARDRAIL DAMAGE	3 Sections damaged beyond repair.	DATE	7-10-58
POST	8x8 D.F.			VEHICLE	Chev. 52 Sedan
POST SPACING	12'-6" O.C.	POST DAMAGE	2 Posts damaged beyond repair.	SPEED	60 MPH
LENGTH OF INSTALLATION	212.5'		12 Posts out of alignment.	IMPACT ANGLE	27°
GROUND CONDITION	Dry	VEHICLE DAMAGE	Total loss	VEHICLE WEIGHT (W/DUMMY & INSTRUMENTATION)	3980
		MAX. DYNAMIC DEFLECTION OF RAIL	48"		
		VEHICLE DECELERATION (PEAK)	Long. .... Transv.

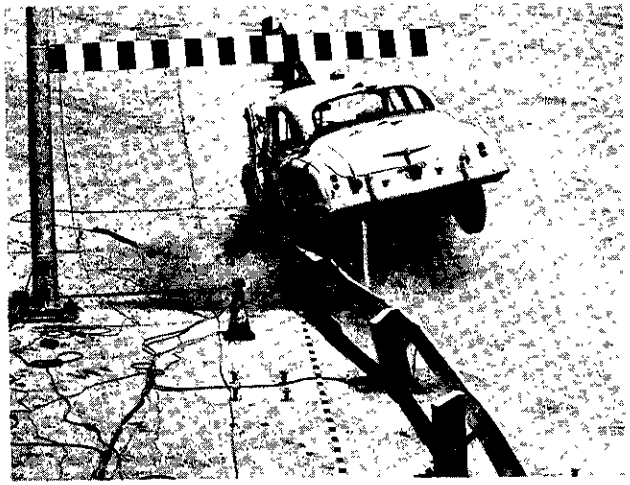
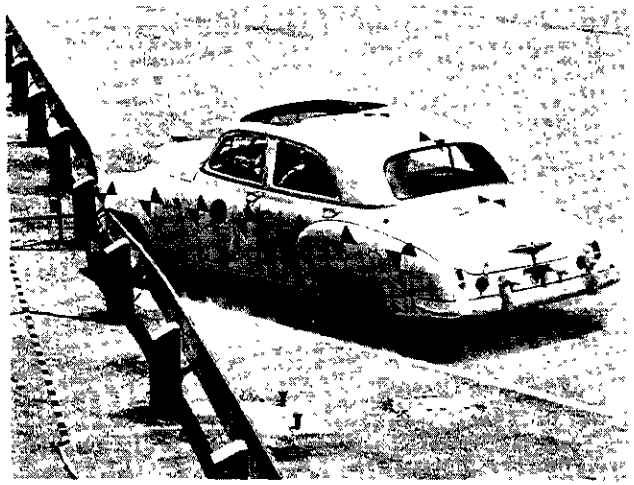
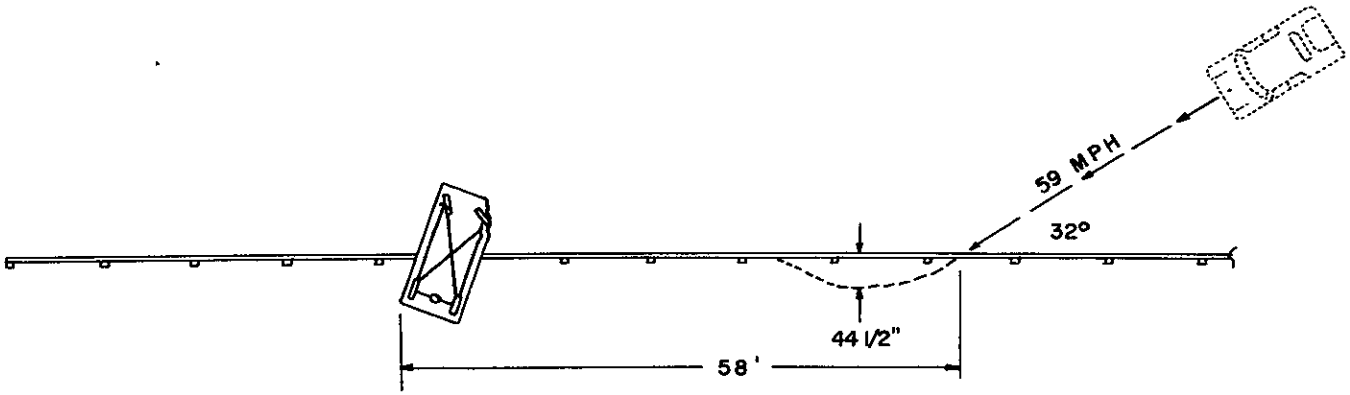
TEST NO. 2
DATE 7-23-58
VEHICLE ..... Chev. 50 Sedan
SPEED ..... 59 MPH
IMPACT ANGLE ..... 32 °
VEHICLE WEIGHT ... 3980
(W/DUMMY & INSTRUMENTATION)

DUMMY INJURY ..... Severe scalp lacerations. Possible minor concussion.
GUARDRAIL DAMAGE ..... 4 Sections damaged beyond repair.

POST DAMAGE ..... 5 Posts damaged beyond repair.
10 Posts out of alignment.
VEHICLE DAMAGE ..... Total loss
MAX. DYNAMIC DEFLECTION OF RAIL ... 55 1/2"
VEHICLE DECELERATION (PEAK) ..... Long. ... Transv.

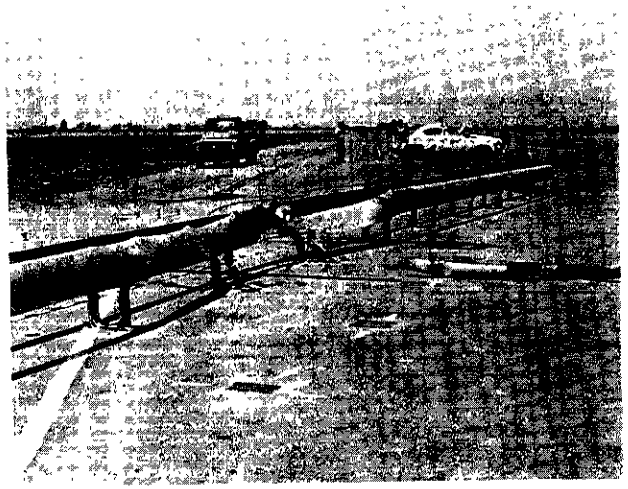
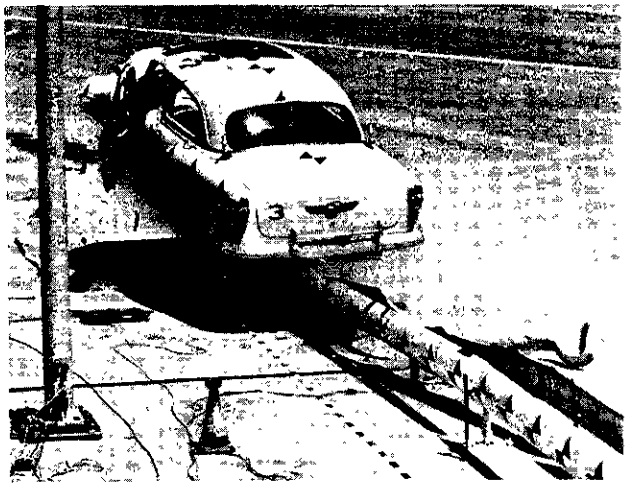
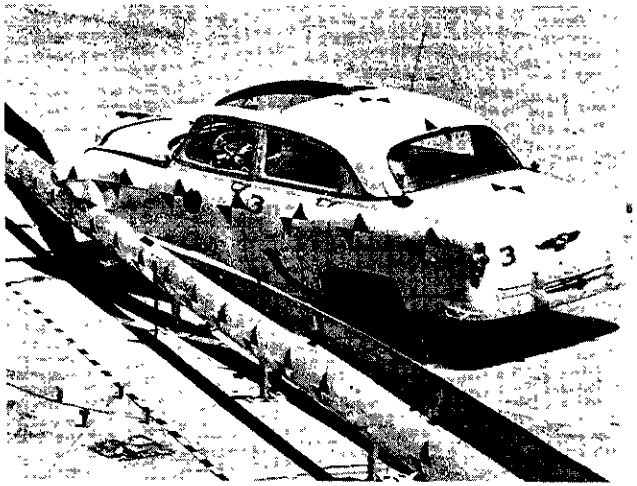
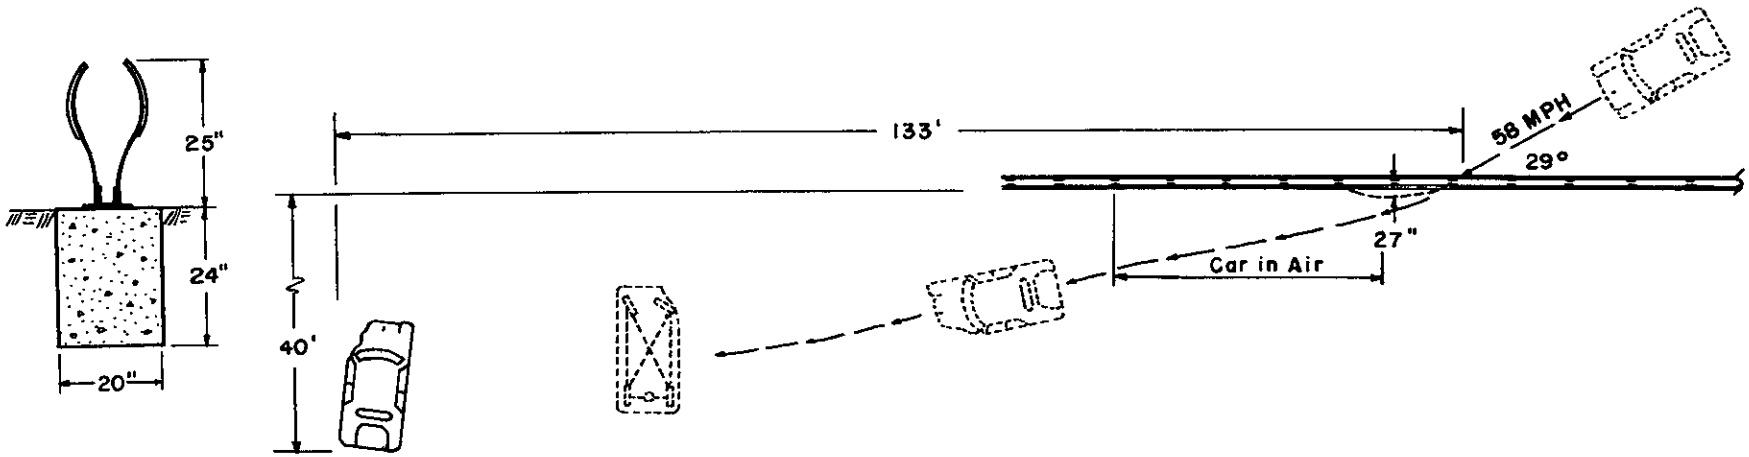
TEST NO. 3
DATE 8-6-58
VEHICLE .....Chev. 53 Sedan
SPEED ..... 58 MPH
IMPACT ANGLE ..... 29°
VEHICLE WEIGHT... 3980
(W/DUMMY & INSTRUMENTATION)

DUMMY INJURY .....Multiple scalp lacerations. Possible minor concussion.
GUARDRAIL DAMAGE .....4 Sections damaged beyond repair. Inside rail failed.
POST DAMAGE .....6 Brackets damaged beyond repair.

VEHICLE DAMAGE .....Total loss
MAX. DYNAMIC DEFLECTION OF RAIL ... 27" Before failure.
VEHICLE DECELERATION (PEAK) .....Long. ... Transv.

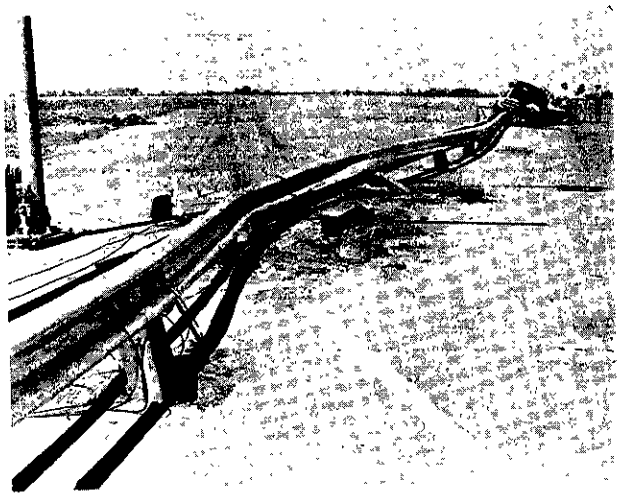
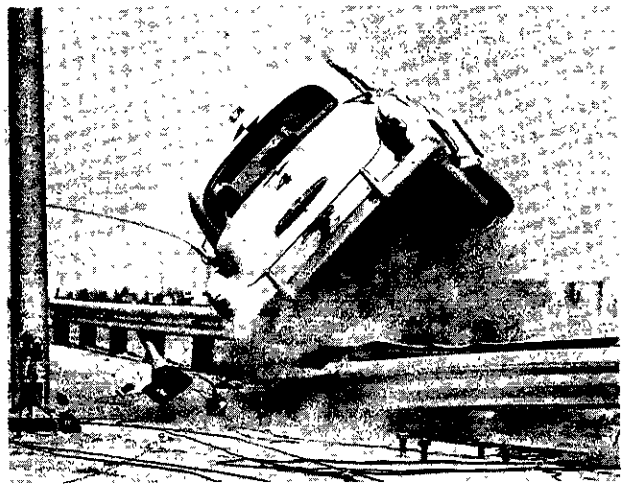
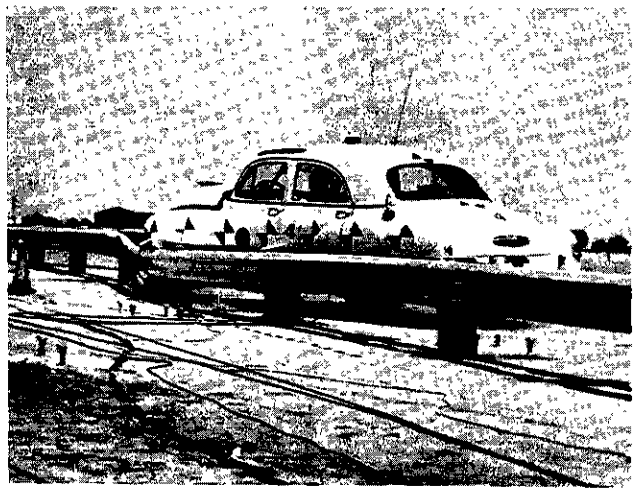
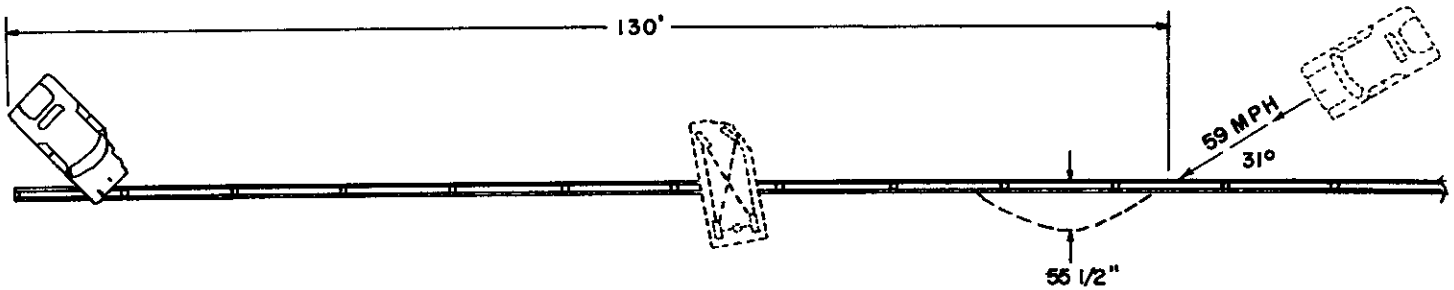
TEST NO. 4
DATE 8-20-58
VEHICLE ..... Chev. 51 Sedan
SPEED ..... 59 MPH
IMPACT ANGLE ..... 31°
VEHICLE WEIGHT... 3980
(W/DUMMY & INSTRUMENTATION)

DUMMY INJURY ..... Minor scalp abrasions. Possible concussion.
GUARDRAIL DAMAGE ..... 3 Sections damaged beyond repair.

POST DAMAGE ..... 1 Post damaged beyond repair.
7 Posts out of alignment.
VEHICLE DAMAGE ..... Total loss.
MAX. DYNAMIC DEFLECTION OF RAIL ... 60 "
VEHICLE DECELERATION (PEAK) ..... Long. ... Transv.

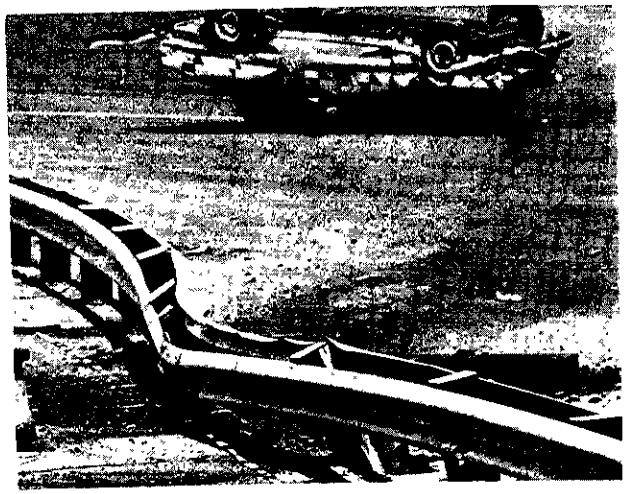
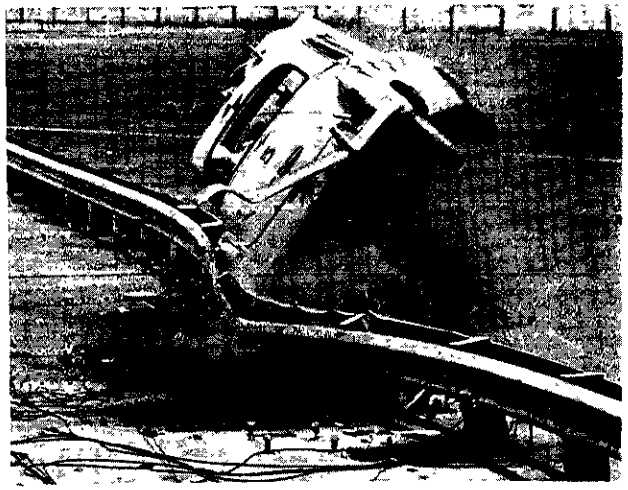
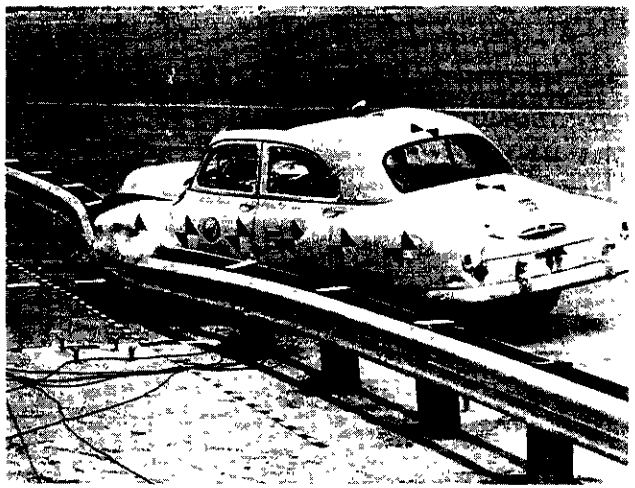
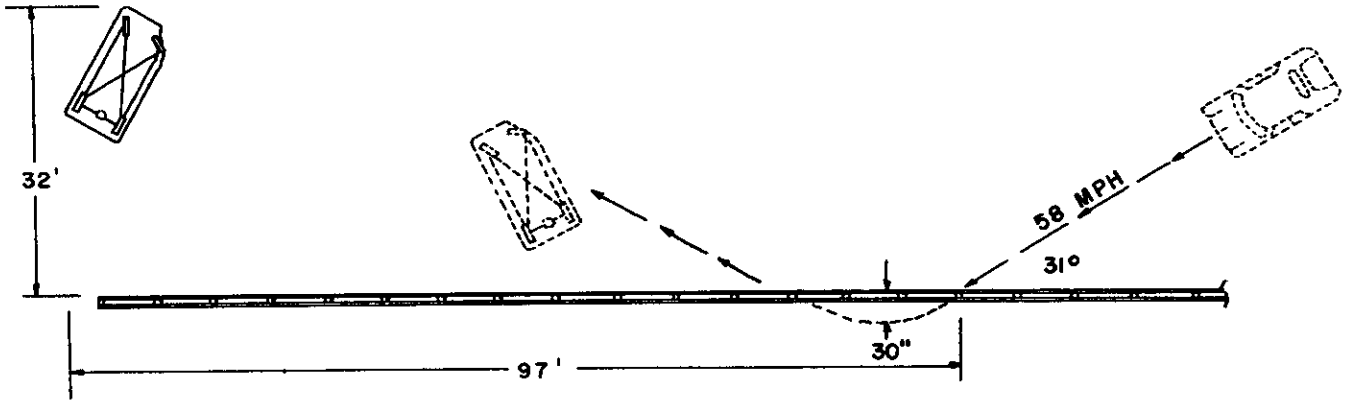
TEST NO.	5
DATE	8-27-58
VEHICLE	Chev. 51 Sedan
SPEED	58 MPH
IMPACT ANGLE	31°
VEHICLE WEIGHT (W/DUMMY & INSTRUMENTATION)	3980

DUMMY INJURY	Scalp lacerations. Possible concussion
GUARDRAIL DAMAGE	2 Sections damaged beyond repair.
POST DAMAGE	3 Posts damaged beyond repair. 5 Posts out of alignment.
VEHICLE DAMAGE	Total loss.
MAX. DYNAMIC DEFLECTION OF RAIL	40.5"
VEHICLE DECELERATION (PEAK)	Long. ... Transv.

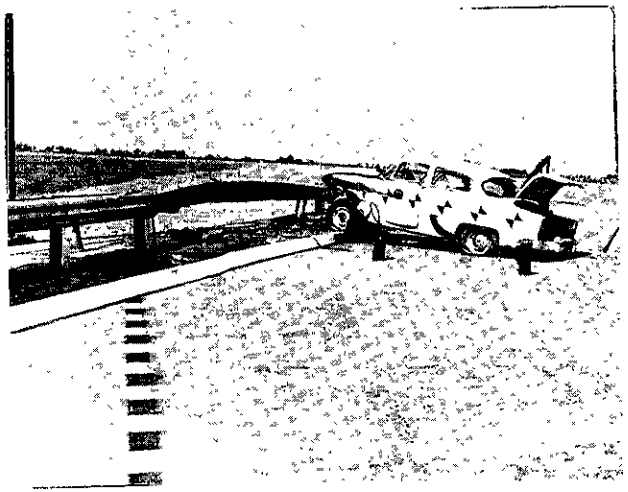
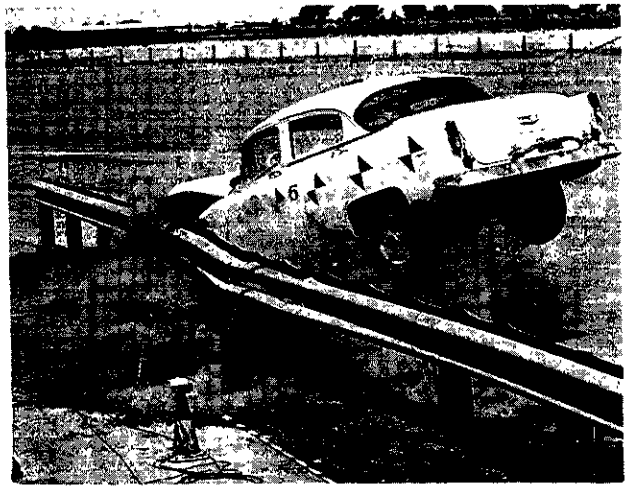
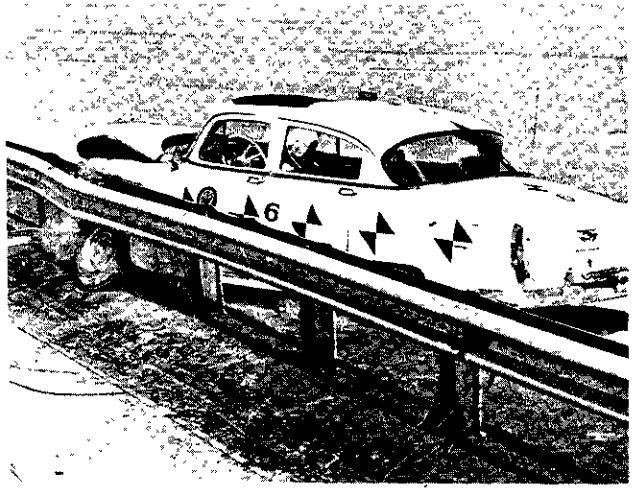
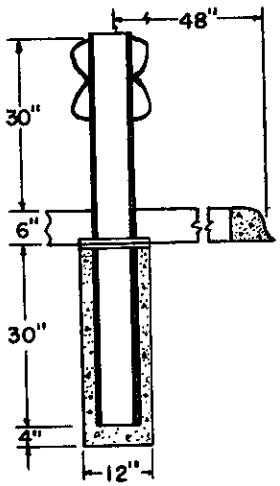
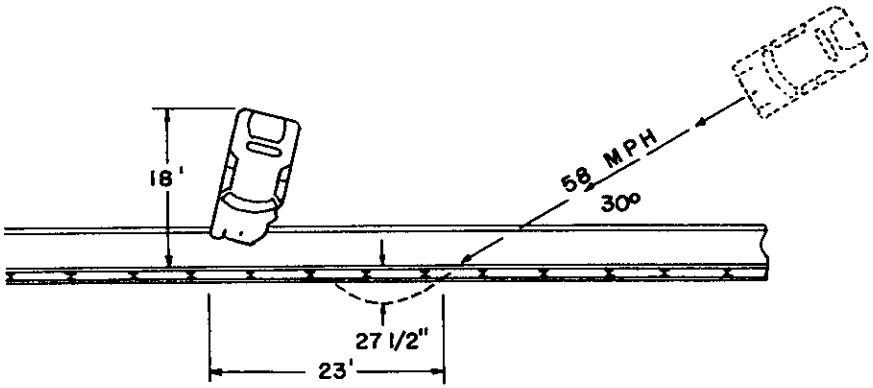
TEST NO. 6
DATE 9-10-58
VEHICLE ..... Chev. 54 Sedan
SPEED ..... 58 M P H
IMPACT ANGLE ..... 30°
VEHICLE WEIGHT.... 4000
(W/DUMMY & INSTRUMENTATION)

DUMMY INJURY ..... Possible neck injury & concussion.
GUARDRAIL DAMAGE ..... 4 Sections damaged beyond repair.

POST DAMAGE ..... 3 Posts knocked out.
2 Posts out of alignment.
VEHICLE DAMAGE ..... Total loss.
MAX. DYNAMIC DEFLECTION OF RAIL ... 36"
VEHICLE DECELERATION (PEAK) ..... Long. ... Transv.

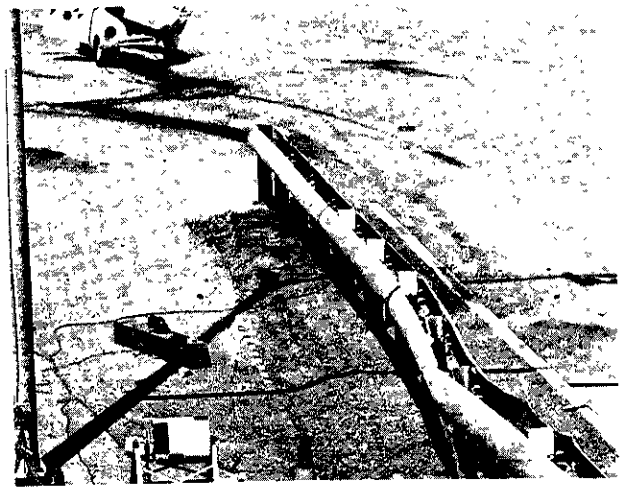
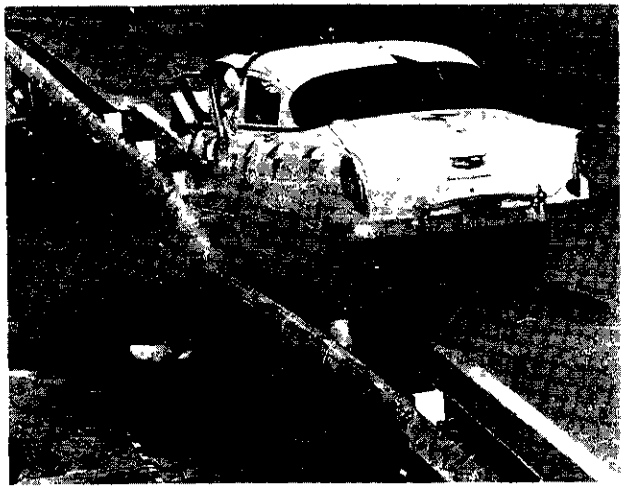
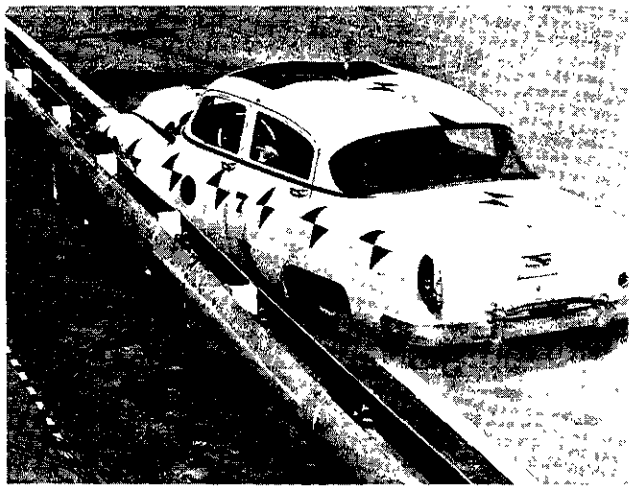
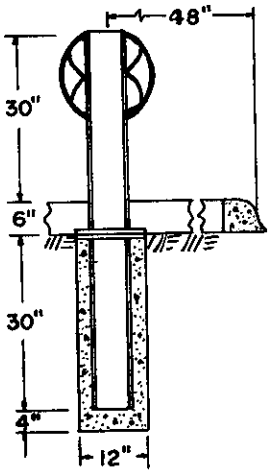
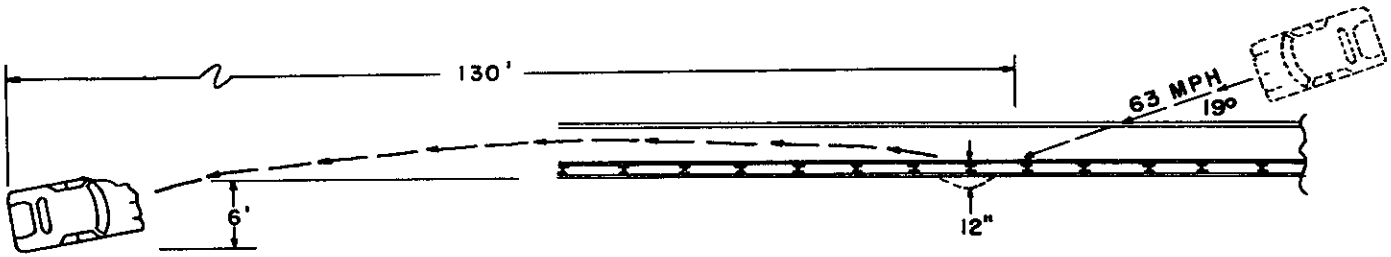
TEST NO. 7
DATE 9-18-58
VEHICLE ..... Chev. 54 Sedan
SPEED ..... 63 MPH
IMPACT ANGLE ..... 19°
VEHICLE WEIGHT.... 4050
(W/DUMMY & INSTRUMENTATION)

DUMMY INJURY ..... Multiple scalp lacerations. Possible internal injury.
GUARDRAIL DAMAGE ..... 2 Sections damaged beyond repair.

POST DAMAGE ..... 2 Posts damaged beyond repair.
2 Posts out of alignment.
VEHICLE DAMAGE ..... Total loss.
MAX. DYNAMIC DEFLECTION OF RAIL... 19"
VEHICLE DECELERATION (PEAK) ..... Long. .... Transv.

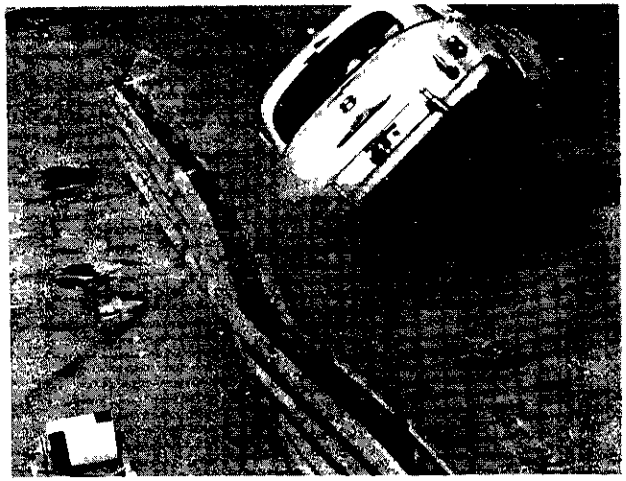
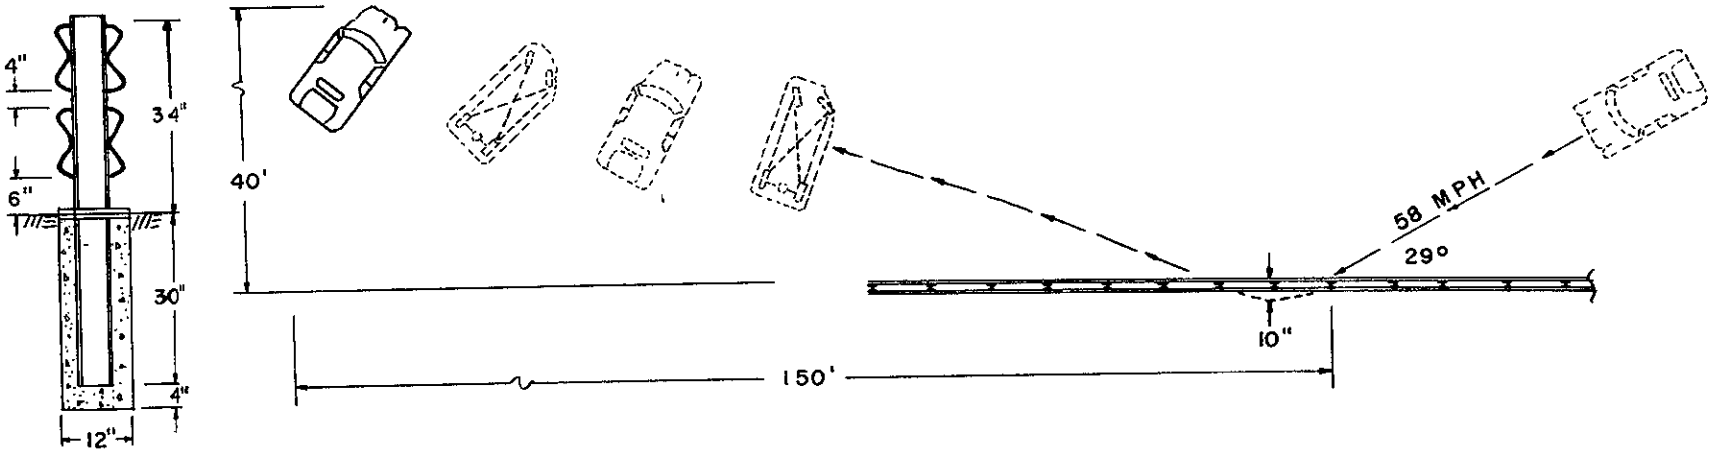
TEST NO 8
DATE 10-2-58
VEHICLE ..... Chev. 52 Sedan
SPEED ..... 58 M.P.H
IMPACT ANGLE ..... 29°
VEHICLE WEIGHT ... 4050
(W/DUMMY & INSTRUMENTATION)

DUMMY INJURY ..... Scalp lacerations. Possible concussion.
GUARDRAIL DAMAGE ..... 2 Sections damaged beyond repair.

POST DAMAGE ..... All can be repaired.
5 Posts out of alignment.
VEHICLE DAMAGE ..... Total loss.
MAX. DYNAMIC DEFLECTION OF RAIL ... 15 "
VEHICLE DECELERATION (PEAK) ..... Long. .... Transv.

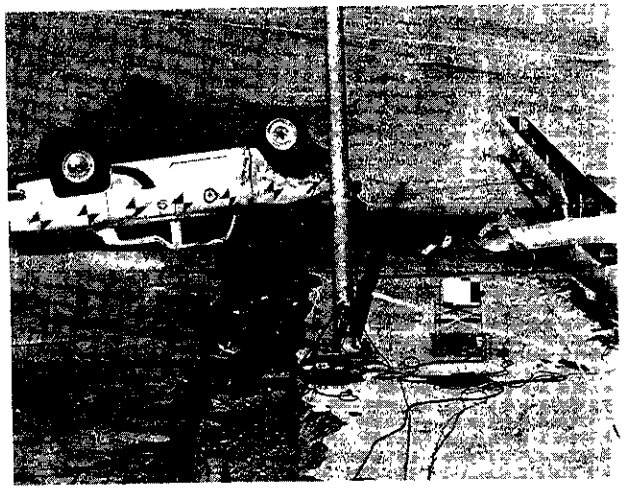
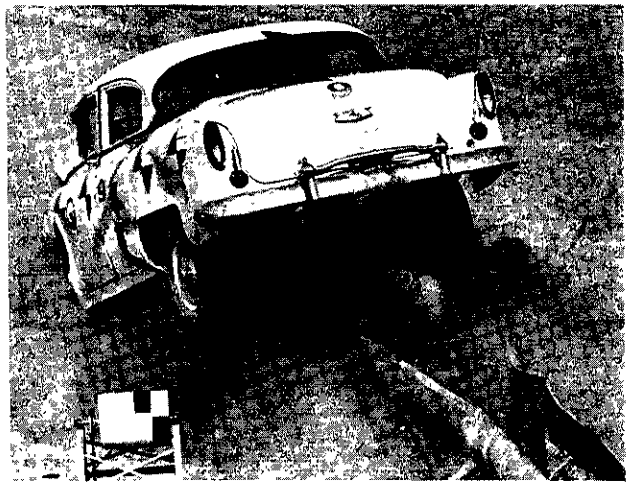
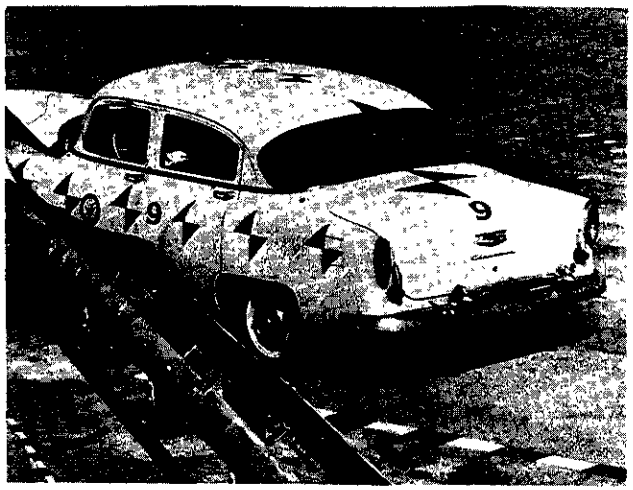
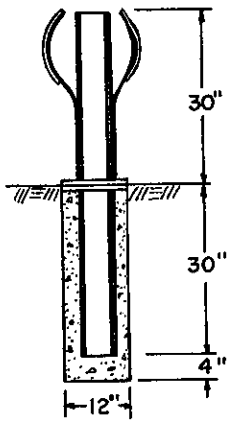
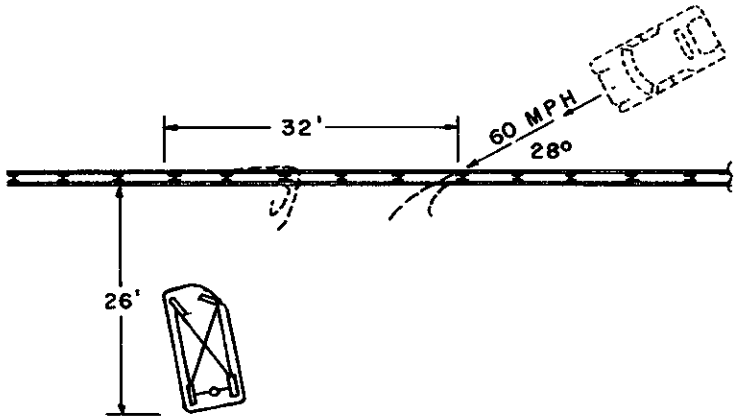
TEST NO. 9
DATE 10-15-58
VEHICLE .....Chev. 54 Sedan
SPEED .....60 MPH
IMPACT ANGLE .....28°
VEHICLE WEIGHT ...3970
(W/DUMMY & INSTRUMENTATION)

In general it appears that the closer the post spacing the more rigid the over-all barrier system. As was illustrated, however, by Test No. 9, care must be used in the over-all design. The lack of distribution of loading to many posts is one of the results of a rigid system, so the beam in a rigid system must be stronger than with flexible posts so as to resist the concentration of loading that occurs due to the relatively short span in which the loading is absorbed. This loading is a tensile load rather than a beam load and tends to snap the rail at the joint.

DUMMY INJURY ..... Possible chest and internal injuries.
GUARDRAIL DAMAGE ..... 4 Sections damaged beyond repair. Both rails failed.
POST DAMAGE ..... 2 Posts damaged beyond repair. 2 Posts out of alignment.
VEHICLE DAMAGE ..... Total loss.
MAX. DYNAMIC DEFLECTION OF RAIL... 15" Before failure.
VEHICLE DECELERATION (PEAK)..... Long. ...Transv.

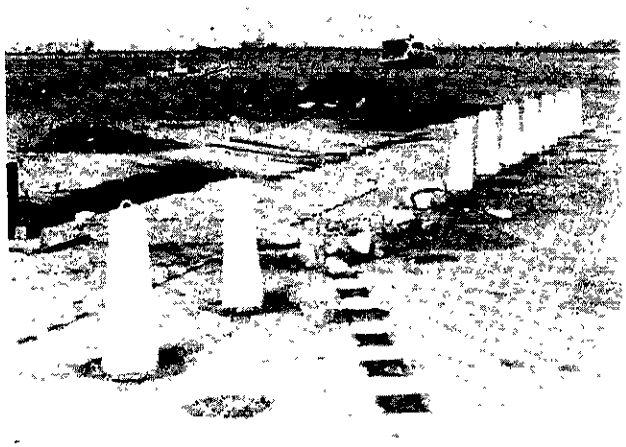
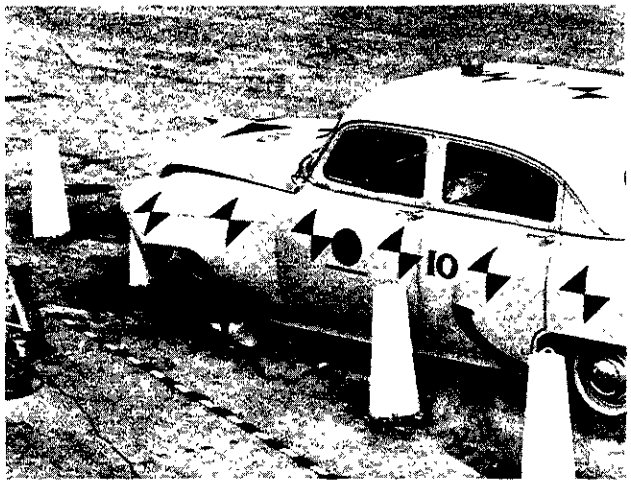
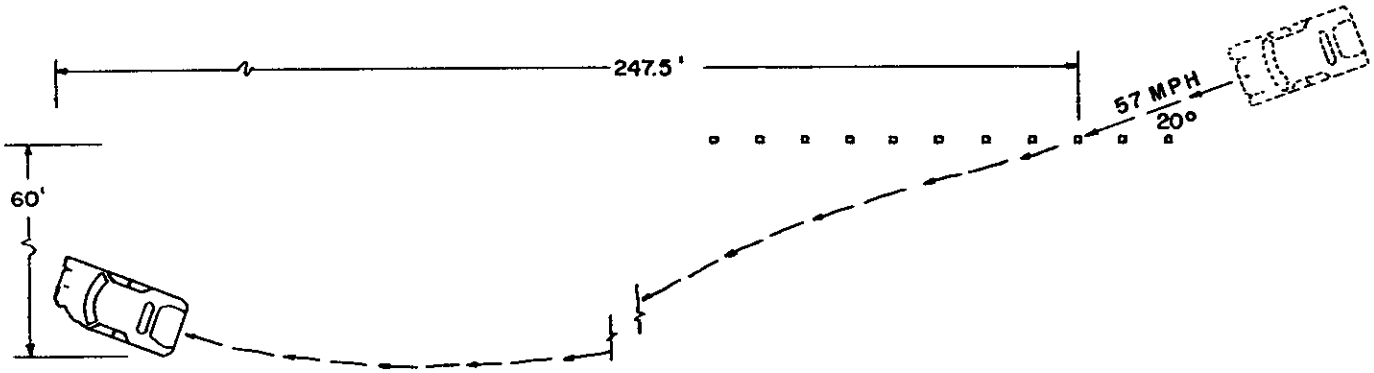
TEST NO. 10
DATE 10-23-58
VEHICLE ..... Chev. 53 Sedan
SPEED ..... 57 MPH
IMPACT ANGLE .... 20°
VEHICLE WEIGHT ... 3970
(W/DUMMY & INSTRUMENTATION)

DUMMY INJURY ..... No apparent injuries.
GUARDRAIL DAMAGE ..... No rail.

POST DAMAGE ..... 3 Posts demolished.
1 Post out of alignment.
VEHICLE DAMAGE ..... Est. $ 200.
MAX. DYNAMIC DEFLECTION OF RAIL ... No rail.
VEHICLE DECELERATION (PEAK) .... Long. .... Transv.

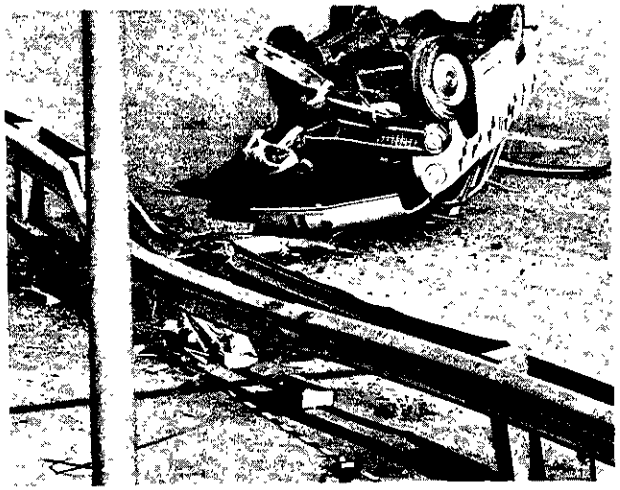
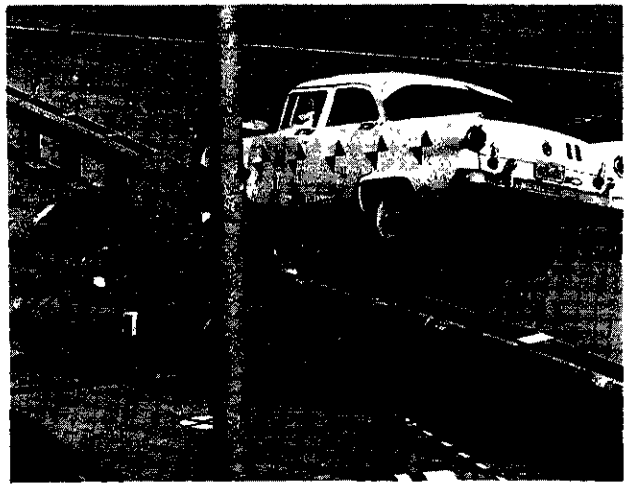
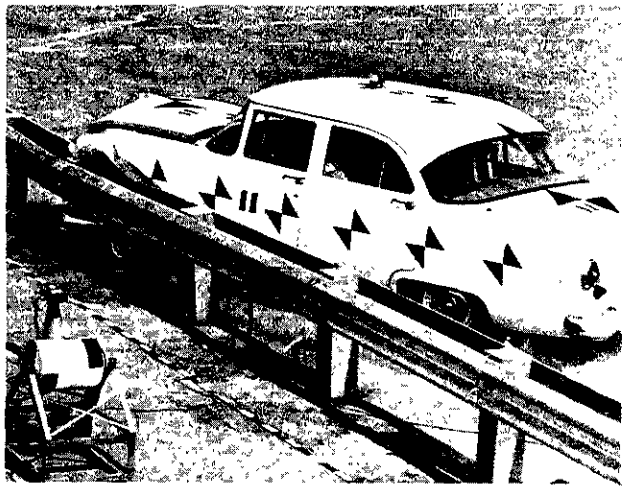
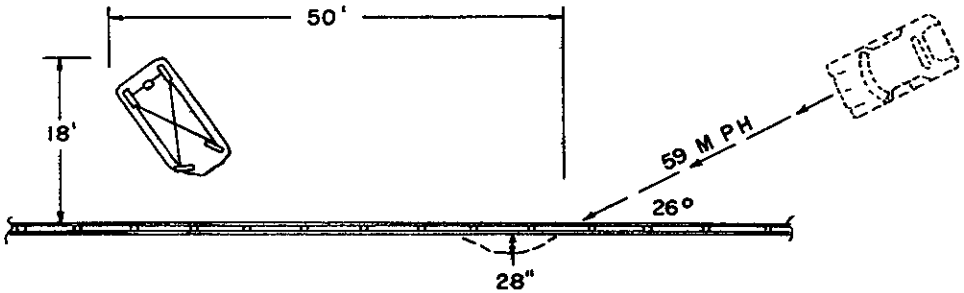
TEST NO. 11
DATE 10-30-58
VEHICLE .....Ford 55 Sedan
SPEED ..... 59 MPH
IMPACT ANGLE .....26°
VEHICLE WEIGHT... 4050
(W/DUMMY & INSTRUMENTATION)

DUMMY INJURY .....Scalp lacerations. Possible internal injuries.
GUARDRAIL DAMAGE .....6 Sections damaged beyond repair.

POST DAMAGE .....3 Posts damaged beyond repair.
3 Posts out of alignment.
VEHICLE DAMAGE ..... Total loss.
MAX. DYNAMIC DEFLECTION OF RAIL...40"
VEHICLE DECELERATION (PEAK).....Long. ...Transv.

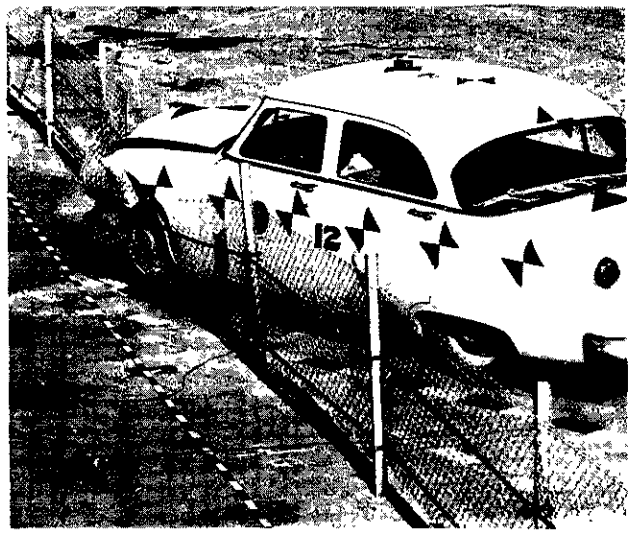
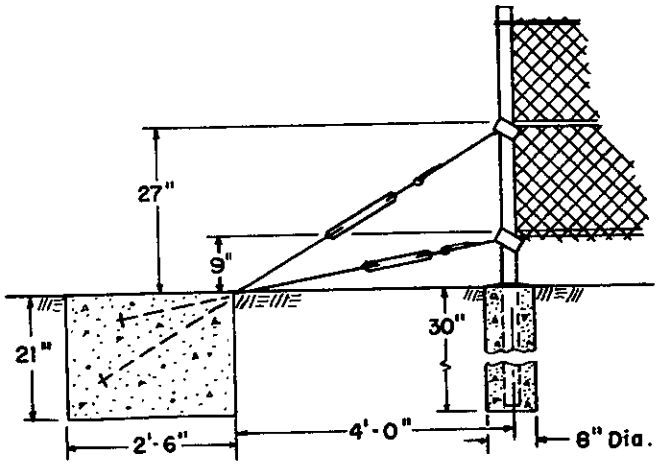
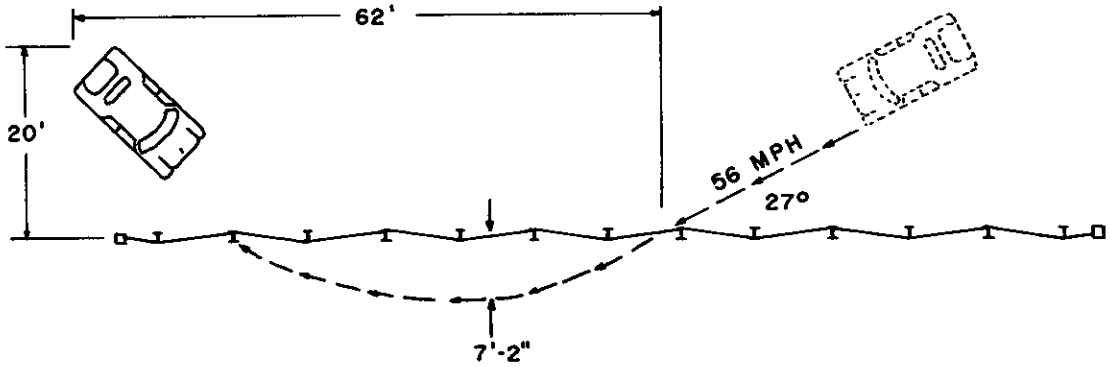
TEST NO. 12
DATE 11-13-58
VEHICLE ..... Ford 52 Sedan
SPEED ..... 56 MPH
IMPACT ANGLE .... 27 °
VEHICLE WEIGHT... 4002
(W/DUMMY & INSTRUMENTATION)

Based on observations in the field, this test resulted in snubbing of the car into the system at a deceleration tolerable to human occupants and at minor damage to the vehicle. The collision was at the standard 30° angle of approach at a speed of 60 mph.

DUMMY INJURY ..... No Visable Injury.
GUARDRAIL DAMAGE ..... 50' of Fence knocked out. No damage to Cable.
POST DAMAGE ..... 7 Posts damaged beyond repair.
6 Posts Bent.
VEHICLE DAMAGE ..... $400.
MAX. DYNAMIC DEFLECTION OF RAIL .. 7'-2"
VEHICLE DECELERATION (PEAK)..... Long. ...Transv.

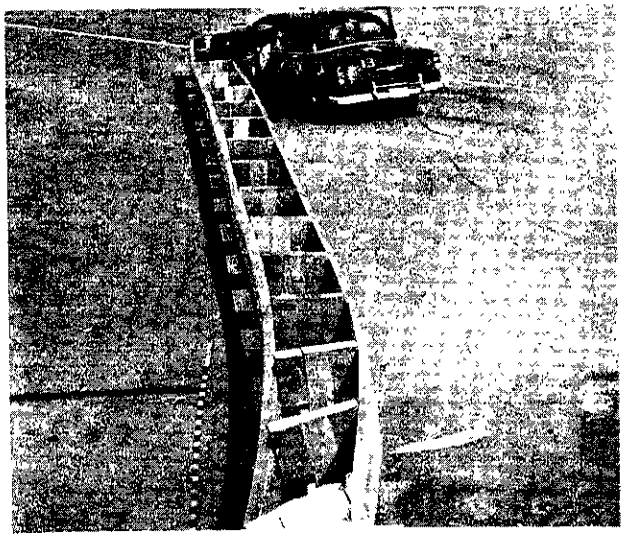
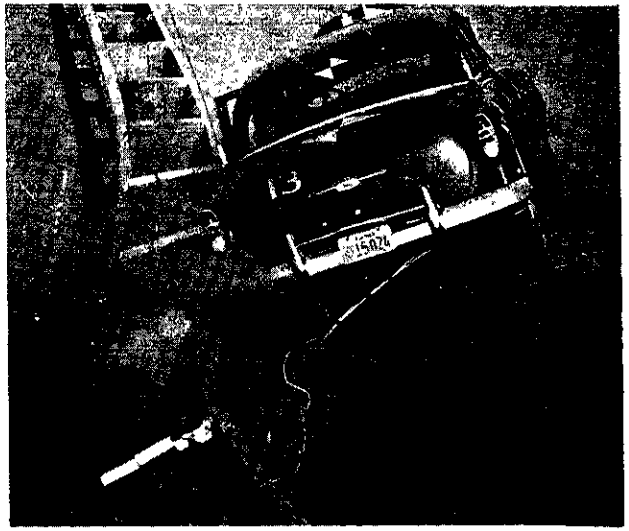
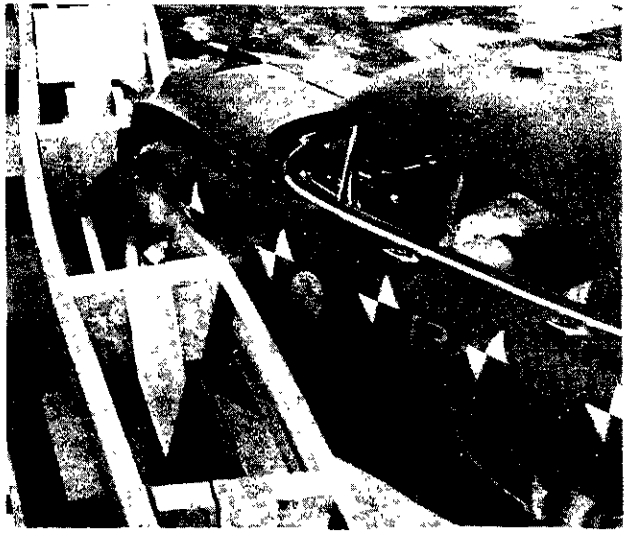
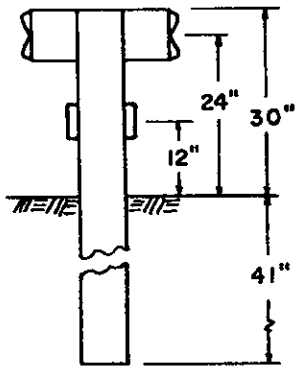
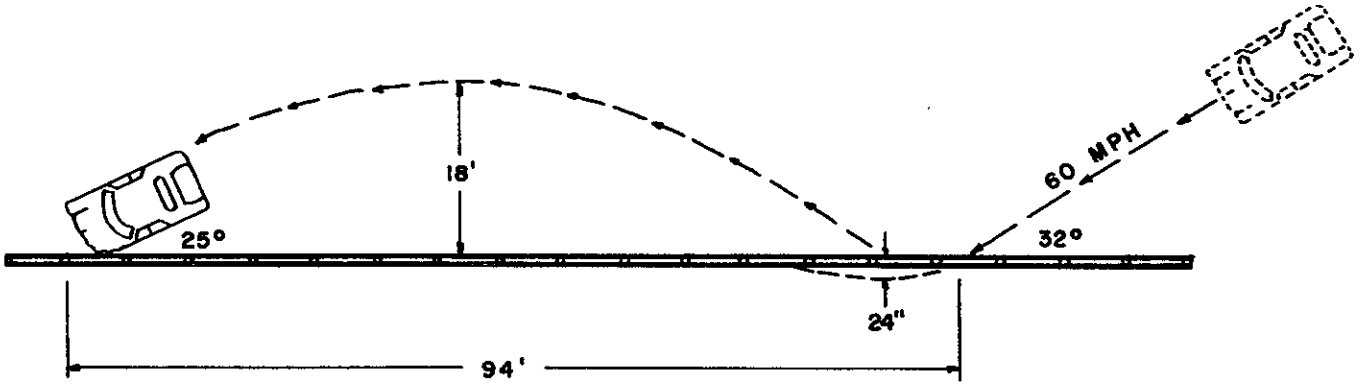
GUARDRAIL	W Section	DUMMY INJURY	Minor head injury.	TEST NO.	13
CHANNEL	6" ⊓ 8.2 #	GUARDRAIL DAMAGE	4 Sections damaged beyond repair.	DATE	12-18-58
BRACKET	8x8x12 D.F Block	CHANNEL DAMAGE	4 Sections damaged beyond repair.	VEHICLE	Chev. 53 Sedan
POST	8x8 D.F.	POST DAMAGE	3 Posts damaged beyond repair.	SPEED	60 MPH
POST SPACING	6'-3" O.C.			IMPACT ANGLE	32°
LENGTH OF INSTALLATION	125'	VEHICLE DAMAGE	Total Loss	VEHICLE WEIGHT (W/DUMMY & INSTRUMENTATION)	4000
GROUND CONDITION	Dry	MAX. DYNAMIC DEFLECTION OF RAIL	37"		
		VEHICLE DECELERATION (PEAK)	Long. ...Transv.

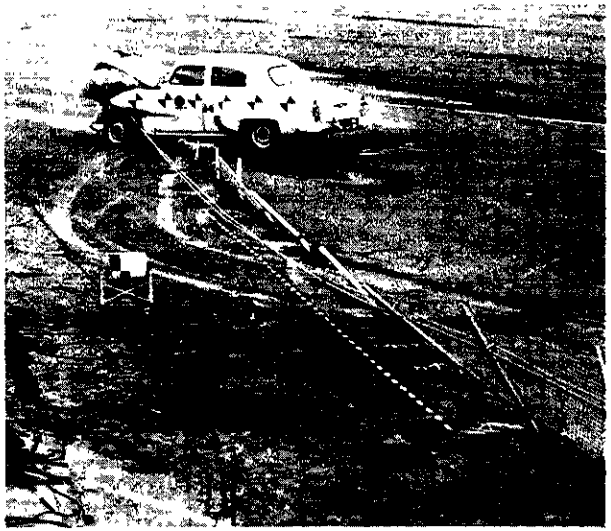
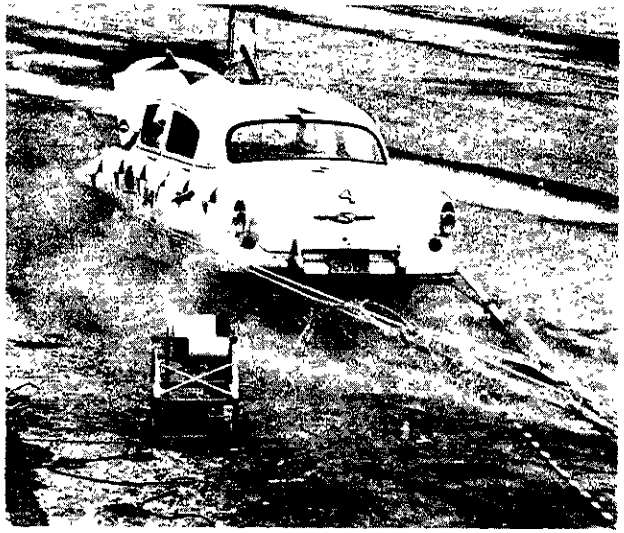
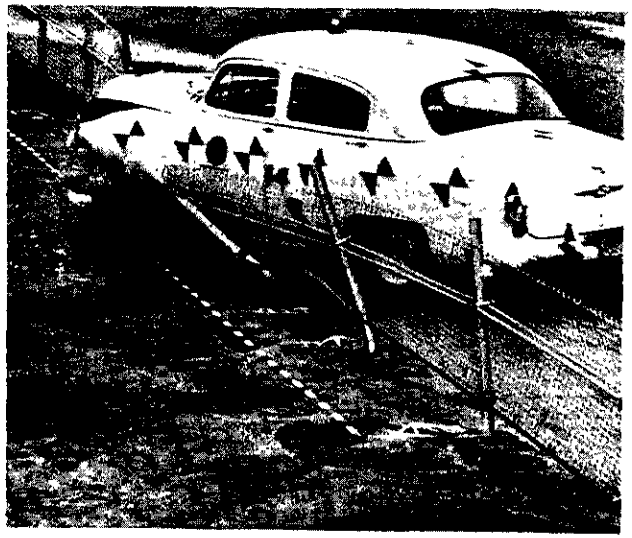
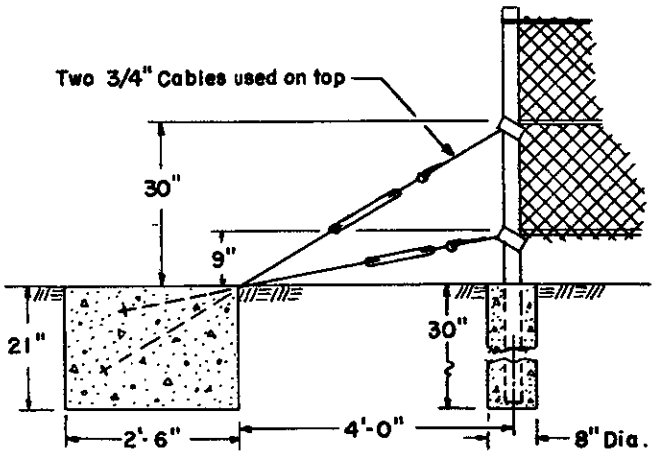
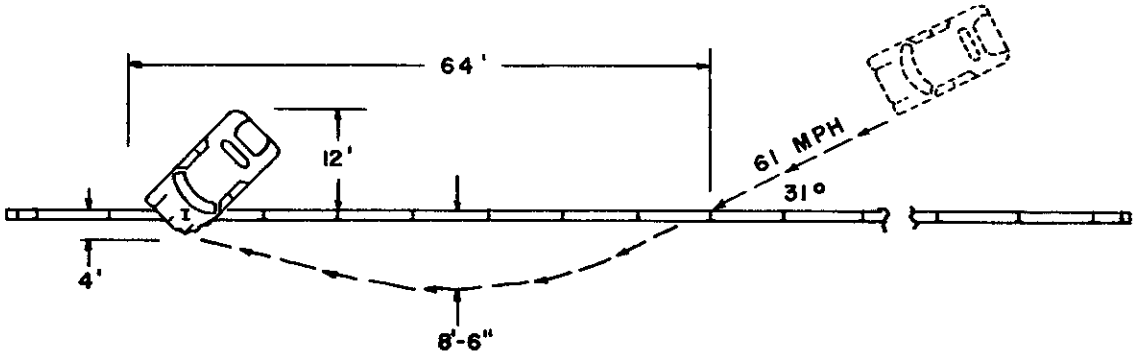
TEST NO. 14

DUMMY INJURY ..... Minor Bruises

GUARDRAIL DAMAGE ..... 80' of Fence knocked out. No damage to Cables.

POST DAMAGE ..... 11 Posts damaged beyond repair.

VEHICLE DAMAGE ..... $400.

MAX. DYNAMIC DEFLECTION OF RAIL ... 8'-6"
