SANDSTORM INVESTIGATION in COACHELLA VALLEY between GARNET AND THOUSAND PALMS

63-03

August 2, 1963

VIII-Riv-26-D

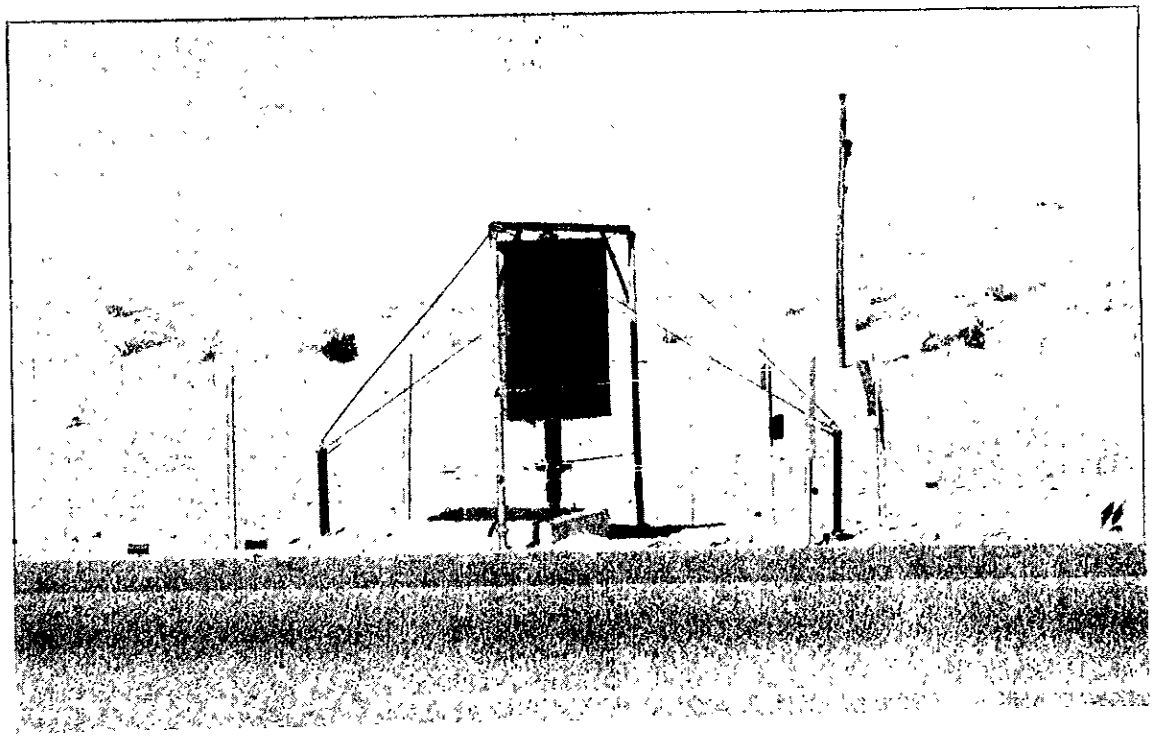
Fig. 3. Rotary Sandstorm Device Installed at the Test Site.

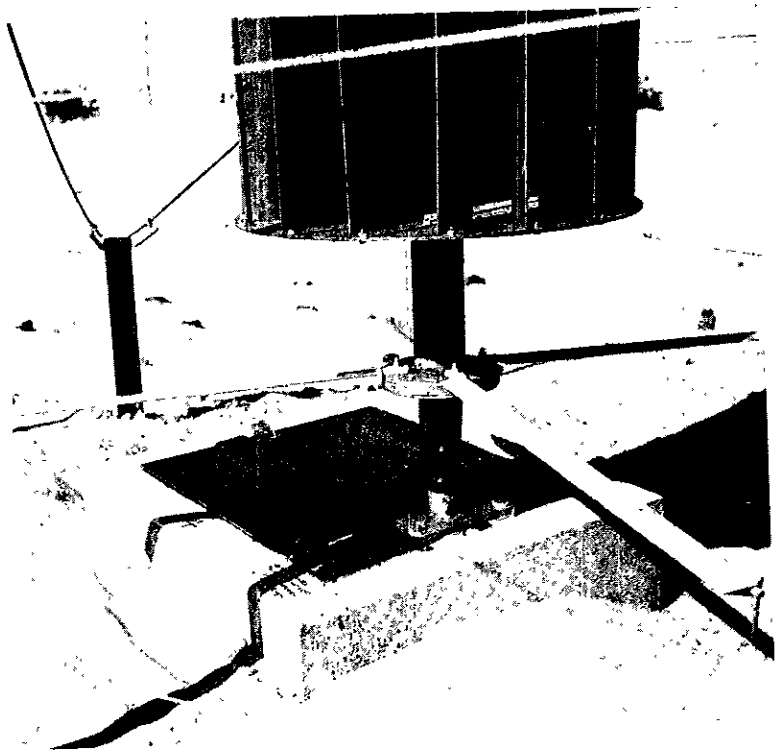
The impact arms were mounted on the lower portion of the devices as shown in Fig. 4. These arms could be removed for observation and measurement of the abrasive damage after periods of severe blowing sand. The impact arms were painted with six layers of contrasting colored automobile paint.

Fig. 4. Details of Impact Arm Mounting

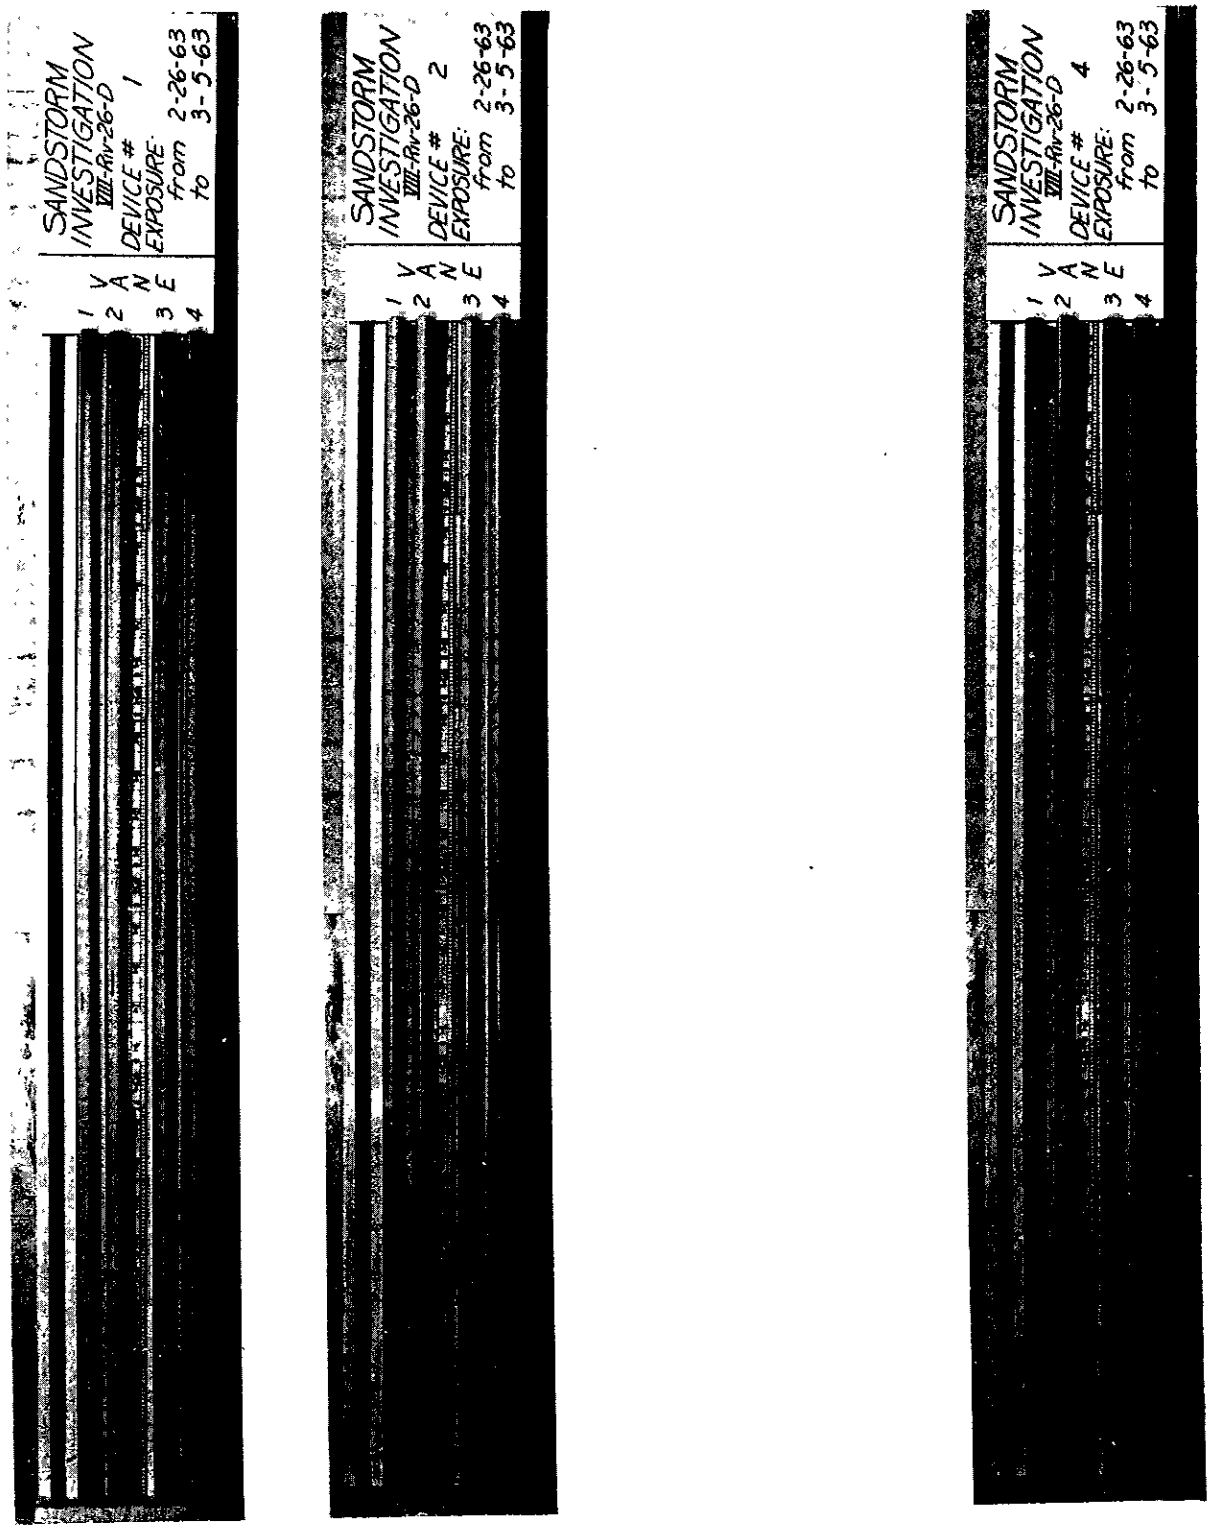
Fig. 6

The damage sustained by the impact arms is shown on the record photographs, Fig. No. 6 through Fig. No. 13. The exposure periods indicated on the photographs correspond to the periods given in the above table. The scale shown on the photographs represents distance in feet and tenths of feet from the axis of rotation of the devices.

Exposure Period 1

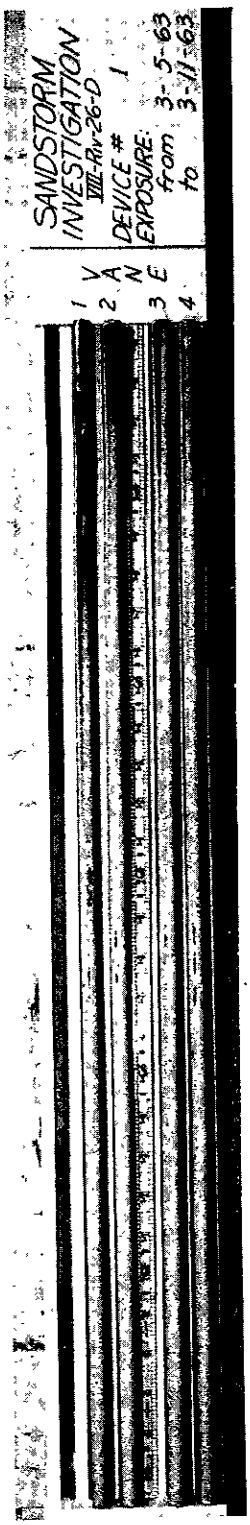
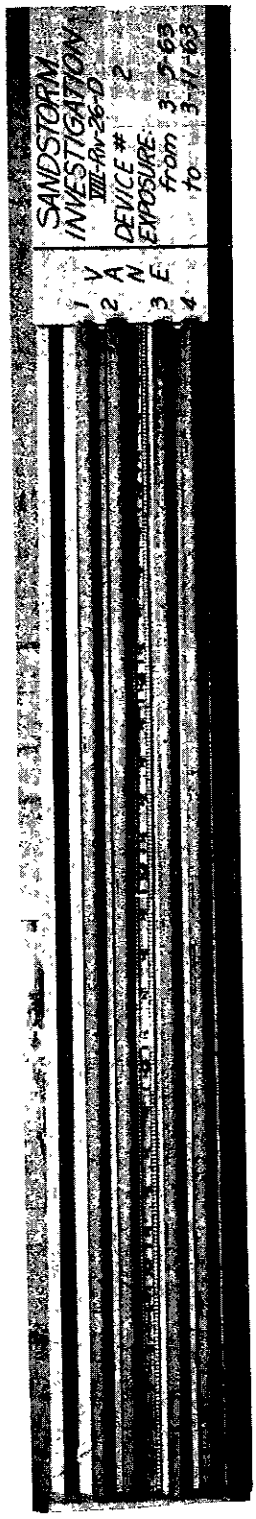
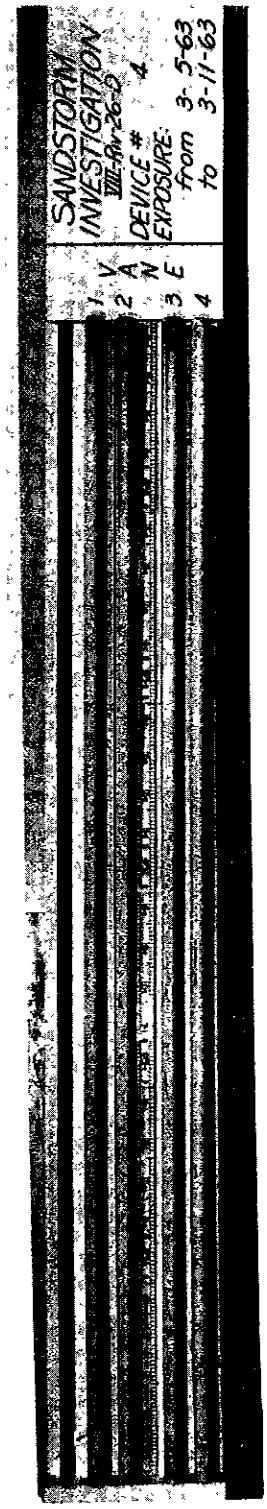
Fig. 7

Exposure Period 2

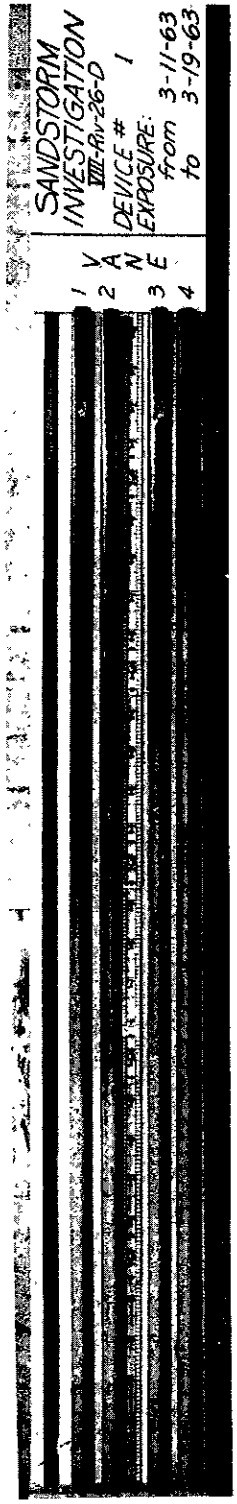
Fig. 8

Exposure Period 3

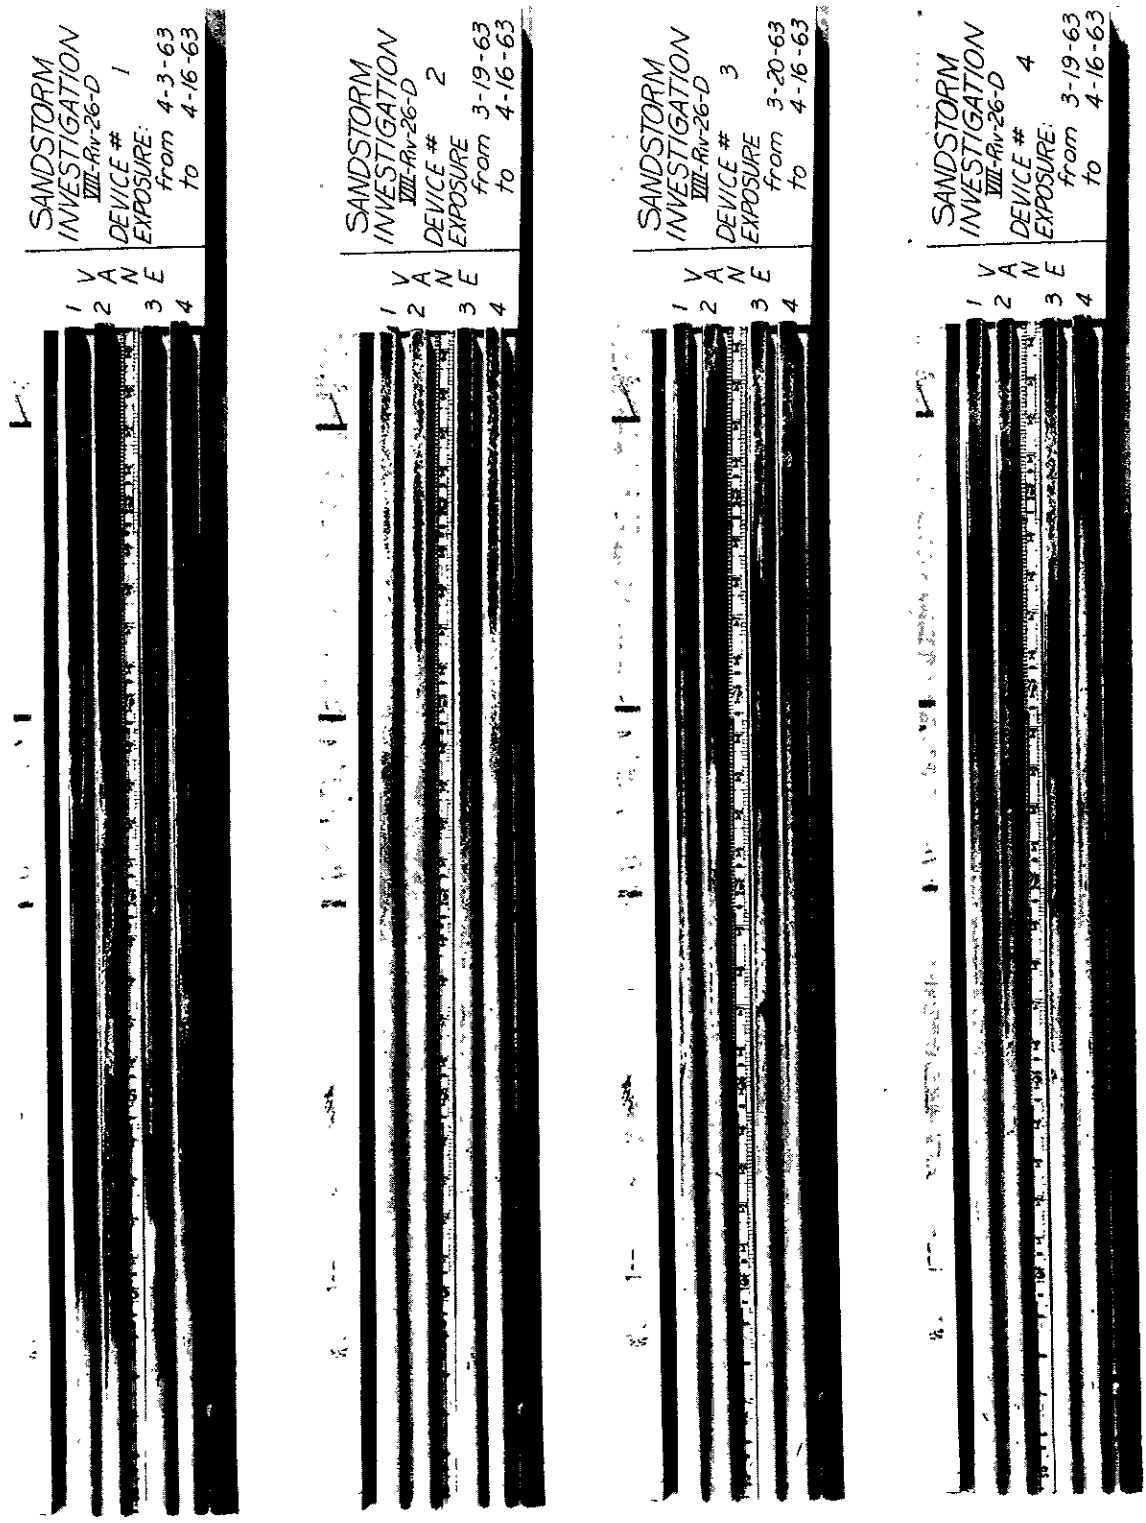
Fig. 10

Exposure Period 4A

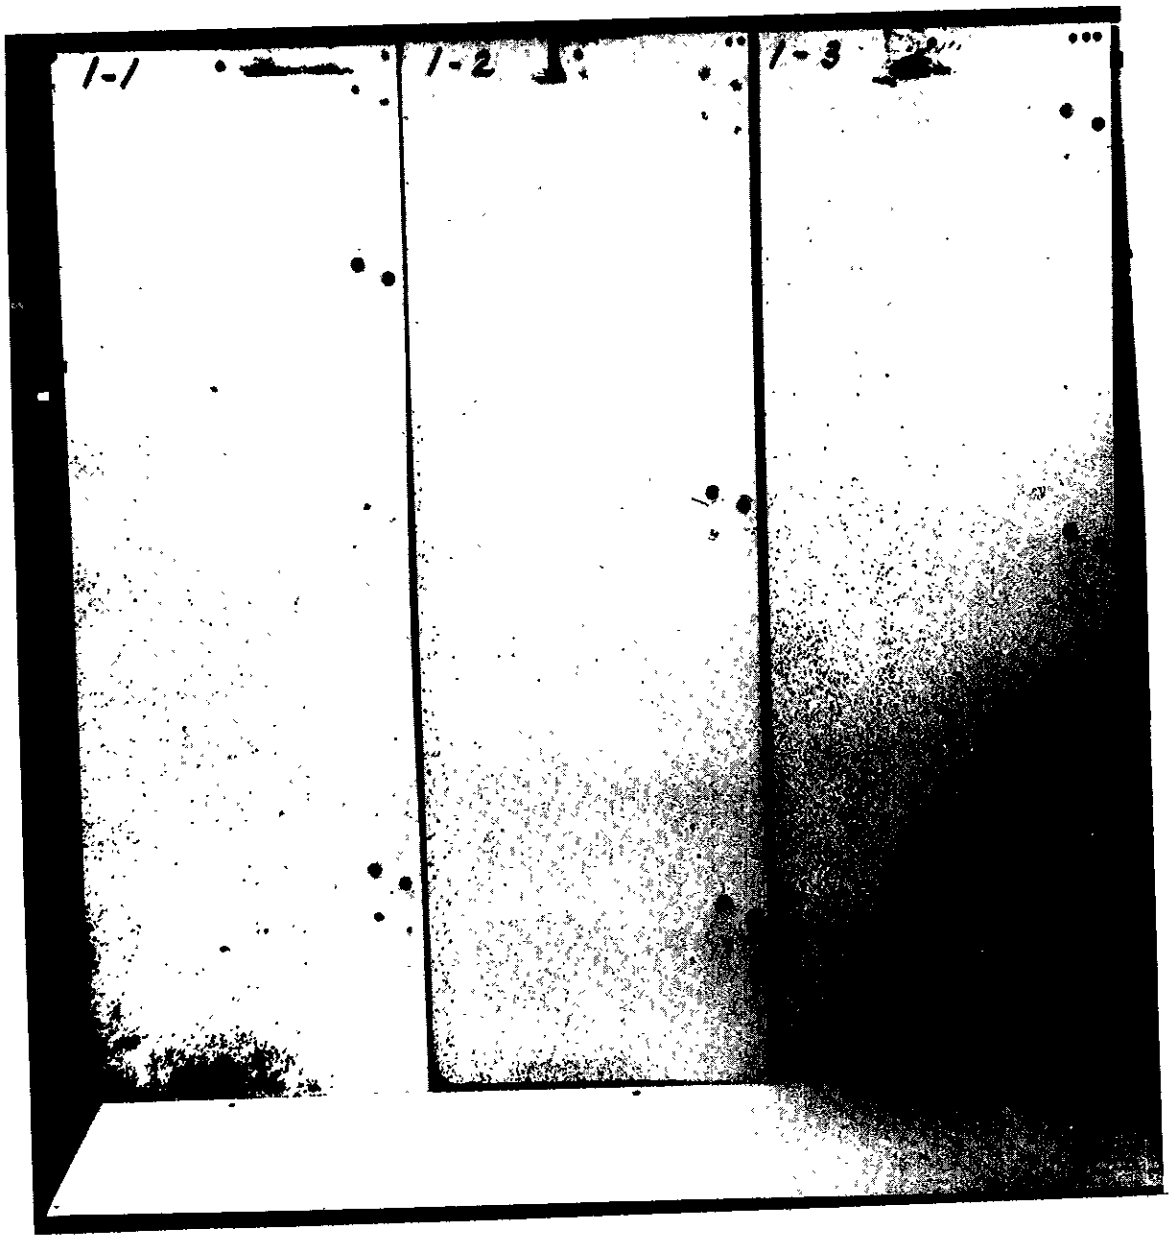
In test run No. 1, Panel 1-1 was exposed easterly or downwind of the dike, Panel 1-2 was exposed through the area where the dike presumably affords the maximum protection, and Panel 1-3 was exposed westerly or upwind of the dike. The vehicle was driven at a speed of 50 mph for this test run. The damage to the three panels was insufficient after one pass to properly evaluate the damage. Two additional passes were made with the same three panels, exposing them in the same sequence as above and at the same speed. A photograph of the panels from test run No. 1 is shown on Fig. No. 20.

The damage to the vehicle mounted panels was greatest for those panels (1-3 and 2-3) exposed westerly and upwind of the dike. The least damage occurred to those panels (1-2 and 2-2) exposed in the protection area of the dike. These results are consistent with the data from the rotary sandstorm devices.

Vehicle Mounted Panels Test Run 1

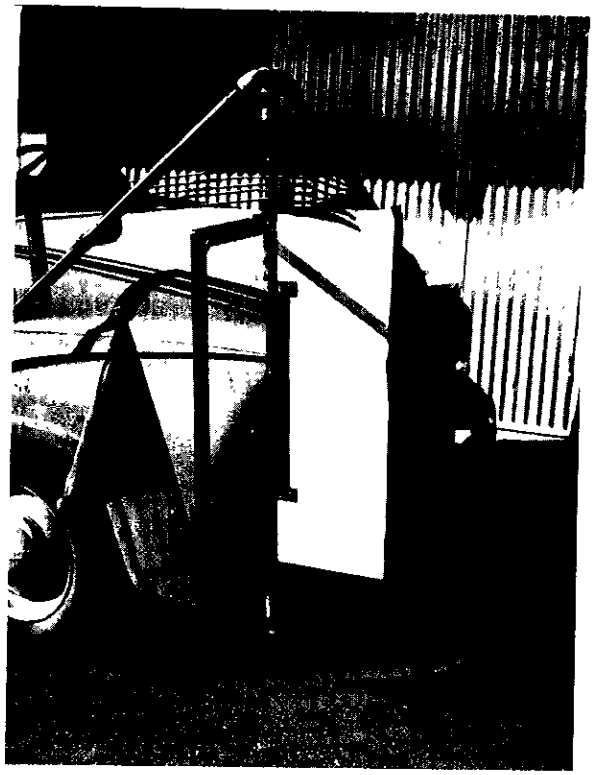
Fig. 18. Vehicle Mounting of Painted Test Panels

Further verification of the results shown by the rotary sandstorm devices was obtained from test runs made with vehicle mounted test panels. The equipment used for these tests was constructed by the District. This equipment consisted of a special frame mounted on the front of a pick-up truck as pictured on Fig. No. 18. A series of painted metal panels were hinged to this frame in such a way that the panels could be exposed to the blowing sand for controlled intervals as the vehicle traveled along the roadway. Details of the panel mountings and the exposure control levers are shown on Fig. No. 19. The control rods, also shown in these figures, were operated from the cab of the vehicle.
