A PRELIMINARY STUDY OF ALUMINUM AS A CULVERT MATERIAL

By
Eric F. Nordlin
Assistant Materials and Research Engineer,
Structures

and
R.F. Stratfull
Corrosion Engineer

Presented at the 44th Annual Meeting
of the Highway Research Board

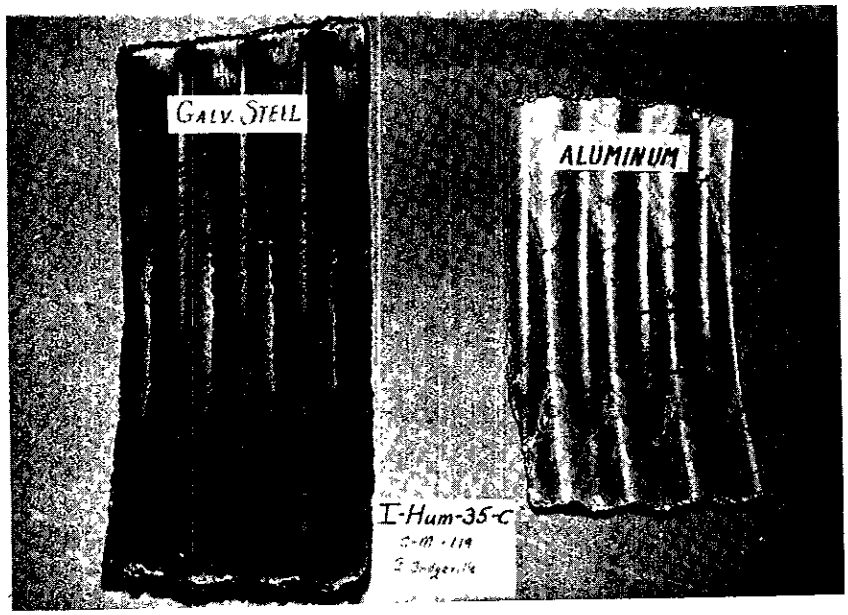
Field Test Site
I-Hum-35-C, Mile 1.19

Inlet of test pipe - aluminum section

Samples removed from invert after 2-year exposure

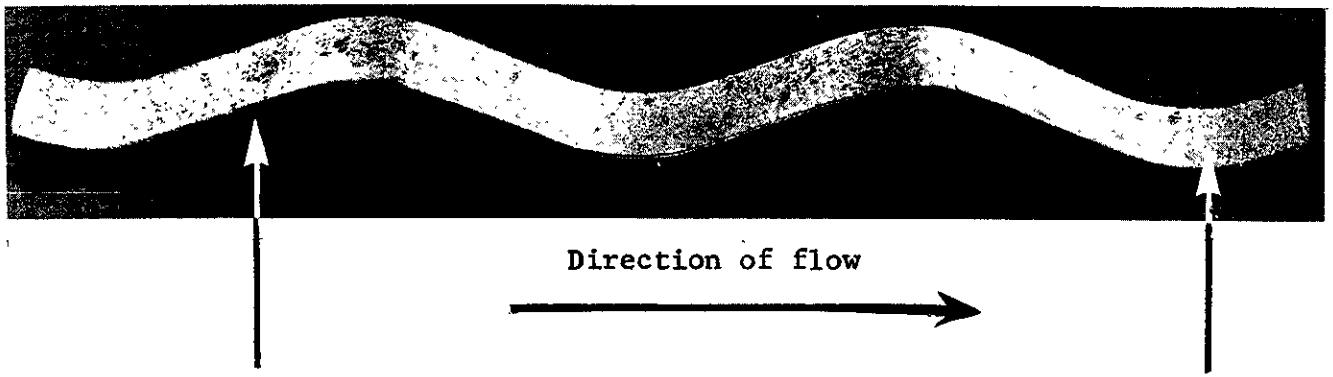
Field Test Site
I-Hum-35-C, Mile 1.19

Sample from invert of aluminum culvert

Typical loss of cladding at abrasion surface - 2 years

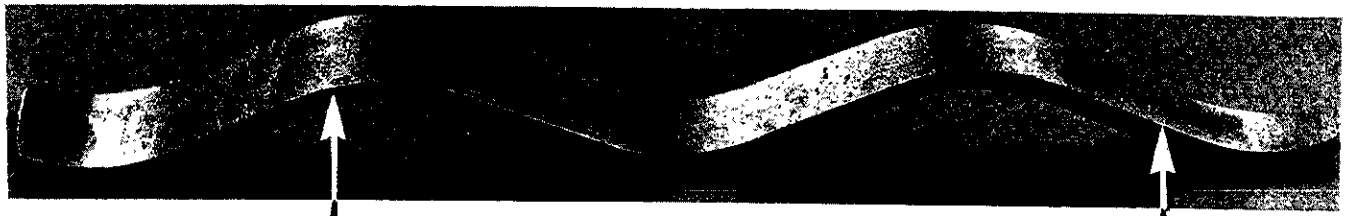
Field Test Site
I-Hum-35-C, Mile 1.19

Sample from invert of galvanized steel culvert

Note loss of zinc and minor loss of steel at abrasion surface - 2 years

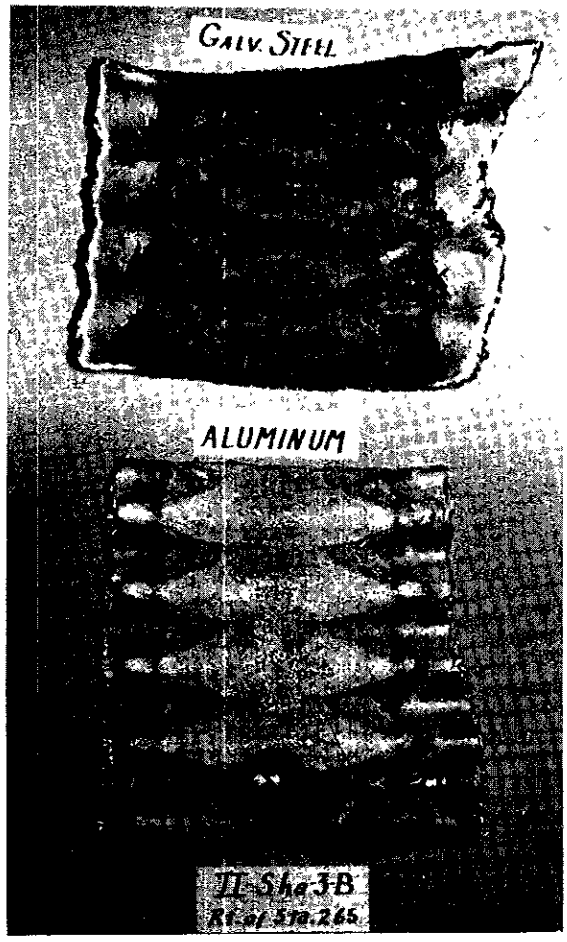
II-Sha-3-B
Right of Station 265±

Typical invert samples removed after approximately 1.5 years of test

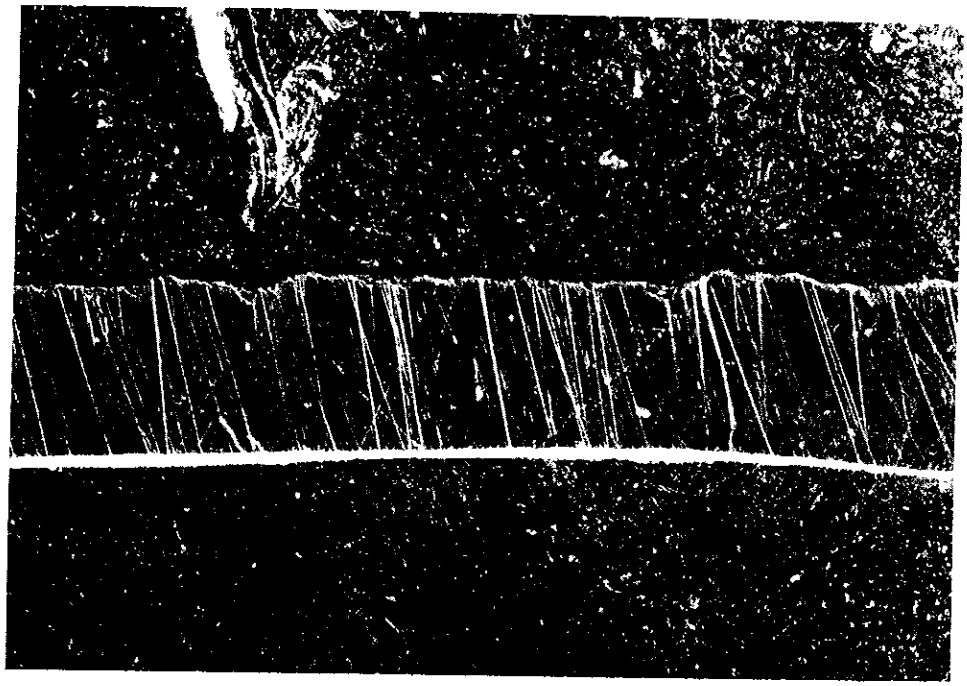
Figure 5

Cross-section of steel after 1.5 years of test

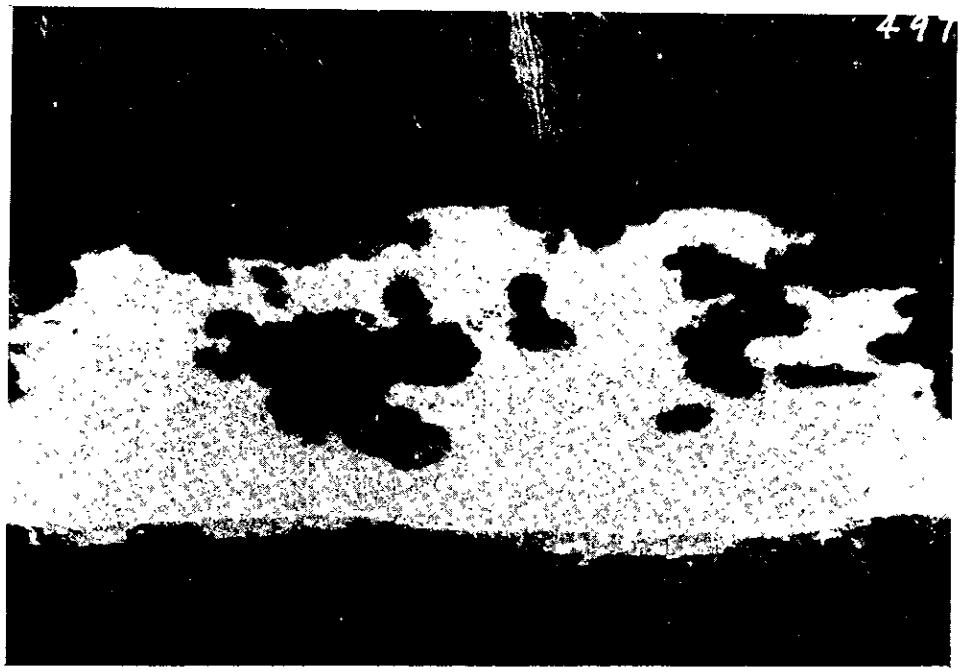
Cross-section of aluminum

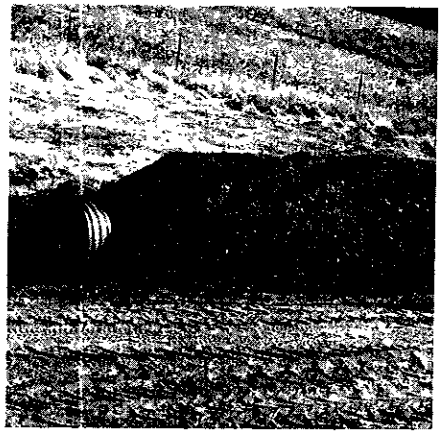
III-But-21-B
Right of Station 594±

Field Test Site

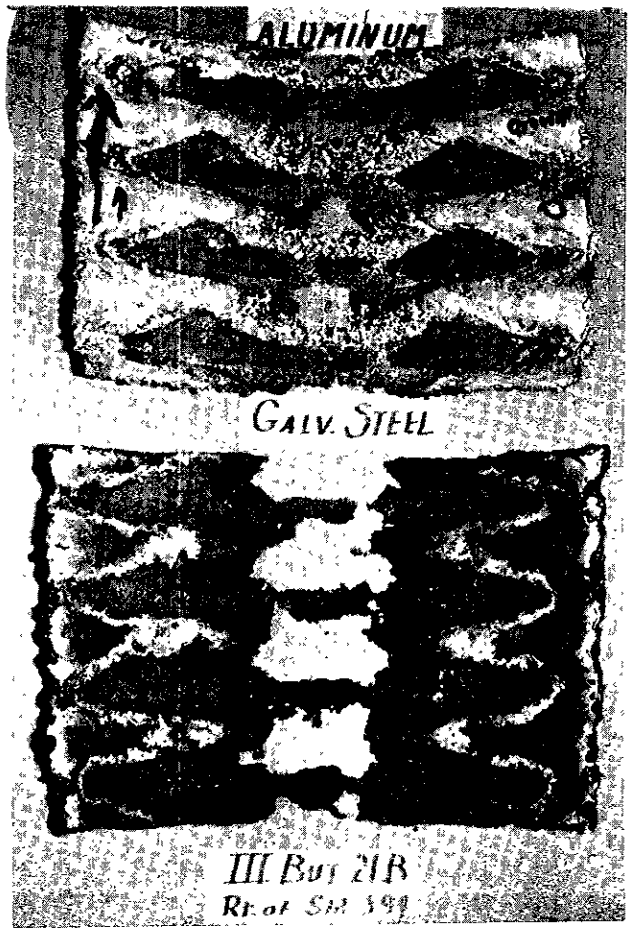
Invert samples removed after approximately 1.7 years of test. (Highly corrosive exposure.)

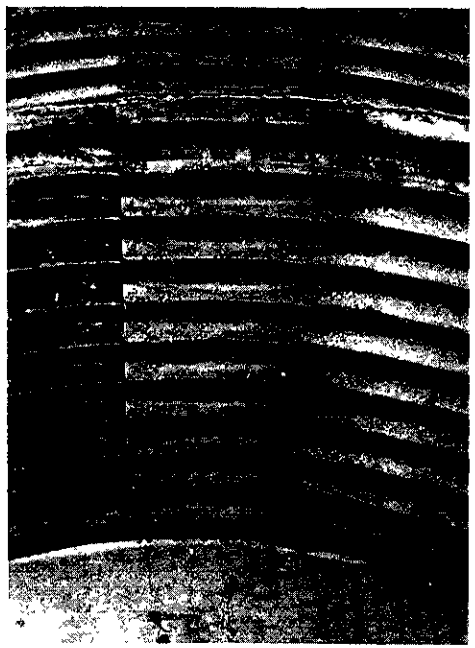
IV-SC1-5-C Sta. 250+25
Bridge No. 37-165

Samples of the invert galvanized steel section. Note wear of rivet heads.

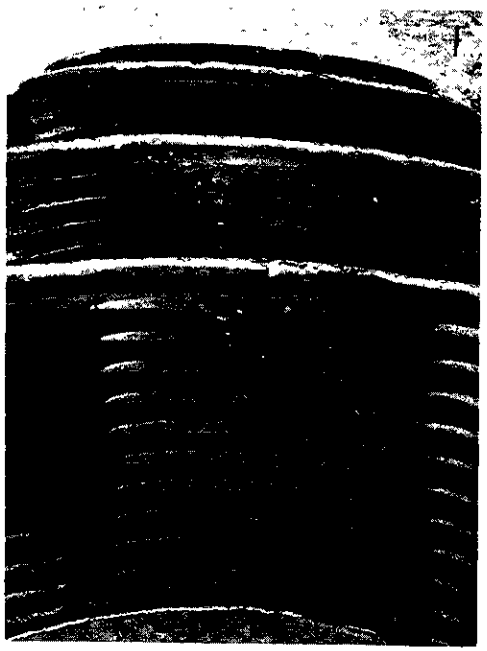
Samples of the invert from the A.D.P.I. section. Note loss of rivets at the joint.

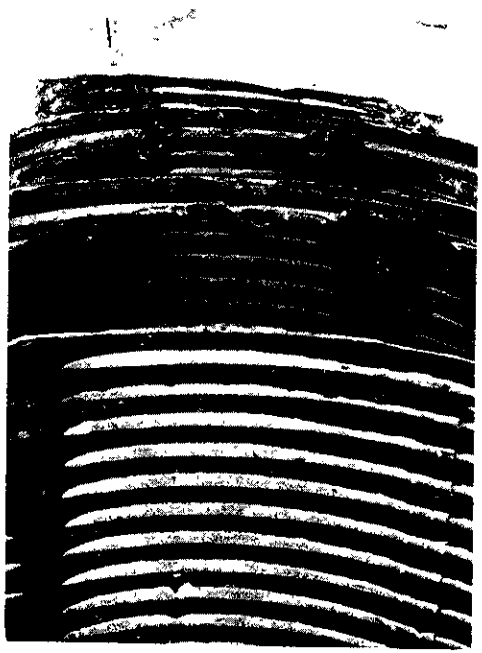
Figure 9

Samples of the invert from A.B.A.D.P.I. section.

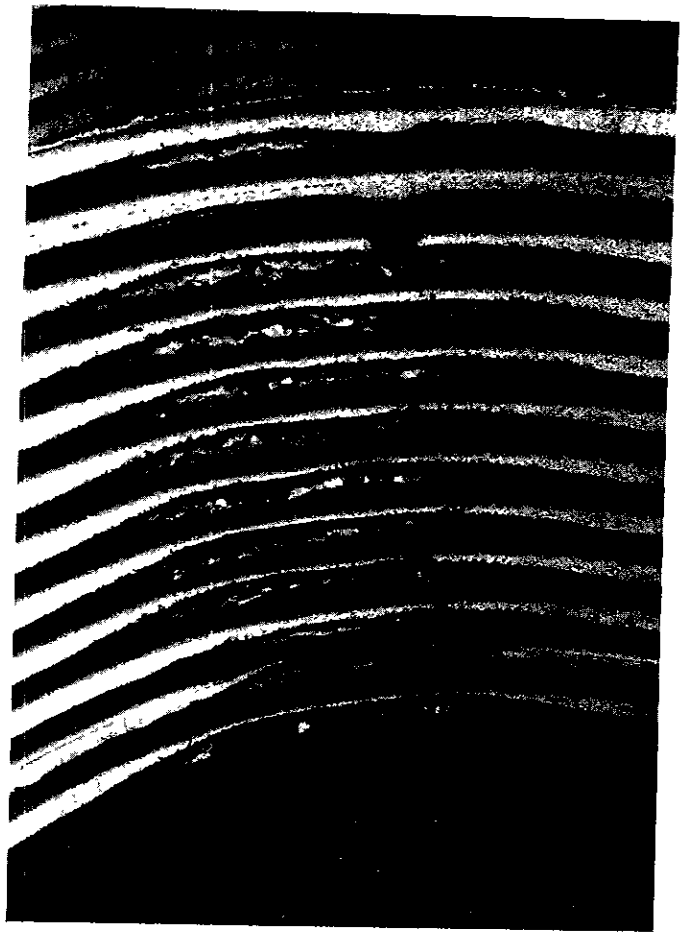
IV-SC1-5-C Sta. 250+25
Bridge No. 37-165

The reader should be aware that the results of erosion are exceedingly difficult to explain and objectively formulate to a mathematical certainty. For instance, the severely damaged test pipe located at IV-SC1-5-C may have had a calculated flow velocity in the range of 25 to 30 feet per second with a bed load of shattered rocks. The minor abrasion damaged culvert near Redding, California (II-Tri-20-A, Sta. 582+73), has a calculated flow velocity in the range of 20 to 25 feet per second, and has a bed load of rounded boulders. Therefore, it is obvious that even though flow velocities are highly important, the size and shape (rounded or shattered) and hardness of the bed material may be of greater consequence in the subsequent degree of abrasion of a culvert.

Severe abrasion of aluminum after 1.4 years of service

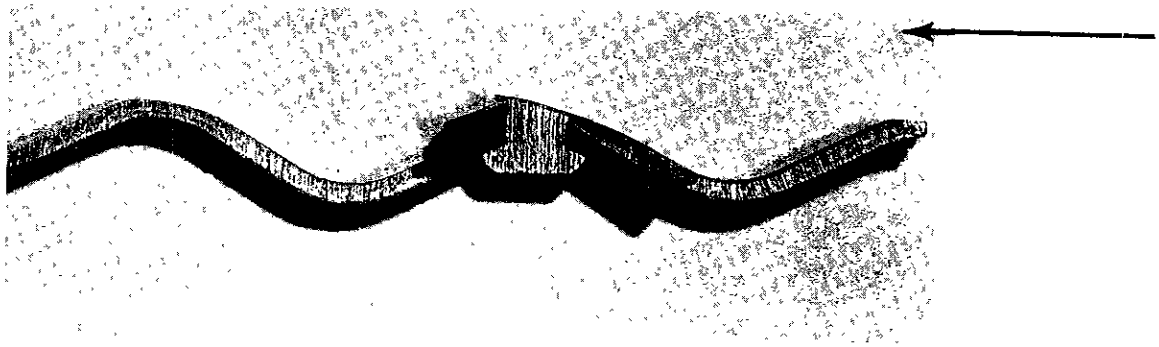
Severe abrasion of galvanized steel after 1.4 years of service. Note loss of head of rivet.

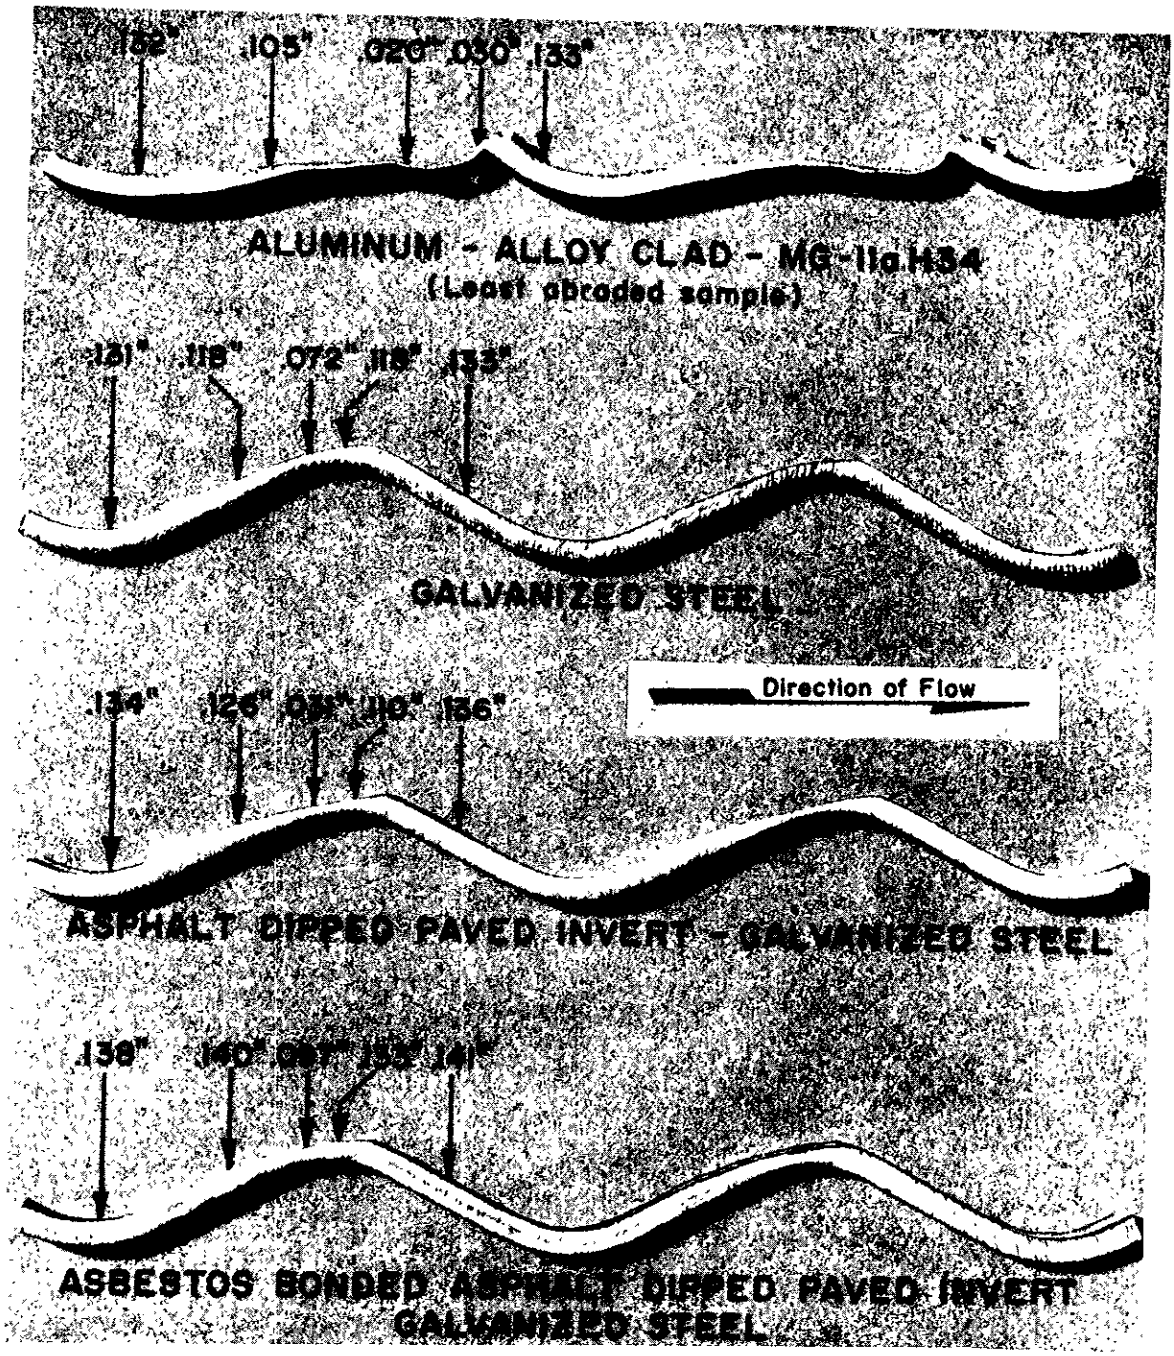
Sta. 250+25

Typical cross-sections of pipe invert after test exposure.

Note: All C.M.P. samples were 10 gage (0.140±)
Steel samples are typical of the most abraded pipe sections

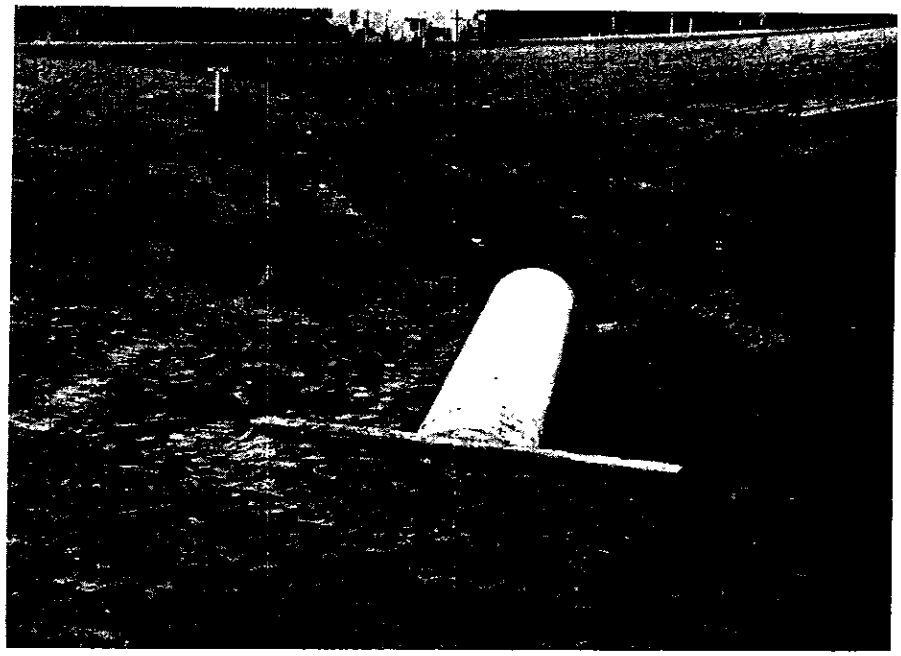
Figure 12

Aluminum culvert, field test site. (Exposed pipe subsequently backfilled.)

Existing galvanized C.M.P. Approximately 2 years of service. (Not placed as part of test program.)

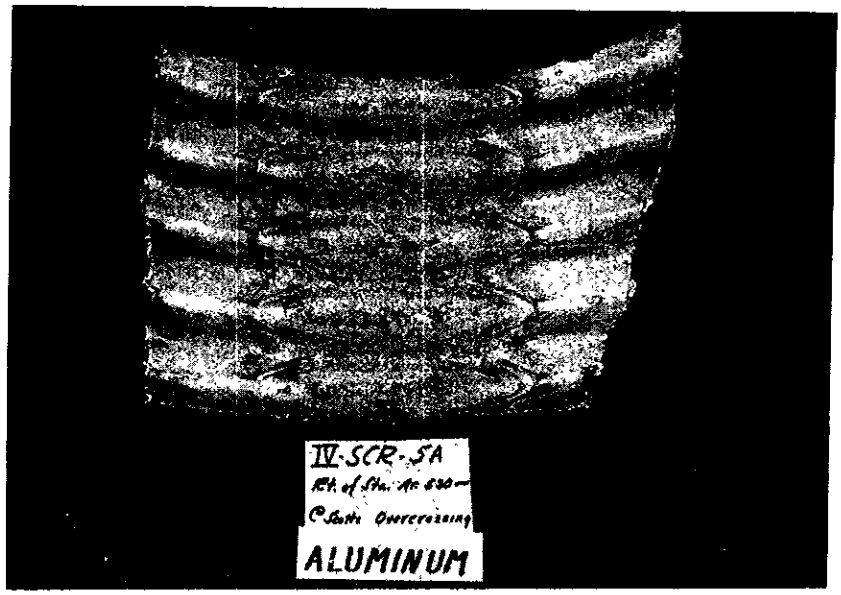
Figure 13

Aluminum invert sample after approximately 0.8 years of test.

Cross-section of aluminum. Non-perforated section.

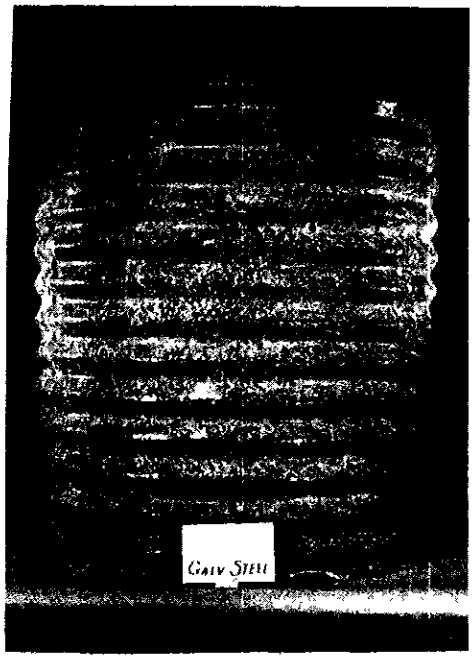
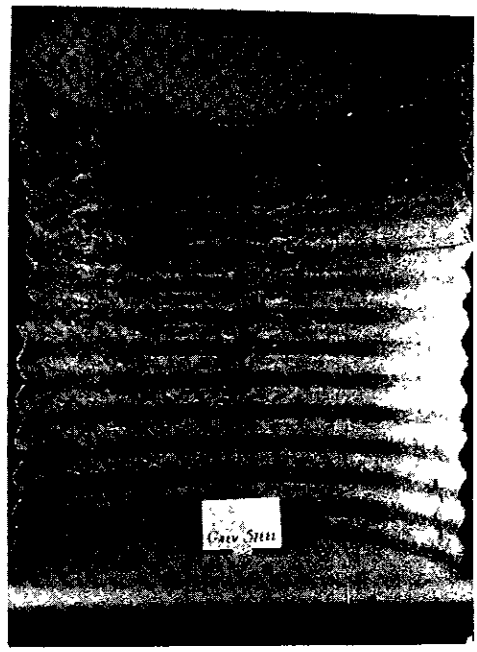
X-S.J-53-C
Right of Station 6±

Appearance of cleaned galvanized steel samples after 2.4 years of test.

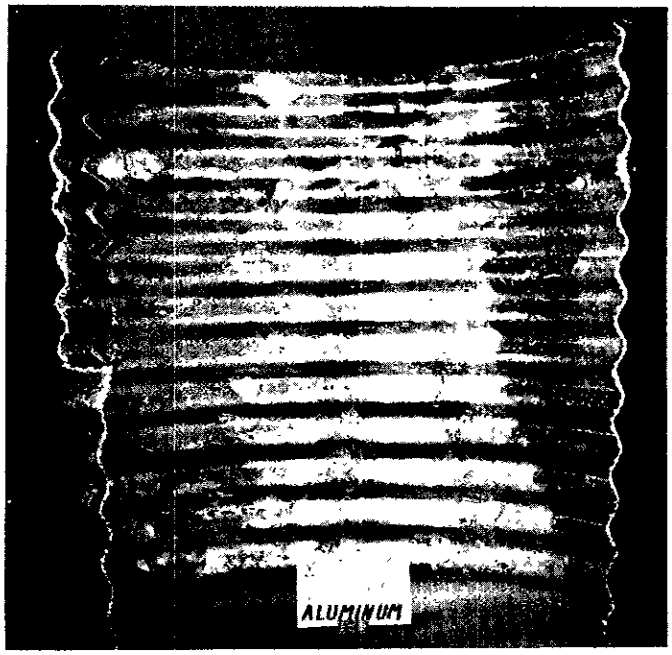
Figure 15

Appearance of inside of aluminum sample after cleaning. (Invert.)

Appearance of soil side of aluminum sample after cleaning.

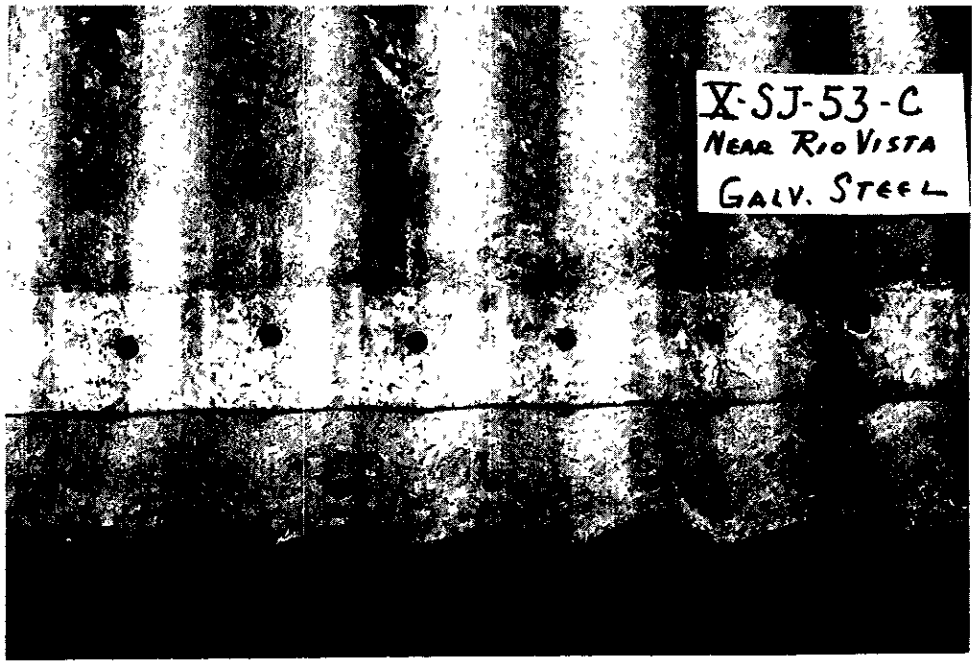
Figure 16

Appearance of galvanized steel joint after cleaning.

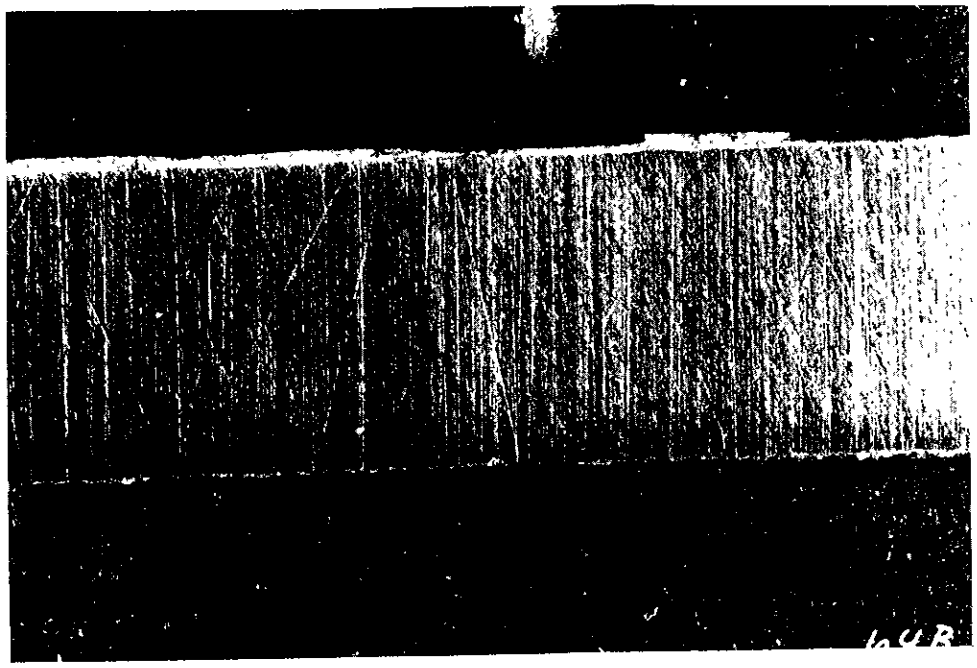
Cross-section of steel.

Note partial loss of galvanizing on both sides.

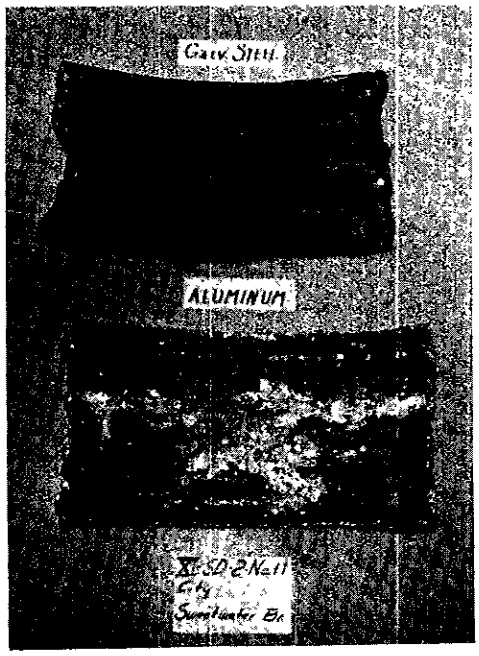
Sample removed from culvert inverts. After approximately 1.6 years of test.

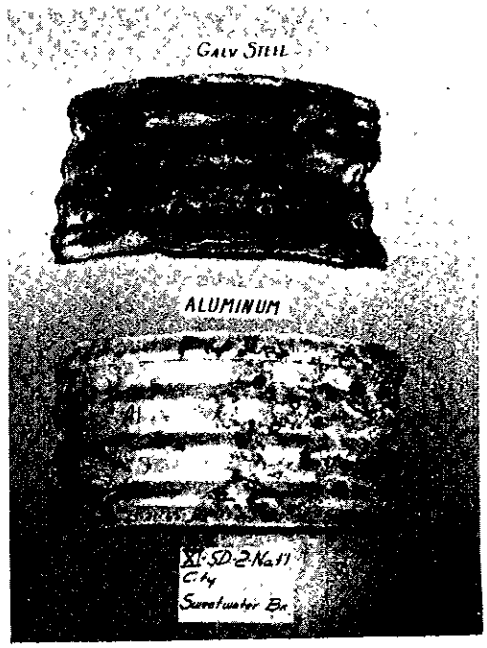
Backfill side of same culvert samples.

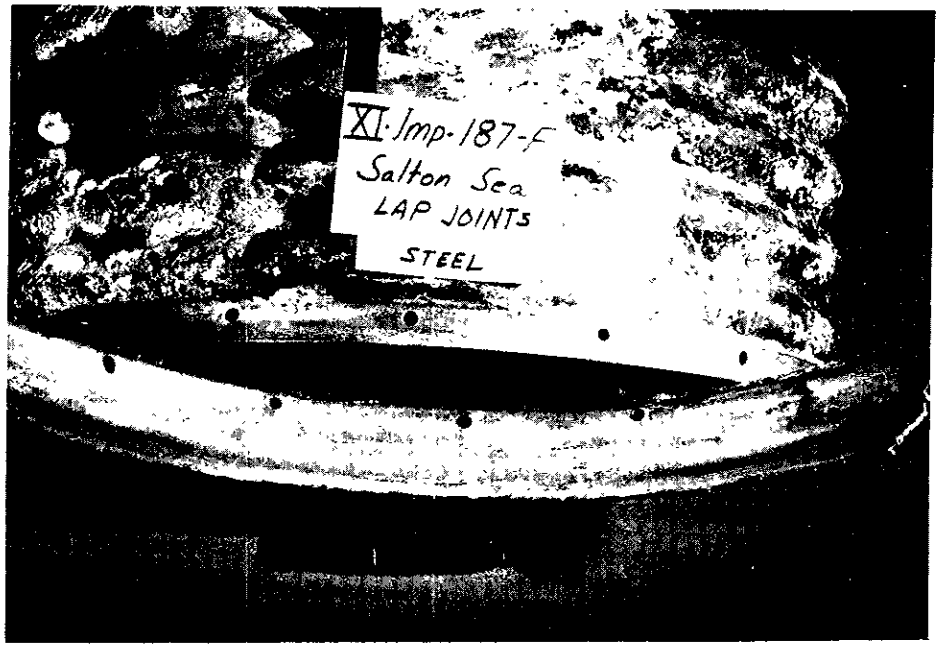
XI-Imp-187-F

Appearance of galvanized steel joint after cleaning. Dark areas are rust.

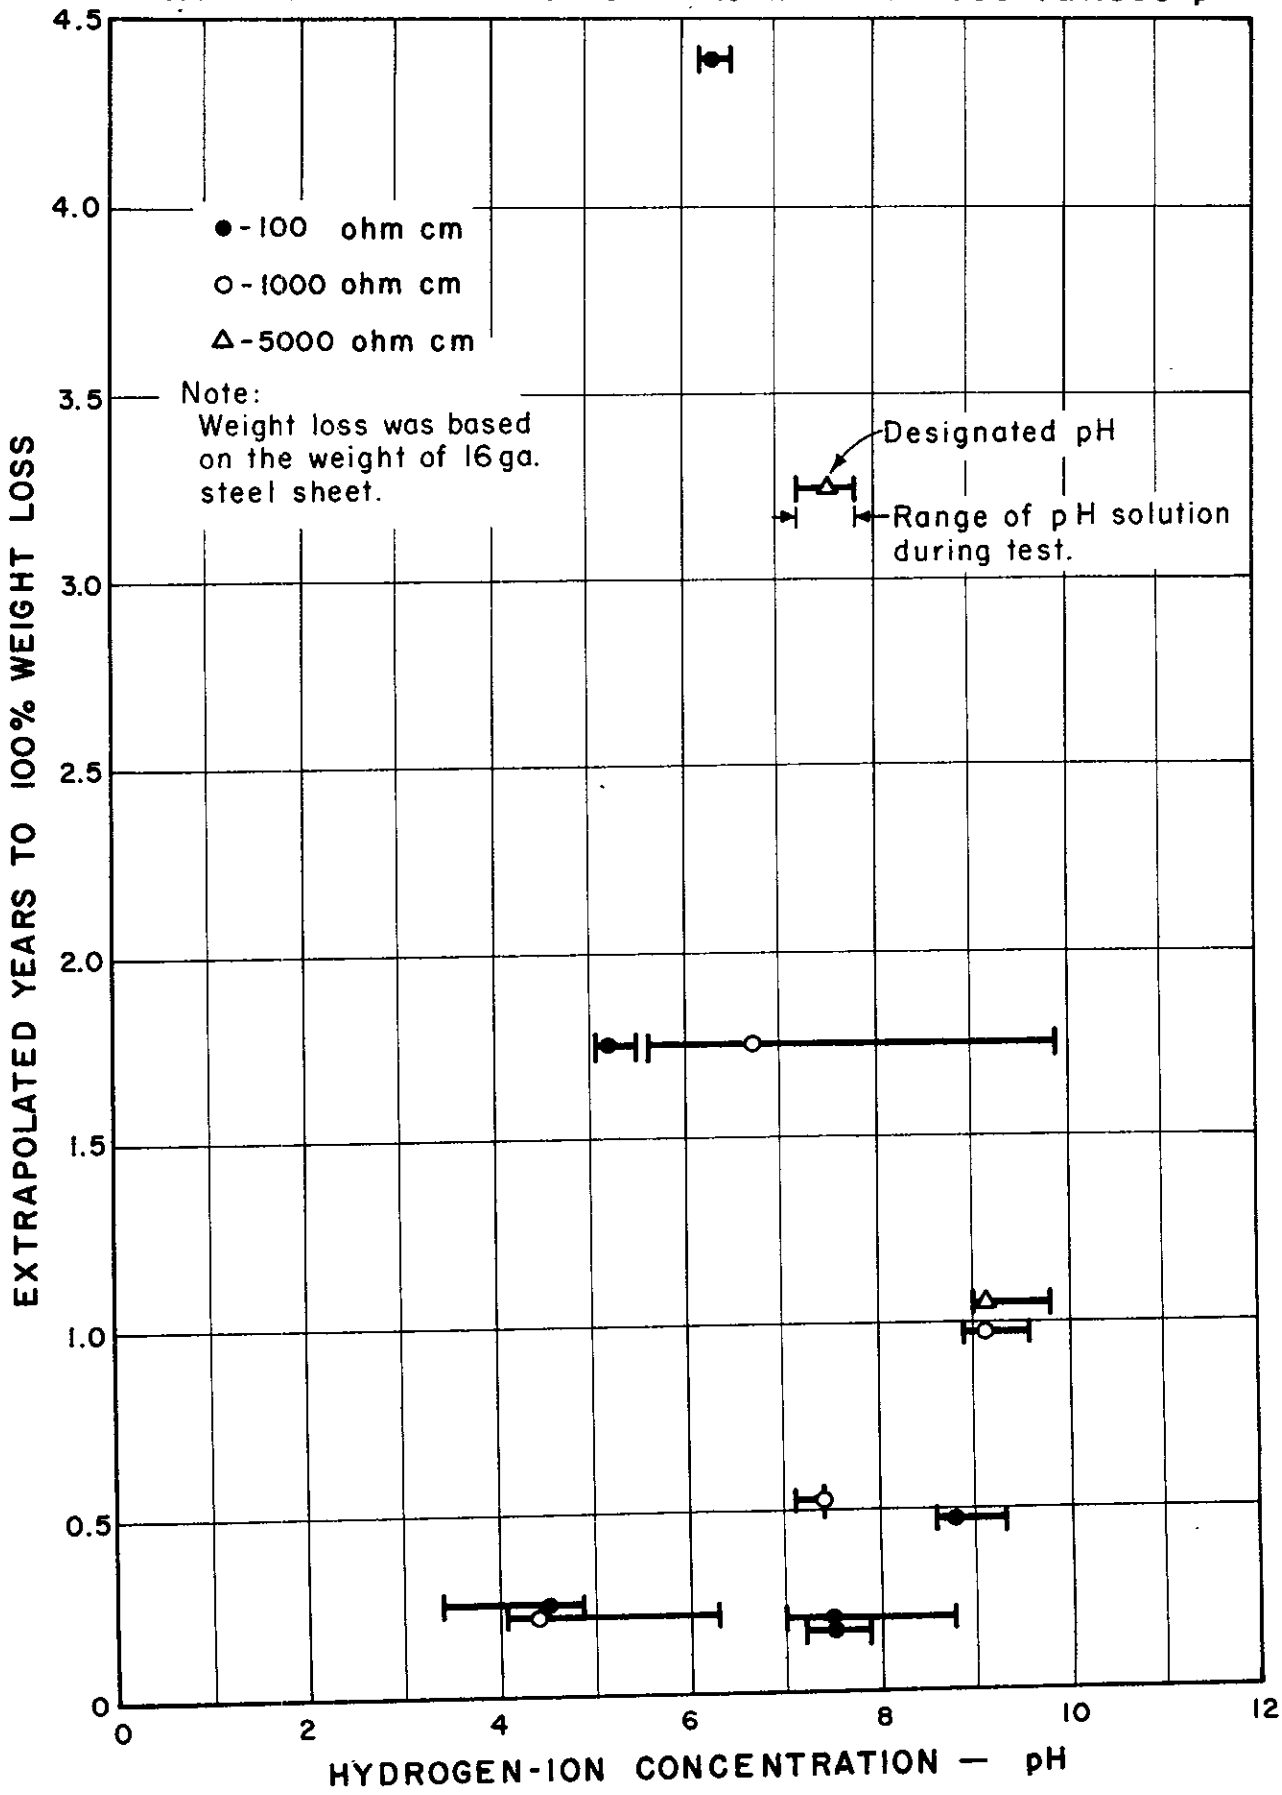
LABORATORY CORROSION-ABRASION TEST OF STEEL

Disregarding the resistivity of a solution, the data shown on Figure 25 indicate that steel could rapidly corrode in aerated solutions where the pH is less than approximately 5.0 and greater than 7.0. However, in the case of steel, it is misleading to infer that steel has its greatest corrosion resistance when it is subjected to an environment with a pH range between 5.0 and 7.0. Further analysis of these data show that for the steel test series, the pH of the solution is an important factor in the corrosion rate only when the pH is less than approximately 7.3. At pH values of less than approximately 7.3, the resistivity and the pH of the solution are the controlling factors. At greater pH values (7.3 or greater), the resistivity is the primary control of the relative corrosion rate of steel.

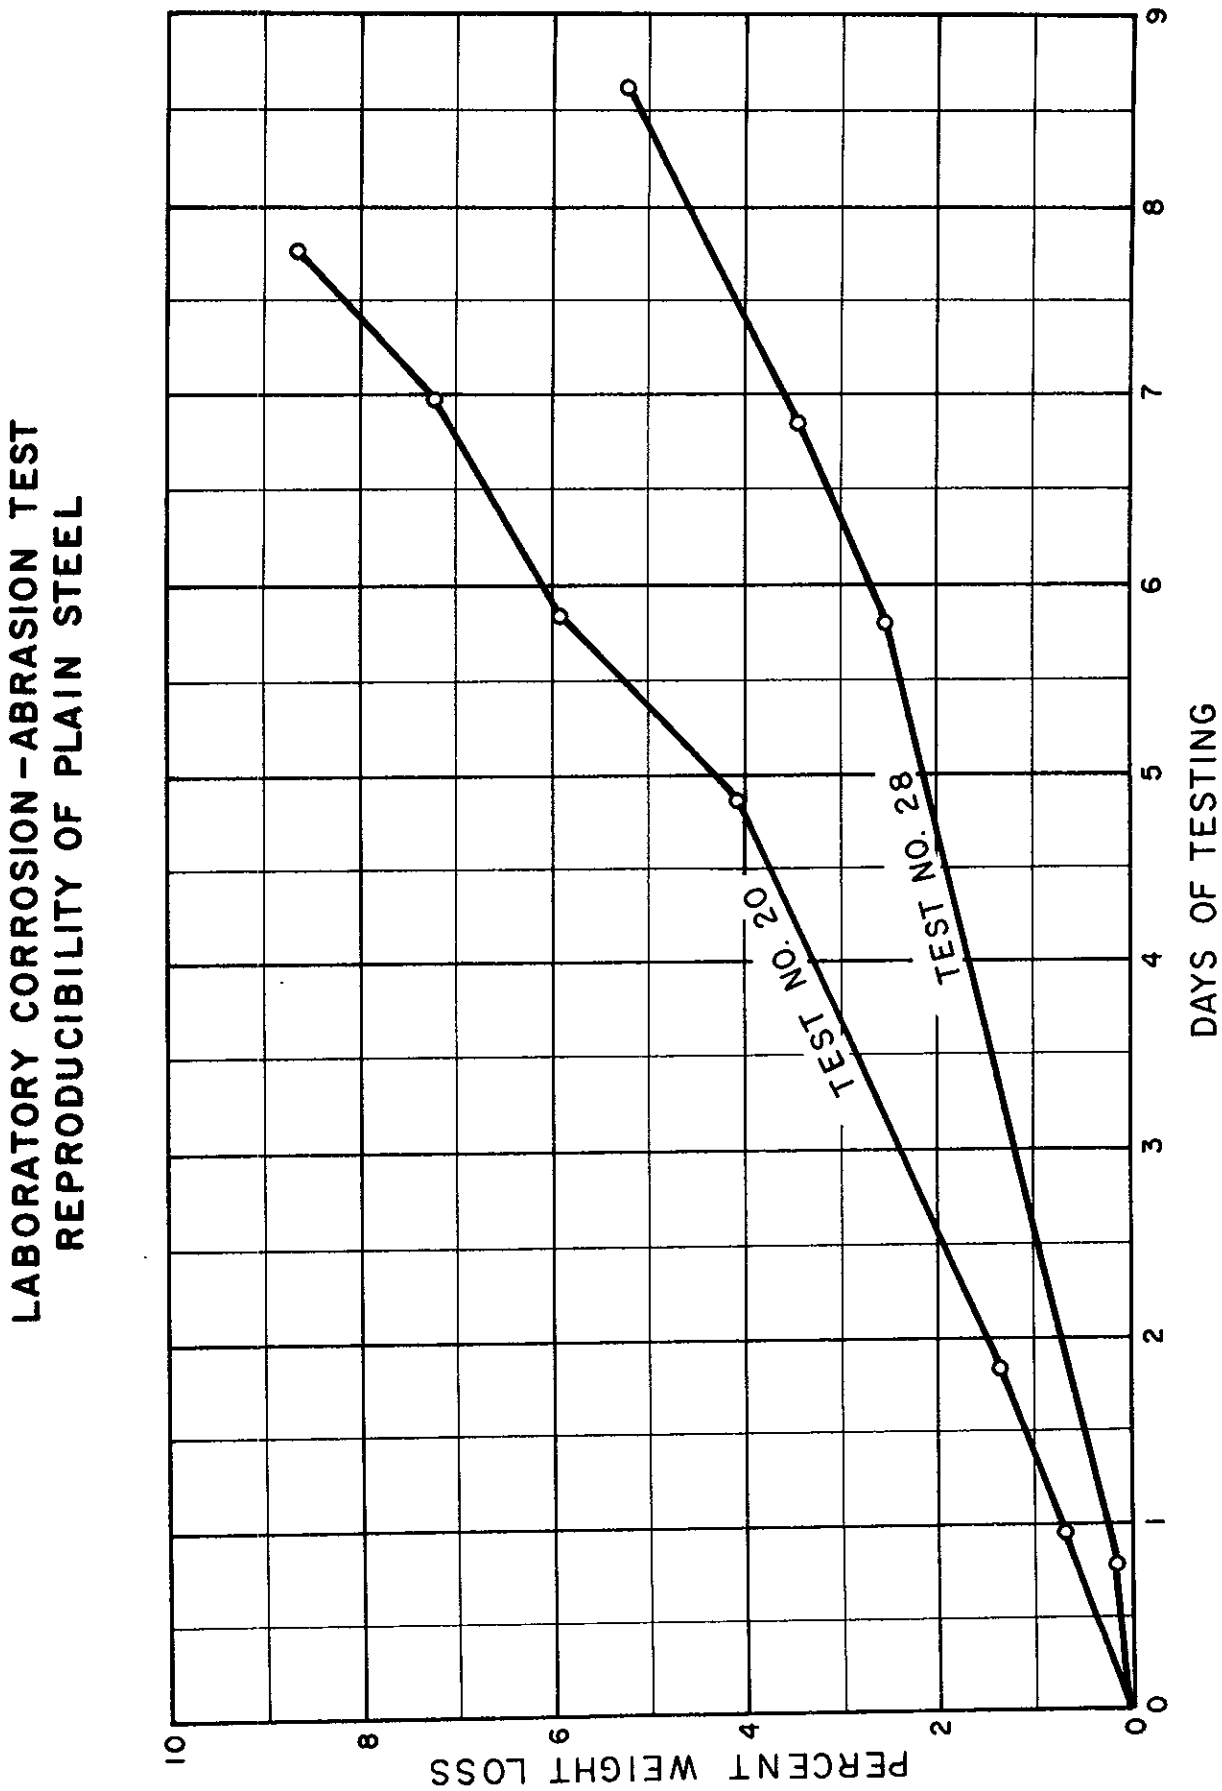
Figure 27

Figures 27 and 28 are shown to depict the accuracy in reproducing a single type of test. From the data shown on these two charts, it is obvious that the individual test results probably have a test accuracy of ± 20%.

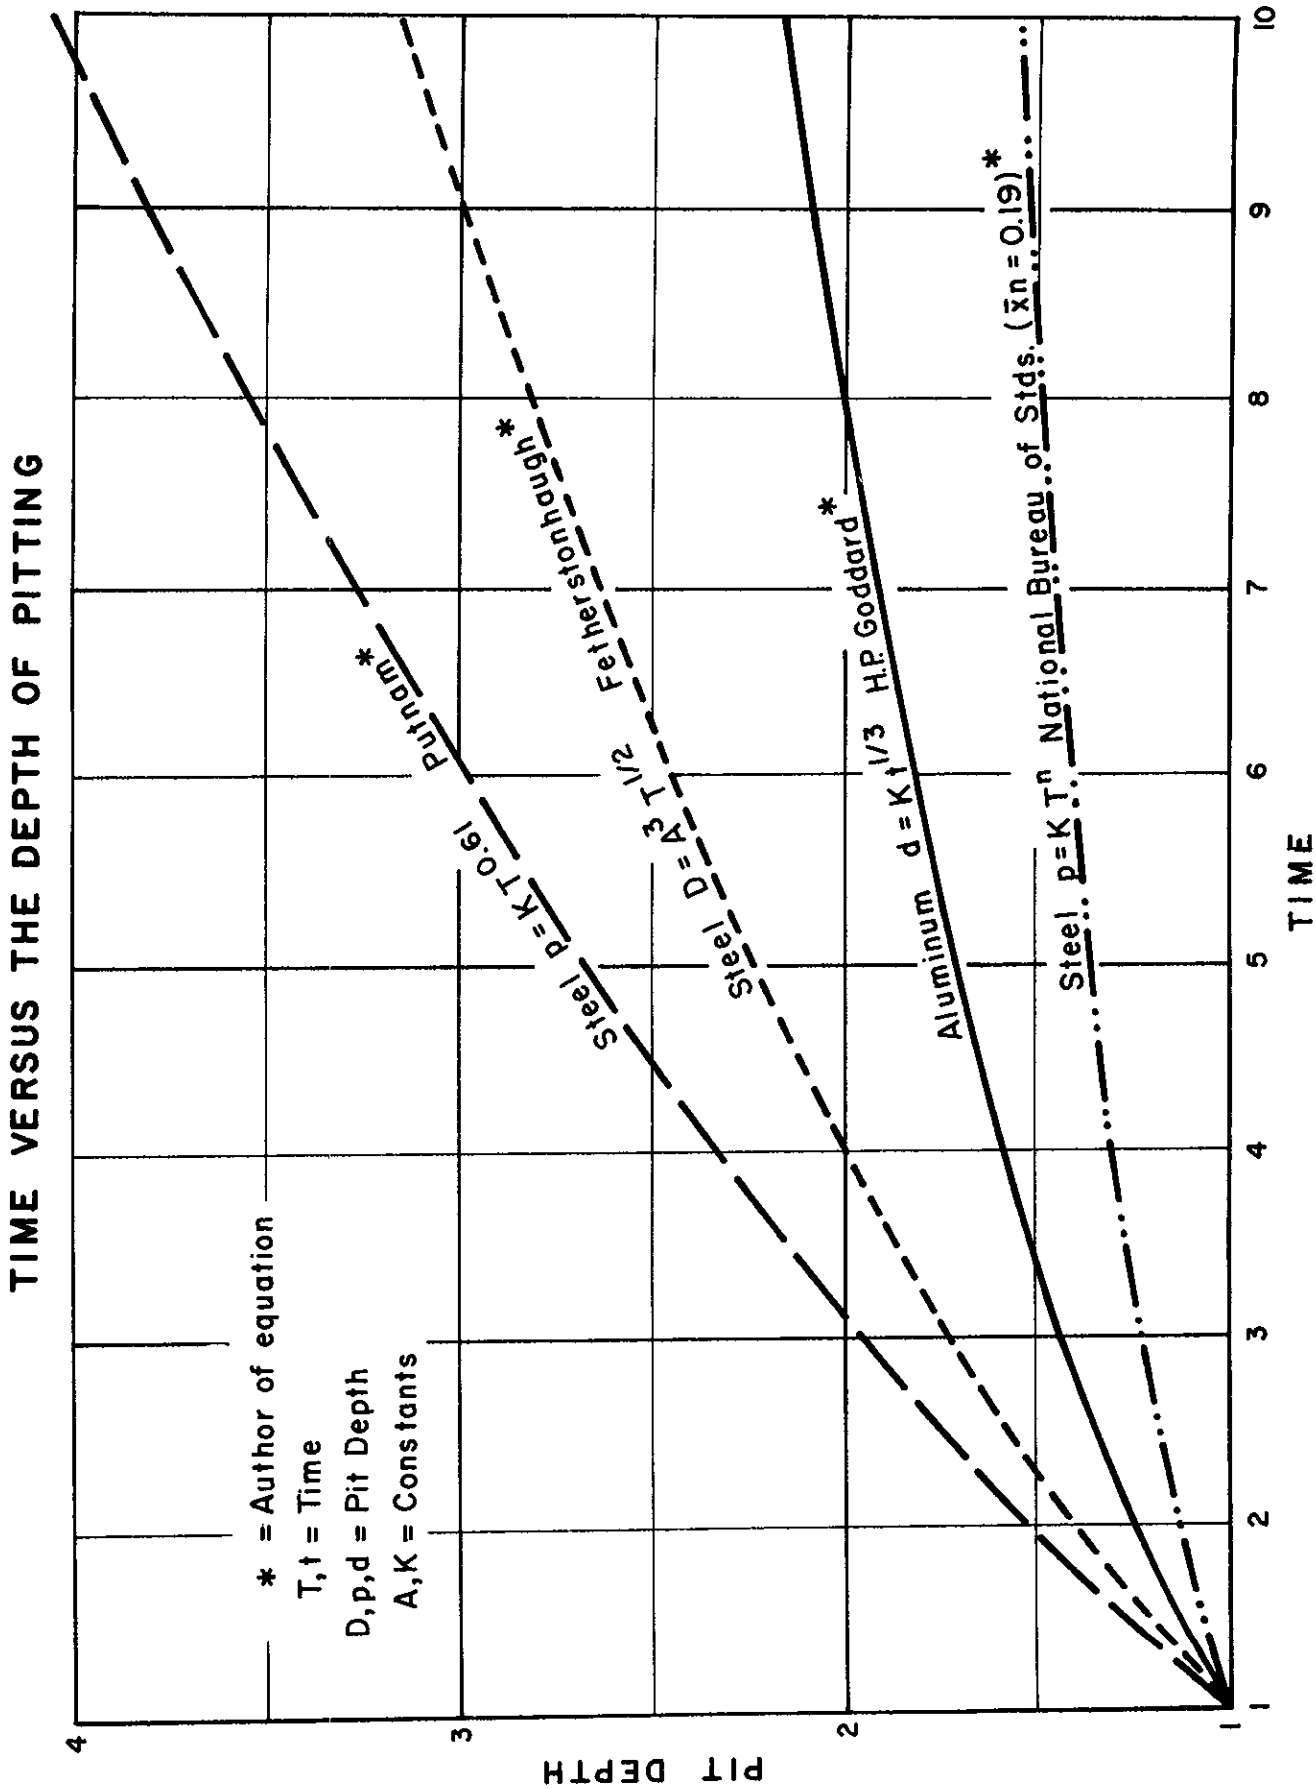
Emperical equations for projecting data developed by other investigators demonstrates the inconsistencies that are possible in predicting corrosion rates (see Figure 29). For this reason, all data obtained under this study were projected on a straight line basis. The purpose of this projection is to assist in the selection of culvert materials in accordance with California practice which only allows those materials that have an anticipated maintenance-free service life of 25 or 50 years, depending upon the highway design criteria. Straight line projections allow direct comparison of various materials. It is recognized that the final maintenance-free life may be less or greater than the straight line projection would indicate. For these reasons, the projections of short-time laboratory test results were only given qualitative consideration and were not used alone in making recommendations or in anticipating service life.

Since equations are available which include a factor describing the decrease in the corrosion rate with time, Figure 29 shows that there is a choice of three for steel[24,25,26] and one for aluminum[8].

Figure 29 should not be construed to indicate that the corrosion rate of one metal is clearly less than the other. This is because the required constant for each equation may be many-fold greater or less than the other. Therefore, when the constants are included in the equations, the result could be that one metal may perforate in a few days while the other metal may require years to perforate.

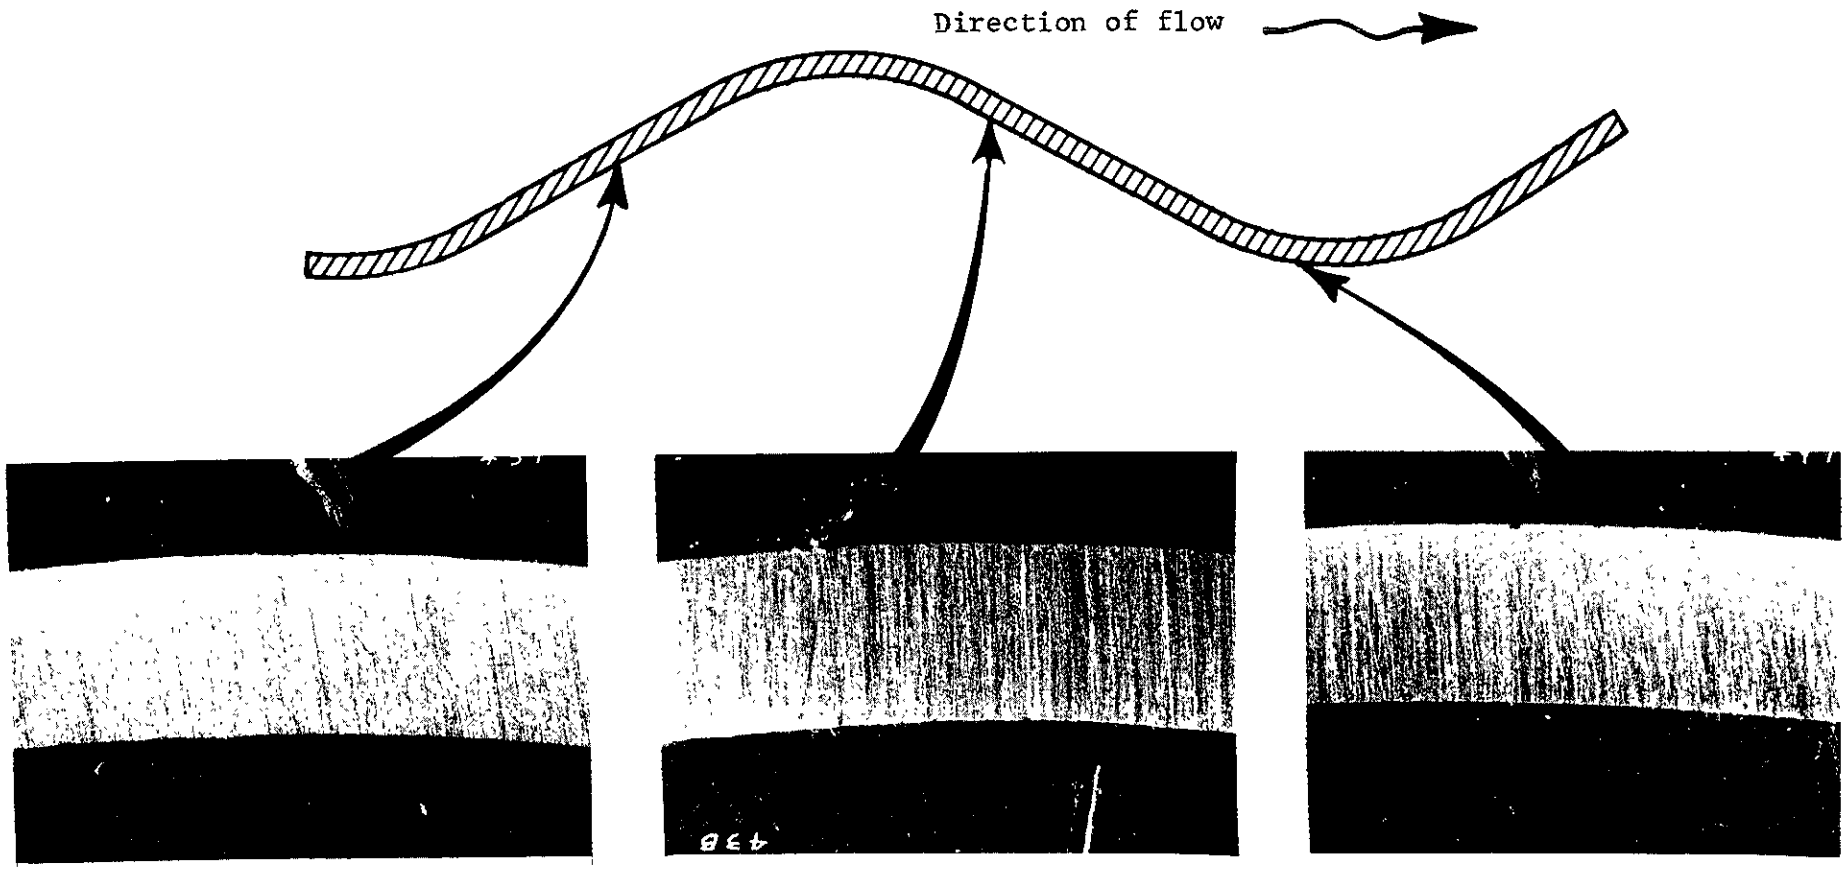
Laboratory Corrosion - Abrasion Test

Cross-sections of plain steel test sample after approximately 8 days of testing. Note the minor abrasion loss of metal as shown on the left photo, which was caused by Ottawa sand and a specimen velocity of approximately 5 fps. Note lack of corrosion in this test.
