A PRELIMINARY STUDY OF ALUMINUM AS A CULVERT MATERIAL

By
Eric F. Nordlin
Assistant Materials and Research Engineer,
Structures

and
R.F. Stratfull
Corrosion Engineer

Presented at the 44th Annual Meeting
of the Highway Research Board

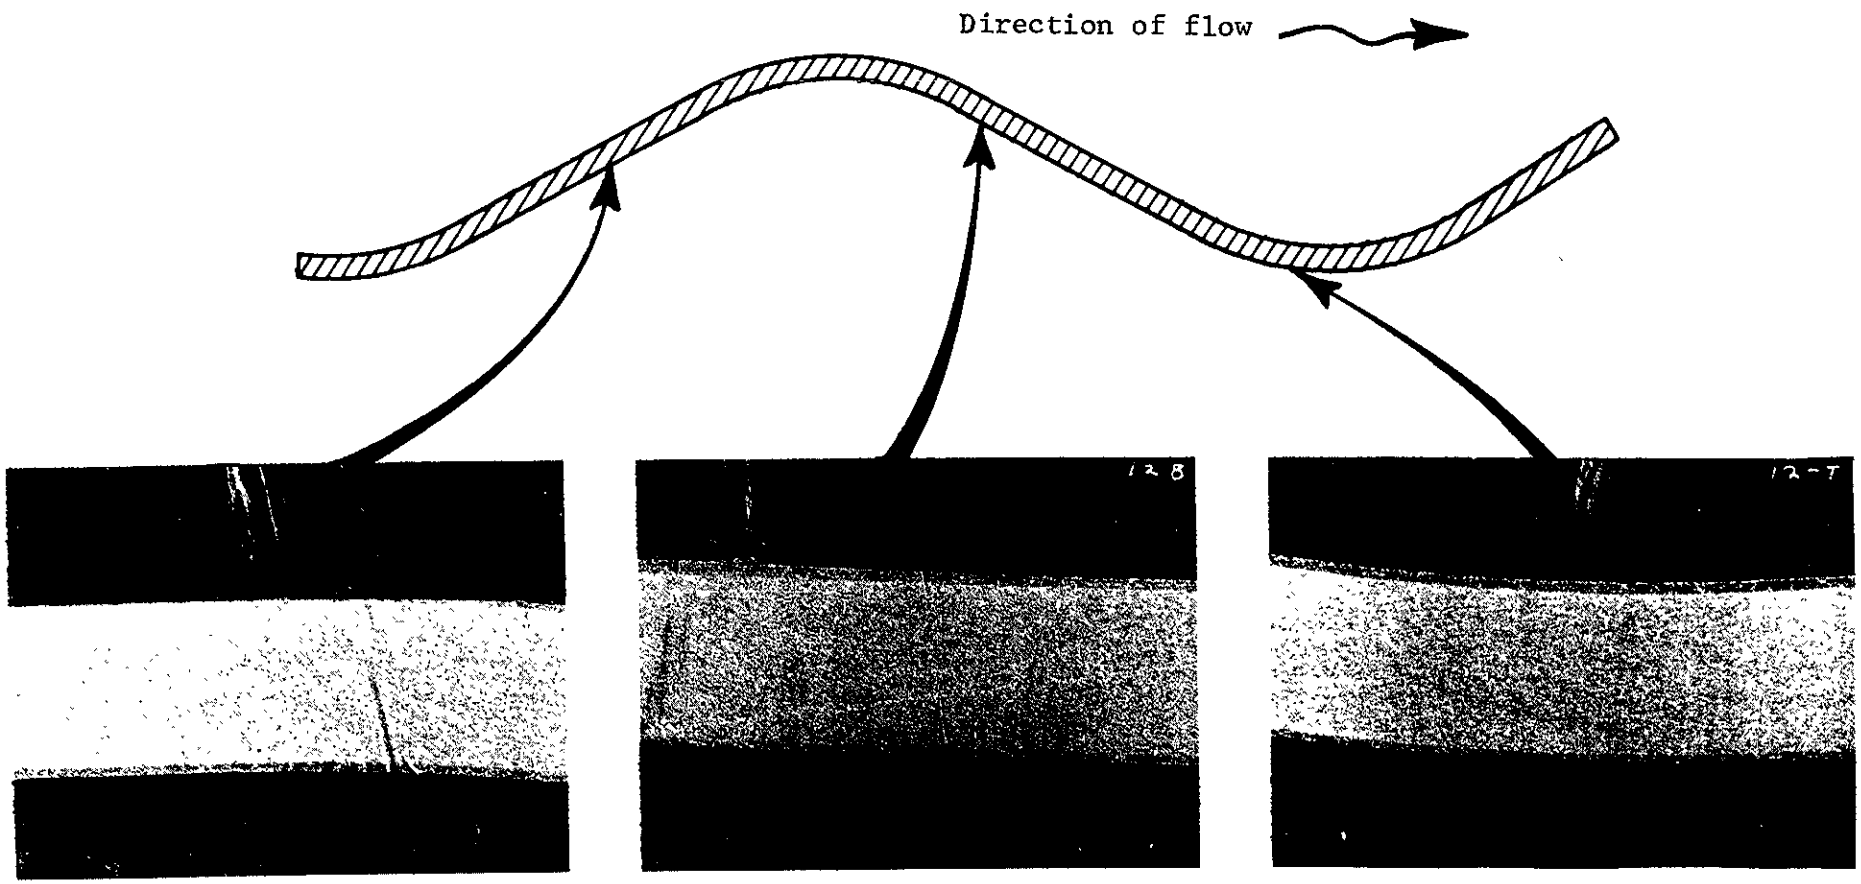
Laboratory Corrosion - Abrasion Test

The test results of this investigation indicate that aluminum is sensitive to abrasion. In fact, the corrosion-inhibiting cladding on the aluminum specimens was penetrated in all of the laboratory corrosion-abrasion tests as would hav been the case with zinc coatings on steel. The specimens in this test had a velocity of 5 fps, and the abrading material was Ottawa sand. The field data agree with the laboratory tests that aluminum is not as abrasion resistant as a steel culvert. Therefore, at this time, it appears necessary to restrict aluminum from indiscriminate use in streams of high flow velocities containing an abrasive bed load.

Cross-sections of aluminum test sample after approximately 8 days of testing. Note the typical loss of cladding as shown on the left photo which was caused by Ottawa sand and a specimen velocity of approximately 5 fps. Note lack of corrosion in this test.

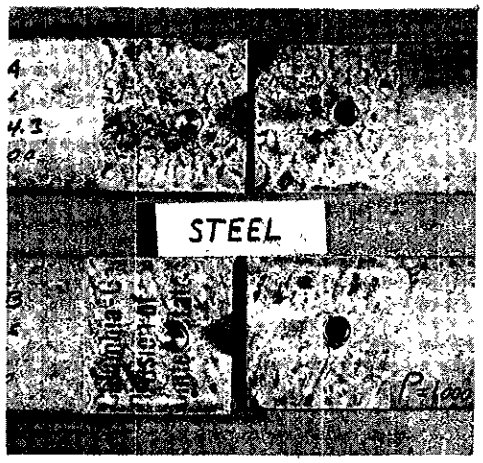
pH 4.3
Resistivity = 1000 ohm cm.
Galvanizing intact; no
corrosion of steel.

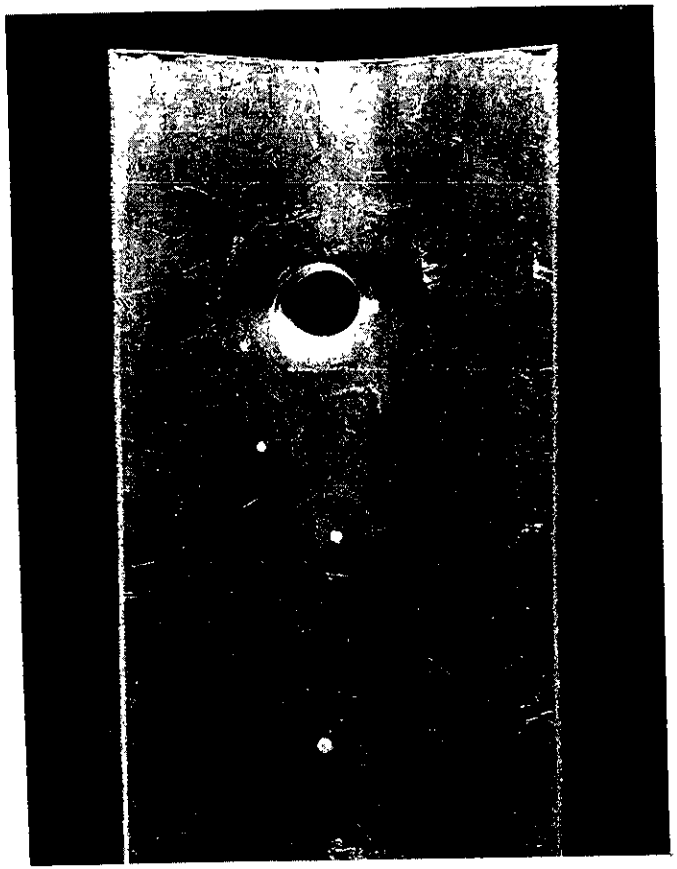
70-day Laboratory Test of Continuous Submersion of Aluminum

Solution pH 7.5, resistivity = 1000 ohm cm.

Note corrosion at edges near rivet hole and where the two pieces of aluminum overlapped (right photo).

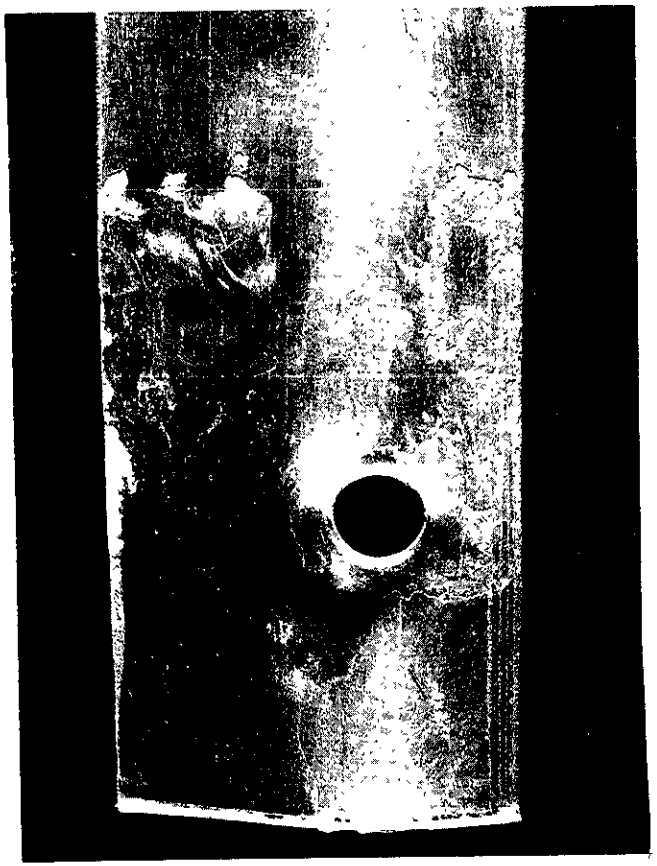
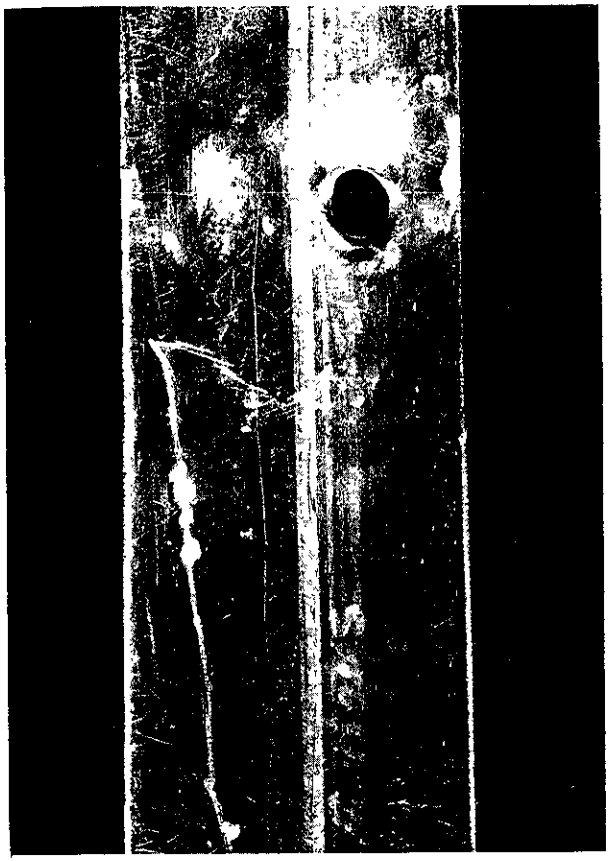
70-day Laboratory Test of Continuous Submersion of Aluminum

Solution pH 9.0, resistivity = 1000 ohm cm.

Note corrosion at edges near rivet holes where the two pieces of aluminum overlapped (left photo), and corrosion in the long scratch (right photo).
