August 1967
Interim Report
M&R No. 636392

DYNAMIC TESTS OF

CONCRETE MEDIAN BARRIER

SERIES XVI

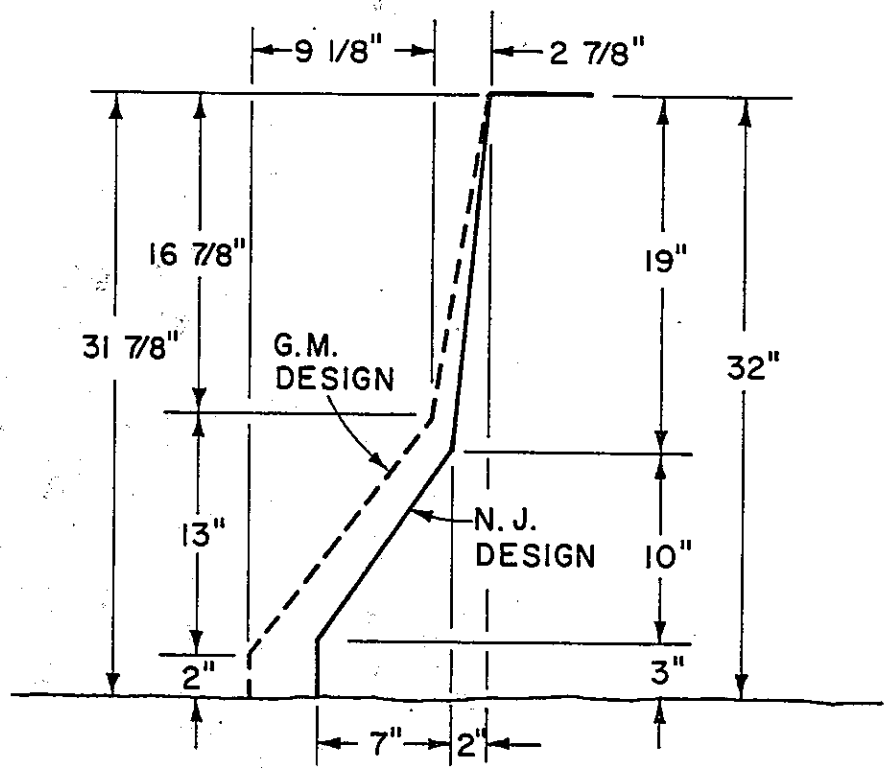
FIGURE 1

In 1963 the General Motors Proving Grounds conducted a series of 21 full scale tests on a concrete bridge parapet design[3] adapted from the New Jersey median barrier design as shown in Figure 1.

This General Motors sloped front design proved to be entirely adequate in redirecting an impacting vehicle with no barrier damage and minimal vehicle damage. However, it should be noted that the tests were all conducted at speeds less than 50 mph and at impact angles of 12° and less. This test criteria did not impose as severe a test loading as would the California standards of 65 mph at 25° for dynamic impact proof testing of barriers. The General Motors design included a metal railing mounted on top of the concrete wall to insure containment of high-speed wide-angle impacts.

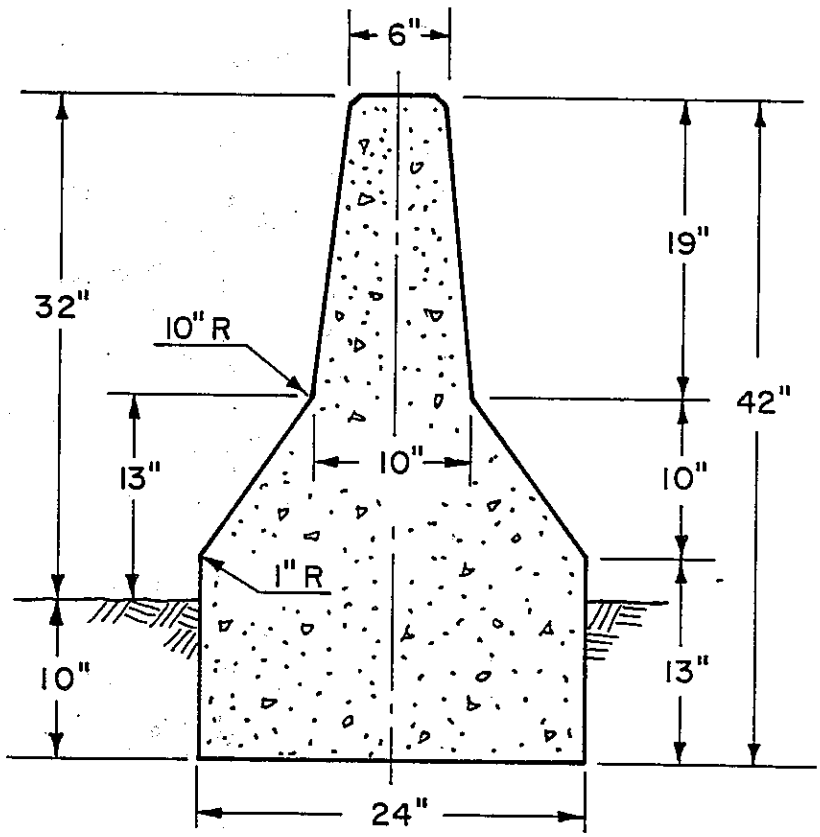
FIGURE 2

The median barrier tested was a contoured, solid concrete wall design as shown below in Figure 2, which was developed by the State of New Jersey Highway Department.

The installation consisted of eight 32 inch high, 20 ft. long, nonreinforced, cast-in-place concrete wall sections. Each individual section consisting of a footing and parapet was a single monolithic pour of approximately 3 cubic yards weighing 6 tons. Adjacent sections were not doweled or connected at the expansion joints (Exhibit 1). The strength of the Class A concrete, specified at 3000 psi minimum at 28 days, was in excess of 6200 psi at the time of the impact test.

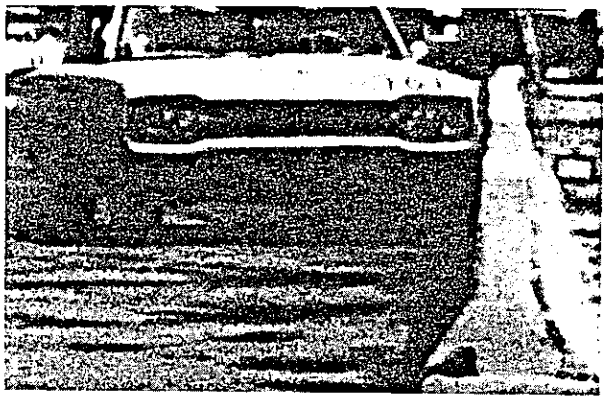
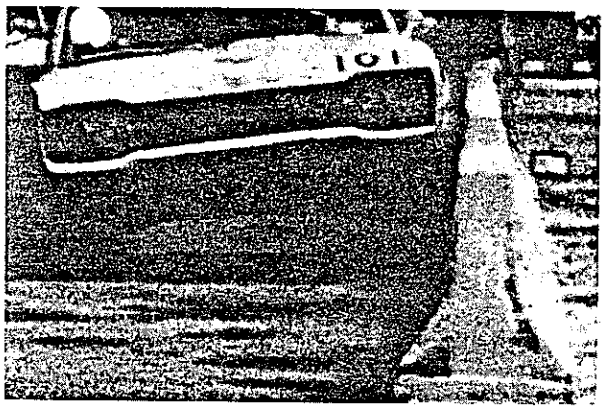
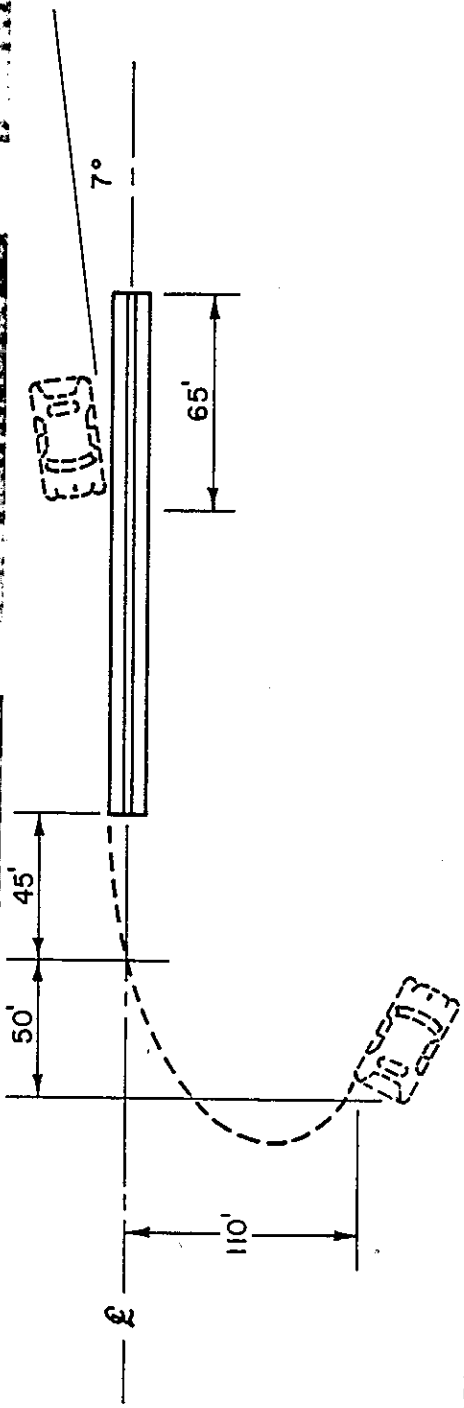
TEST 161-A PLATE A

TEST NO.	161-A
DATE	5-4-67
VEHICLE	1965 Dodge sedan
VEHICLE WEIGHT (W/DUMMY AND INSTRUMENTATION)	4540 #
IMPACT SPEED	38 mph
IMPACT ANGLE	7°
EXIT ANGLE	0°

BARRIER	Unreinforced Concrete
LENGTH OF INSTALLATION	160 ft.
UNIT LENGTH	20 ft.
UNIT WEIGHT	13,200 #
GROUND CONDITION	Dry
CONTACT W/BARRIER	95'
MAX. VEHICLE CLIMB	8"
MAX. VEHICLE REBOUND	0

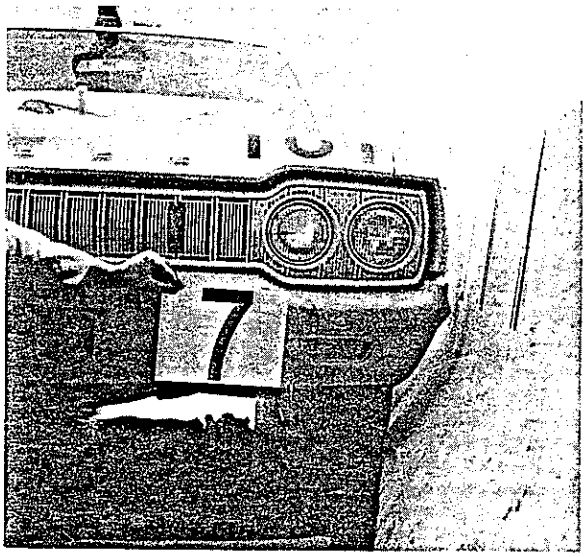
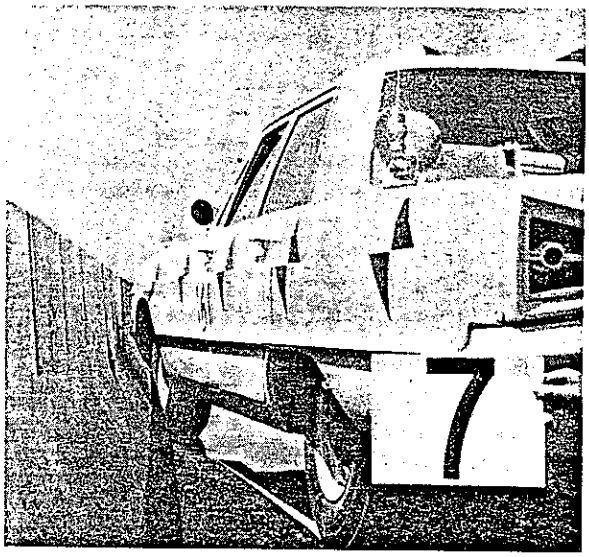
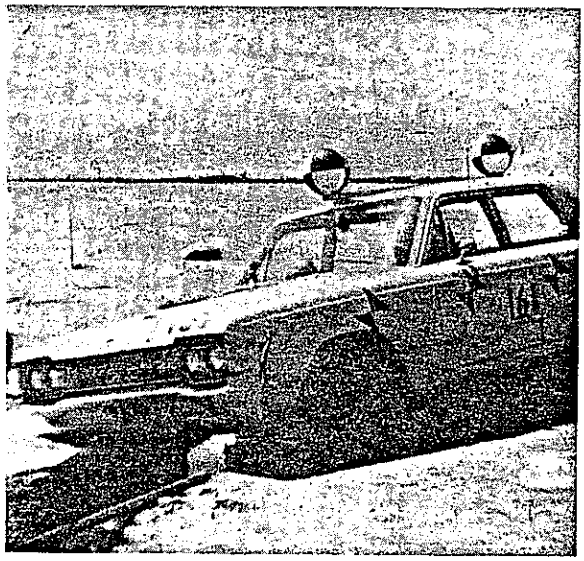
TEST 161-A PLATE C

The vehicle body contacted the upper barrier parapet 3 feet beyond initial impact and for a distance of 6.5 feet. The only damage sustained by the vehicle was slight sheet metal damage and paint scratches in the left front fender area. A close inspection of the steering mechanism and running gear revealed no damage or misalignment that would alter the vehicle's steering characteristics. This vehicle was used without repairs for the succeeding test.

The barrier sustained no damage.

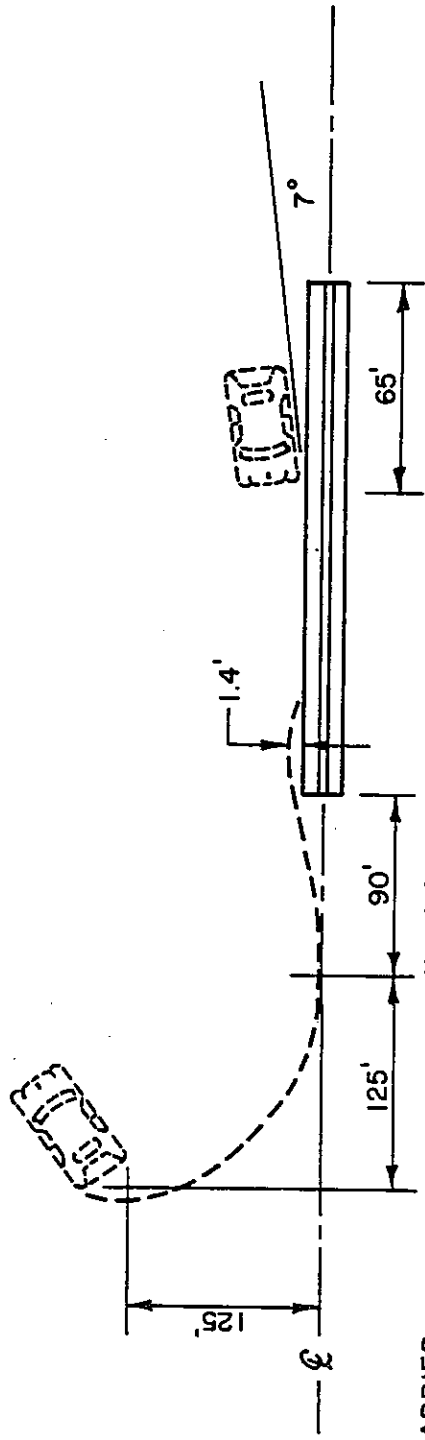
TEST 161-B PLATE A

TEST NO.	161-B
DATE	5-4-67
VEHICLE	1965 Dodge sedan
VEHICLE WEIGHT (W/DUMMY AND INSTRUMENTATION)	4540 #
IMPACT SPEED	65 mph
IMPACT ANGLE	7°
EXIT ANGLE	°

BARRIER	Unreinforced Concrete
LENGTH OF INSTALLATION	160 ft.
UNIT LENGTH	20 ft.
UNIT WEIGHT	13,200 #
GROUND CONDITION	Dry
CONTACT W/BARRIER	35'
MAX. VEHICLE CLIMB	14"
MAX. VEHICLE REBOUND	1.4'

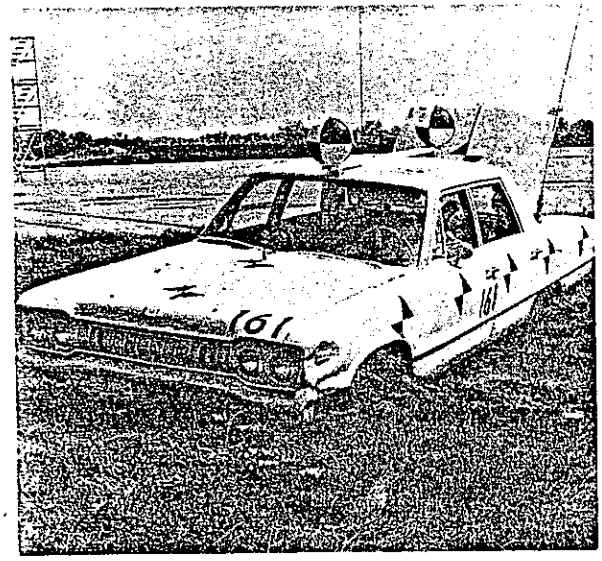
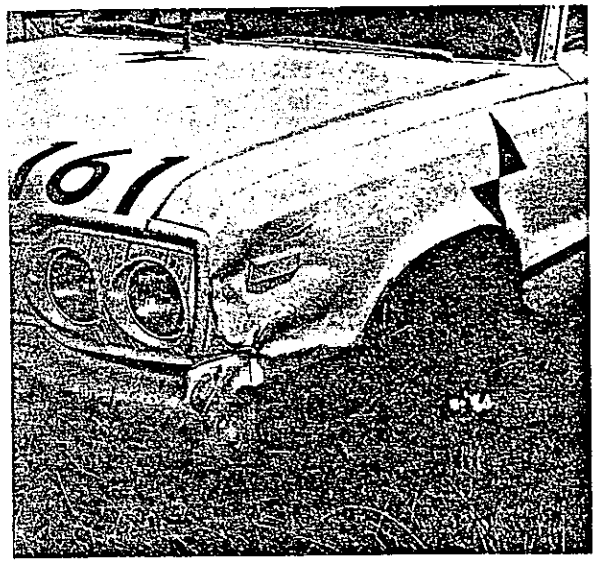
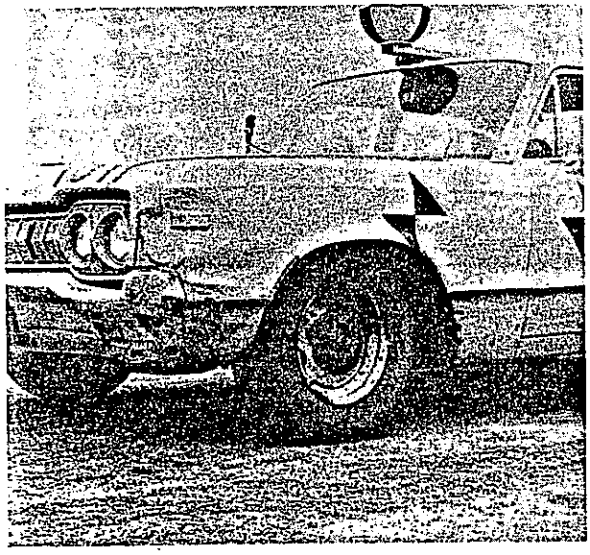
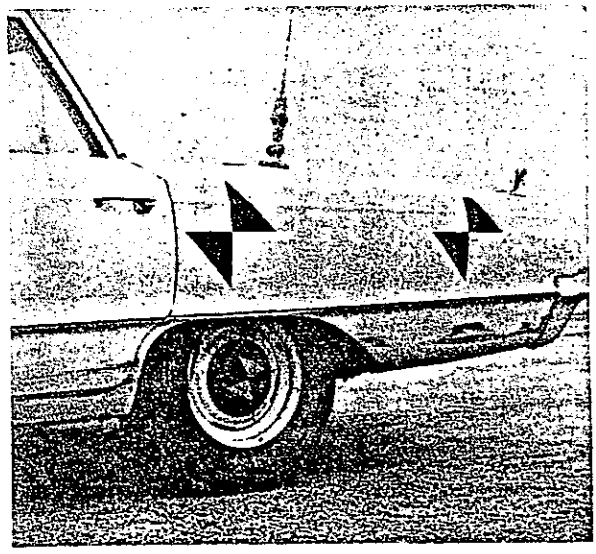
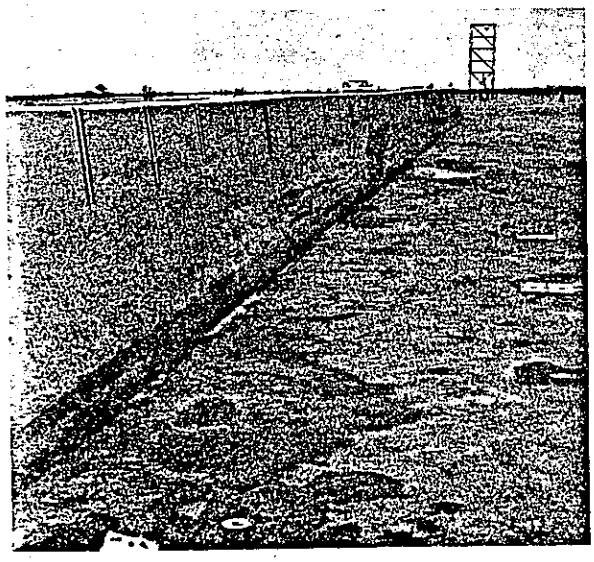
TEST 161-B PLATE C

The vehicle body contacted the upper portion of the parapet at initial impact and for a distance of 12.5 feet. Vehicle damage consisted of minor sheet metal damage to the front fender, a dented bumper, and paint scratches at the left rear door and quarter panel. The left front wheel was bent and required replacement. No damage to the steering mechanism or running gear was found, and this vehicle was used with no further repairs for the succeeding test.

Data film and impactograph recordings of the dummy driver indicate that a live driver would have sustained nothing more severe than bruises. The barrier sustained no damage.

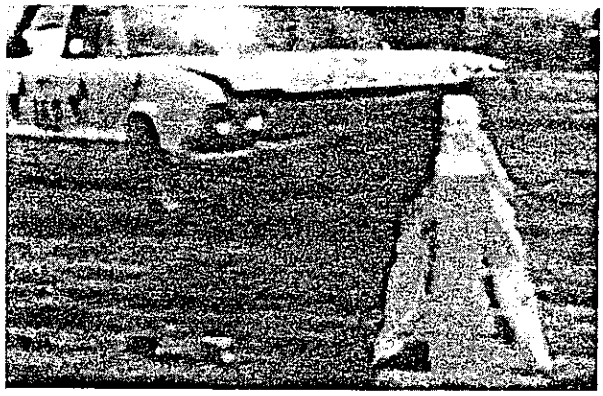
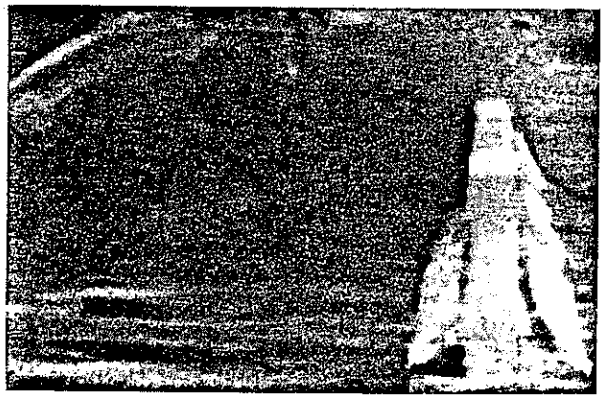
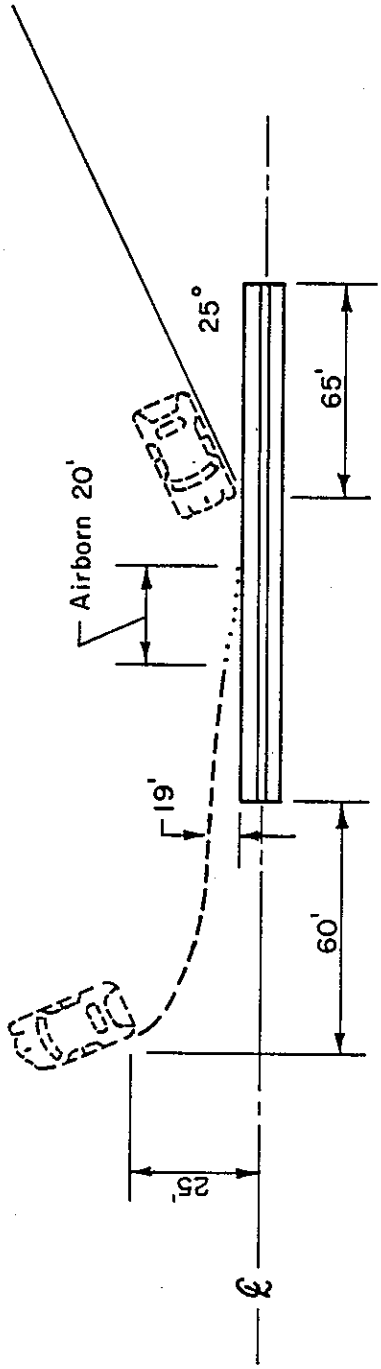
TEST 162 PLATE A

The vehicle body contacted the barrier immediately at initial impact and for a distance of 12 feet. As the vehicle was redirected parallel to and away from the barrier, moderate damage was sustained by the left front quarter panel and rear bumper with minor paint scratches along the left side. The left front end sustained severe sheet metal and undercarriage damage.

The barrier sustained no damage other than very slight spalling of concrete at the expansion joint immediately adjacent to the point of impact.

BARRIER	Unreinforced Concrete
LENGTH OF INSTALLATION	160 ft.
UNIT LENGTH	20 ft.
UNIT WEIGHT	13,200#
GROUND CONDITION	Dry
CONTACT W/BARRIER	12.5'
MAX. VEHICLE CLIMB	21"
MAX. VEHICLE REBOUND	19.0'

TEST NO.	162
DATE	5-9-67
VEHICLE	1965 Dodge sedan
VEHICLE WEIGHT (W/DUMMY AND INSTRUMENTATION)	4540#
IMPACT SPEED	63 mph
IMPACT ANGLE	25°
EXIT ANGLE	16°

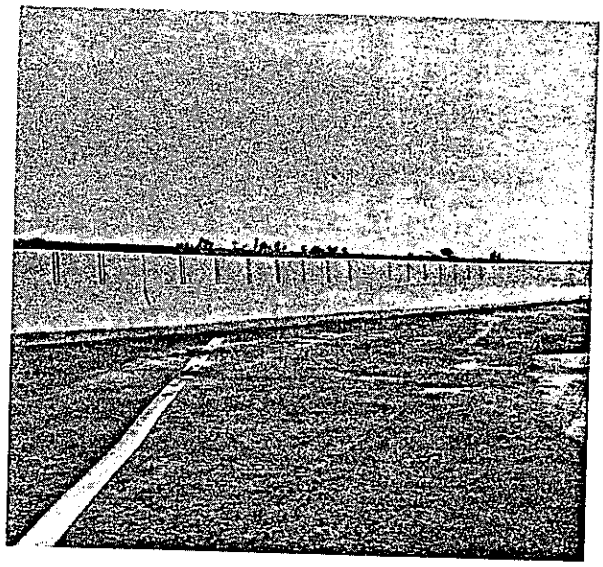
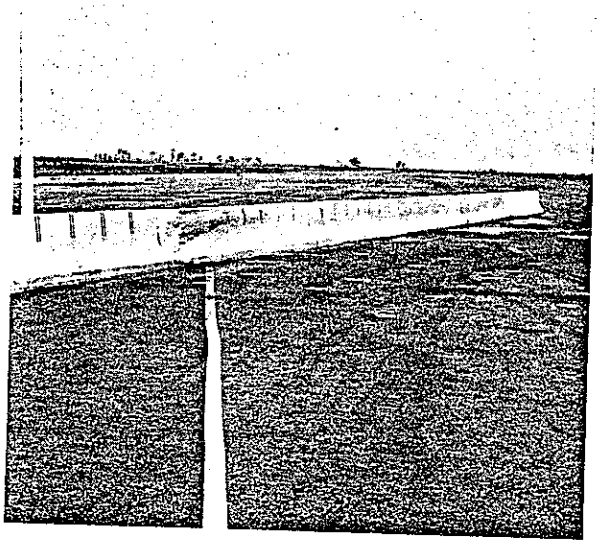
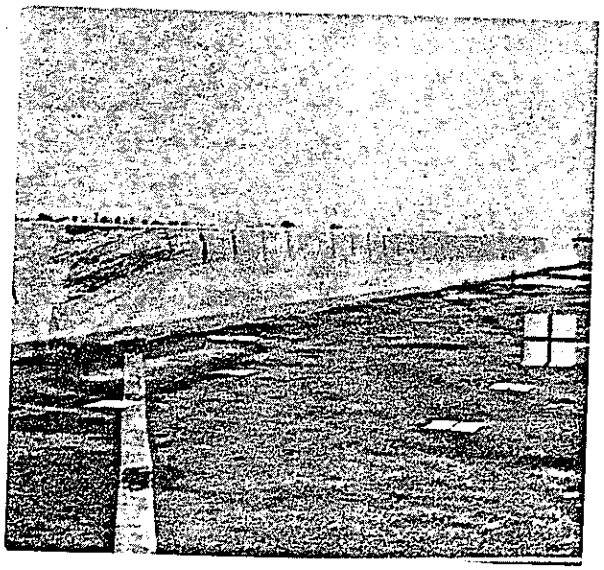
TEST 162 PLATE C

Restrained by a conventional lap belt, the dummy driver was propelled by the relatively severe lateral deceleration forces into the left front door and door frame with sufficient force to "spring" the door open and tear the door post from the roof.

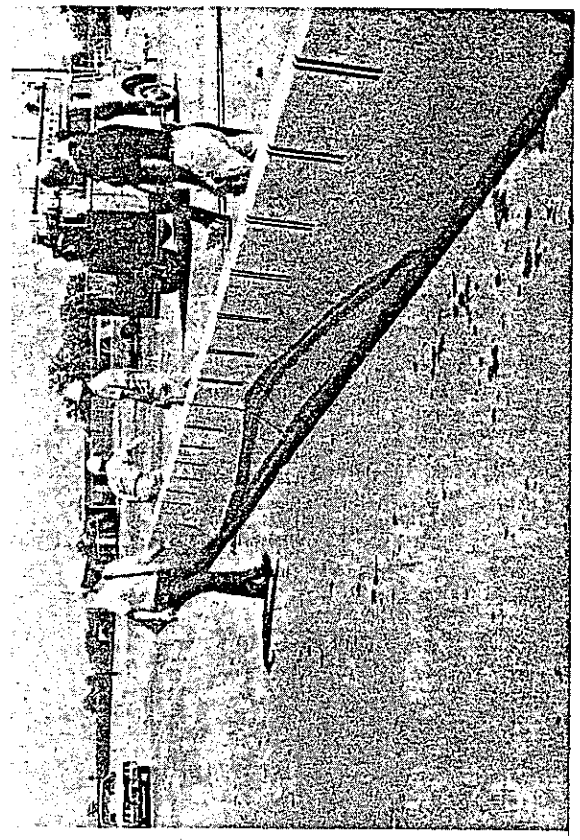
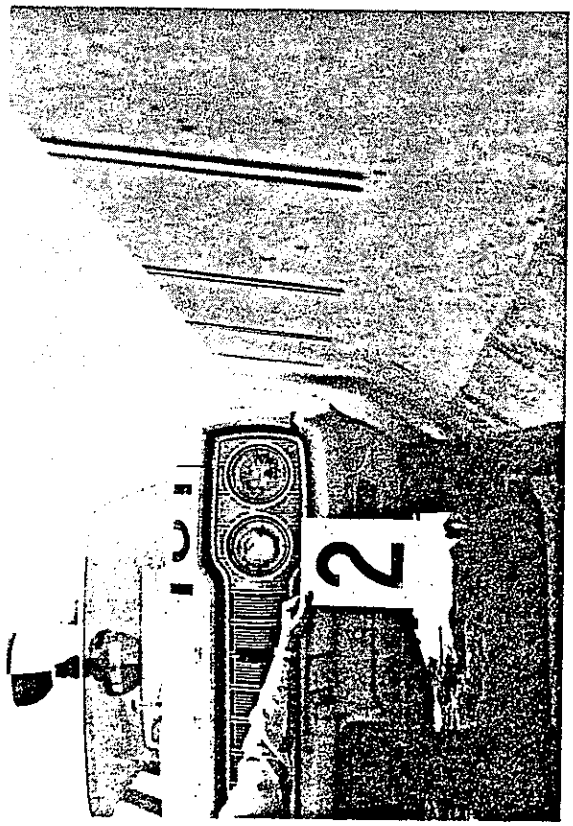
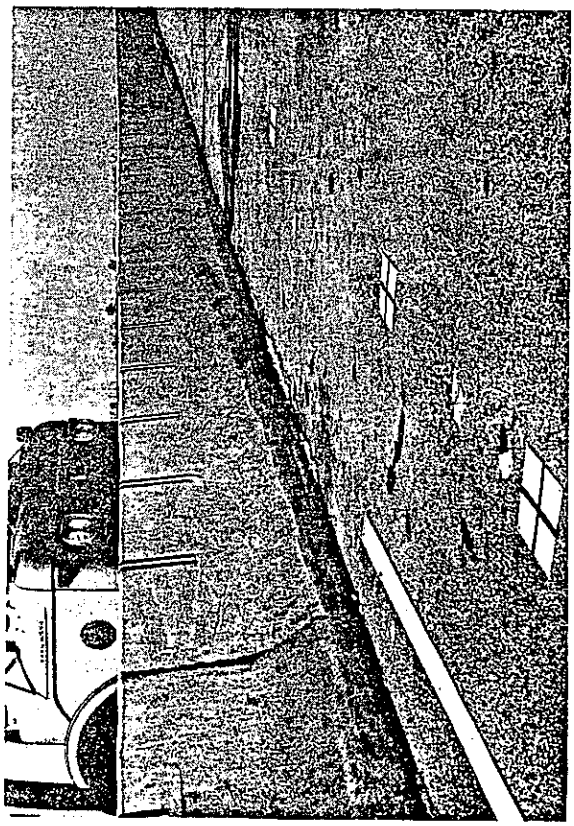
EXHIBIT 3

No damage was sustained by either the vehicle or the barrier (Exhibit 3).

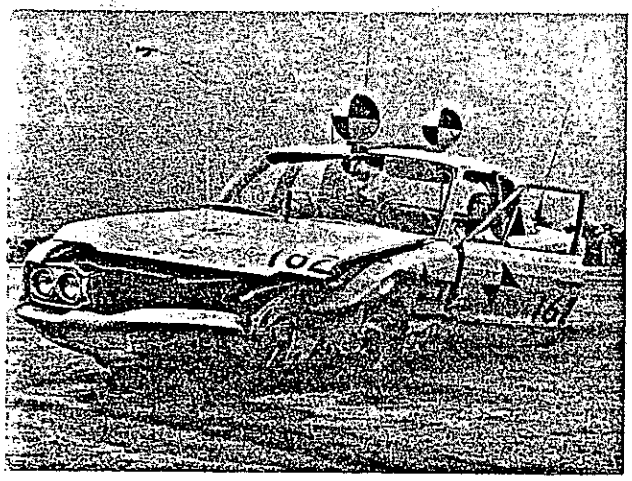
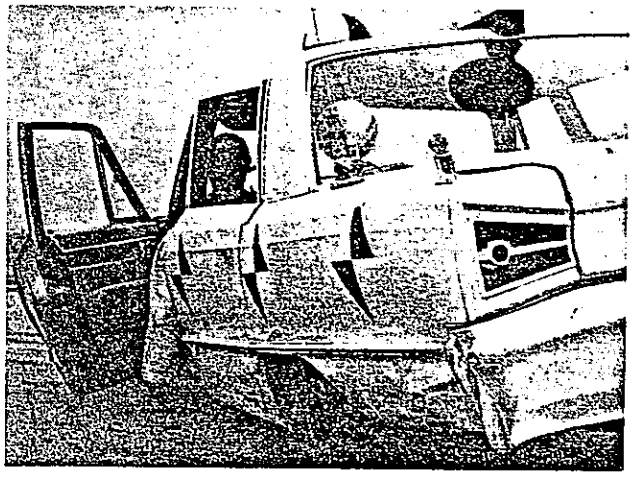
TEST 162 - NEW JERSEY CONCRETE MEDIAN BARRIER

Although the damage to the vehicle was considered severe, it was comparable to that sustained in similar high-speed, wide-angle tests on the standard blocked-out beam type barrier and a test on a concrete parapet bridge rail (Exhibit 4).
